Appendix E

Cultural Resources Phase I Assessment

Subj: Cultural Resources Phase I Assessment for Ladyface Vista Office Project
(Envicom Project # 2021-038-01)

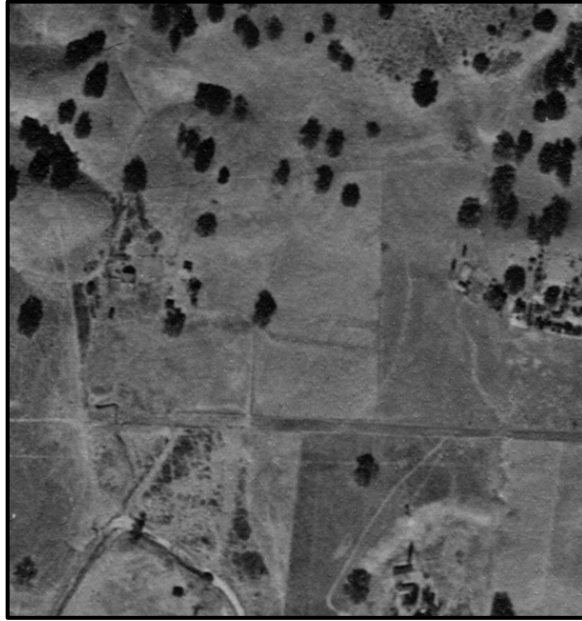
Figure 5: The Project area in 1945 image, showing the Project property (center) (UCSB Historic Aerial Image Database).

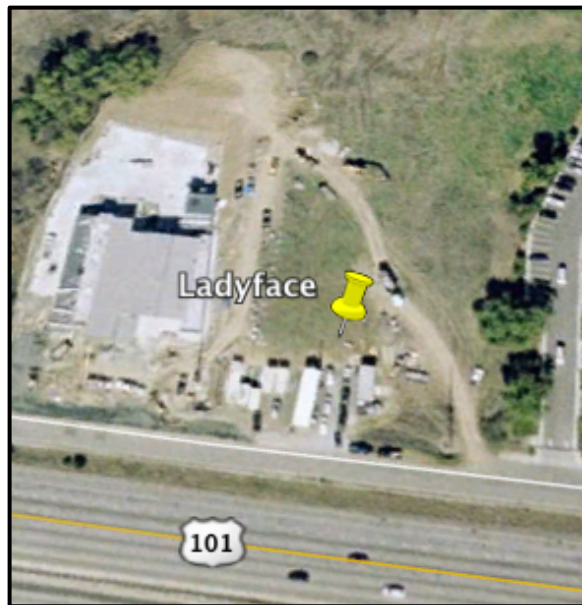
Figure 6: Google Earth Image of the Project property in 2006, showing impacts from the construction of the fire station to the west.

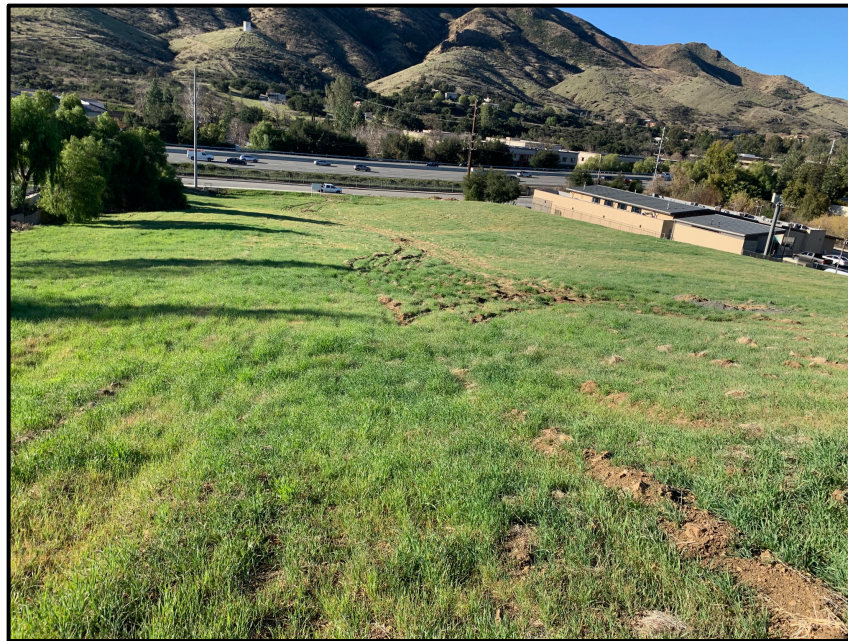
Figure 8: Overview of the Project property, facing south, showing vehicular impacts in the center of the property.

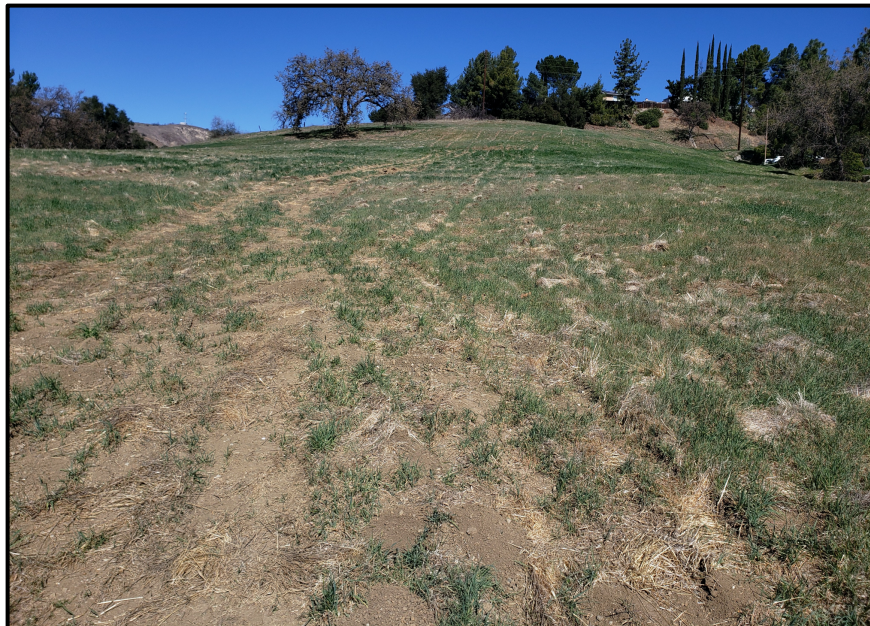
Figure 10: Close-up of the northern half of the property, showing ground visibility, facing north.
