JURISDICTIONAL DELINEATION
MOORPARK 67 / NORTH RANCH RESIDENTIAL
DEVELOPMENT PROJECT
City of Moorpark

APNs 5110-190-285 & -305

August 2021

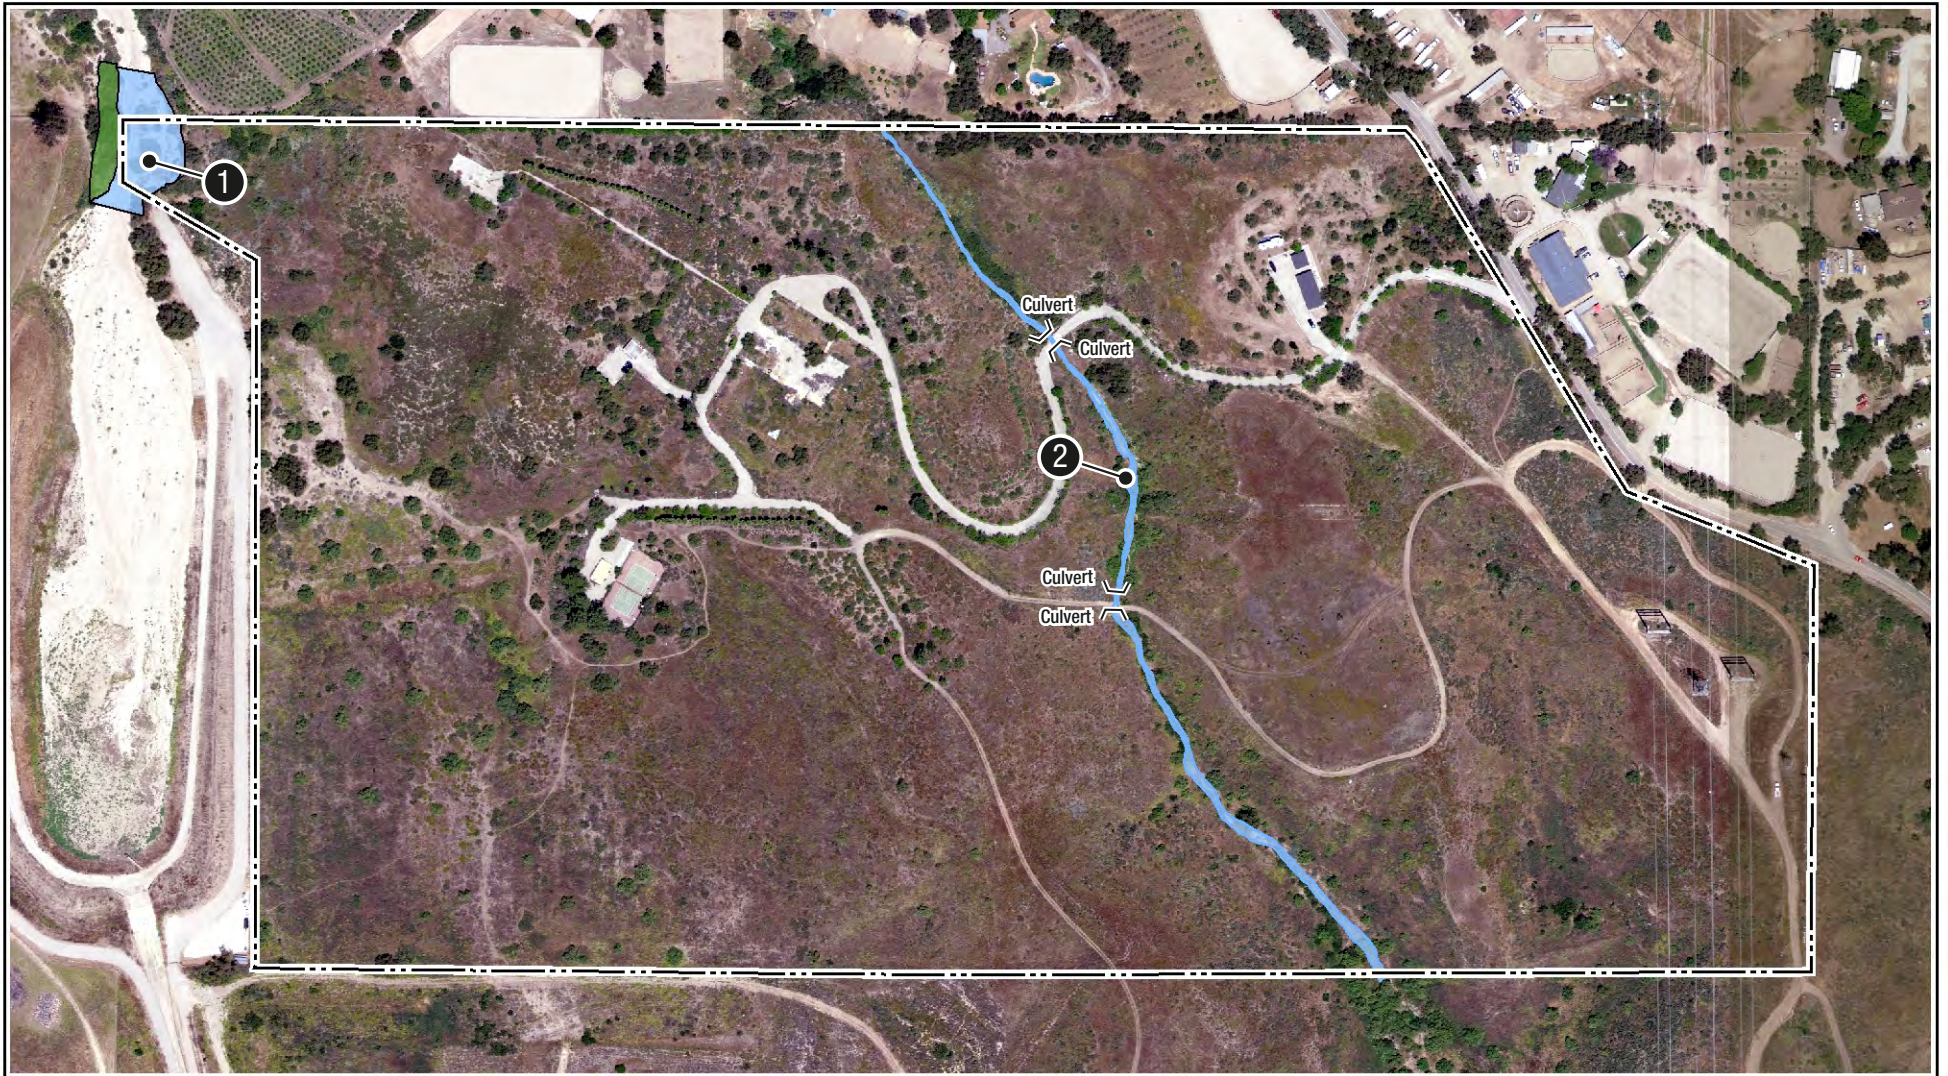
Jurisdictional Delineation Map

The jurisdictional features within the delineation project site include an unnamed blueline stream and a smaller ephemeral drainage. The jurisdictional features within the project site are shown on **Figure 3, Jurisdictional Delineation Map**.

The unnamed stream in the northwest corner is the largest feature at the site, and it is reported to be intermittent. It has a distinct bed, bank, and channel with riparian vegetation. The stream flows into a retention basin that is just west of the project site and then is directed into a concrete flood control channel. The channel continues for approximately 1.5 miles to the southeast until it connects with the Arroyo Simi/Arroyo Las Posas system. These systems then connect with Calleguas Creek, which flows into the Pacific Ocean (a navigable water of the United States) at Mugu Lagoon. The vegetation includes a mix of wetland and upland indicators including native and non-native species such as mulefat (*Baccharis salicifolia*), cockbur (*Xanthium strumarium*), scalebroom (*Lepidospartum squamatum*), prickly pear cactus (*Opuntia littoralis*), and giant reed (*Arundo donax*). Otherwise, the middle portion of the stream is a sandy bottom that is generally barren and sparsely vegetated. While there was observed vegetation drift deposits, sandy soils examined at the test pit did not exhibit hydric indicators or indicators of anaerobic conditions. This stream section in the project site is classified as Riverine, Intermittent Non-Wetland Waters. Representative photos of this jurisdictional feature are provided on **Plate 1, Representative Photos of the Unnamed Blueline Stream**.

The unnamed stream is waters of the State under jurisdiction of RWQCB as well as streambed and riparian habitat under jurisdiction of CDFW. There is no jurisdictional habitat beyond the stream's banks on the eastern side but does extend beyond the banks on the western side (outside of the project boundary). The acreage of linear footage of jurisdictional waters and habitat for unnamed blueline stream within the project site is provided in **Table 1, Jurisdictional Features in Project Site**.

Jurisdictional Feature	RWQCB Waters of the State / CDFW Streambed (Acres / Linear Feet)	CDFW Riparian Habitat (Acres / Linear Feet)
Unnamed Blueline Stream	0.43 / 220	0.16 / 220
Ephemeral Drainage	0.28 / 1,630	0.00 / 0
TOTALS	0.71 / 1,850	0.16 / 220

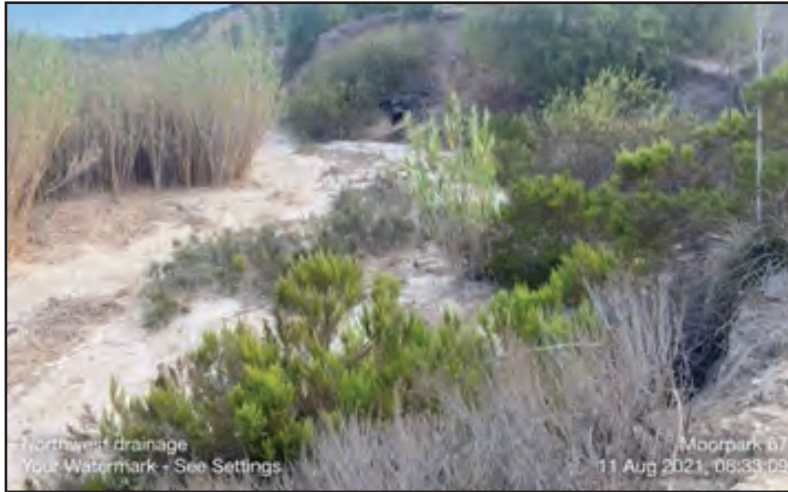
Photo 1A: View to the north showing the stream in the northwest portion of the project site.

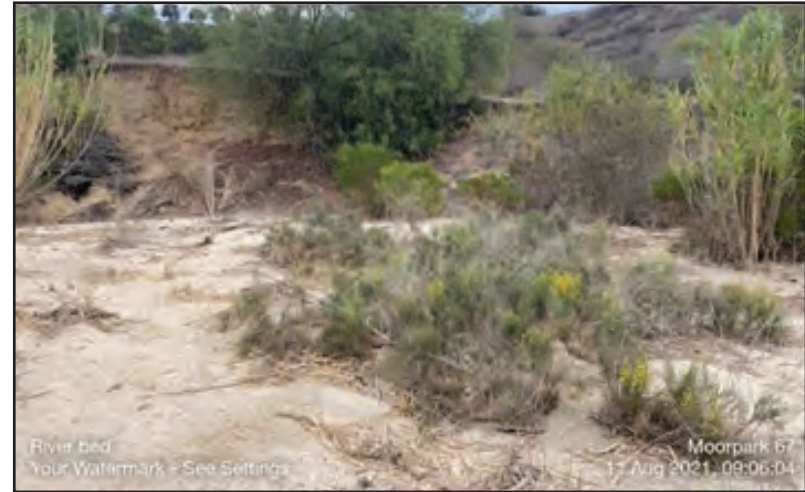
Photo 1B: View to the northeast showing the vegetation profile in the stream in the northwest portion of the site.

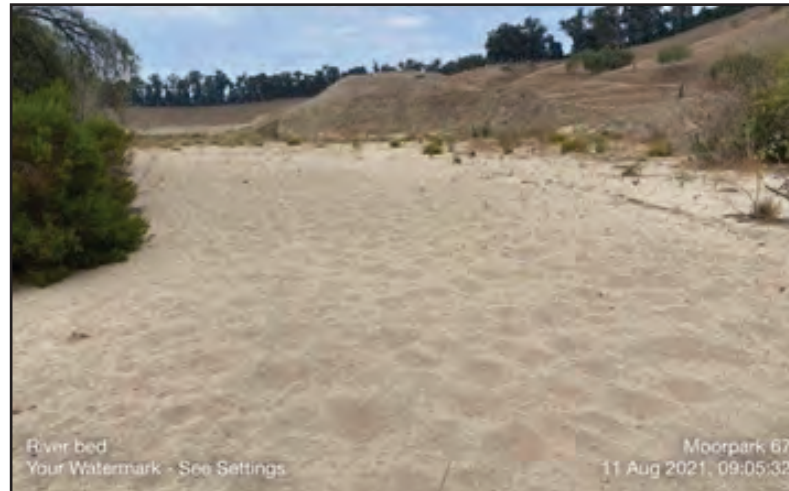
Photo 1C: View to the southwest showing the stream as it continues south into the basin.

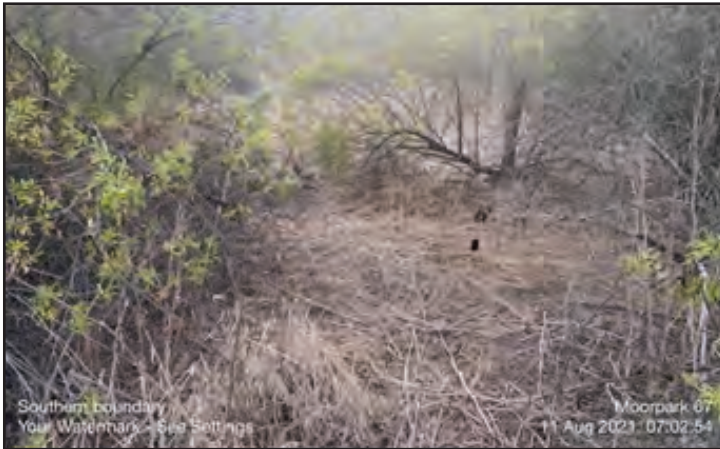
Photo 2A: View looking northeast at the southernmost edge of the drainage feature on the project site.

The drainage supports riparian vegetation covering more of the channel in certain areas while other areas are more barren. Mulefat (*Baccharis salicifolia*) is the dominant plant species along the entire course of the drainage with blue elderberry (*Sambucus mexicana*), black mustard (*Brassica nigra*), and Peruvian pepper-tree (*Schinus molle*). Mulefat is listed as FAC, meaning that it is equally likely to occur in wetlands as non-wetlands. There is no jurisdictional habitat beyond their banks. Representative photos of this jurisdictional feature are provided on **Plate 2, Representative Photos of the Ephemeral Drainage**.

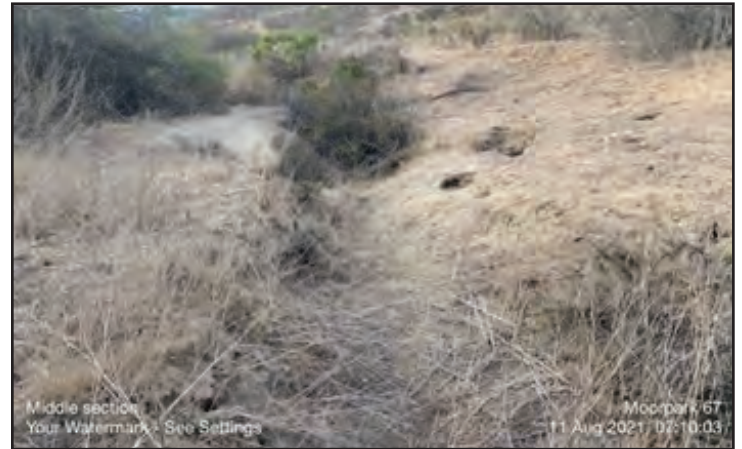
Photo 2B: View looking south at the definable bed and bank of the drainage feature on the project site.

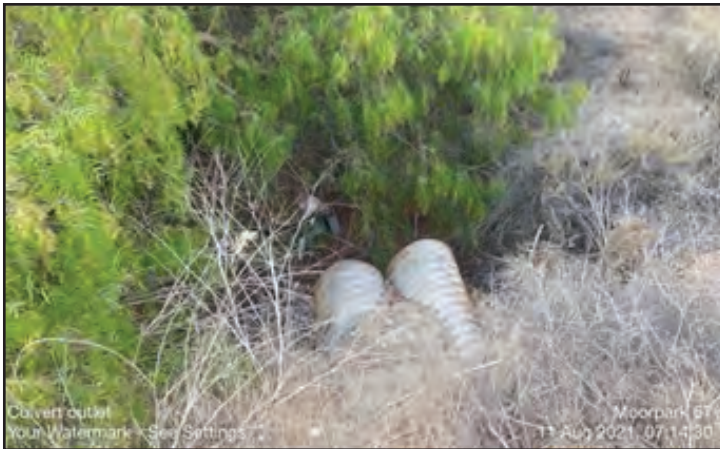
Photo 2C: View looking south at the culvert pipe outlet that allows the water to flow underneath a dirt road.

horse stables, and orchard operations to the north of the site also contribute to the system. The incised channel terminates just south of the project site, with water continuing as sheet-flow. The smaller ephemeral drainage with the incised channel consists of swales and erosional features (e.g., gullies, small volume, infrequent, or short duration flow). There are two steel pipes as a part of the drainage, one that runs underneath the paved road in the northern portion and another that runs underneath the dirt road in the southern portion of the site.

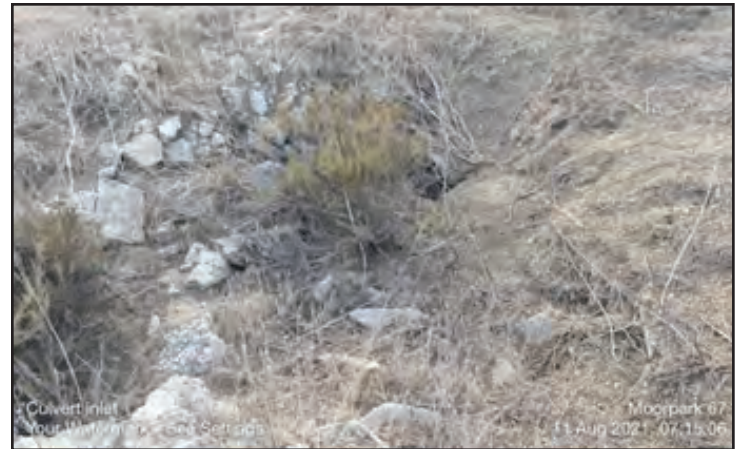
Photo 2D: View looking southeast at the culvert inlet that receives runoff from the residential developments north of the site.

There is also one (1) smaller ephemeral drainage within the project site, which drains upland areas or receives runoff from streets within the adjacent residential developments. The second drainage feature runs from north to south in the middle of the property. The source of water for this system is natural runoff from a watershed that drains a small area north and the eastern portion of the site. Nuisance water from the single-family homes,

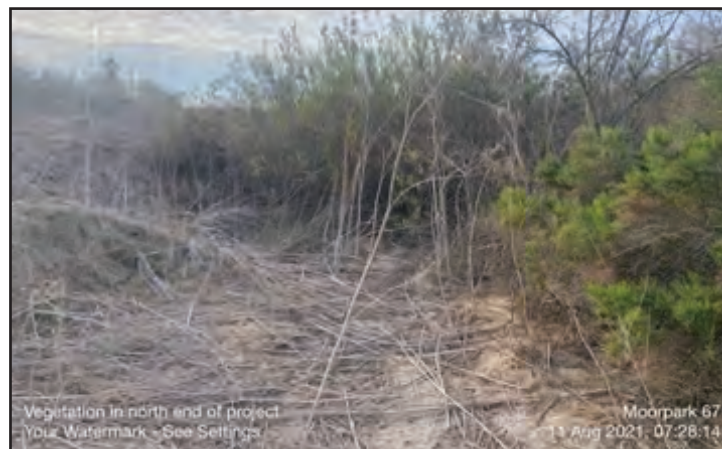
Photo 2E: View looking southeast showing the vegetation profile of the drainage feature consisting mostly of mule fat.

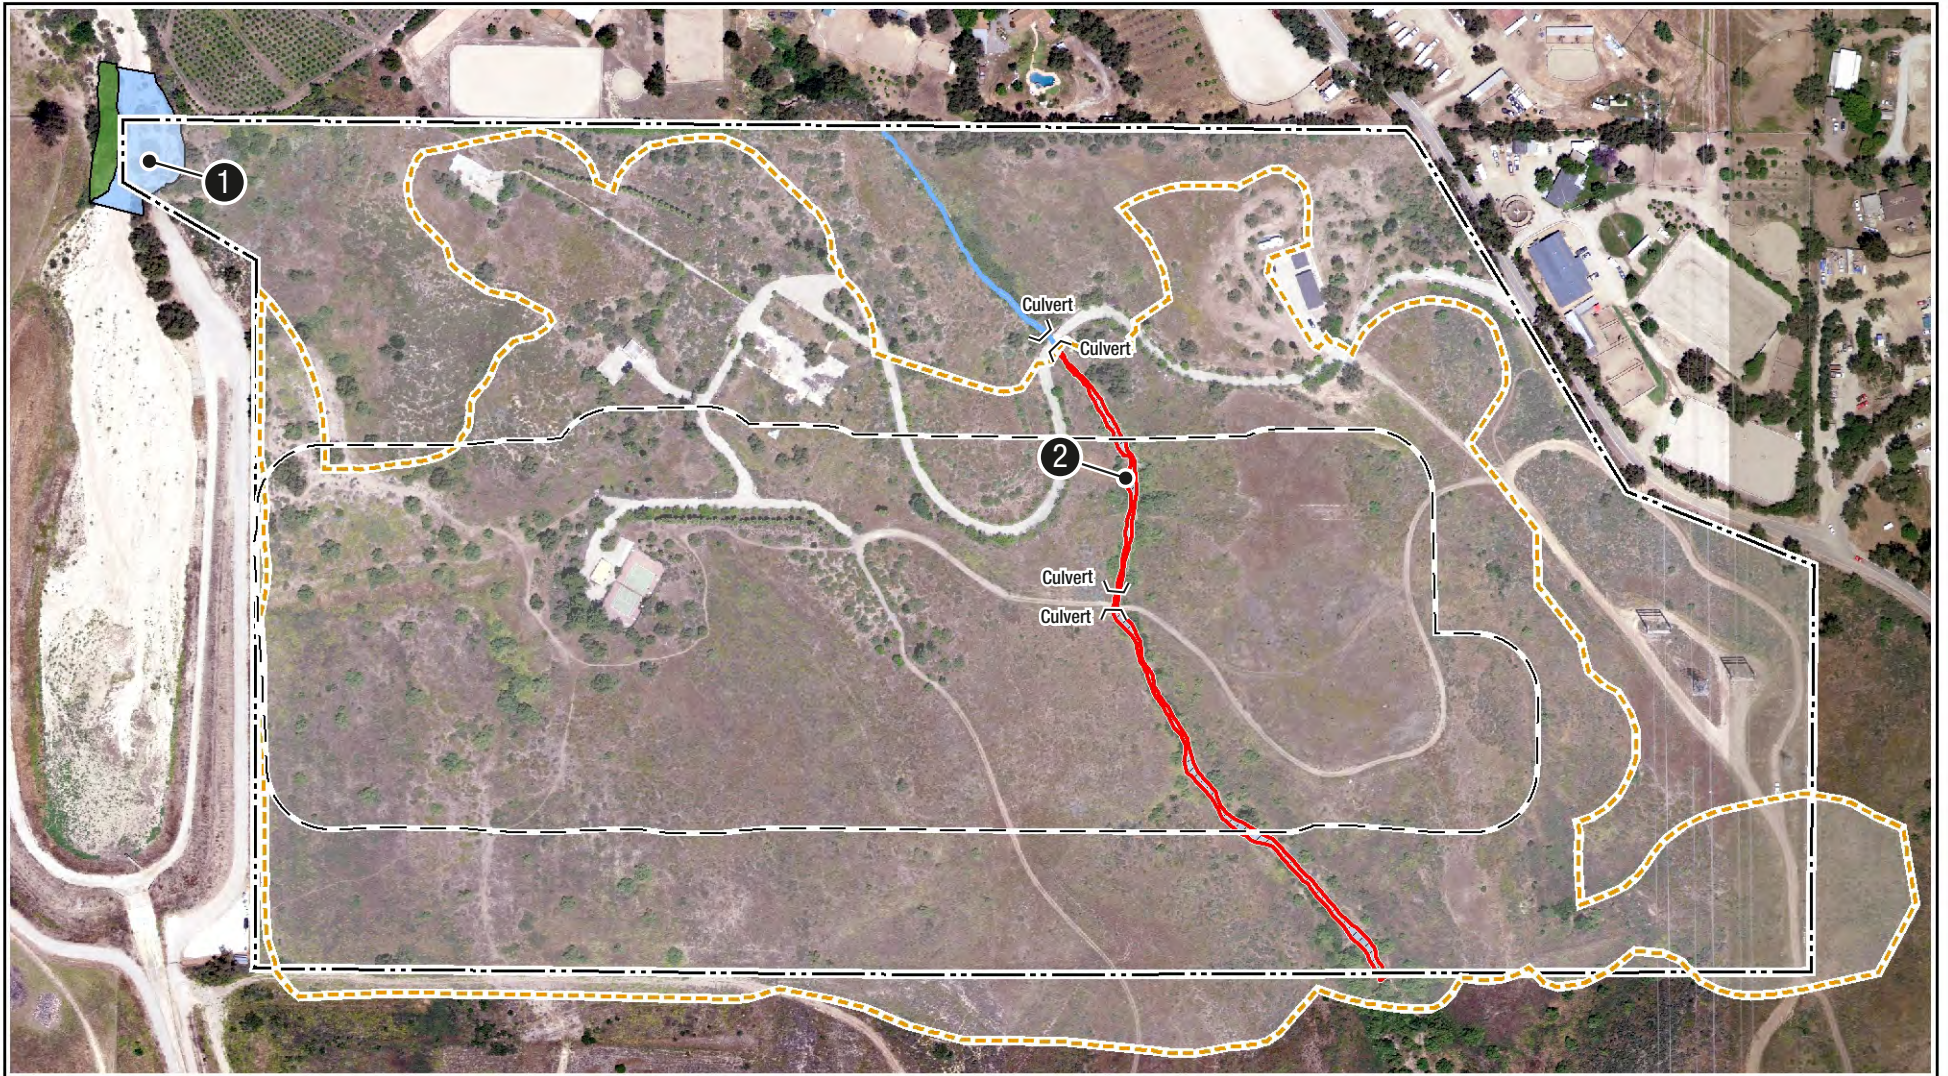
Jurisdictional Delineation Impact Map

The proposed residential development would permanently impact 0.24 acre (1,155 linear feet) of RWQCB jurisdictional waters of the State / CDFW jurisdictional habitat (**Table 2, Project Impacts to Onsite Jurisdictional Features**). The 0.24 acre of RWQCB Waters of the State / CDFW Streambed that would be removed by Project development is located within the ephemeral drainage and primarily comprises Mulefat (*Baccharis salicifolia*) scrub. Potential fuel modification clearing activities will occur within the limits of grading, therefore no additional impacts to jurisdictional habitat from fuel modification activities are anticipated. The proposed limits of grading and anticipated fuel modification activities based on the standard Ventura County requirements of at least 100-feet from structures (Ventura County Fire Protection District Fire Prevention Bureau, Standard 515, Chapter 1.4) are shown overlaid on Figure 4. There are no anticipated impacts to the unnamed blueline stream in the northwestern edge of the project site.

MM-1 Prior to issuance of the grading permit, the Applicant shall prepare and submit a Streambed Alteration Notification package to the CDFW for alterations to CDFW jurisdictional streambed and habitat. A Streambed Alteration Agreement shall be entered into with the CDFW under Section 1602 of the California Fish and Game Code, and the Applicant shall comply with the associated conditions. Prior to issuance of the grading permit, the Applicant shall also consult with RWQCB and ACOE to determine if permits are required from those agencies. If required, the appropriate permits shall be obtained from the RWQCB and/or ACOE, and the Applicant shall comply the permit conditions. The Applicant shall provide evidence to VCDRP that the required permits have been obtained prior to issuance of a grading permit. Mitigation for unavoidable impacts to jurisdictional waters and habitat shall be provided through implementation of the Habitat Mitigation and Monitoring Plan as required by MM-2.

The Project shall implement the requirements of a final approved Habitat Mitigation and Monitoring Plan, which shall mitigate for permanent grading impacts to 0.24 acre (1,155 linear feet) of RWQCB waters of the State / CDFW streambed at a 2:1 ratio. The Habitat Mitigation and Monitoring Plan shall mitigate for the permanent impacts to jurisdictional areas via an acceptable mitigation approach that involves one or a combination of the onsite or offsite enhancement of degraded in-kind habitats subject to the approval of the City of Moorpark, CDFW, and RWQCB (if applicable). The preferred mitigation approach is enhancement of on-site or off-site habitats within the ephemeral drainage, including plantings of appropriate native species and weed removals. The final Habitat Mitigation and Monitoring Plan shall be developed by a qualified biologist, restoration ecologist or resource specialist and submitted to and approved by the City of Moorpark, CDFW, and RWQCB prior to issuance of a grading permit for the Project. In broad terms, this Program shall at a minimum include:
