Project No. E19442.000  
2 January, 2020

Subject: **6331 Filbert Avenue, Orangevale, CA 95662**  
Sacramento County Assessor Parcel Number (APN): 223-0091-002  
*Phase II Environmental Site Assessment*

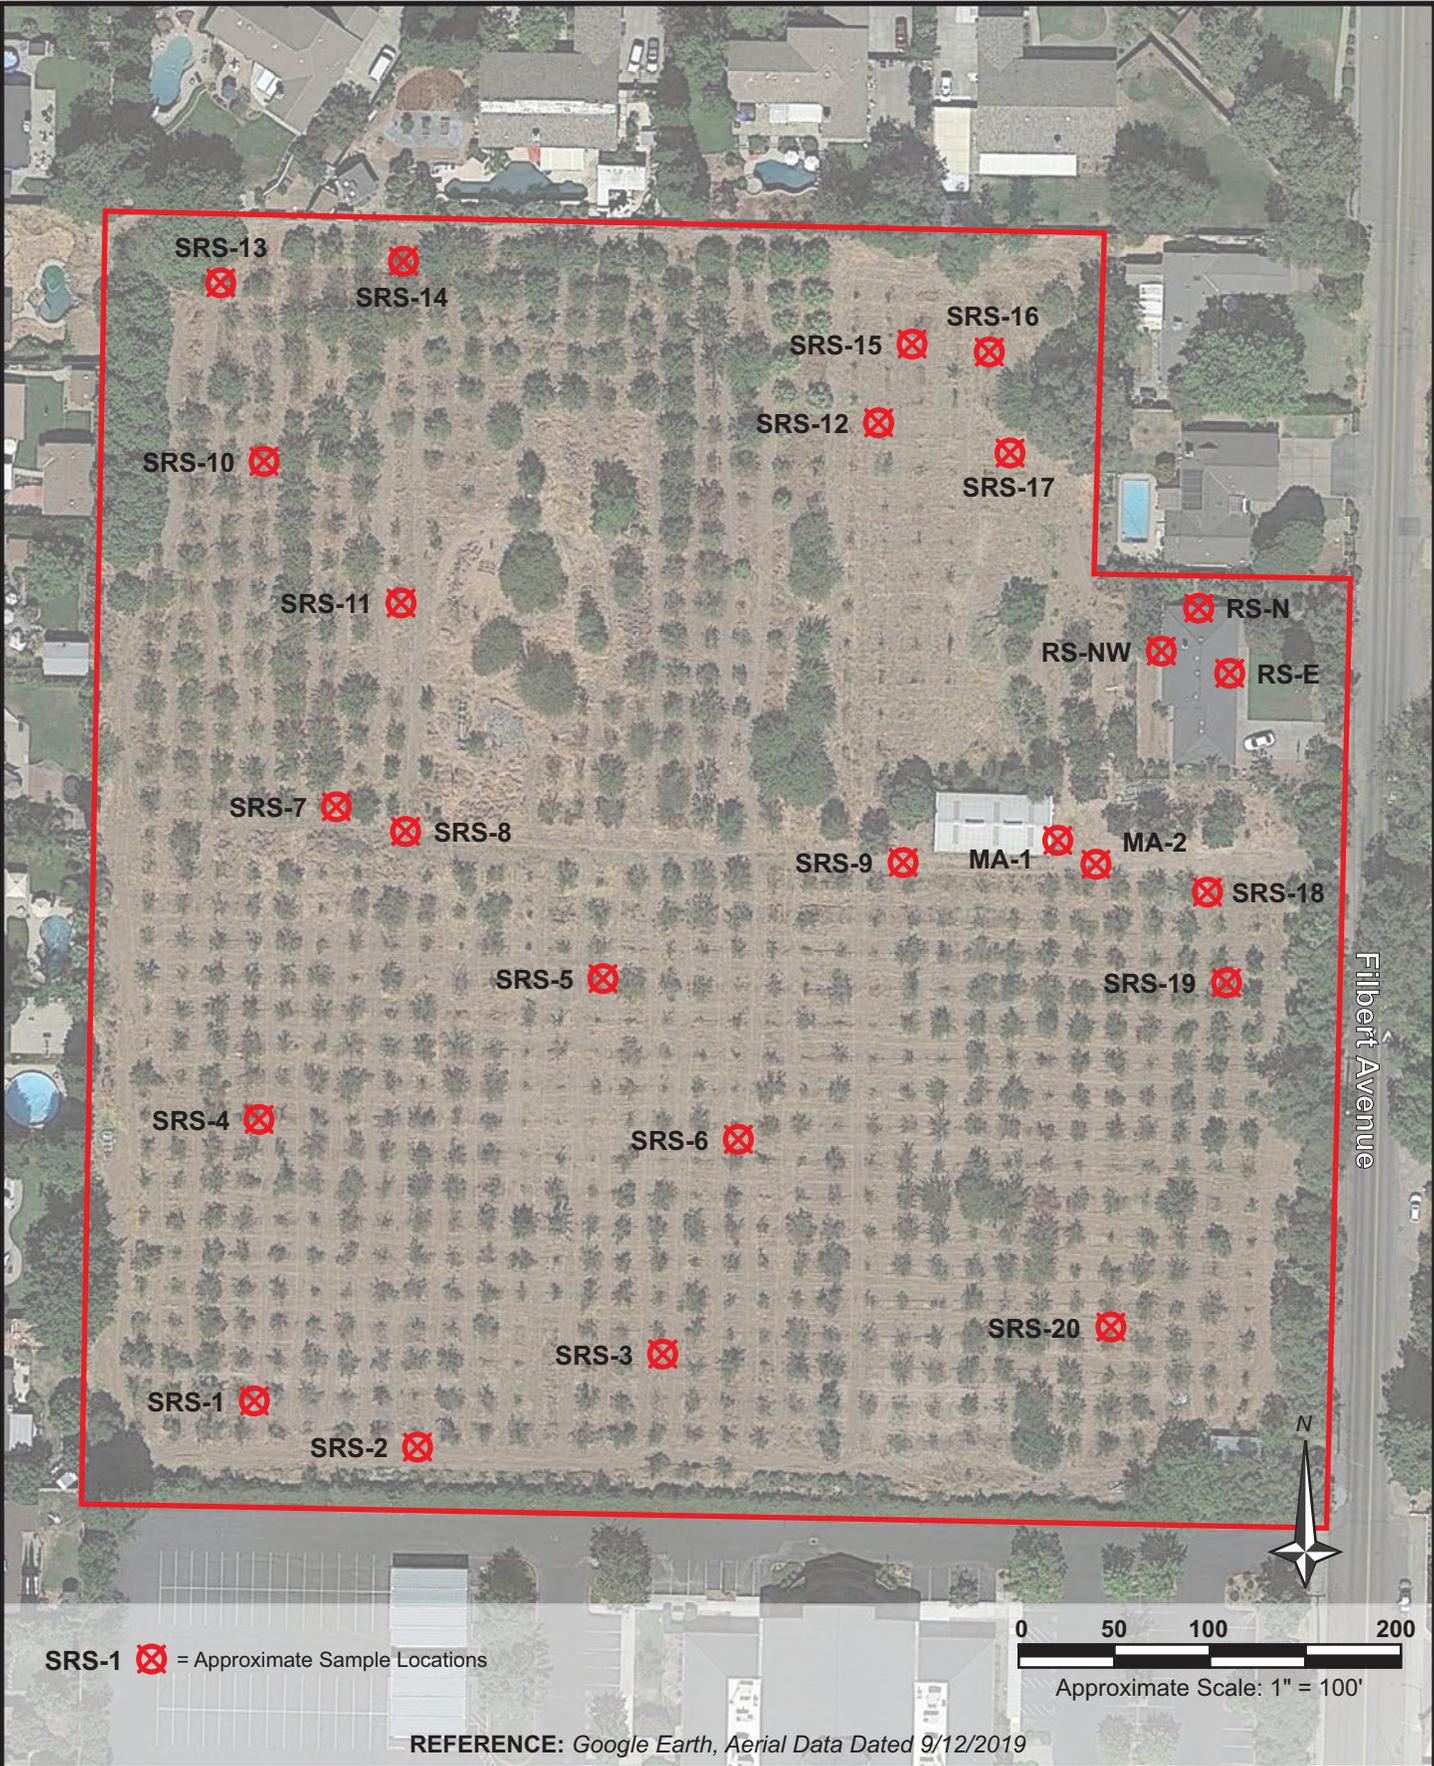
On 17 December 2019, a representative of Youngdahl Consulting Group, Inc. returned to the site to collect near-surface soil samples in accordance with the sample plan generated based on historical and reconnaissance observations and the Reference 2 guidance document. Table 1 of the Reference 2 guidance document recommends the collection of five 4-part composite soil samples for OCP analysis, and five discrete soil samples for Arsenic analysis for sites up to 10 acres in size. A sampling grid was generated and stratified random sample (SRS) locations were established using a random number generator and located in the *orchard area* by sub-meter global positioning coordinates. Twenty SRS points were selected to generate five 4-part composite soil samples to be analyzed for chlorinated pesticides. Of the twenty SRS points, five sample locations were selected for analyses of lead arsenate pesticides. In accordance with the Reference 2 guidance document, soil samples were collected from near surface materials, at a depth just below surficial extraneous material (0-6"), from alternating locations under the current drip-line of existing orchard trees, under the tree canopy, between the tree rows, and between trees within a row. Four SRS points from adjacent locations were field composited for each of the five OCP analyses (SRSC-01 through SRSC-05). Five SRS points were then selected for lead and arsenic analysis from locations selected to cumulatively generalize the whole site (SRS-03, SRS-04, SRS-08, SRS-13, SRS-19).

Judgmental sample locations were selected based on historical and site reconnaissance observations for two discrete near surface soil samples in equipment storage and *maintenance areas* (MA-01, MA-02) to be analyzed for waste oil wear metals, and total petroleum hydrocarbons quantified as motor oil and diesel.

Judgmental near surface discrete soil sample locations were selected adjacent to the *residential structure* (RS-E, RS-N, RS-NW) foundation perimeter in three locations not covered with concrete flatwork to be analyzed for lead from a past use of lead-based paint and for chlorinated pesticides potentially used to control termites.

Sample locations are shown on Figure 2 – Site Plan. All samples were collected with decontaminated hand tools into pre-cleaned, laboratory-supplied glass jars with Teflon-lined caps and placed on wet ice for transport to CLS in Rancho Cordova, CA under chain of custody protocol.

Arsenic concentrations did not exceed typical naturally occurring background levels and are not of concern. Lead concentrations did not exceed the HHRA screening levels for residential and industrial/commercial soils and samples tested for organochlorinated pesticides were reported to be non-detect. It is the opinion of Youngdahl's environmental professional that no additional action is required for the Subject Property.

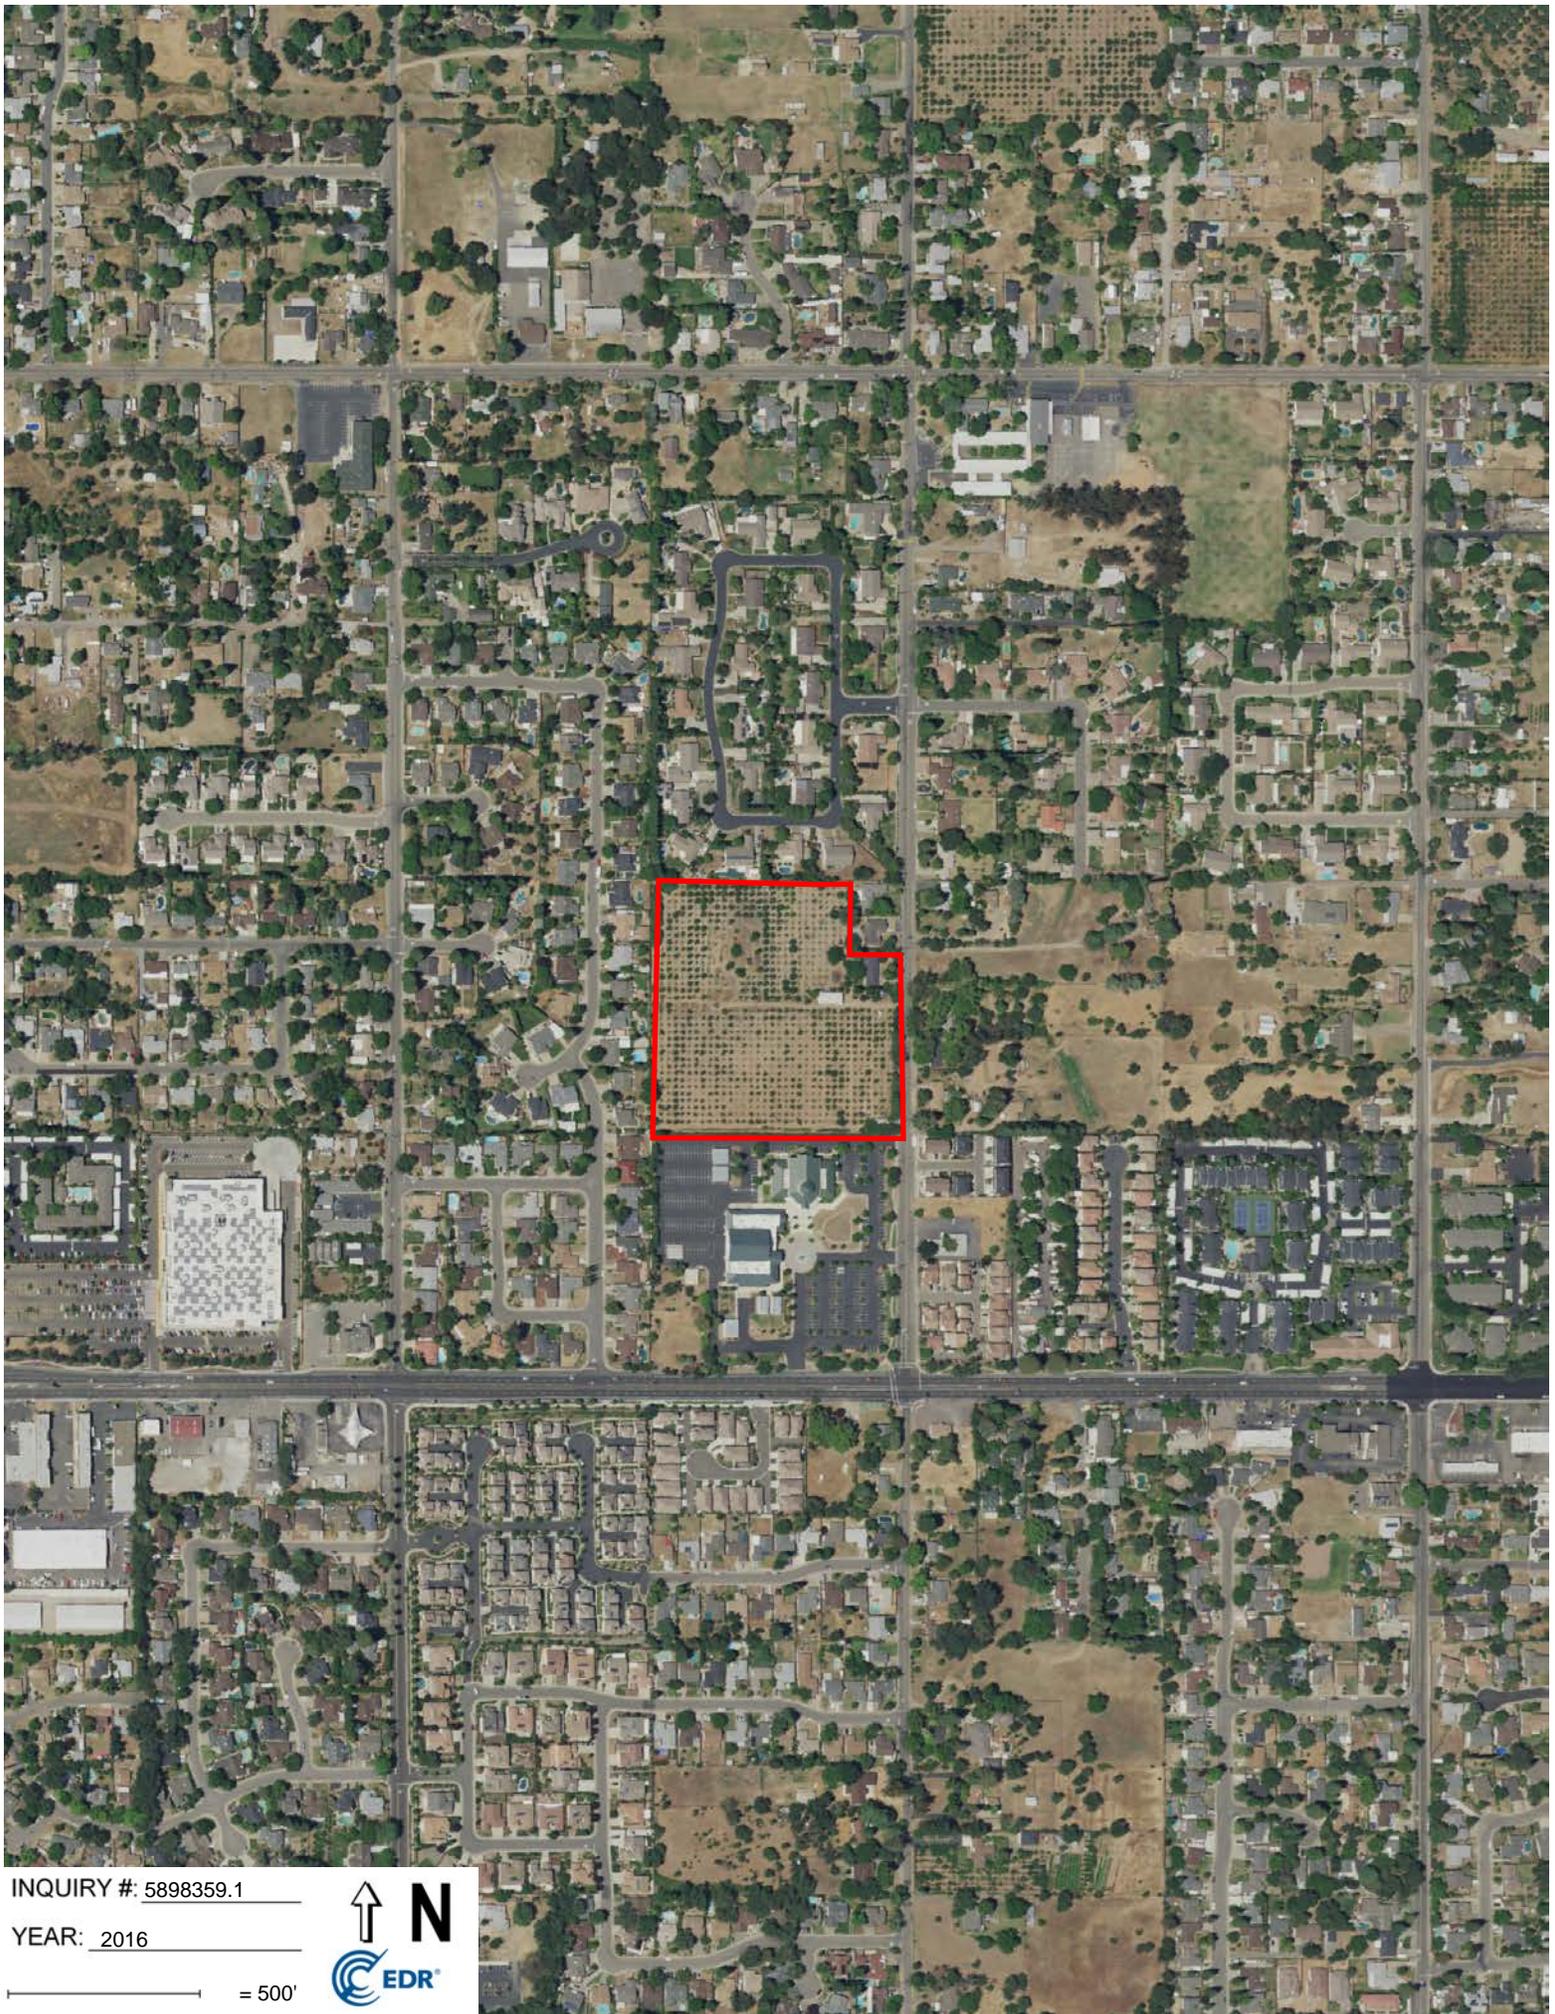
YEAR: 2016

Youngdahl subcontracted the services of Environmental Data Resources (EDR/Lightbox) to provide historic aerial photographs of the Subject Property. Review of the aerial photos indicates that the Subject Property has been under agricultural use as an orchard since as early as 1937, consistent with the Client's narrative of the Subject Property history. The EDR aerial photograph package is attached as Appendix A. The State of California Water Resources Control Board's GeoTracker database was researched to identify if sites with groundwater contamination exist at or near the Subject Property. Also, the Department of Toxic Substance Control's (DTSC) Envirostor database was researched for sites of environmental concern at or near the Subject Property. The Subject Property was not identified on the GeoTracker or Envirostor web sites.
