# Determination of Biologically Equivalent or Superior Preservation Report

2<sup>nd</sup> Street Improvement Riverside County, Beaumont, California

# **City of Beaumont, California (Permittee/Applicant)**

# **Caskey Biological Consulting, LLC (Consultant)**

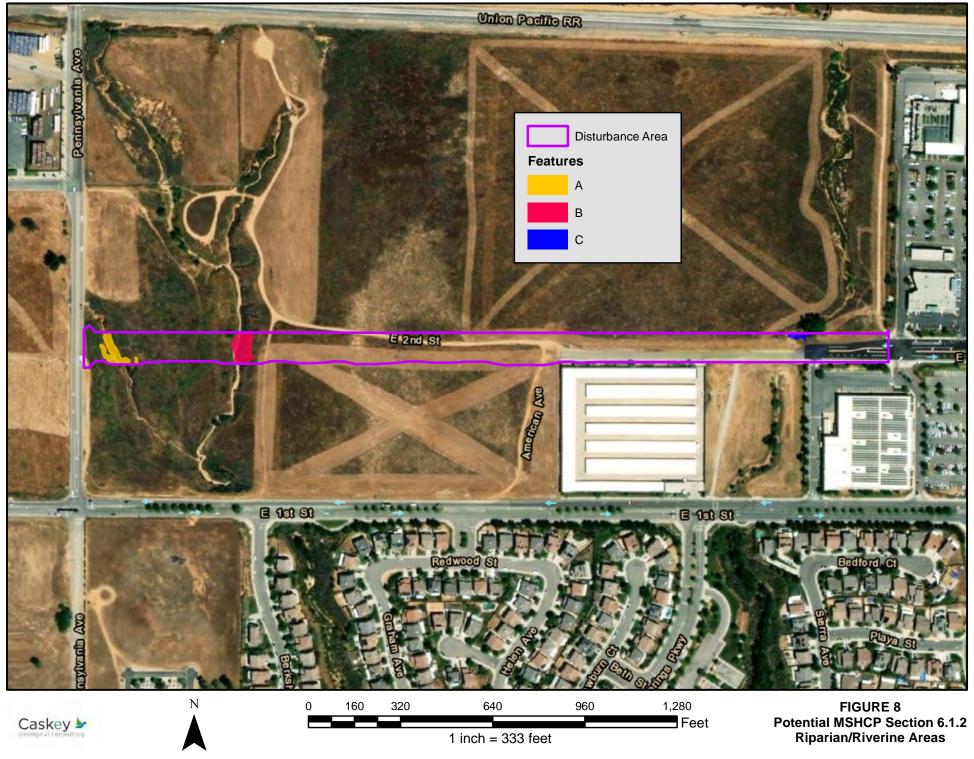
Field personnel identified and mapped four features that potentially meet the criteria of a MSHCP Section 6.1.2 Riparian/Riverine Area; this included four ephemeral waterways, including Potrero Creek, and a human-created ditch. No wetland features were observed within the Project. Figure 8 – Potential MSHCP Section 6.1.2 Riparian/Riverine Areas (Page 15) depicts the location of Features A, B, C, and D on the Project. Based on the grading footprint and RW alignment, the Project will potentially permanently impact 0.30-acre of ephemeral Riverine habitat in Features A and B by placing culverts, and temporarily impact 0.03-acre of ephemeral Riverine habitat in Feature C through grading activities.

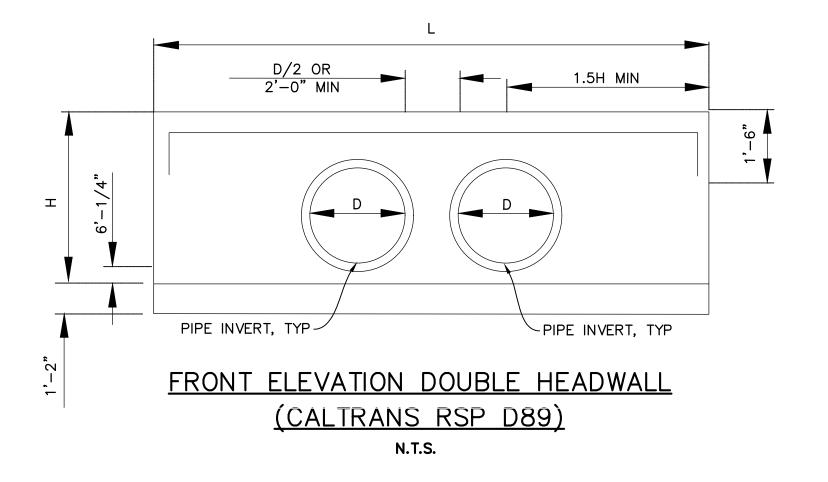
HEADWALL INVERT ELEVATIONS:			
CULVERT No.	ELEVATION (FT)	CULVERT FACING	
A A	2570.00 2572.00	NORTH SOUTH	
B B	2565.00 2567.00	NORTH SOUTH	
CC	2577.00 2579.00	NORTH SOUTH

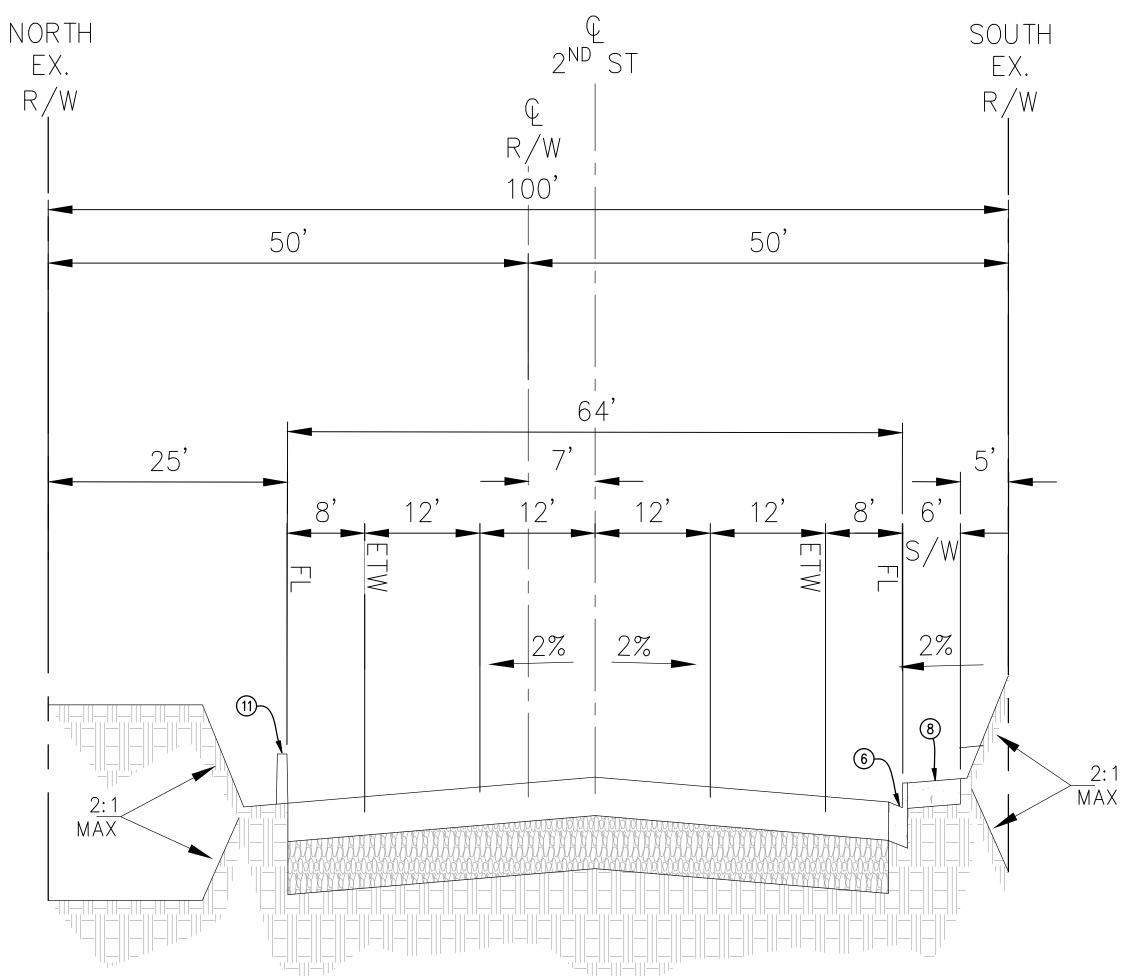
## TYPICAL STREET SECTION (LOOKING EAST)

CONSTRUCTION NOTES	<u>QUANTITY</u> ESTIMATES
(1)	PROTECT IN PLACE.	<u>L3 IIWA IL3</u>
2	SAWCUT AND REMOVE EXISTING AC PAVEMENT TO SUBGRADE.	23,064 FT^2
3	COLDMILL EXISTING AC PAVEMENT (2").	23,064 FT^2
4	CONSTRUCT XX" HMA (1/2 INCH TYPE A PG-64-10) OVER XX" CLASS AB OVER COMPACTED SUBGRADE.	153,749 FT^2
5	CONSTRUCT VARIABLE DEPTH AC OVERLAY (2" MIN).	153,749 FT^2
6	CONSTRUCT TYPE A-8 CURB AND GUTTER PER COUNTY OF RIVERSIDE STD. DETAIL 201.	1,622 FT.
7	CONSTRUCT CURB RAMP (CASE PER PLAN) PER COUNTY OF RIVERSIDE STD. DETAIL 403. [IMPROVEMENTS BY OTHERS; NOT PART OF PROJECT]	2 EA.
8	CONSTRUCT PCC SIDEWALK PER COUNTY OF RIVERSIDE STD. DETAIL 401.	8,829 FT^2
9	CONSTRUCT 4'X3' TRUNCATED DOMES. DETECTABLE WARNING DETAIL PER COUNTY OF RIVERSIDE STD. DETAIL 403. [IMPROVEMENTS BY OTHERS; NOT PART OF PROJECT]	-
10	REMOVE EXISTING CURB AND GUTTER.	3,338 FT.

11)	CONSTRUCT AC DIKE TO 8" PER RIVERSIDE COUNTY STANDARD NO. 212.	2,457 FT.
12	REMOVE PCC SW.	_
13)	CONSTRUCT TYPE D (8-INCH) CURB PER COUNTY OF RIVERSIDE STD DETAIL 201.	-

24)	EXISTING HEADWALL.	2 EA
<b>(25)</b>	EXISTING 60" Ø CONCRETE PIPE.	2 EA

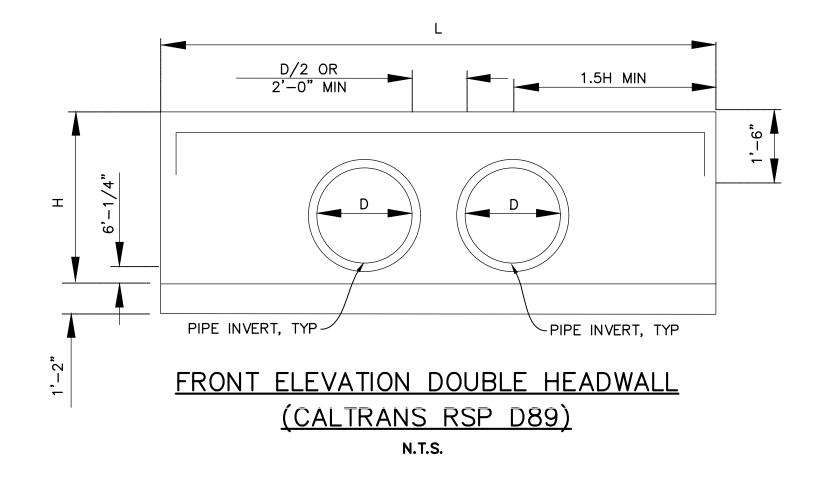
HEADWALL INVERT ELEVATIONS:					
CULVERT No.	ELEVATION (FT)	CULVERT FACING			
A A	2570.00 2572.00	NORTH SOUTH			
B B	2565.00 2567.00	NORTH SOUTH			
CC	2577.00 2579.00	NORTH SOUTH

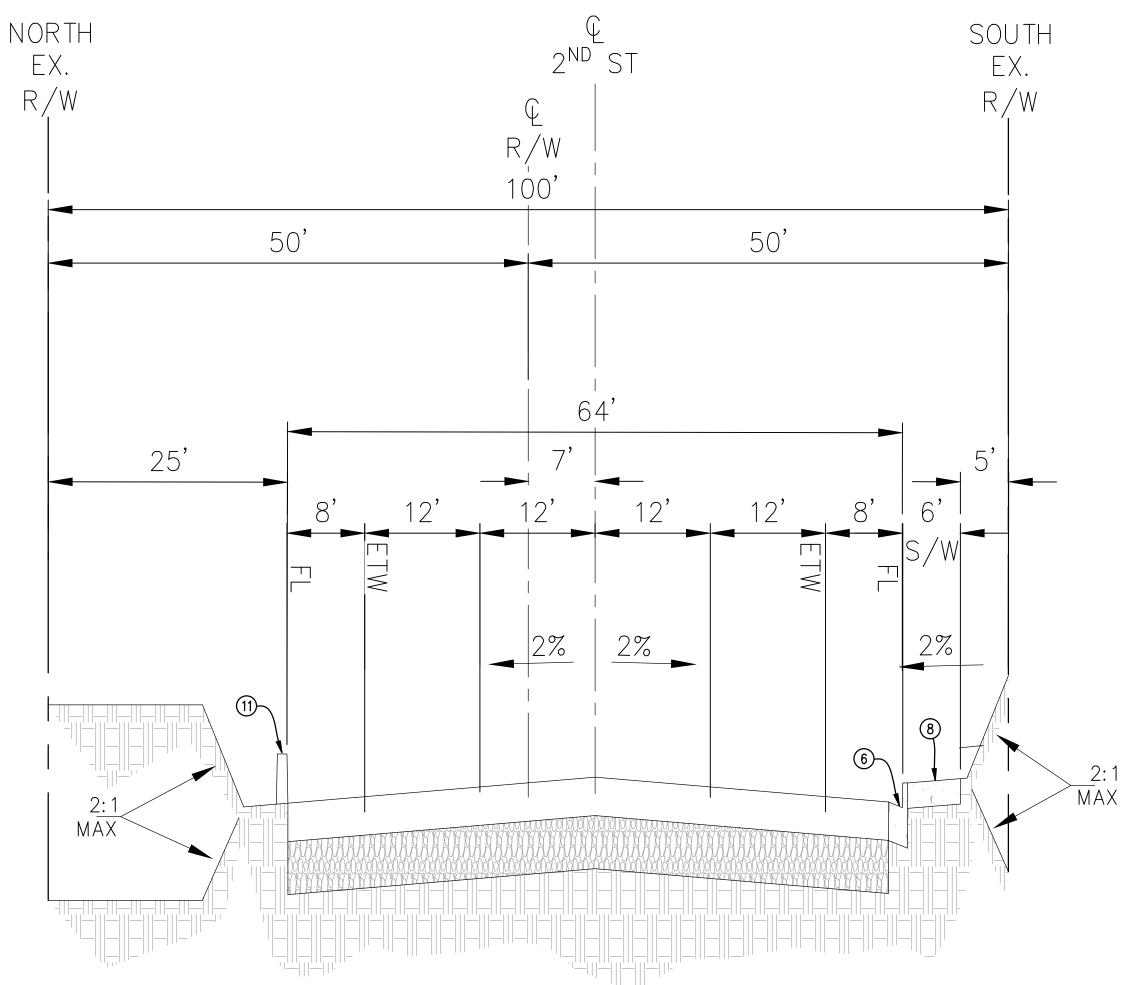
## TYPICAL STREET SECTION (LOOKING EAST)

CONSTRUCTION NOTES	QUANTITY ESTIMATES
1	PROTECT IN PLACE.	
2	SAWCUT AND REMOVE EXISTING AC PAVEMENT TO SUBGRADE.	23,064 FT^2
3	COLDMILL EXISTING AC PAVEMENT (2").	23,064 FT^2
4	CONSTRUCT XX" HMA (1/2 INCH TYPE A PG-64-10) OVER XX" CLASS AB OVER COMPACTED SUBGRADE.	153,749 FT^2

(5)	CONSTRUCT VARIABLE DEPTH AC OVERLAY (2" MIN).	153,749 FT^2
6	CONSTRUCT TYPE A-8 CURB AND GUTTER PER COUNTY OF RIVERSIDE STD. DETAIL 201.	1,622 FT.
7	CONSTRUCT CURB RAMP (CASE PER PLAN) PER COUNTY OF RIVERSIDE STD. DETAIL 403. [IMPROVEMENTS BY OTHERS; NOT PART OF PROJECT]	2 EA.
8	CONSTRUCT PCC SIDEWALK PER COUNTY OF RIVERSIDE STD. DETAIL 401.	8,829 FT^2
9	CONSTRUCT 4'X3' TRUNCATED DOMES. DETECTABLE WARNING DETAIL PER COUNTY OF RIVERSIDE STD. DETAIL 403. [IMPROVEMENTS BY OTHERS; NOT PART OF PROJECT]	-
10	REMOVE EXISTING CURB AND GUTTER.	3,338 FT.

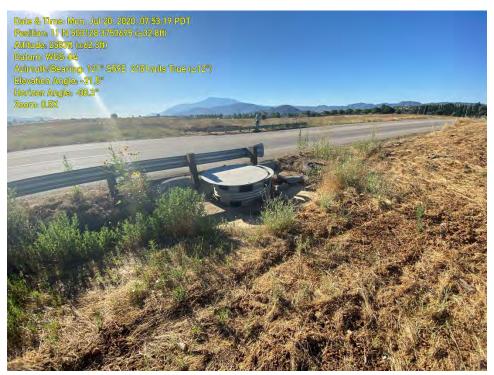
**PHOTOGRAPH 3:** The westside of Pennsylvania Avenue where storm runoff entered a standpipe connected to the culvert where Feature A began.

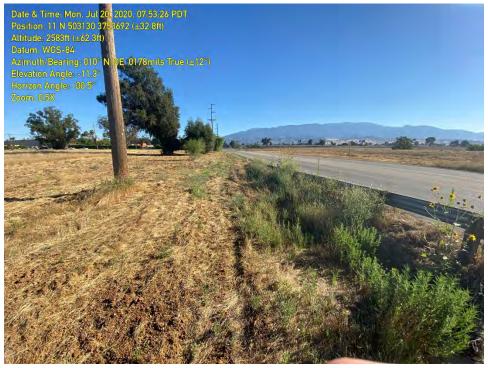
**PHOTOGRAPH 4:** No roadside drainage was present, or evidence thereof, indicating all flow for Feature A originated from road runoff.

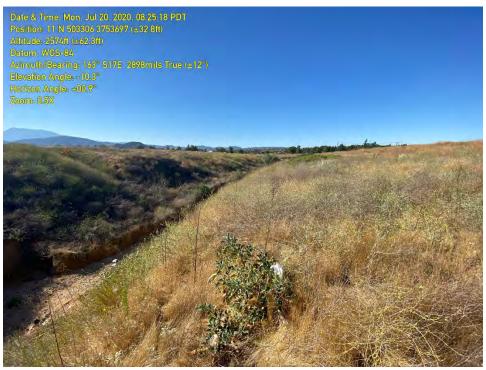
**PHOTOGRAPH 5:** A view looking down Feature B.

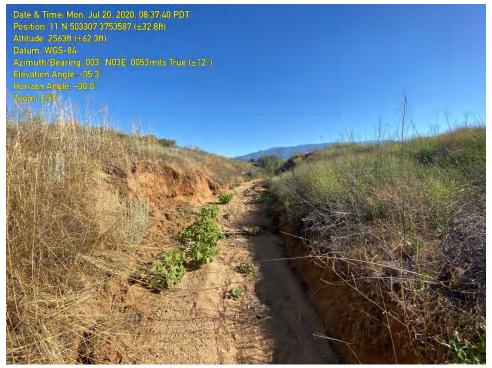
**PHOTOGRAPH 6:** The depth of Feature B varied and decreased from the upstream end to the downstream portion.

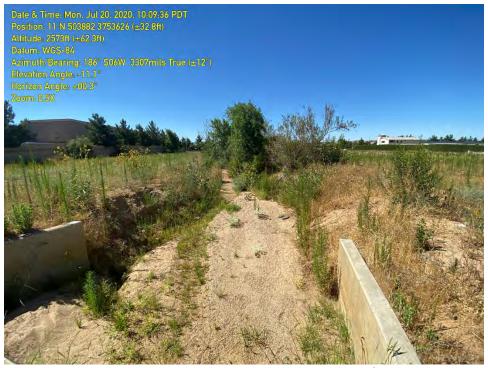
**PHOTOGRAPH 8:** The low-quality willow scrub in Feature C downstream of 2<sup>nd</sup> Street.

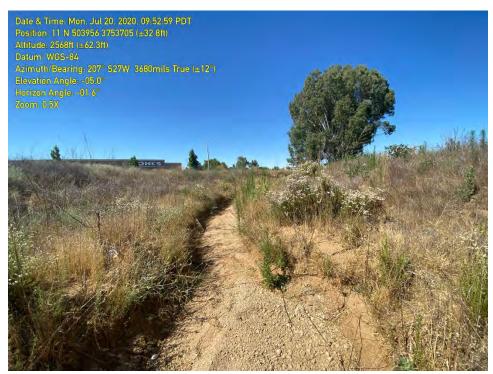
**PHOTOGRAPH 9:** Feature C upstream of  $2^{nd}$  Street looking downstream. No riparian habitat present. The large blue gum tree depicted in the background.

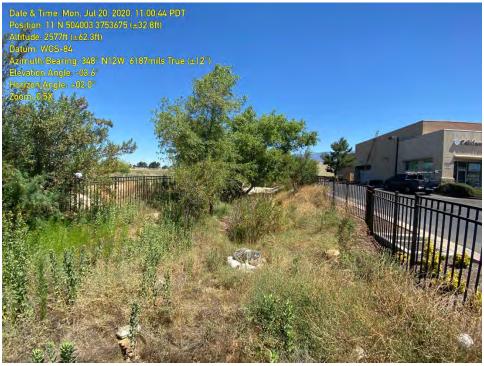
**PHOTOGRAPH 10:** The human-created ditch Feature D with low-quality riparian habitat. The drainpipe entered the underground drainage system.

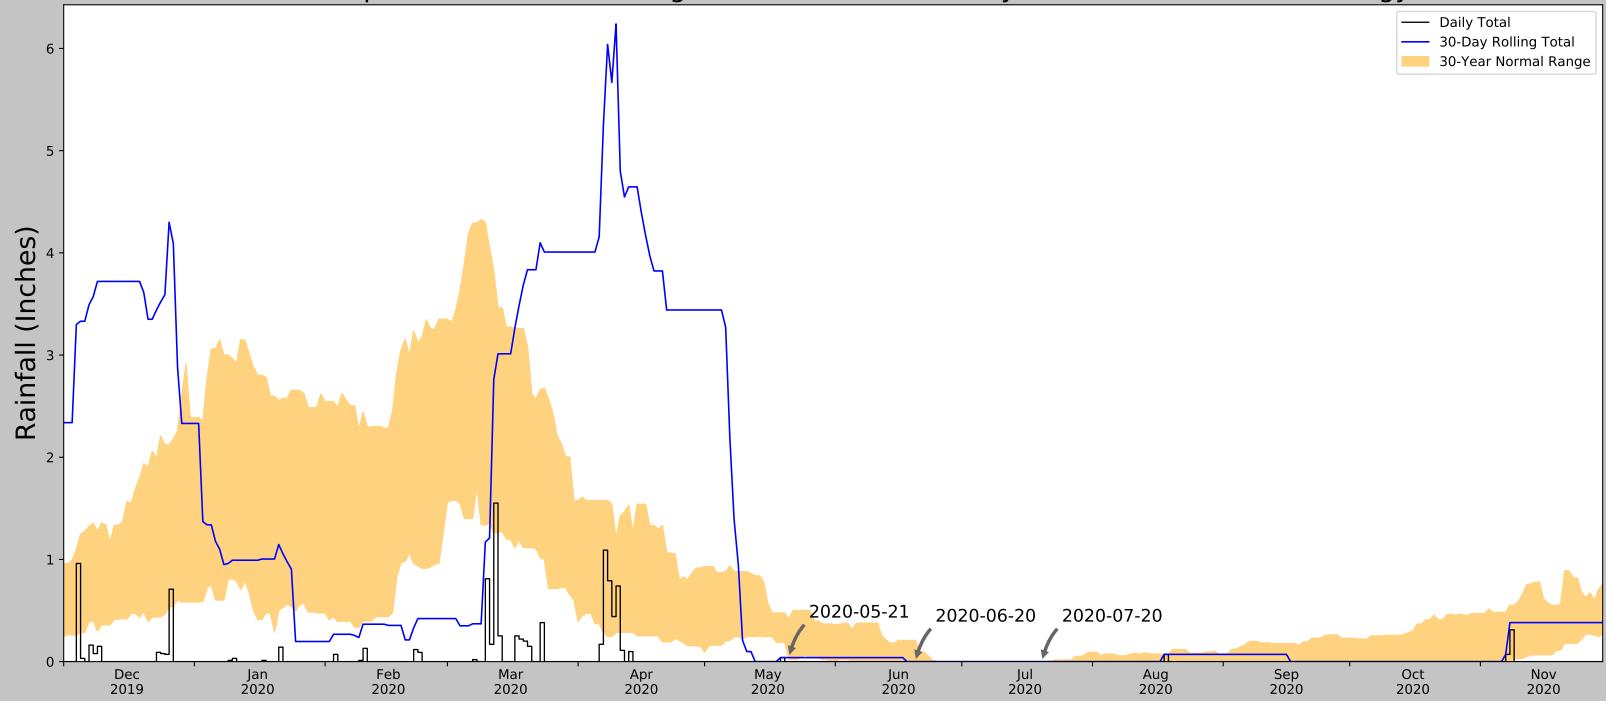
# Antecedent Precipitation vs Normal Range based on NOAA's Daily Global Historical Climatology Network

Coordinates	33.923289, -116.961809
Observation Date	2020-07-20
Elevation (ft)	2586.24
Drought Index (PDSI)	Normal
WebWIMP H <sub>2</sub> O Balance	Dry Season

30 Days Ending	30 <sup>th</sup> %ile (in)	70 <sup>th</sup> %ile (in)	Observed (in)	Wetness Condition	Condition Value	Month Weight	Product
2020-07-20	0.0	0.0	0.0	Normal	2	3	6
2020-06-20	0.0	0.206693	0.0	Normal	2	2	4
2020-05-21	0.027953	0.414567	0.03937	Normal	2	1	2
Result							Normal Conditions - 12

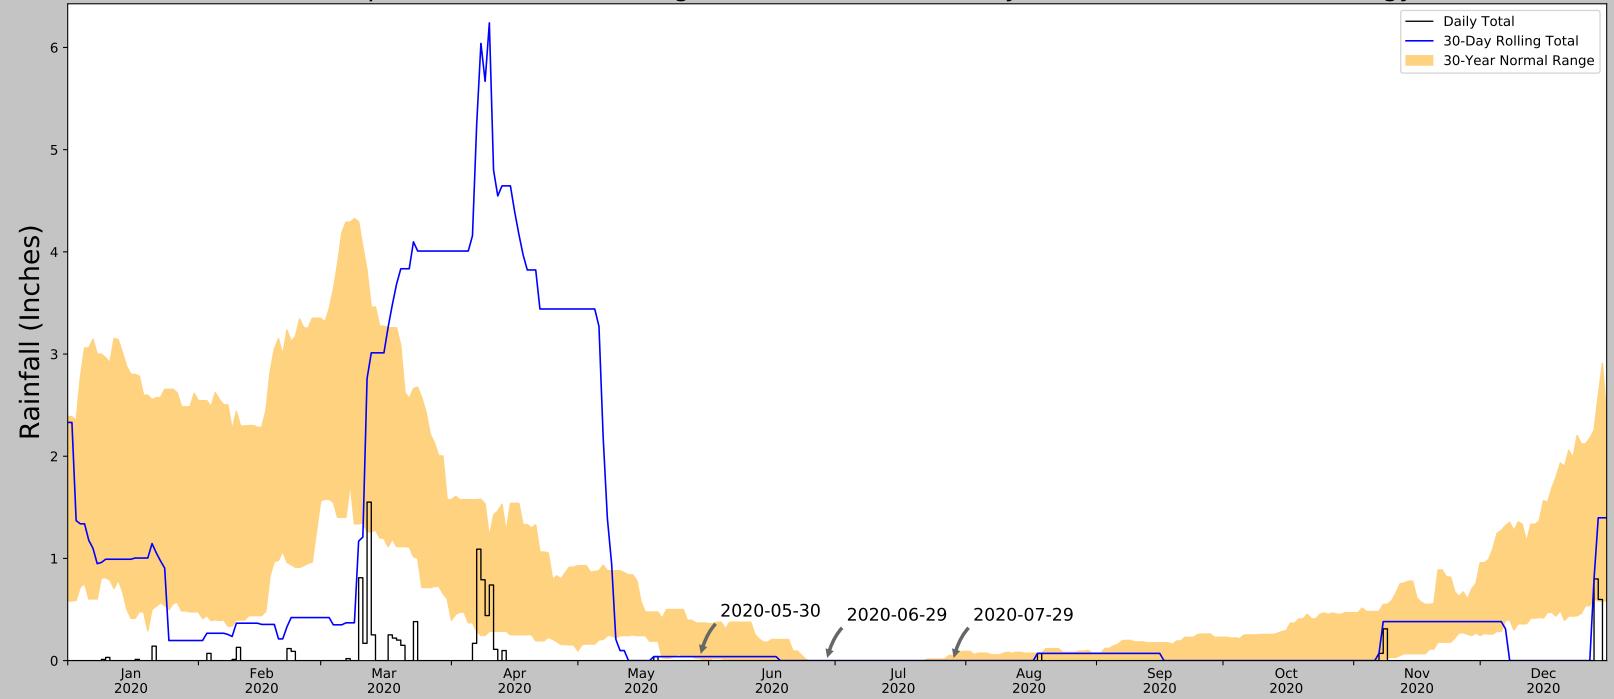
# Antecedent Precipitation vs Normal Range based on NOAA's Daily Global Historical Climatology Network

Coordinates	33.923289, -116.961809
Observation Date	2020-07-29
Elevation (ft)	2586.24
Drought Index (PDSI)	Normal
WebWIMP H <sub>2</sub> O Balance	Dry Season

30 Days Ending	30 <sup>th</sup> %ile (in)	70 <sup>th</sup> %ile (in)	Observed (in)	Wetness Condition	Condition Value	Month Weight	Product
2020-07-29	0.0	0.051181	0.0	Normal	2	3	6
2020-06-29	0.0	0.0	0.0	Normal	2	2	4
2020-05-30	0.022047	0.36811	0.03937	Normal	2	1	2
Result							Normal Conditions - 12

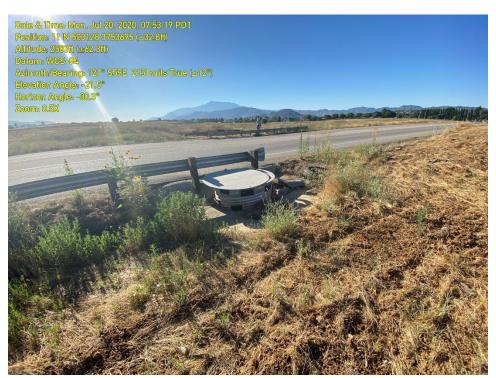
**PHOTOGRAPH 3:** The westside of Pennsylvania Avenue where storm runoff entered a standpipe connected to the culvert where Feature A began.

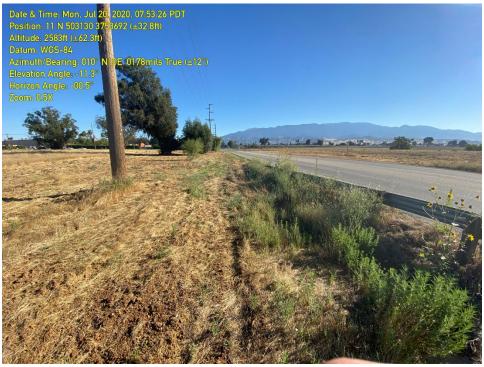
**PHOTOGRAPH 4:** No roadside drainage was present, or evidence thereof, indicating all flow for Feature A originated from road runoff.

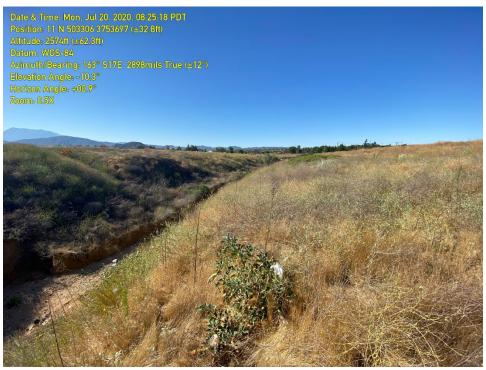
PHOTOGRAPH 5: A view looking down Feature B.

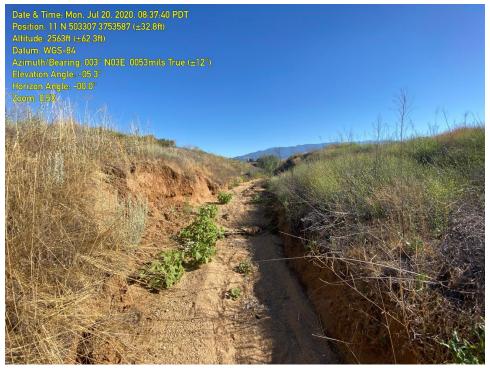
PHOTOGRAPH 6: The depth of Feature B varied and decreased from the upstream end to the downstream portion.

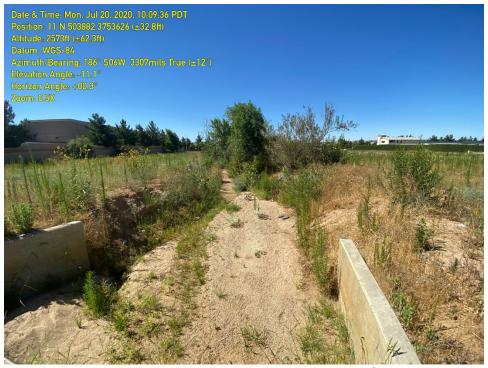
**PHOTOGRAPH 8:** The low-quality willow scrub in Feature C downstream of 2<sup>nd</sup> Street.

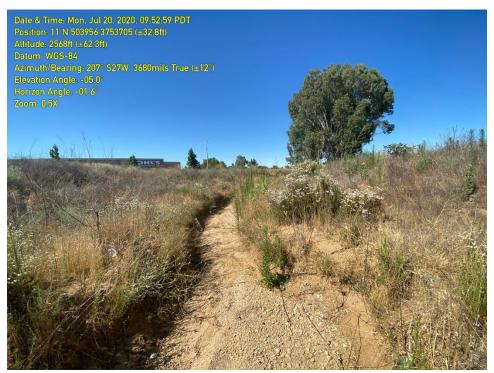
**PHOTOGRAPH 9:** Feature C upstream of  $2^{nd}$  Street looking downstream. No riparian habitat present. The large blue gum tree depicted in the background.

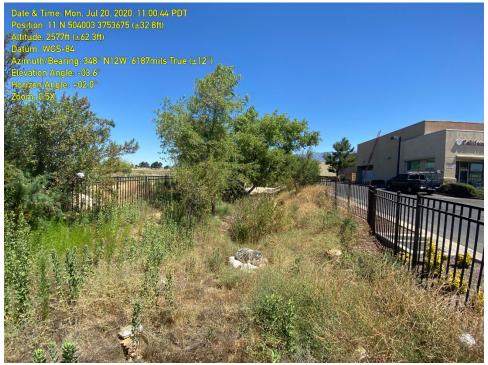
**PHOTOGRAPH 10:** The human-created ditch Feature D with low-quality riparian habitat. The drainpipe entered the underground drainage system.
