PHASE II SUBSURFACE INVESTIGATION REPORT

Highland, CA

27107 West 5th Street Highland, California 92346

Partner Project Number: 22-362099.1

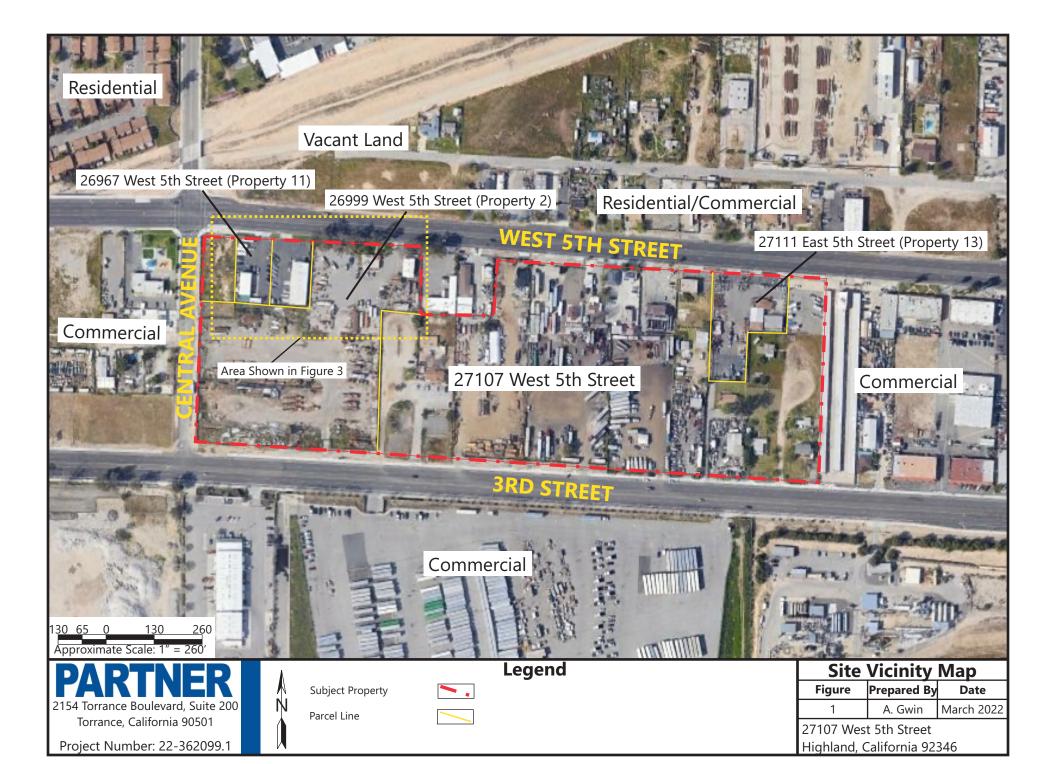
Figures 1. Site Vicinity Map

The subject property is bound by vacant land, residential and commercial property to the north across West 5th Street, a commercial property to the east, commercial property to the south across 3rd Street, and commercial property and vacant land to the west across Central Avenue. Refer to Figure 1 for a site vicinity map showing site features and surrounding properties.

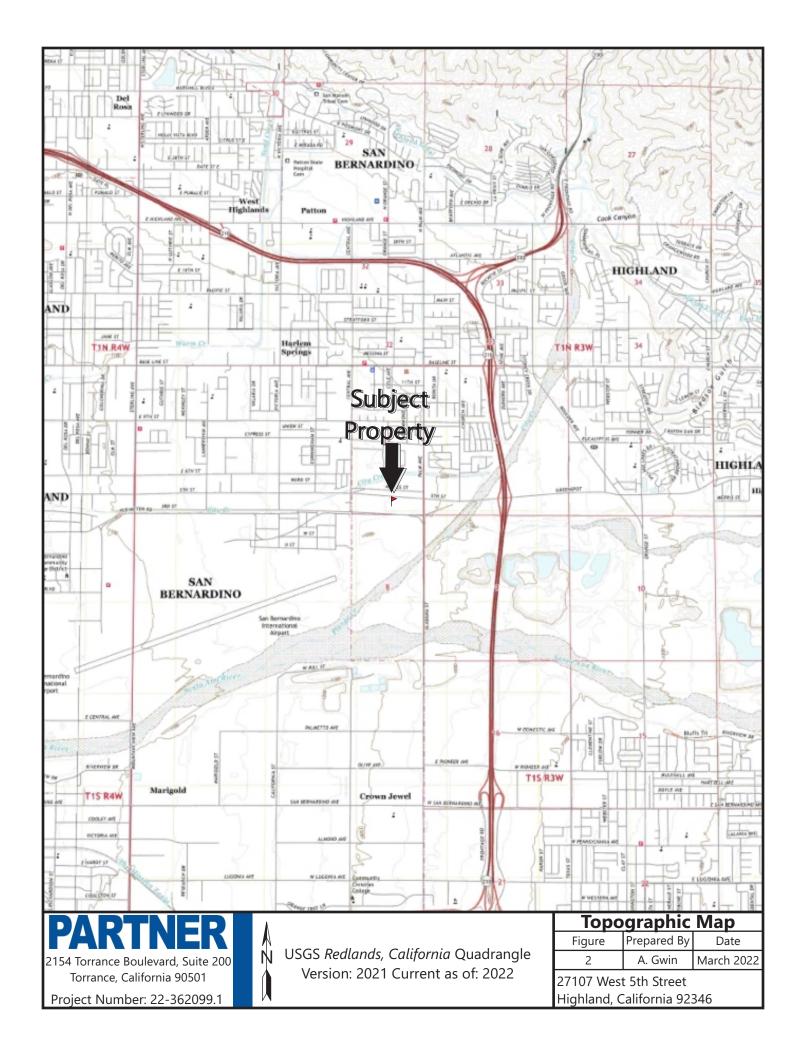
2. Topographic Map

Review of the United States Geological Survey (USGS) *Redlands, California* Quadrangle topographic map indicates the subject property is situated approximately 1,181 feet above mean sea level, and the local topography is sloping gently to the south. Refer to Figure 2 for a topographic map of the site vicinity.

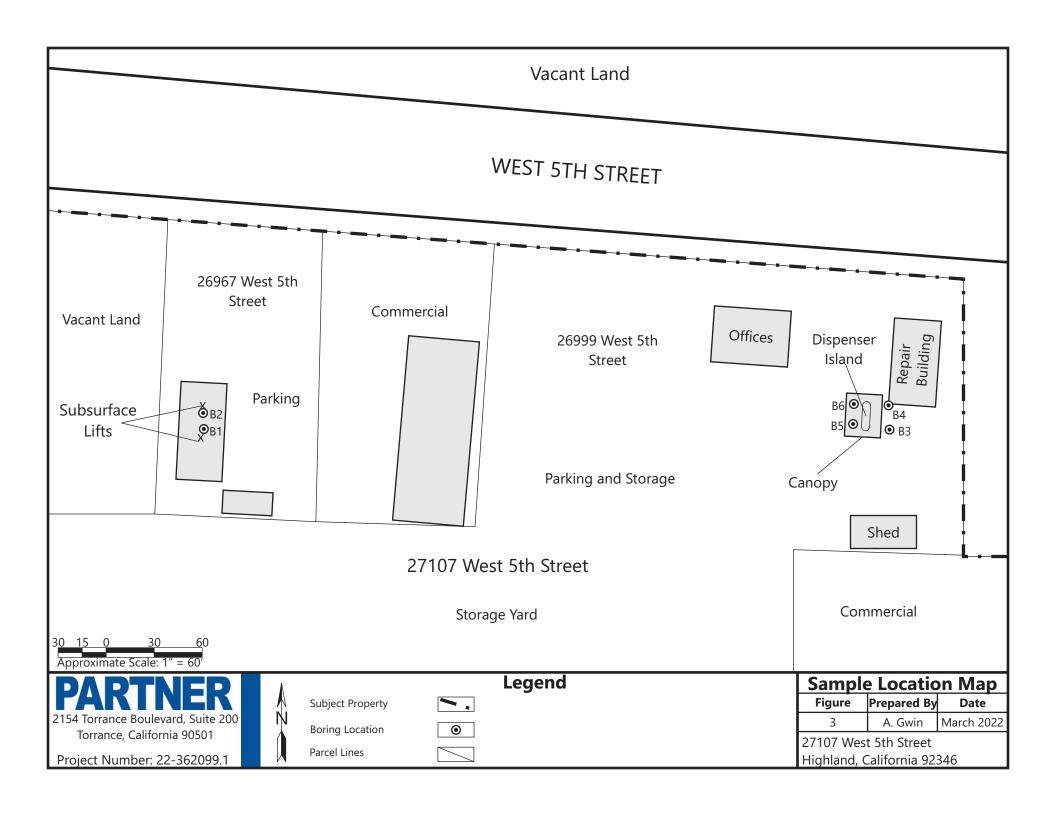
3. Sample Location Map

Borings B1 and B2 were advanced to the north of the southern subsurface lift and to the south of the northern subsurface lift, respectively. Borings B3 and B4 were advanced to the southeast and the northeast of the dispenser island, respectively. Borings B5 and B6 were advanced to the southwest and the northwest of the dispenser island, respectively. Placement of borings B3 and B4 was modified due to a vehicle blocking the area adjacent to the east side of the fuel canopy.

Refer to Figure 3 for a map indicating sample locations.
