Kopta Slough Riparian Habitat Restoration Plan

Sacramento River (RM 221.5)

January 2022

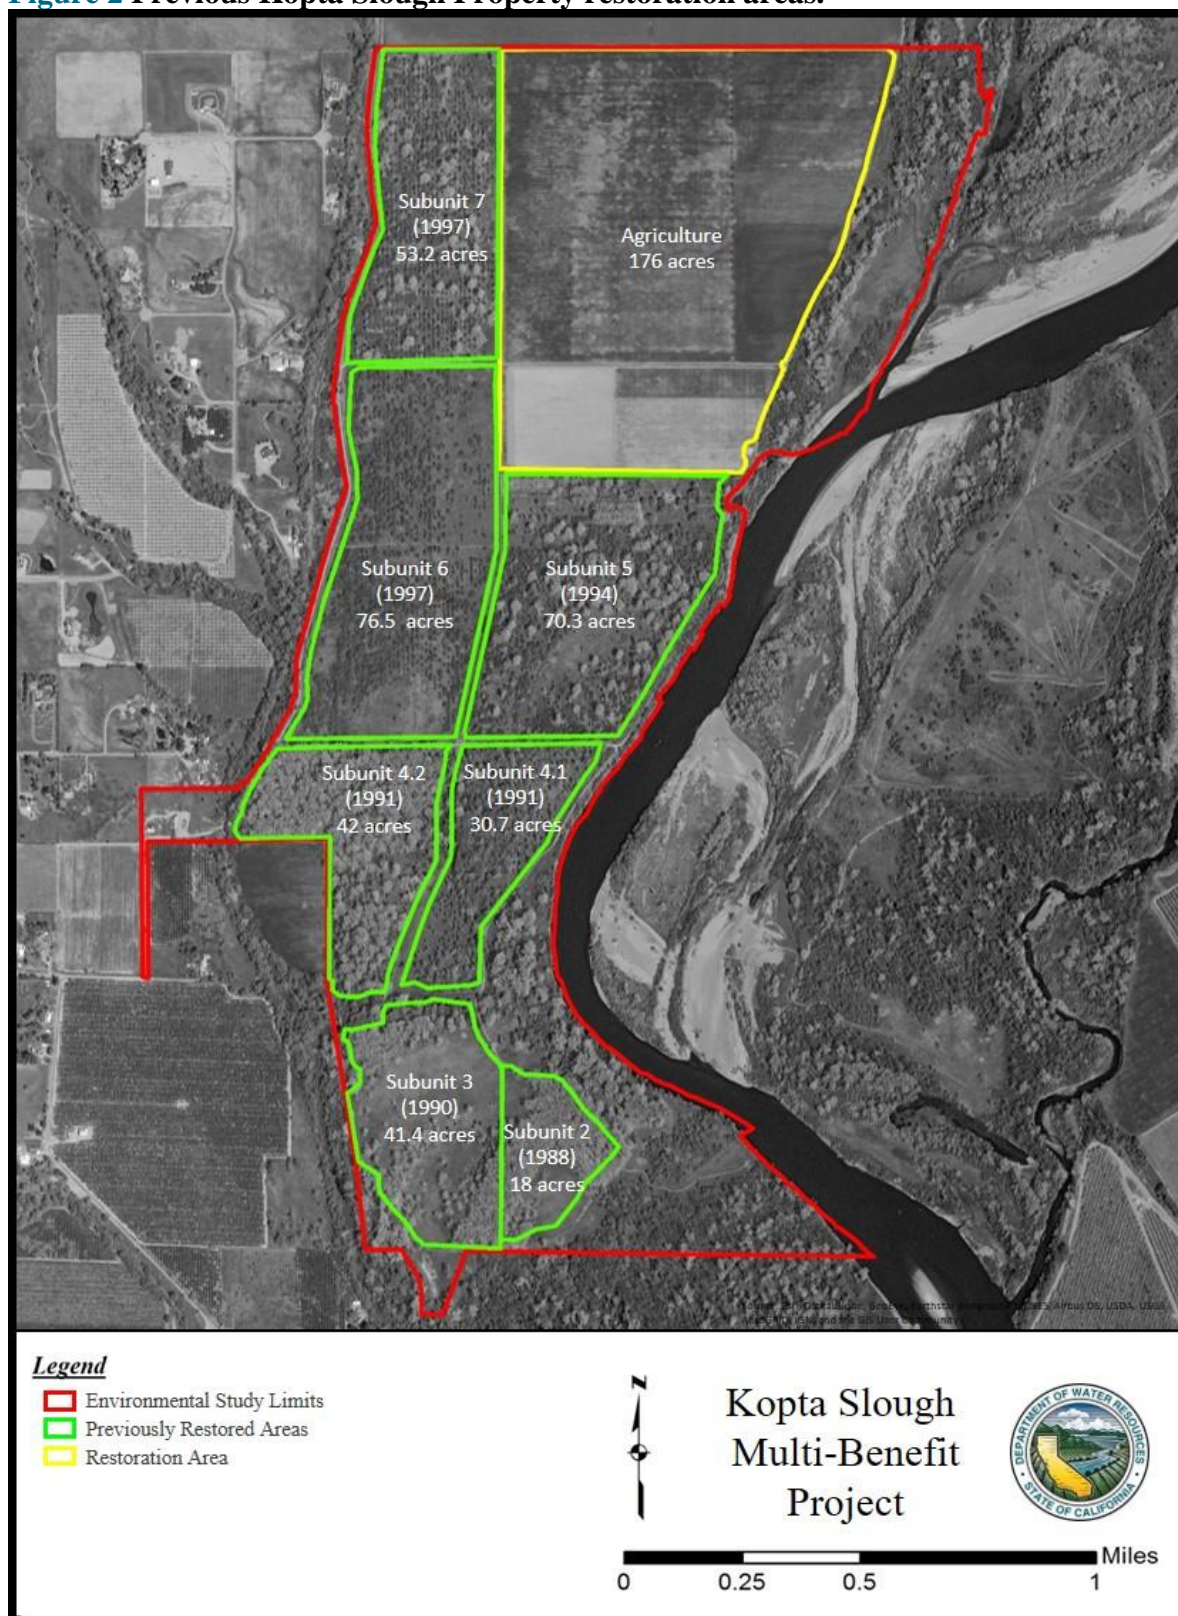
Figure 2 Previous Kopta Slough Property restoration areas.

The focus of this restoration plan is on riparian revegetation following an initial restorative action by the California Department of Water Resources. This DWR action involves removing approximately 5,600 linear feet of rock revetment along the Sacramento River's right bank at the Kopta Slough Property to create the dynamic hydrologic and geomorphic forces necessary for ecological restoration of the Sacramento River and its floodplain. It will also build on previous TNC restoration efforts, which since 1989 have restored 332 acres of the property (Fig. 2).

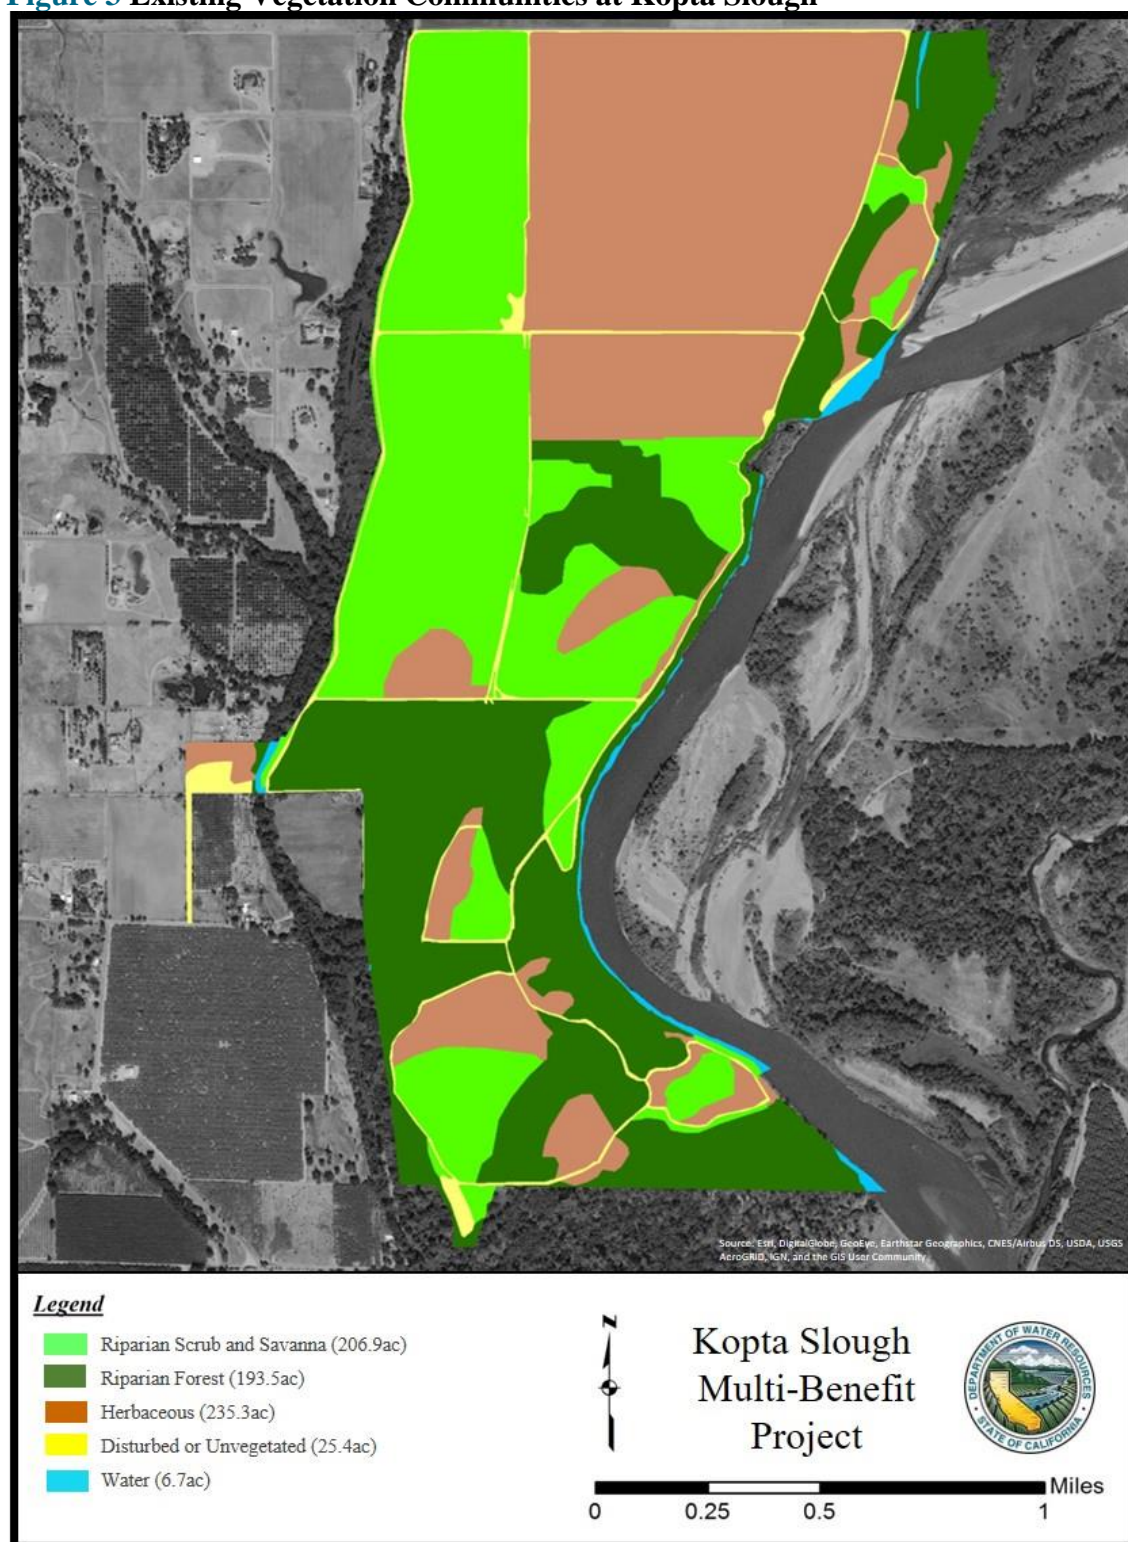
Figure 3 Existing Vegetation Communities at Kopta Slough

A vegetation map of the surrounding area was produced by CSU Chico's Geographic Information Center in 2008 (Figure 3). The remnant vegetation on the Kopta Slough Property is primarily found in lower lying areas than the proposed restoration area and is composed of willow stands, cottonwoods, and black walnut.
