Limited Phase II Environmental Site Assessment Report

**717, 725, 745, 807 and 825 East State Street;
810 East Main Street; 316 South Bon View Avenue;
and 235 South Campus Avenue
Ontario, California 91761**

**Converse Project No. 19-16-123-12
April 14, 2021**

**Converse Consultants
717 S. Myrtle Avenue
Monrovia, California 91016**

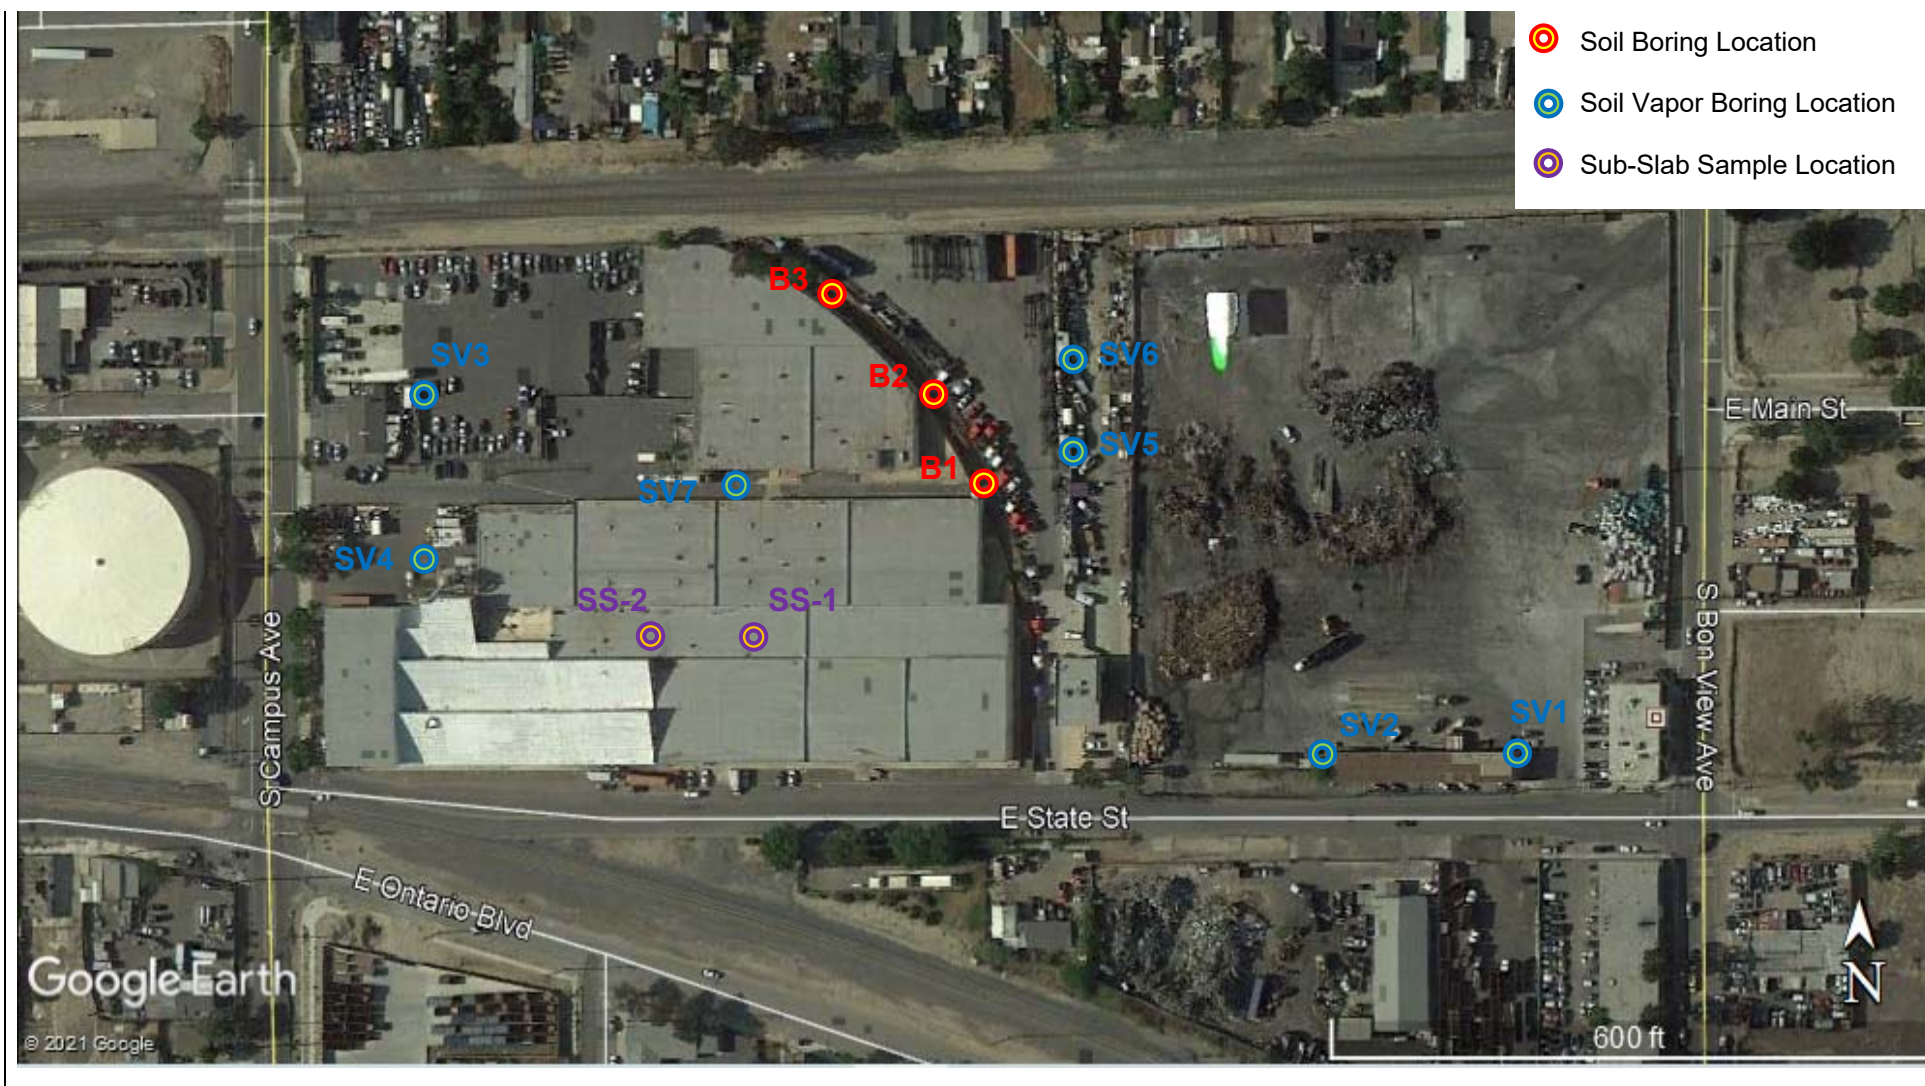
SAMPLE LOCATION MAP

- Two (2) sub-slab vapor sample points were installed at Site Parcel 5, in the interior of 745 E State Street, in the general vicinity of reported former spray booths.
- Two (2) borings were completed to depths of 15 feet bgs at Site Parcel 6 in the vicinity of hazardous materials storage areas. Soil vapor probes were installed at depths of 5 and 15 feet bgs.
- Analysis of soil, sub-slab, and soil vapor samples as follows:
 - Soil samples collected from borings B1, B2, and B3 were analyzed in accordance with EPA Methods 8081A for organochlorine pesticides (OCPs), 8141A for organophosphorus pesticides (OPPs), 8151A for Chlorinated Herbicides (CHs), and EPA Method 6010 for metals.
 - All sub-slab and soil vapor samples were analyzed by an onsite mobile laboratory for VOCs in accordance with EPA Test Method 8260B.

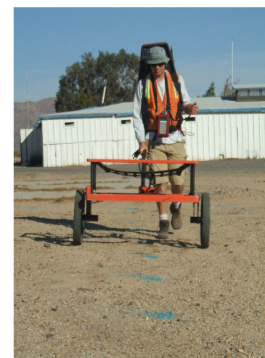
The EM-61 high-sensitivity metal detector was used in an effort to delineate areas where metallic objects (such as underground storage tanks and buried metal piping) may be buried. The EM-61 transmitter generates short pulses of a primary magnetic field that induces electromagnetic currents in nearby metallic objects. Between pulses, the two receiver coils measure the decay of these electromagnetic currents in millivolts (mV). The measured values are proportional to the metal content (ferrous and non-ferrous) of the nearby objects.

EM-61 data acquisition
(archive photo)

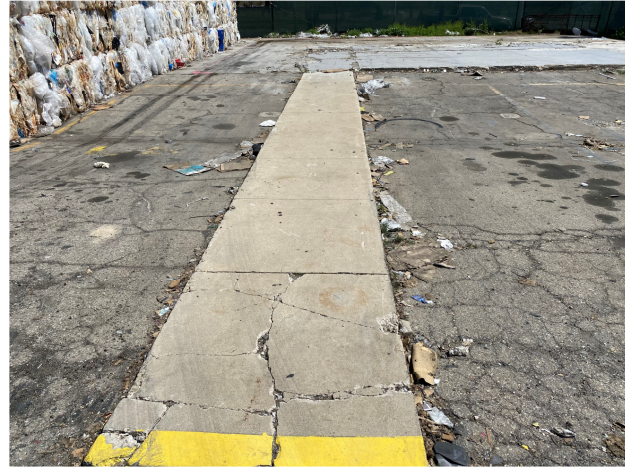
As most of the site was covered with large bundles of trash, only three areas on-site were able to be investigated using the EM-61. During this investigation, EM-61 readings were collected along roughly parallel survey lines spaced approximately 2.5 feet apart within the area of the investigation. These measurements were recorded at a rate of 5 readings per second and stored in the Archer digital field computer. GPS positions were streamed into the field computer at one second intervals, and the EM-61 measurements were interpolated between GPS positions. This resulted in a 1-foot station spacing on average. Survey lines were displayed on the field computer in real time for navigation. If the submeter accuracy was lost during data acquisition an alarm from the field computer was sounded and data acquisition was paused until accuracy was regained. These data were processed in the field and used to generate contour maps to assist in identifying anomalies that may be caused by large buried metallic objects like USTs. Linear EM-61 anomalies were relocated with the utility locating equipment.

Southwest portion of the property showing large bundles of trash, view is to the East

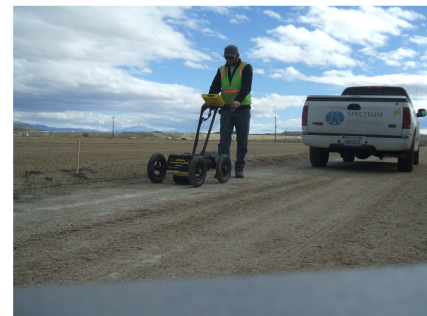
During GPR surveys, an antenna containing both a transmitter and a receiver is pushed along the ground surface. The transmitter radiates short pulses of high-frequency electromagnetic energy (with a center frequency of 500-MHz at this site) into the ground. As radio waves propagate into the ground, these signals are reflected at boundaries with contrasting electrical properties. These reflected signals are then received at the antenna and are displayed as vertical profiles on the GPR unit.

Data collection using the Noggin GPR (archive photo)

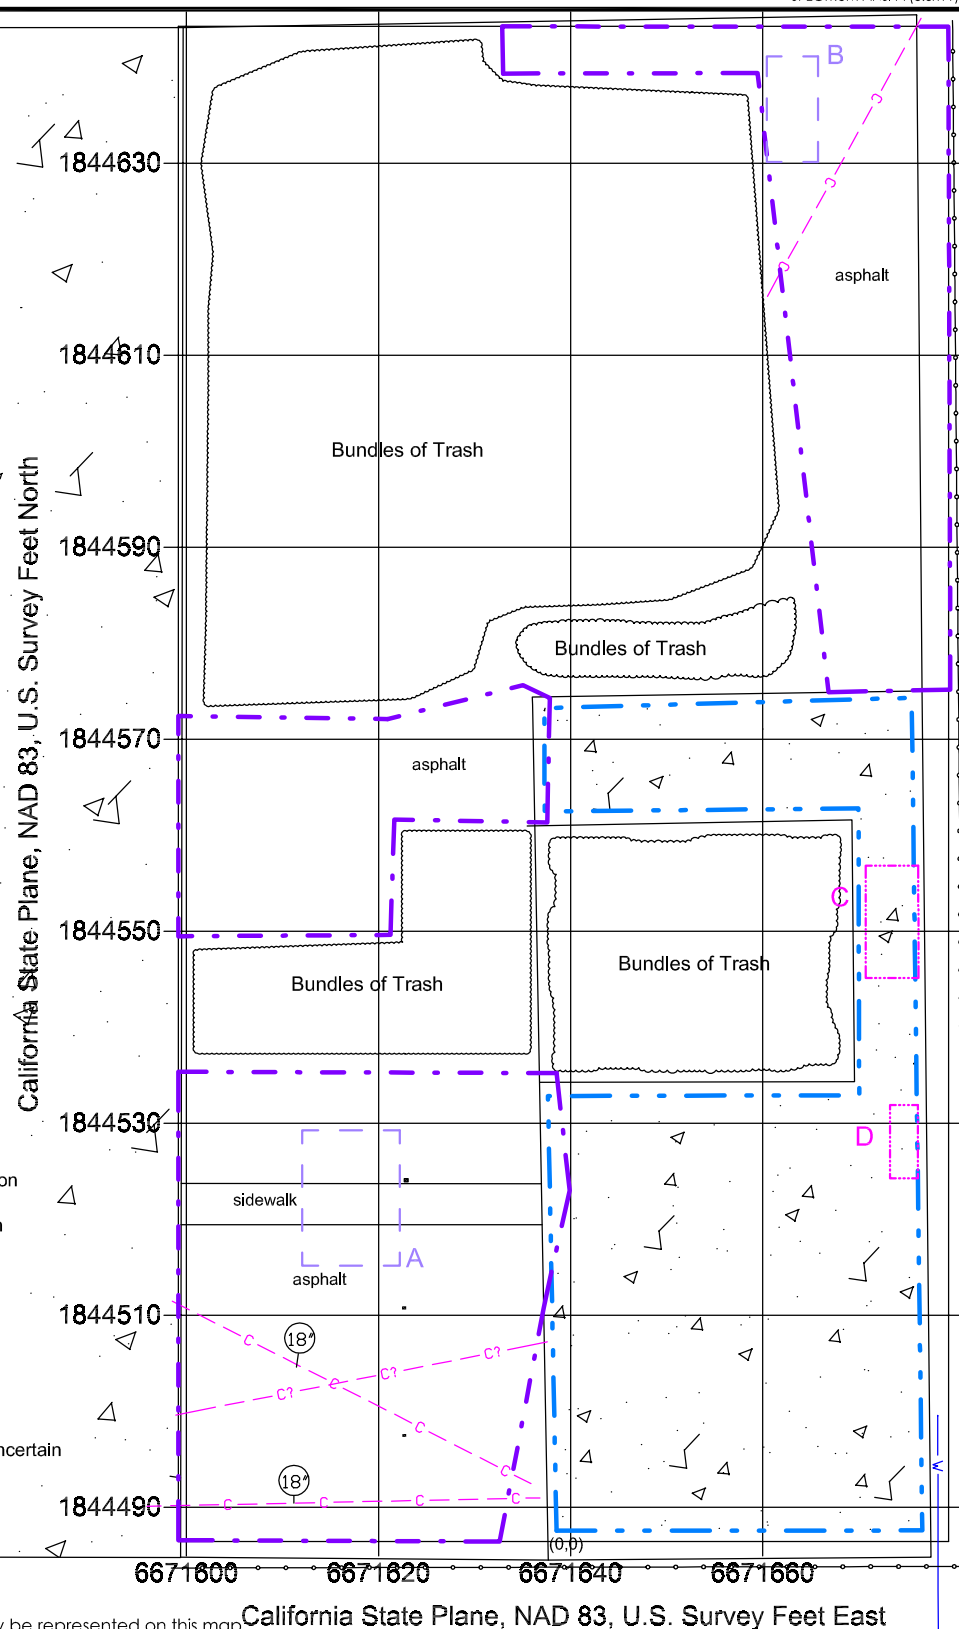
MAP		Geophysical Interpretation Map		FIGURE NO. A
PROJECT		Vacant Lot 316 S Bon View Ave Ontario, CA		
PREPARED FOR		Converse Consultants Costa Mesa, CA		PROJECT NO. 5126
SCALE	DWG BY	REVIEWED BY	DATE	
1 inch = 20 Feet	C.Embrey	BAU	4/9/21

- Anomaly B is an EM-61 anomaly. This anomaly is rectangular with approximate dimensions of 11 feet by 5 feet. EM-Utility locating methods and GPR provided no further information in the area, however, its close proximity to the large trash bundles could be the cause of this signature.

- Anomaly C is a GPR anomaly. This anomaly is rectangular with apparent dimensions of 12 feet by 5.5 feet. There were no surface features that might account for this anomaly however, its close proximity to the large trash bundles could be the cause of this signature.

It was also noted that the investigation was limited by the presence of large stacks of bundled trash, surface debris, metal fencing, and reinforced concrete. The signal penetration depth of the GPR for this site was estimated at approximately 3.5 feet, so it was also noted that it cannot be guaranteed that subsurface features such as USTs are not present below this depth.

The findings of the geophysical survey were inconclusive and it is possible that USTs may still be present at the Site. No further action is recommended at this time, as the current use of the Site is likely to prevent conclusive findings with regard to the potential presence of USTs. It is noted that care should be taken when conducting redevelopment or other subsurface activities in the vicinity of Site (Parcel 1) currently addressed as 316 S Bon View Avenue to prevent damage to potential USTs that could result in a release. If UST are encountered, then they should be appropriately removed under regulatory oversight.

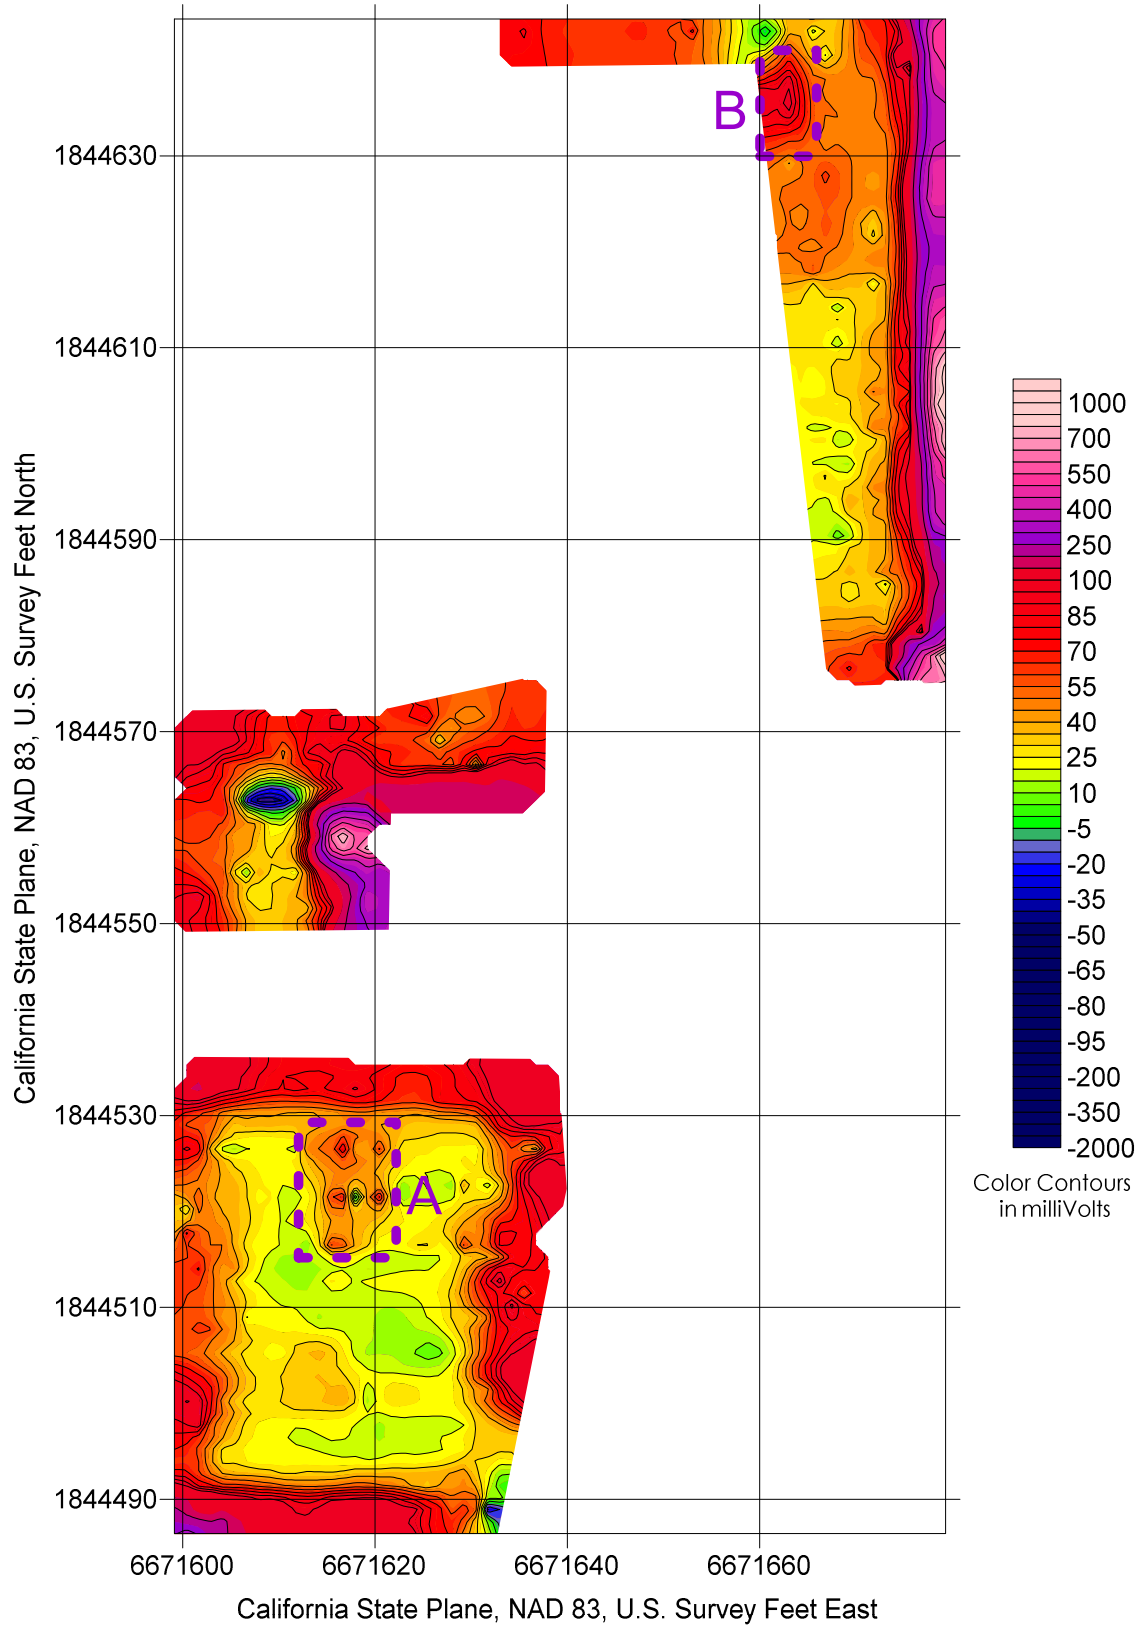
Moderate-high to high amplitude EM-61 differential anomalies were identified along the edges of each section of data most likely caused by the perimeter fence, large bundles of trash and the remnants of the reinforced concrete foundation. A negative amplitude EM-61 differential anomaly was identified in the middle data set, most likely caused by surface metal or metal in the very shallow subsurface.
