Trinidad Water Storage Tank and Pipeline Replacement Project

Public Circulation Initial Study & Proposed Mitigated Negative Declaration

City of Trinidad

January 20, 2023

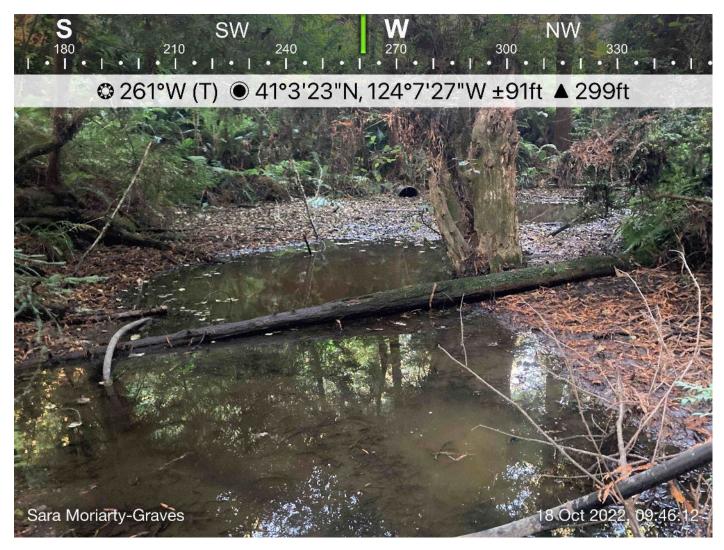
Photo C-4. Standing water present adjacent to the PSB (and within the BSA), near the access road to the water tank.

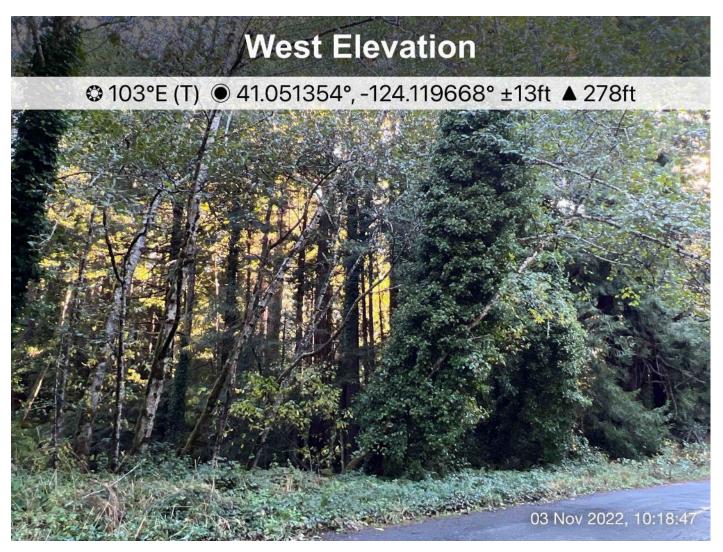
Photo C-8. View of riparian habitat and degraded roadside habitat invaded by English ivy above Deadman's Creek culvert under Westhaven Drive.

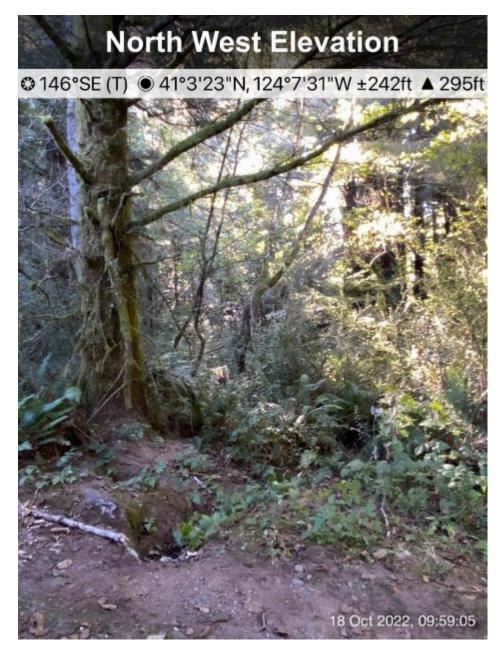
Photo 1. Location of UP1 depression adjacent to the access road to the water tanks.

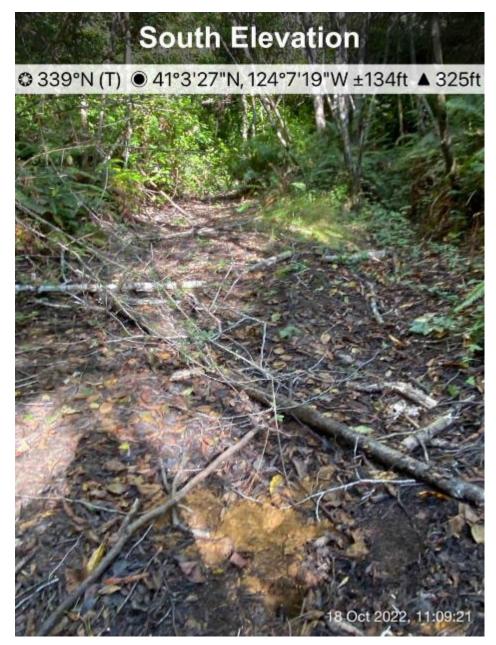
Photo 2. Location of UP2 in the old railroad grade east of the water tanks.

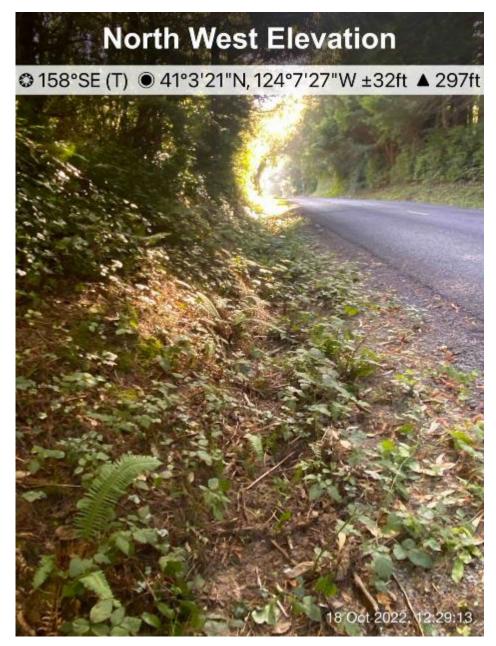
Photo 3. Location of UP3 which is a ditch that is hydrologically connected to Wetland 1, a 1-parameter wetland.

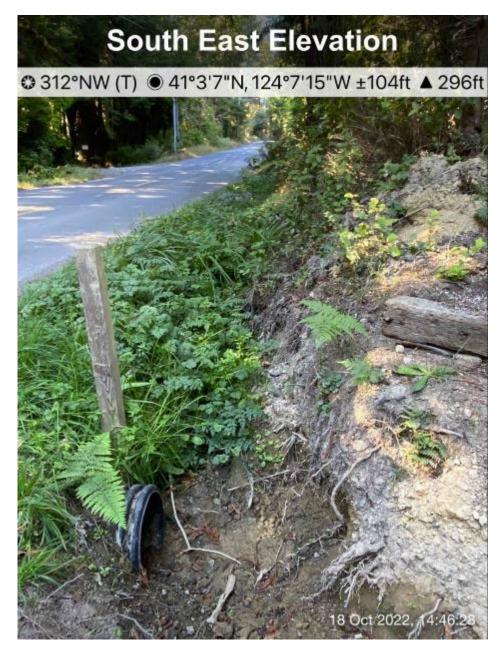
Photo 5. Wetland 3 (3-parameter wetland) ditch and culvert that crosses underneath Westhaven Drive.

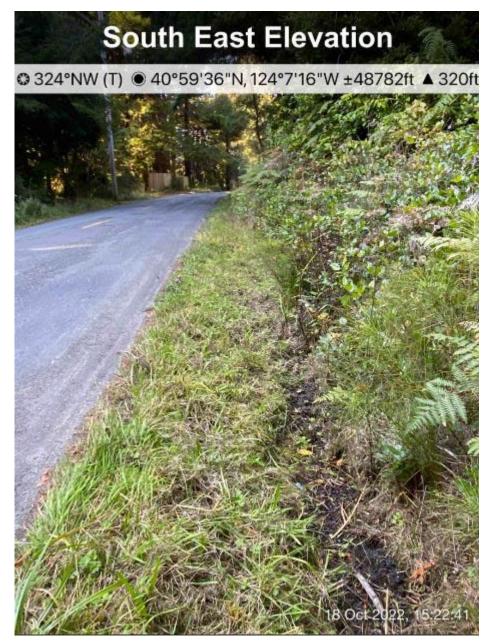
Photo 6. Northern end of Wetland 3 ditch.

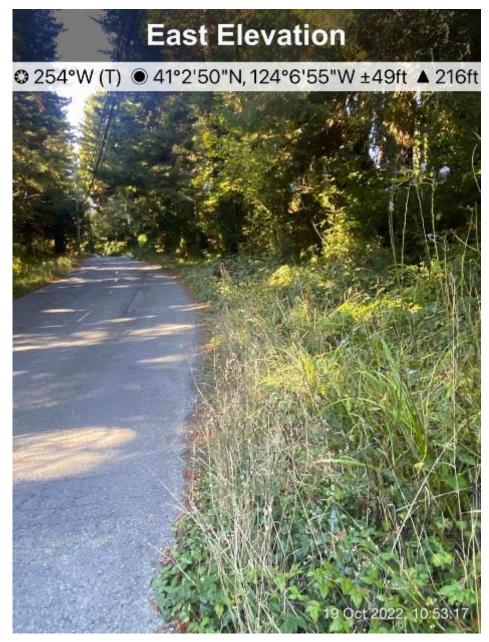
Photo 7. Wetland 5 ditch (1-parameter wetland).

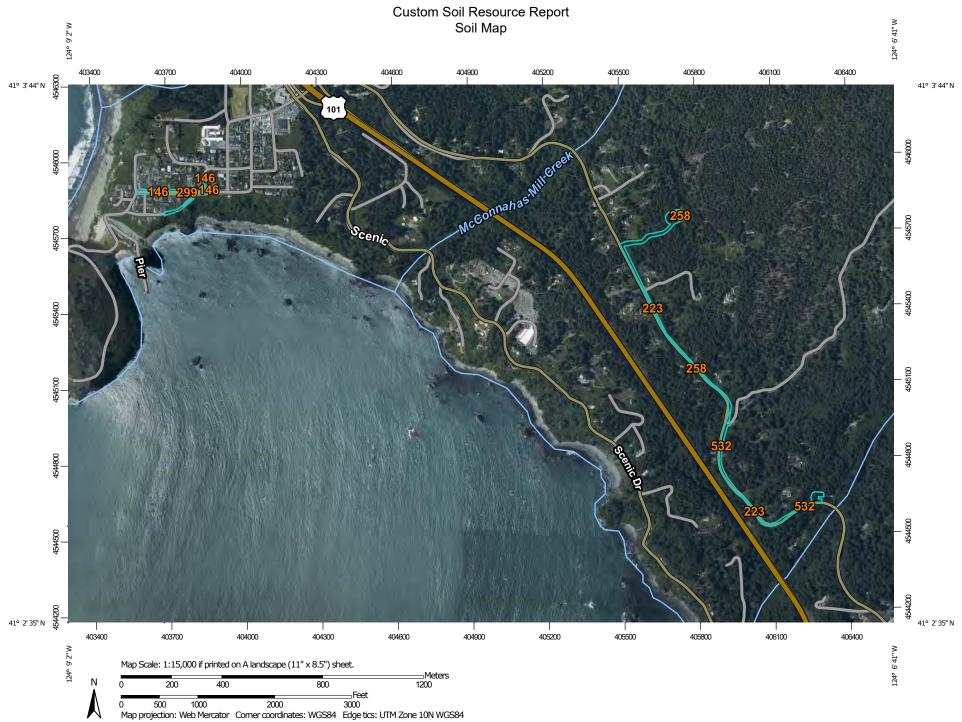
Soil Map

The soil map section includes the soil map for the defined area of interest, a list of soil map units on the map and extent of each map unit, and cartographic symbols displayed on the map. Also presented are various metadata about data used to produce the map, and a description of each soil map unit.
