Phase I Environmental Assessment Report

**PHASE I
ENVIRONMENTAL ASSESSMENT REPORT**

**APN 380-290-002
WILDOMAR, CA**

PROJECT NO. 257922

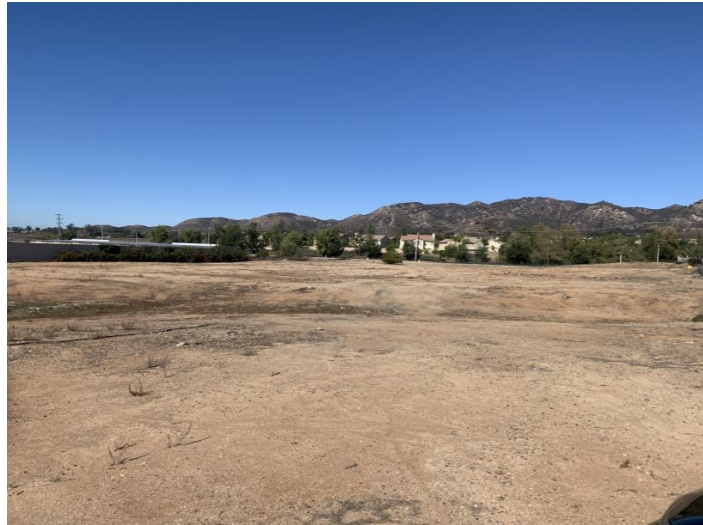
Photo 1

Viewing the site from near its southeastern corner; facing north-northwest

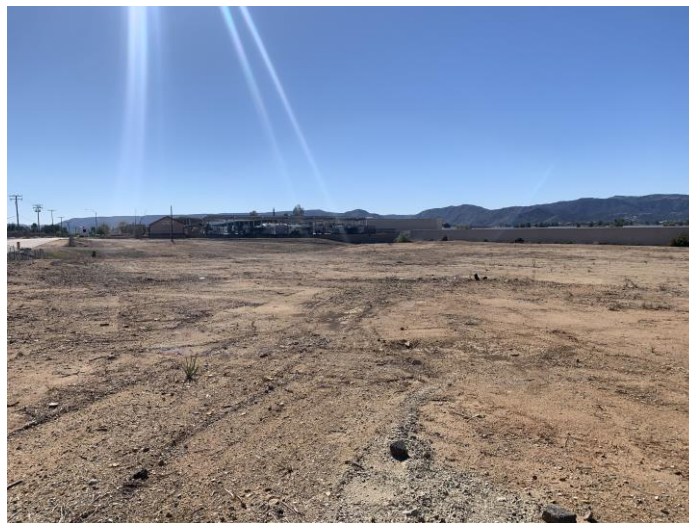
Photo 2

Viewing the site from near its northeastern corner; facing south-southwest

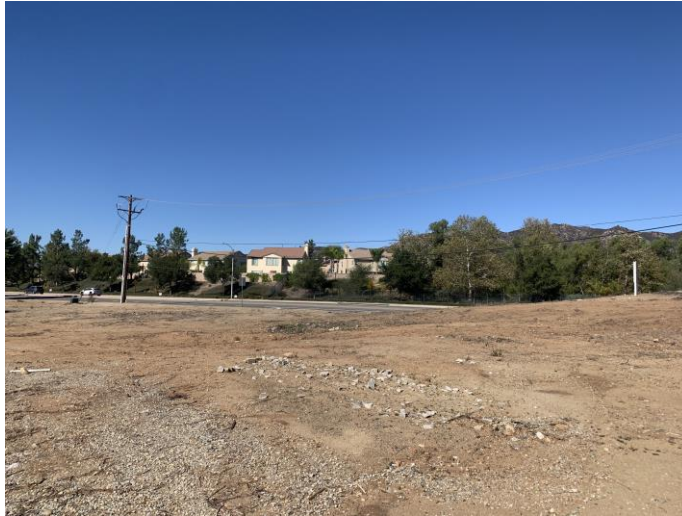
Photo 3

Viewing the northern end of the site with residential community, across Clinton Keith Road, to the north of the site on the back (facing northwest)

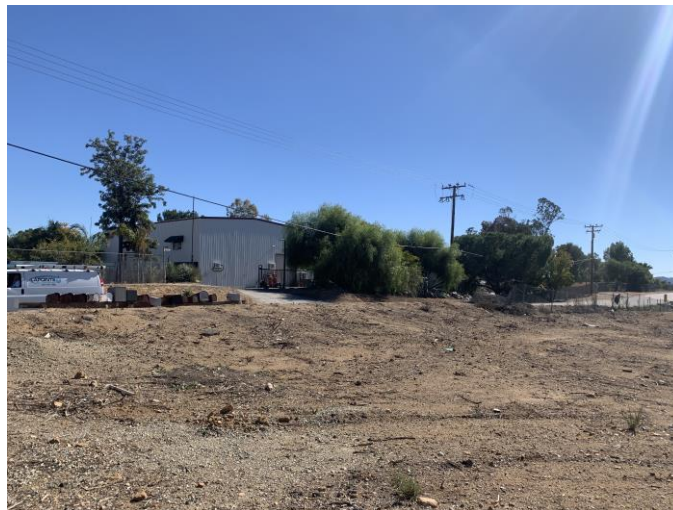
Photo 4

Viewing the eastern portion of the site with various residential/light industrial properties, across Jana Lane, to the east of the site (facing south-southeast)

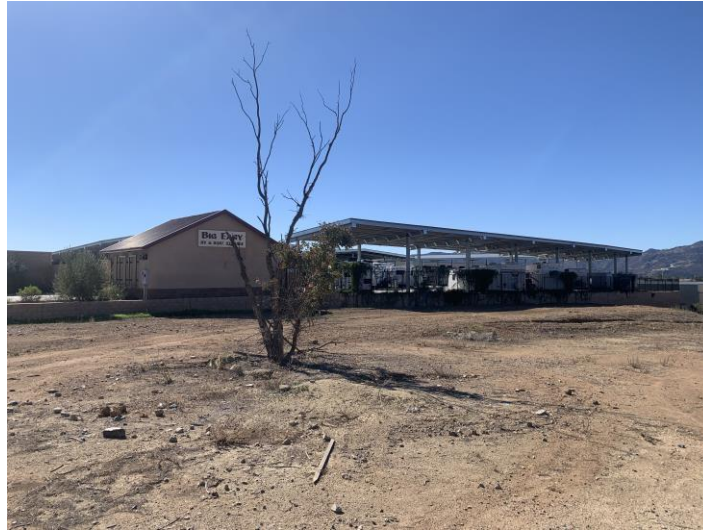
Photo 5

Viewing the southern end of the site with Big Easy Storage (36215 Jana Lane) to the south of the site on the back (facing southwest)

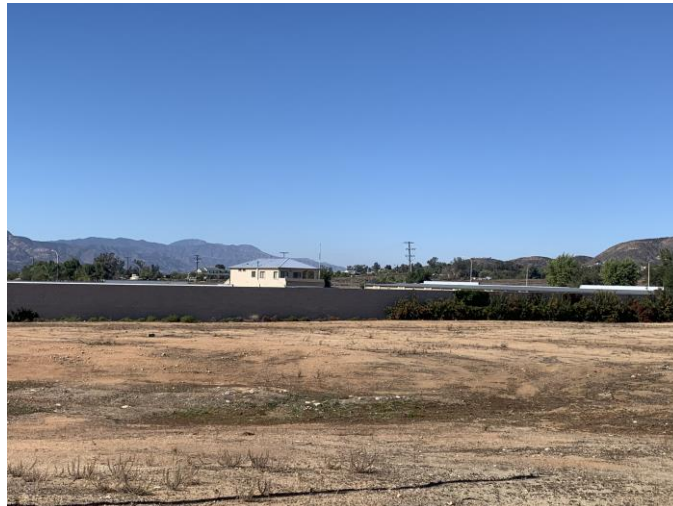
Photo 6

Viewing the central and the west-central portions of the site with Life Storage –Wildomar (24781 Clinton Keith Road) to the west of the main portion of the site on the back (facing northwest)

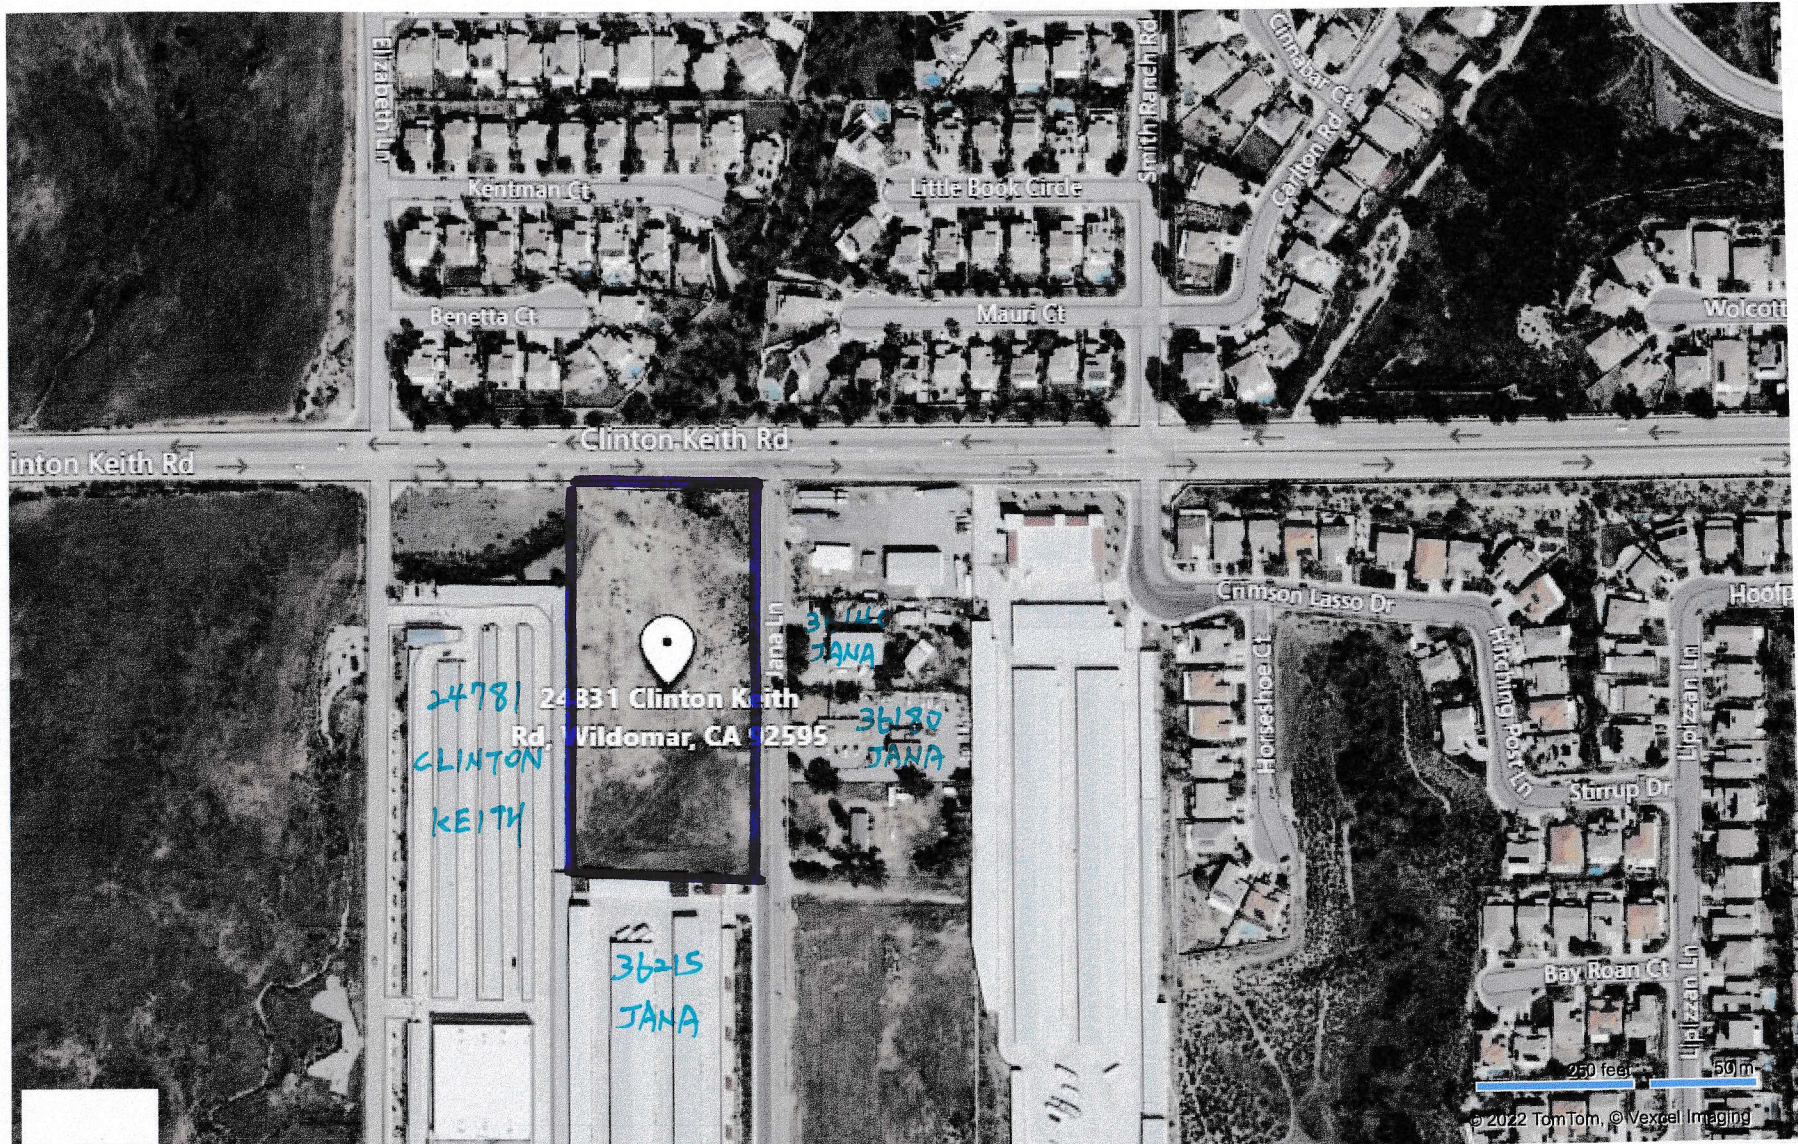
FIGURE 3

**RECENT AERIAL PHOTO SHOWING SITE/ITS VICINITY GENERAL
LAYOUT**
