CarMax Redlands, CA

**West Lugonia Avenue and New York Street**

Redlands, San Bernardino County, California

Phase I Environmental Site Assessment Re:

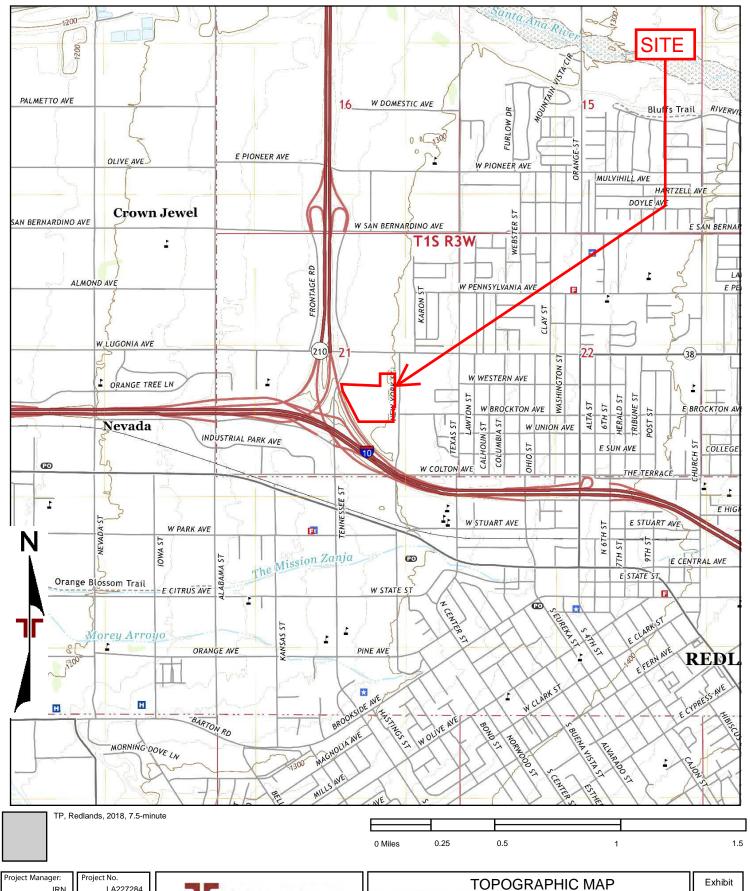
# APPENDIX A EXHIBIT 1 – TOPOGRAPHIC MAP EXHIBIT 2 – SITE DIAGRAM

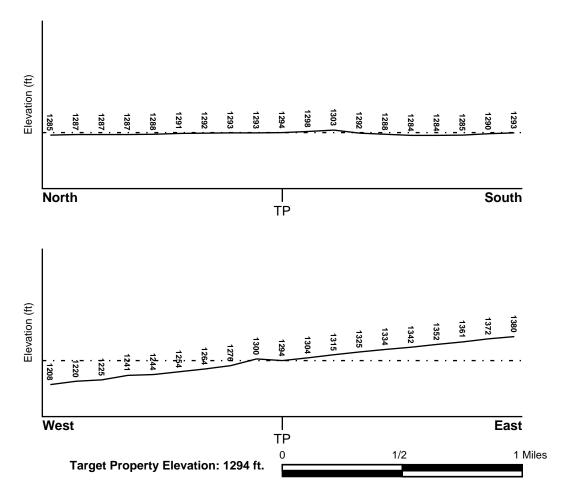
#### SURROUNDING TOPOGRAPHY: ELEVATION PROFILES

General Topographic Gradient: General West

Source: Topography has been determined from the USGS 7.5' Digital Elevation Model and should be evaluated on a relative (not an absolute) basis. Relative elevation information between sites of close proximity should be field verified.
