GEOLOGIC RECONNAISSANCE

AVION SAN DIEGO, CALIFORNIA

**JANUARY 19, 2018
PROJECT NO. G2213-32-01**

Subject: GEOLOGIC RECONNAISSANCE
AVION
SAN DIEGO, CALIFORNIA

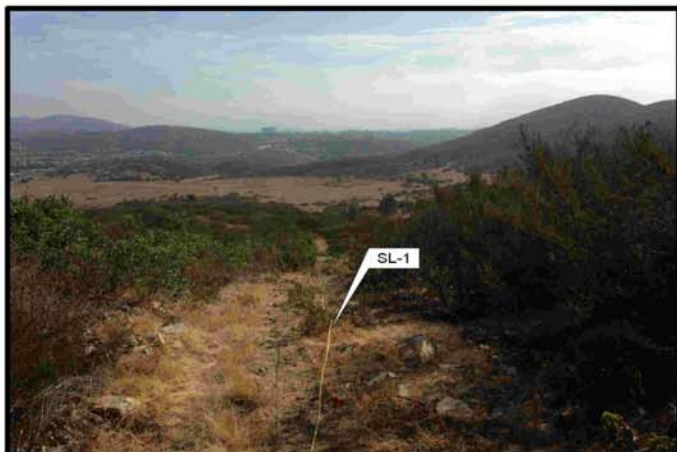
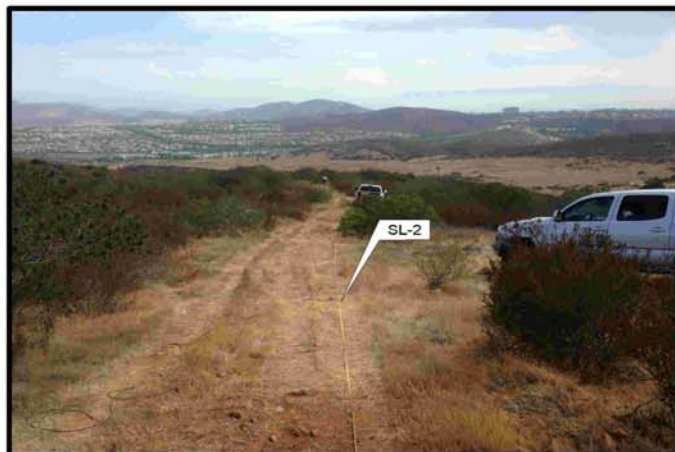
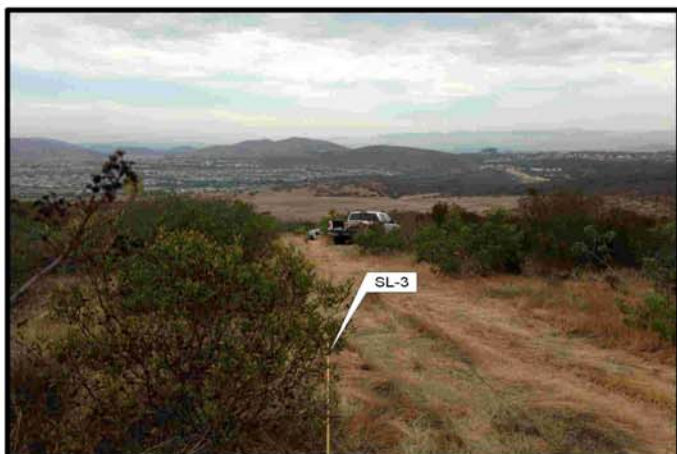
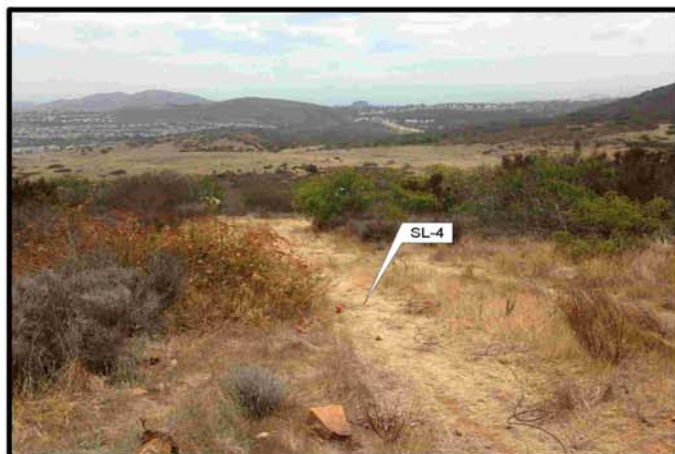
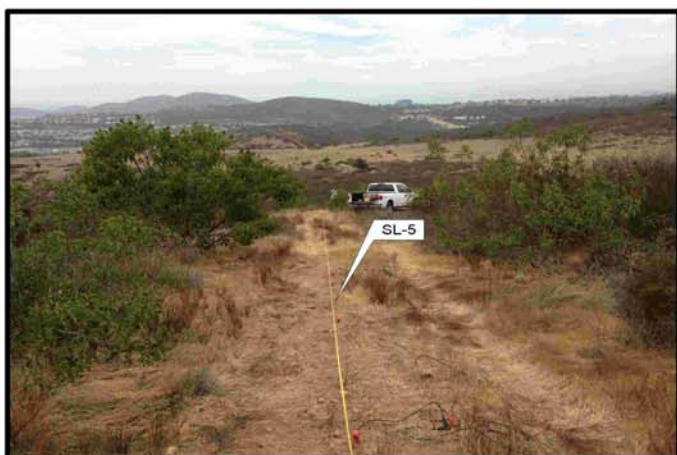
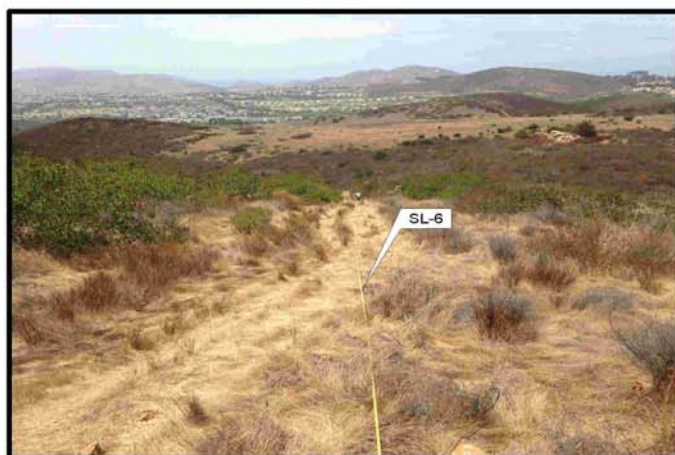
SITE PHOTOGRAPHS

The project site is located along the south side of Bernardo Center Drive and is accessed at the south side of the intersection of Dove Canyon Road and Bernardo Center Drive (Figures 1 and 2). The study area is located along a dirt road which generally follows a south to north trending ridge. Vegetation in the area of the lines primarily consists of sage brush, scattered trees, and annual grass. Fragments of metavolcanic rock were observed in and near the study area; however, no undisturbed outcrops were observed in the area of the lines. Figures 2 and 3 depict the general site conditions.
