**FAULT RUPTURE HAZARD
INVESTIGATION**

**PROPOSED MULTI-FAMILY
RESIDENTIAL DEVELOPMENT
HAWTHORNE BOULEVARD AND
VIA VALMONTE
TORRANCE, CALIFORNIA**

PROJECT NO. A9201-06-01C

JANUARY 21, 2016

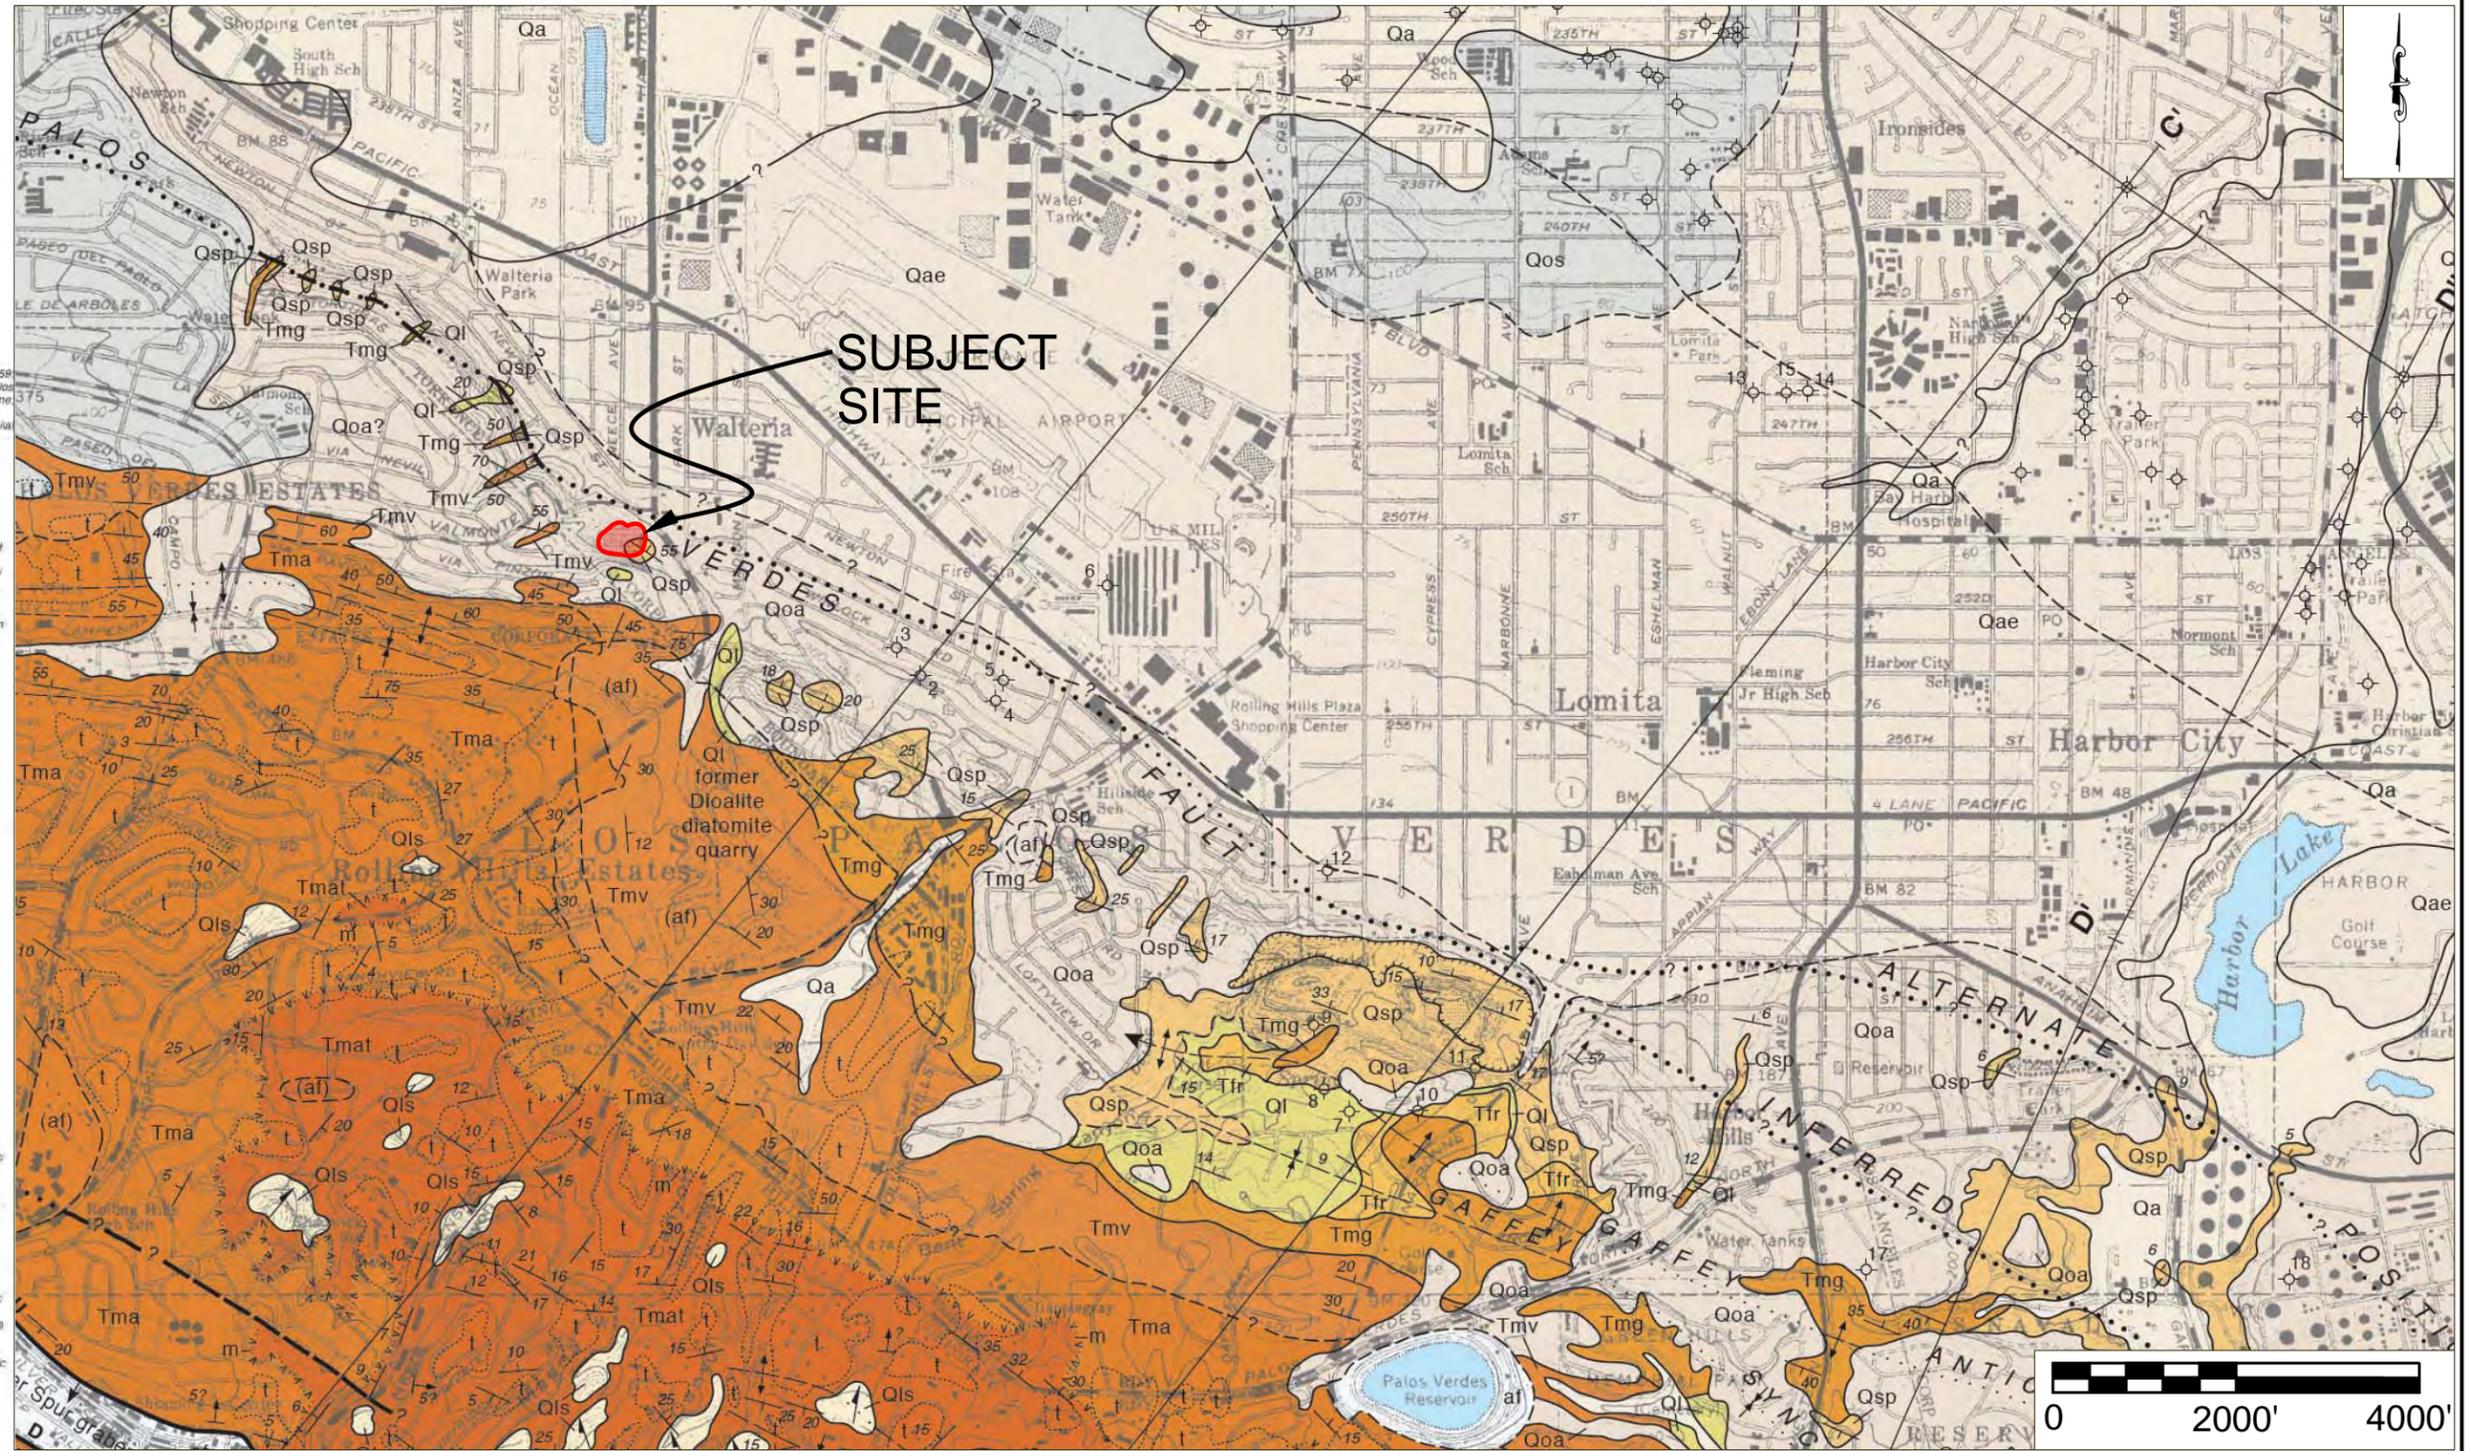
As shown on the geologic map in Figure 4, the site is located near several inferred splays of the Palos Verdes Fault. The location of the fault in this area is poorly constrained, but was inferred to be near the base of the slope based on the idea that the strong lineament defining the base of the slope is a direct reflection of the fault's location (ECI, 2005). The ECI (2005) report discusses splays of the fault mapped by Dibblee (1999), Stephenson et al. (1995) and Jennings (1994) and lineaments identified by Rockwell (2005), all which are located offsite. The closest splay of the fault, as shown in the City of Torrance Safety Element of the General Plan, is inferred by Stephenson et al. (1995) and Dibblee (1999) and trends northwest along Via Valmonte from the intersection of Hawthorne Boulevard. Because of the uncertainty in the precise fault location, the city has established a Fault Hazard Management Zone for the Palos Verdes Fault Zone that is several hundred feet wide, surrounding the inferred fault location. As noted on Figure 3, the northern and eastern portions of the site are located within the city-designated Fault Hazard Management Zone.

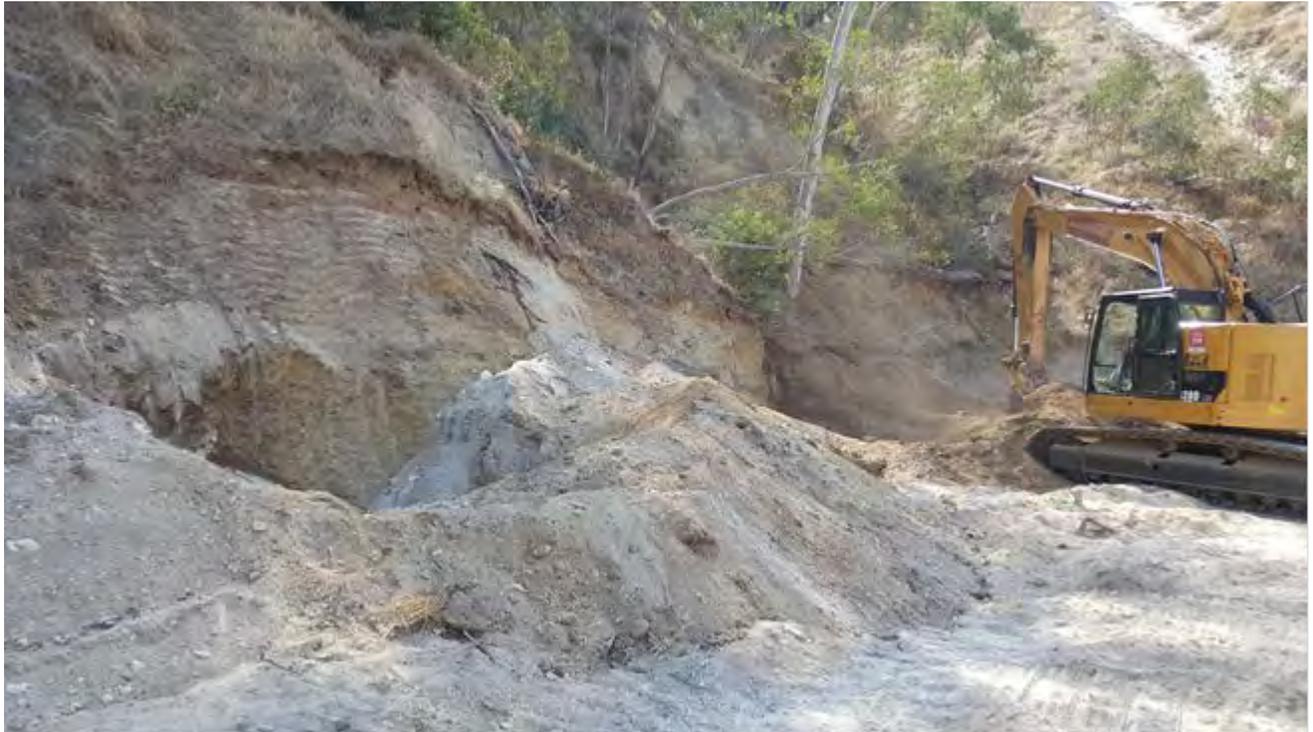
Photo 11: Excavator Pot-Holing along North-Facing Slope

“Pot-holing” was performed along the base of the north-facing slope along the southern project boundary to determine if the contact between the San Pedro Sand and the underlying sedimentary bedrock of the Monterey Formation is faulted or depositional. The locations of the pot-holes are shown on Figure 2.

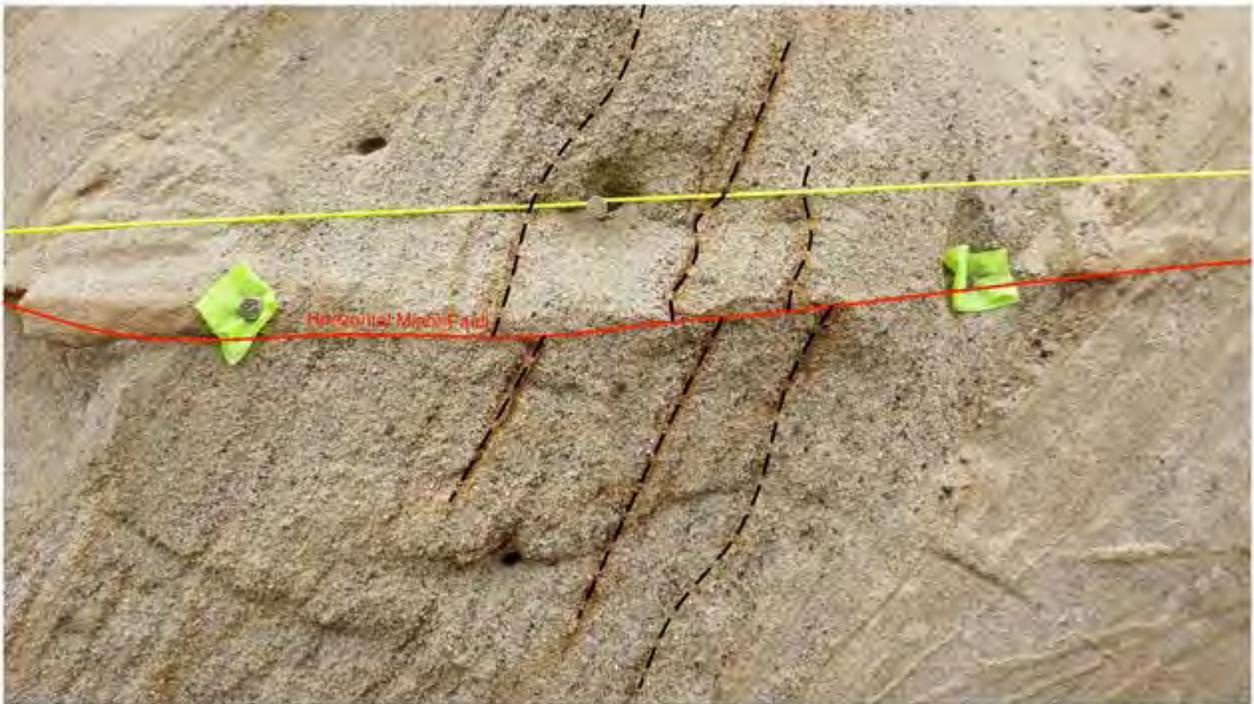
Trench 1: Station 0+36 Closeup of Offset Beds

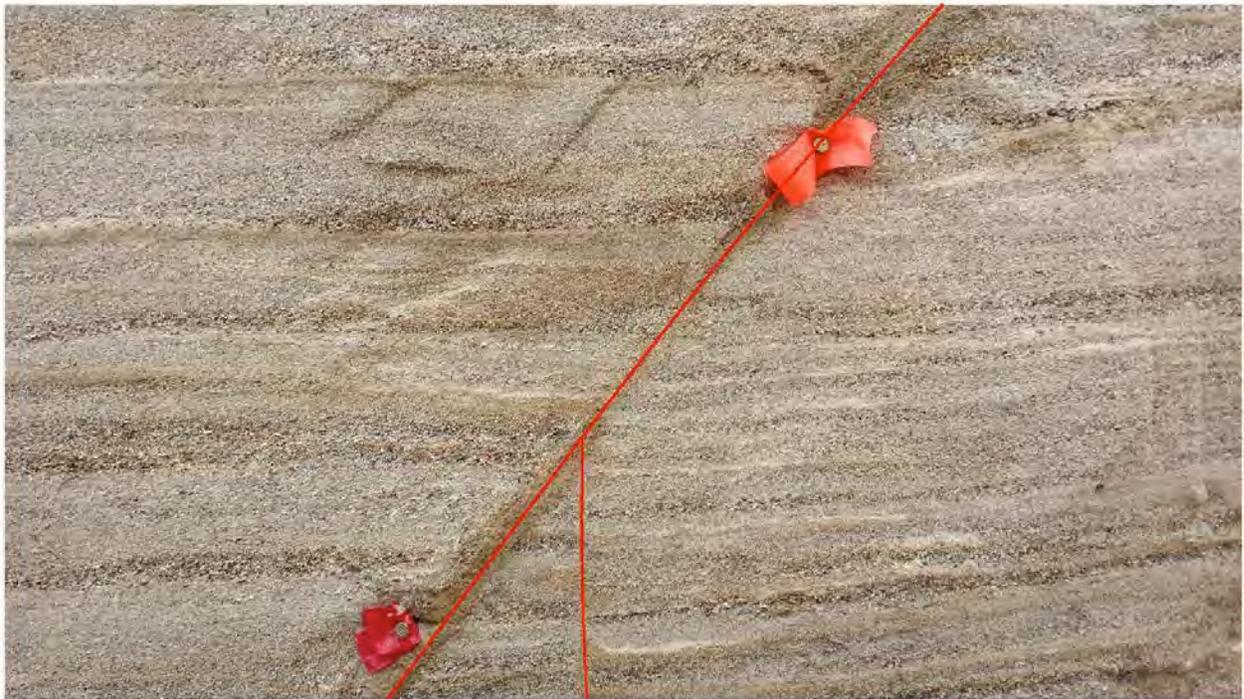
Trench 1: Station 0+60 Closeup of Offset Beds
