COOKE PROPERTY
VALLEJO, CALIFORNIA

PRELIMINARY GEOTECHNICAL REPORT

April 17, 2017

Project No.
13495.000.000

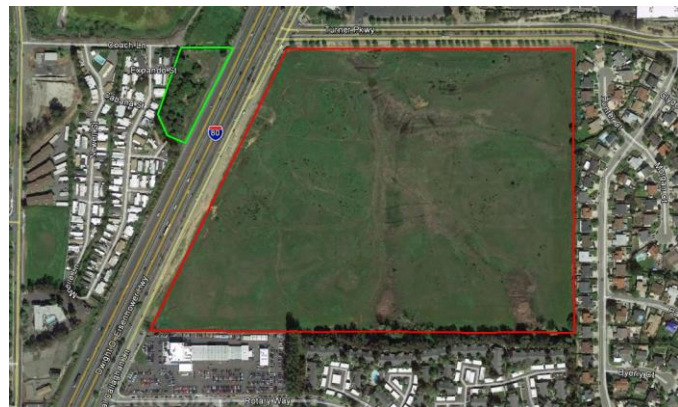
FIGURE 1.2-1: Cooke Property - Eastern & Western Parcels

The subject property is located southeast of the intersection of Turner Parkway and Admiral Callaghan Lane and southeast of Coach Lane in Vallejo, California, as shown on the Vicinity Map, Figure 1 (attached). As shown in Figure 1.2-1, the property is split by Interstate 80 into two parcels, one to the west of Interstate 80, and the other to the east. The eastern approximately 51.3-acre parcel is located south of Turner Parkway and east of Admiral Callaghan Lane. The western approximately 1.5-acre parcel is located

at the end of Coach Lane. The properties are identified by Assessor's Parcel Numbers (APN) 814-900-10 and 523-202-50 for the eastern and western sites, respectively.

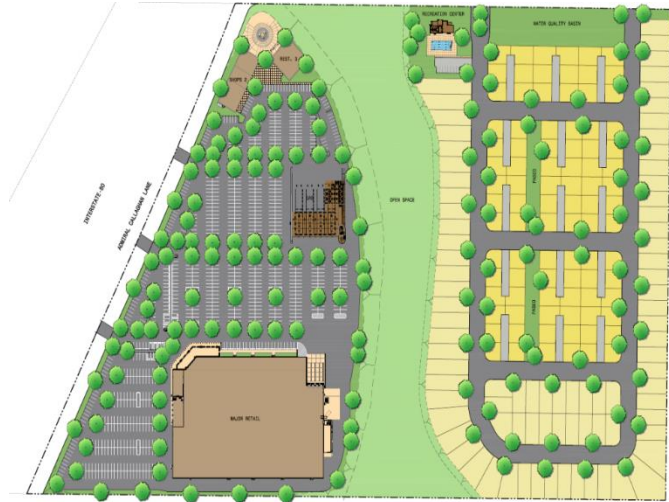
FIGURE 1.3-1: Preliminary Site Plan – Eastern Parcel

Based on our discussions with you and review of the information provided, we understand that the site is to be developed for residential and commercial use. Based on a conceptual layout provided, as shown in Figure 1.3-1, development is primarily planned on the eastern parcel. Development along the western side is to include a major retail building, shops, a rest area, and a gas station, while the eastern portion is to include residential housing, several driveways, paseos, a recreation center with a pool, and a water quality basin. The central portion of the development center is planned for open space. Development plans for the western parcel are not yet known.

No grading plans have been developed at this time; however, the conceptual layout suggests the site will be graded to match the adjacent streets. This would require cuts up to approximately 20 feet and fills up to approximately 12 feet. We anticipate the commercial areas will include typical paved parking, drive aisles, trash enclosures, and exterior flatwork and the retail building and shops will be typical one-story retail construction. We anticipate the residential area to single or multi-family one- to two-story wood-frame structures with associated parking, sidewalks, and underground utilities.

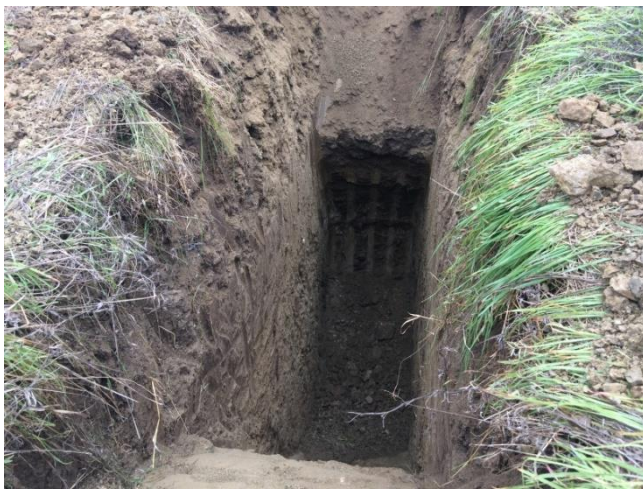
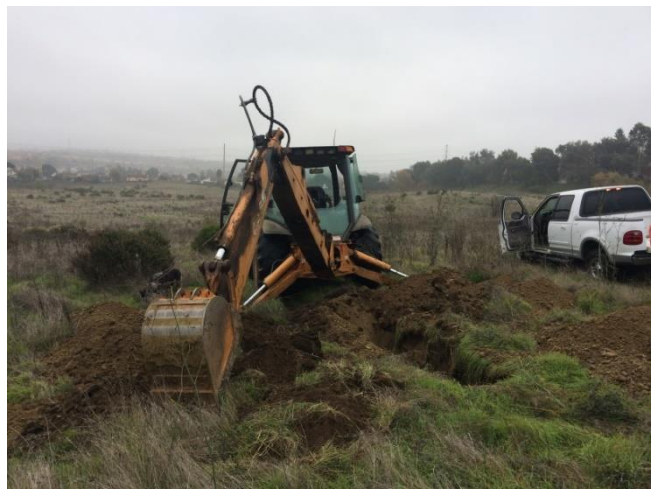
| Depth (Feet) | Description | Depth of Test (Feet) | Plasticity Index | Expansion Index | Laboratory Moisture Content% | Unconfined Compression (Tsf) *field approx |
|---|---|---|---|---|---|---|
| 6 | Very thin bedding | | | | | |
| 10 | Bottom of test pit at 10 feet. No groundwater encountered. | | | | | |

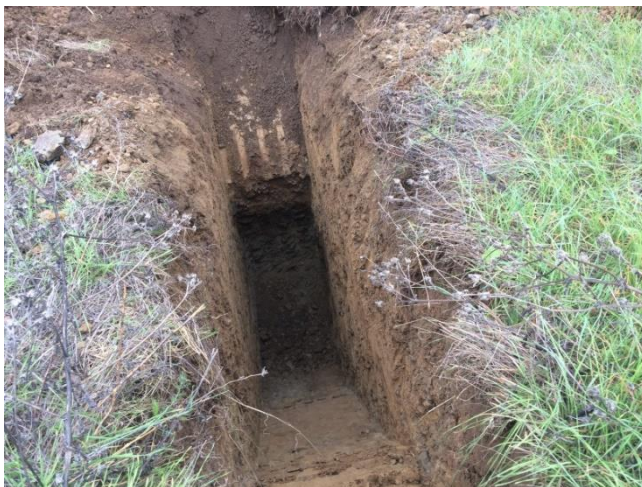
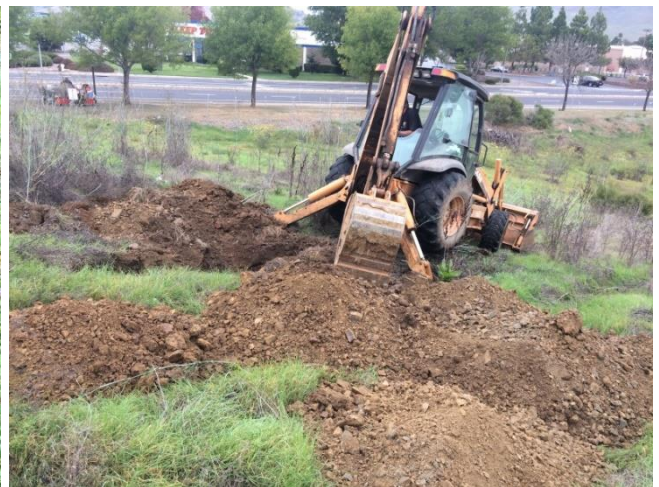
TEST PIT LOG 1-TP2

| Depth (Feet) | Description | Depth of Test (Feet) | Plasticity Index | Expansion Index | Laboratory Moisture Content% | Unconfined Compression (Tsf) *field approx |
|---|---|---|---|---|---|---|
| 5 – 10 | SILTSTONE dark gray, medium strong, moderately weathered, moderately to closely fractured, thin bedding | | | | | 4.5* |
| 10 | Bottom of test pit at 10 feet. No groundwater encountered. | | | | | |

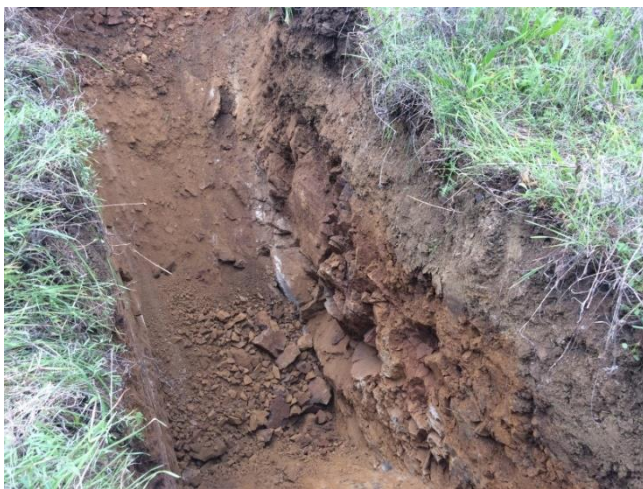
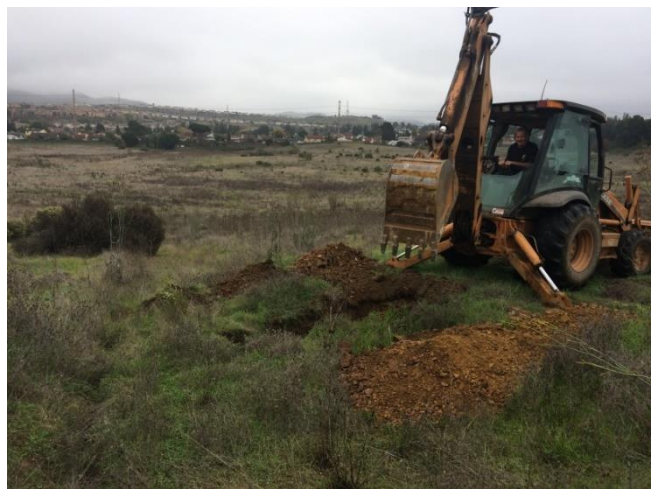
TEST PIT LOG 1-TP3

We used a 590 CASE backhoe during our exploratory work and were able to excavate to the target test pit depth of 10 feet at six of the eight exploration locations. Backhoe refusal was encountered at locations TP-3 and TP-6 at depths of 4½ and 2½ feet below existing grade. Based on these results, it is our opinion that conventional grading equipment will likely be able to excavate the soil, siltstone, and claystone with only moderate effort; however, larger equipment and greater effort will be needed for excavations extending into the sandstone. We recommend further exploration be performed as part of the design level geotechnical study to further evaluate excavatability.

| Depth (Feet) | Description | Depth of Test (Feet) | Plasticity Index | Expansion Index | Laboratory Moisture Content% | Unconfined Compression (Tsf) *field approx |
|---|--|---|---|---|---|---|
| 1½ - 4½ | SANDSTONE yellowish brown to red, strong to very strong, slightly weathered, moderately fractured, thinly bedded | | | | | |
| 4½ | Refusal to excavation at 4½ feet. No groundwater encountered. | | | | | |

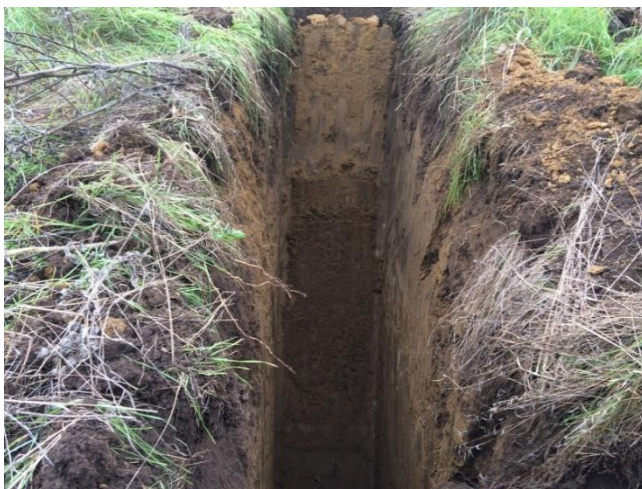
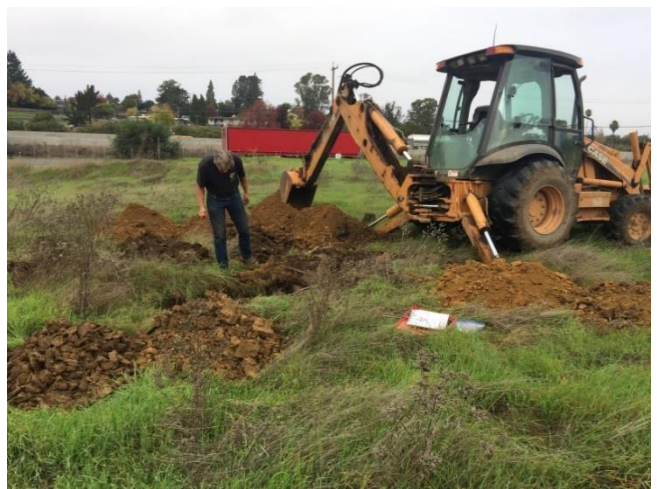
TEST PIT LOG 1-TP4

| Depth (Feet) | Description | Depth of Test (Feet) | Plasticity Index | Expansion Index | Laboratory Moisture Content% | Unconfined Compression (Tsf) *field approx |
|---|---|---|---|---|---|---|
| 6½ - 10 | CLAYEY SAND WITH GRAVEL (SC) orange brown, hard, moist, some sub-rounded cobble up to 8", black charcoal, fine to coarse grained sand | | | | | |
| 10 | Bottom of test pit at 10 feet. No groundwater encountered. | | | | | |

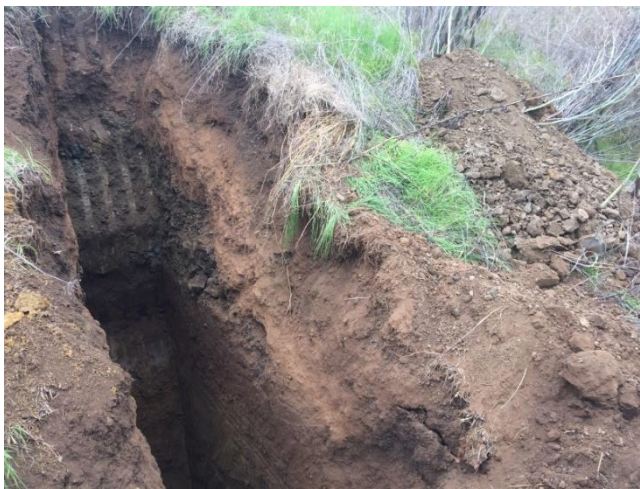
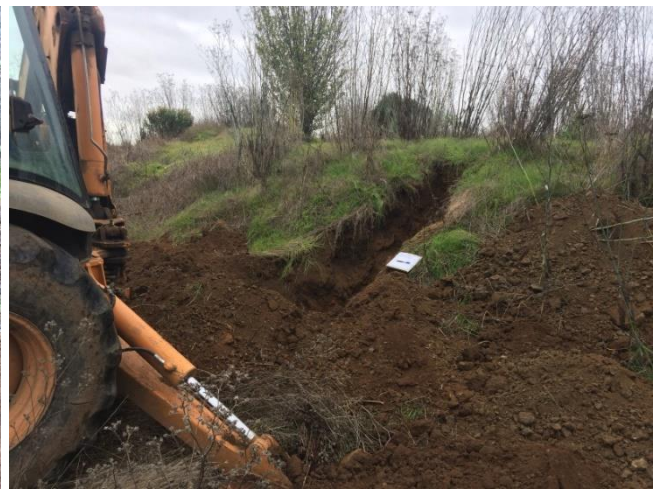
TEST PIT LOG 1-TP5

| Depth (Feet) | Description | Depth of Test (Feet) | Plasticity Index | Expansion Index | Laboratory Moisture Content% | Unconfined Compression (Tsf) *field approx |
|---|--|---|---|---|---|---|
| 8½ - 14 | LEAN CLAY WITH SAND (CL) yellowish brown, very stiff, moist, medium plasticity | 9 | | | 22.2 | 4.0* |
| 14 | Bottom of test pit at 14 feet. No groundwater encountered. | | | | | 3.5* 4.5+* |

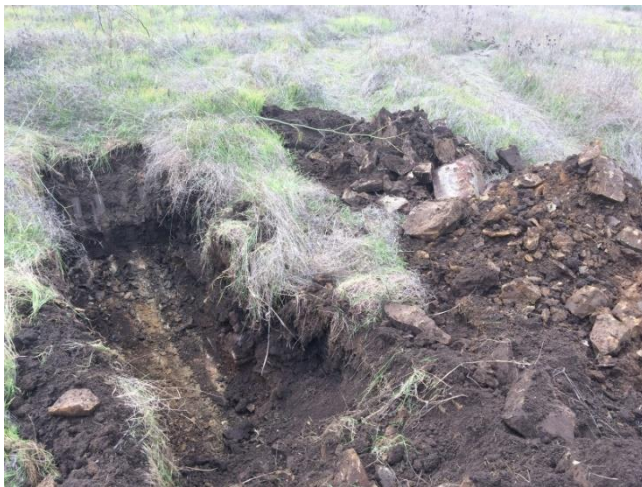
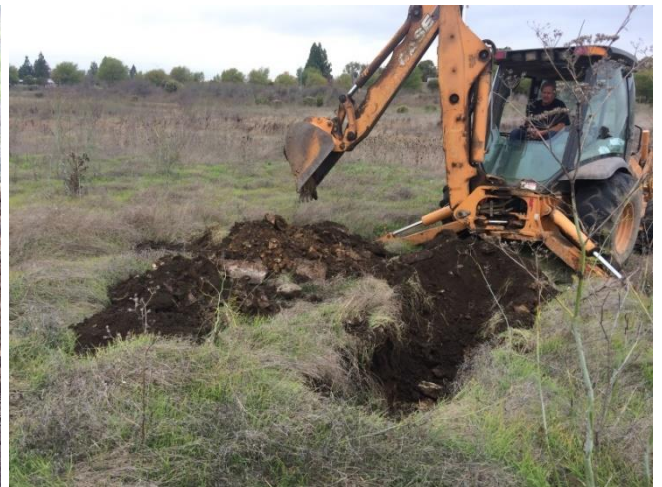
TEST PIT LOG 1-TP6

| Depth (Feet) | Description | Depth of Test (Feet) | Plasticity Index | Expansion Index | Laboratory Moisture Content% | Unconfined Compression (Tsf) *field approx |
|---|--|---|---|---|---|---|
| 2 | Angular boulders up to 24" near bedrock surface | | | | | |
| 2½ | Excavation refusal at 2½ feet. Backhoe teeth smoking on sandstone. No groundwater encountered. | | | | | |

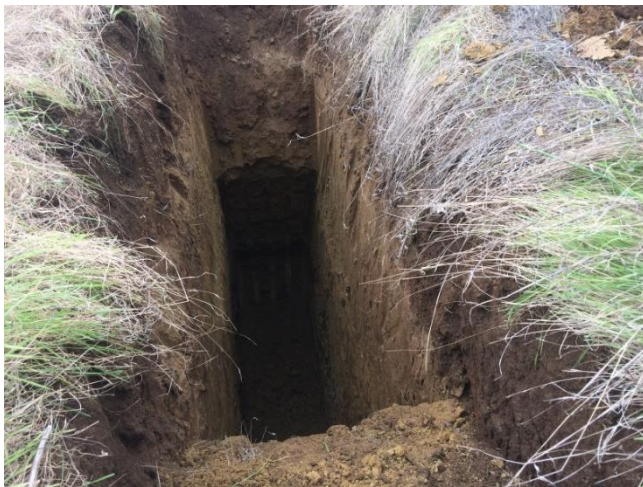
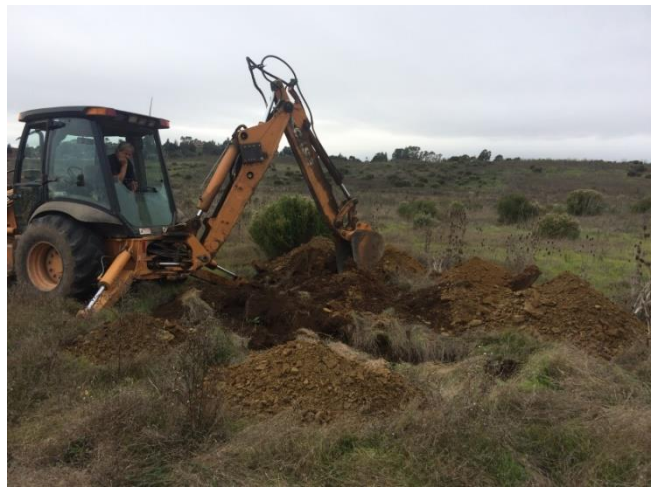
TEST PIT LOG 1-TP7

| Depth (Feet) | Description | Depth of Test (Feet) | Plasticity Index | Expansion Index | Laboratory Moisture Content% | Unconfined Compression (Tsf) *field approx |
|---|--|---|---|---|---|---|
| 7 – 11 | SILTSTONE AND CLAYSTONE greenish brown to brown, medium strong, moderately weathered, closely fractured, very thin bedding | | | | | |
| 11 | Bottom of test pit at 11 feet. No groundwater encountered. | | | | | |

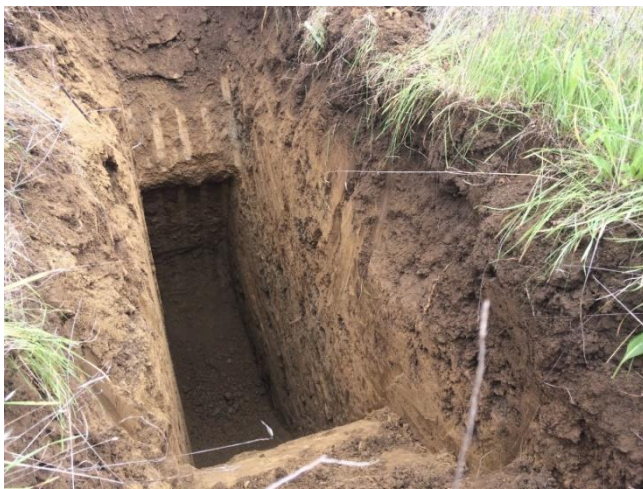
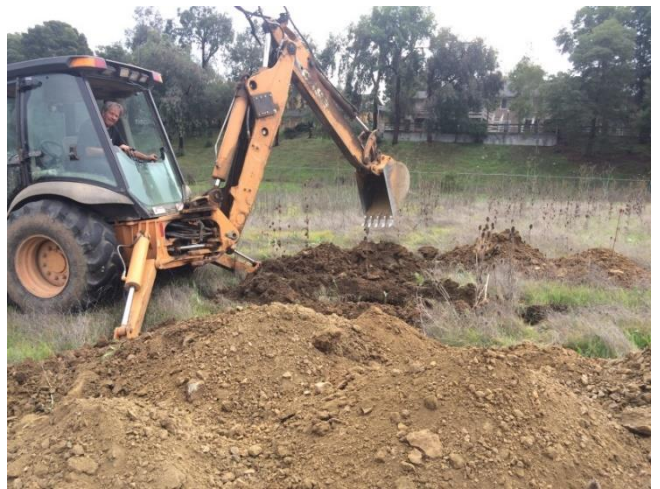
TEST PIT LOG 1-TP8

| Depth (Feet) | Description | Depth of Test (Feet) | Plasticity Index | Expansion Index | Laboratory Moisture Content% | Unconfined Compression (Tsf) *field approx |
|---|---|---|---|---|---|---|
| 6 – 10 | SILTSTONE AND CLAYSTONE grayish brown, medium strong, moderately weathered, closely to moderately fractured, very thin bedding | | | | | |
| 10 | Bottom of test pit at 10 feet. No groundwater encountered. | | | | | |

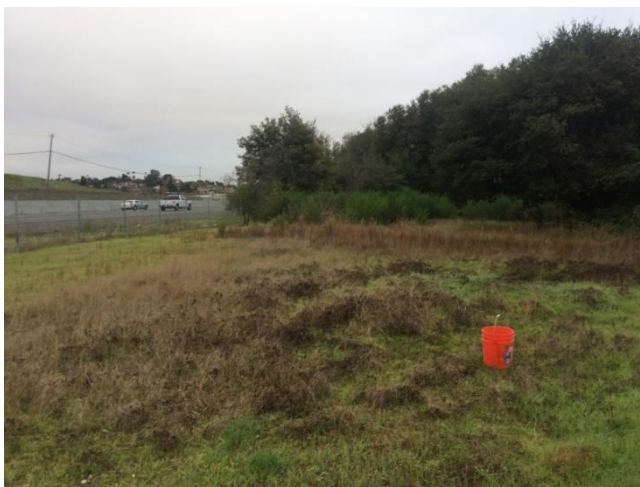
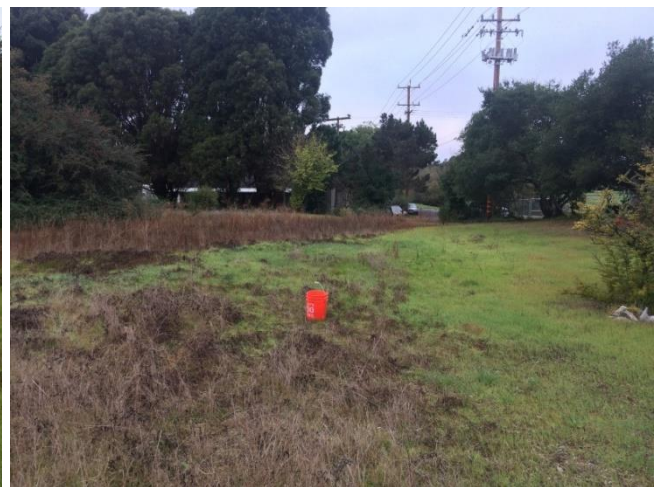
TEST PIT LOG 1-TPHA1

| Depth (Feet) | Description | Depth of Test (Feet) | Plasticity Index | Expansion Index | Laboratory Moisture Content% | Unconfined Compression (Tsf) *field approx |
|---|---|---|---|---|---|---|
| 1 – 2 ½ | ELASTIC SILT (MH) olive brown, hard, high plasticity, fine to medium grained sand | 1 | 61 | | 13.5 | |
| 2½ | Bottom of test pit at 2½ feet. No groundwater encountered. | | | | | |
