Preliminary Geotechnical Evaluation and Geologic Field Reconnaissance Report

NELSON SLOAN QUARRY RESTORATION AND BENEFICIAL
REUSE OF SEDIMENT PROJECT REPORT
2721 MONUMENT ROAD
SAN DIEGO, CALIFORNIA

File No. 133467-002
April 2021

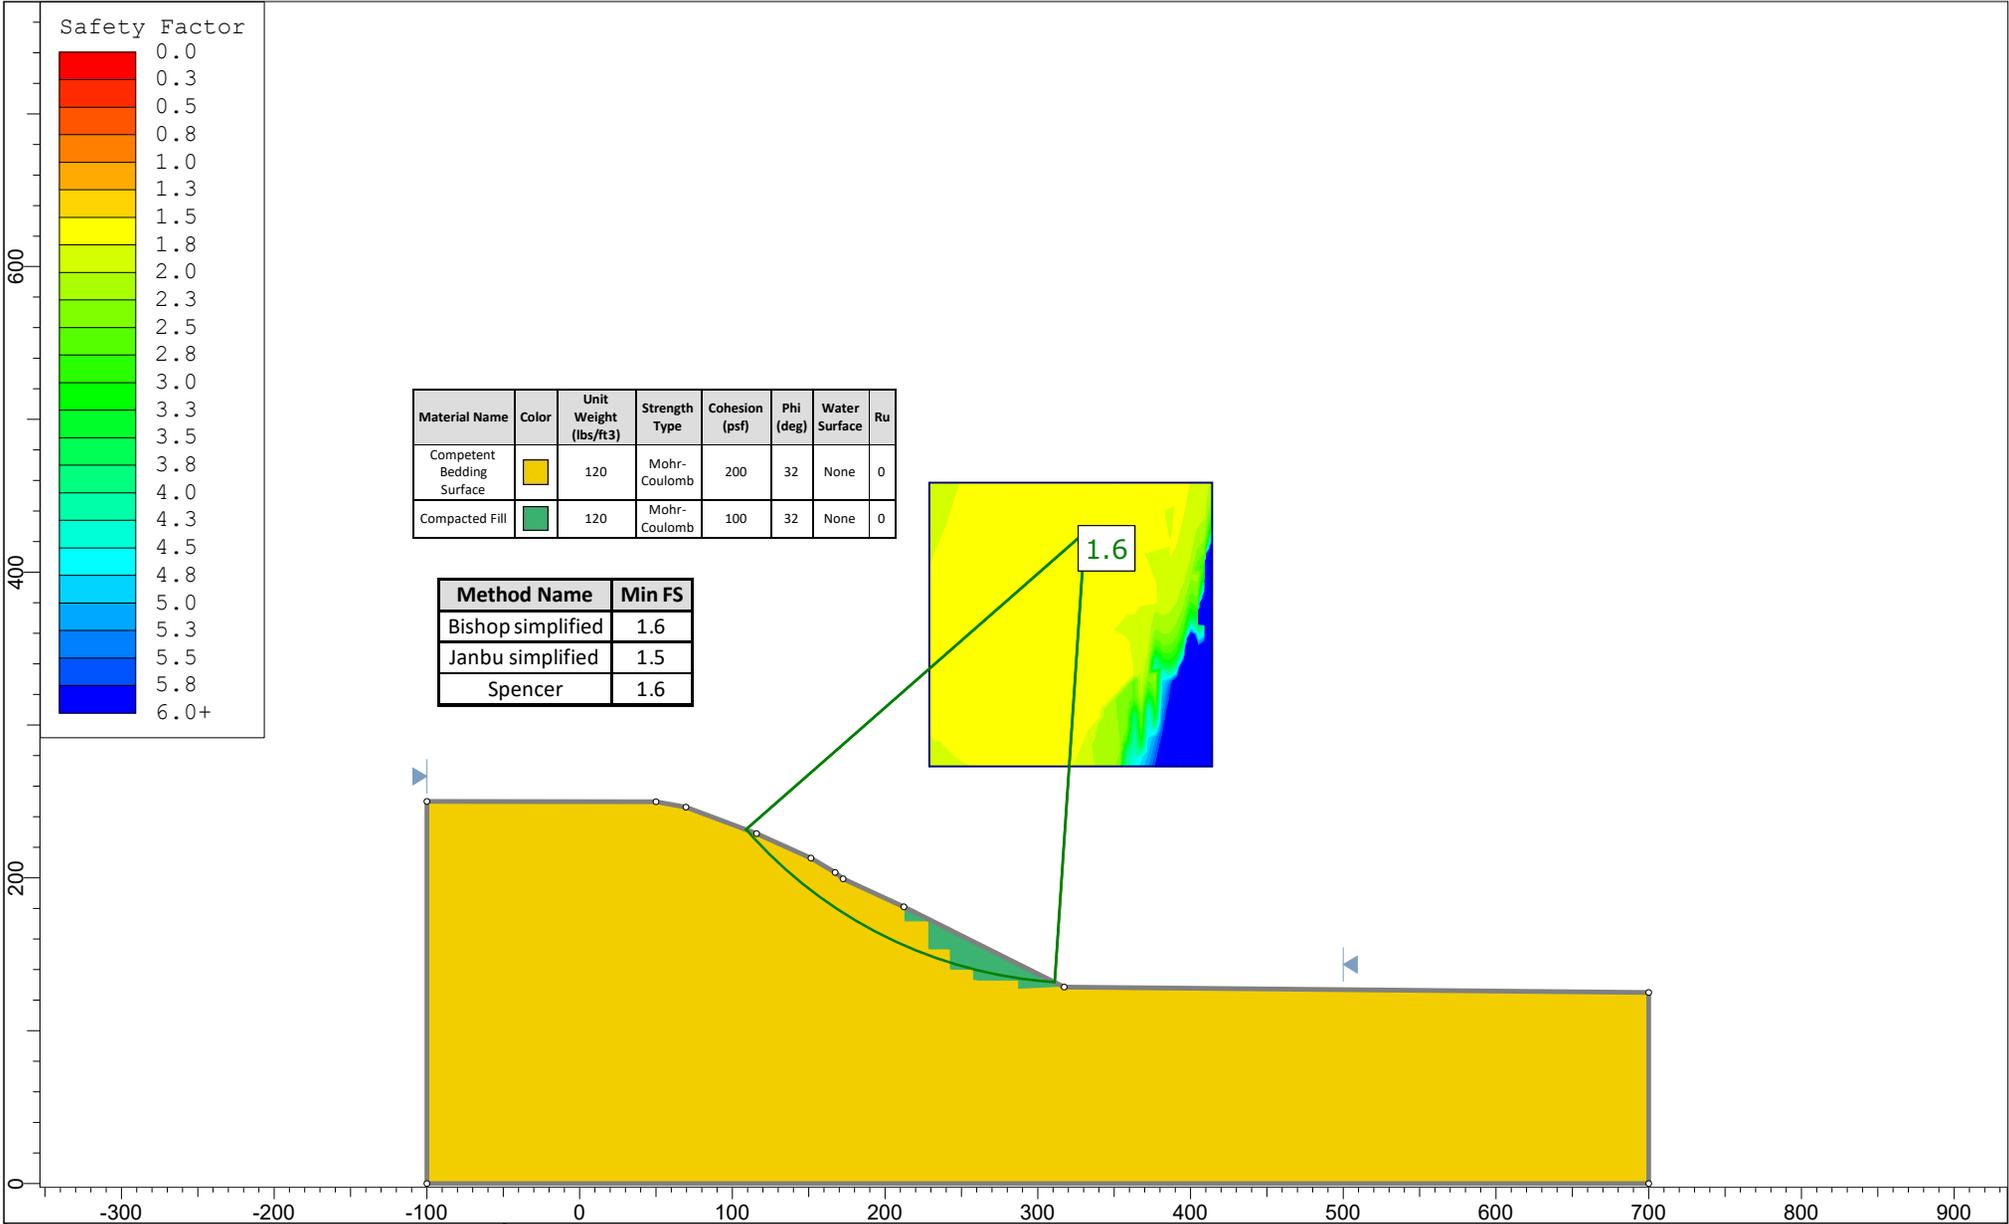
<i>Project</i> NELSON SLOAN QUARRY, SAN DIEGO COUNTY, CALIFORNIA	
	<i>Group</i> Phase 1	<i>Scenario</i> Master Scenario
	<i>Drawn By</i> N. Akbariyh	<i>Company</i> HALEY & ALDRICH, INC.
	<i>Date</i> 4/14/2021	Figure B-1
	SLIDEINTERPRET 9.004

Method Name	Min FS
Bishop simplified	1.6
Janbu simplified	1.5
Spencer	1.6

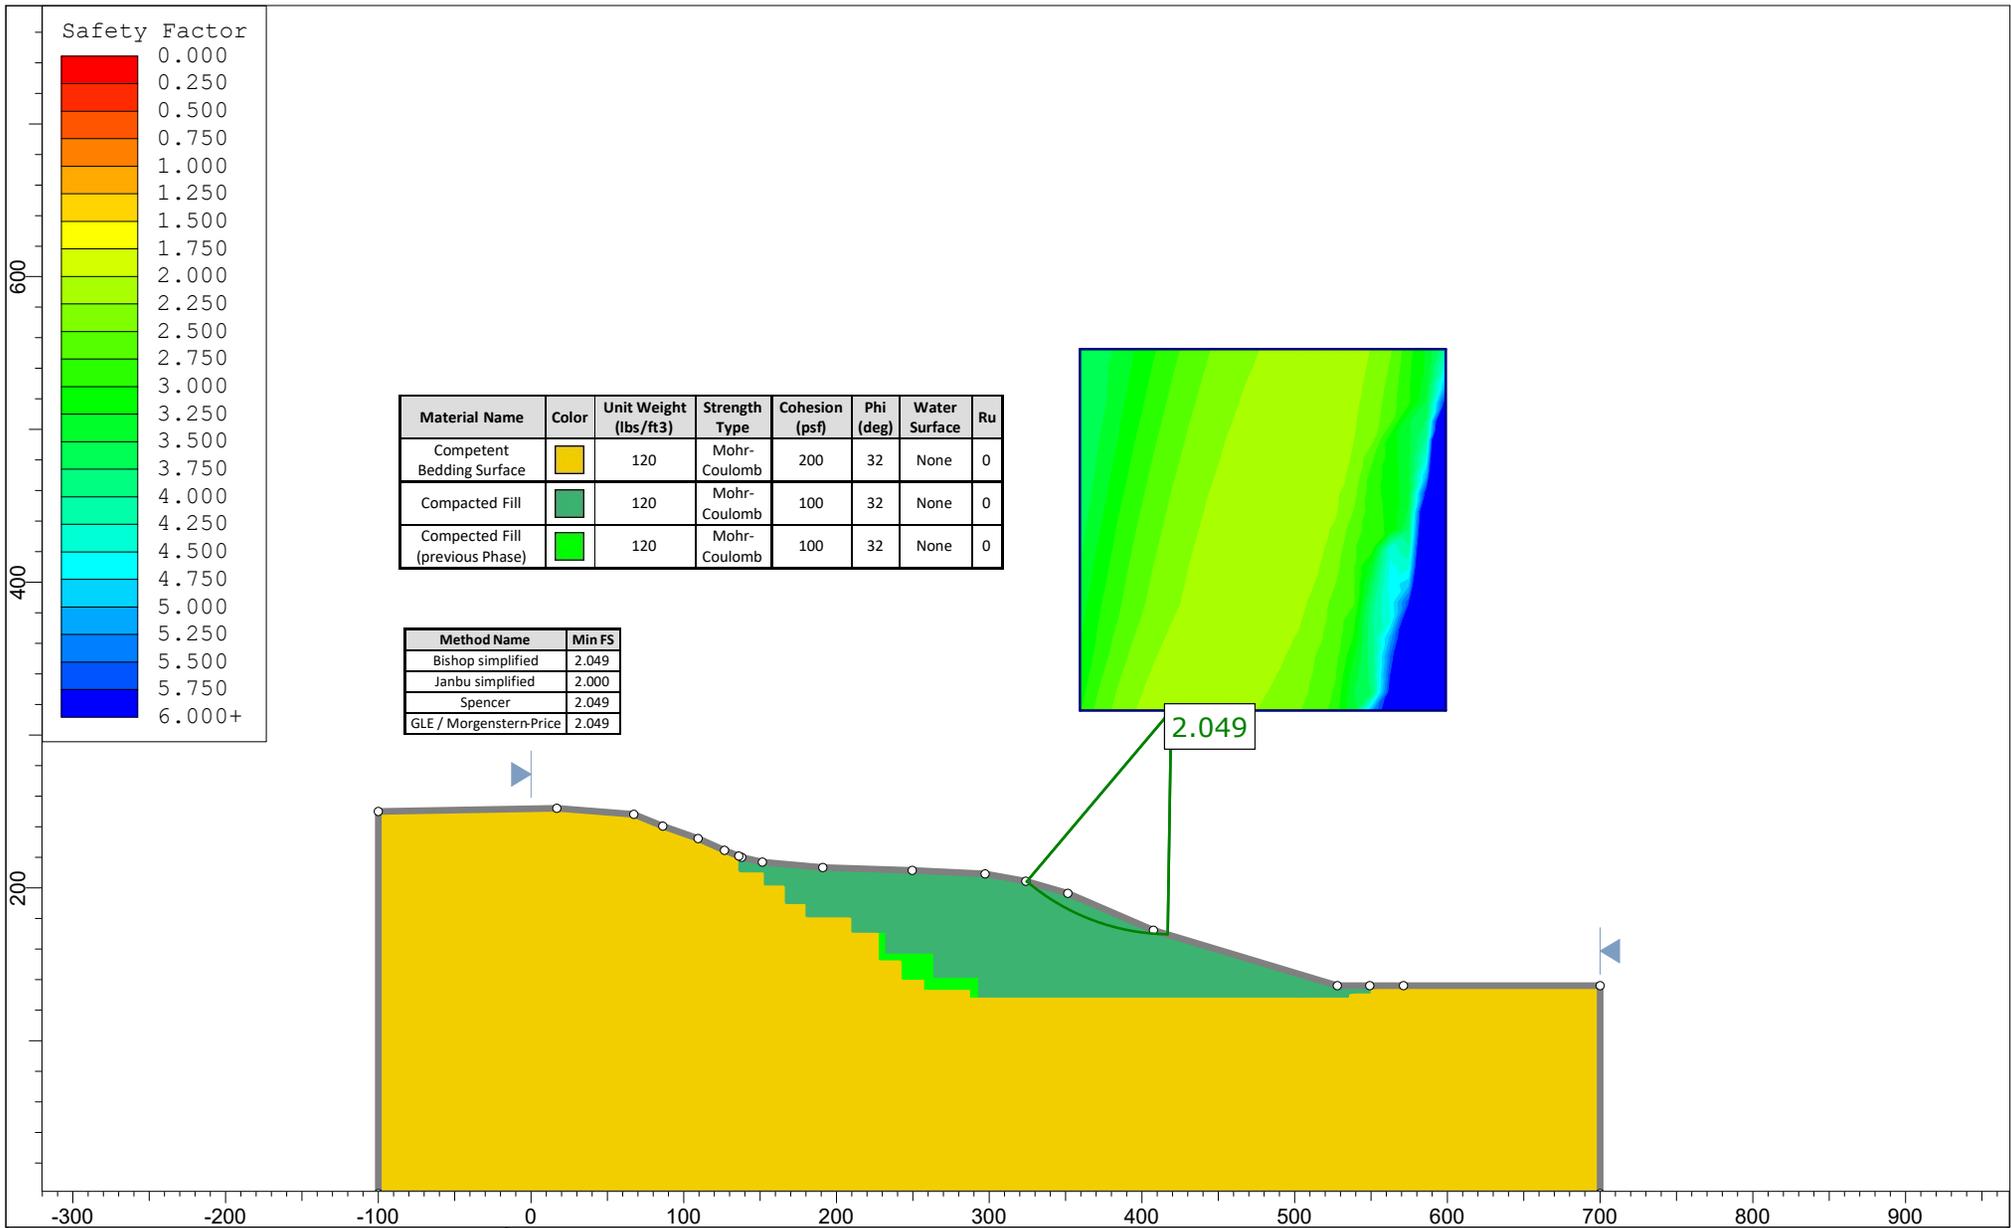
Project		NELSON SLOAN QUARRY, SAN DIEGO COUNTY, CALIFORNIA	
	Group	Phase 2	Scenario	Master Scenario
	Drawn By	N. Akbariyh	Company	HALEY & ALDRICH, INC.
	Date	4/14/2021	Figure B-2	
	SLIDEINTERPRET 9.004

Method Name	Min FS
Bishop simplified	2.049
Janbu simplified	2.000
Spencer	2.049
GLE / Morgenstern-Price	2.049

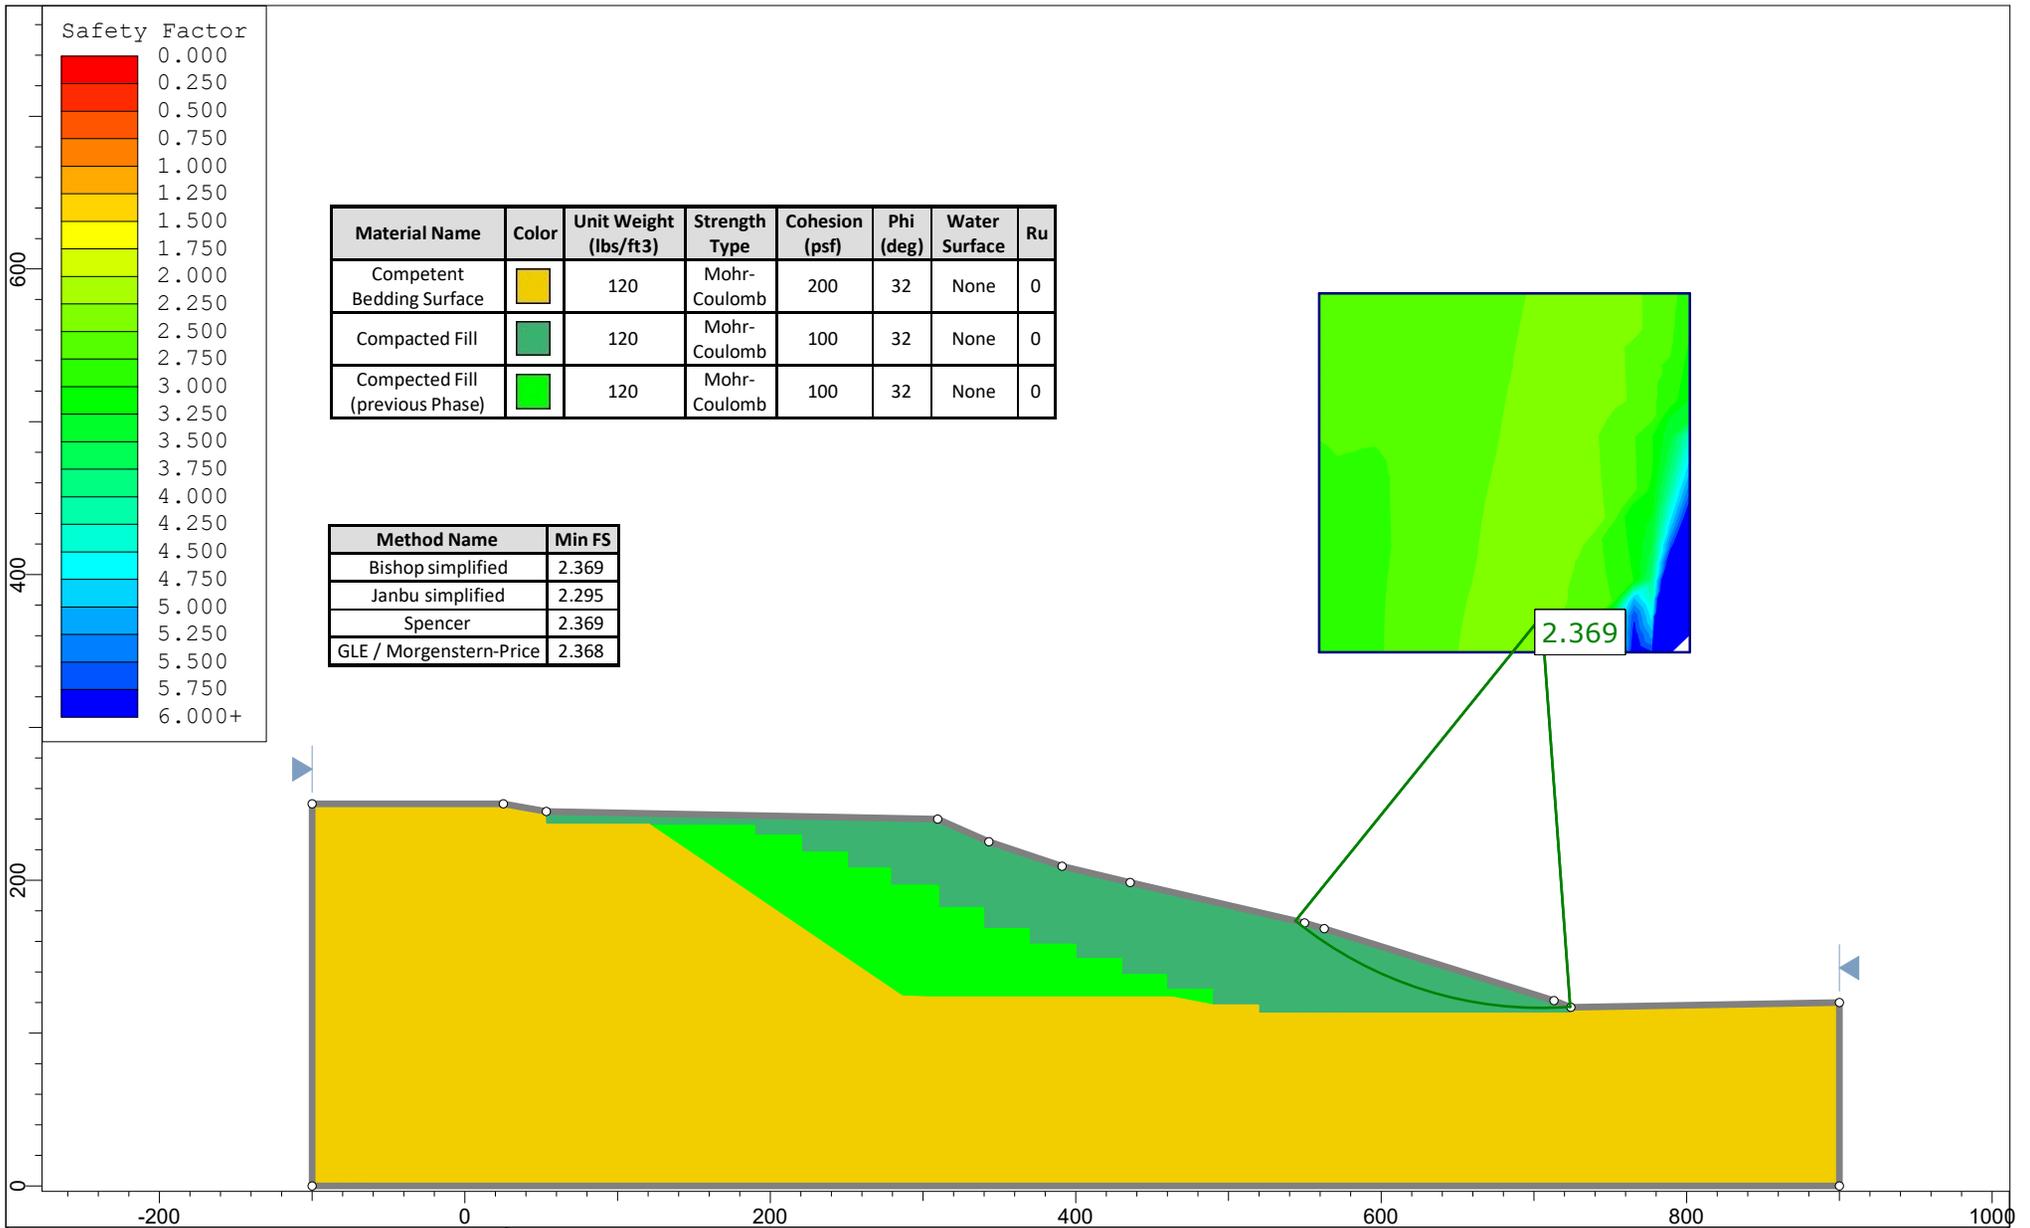
Project	NELSON SLOAN QUARRY, SAN DIEGO COUNTY, CALIFORNIA		
Group	Phase 4	Scenario	Master Scenario
Drawn By	N. Akbariyeh	Company	HALEY & ALDRICH, INC.
Date	4/15/2021	Figure B-4

Method Name	Min FS
Bishop simplified	2.369
Janbu simplified	2.295
Spencer	2.369
GLE / Morgenstern-Price	2.368

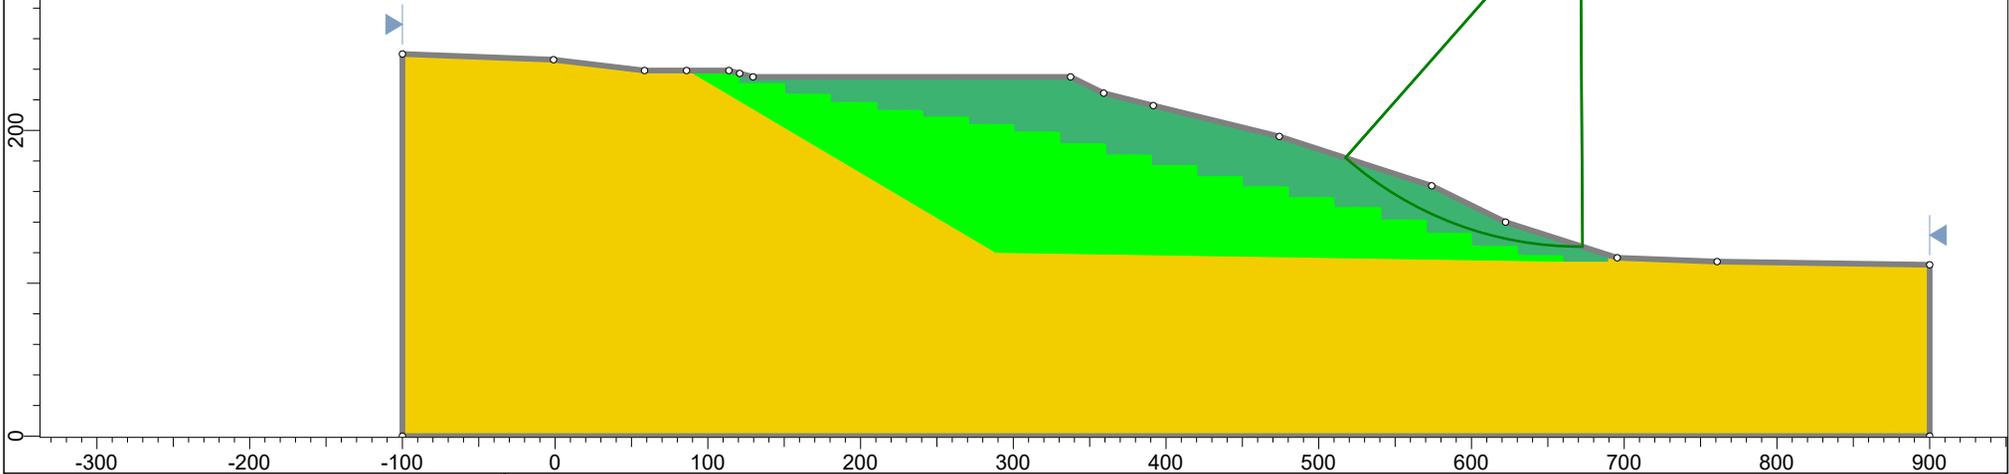
<i>Project</i> NELSON SLOAN QUARRY, SAN DIEGO COUNTY, CALIFORNIA	
	<i>Group</i> Phase 5	<i>Scenario</i> Master Scenario
	<i>Drawn By</i> N. Akbariyeh	<i>Company</i> HALEY & ALDRICH, INC.
	<i>Date</i> 4/15/2021	Figure B-5
	SLIDEINTERPRET 9.004

Method Name	Min FS
Bishop simplified	1.899
Janbu simplified	1.848
Spencer	1.898
GLE / Morgenstern-Price	1.899
