### **Fault Hazards Investigation**

**FAULT HAZARD INVESTIGATION  
RIVERSIDE COUNTY REFERENCE GEO 02503  
PROPOSED CHURCH COMPLEX  
APN 376-410-002 and 376-410-024  
CITY OF WILDOMAR, CALIFORNIA**

**PROJECT NO. 4348-F  
FEBRUARY 17, 2017**

Subject: Fault Hazard Investigation Report  
Proposed Church Complex, APN 376-410-002 & 024  
City of Wildomar, Riverside County, California.

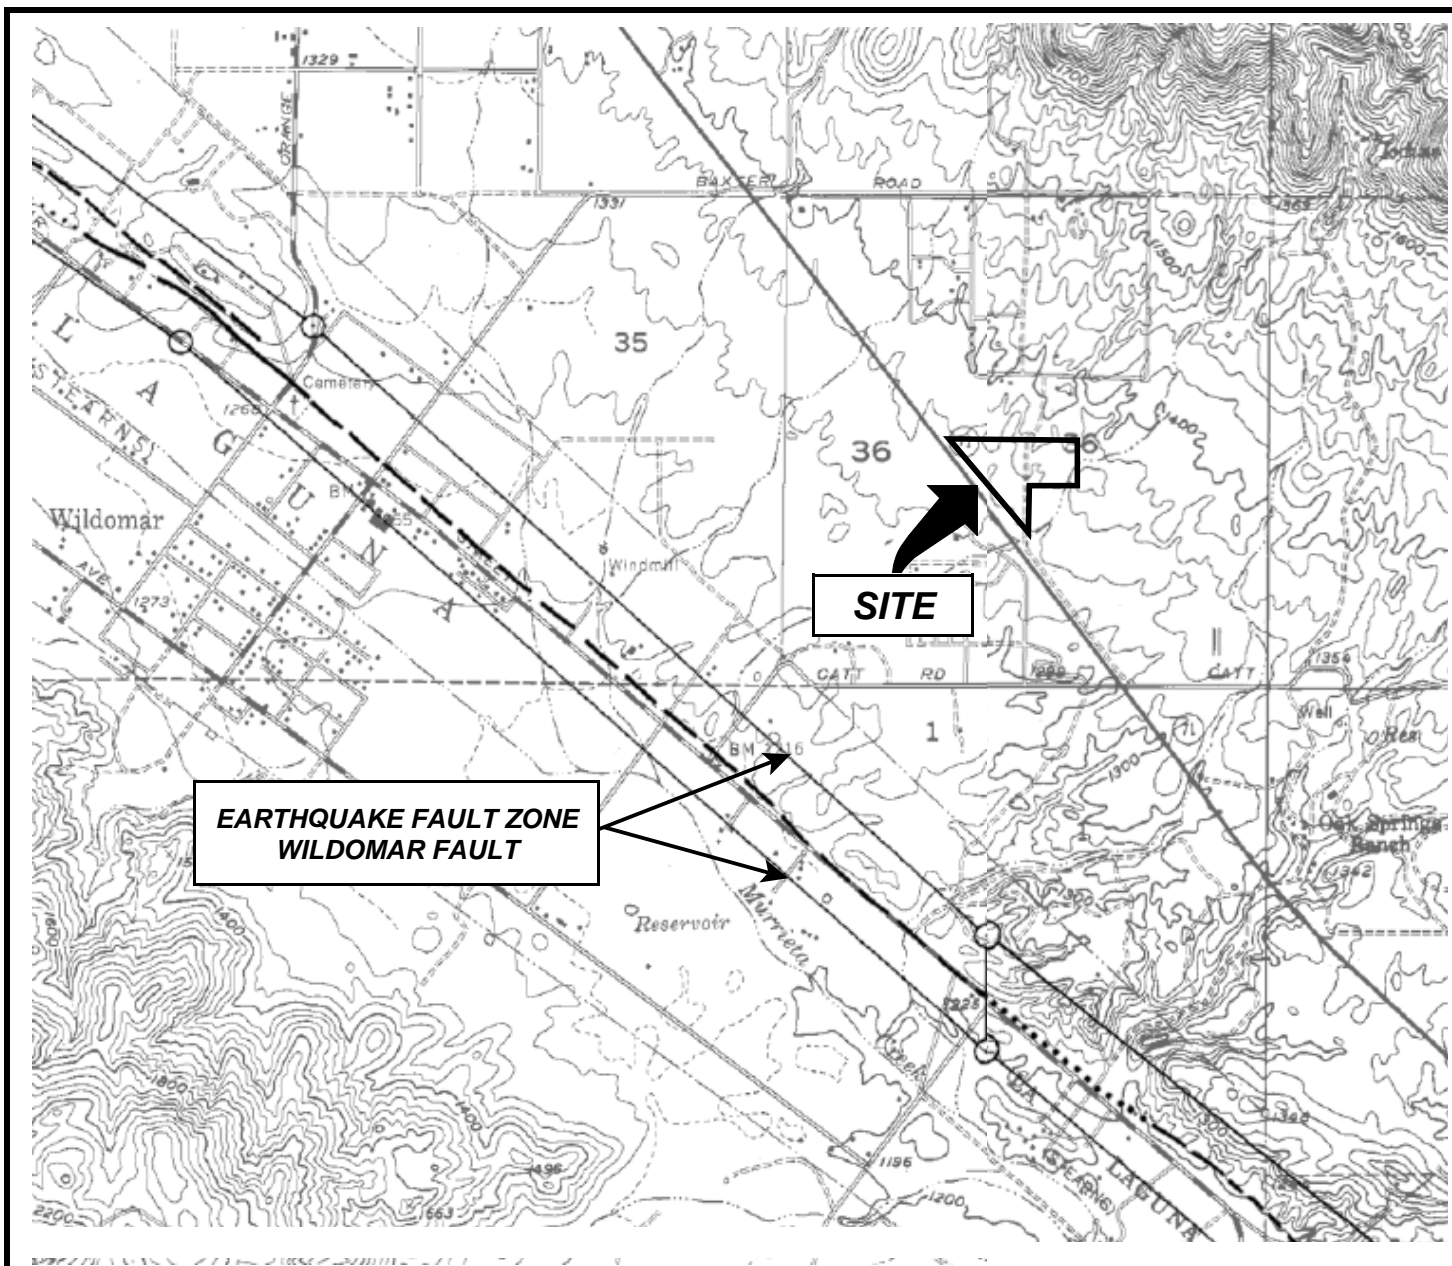
**FIGURE 2**

The City of Wildomar includes three primary fault strands that are segments of the 175-mile-long Elsinore fault zone. The Willard fault (Engle, 1959) comprises multiple short, discontinuous, and often overlapping traces usually close to the topographic boundary of the Elsinore Mountains to the west and the Temecula-Elsinore trough to the east. The Wildomar fault (Mann, 1955) is delineated by prominent scarps, sag ponds, and other fault-created topographic features aligned more or less with the middle of the Temecula-Elsinore trough. Palomar Street in the City of Wildomar is parallel to and locally even coincident with the Wildomar fault. Lastly, an extension of the Glen Ivy North fault strand, originally known only in the subsurface from water well data obtained near Lake Elsinore, has been mapped along the eastern side of the trough within the City in recent years. The fault line was missed by State workers in the technical report used as the basis for Alquist-Priolo Earthquake Fault Zones in the valley. The official State zones adopted in 1980 included all of the Wildomar strand from Lake Elsinore to Temecula and beyond, while the Willard fault was excluded entirely from zonation after maps were revised to re-characterize surface displacements as older offsets of sediments along several Willard traces west of the historic Wildomar town center (Figure No. 2; ref. Saul, 1978).

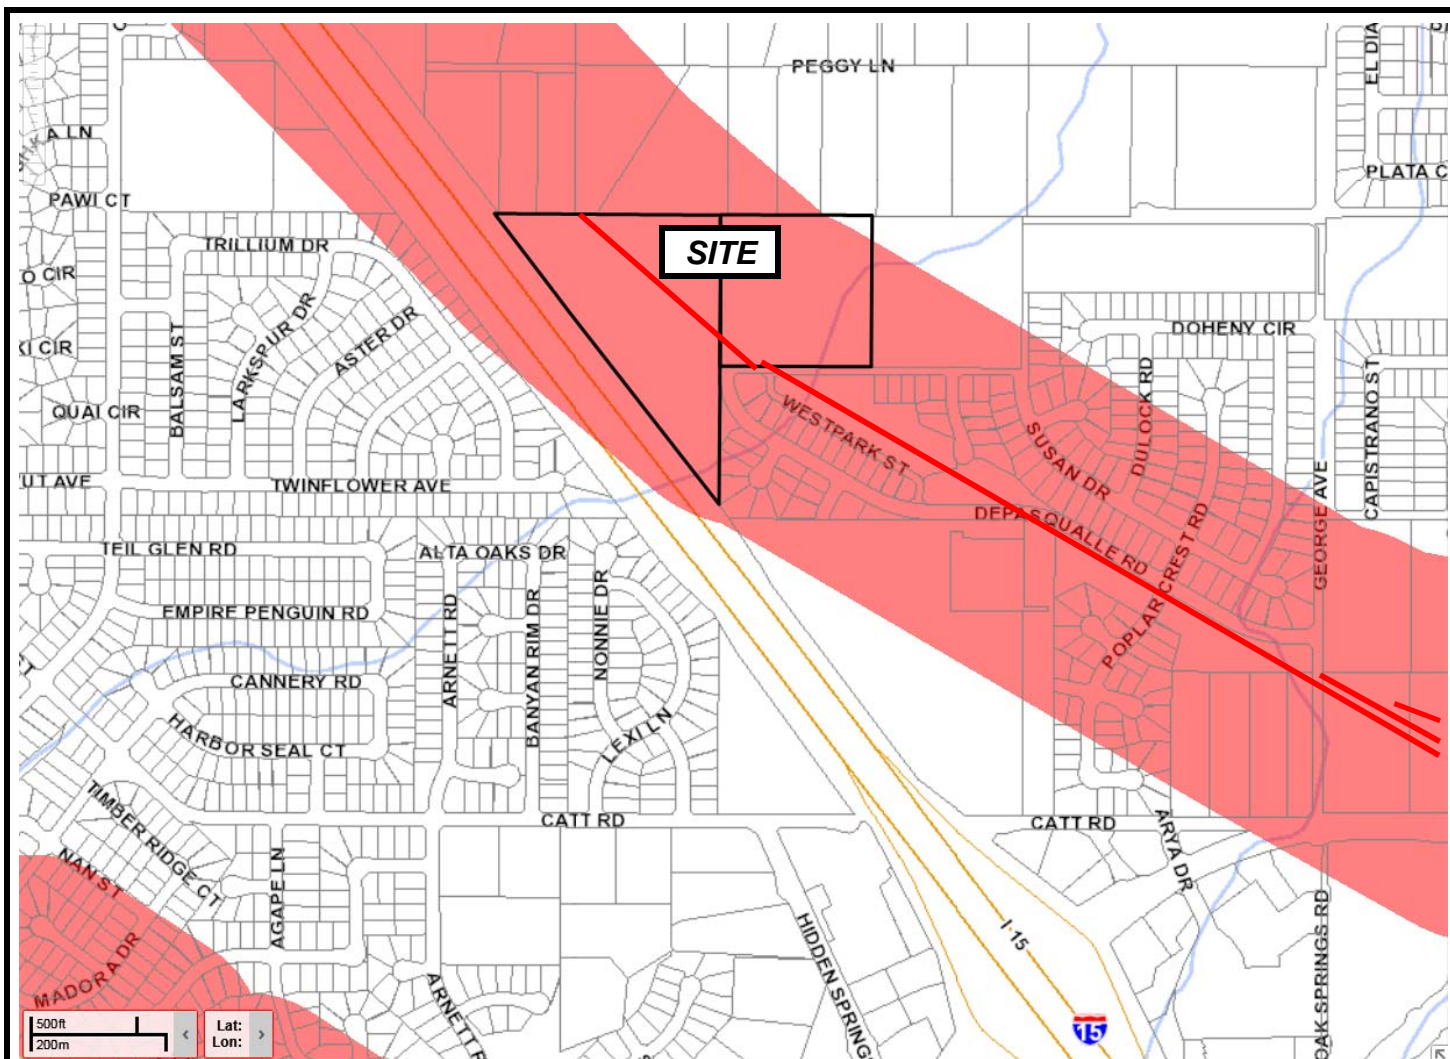
FIGURE 3

APN 376-410-002 and 376-410-024 are not in an official Alquist-Priolo Earthquake Fault Zone. However, they are almost wholly within a County Fault Zone established along the mapped southeastern extension of the Glen Ivy North fault (Figure No. 3). The City of Wildomar has adopted all County hazard zones into their General Plan and City ordinances. Criteria that would support a hypothesis of a fault line with recent activity within the church site would include well-expressed geomorphic lineaments, vegetation contrasts, and juxtaposition of disparate soil and rock units.

**Reference:** Riverside County Transportation and Land Management Agency, "Map My County" utility (2016), access date 2/13/17. County regulatory zones shown in red; mapped active or potentially active faults shown in darker red; remaining lines are parcel boundaries.

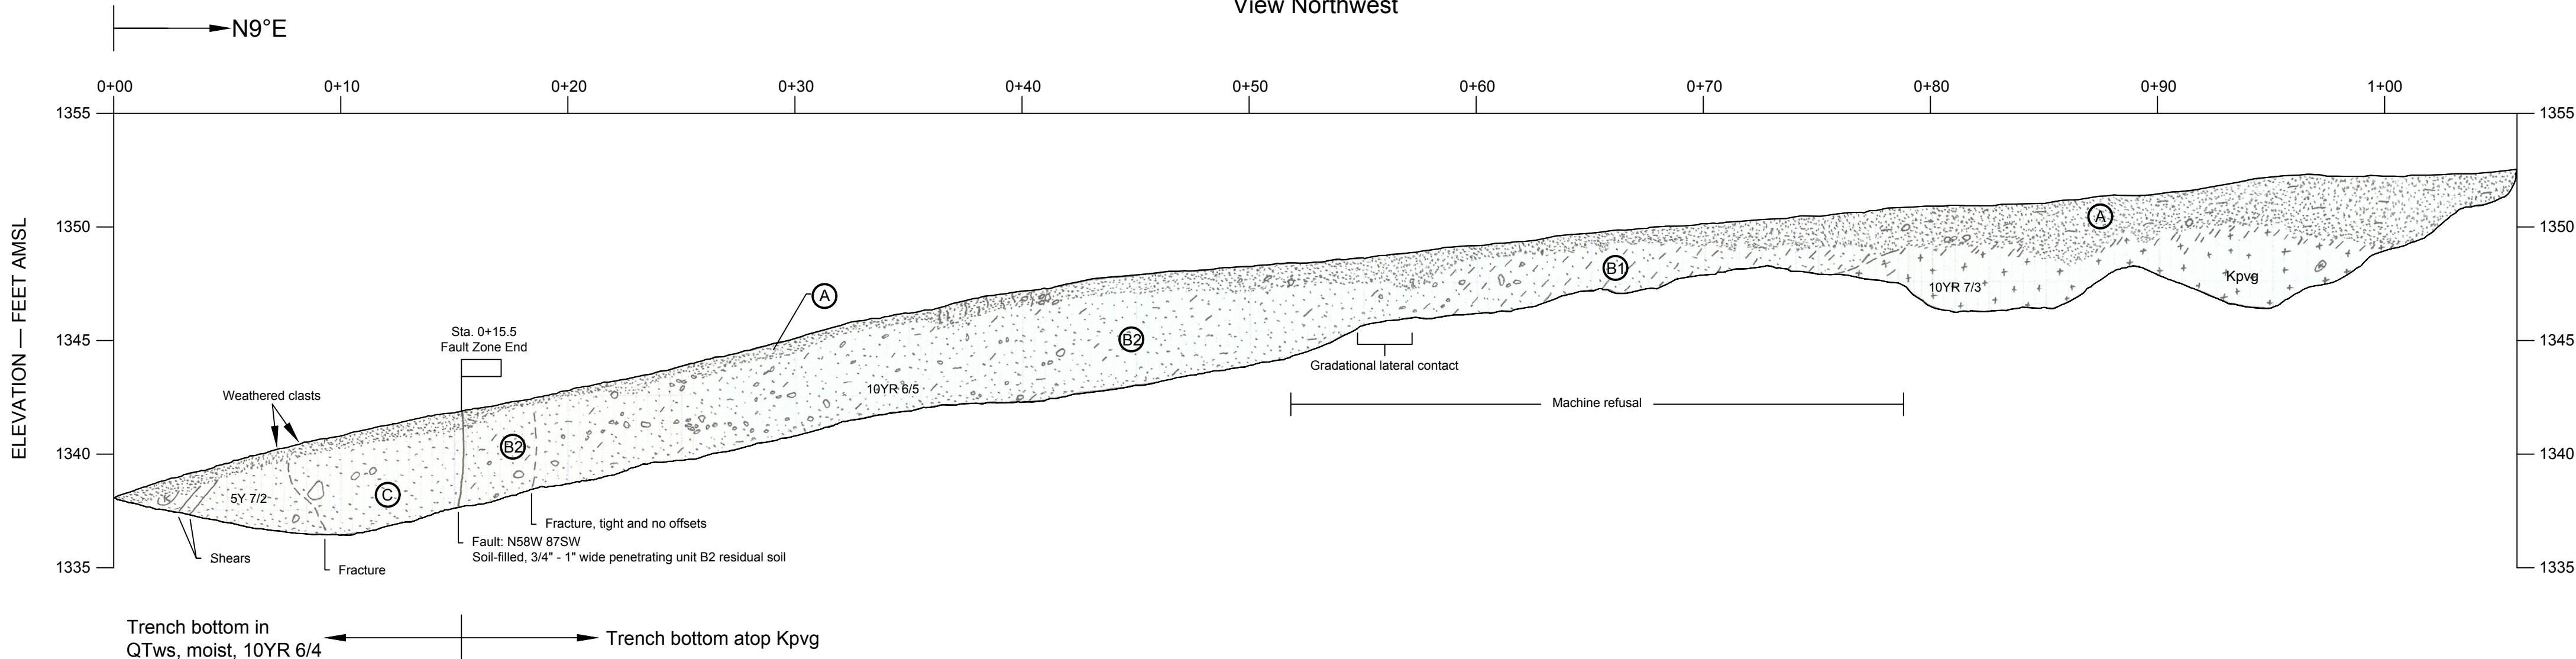
Trench FT-4  
View Northwest

- (A) Modern topsoil and colluvium: Loose to very locally cemented, brown (10YR 5/3) to yellowish brown (10YR 5/4) silty sand, Unified Soil Classification System symbol SM. Surficial colluvium ranges from only inches thick up to about 3 feet thick near Sta. 1+00. Most colluvium northeast of Sta. 0+75 is siltier than typical, very porous, and heavily bioturbated. Unit rarely has small angular stones derived from Kpvg bedrock. Disturbed by past cultivation in upper several inches. Interpreted latest Holocene and historic age.
