Tree & Palm Evaluation Report

4555 Executive Drive, San Diego, CA

Arborgate Consulting, Inc.
Greg Applegate, RCA #365
1131 Lucinda Way
Tustin, CA 92780
714/ 731-6240

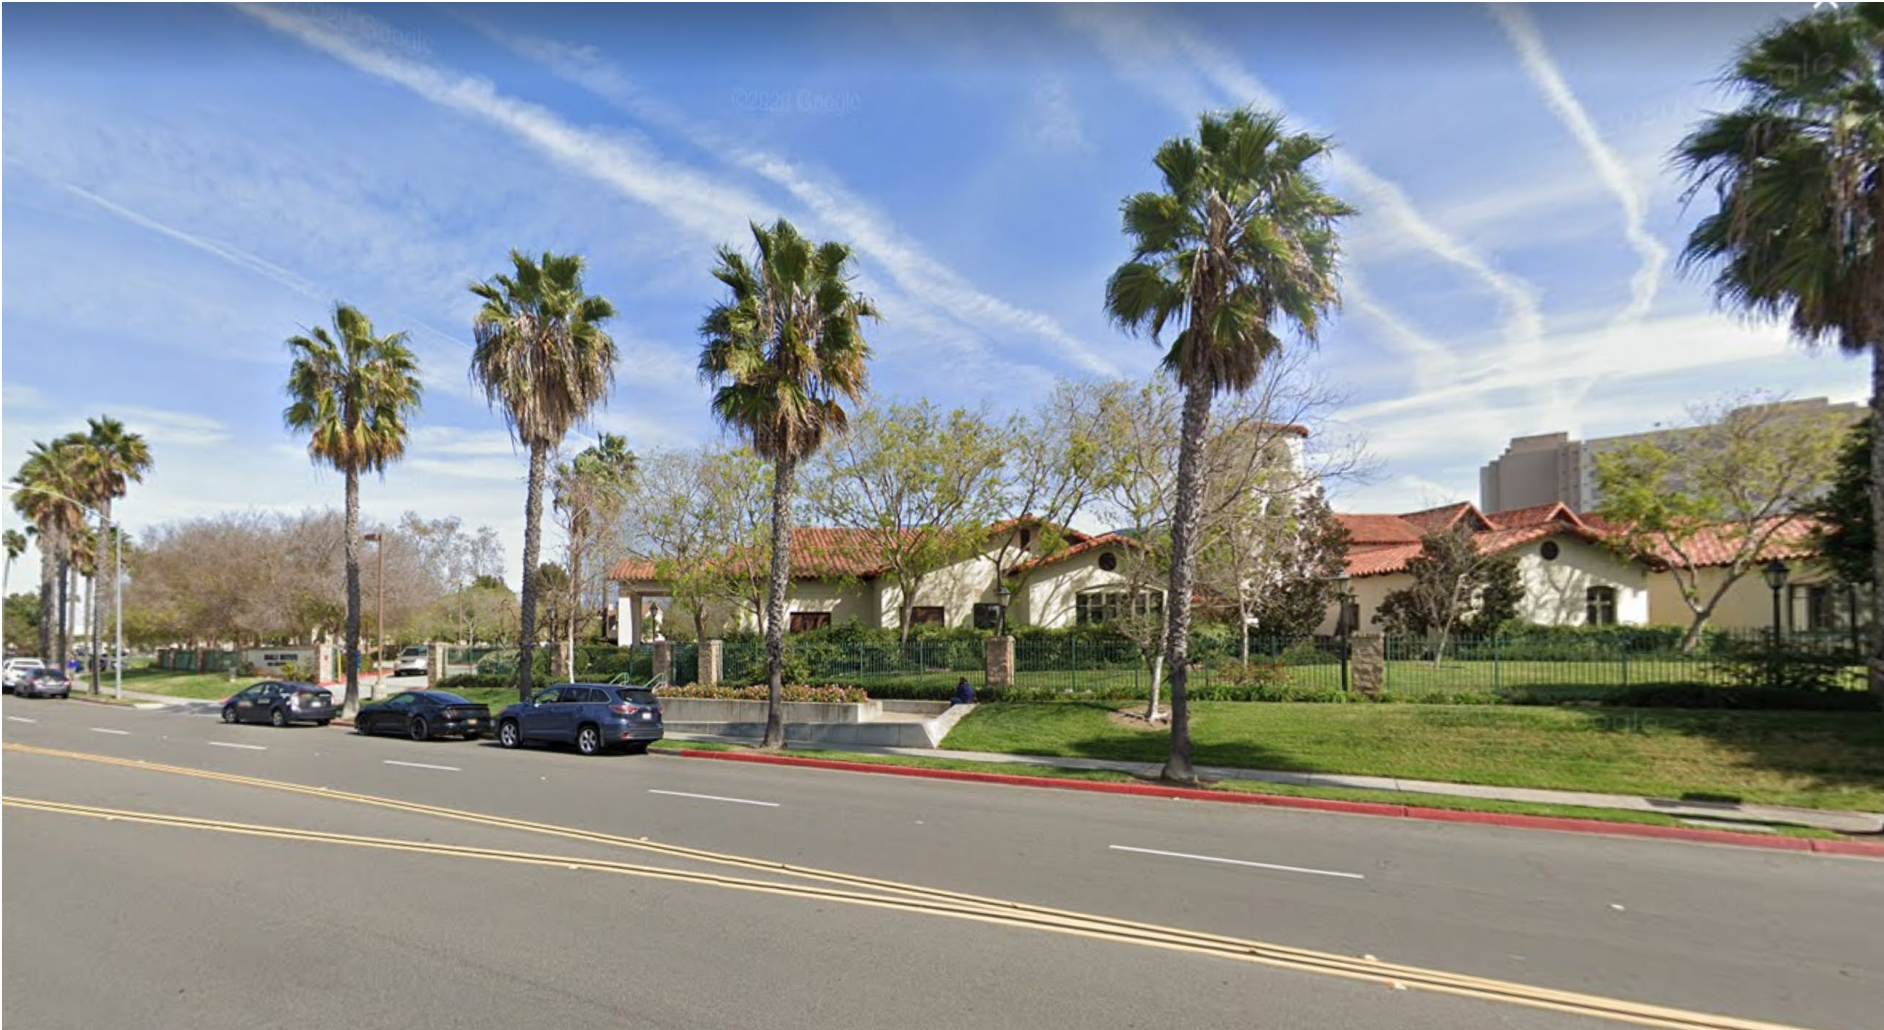
Mexican fan palms #1 to 19 are in the narrow parkway along Executive Drive and Executive Way

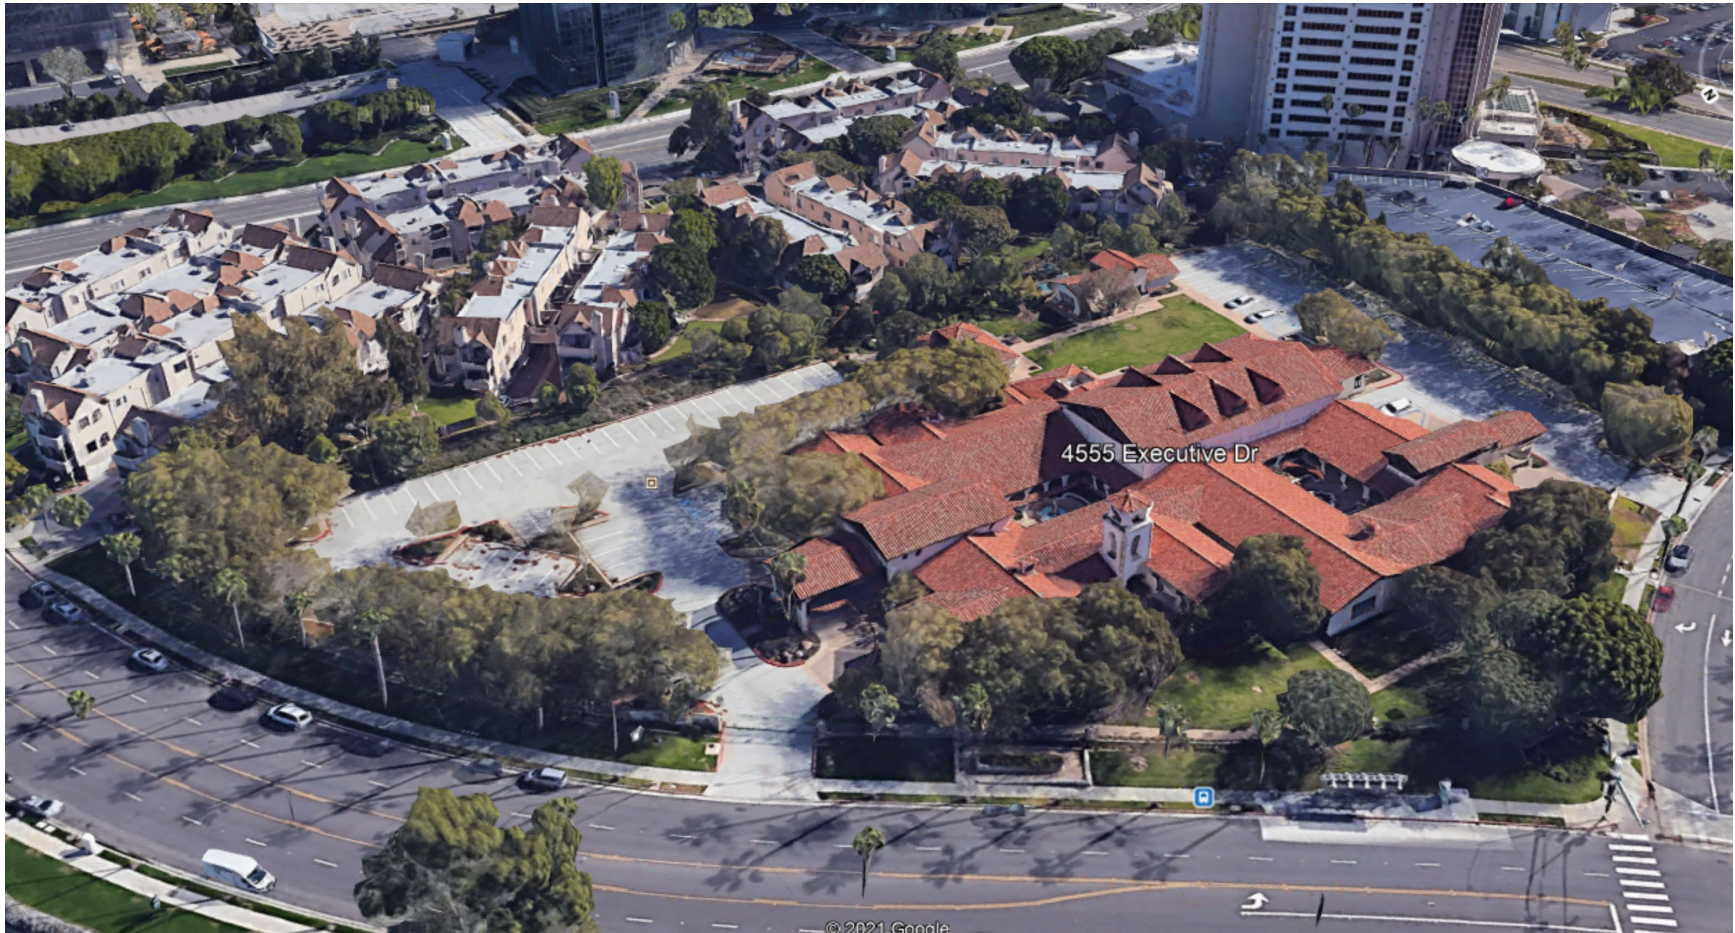
Overall view per Google. The large tree at the corner is no longer there.

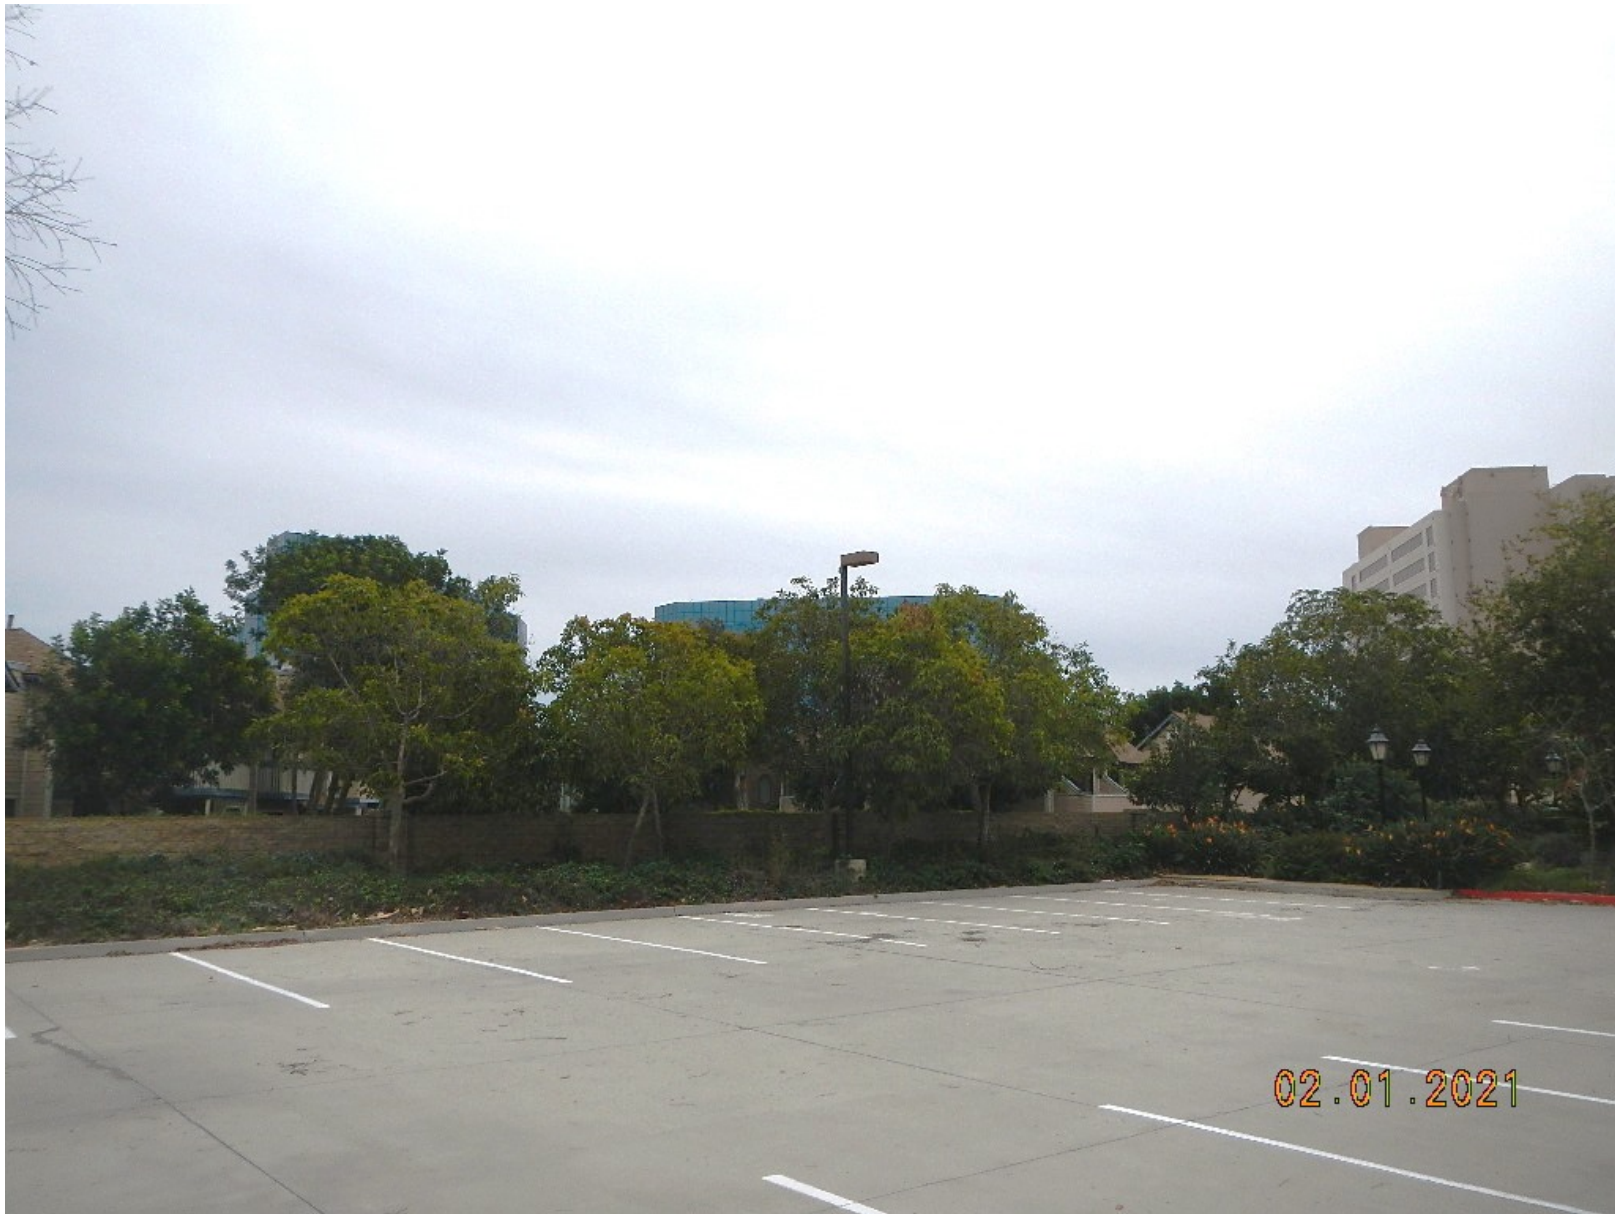
#67 to 73 Brisbane box

Tree#	Species	DBH	Ht.	Wd.	Health	Structure	Root condition	Pest or disease	Comments
67	Lophostemon confertus	6.8	26	24	D	D	covered		Sp cod 2long Db
68	Lophostemon confertus	4	18	15	D	D	covered		Sp cod top-Db
69	Lophostemon confertus	5.1	24	22	C-	C-	covered		Sp cod Db
70	Lophostemon confertus	4.7	24	18	C-	C-	covered		Leans mSp, dead leader
71	Lophostemon confertus	6	26	24	C-	C	covered		Cod 2long
72	Lophostemon confertus	6.5	26	24	D	C	covered		Sp 2long
73	Lophostemon confertus	9	30	28	C-	C-	covered		Leans mSp
74	Ulmus parvifolia	10	34	36	B	C	Sh MB		OL stubs
75	Ulmus parvifolia	9	34	32	B	C-	<u>Sh</u>		Cod leans Cr#76
76	Ulmus parvifolia	8.3	34	28	B	C	<u>Sh</u>		Cod Lt FC Cr#75
77	Ulmus parvifolia	6	24	24	B	C-	covered		CrS cod, old-FC Cr#78
78	Ulmus parvifolia	5.3	27	24	B	C	covered		Cod old-FC Cr#77
79	Ulmus parvifolia	8	32	26	C	C-	Sh MB		TO Dk Cr#80
80	Ulmus parvifolia	6.9	32	26	C	C	Sh MB		OL cod Cr
81	Ulmus parvifolia	8.6	32	26	C	C	Sh MB		OL Lt Cr

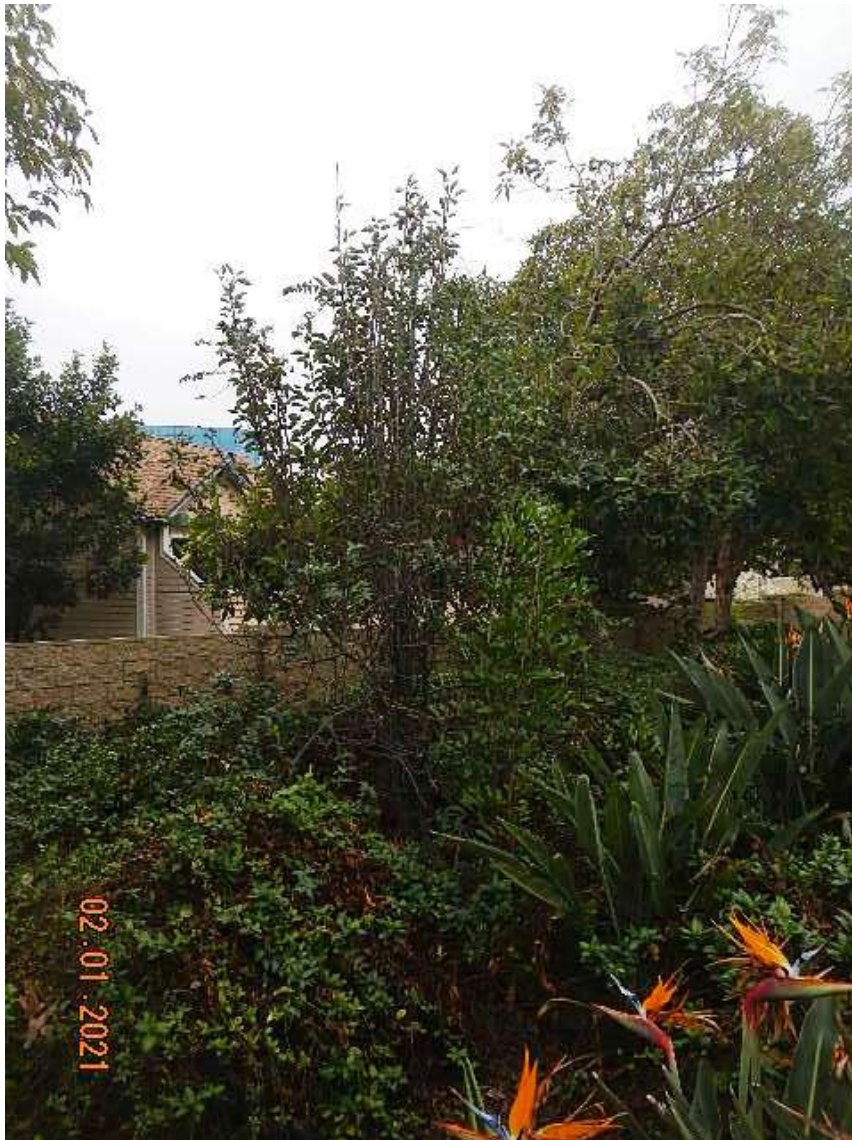
#90 Callery pear

Tree#	Species	DBH	Ht.	Wd.	Health	Structure	Root condition	Pest or disease	Comments
90	Pyrus calleryana cv	3+3	15	7	C	D	covered		Bushy Xing epi climbing vine
91	Lophostemon confertus	6	24	16	C	D	covered		T-bow Hd 2long
92	Lophostemon confertus	6.3	32	30	C	C	covered		mSp 2long
93	Lophostemon confertus	11	38	30	C	D	covered		Cod <u>TO</u> 2long
94	Lophostemon confertus	4.1	18	18	C-	D	covered		Leans Sup by#93 1s
95	Erythrina coralloides	4+6+7.5	20	20	B	C	covered		T-bow cod Xing
96	Lophostemon confertus	8.4	38	35	C	C-	covered		mSp cod 2long
97	Erythrina coralloides	12 @ 3'	18	18	B	C	covered		Cod Xing
98	Lophostemon confertus	7	30	28	C	D	covered		Leans DL Xing 2long
99	Lophostemon confertus	7	25	26	C-	C-	covered		Sp cod Db
100	Lophostemon confertus	6.2	25	20	C	C-	covered		mSp cod mDb
101	Lophostemon confertus	7.2	28	24	C-	C-	covered		Sp cod 2long
102	Lophostemon confertus	6.1	23	20	C-	C-	covered		Sp cod 2long

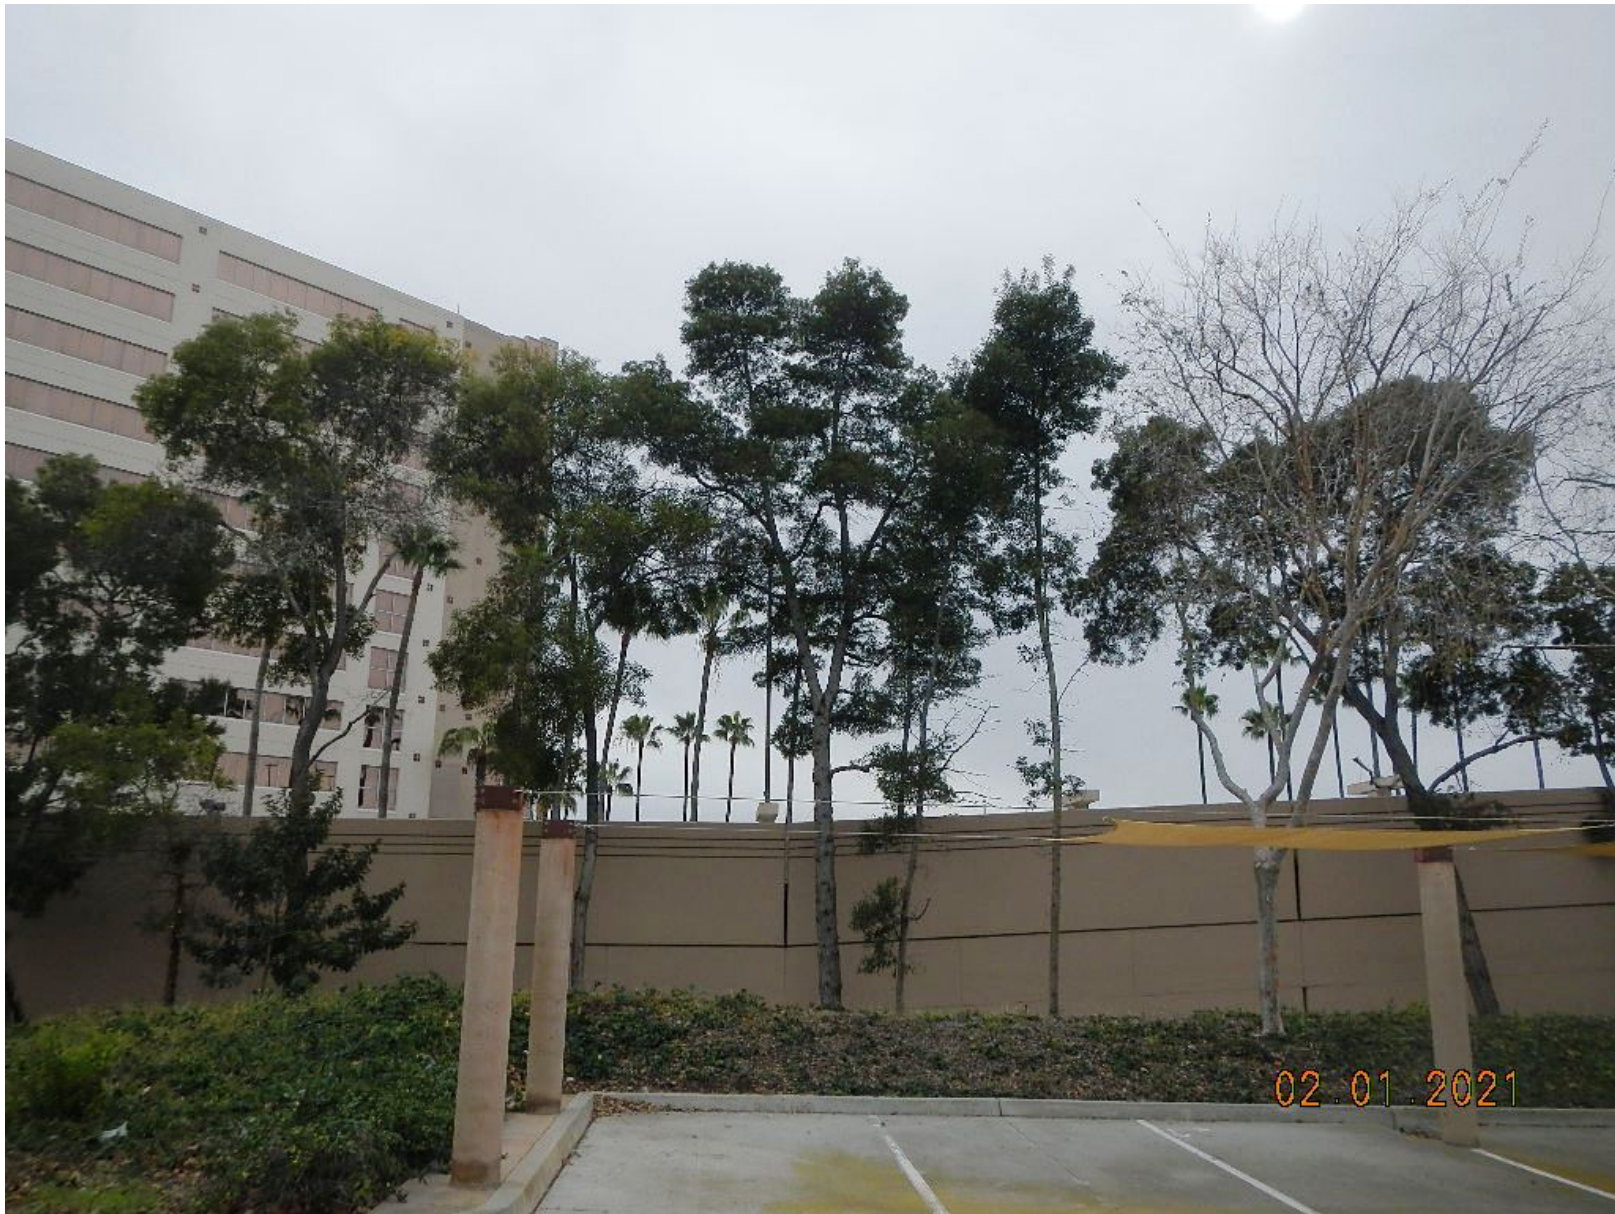
#109 to 112 Black acacias in back, Elm #114 in front

Tree#	Species	DBH	Ht.	Wd.	Health	Structure	Root condition	Pest or disease	Comments
113	Acacia melanoxylon	5	40	8	C-	C-	fill		OL
114	Ulmus parvifolia	8	32	26	C	C-	okay		OL cod Lt FC
115	Ulmus parvifolia	10	35	35	B	C-	fill		OL cod Lt
116	Acacia melanoxylon	2	8	5	B	C	covered		Ivy climbing T
117	Acacia melanoxylon	15	50	26	B	C	fill		OL cod-top
118	Acacia melanoxylon	12	40	14	C-	D	fill		Leaning on bldg
119	Acacia melanoxylon	12	40	20	C-	D	fill		1s TO leans T-bow
120	Ulmus parvifolia	8	35	30	C	C-	covered		OL Lt
121	Acacia melanoxylon	2	12	7	C-	C	covered		Sp epi mDb
122	Acacia melanoxylon	3	13	9	D	D	covered		1s top-Db
123	Acacia melanoxylon	2	13	8	B	B	covered		Cr
124	Ulmus parvifolia	9	35	38	C	C	fill		OL Lt cod stubs
125	Acacia melanoxylon	10	50	16	D	D	fill		OL Db cod inc
126	Acacia melanoxylon	7	40	18	F	F	fill	death	OL Sp, dead tree on it
127	Ulmus parvifolia	8.5	38	7	C-	C-	fill		1s OL Lt
128	Acacia melanoxylon	15	50	26	B	C	fill		OL TO lower-Db

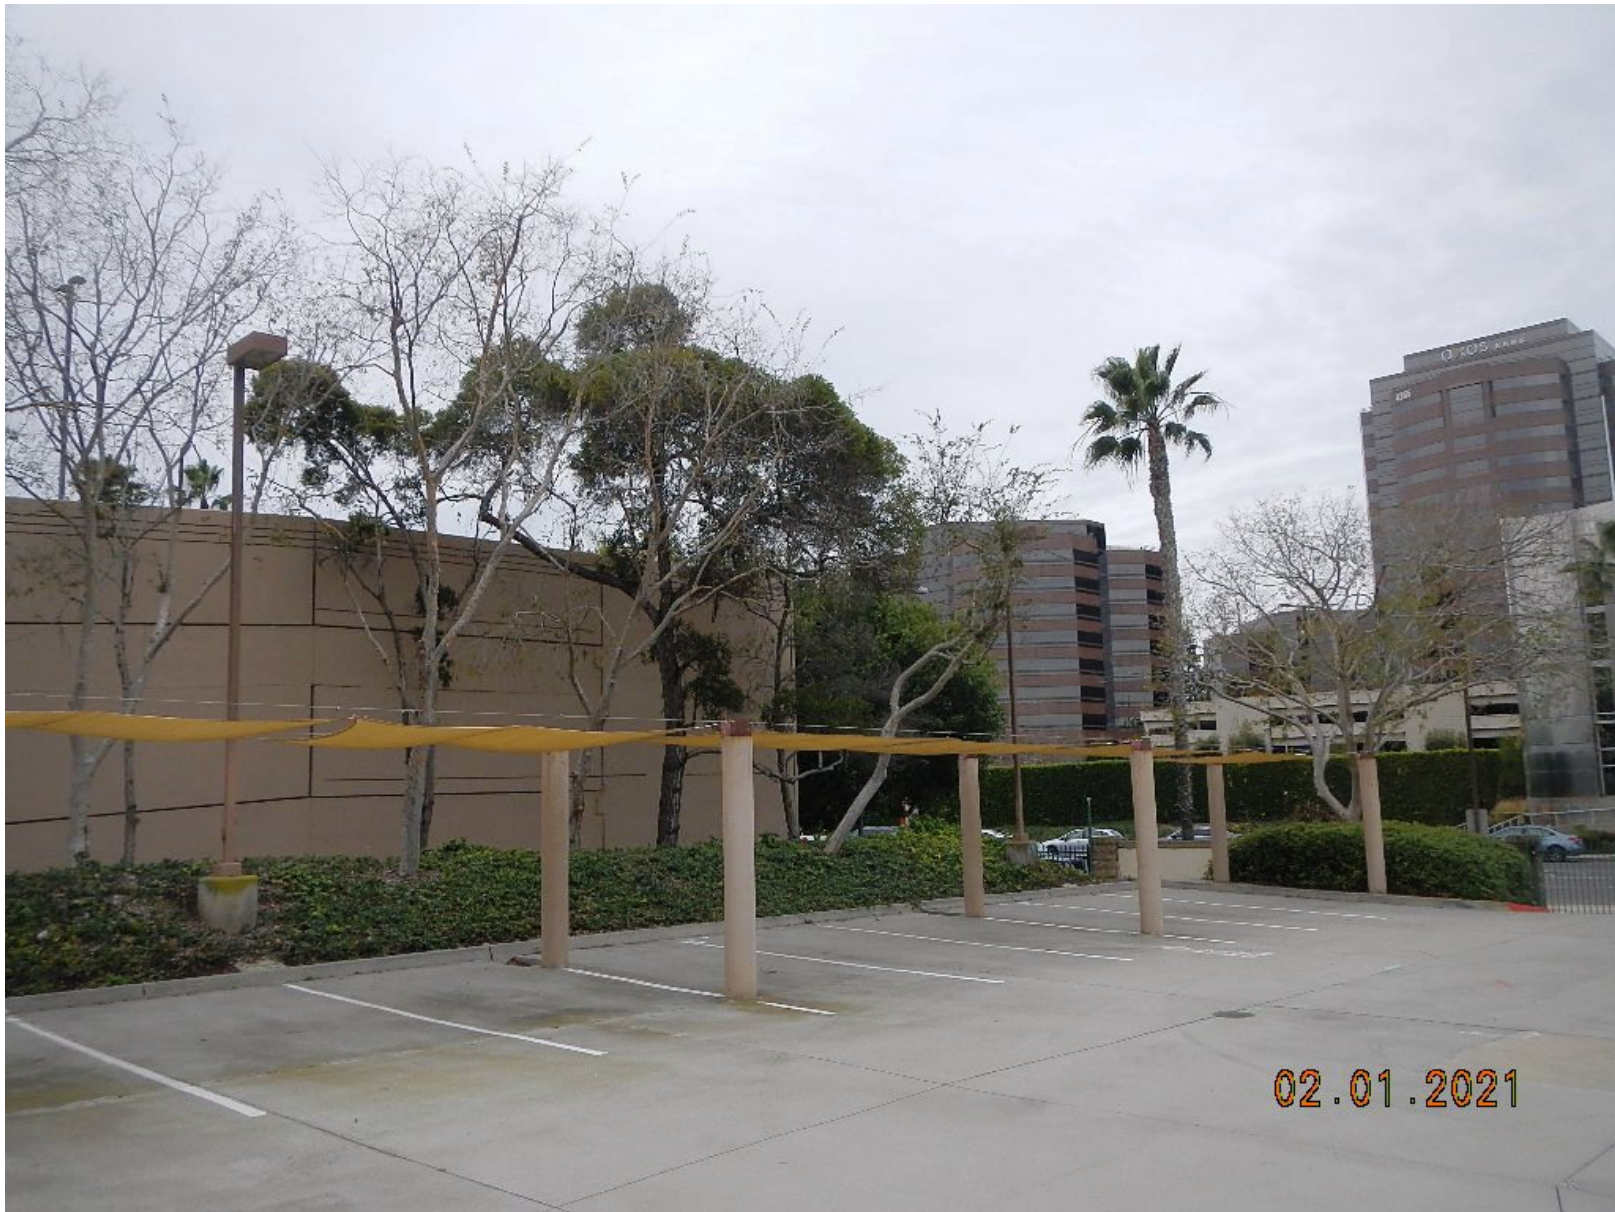
Elms 135 to 139 in front and black acacia #103 to 133 in back

Tree#	Species	DBH	Ht.	Wd.	Health	Structure	Root condition	Pest or disease	Comments
136	Ulmus parvifolia	7.5	32	28	C-	C-	1sRF		mLean OL Lt
137	Ulmus parvifolia	7.7	32	26	C	C-	noRF		Cr sup FC OL Lt
138	Ulmus parvifolia	8.2	28	22	C	D	noRF		Leans cod OP OL Lt
139	Ulmus parvifolia	10	34	32	C	C-	covered		Cod Lt Xing FC
140	Erythrina coralloides	10+10	22	18	B	C-	Sh	not now	Cod Xing Hd FC
141	Ulmus parvifolia	8.1	32	24	C	C-	okay		Cod OL Lt epi
142	Ulmus parvifolia	7.2	32	26	C	C-	covered		Cod Lt FC Hd DL
143	Ulmus parvifolia	7.4	34	20	C	C-	covered		Cod TO Lt epi
144	Erythrina coralloides	7+4+4+3	15	15	B	B	covered	not now	Cod mXing
145	Erythrina coralloides	10 @ 2'	12	18	B	C-	covered	not now	Topd Hd Xing
146	Ulmus parvifolia	12	40	40	A	B	covered		Cod Xing epi Hd, SW-lift
147	Ulmus parvifolia	9	36	30	B	C	Sh MB		Cod Lt
148	Ulmus parvifolia	10	36	32	B	B	Sh MB		Cod Lt
149	Ficus microcarpa	19	36	40	A	C	Sh MB	Gall wasp	Cod inc CrS Lt
