Appendix F

TREE REPORT PER THE GENERAL MSHCP HABITAT ASSESSMENT/CONSTRAINTS ANALYSIS FOR THE 15.78-ACRE MURRIETA PROJECT SITE

WESTERN RIVERSIDE COUNTY, CALIFORNIA

July 1, 2019

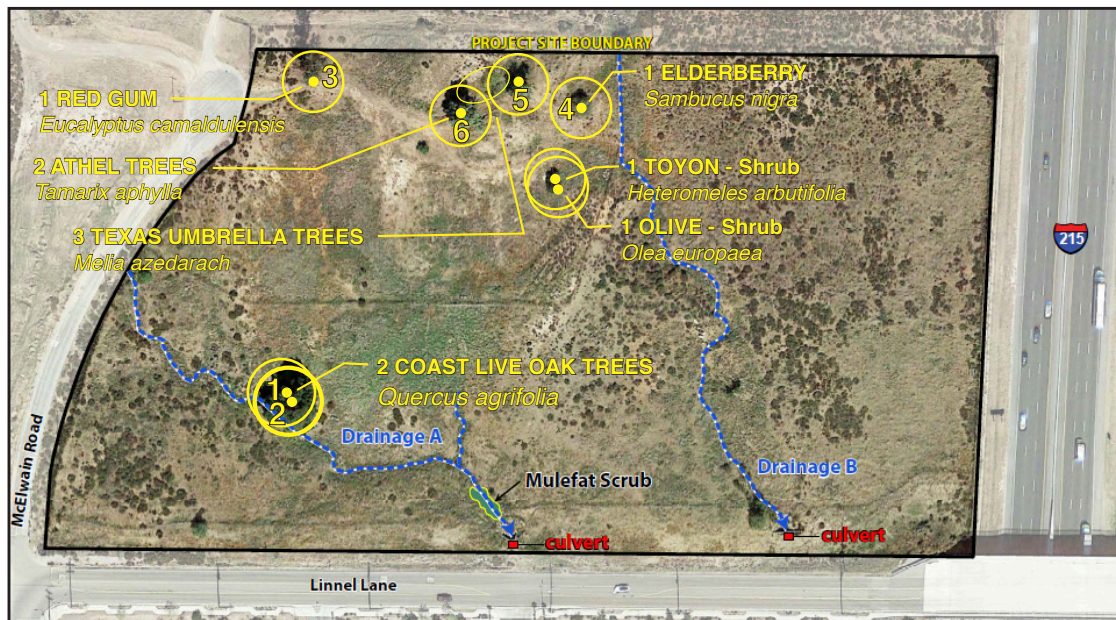
Figure 3. Tree locations on project site.

Six mature, ornamental trees, including two coast live oak trees, *Quercus agrifolia* occupy the site. Tree locations within the Project Site are as shown in Figure 3, Tree Locations. Two oak trees are located in the southern portion of the site. Other trees are scattered in the northern portion of the site. The Project Site is currently dominated by disturbed/ruderal, California buckwheat scrub and coastal sage scrub.

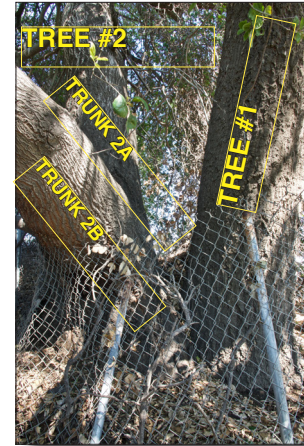
Figure 5. Two oak trees side by side.

Tree #1 appears to have been under considerable drought related stress in the past. The trees' color, typical of the species, is "off", as can also be clearly seen in photographs of the tree. Tip dieback in the canopy is evident, and a "thinning" in the overall canopy leaf density was observed. It should be noted that the thinning of the canopy is not a negative health issue at this point, but may have been related to the current drought. Currently, the tree is already flowering, see Figure 6, which is a good sign. Recent rain events will also help the tree to regain its vigor. The tree is rated a "B" in health and a "B" in aesthetics, for an overall rating of "B".

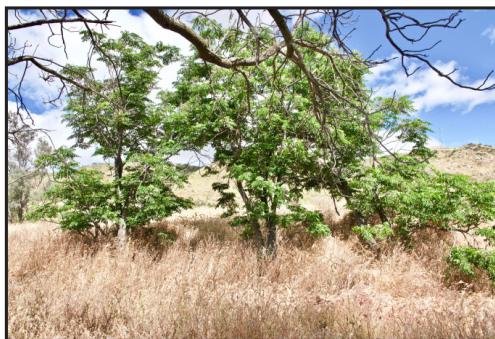
These trees, Figure 15, 16 and 17, do not meet the requirements of the Municipal Code 16.42, because of their small trunk size, or because they are dead.

Figure 16. Three Texas Umbrella trees (*Melia azedarach*), all with a DBH of less than 9.5 inches.

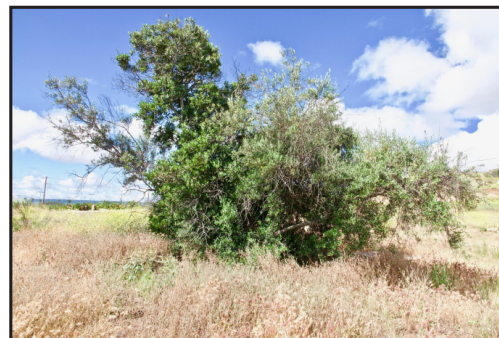
Figure 17. A toyon (*Heteromeles arbutifolia*) and an olive (*Olea europaea*), entwined with each other, both with a DBH of less than 9.5 inches.

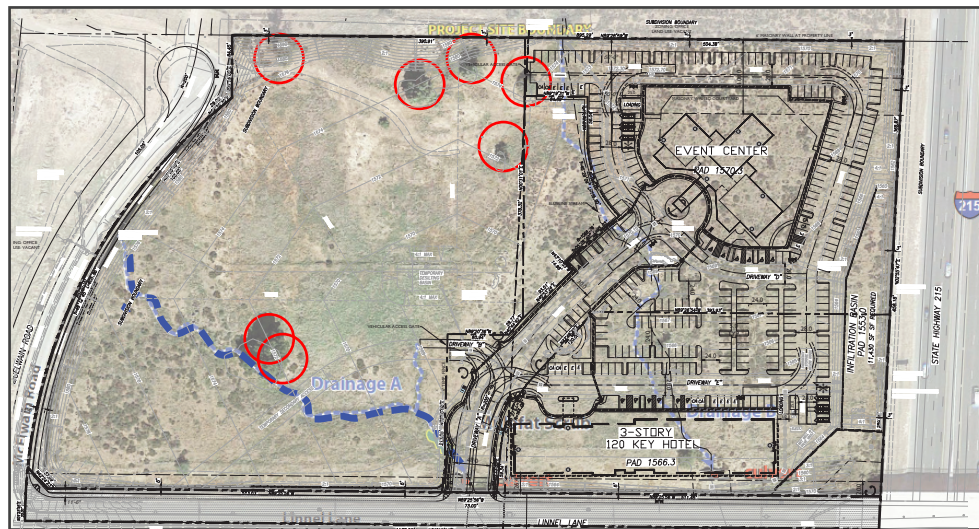
A commercial development is proposed to be built at the project site, see Figure 18. According to the development plans, this would seriously impact the existing trees, i.e., it would eliminate them all together. Figure 19 shows the proposed development plans overlaid onto the existing project site.

Figure 19. Proposed hotel/event center development overlaid onto the existing site, with impacted trees shown in red .
