## Tree Inventory Report

Hummingbird Energy  
San Jose, CA 95139

PREPARED BY:  
**HortScience | Bartlett Consulting**  
325 Ray Street  
Pleasanton, CA 94566

July 16<sup>th</sup>, 2019

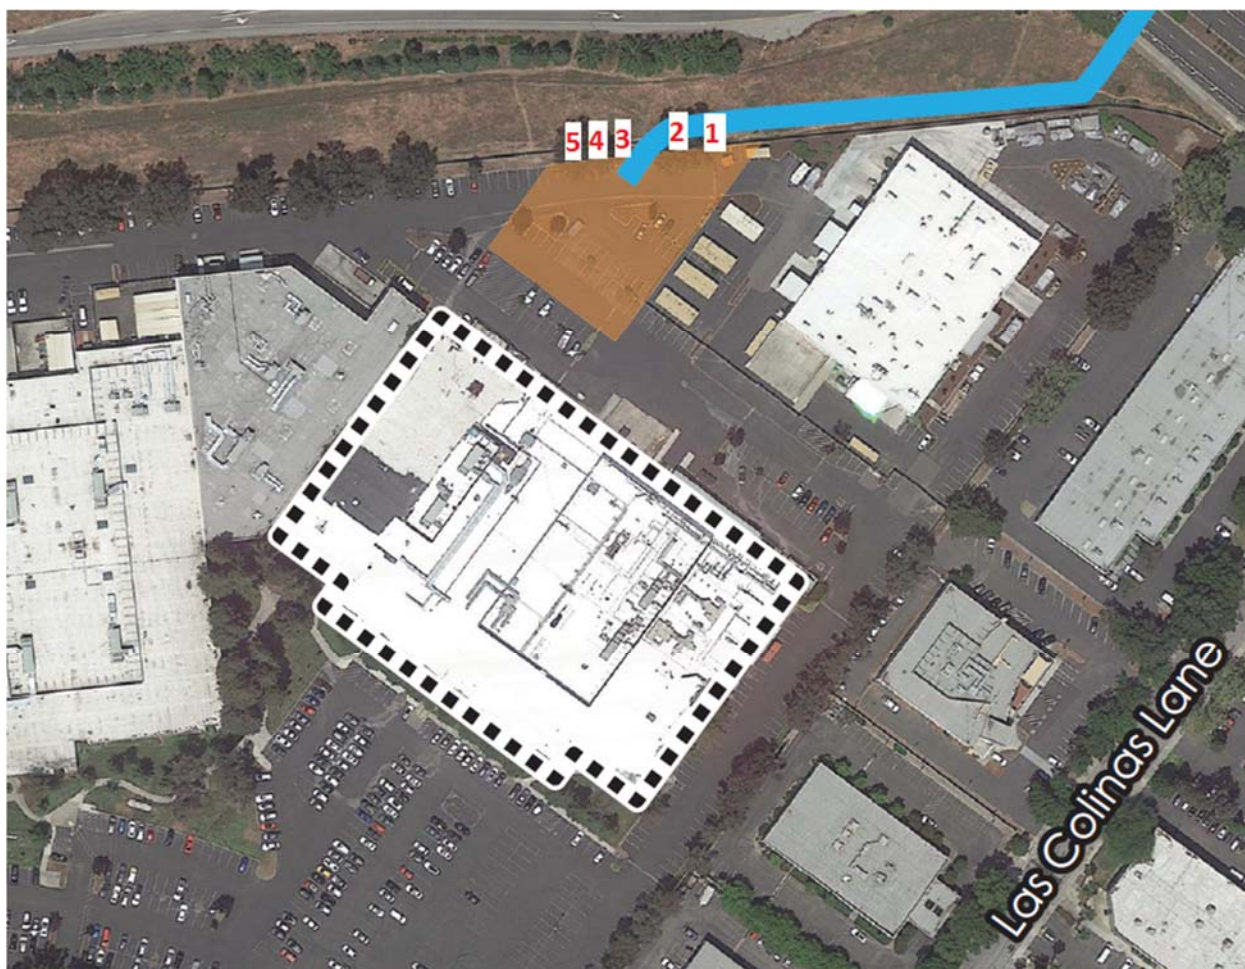
DJP&A visited the Hummingbird Energy Storage Project site on August 7, 2019 to measure five additional trees. The location of the trees are shown below.

The five trees are located along the northern edge of the proposed substation. Table 1 below shows the measured tree diameter for each of the five trees, all of which are Red Ironbark (*Eucalyptus sideroxylon*).
