Site Management Plan

WDID-1_12CC415333

Humboldt County

9/18/2019

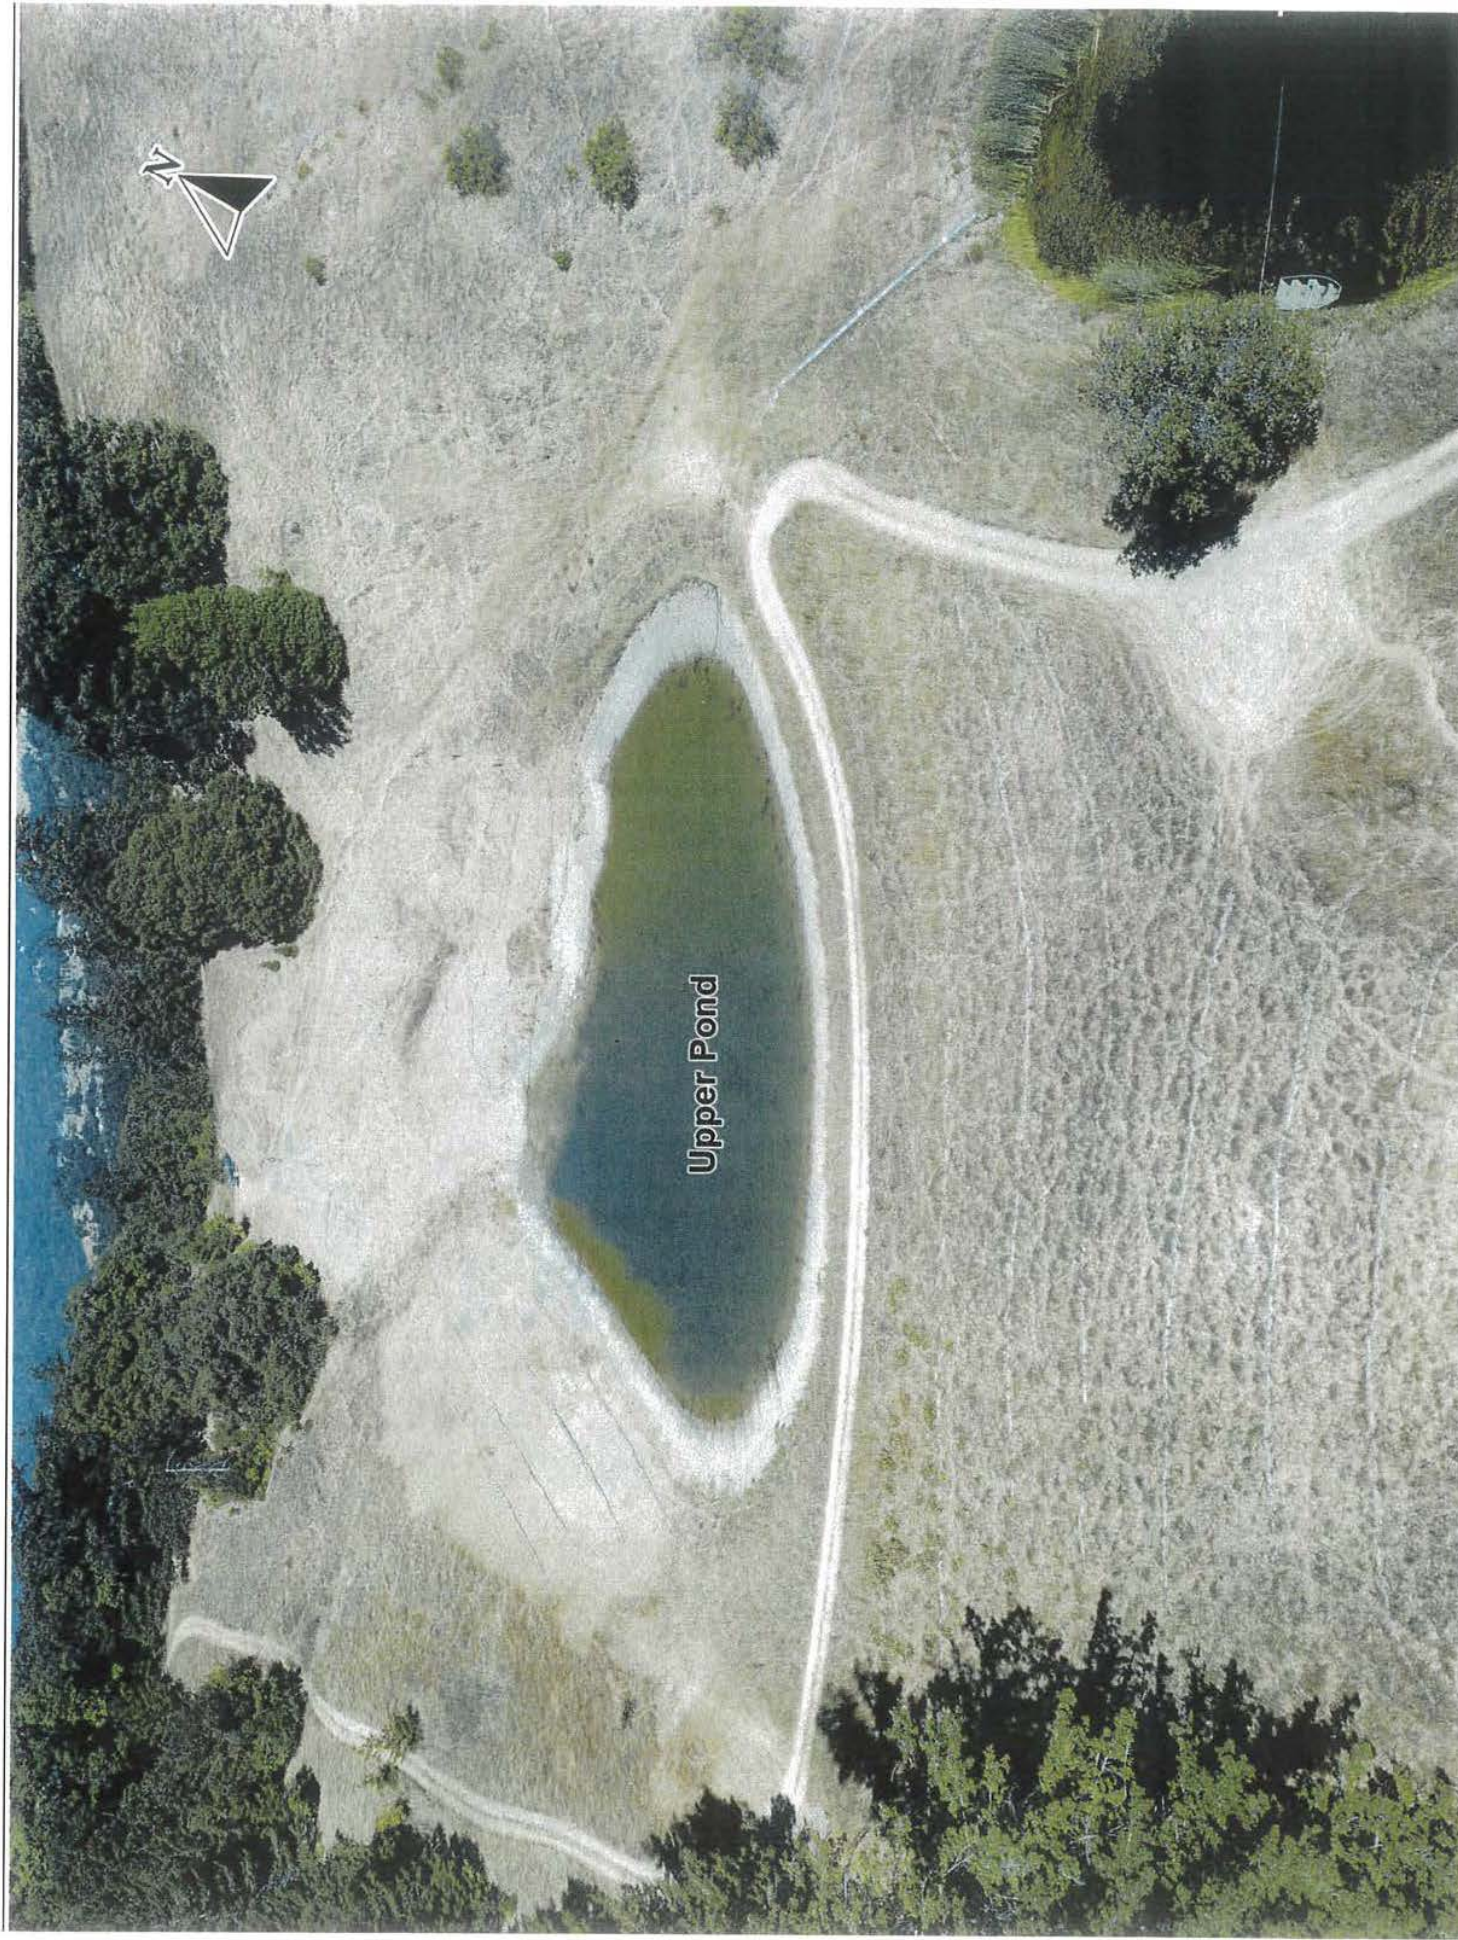
Runoff from compacted and graded cut-slope
collecting into swale feature creating overland flow

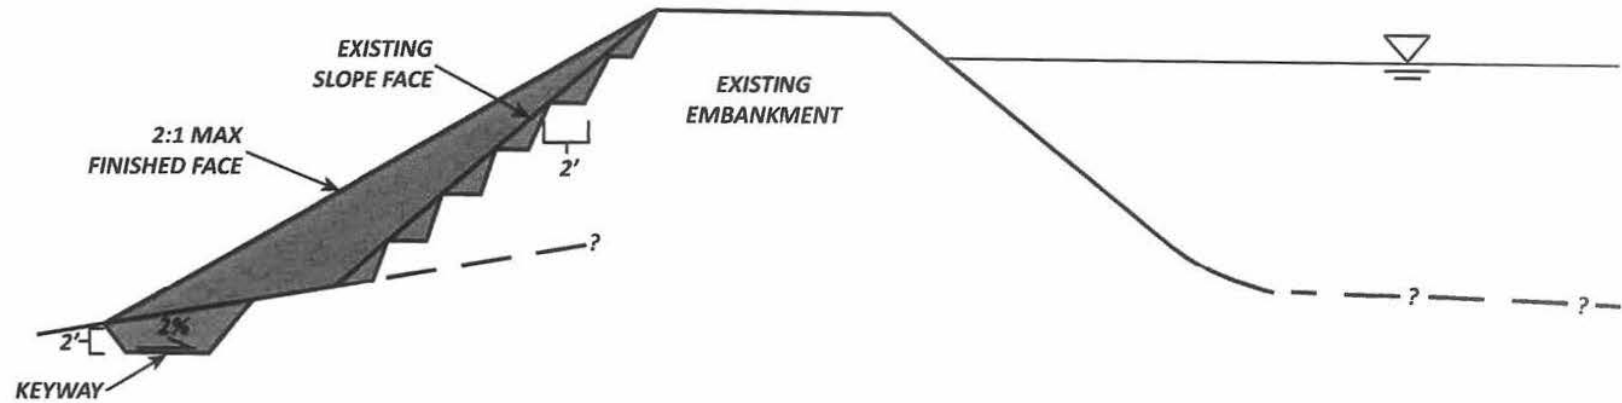
A) ADD FILL TO THE EXISTING OUTBOARD SLOPE FACE TO CREATE 2:1 SLOPE

The outer embankment face needs to be reduced to a slope no steeper than 2:1. Reducing the slope gradient of the embankment face may occur by one of the following methods, which are depicted in Figure 1:

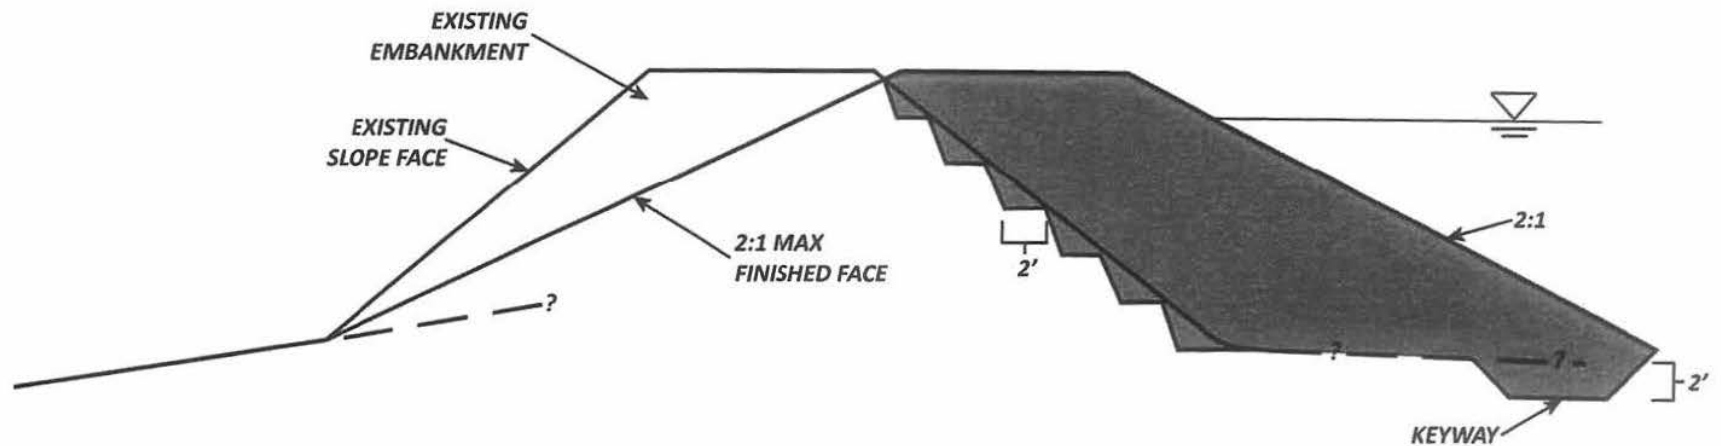
B) LAY EXISTING OUTBOARD SLOPE FACE BACK TO CREATE 2:1 SLOPE; ADD FILL TO INBOARD FACE

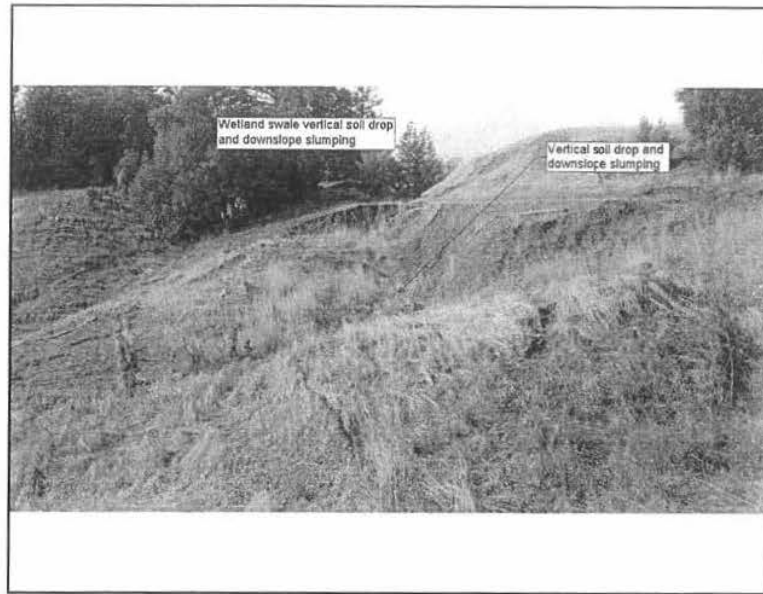
Photograph 3. Photograph taken January 10, 2019 of the landslide areas above Reservoir 1. No bed and bank features that would constitute streams were present.

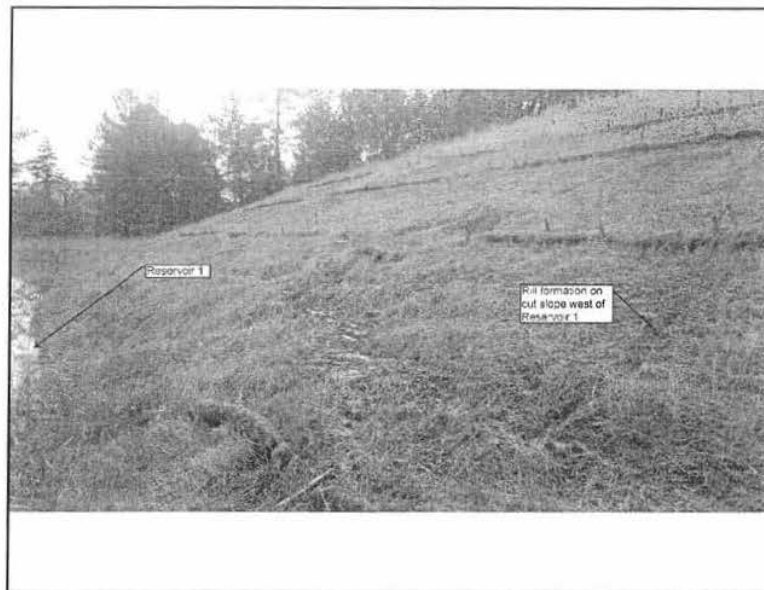
Photograph 4. The cut slope on the west side of Reservoir 1. Rills have formed, but nothing meeting the definition of stream was present.

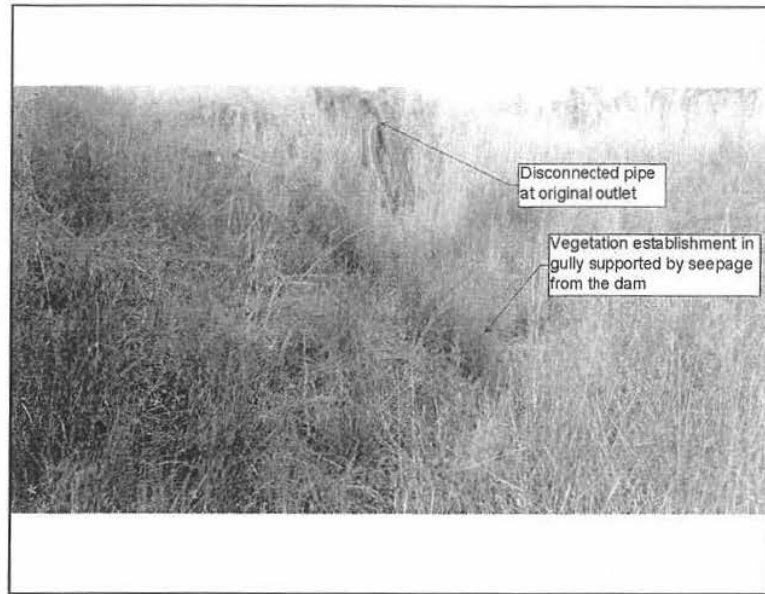
south face of the dam separated; this outlet was abandoned and the new drain pipe was installed. Seepage from the base of the dam, which likely results from lateral transmissivity through the dam from the reservoir, is beginning to support perennial vegetation growth (Photo 6).

Photograph 6. Gully below Reservoir 2 eroded by outfall from the reservoir from the drain pipe separating. A new outlet on the east side of the reservoir was installed. Seepage from the bottom of the reservoir is becoming established

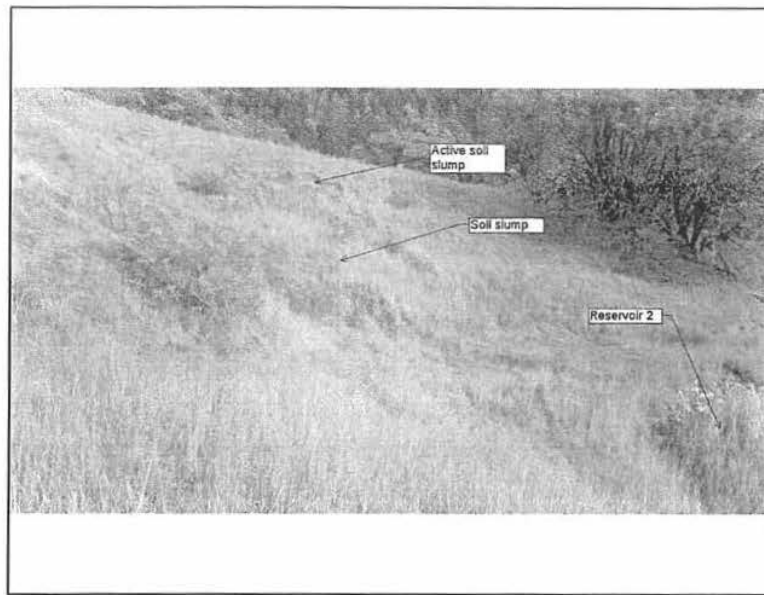
Photograph 8. The area above Reservoir 2 is a landslide area that is still somewhat active as indicated by soil slumping and recent active soil slumping.

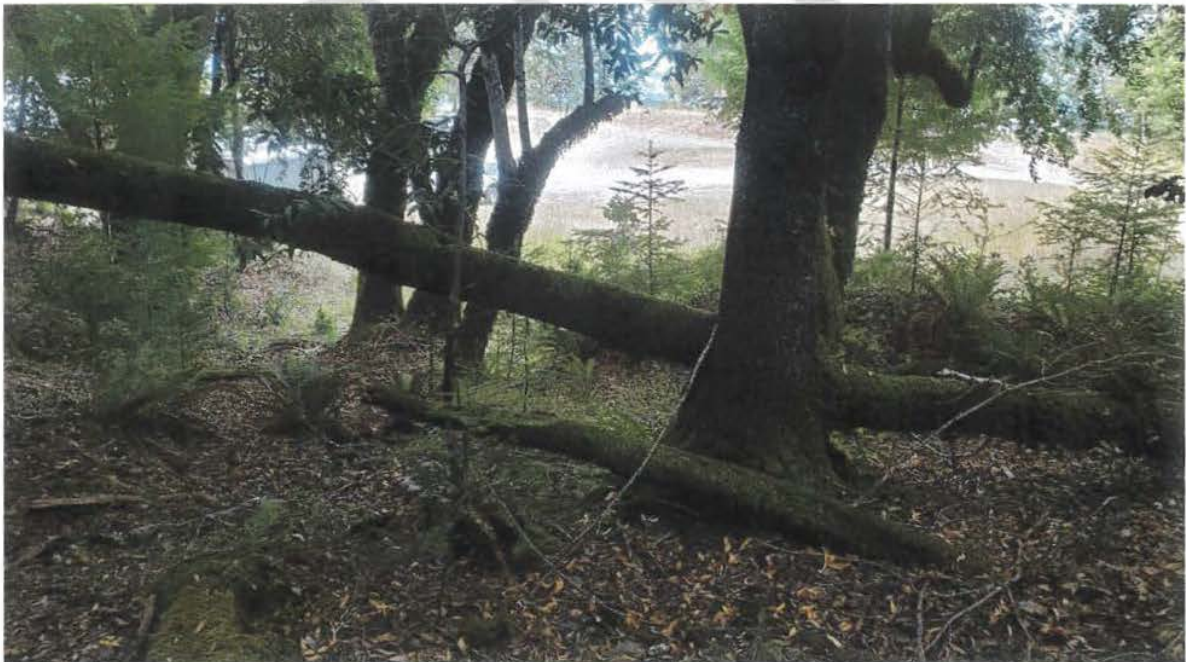
Undefined watercourse at Site 13 looking downstream. The watercourse terminates at the edge of the tree line.

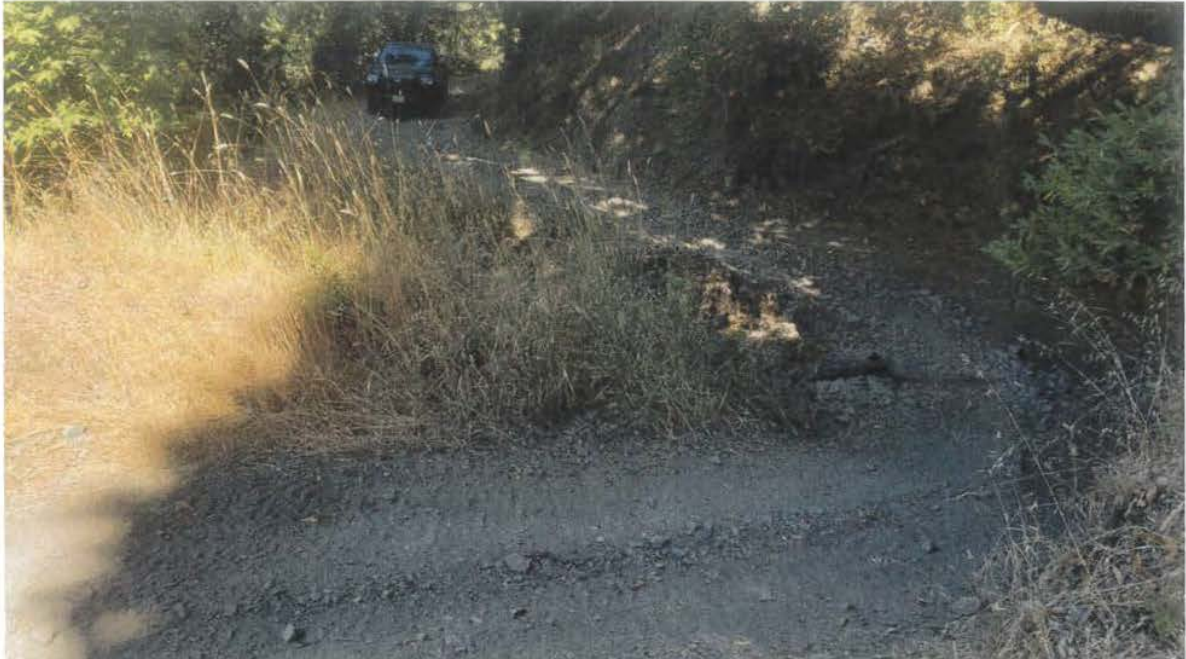
Photograph of the watercourse crossing at Site 16. This crossing is to be upgraded to a culverted crossing and the road approaches rocked to the garden parking area immediately to the left out of frame of this photograph.

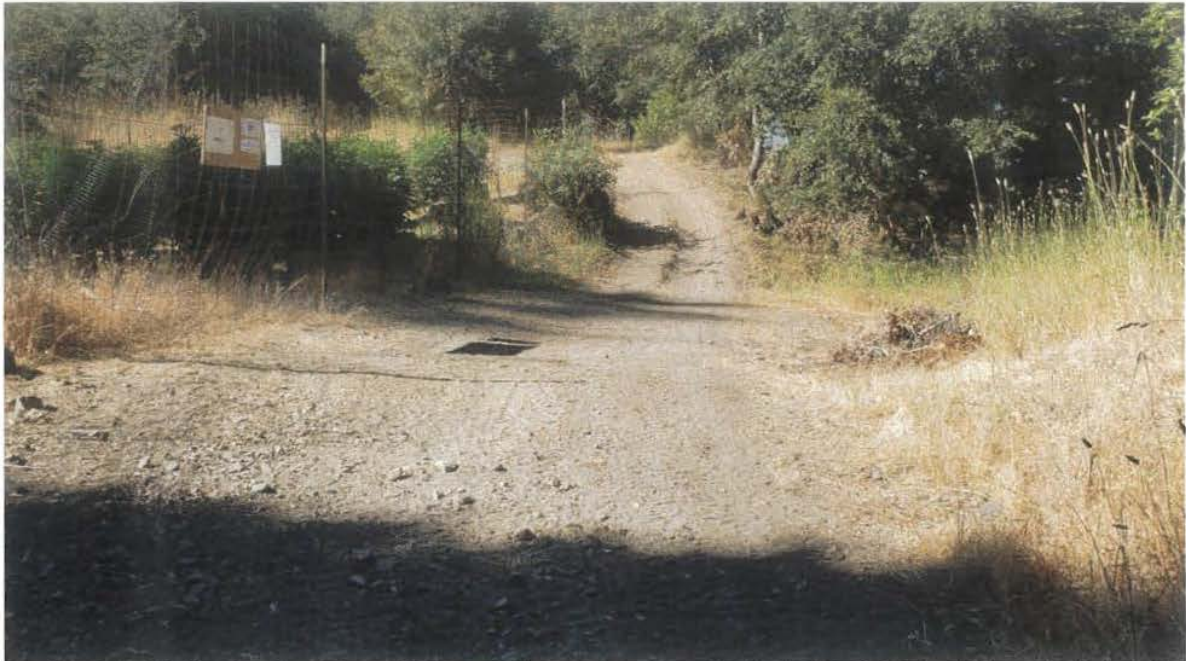
Photograph of Cultivation Area B's parking area. This area is to be rocked and staked straw wattles are to be installed to the right of the road along the brush line above the watercourse.

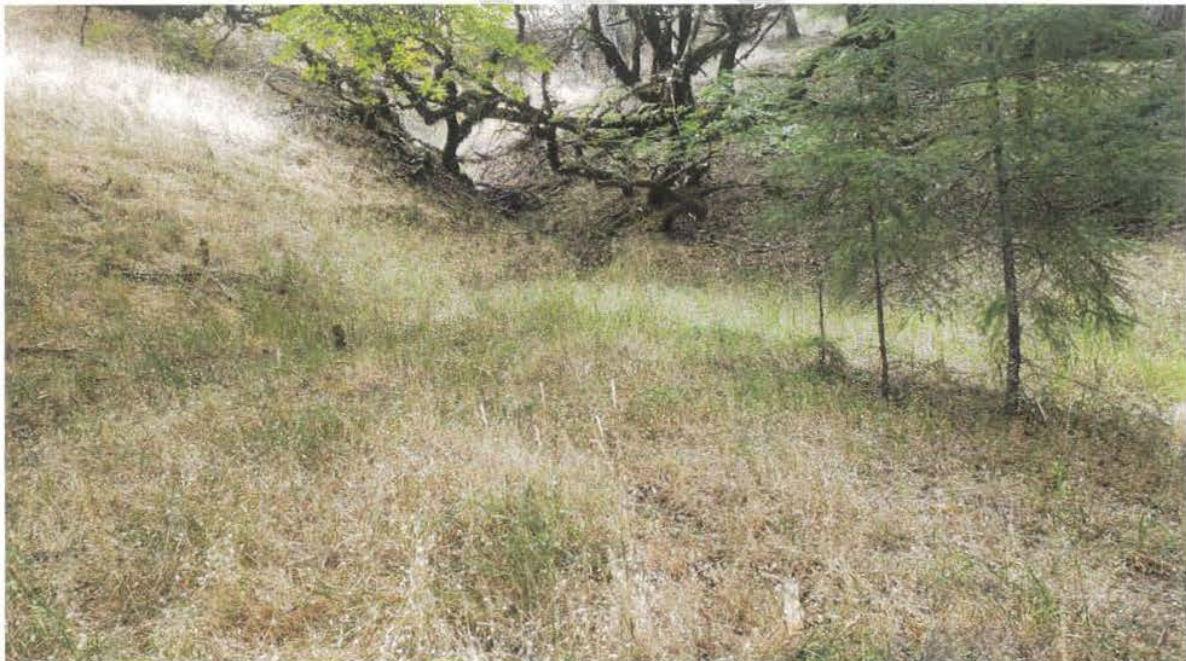
Looking upstream at the diverted watercourse at Site 21. Historically the watercourse drained to the right of the photograph behind the sapling trees to the right. Bed load delivery during large storm events has created an alluvial fan that has diverted the watercourse towards the position of where the photograph was taken.

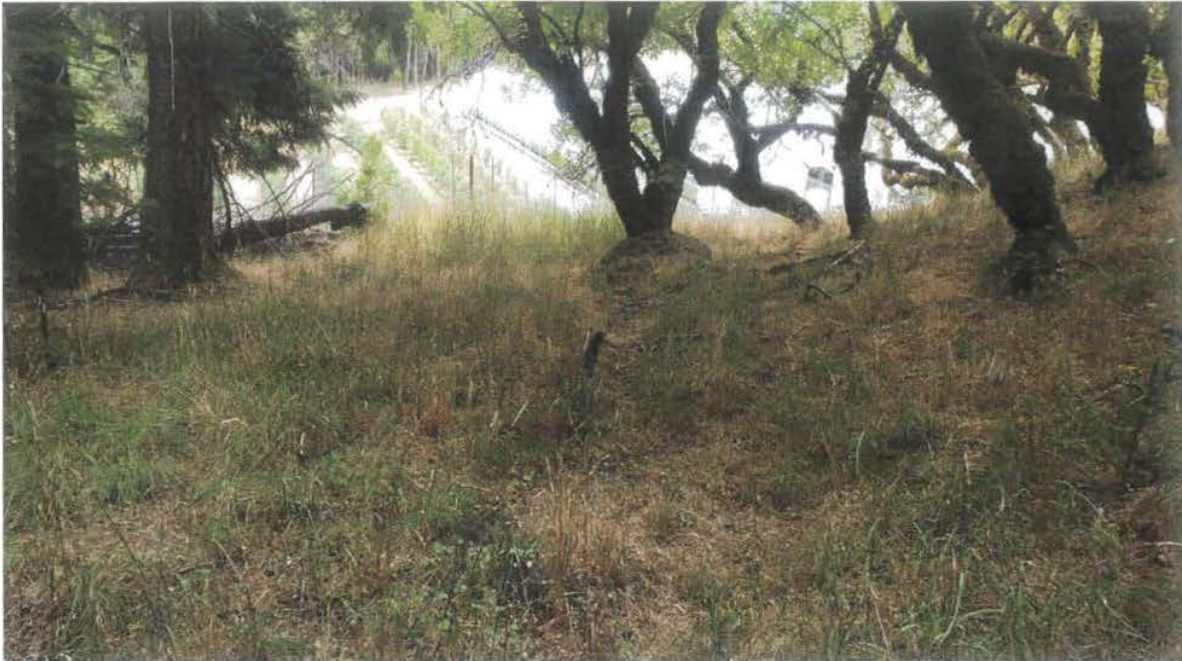
Looking down stream of the diverted watercourse at Site 21.

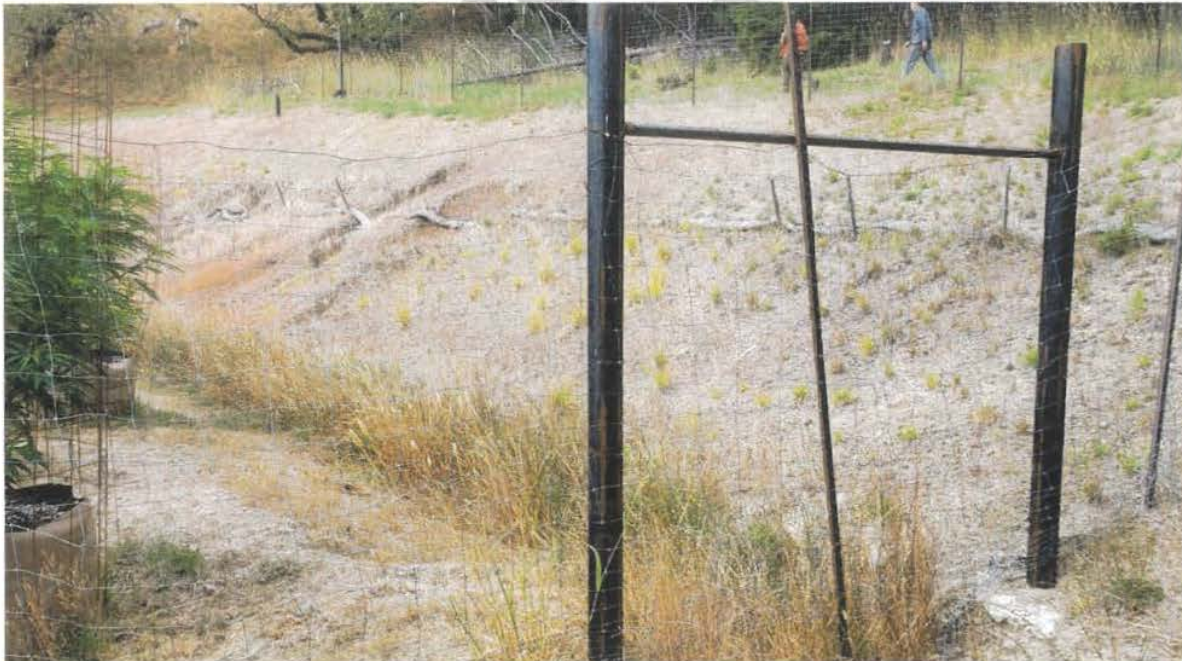
Looking at the drainage ditch along the northeastern side of Cultivation Area A. The diverted watercourse from Site 21 is draining over the cut bank and causing the erosion of the cutbank as scene in this photograph.

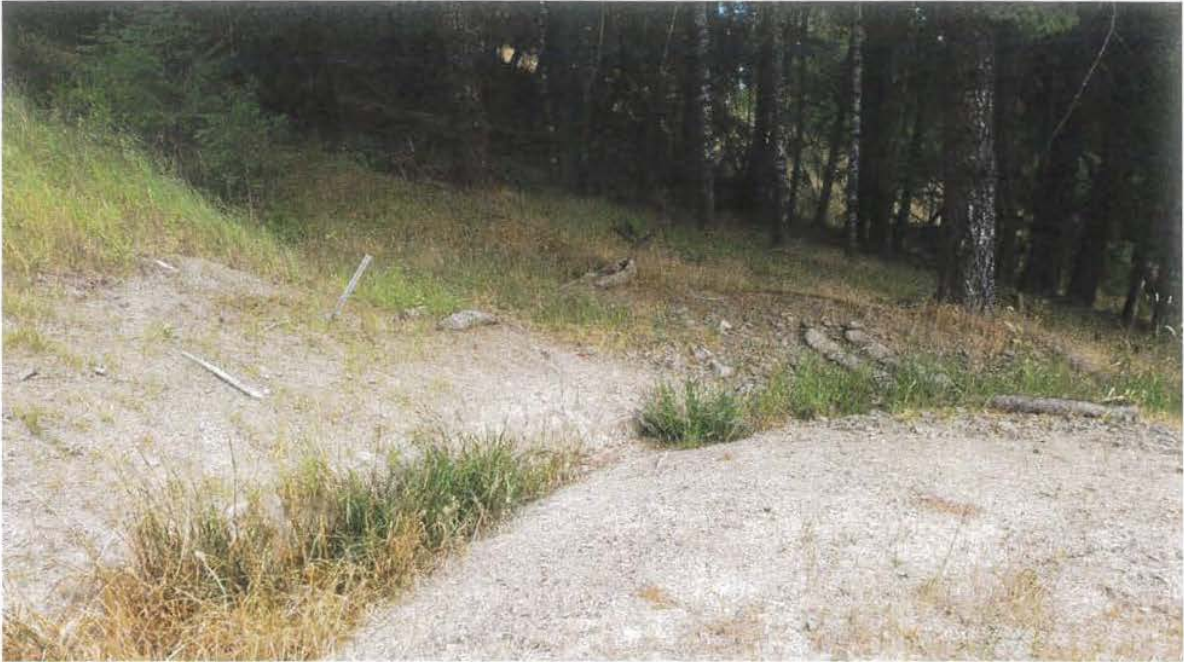
The drainage ditch then drains into the head of a Class III watercourse. The re-alignment of the watercourse at Site 21 will have the watercourse drain into the channel located at the base of the sapling trees in the upper left of the photo.

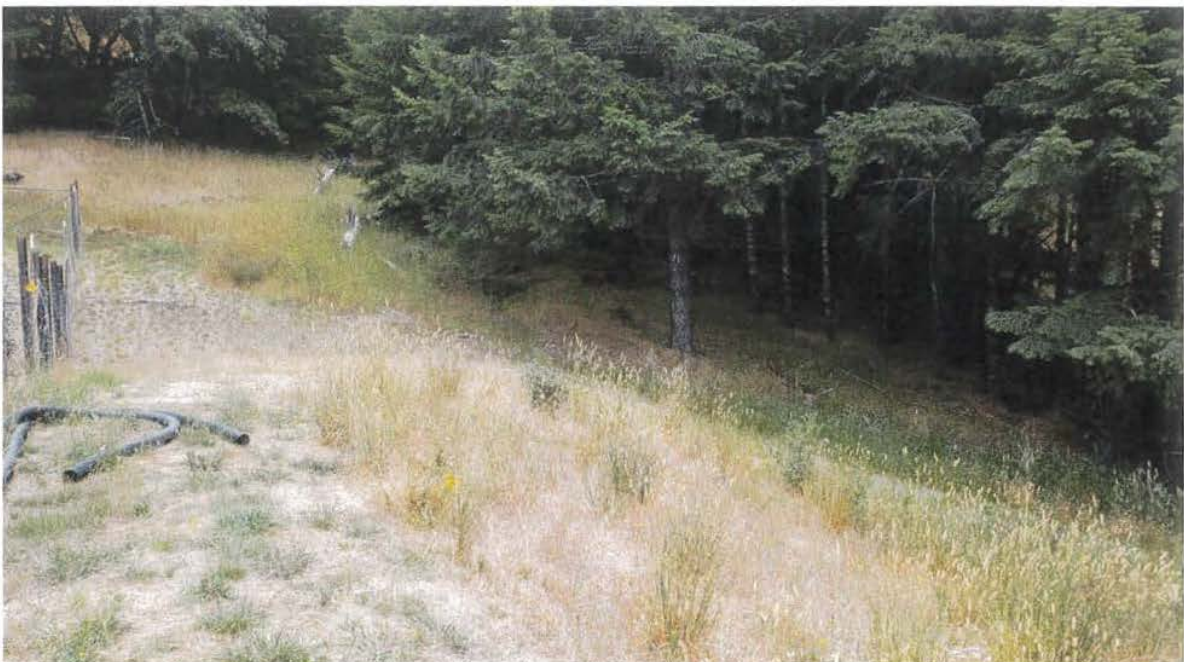
Photo looking at the outlet of the drainage ditch previously shown in the photo above. The Class III watercourse is located approximately center left of the photo where the flagging tied to trees is located along the tree line.

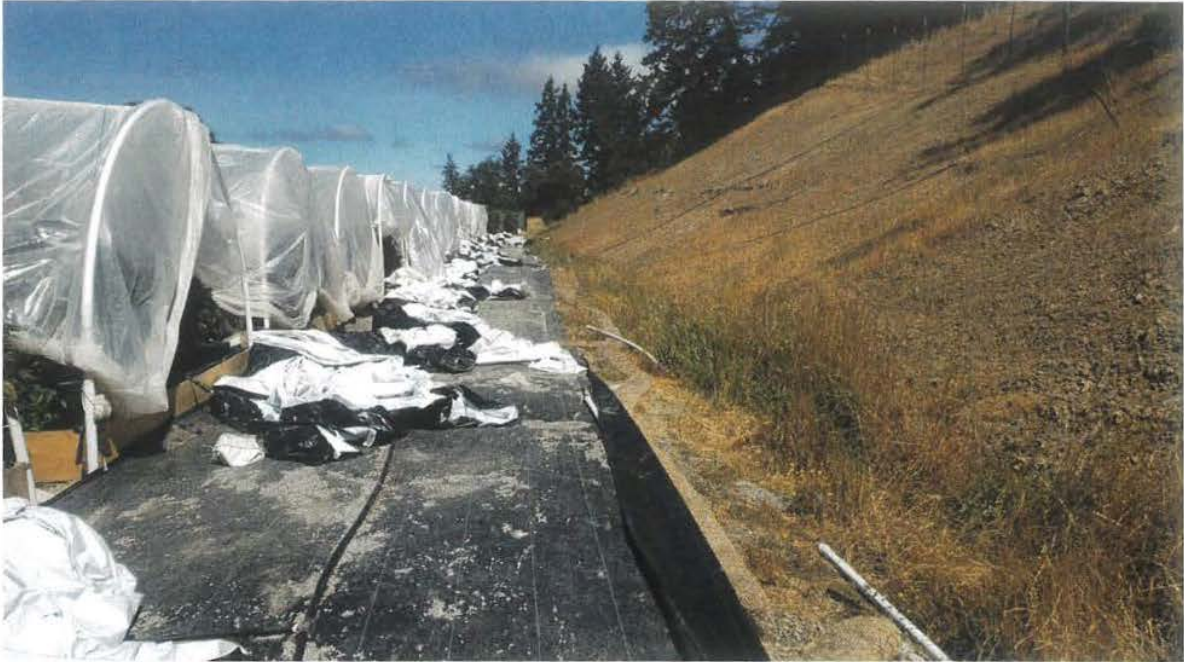
Photograph of the drainage ditch along the northeastern edge of Cultivation Area A. This photograph was taken looking northwest. Note the well vegetated ditch, straw wattles, graveled surface, and weed matting all used to slow and capture surface runoff from the cultivation area.

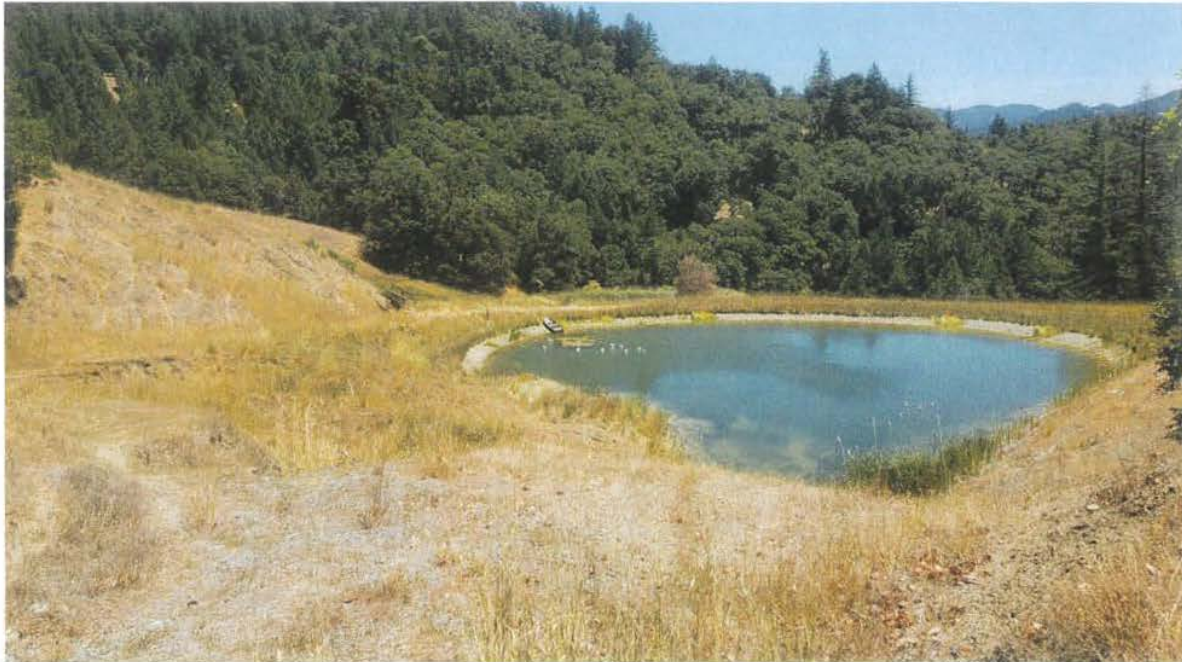
Photograph of the Upper Pond (Off-stream rain catchment) looking down slope at Site 36 and 37.

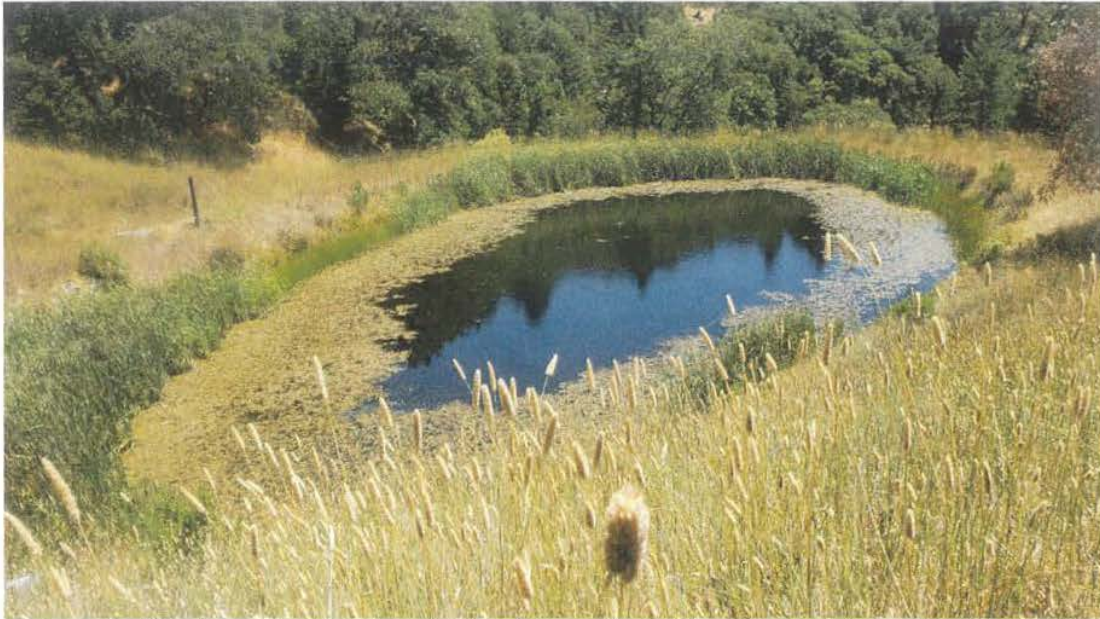
Photograph of the Lower Pond (on-stream). The primary spillway (Site 38) is located along the left side of the pond in the photograph and the secondary spillway (Site 39, to become the primary spillway) is located to the right. The overflow spillway from the Upper Pond is located in the left-hand corner of the photograph.

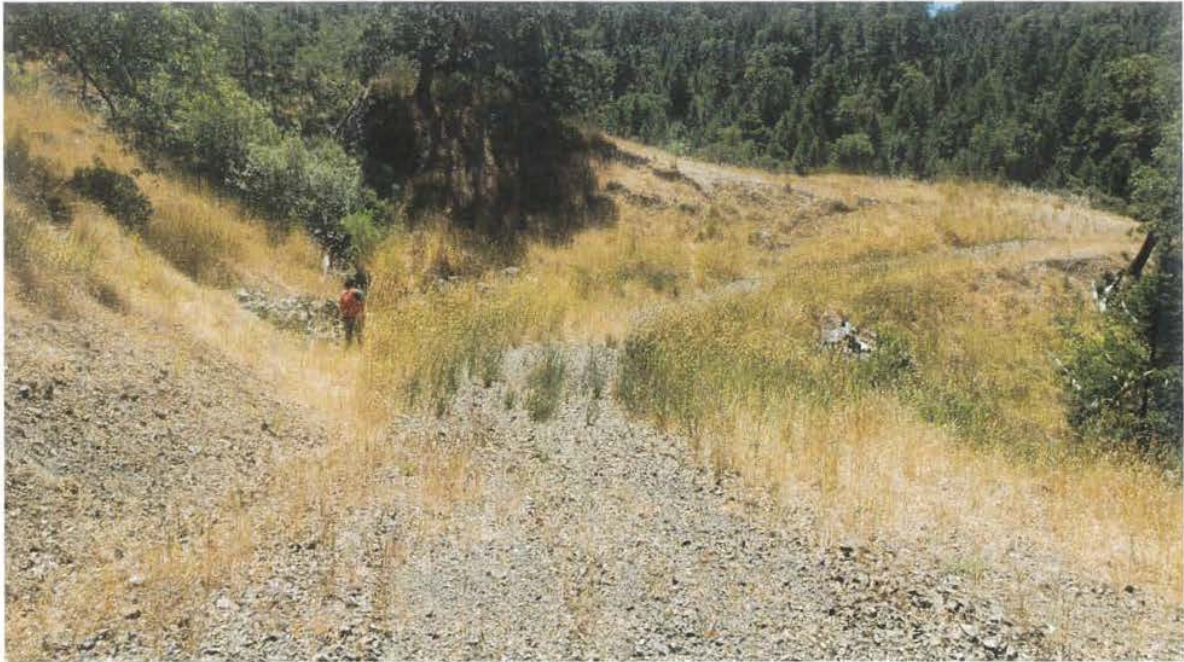
Photograph of the watercourse crossing at Site 69.

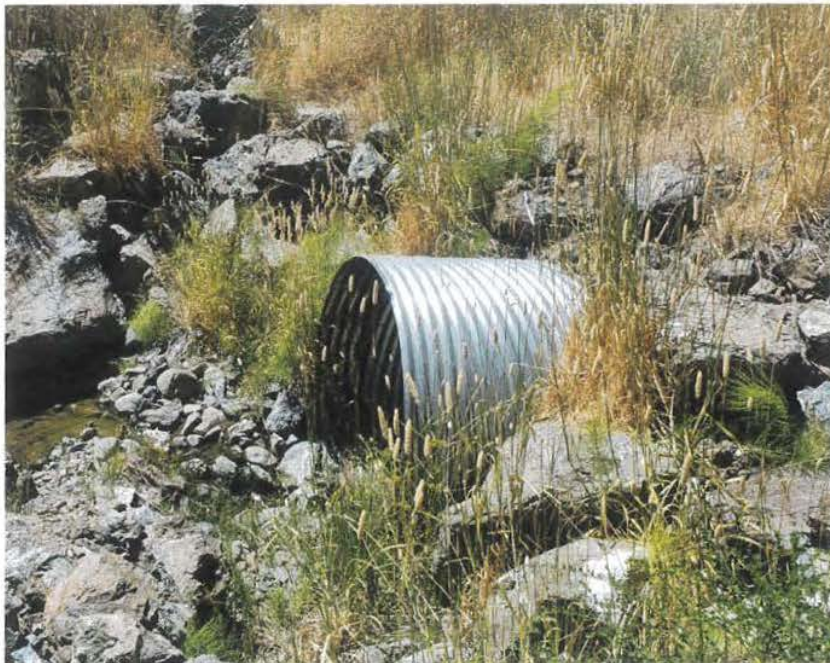
Photograph of the inlet of the watercourse crossing at Site 69.

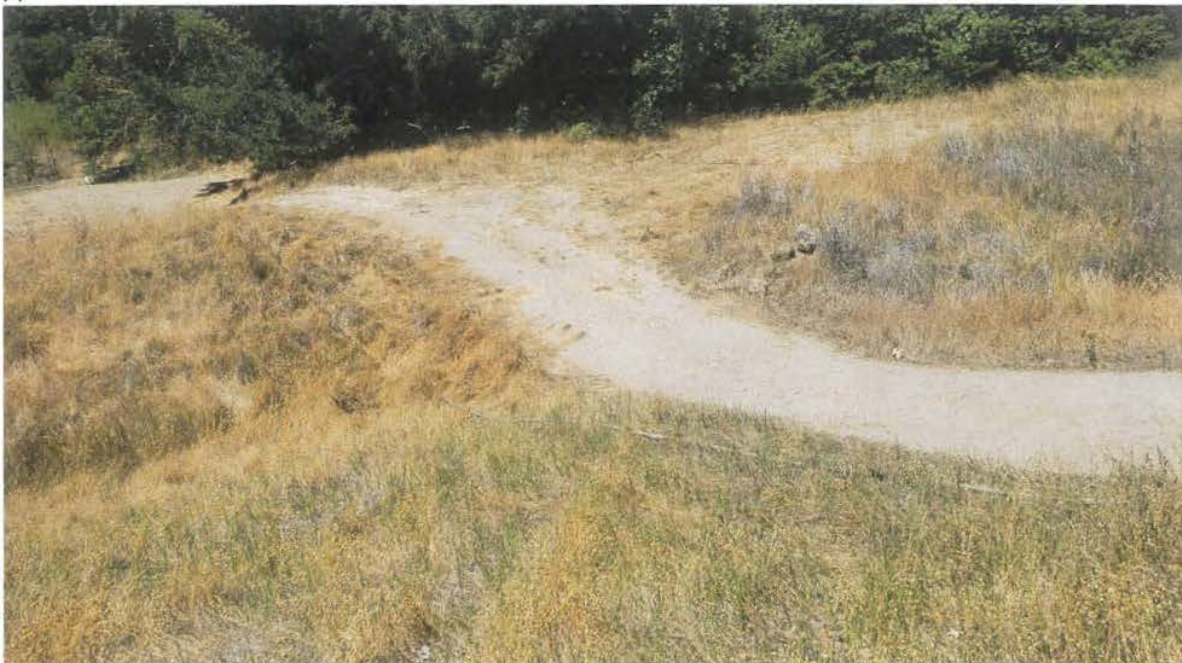
Photograph of the dirt ford watercourse crossing at Site 72 to be abandoned after the remove and relocation of Cultivation Area F.
