**TREE INVENTORY REPORT
DISTRICT NOHO
5430 NORTH LANKERSHIM BOULEVARD
LOS ANGELES, CALIFORNIA 91601**

**NOVEMBER 14, 2019
(REV. JUNE 4, 2020)**

Re: District NOHO Project, North Hollywood, California – Tree Inventory Report

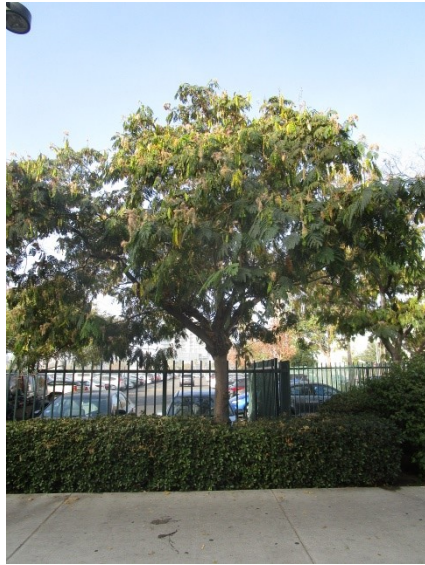
Tree 1

Tree #	Common Name	Botanical Name	Diameter at 4.5 feet (DBH) in inches	Height	Canopy Spread (NS / EW) in feet	Health	Structure	Suitable for Relocation ?	"Protected" or "Significant"	Comments
1	mimosa tree	<i>Albizia julibrissin</i>	8.1	15	25 / 25	B-	B-	No	Significant	HOB; moderate dieback; stake tie embedded in trunk; MPE
2	mimosa tree	<i>Albizia julibrissin</i>	7.2	15	18 / 21	C	C	No	No	HOB; moderate dieback; top dieback; MPE
3	mimosa tree	<i>Albizia julibrissin</i>	6.2	10	15 / 18	C-	C-	No	No	moderate dieback; top dieback; MPE
4	Brisbane box	<i>Lophostemon confertus</i>	8	20	20 / 15	B+	B+	No	Significant	stake tie embedded in trunk; MPE
5	Brisbane box	<i>Lophostemon confertus</i>	6.1	15	N/A	F	F	No	No	DEAD
6	Brisbane box	<i>Lophostemon confertus</i>	6.5	15	18 / 15	C	C	No	No	stake tie embedded in trunk; moderate dieback
7	Brisbane box	<i>Lophostemon confertus</i>	6.7	15	N/A	F	F	No	No	DEAD
8	Brisbane box	<i>Lophostemon confertus</i>	7	15	N/A	F	F	No	No	DEAD

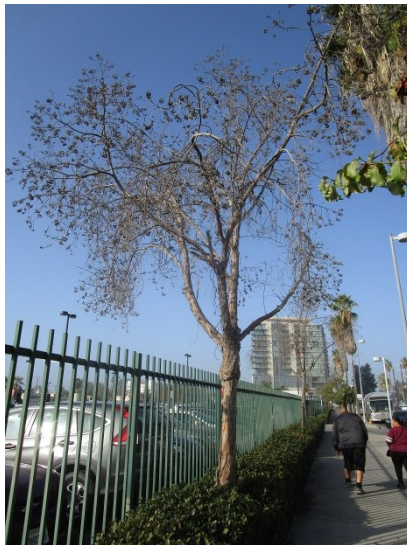
Tree 10

9	Brisbane box	<i>Lophostemon confertus</i>	6	15	N/A	F	F	No	No	DEAD; fence holding tree upright; recommend remove immediately
10	Brisbane box	<i>Lophostemon confertus</i>	6.8	15	N/A	F	F	No	No	DEAD

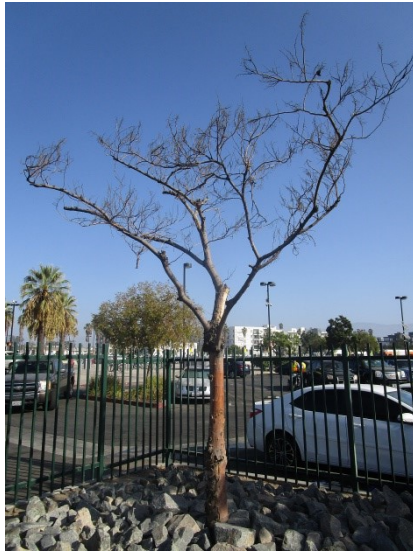
Tree 19

19	mimosa tree	<i>Albizia julibrissin</i>	5.7	10	N/A	F	F	No	No	DEAD
20	mimosa tree	<i>Albizia julibrissin</i>	6.2	10	10 / 6	D	D	No	No	significant dieback; tie embedded in trunk; top dieback
21	Brisbane box	<i>Lophostemon confertus</i>	7.7	18	21 / 18	B	B	No	No	sparse canopy; basal sprouts; tie embedded
