ORTEGA PARK MURAL EVALUATION REPORT
JULY 13, 2021

Prepared by:
Site & Studio Conservation, LLC.
Kiernan Graves
Evelynn Bird
Abigail Rodriguez
Magdalena Solano

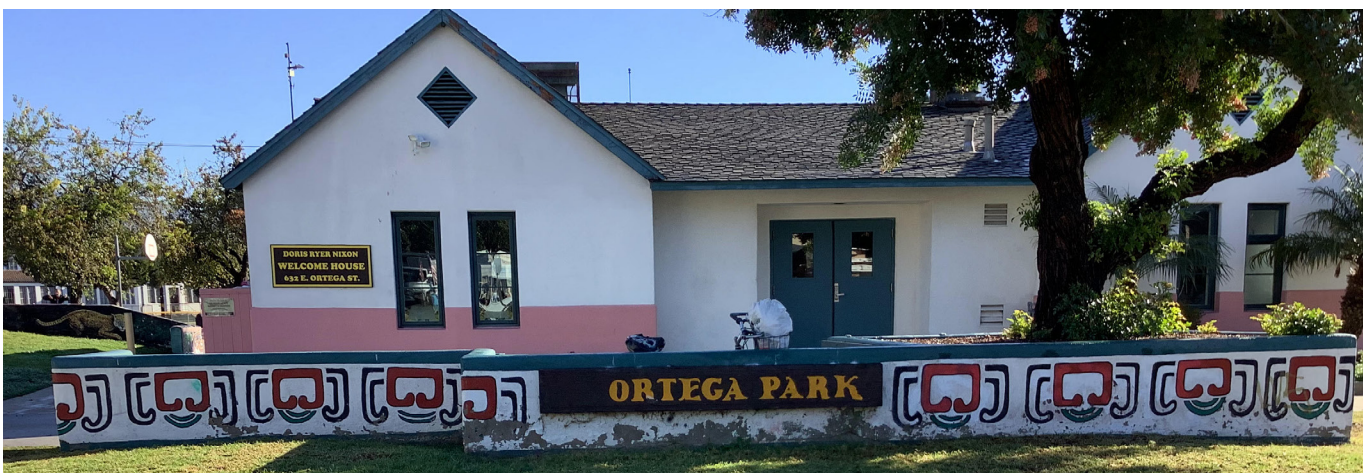
Figure 5. Decorative symbols painted by Vallejo.

This decorative scheme was not intended to be part of the survey, however after discussion with Vallejo and learning that it was painted by him, it was included for documentation purposes. As there are very few records pertaining to this area of the park it is unknown how much the mural has been restored over time, but according to Vallejo, it appears the same as when he painted it, likely as part of the 1985-6 renovations. (Figure 5)

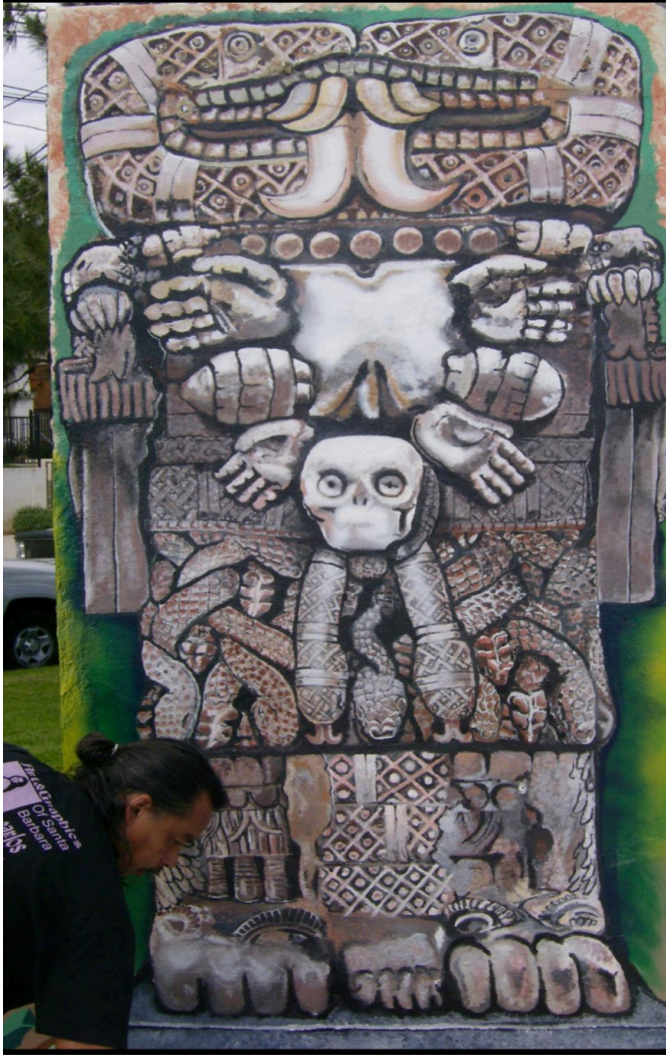
Figure 6. Cuellar painting the original *Coatlicue* in 2007
(Image from Venegas 2020)

Due to health and safety concerns of the neighborhood, the stage walls were torn down in 2004 and the murals painted on them destroyed. What remains today are low retaining walls which flank a tall central panel, left in place because of the electrical box attached to the back. These murals have gone through a multitude of iterations, namely because after the stage walls were demolished, the SBAA designated the space for ongoing training of the young artists working on the mural painting and restoration projects. Since the demolition of the stage, the works of art on the walls were always intended to be temporary and are completely repainted every few years. Of interest, the general subject matter of each area has remained the same, even as new artists put their own style on the subject matter (Figures 6 and 7).

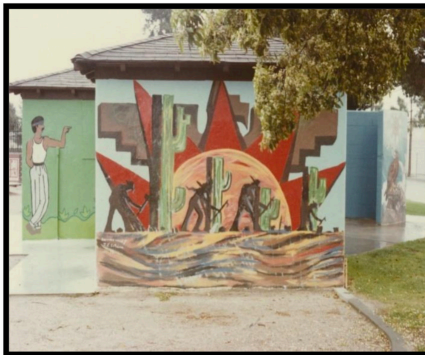
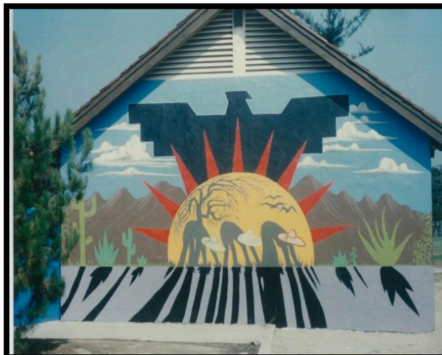
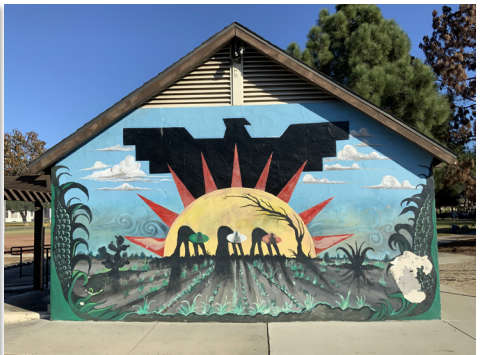
Figures 8, 9, 10. *Campesinos* and its iterations, from left to right: 1979, 1985, present.
(Archival images from Venegas 2020)

Campesinos first painted by Vallejo is a mural that has changed fairly significantly in composition—though not in the feeling nor subject matter—at two different times throughout its life. In 1985-6, the original building was torn down and Vallejo repainted his own design, changing a great deal of the composition but retaining the same style and content. Most recently, with Vallejo's permission, Unzueta again repainted the mural in the same location, adding a number of decorative elements but to the landscape, creating what most of the artists agree to be a more balanced and elevated design, but left the main composition, style and palette the same (Figures 8, 9, 10).

Beginning with *Campesinos* in 1979, this set of three murals functions as a tangible connection between California/Chicano/Santa Barbara history and present Eastside residents. *Campesinos* was painted by Armando Vallejo 1979 and subsequently repainted in 1986. Though he modified his original composition and style, the subject matter, iconography and powerful imagery remained. In 2008, during a restoration project for the two surrounding murals, Unzueta repainted the mural and altered the composition by adding and changing several elements of the mural. It was at this time that the corn, cactus, wind swirls, crops in the foreground, and colors on the hats were added. The mural, as it stands today, has a solid black Huelga eagle rising behind the sun, symbolically referencing the United Farm Workers labor movement. Additionally, the red, white, and green hats of the *Campesinos* are a reference to the Mexican flag. The bent position of the figures is a tribute to the backbreaking work and struggle of Mexican-American immigrants labor in California's agricultural industry, some of whom reside in the eastside of Santa Barbara. The powerful and symbolic imagery of the farm worker was particularly mentioned as meaningful and important by many of the community members interviewed (Figures 8, 9 and 10).

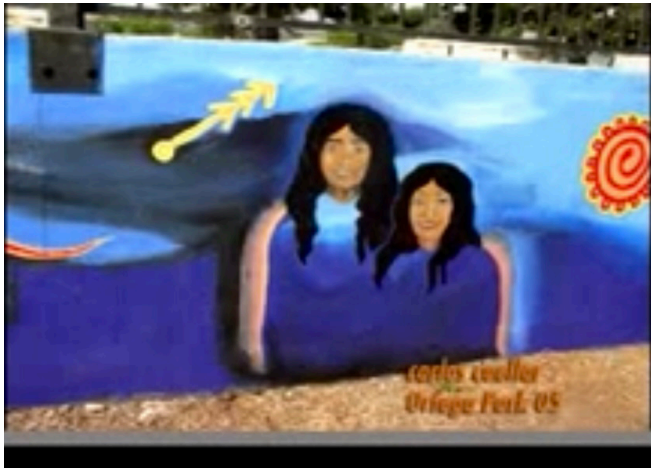
Figure 13. *Aztec Chumash Solstice* before restoration. (Image is taken from a video put together with archive images by Cuellar.)

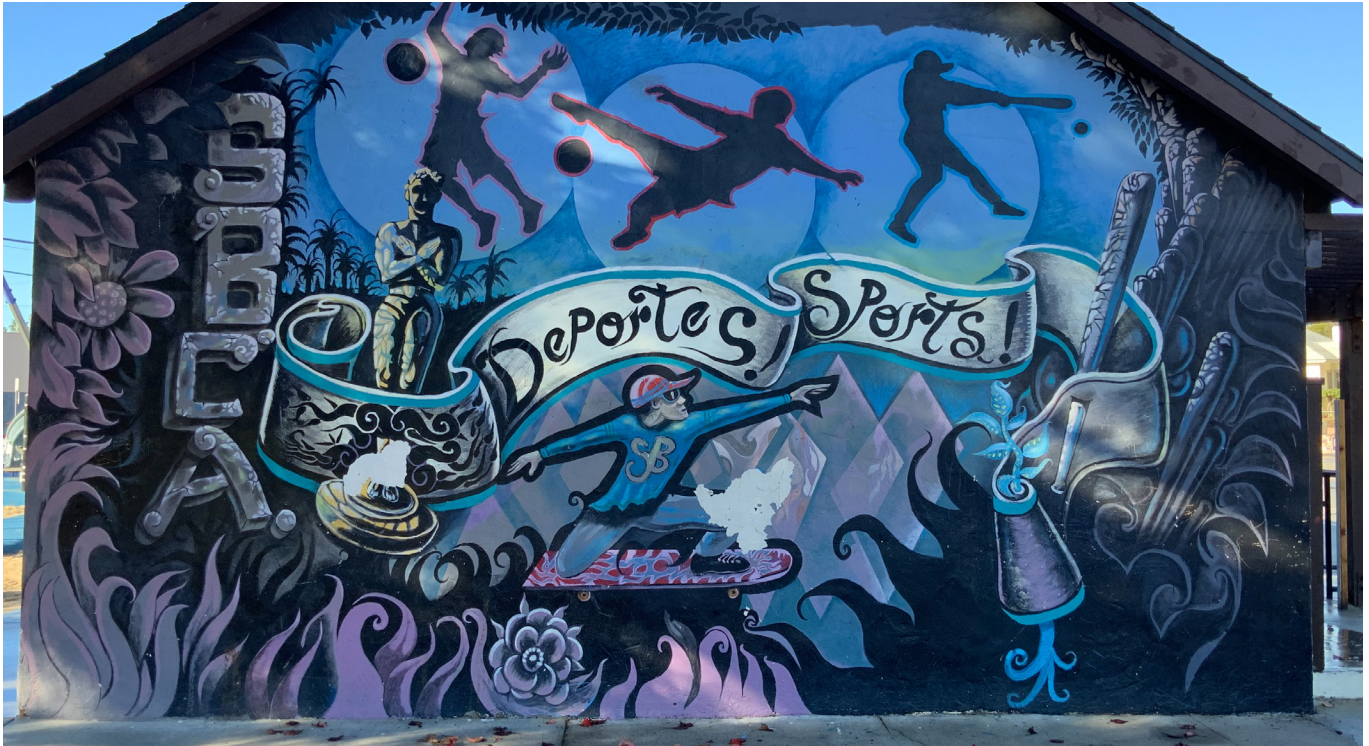
Figure 15. *Deportes*

referencing the numerous t-ball and softball leagues who use the park. The entire work makes use of a limited palette by skillfully contrasting dark and light across the wall. The scene overall appears to be enveloped by nature, giving a soft edge to the urban landscape (Figure 15).

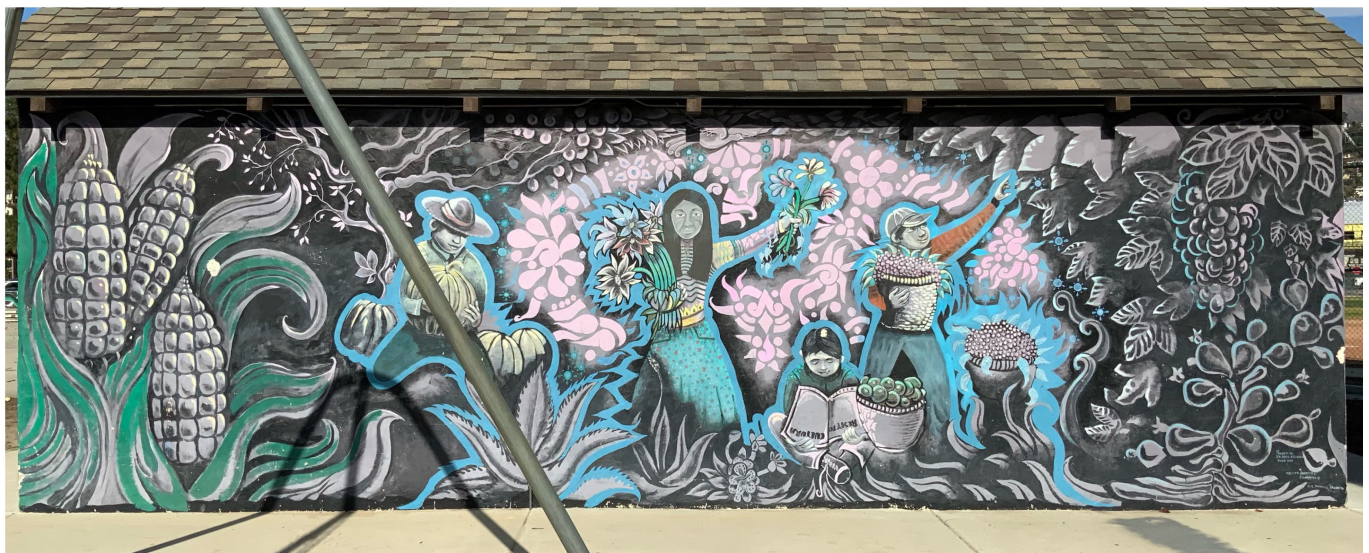
Figure 16. *Niños de Maíz*

The final mural on the restroom building is *Niños del Maíz*. This mural was painted in 2008 as a replacement for a damaged work by Unzueta. Unzueta has stated that the work pays homage to the farmworker families in the Santa Barbara region. When this mural is put in conversation with Vallejo's *Campesinos*, a strong tangible connection between the past and the present is presented for the patrons of the park. Restored in 2011, the mural is framed by local crops: ears of corn on the proper right and grape vines on the proper left. There are four figures in the middle, surrounded by a soft pink Otomi-inspired floral design. Each figure is actively engaged with a different activity, including inspecting a pumpkin, selling flowers, and picking grapes. The figure at the center and foreground of the mural is holding a book open next to what appears to be a basket of avocados. The pages of the book say "RESPE TO CULTURA" or respect culture. Similar to the *Campesinos* mural, *Niños del Maíz* communicates a rich story about local agriculture, Chicano laborers, and culture through a limited but dynamic palette. The strength of the messages in each of these murals is amplified by the relationship of the three works to one another. Together they elicit themes of community, history, and identity (Figure 16).

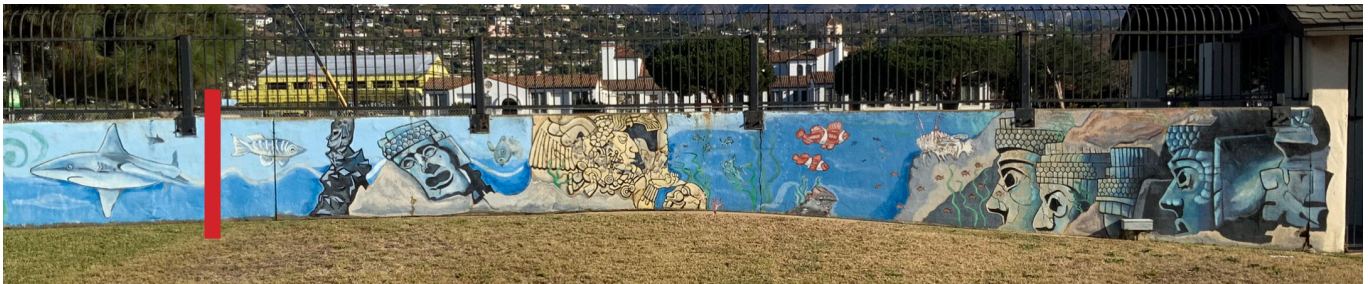
Figure 18. Detail from *Dolphins* and the entire composition of *Underwater Atlantes/Toltecas*, with the red line showing the delineation between the two murals, according to Cuellar.

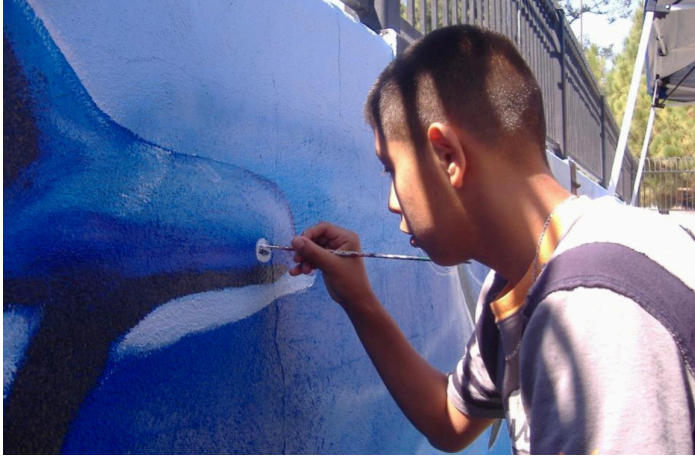
fond memories of swimming in the pool in the summer and learning about aquatic life through these murals (interview by Solano with Diana Cabral, Unzueta's niece, January 2021) (Figure 19).

Figure 19. Detail from *Dolphins* showing painting in progress.
(Image from Venegas 2020)

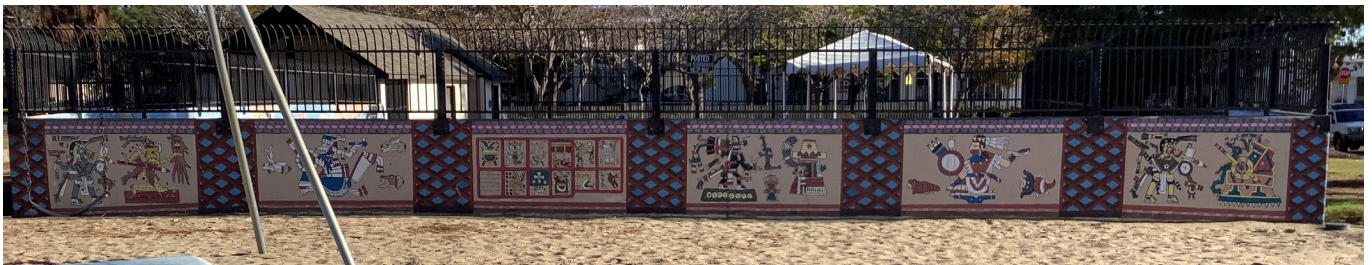
Figure 20. *Codex Cospi*

On the exterior wall of the pool, all murals date to 1979. *Codex Cospi*, painted by artist John Russell, depicts scenes from an Aztec manuscript that has origins from Puebla or Tlaxcala (Miller 2012). These manuscripts and murals depict divine cycles of cosmic creation in the form of an early calendar, with a large focus on ritual and Quetzalcoatl, perceived as the creator god (Figure 20).

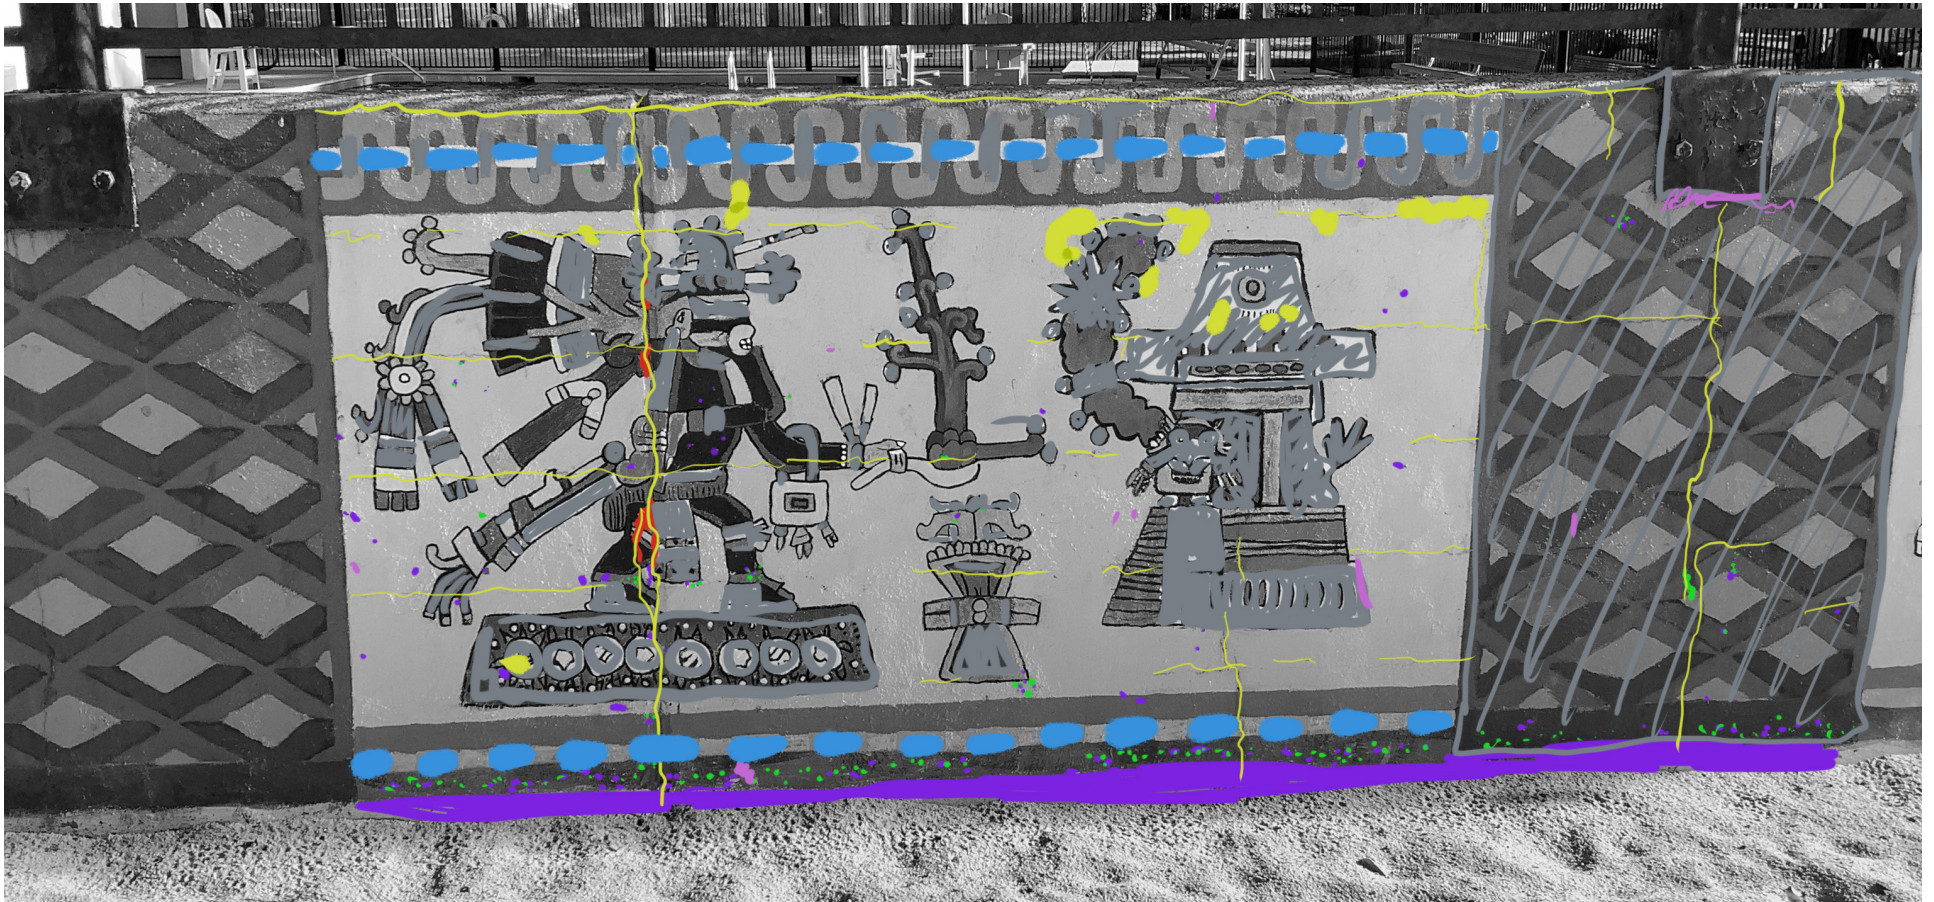
John Russell
1979

Conditions:
