March 14, 2019
SL11157-1

Parcel 9, North Ocean
Avenue
APN: 064-481-009
Cayucos Area
San Luis Obispo
County, California

COASTAL BLUFF EVALUATION

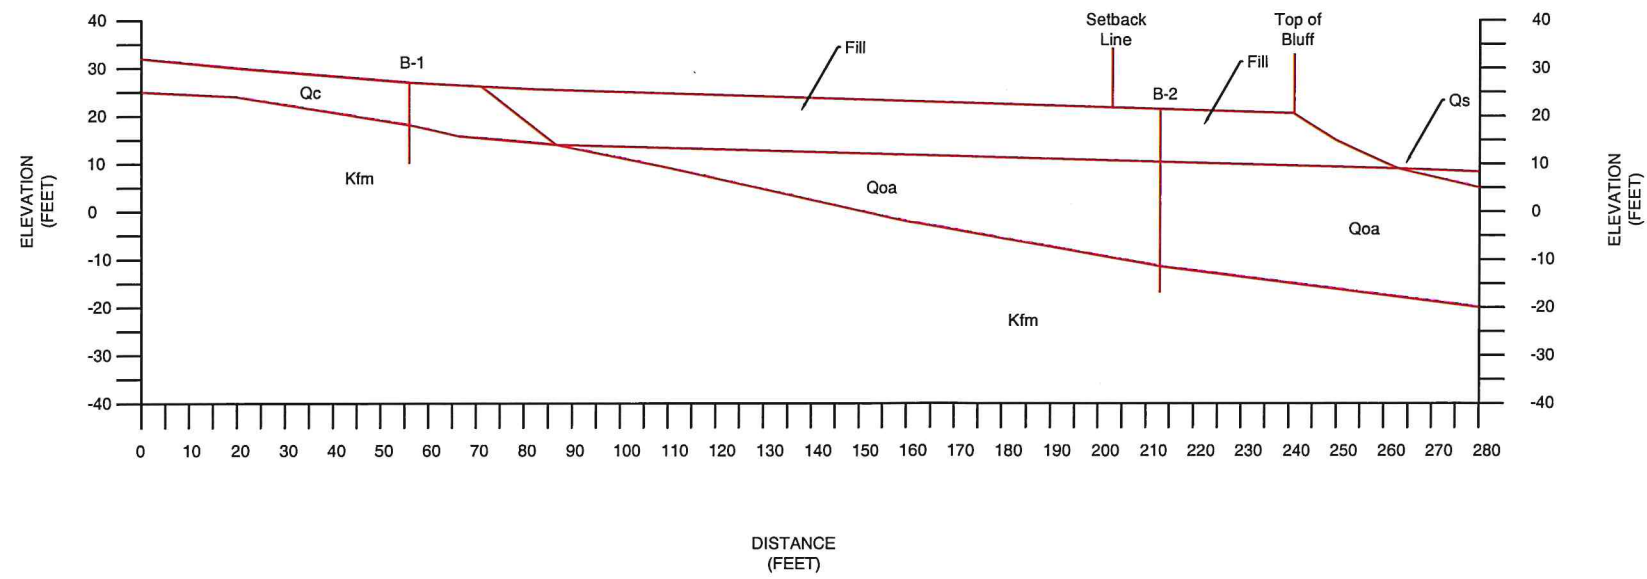
PLATE
1B
PROJECT
SL11157-1

As required in Establishing Development Setbacks from Coastal Bluff (Johnsson, 2003), “The analyses should demonstrate a factor of safety greater than or equal to 1.5 for static condition and greater than or equal to 1.1 for the seismic condition.” The bluff located along the southern property line was analyzed to determine whether the existing coastal bluff meets the minimum requirements for slope stability. One profile was modeled utilizing SLOPE/W, a computer-modeling program. Profile A-A’ traverses the Site in an approximate north to south direction; refer to Plate 1 for approximate location of profile. The location of Boring B-1, B-2 and the top of bluff are approximately depicted on the profile.

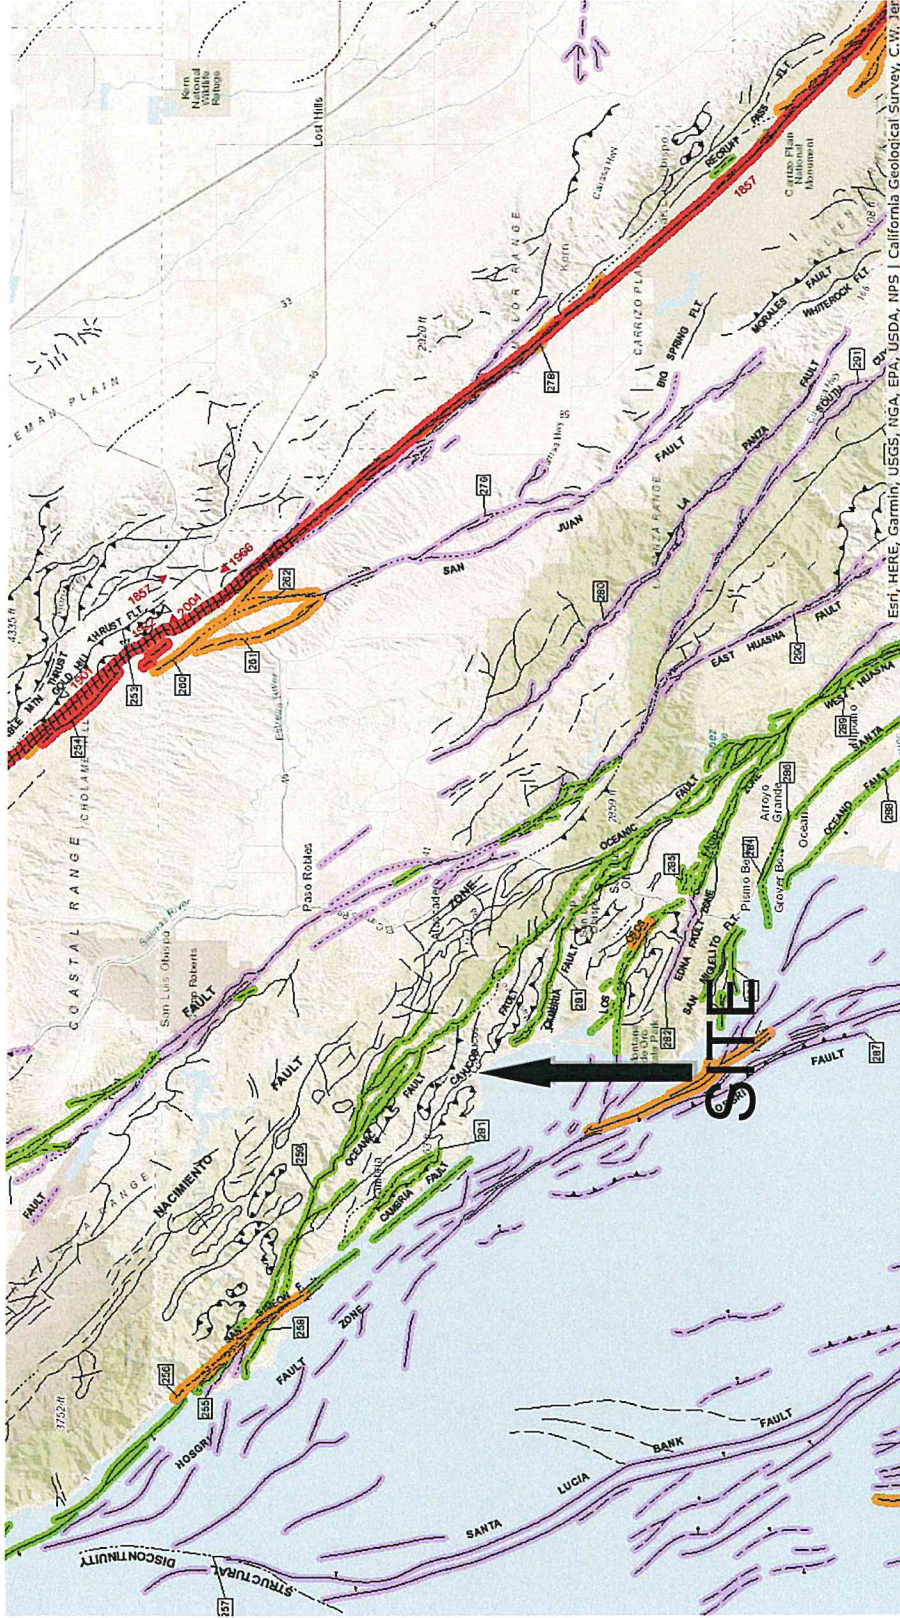
PLATE
3

The closest known active portion of a Holocene age fault is an active portion of the Hosgri Fault Zone that is located approximately 9.5 miles northwest of the Site (Jennings, 2010). Plate 3 is a Regional Fault Map for the area. The San Andreas fault is the most likely active fault to produce ground shaking at the Site although it is not expected to generate the highest ground accelerations because of its distance from the Site.

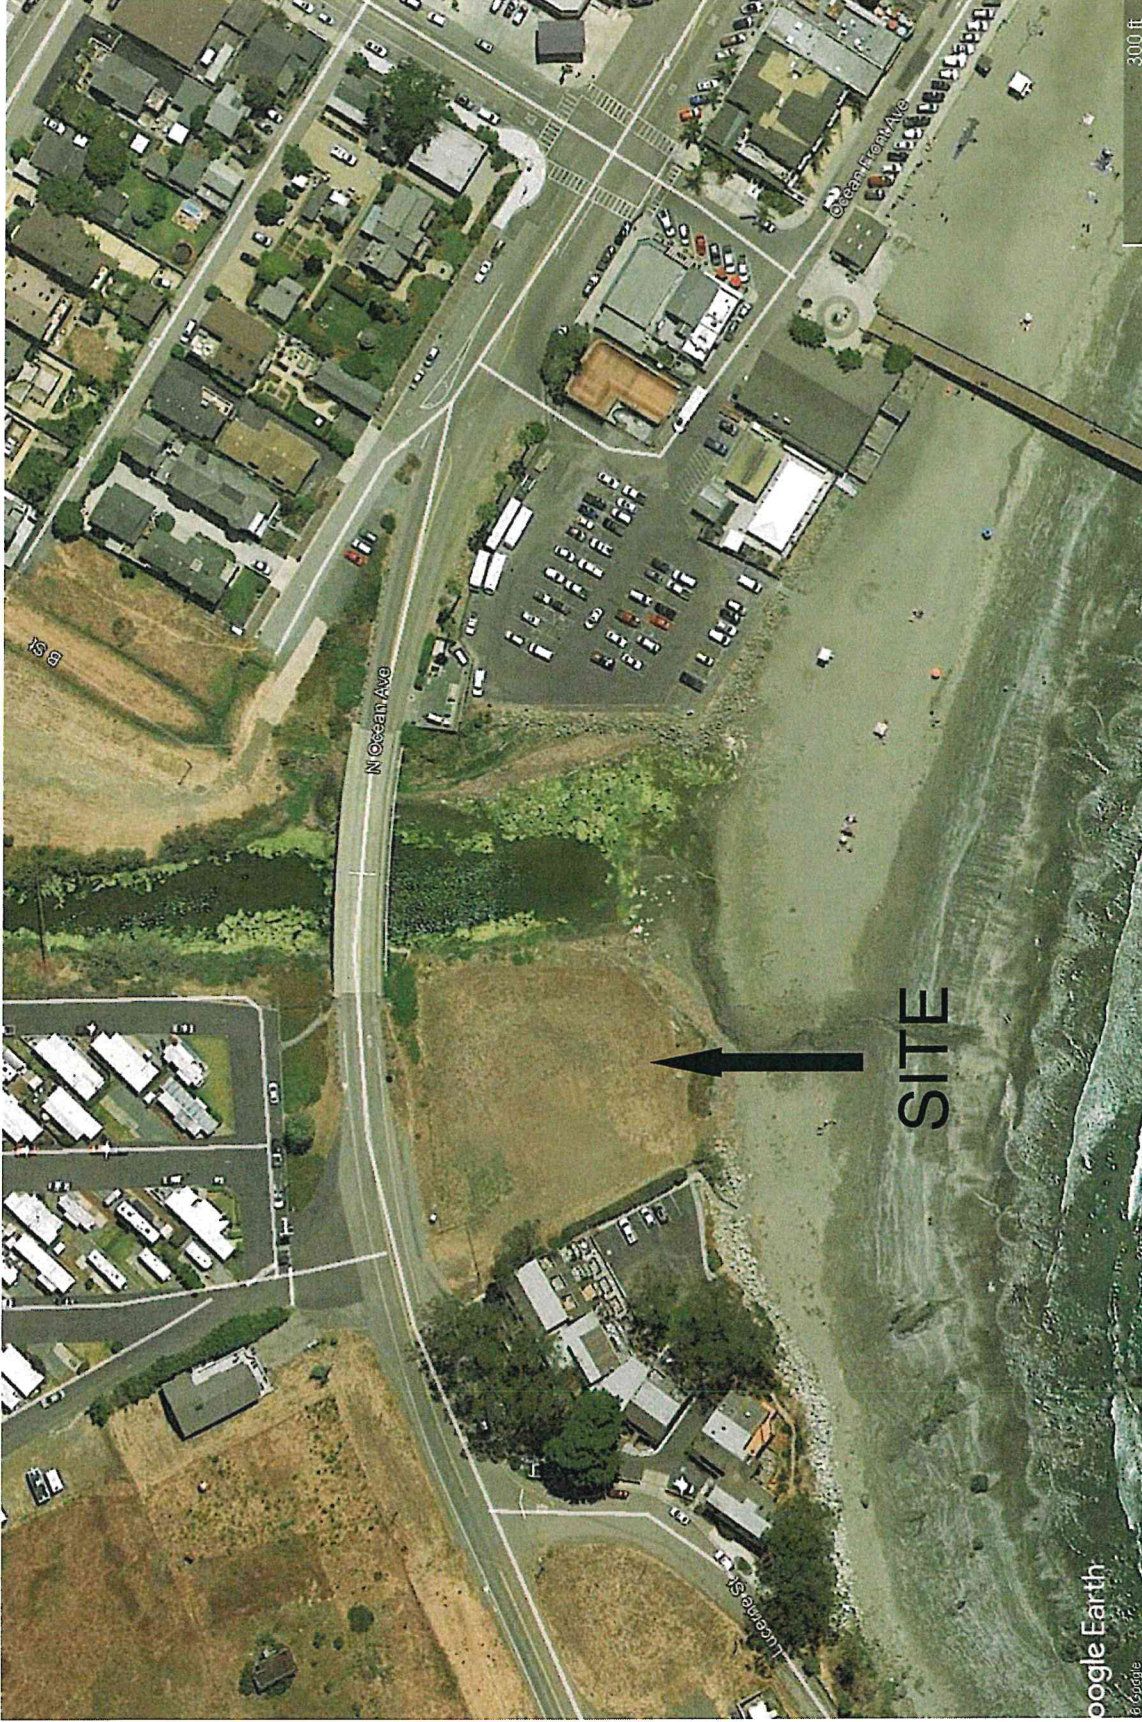
PLATE
4

Dibblee, 2006 and DeLattre, 2016 did not map landslides in the vicinity of the property. During site mapping and review of aerial photography, landslides were not observed at the Site. There appears to be a low potential for landslide to affect the proposed development. Plate 4 presents an aerial photograph. There is a low rockfall potential to affect the proposed residence based on the lack of boulders upslope of the proposed development.
