6000 Condor Dr. Arborist Report

Prepared for HPA inc.
c/o Tammi Bailey
18831 Bardeen Ave. Suite 100
Irvine, CA 92612

Prepared by James Komen
BCMA WE-9909B
RCA #555

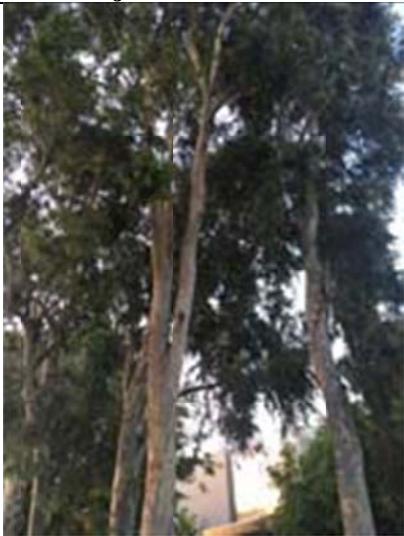
<p>Tree 1 <i>Corymbia citriodora</i> – Lemon Gum</p> <p>This tree is a protected Mature Tree because it has a cumulative trunk area of more than 72 in². It is growing within the public right of way. It will be retained in the landscape. It has an appraised value of \$34,375.63.</p> <p>This tree has excellent health and excellent form. No treatment is recommended.</p>

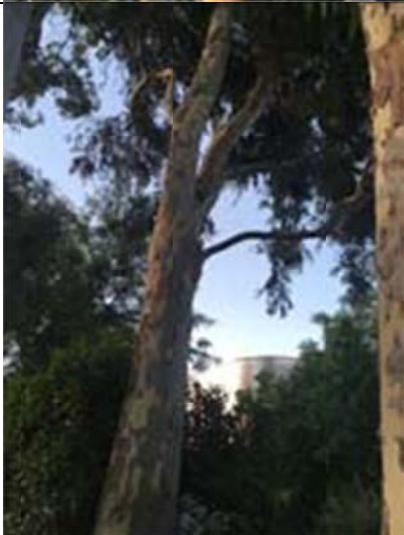
<p>Tree 2 <i>Corymbia citriodora</i> – Lemon Gum</p> <p>This tree is a protected Mature Tree because it has a cumulative trunk area of more than 72 in². It will be retained in the landscape. It has an appraised value of \$25,719.92.</p> <p>This tree has excellent health and good form. No treatment is recommended.</p>

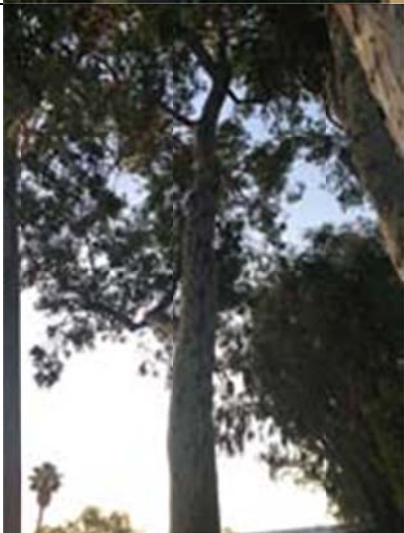
<p>Tree 3 <i>Corymbia citriodora</i> – Lemon Gum</p> <p>This tree is a protected Mature Tree because it has a cumulative trunk area of more than 72 in². It will be retained in the landscape. It has an appraised value of \$16,206.55.</p> <p>This tree has excellent health and good form. I recommend pruning its dead branch.</p>

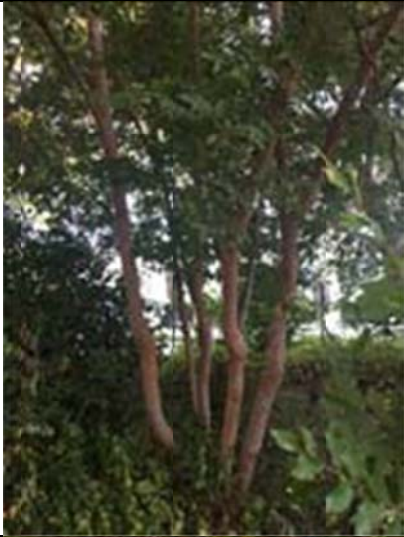
<p>Tree 10 <i>Ulmus parvifolia</i> – Chinese Elm</p> <p>This tree is too small to be protected by ordinance. It will be retained in the landscape. It has an appraised value of \$2,037.57.</p> <p>This tree has been partially suppressed by competition. It has excellent health and good form. No treatment is recommended.</p> <p>The proposed grading will encroach within the critical root zone of this tree. All project activity within the drip line of this tree should be directly supervised by a Certified Arborist. This tree is intended to be retained in place throughout the project even though some of its roots may be impacted.</p>

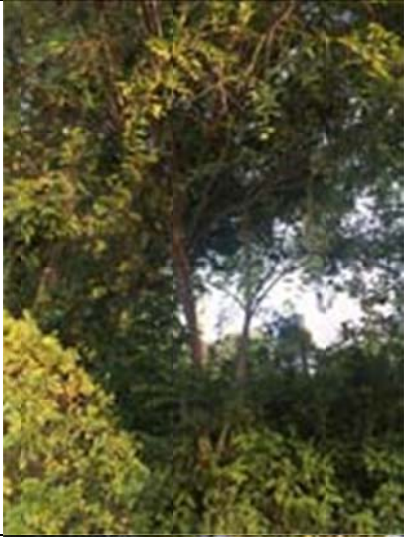
<p>Tree 11 <i>Ulmus parvifolia</i> – Chinese Elm</p> <p>This tree is too small to be protected by ordinance. It will be removed because it is growing within the footprint of the proposed grading. It has an appraised value of \$2,147.13.</p> <p>This tree has been partially suppressed by competition. It has excellent health and good form.</p>

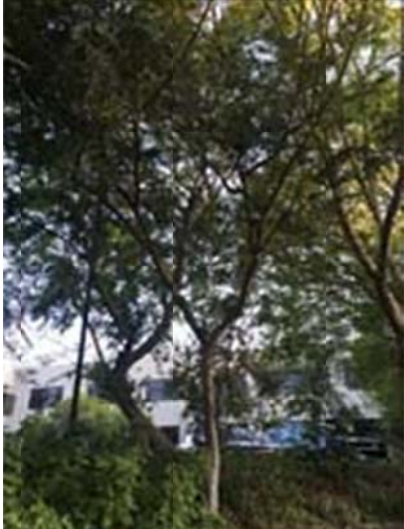
<p>Tree 12 <i>Ulmus parvifolia</i> – Chinese Elm</p> <p>This tree is too small to be protected by ordinance. It will be removed because it is growing within the footprint of the proposed grading. It has an appraised value of \$1,489.76.</p> <p>This tree has been partially suppressed by competition. It has excellent health and good form.</p>

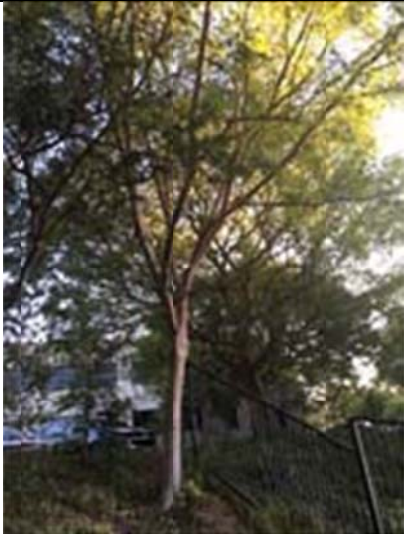
<p>Tree 13 <i>Ulmus parvifolia</i> – Chinese Elm</p> <p>This tree is a protected Mature Tree because it has a cumulative trunk area of more than 72 in². It will be removed because it is growing within the footprint of the proposed grading. It has an appraised value of \$6,135.23.</p> <p>This tree has excellent health and excellent form.</p>

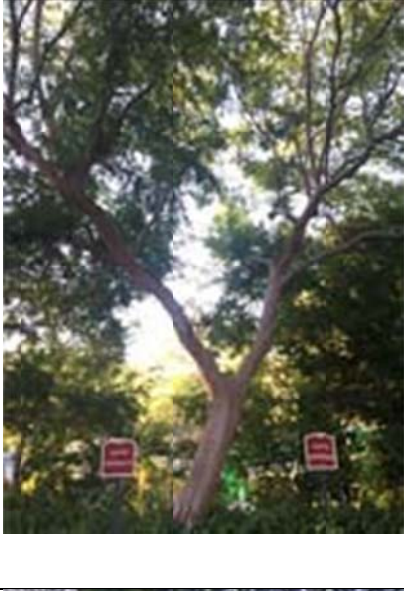
<p>Tree OP14 <i>Ulmus parvifolia</i> – Chinese Elm</p> <p>This tree is a protected Mature Tree because it has a cumulative trunk area of more than 72 in². It is growing on an adjacent property. It will be retained in the landscape. It has an appraised value of \$8,940.04.</p> <p>This tree has minor deadwood, but it is overall still healthy. It has excellent health and excellent form. I recommend pruning off the deadwood.</p> <p>The proposed grading will encroach within the critical root zone of this tree. All project activity within the drip line of this tree should be directly supervised by a Certified Arborist. This tree is intended to be retained in place throughout the project even though some of its roots may be impacted.</p>

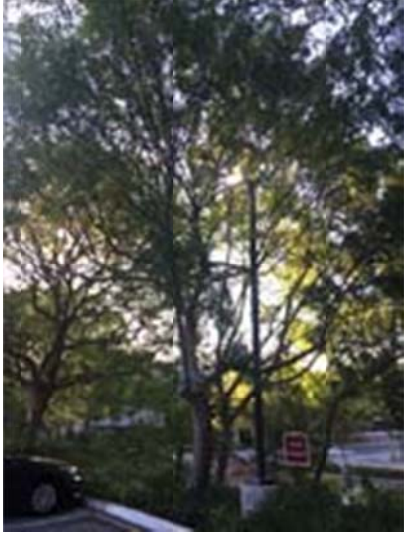
<p>Tree OP15 <i>Ulmus parvifolia</i> – Chinese Elm</p> <p>This tree is a protected Mature Tree because it has a cumulative trunk area of more than 72 in². It is growing on an adjacent property. It will be retained in the landscape. It has an appraised value of \$7,169.99.</p> <p>This tree has excellent health and excellent form. No treatment is recommended.</p> <p>The proposed grading will encroach within the critical root zone of this tree. All project activity within the drip line of this tree should be directly supervised by a Certified Arborist. This tree is intended to be retained in place throughout the project even though some of its roots may be impacted.</p>

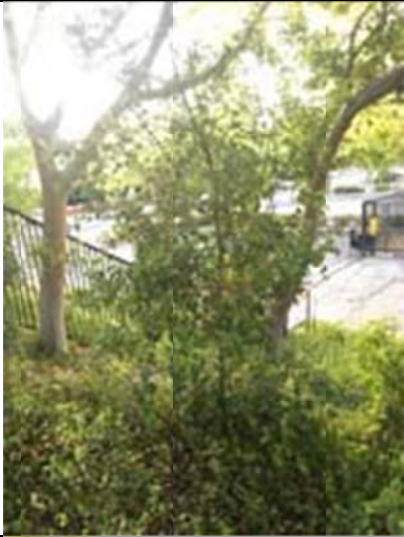
<p>Tree 16 <i>Quercus agrifolia</i> – Coast Live Oak</p> <p>This is a protected Native Oak Tree. It will be removed because it is growing within the footprint of the proposed grading. It has an appraised value of \$350.30.</p> <p>This young volunteer tree is healthy. It has excellent health and excellent form.</p>

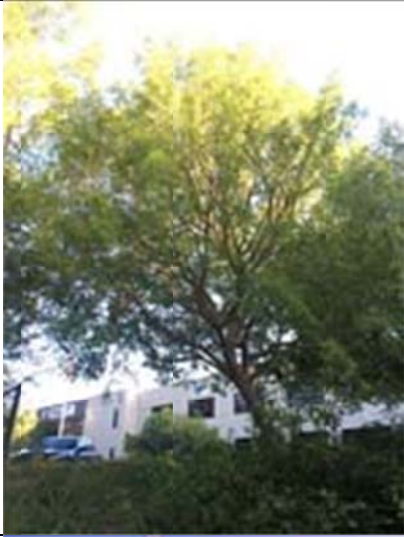
<p>Tree OP17 <i>Ulmus parvifolia</i> – Chinese Elm</p> <p>This tree is a protected Mature Tree because it has a cumulative trunk area of more than 72 in². It is growing on an adjacent property. It will be removed because it is growing within the footprint of the proposed grading. It has an appraised value of \$8,764.74.</p> <p>This tree has excellent health and excellent form.</p>

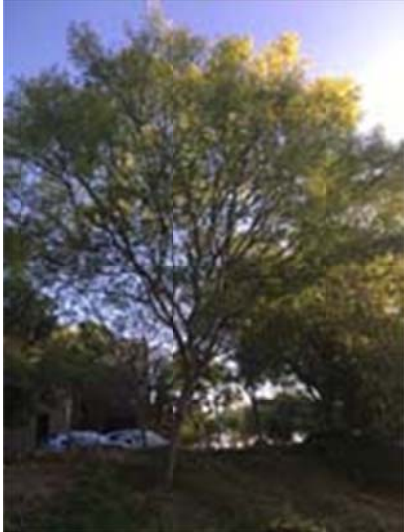
<p>Tree 18 <i>Ulmus parvifolia</i> – Chinese Elm</p> <p>This tree is a protected Mature Tree because it has a cumulative trunk area of more than 72 in². It will be removed because it is growing within the footprint of the proposed grading. It has an appraised value of \$6,091.40.</p> <p>This tree has excellent health and excellent form.</p>

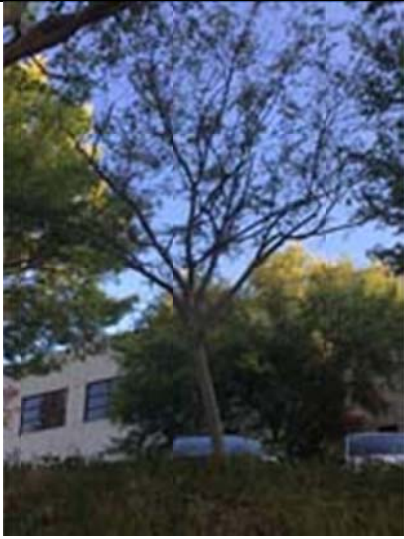
<p>Tree OP19 <i>Ulmus parvifolia</i> – Chinese Elm</p> <p>This tree is too small to be protected by ordinance. It is growing on an adjacent property. It will be retained in the landscape. It has an appraised value of \$1,489.76.</p> <p>This tree has been suppressed by competition with its neighbors. It has good health and excellent form. No treatment is recommended.</p> <p>The proposed grading will encroach within the critical root zone of this tree. All project activity within the drip line of this tree should be directly supervised by a Certified Arborist. This tree is intended to be retained in place throughout the project even though some of its roots may be impacted.</p>

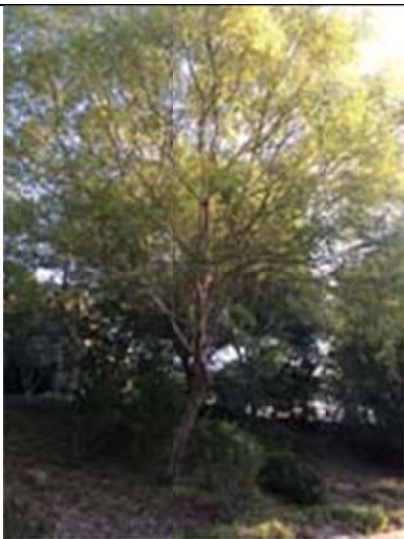
<p>Tree 20 <i>Ulmus parvifolia</i> – Chinese Elm</p> <p>This tree is a protected Mature Tree because it has a cumulative trunk area of more than 72 in². It will be removed because it is growing within the footprint of the proposed grading. It has an appraised value of \$5,477.85.</p> <p>This tree has excellent health and excellent form.</p>

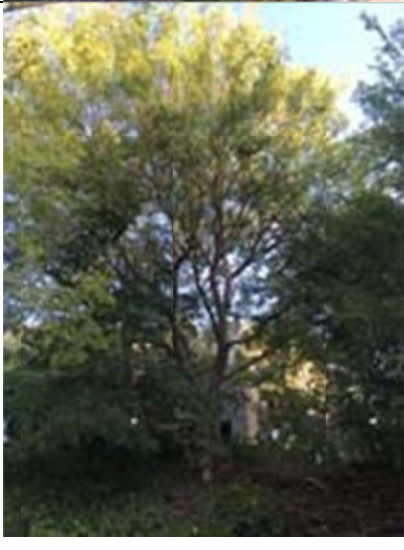
<p>Tree OP21 <i>Ulmus parvifolia</i> – Chinese Elm</p> <p>This tree is a protected Mature Tree because it has a cumulative trunk area of more than 72 in². It is growing on an adjacent property. It will be retained in the landscape. It has an appraised value of \$8,764.74.</p> <p>This tree has excellent health and excellent form. No treatment is recommended.</p> <p>The proposed grading will encroach within the critical root zone of this tree. All project activity within the drip line of this tree should be directly supervised by a Certified Arborist. This tree is intended to be retained in place throughout the project even though some of its roots may be impacted.</p>

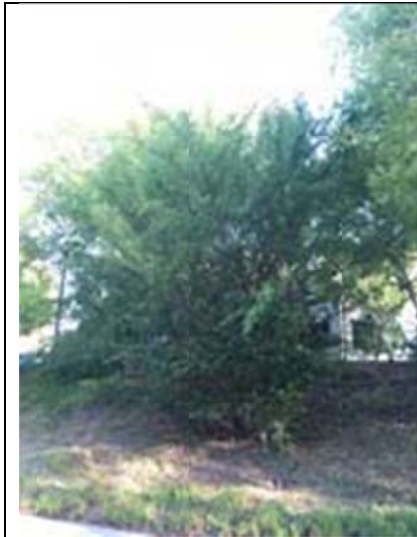
Tree 22

This tree is too small to be protected by ordinance. It will be removed because it is growing within the footprint of the proposed grading. It has an appraised value of \$1,781.92.

This tree has a multi-stem form. It has excellent health and good form.

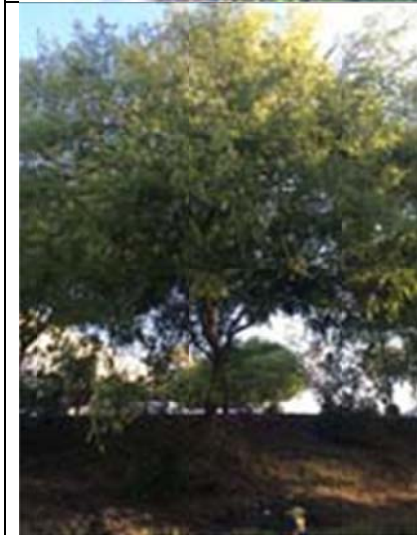
Tree 23

This tree is a protected Mature Tree because it has a cumulative trunk area of more than 72 in². It will be removed because it is growing within the footprint of the proposed grading. It has an appraised value of \$7,810.33.

This tree has an impounded nursery tie from when it was first planted. I observed a cavity in its trunk. Despite these defects, this tree has good health and excellent form.

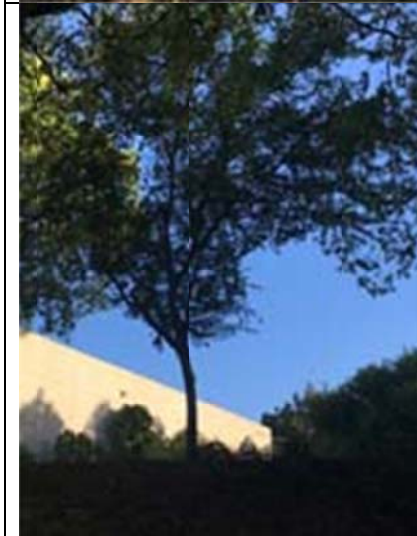
Tree OP24

This tree has excellent health and excellent form. No treatment is recommended.

The proposed grading will encroach within the critical root zone of this tree. All project activity within the drip line of this tree should be directly supervised by a Certified Arborist. This tree is intended to be retained in place throughout the project even though some of its roots may be impacted.

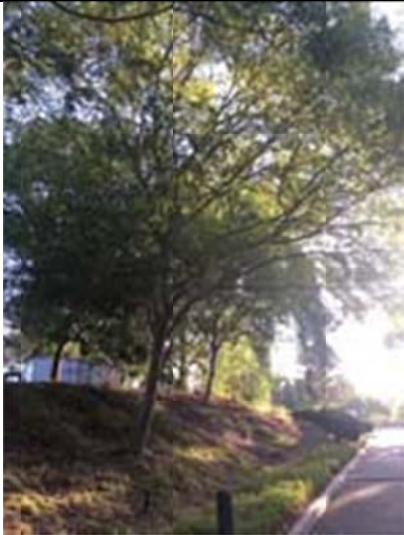
<p>Tree 25 <i>Ulmus parvifolia</i> – Chinese Elm</p> <p>This tree is a protected Mature Tree because it has a cumulative trunk area of more than 72 in². It will be removed because it is growing within the footprint of the proposed grading. It has an appraised value of \$6,485.83.</p> <p>This tree has excellent health and excellent form.</p>

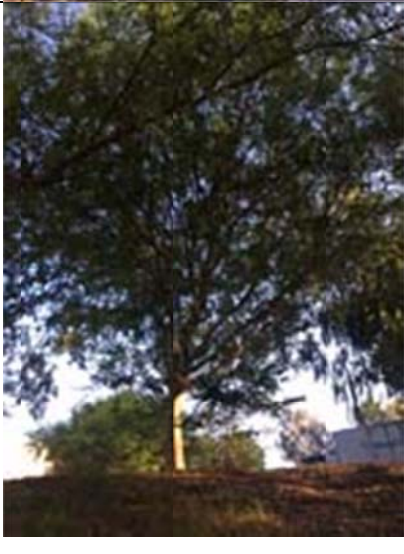
<p>Tree OP26 <i>Ulmus parvifolia</i> – Chinese Elm</p> <p>This tree is a protected Mature Tree because it has a cumulative trunk area of more than 72 in². It is growing on an adjacent property. It will be retained in the landscape. It has an appraised value of \$5,477.85.</p> <p>This tree has excellent health and excellent form. No treatment is recommended.</p> <p>The proposed grading will encroach within the critical root zone of this tree. All project activity within the drip line of this tree should be directly supervised by a Certified Arborist. This tree is intended to be retained in place throughout the project even though some of its roots may be impacted.</p>

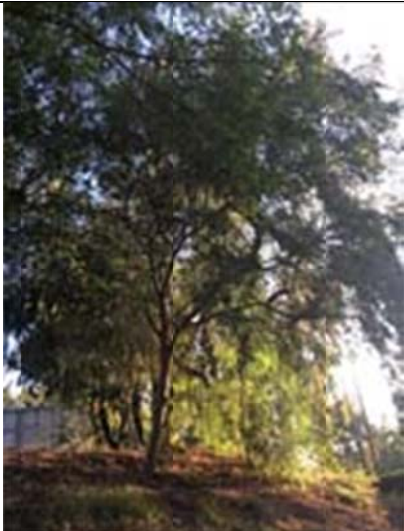
<p>Tree 27 <i>Ulmus parvifolia</i> – Chinese Elm</p> <p>This tree is too small to be protected by ordinance. It will be removed because it is growing within the footprint of the proposed grading. It has an appraised value of \$3,724.84.</p> <p>This tree has excellent health and excellent form.</p>

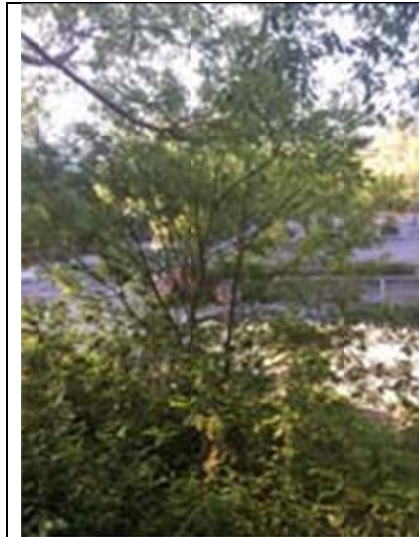
Tree 28

This tree is too small to be protected by ordinance. It will be removed because it is growing within the footprint of the proposed grading. It has an appraised value of \$905.42.

This tree has a multi-stem form. It has excellent health and good form.

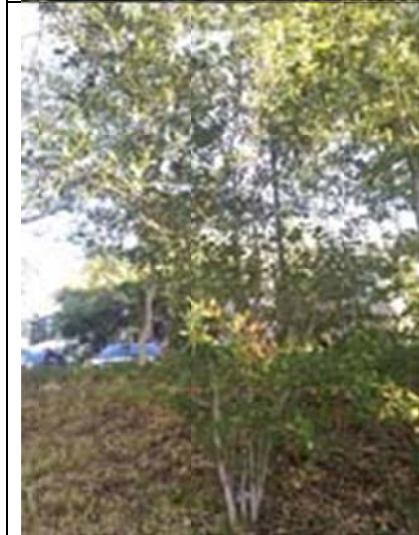
Tree 29

This is a protected Native Oak Tree. It will be removed because it is growing within the footprint of the proposed grading. It has an appraised value of \$272.39.

This young volunteer tree has a multi-stem form. It has excellent health and good form.

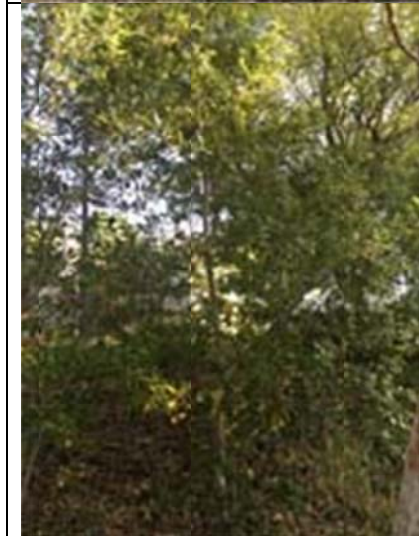
Tree 30

This is a protected Native Oak Tree. It will be removed because it is growing within the footprint of the proposed grading. It has an appraised value of \$350.30.

This young volunteer tree has excellent health and excellent form.

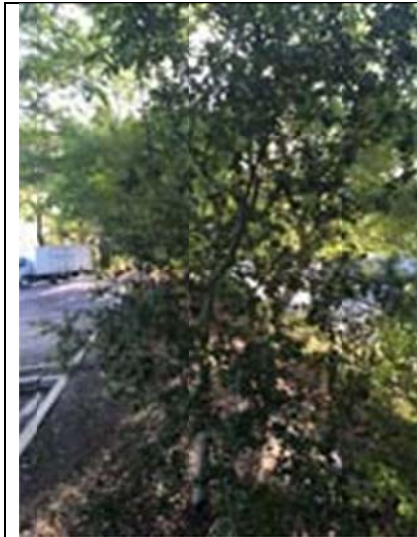
Tree 31

This is a protected Native Oak Tree. It will be removed because it is growing within the footprint of the proposed grading. It has an appraised value of \$525.60.

This young volunteer tree has excellent health and good form.

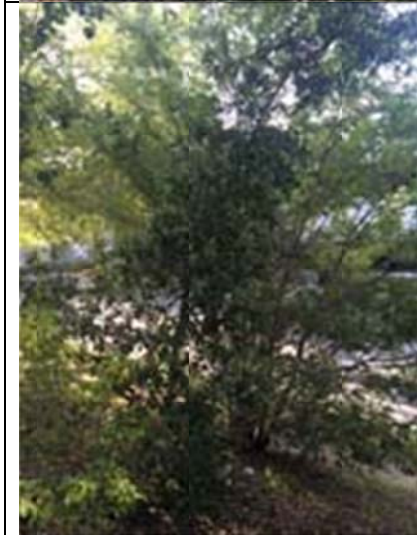
Tree 32

This is a protected Native Oak Tree. It will be removed because it is growing within the footprint of the proposed grading. It has an appraised value of \$525.60.

This young volunteer tree has excellent health and good form.

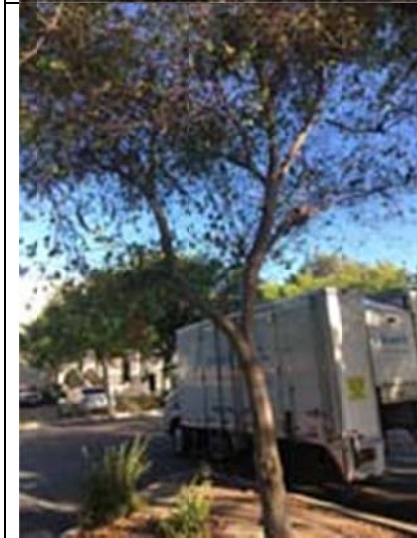
Tree OP33

This tree has been suppressed by competition with its neighbors. It has average health and good form. No treatment is recommended.

The proposed grading will encroach within the critical root zone of this tree. All project activity within the drip line of this tree should be directly supervised by a Certified Arborist. This tree is intended to be retained in place throughout the project even though some of its roots may be impacted.

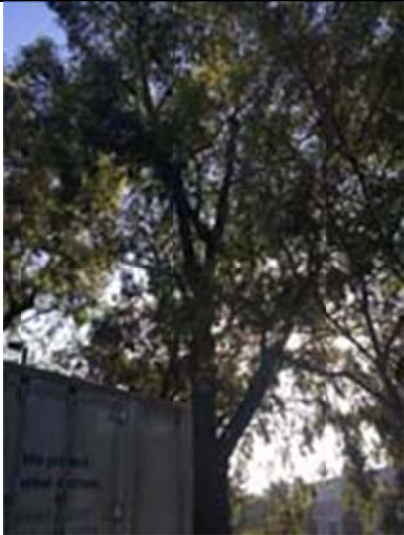
<p>Tree OP34 <i>Eucalyptus sideroxylon</i> – Red Ironbark</p> <p>This tree is a prohibited species in Moorpark. It is growing on an adjacent property.</p> <p>This tree has a history of past topping, but it is still vigorous. It has good health and good form.</p> <p>This tree will be removed because it is growing too close to the footprint of the proposed grading. It will not likely survive the necessary root cutting.</p>

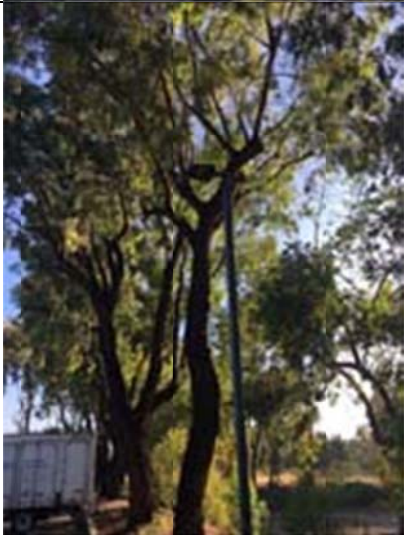
<p>Tree OP35 <i>Eucalyptus sideroxylon</i> – Red Ironbark</p> <p>This tree is a prohibited species in Moorpark. It is growing on an adjacent property.</p> <p>This tree has a history of past topping, but it is still vigorous. It has good health and good form.</p> <p>This tree will be removed because it is growing too close to the footprint of the proposed grading. It will not likely survive the necessary root cutting.</p>

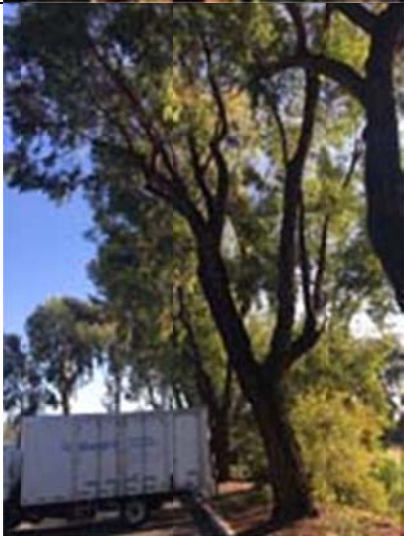
<p>Tree OP36 <i>Eucalyptus sideroxylon</i> – Red Ironbark</p> <p>This tree is a prohibited species in Moorpark. It is growing on an adjacent property.</p> <p>This tree has a history of past topping, but it is still vigorous. It has good health and good form.</p> <p>This tree will be removed because it is growing too close to the footprint of the proposed grading. It will not likely survive the necessary root cutting.</p>

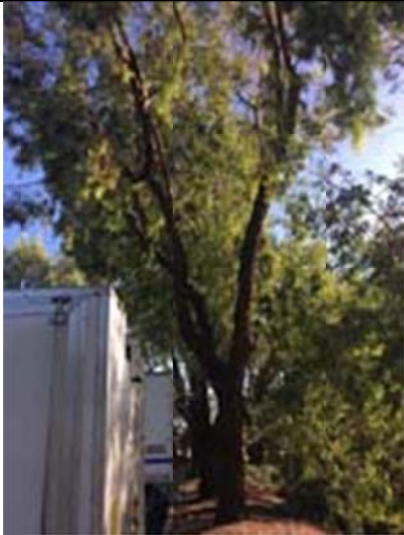
<p>Tree OP37 <i>Eucalyptus sideroxylon</i> – Red Ironbark</p> <p>This tree is a prohibited species in Moorpark. It is growing on an adjacent property.</p> <p>This tree has a history of past topping, but it is still vigorous. It has good health and good form.</p> <p>This tree will be removed because it is growing too close to the footprint of the proposed grading. It will not likely survive the necessary root cutting.</p>

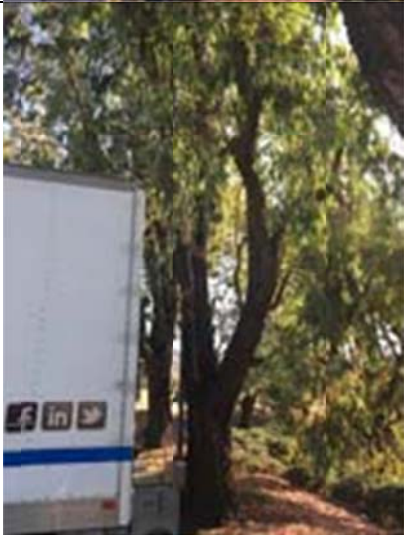
<p>Tree OP38 <i>Eucalyptus sideroxylon</i> – Red Ironbark</p> <p>This tree is a prohibited species in Moorpark. It is growing on an adjacent property.</p> <p>This tree has a history of past topping, but it is still vigorous. It has good health and good form.</p> <p>This tree will be removed because it is growing too close to the footprint of the proposed grading. It will not likely survive the necessary root cutting.</p>

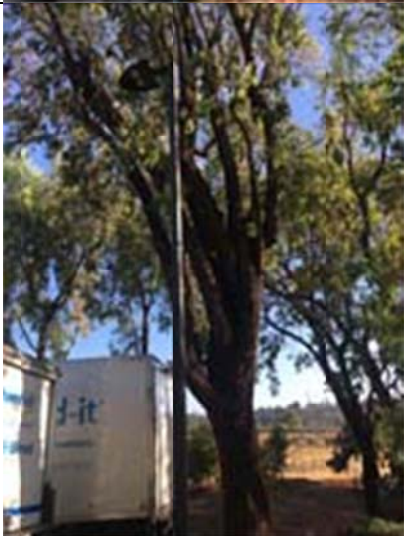
<p>Tree OP39 <i>Eucalyptus sideroxylon</i> – Red Ironbark</p> <p>This tree is a prohibited species in Moorpark. It is growing on an adjacent property.</p> <p>This tree has a history of past topping, but it is still vigorous. It has a co-dominant stem defect. It has good health and average form.</p> <p>This tree will be removed because it is growing too close to the footprint of the proposed grading. It will not likely survive the necessary root cutting.</p>

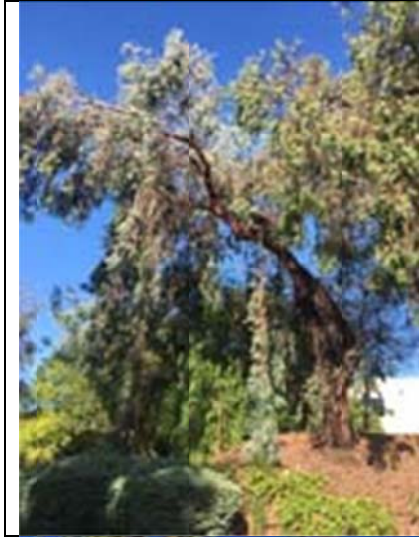
Tree 40

This tree is a prohibited species in Moorpark. It will be removed.

This tree has a prevailing lean and symptoms of minor drought stress. It has good health and good form.

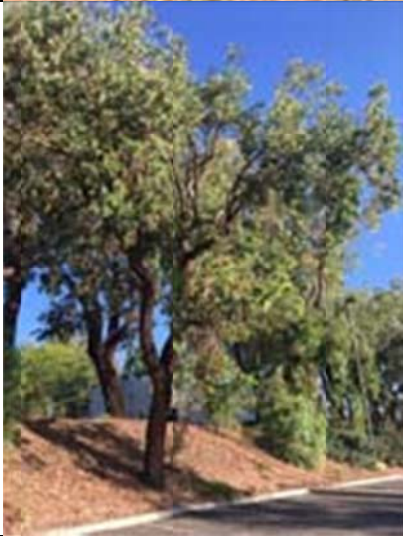
This tree is a prohibited species in Moorpark. It will be removed.

This tree has minor drought stress. It has good health and excellent form.

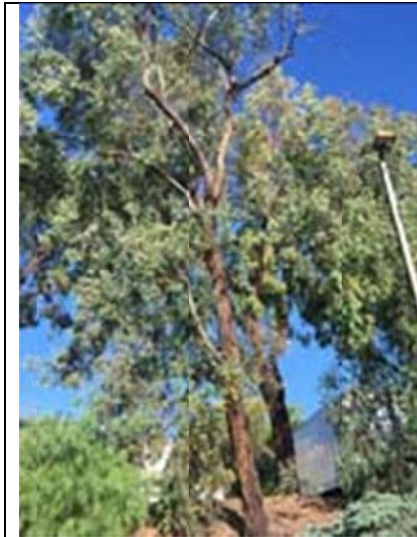
Tree 42

This tree is a prohibited species in Moorpark. It will be removed.

This tree has minor drought stress. It has good health and excellent form.

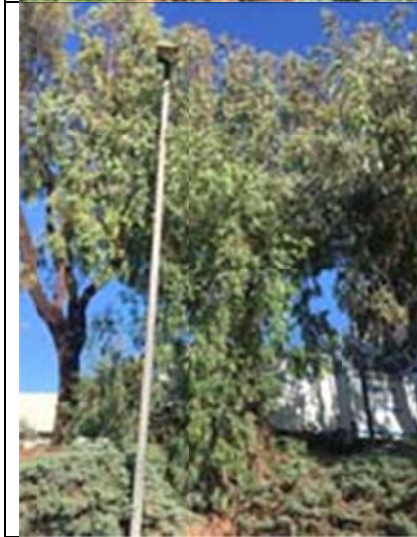
Tree 43

This tree is a prohibited species in Moorpark. It will be removed.

This tree has minor drought stress. It has good health and good form.

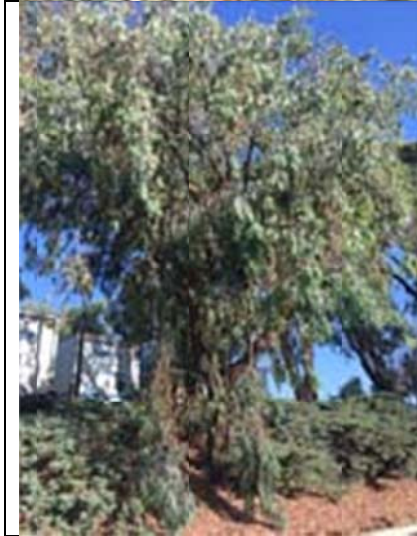
Tree 44

This tree is a prohibited species in Moorpark. It will be removed.

This tree has minor suppression by competition. It has good health and good form.

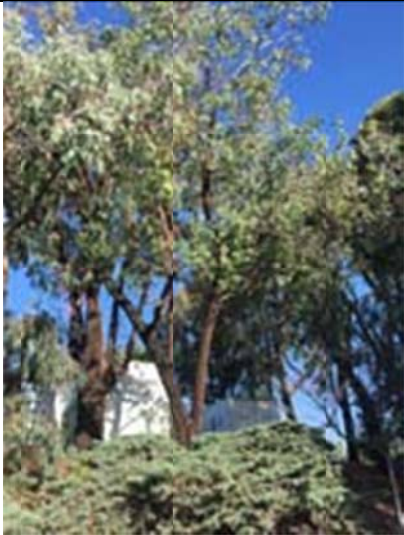
Tree 45

This tree is a prohibited species in Moorpark. It will be removed.

This tree has minor drought stress. It has good health and good form.

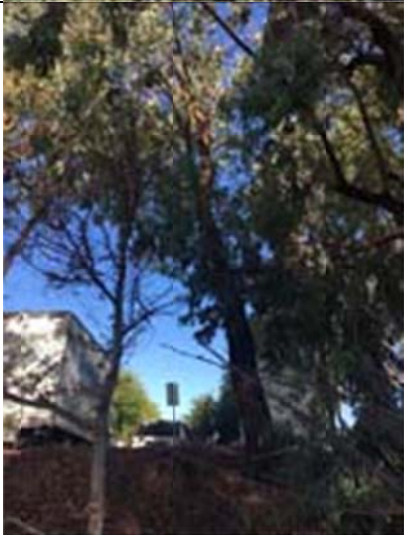
<p>Tree 46 <i>Eucalyptus sideroxylon</i> – Red Ironbark</p> <p>This tree is a prohibited species in Moorpark. It will be removed.</p> <p>This tree has minor drought stress and a co-dominant branch defect. It has good health and good form.</p>

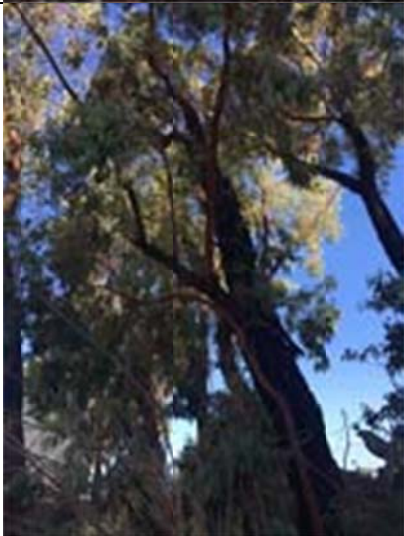
<p>Tree 47 <i>Eucalyptus sideroxylon</i> – Red Ironbark</p> <p>This tree is a prohibited species in Moorpark. It will be removed.</p> <p>This tree has minor suppression by competition. It has good health and good form.</p>

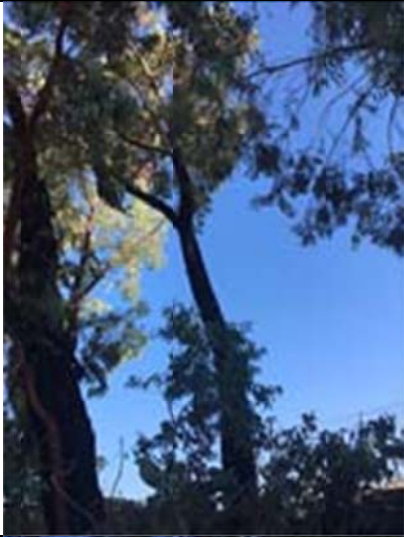
<p>Tree 48 <i>Eucalyptus sideroxylon</i> – Red Ironbark</p> <p>This tree is a prohibited species in Moorpark. It will be removed.</p> <p>This tree has been subject to minor suppression by competition with its neighbors. I observed sap exudation from its trunk, potentially indicating a defect concealed under the bark. This tree has average health and good form.</p>

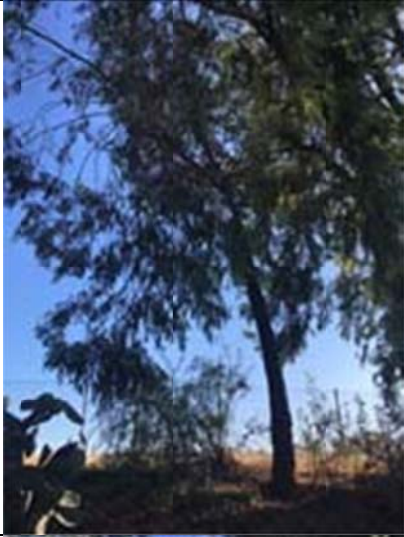
<p>Tree 49 <i>Eucalyptus sideroxylon</i> – Red Ironbark</p> <p>This tree is a prohibited species in Moorpark. It will be removed.</p> <p>This tree has been subject to minor suppression by competition with its neighbors. I observed sap exudation from its trunk, potentially indicating a defect concealed under the bark. It has average health and good form.</p>

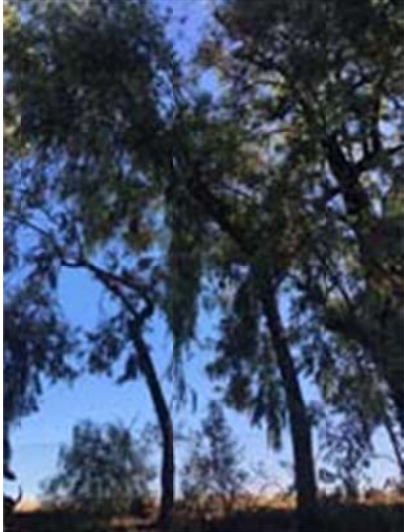
<p>Tree 50 <i>Eucalyptus sideroxylon</i> – Red Ironbark</p> <p>This tree is a prohibited species in Moorpark. It will be removed.</p> <p>This tree has been suppressed by competition with its neighbors. It has good health and good form.</p>

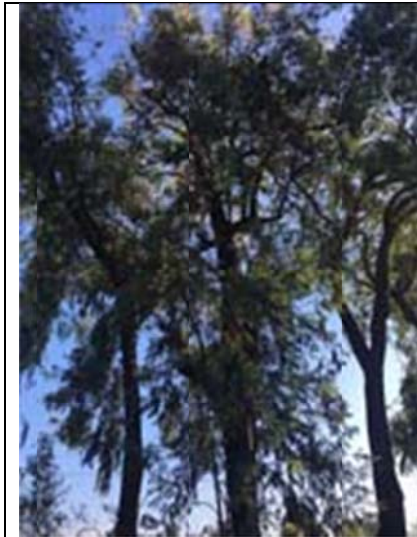
<p>Tree 51 <i>Eucalyptus sideroxylon</i> – Red Ironbark</p> <p>This tree is a prohibited species in Moorpark. It will be removed.</p> <p>This tree has excellent health and excellent form.</p>

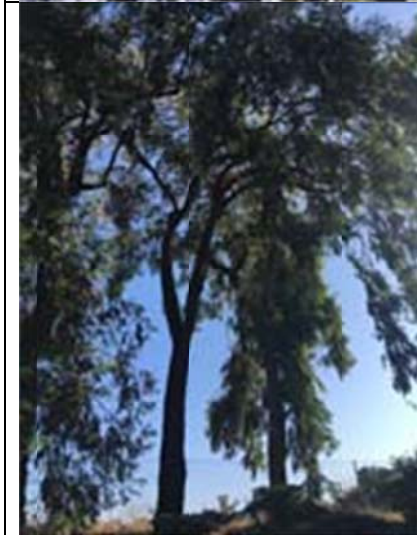
Tree 52

This tree is a prohibited species in Moorpark. It will be removed.

This tree has co-dominant trunks. It has excellent health and good form.

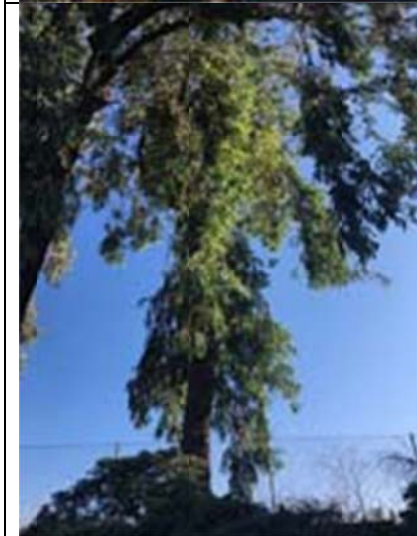
Tree 53

This tree is a prohibited species in Moorpark. It will be removed.

This tree has excellent health and excellent form.

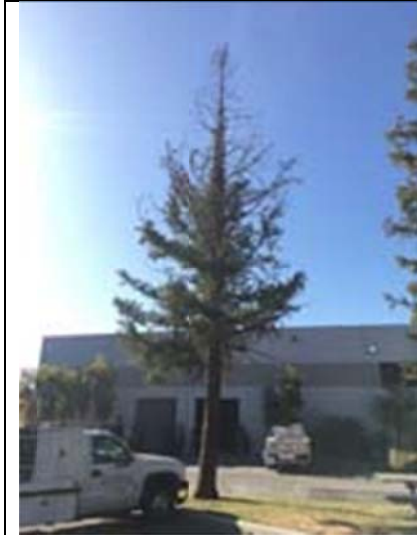
Tree 54

This tree is a prohibited species in Moorpark. It will be removed.

This tree has been partially suppressed by competition. It has good health and excellent form.

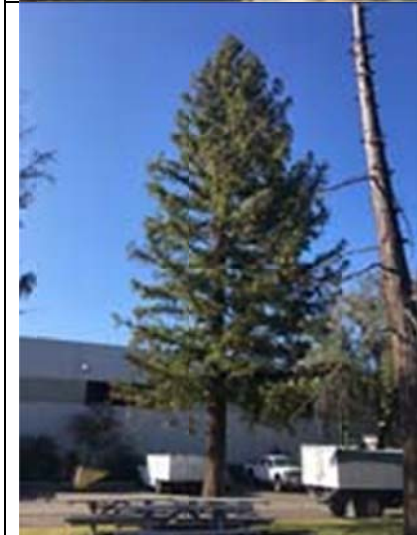
Tree 55

This tree is a protected Mature Tree because it has a cumulative trunk area of more than 72 in². It will be removed because it is growing within the footprint of the proposed parking lot expansion. It has an appraised value of \$862.07.

This tree has a dead top, but it is still alive. It has poor health and poor form.

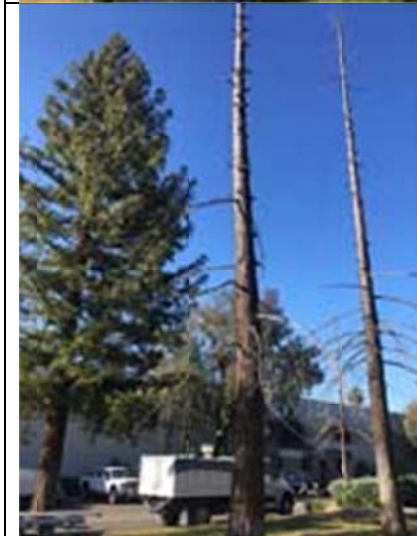
Tree 56

This tree is a protected Mature Tree because it has a cumulative trunk area of more than 72 in². It will be removed because it is growing within the footprint of the proposed parking lot expansion. It has an appraised value of \$3,267.51.

This tree has a sparse canopy from drought stress. It has average health and excellent form.

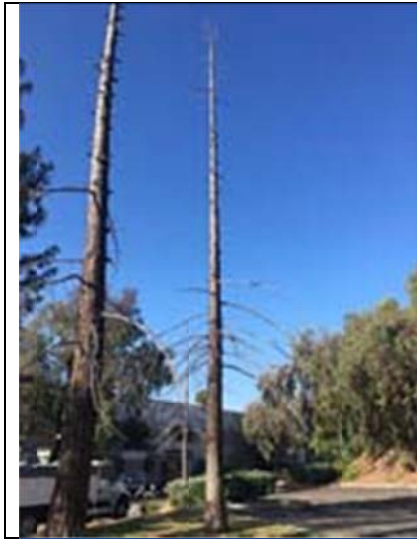
Tree 57

This tree is a protected Mature Tree because it has a cumulative trunk area of more than 72 in². It will be removed because it is dead. It has an appraised value of \$0.

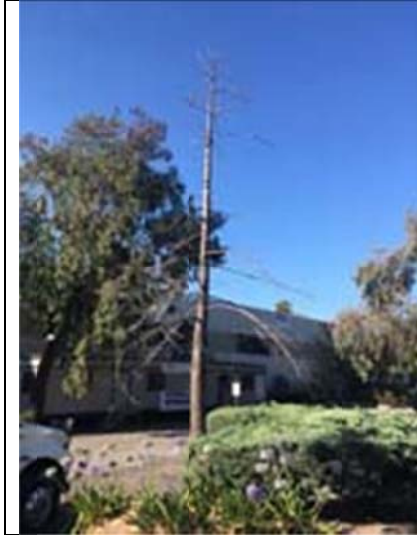
Tree 58

This tree is a protected Mature Tree because it has a cumulative trunk area of more than 72 in². It will be removed because it is dead. It has an appraised value of \$0.

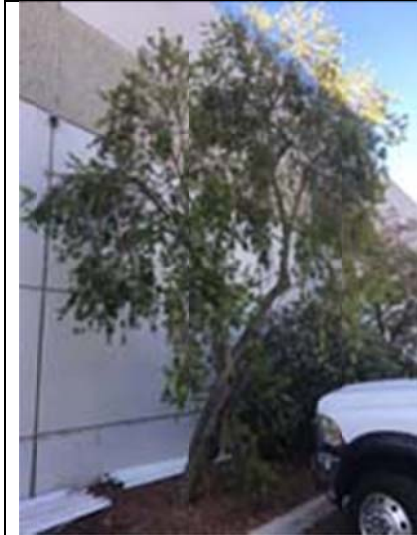
Tree 60

This tree is a protected Mature Tree because it has a cumulative trunk area of more than 72 in². It will be removed because it is growing within the footprint of the proposed parking lot expansion. It has an appraised value of \$13,488.05.

This tree has a minor prevailing lean. It has excellent health and excellent form.

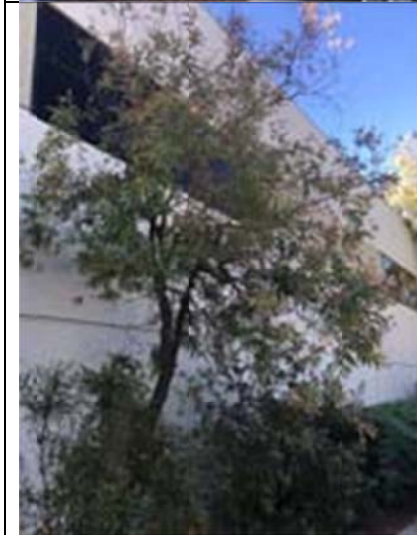
Tree 61

This tree is too small to be protected by ordinance. It will be removed because it is growing within the footprint of the proposed parking lot expansion. It has an appraised value of \$2,380.71.

This tree has co-dominant trunks. It has excellent health and average form.

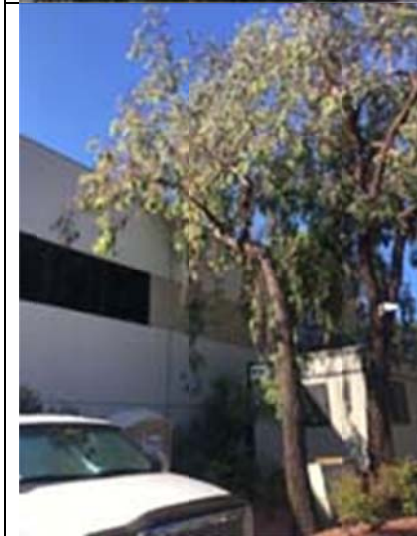
Tree 62

This tree is a prohibited species in Moorpark. It will be removed.

This tree has heat/drought stress. It has average health and good form.

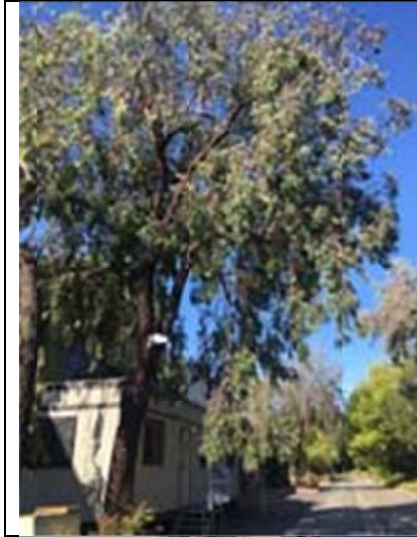
Tree 63

This tree is a prohibited species in Moorpark. It will be removed.

This tree has minor suppression by competition. It has good health and good form.

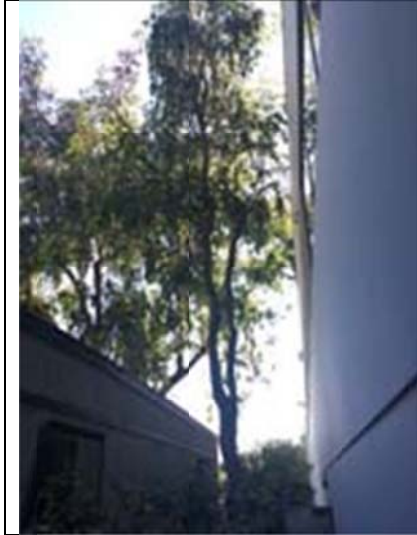
Tree 64

This tree is a prohibited species in Moorpark. It will be removed.

This tree has excellent health and good form.

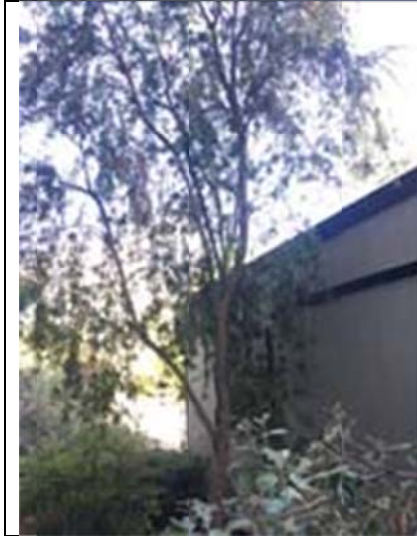
Tree 65

This tree is too small to be protected by ordinance. It will be removed because it is growing within the footprint of the proposed parking lot expansion. It has an appraised value of \$5,429.78.

This tree has sap exudation. It has good health and excellent form.

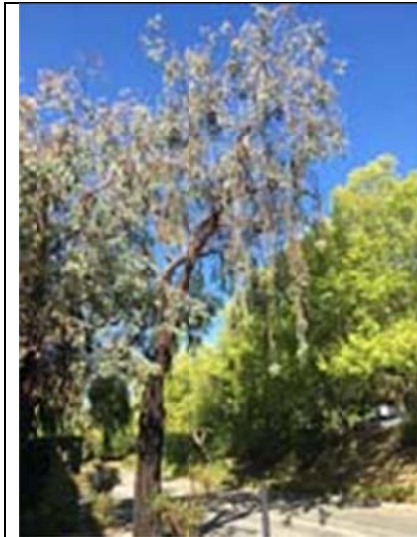
Tree 66

This tree is too small to be protected by ordinance. It will be removed because it is growing within the footprint of the proposed parking lot expansion. It has an appraised value of \$2,834.83.

This tree has co-dominant trunks. It has excellent health and average form.

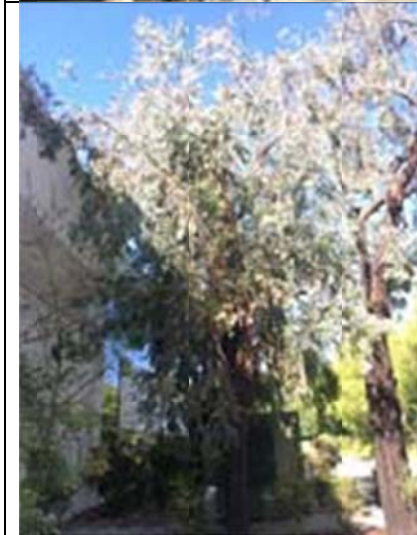
Tree 67

This tree is a prohibited species in Moorpark. It will be removed.

This tree has minor drought stress. It has good health and good form.

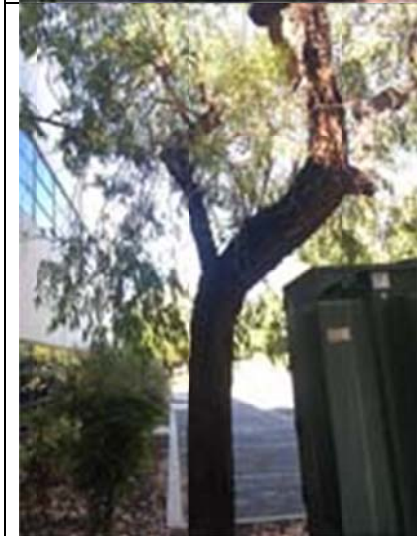
Tree 68

This tree is a prohibited species in Moorpark. It will be removed.

This tree has co-dominant branches. It has excellent health and good form.

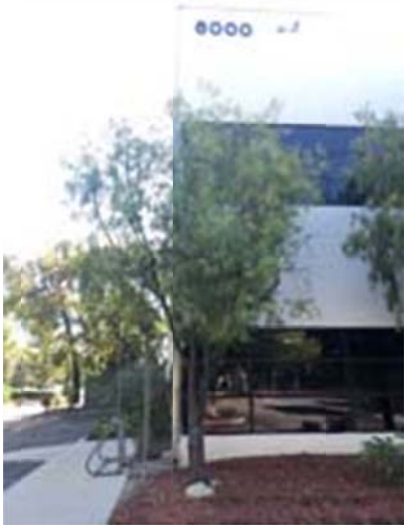
Tree 69

This tree is a prohibited species in Moorpark. It will be removed.

This tree has excellent health and excellent form.

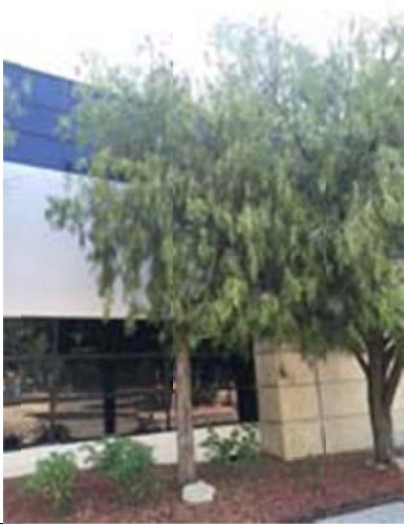
<p>Tree 70 <i>Geijera parviflora</i> – Australian Willow</p> <p>This tree is too small to be protected by ordinance. It will be removed because it is growing within the footprint of the proposed parking lot expansion. It has an appraised value of \$2,708.38.</p> <p>This tree has co-dominant branches and a minor bark fungus. It has good health and good form.</p>

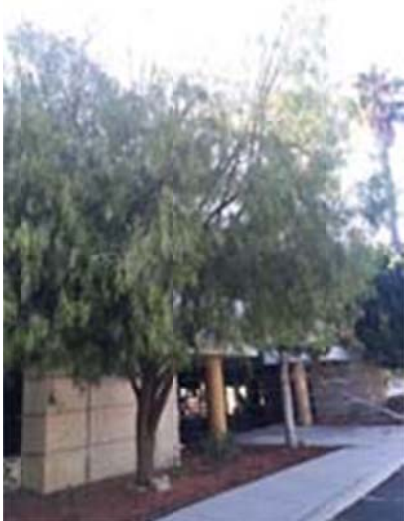
<p>Tree 71 <i>Geijera parviflora</i> – Australian Willow</p> <p>This tree is too small to be protected by ordinance. It will be removed because it is growing within the footprint of the proposed landscaped area expansion. It has an appraised value of \$2,813.94.</p> <p>This tree has trunk bark loss. It has average health and good form.</p>

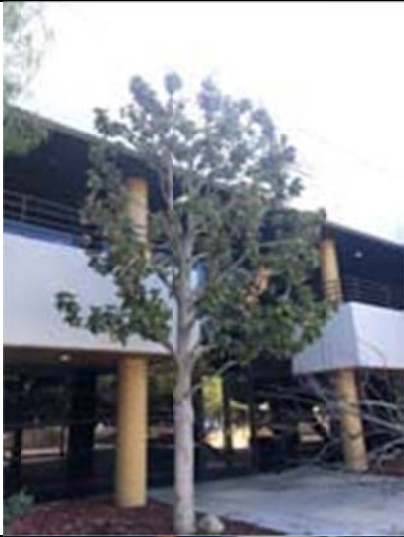
<p>Tree 72 <i>Geijera parviflora</i> – Australian Willow</p> <p>This tree is a protected Mature Tree because it has a cumulative trunk area of more than 72 in². It will be removed because it is growing within the footprint of the proposed landscaped area expansion. It has an appraised value of \$10,196.37.</p> <p>This tree has co-dominant trunks. It has excellent health and average form.</p>

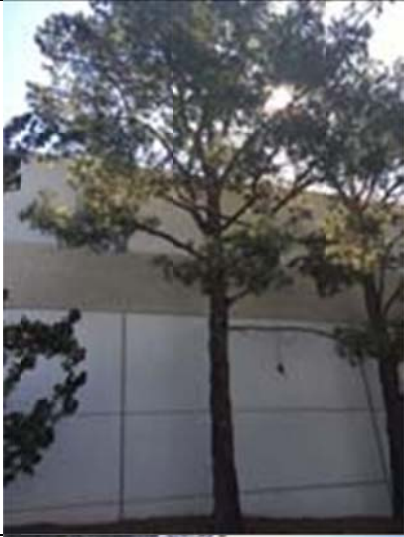
<p>Tree 79 <i>Juniperus chinensis</i> – Hollywood Juniper</p> <p>This tree is too small to be protected by ordinance. It will be removed because it is growing within the footprint of the proposed parking lot expansion. It has an appraised value of \$2,122.79.</p> <p>This tree has symptoms of drought stress. It has average health and good form.</p>

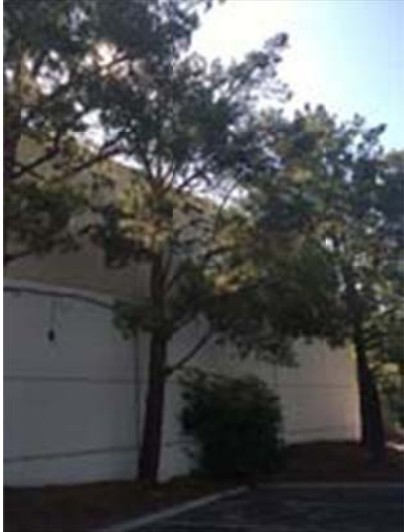
<p>Tree 80 <i>Pinus eldarica</i> – Mondell Pine</p> <p>This tree is a protected Mature Tree because it has a cumulative trunk area of more than 72 in². It will be removed because it is growing within the footprint of a proposed walkway. It has an appraised value of \$8,266.84.</p> <p>This tree has a history of past excessive pruning. It has average health and good form.</p>

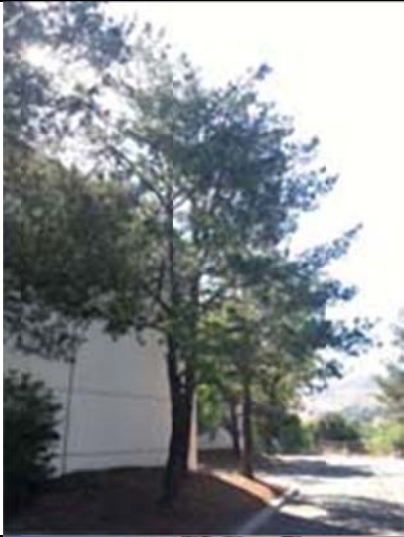
<p>Tree 81 <i>Pinus eldarica</i> – Mondell Pine</p> <p>This tree is a protected Mature Tree because it has a cumulative trunk area of more than 72 in². It will be removed because it is growing within the footprint of a proposed walkway. It has an appraised value of \$9,246.82.</p> <p>This tree has a history of past excessive pruning. It has average health and good form.</p>

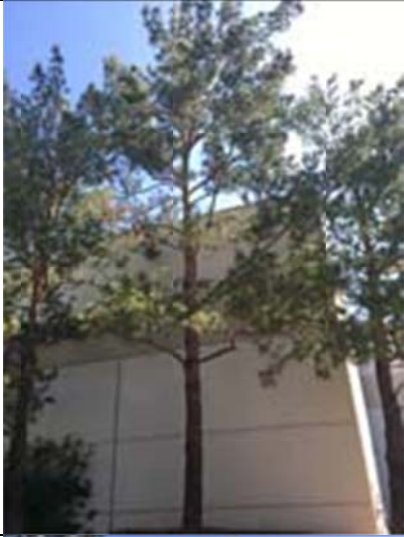
<p>Tree 82 <i>Pinus eldarica</i> – Mondell Pine</p> <p>This tree is a protected Mature Tree because it has a cumulative trunk area of more than 72 in². It will be removed because it is growing within the footprint of a proposed walkway. It has an appraised value of \$7,022.69.</p> <p>This tree has a history of past excessive pruning. It has average health and good form.</p>

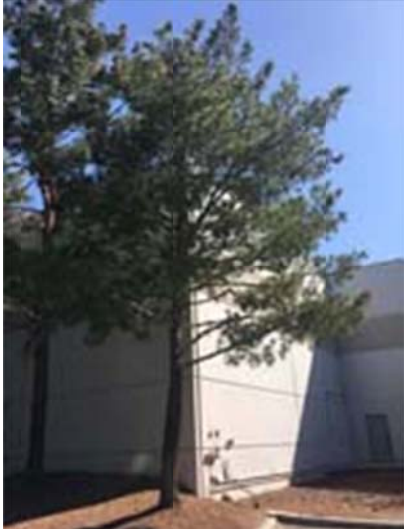
<p>Tree 83 <i>Pinus eldarica</i> – Mondell Pine</p> <p>This tree is a protected Mature Tree because it has a cumulative trunk area of more than 72 in². It will be removed because it is growing within the footprint of a proposed walkway. It has an appraised value of \$6,200.97.</p> <p>This tree has a history of past excessive pruning. It has average health and average form.</p>

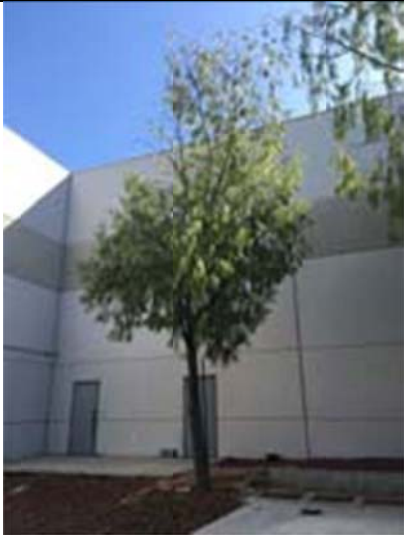
<p>Tree 84 <i>Pinus eldarica</i> – Mondell Pine</p> <p>This tree is a protected Mature Tree because it has a cumulative trunk area of more than 72 in². It will be removed because it is growing within the footprint of a proposed walkway. It has an appraised value of \$6,474.88.</p> <p>This tree has a history of past excessive pruning. It has average health and good form.</p>

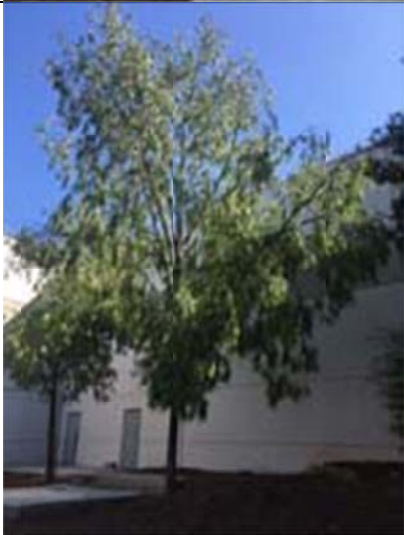
<p>Tree 85 <i>Geijera parviflora</i> – Australian Willow</p> <p>This tree is too small to be protected by ordinance. It will be removed because it is growing within the footprint of a proposed walkway. It has an appraised value of \$1,952.98.</p> <p>This tree has drought stress and top dieback. It is still attached to its nursery stake. It has average health and good form.</p>

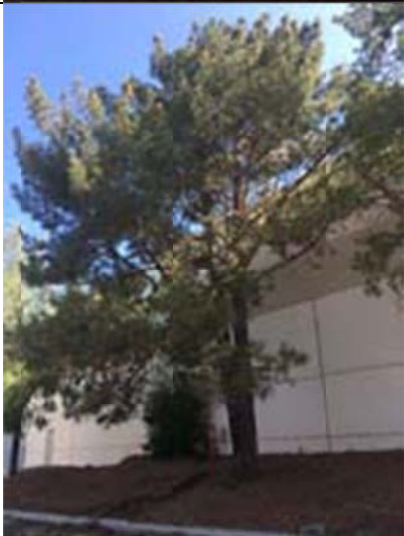
<p>Tree 86 <i>Geijera parviflora</i> – Australian Willow</p> <p>This tree is a protected Mature Tree because it has a cumulative trunk area of more than 72 in². It will be removed because it is growing within the footprint of the proposed driveway. It has an appraised value of \$4,463.27.</p> <p>This tree has symptoms of drought stress. It has good health and good form.</p>
