6000 Condor Dr. Arborist Report

Prepared for HPA inc.
c/o Tammi Bailey
18831 Bardeen Ave. Suite 100
Irvine, CA 92612

Prepared by James Komen
BCMA WE-9909B
RCA #555

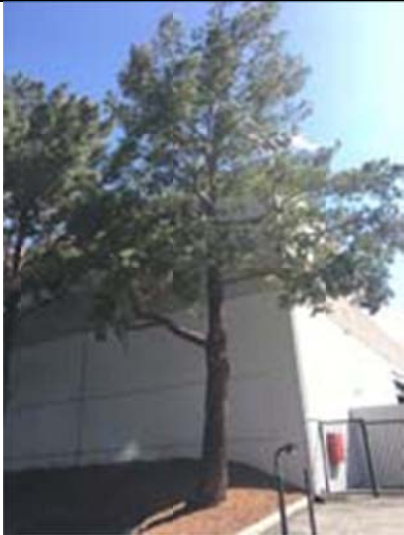
<p>Tree 87 <i>Pinus eldarica</i> – Mondell Pine</p> <p>This tree is a protected Mature Tree because it has a cumulative trunk area of more than 72 in². It will be removed because it is growing within the footprint of the proposed landscaped area expansion. It has an appraised value of \$16,913.80.</p> <p>This tree has co-dominant trunks. It has average health and good form.</p>

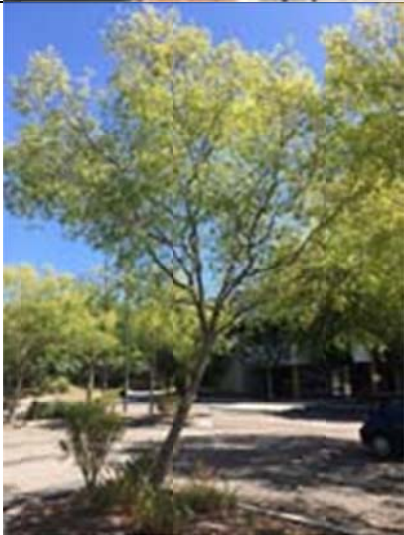
<p>Tree 88 <i>Pinus eldarica</i> – Mondell Pine</p> <p>This tree is a protected Mature Tree because it has a cumulative trunk area of more than 72 in². It will be removed because it is growing within the footprint of the proposed landscaped area expansion. It has an appraised value of \$10,282.80.</p> <p>This tree has a history of past excessive pruning. It has average health and good form.</p>

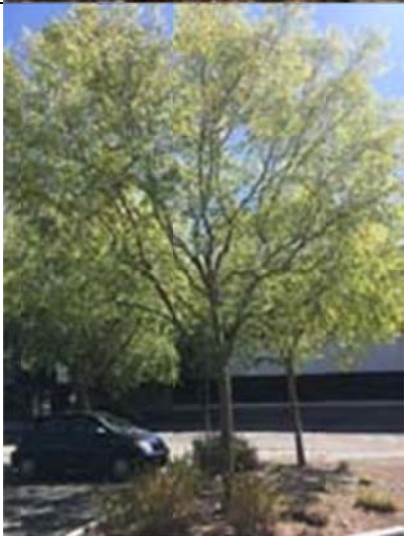
<p>Tree 89 <i>Ulmus parvifolia</i> – Chinese Elm</p> <p>This tree is too small to be protected by ordinance. It will be removed because it is growing within the footprint of the proposed driveway. It has an appraised value of \$1,489.76.</p> <p>This tree has heat/drought stress. It has good health and excellent form.</p>

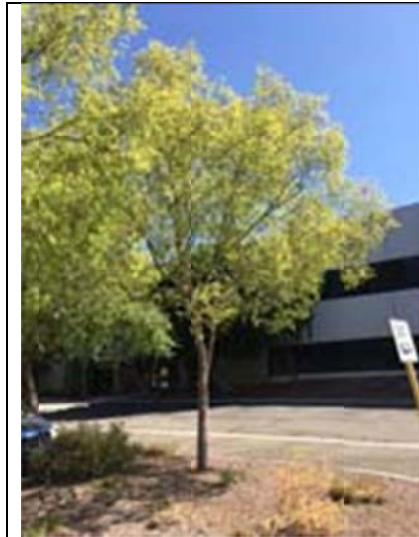
<p>Tree 90 <i>Ulmus parvifolia</i> – Chinese Elm</p> <p>This tree is too small to be protected by ordinance. It will be removed because it is growing within the footprint of the proposed driveway. It has an appraised value of \$2,512.34.</p> <p>This tree has heat/drought stress. It has good health and excellent form.</p>

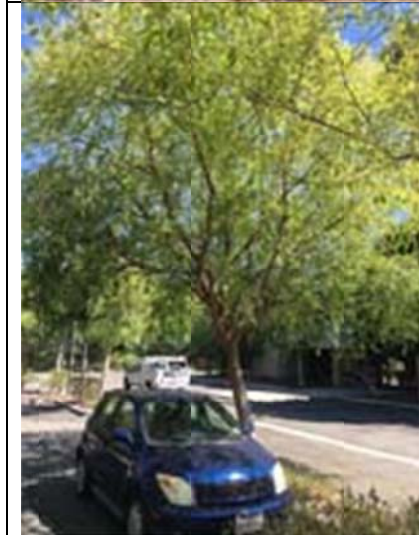
Tree 91

This tree is too small to be protected by ordinance. It will be removed because it is growing within the footprint of the proposed parking lot expansion. It has an appraised value of \$1,964.53.

This tree has heat/drought stress. It has good health and excellent form.

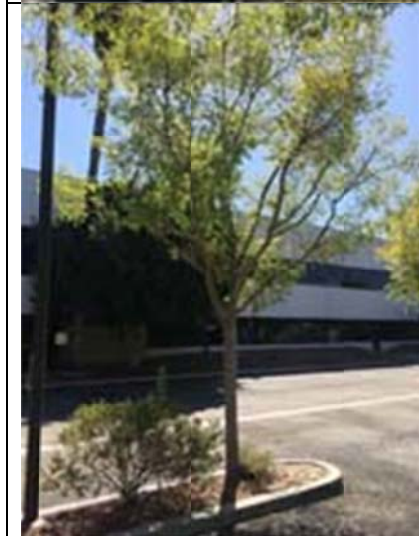
Tree 92

This tree is a protected Mature Tree because it has a cumulative trunk area of more than 72 in². It will be removed because it is growing within the footprint of the proposed parking lot expansion. It has an appraised value of \$3,827.10.

This tree has heat/drought stress. It has good health and excellent form.

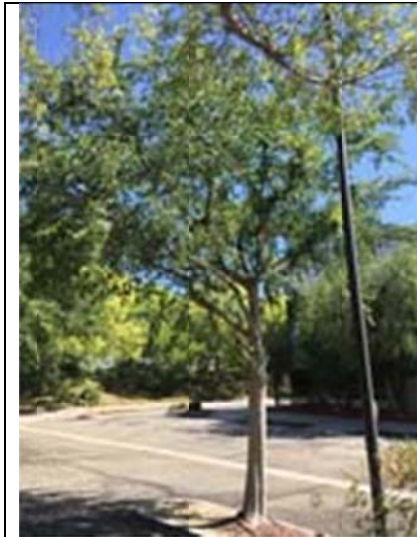
Tree 93

This tree is too small to be protected by ordinance. It will be removed because it is growing within the footprint of the proposed parking lot expansion. It has an appraised value of \$1,489.76.

This tree has symptoms of heat and drought stress. It has good health and excellent form.

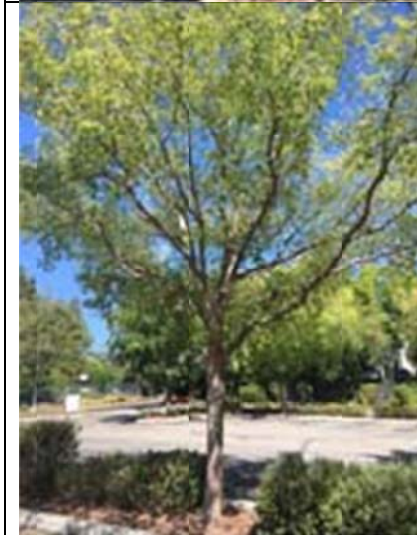
Tree 94

This tree is too small to be protected by ordinance. It will be removed because it is growing within the footprint of the proposed parking lot expansion. It has an appraised value of \$3,724.84.

This tree has excellent health and excellent form.

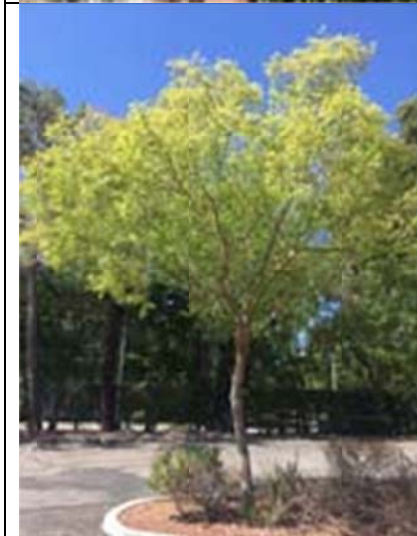
Tree 95

This tree is too small to be protected by ordinance. It will be removed because it is growing within the footprint of the proposed parking lot expansion. It has an appraised value of \$2,512.34.

This tree has symptoms of heat and drought stress. It has good health and excellent form.

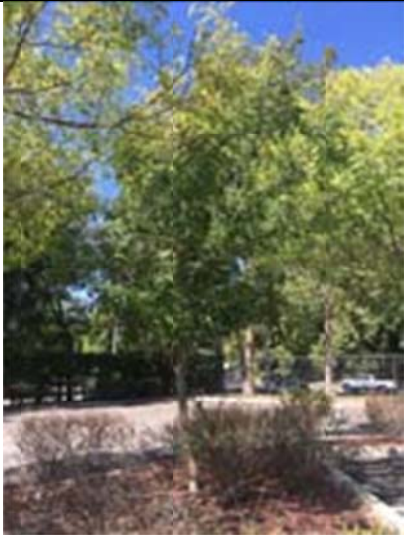
Tree 96

This tree is too small to be protected by ordinance. It will be removed because it is growing within the footprint of the proposed driveway. It has an appraised value of \$1,964.53.

This tree has symptoms of heat and drought stress. It has good health and excellent form.

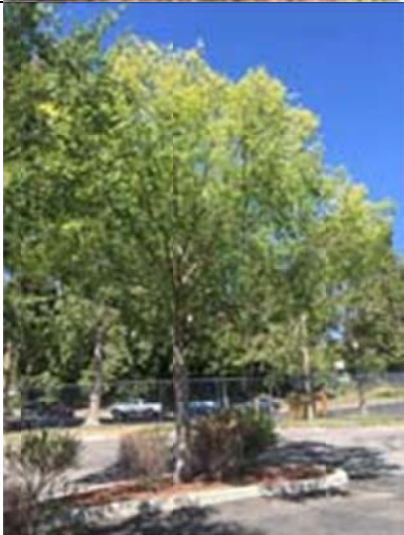
<p>Tree 97 <i>Ulmus parvifolia</i> – Chinese Elm</p> <p>This tree is too small to be protected by ordinance. It will be removed because it is growing within the footprint of the proposed landscaped area expansion. It has an appraised value of \$1,088.03.</p> <p>This tree has symptoms of heat and drought stress. It has good health and excellent form.</p>

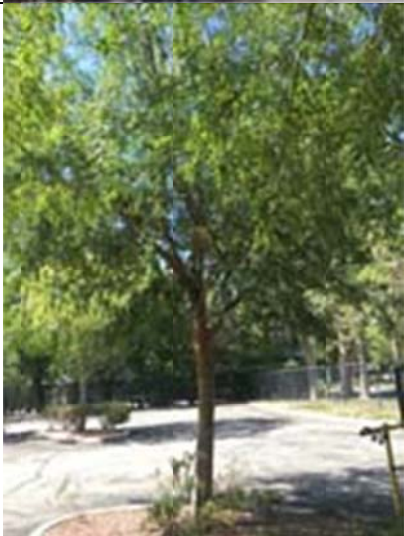
<p>Tree 98 <i>Ulmus parvifolia</i> – Chinese Elm</p> <p>This tree is too small to be protected by ordinance. It will be removed because it is growing within the footprint of the proposed landscaped area expansion. It has an appraised value of \$3,133.20.</p> <p>This tree has symptoms of heat and drought stress. It has good health and excellent form.</p>

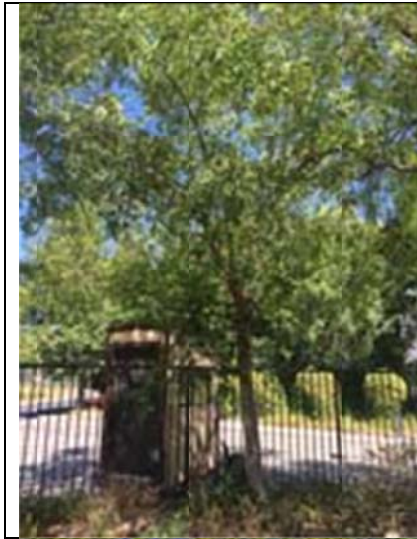
<p>Tree 99 <i>Ulmus parvifolia</i> – Chinese Elm</p> <p>This tree is too small to be protected by ordinance. It will be removed because it is growing within the footprint of the proposed driveway. It has an appraised value of \$2,512.34.</p> <p>This tree has a co-dominant branch defect. It has excellent health and good form.</p>

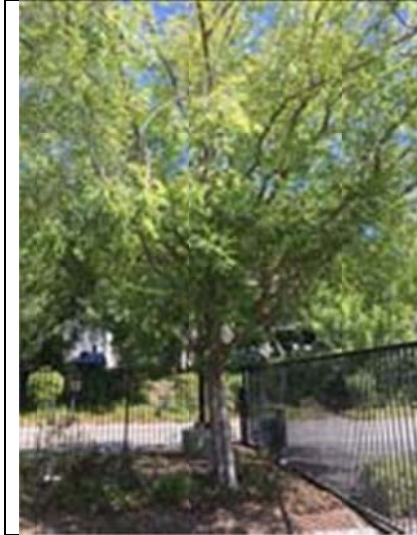
Tree 100

This tree is too small to be protected by ordinance. It will be removed because it is growing within the footprint of the proposed driveway. It has an appraised value of \$2,083.83.

This tree has symptoms of heat and drought stress. It has good health and excellent form.

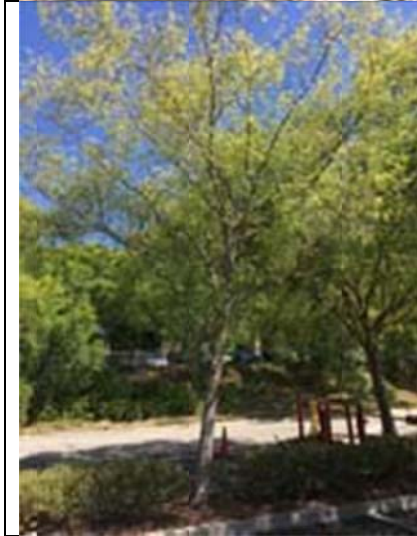
Tree 101

This tree is a protected Mature Tree because it has a cumulative trunk area of more than 72 in². It will be removed because it is growing within the footprint of the proposed driveway. It has an appraised value of \$3,827.10.

This tree has symptoms of heat and drought stress. It has good health and excellent form.

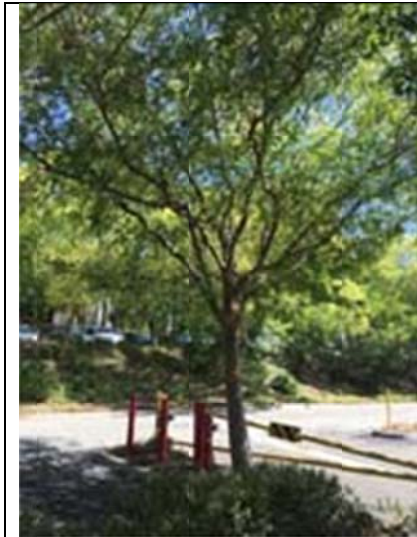
Tree 102

This tree is too small to be protected by ordinance. It will be removed because it is growing within the footprint of the proposed driveway. It has an appraised value of \$2,083.83.

This tree has symptoms of heat and drought stress. It has good health and excellent form.

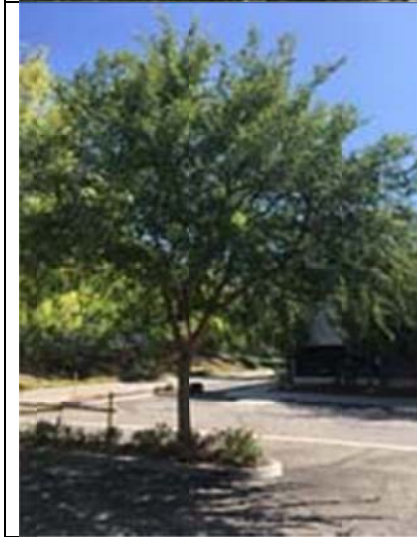
Tree 103

This tree is too small to be protected by ordinance. It will be removed because it is growing within the footprint of the proposed driveway. It has an appraised value of \$3,724.84.

This tree has excellent health and excellent form.

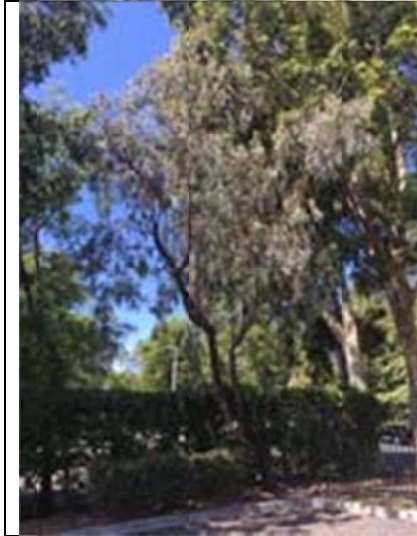
Tree 104

This tree is too small to be protected by ordinance. It will be removed because it is growing within the footprint of the proposed driveway. It has an appraised value of \$3,724.84.

This tree has excellent health and excellent form.

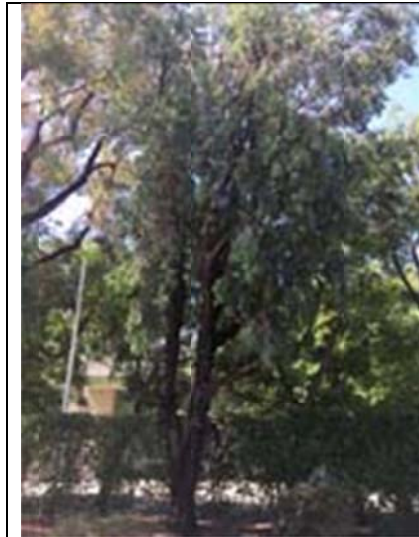
Tree 105

This tree is a prohibited species in Moorpark. It will be removed.

This tree has symptoms of minor drought stress. It has good health and good form.

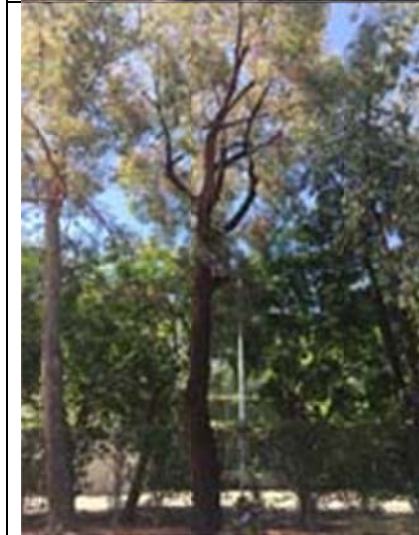
Tree 106

This tree is a prohibited species in Moorpark. It will be removed.

This tree has co-dominant trunks. It has excellent health and average form.

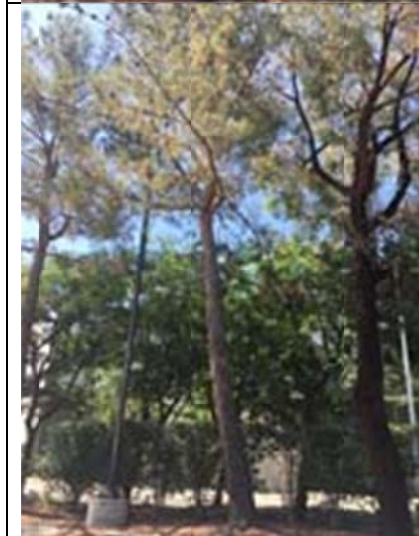
Tree 107

This tree is a prohibited species in Moorpark. It will be removed.

This tree is healthy. It has good health and excellent form.

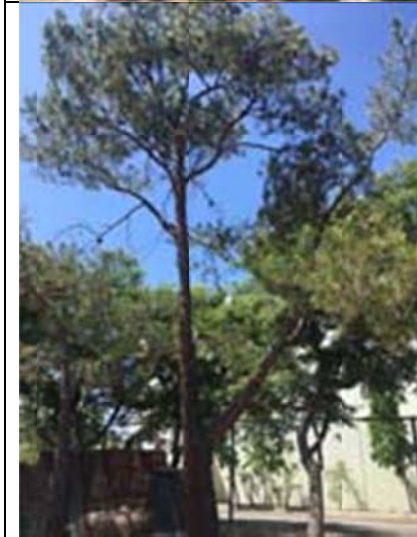
This tree is a prohibited species in Moorpark. It will be removed.

This tree is still vigorous despite its past excessive thinning. It has good health and good form.

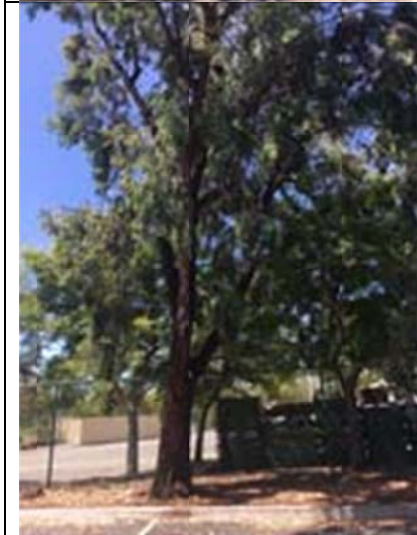
This tree is a prohibited species in Moorpark. It will be removed.

This tree has excellent health and good form.

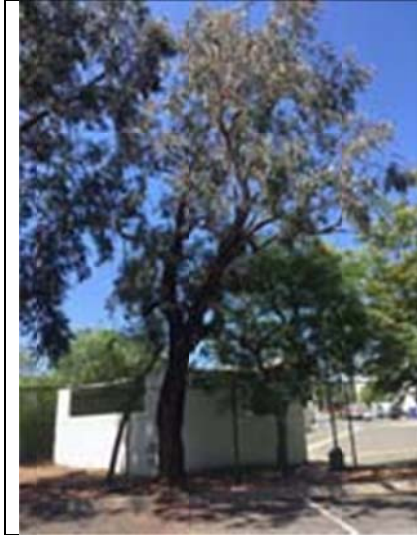
This tree is a prohibited species in Moorpark. It will be removed.

This tree has excellent health and excellent form.

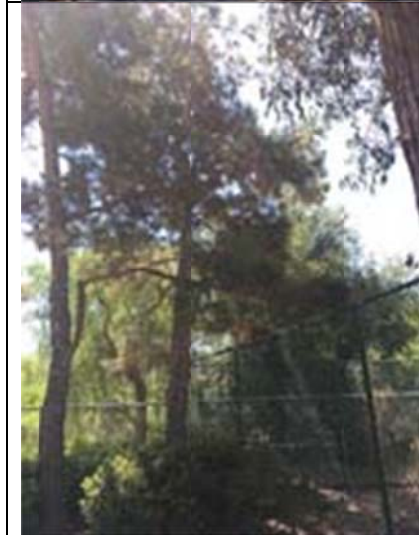
This tree is a prohibited species in Moorpark. It will be removed.

This tree has excellent health and excellent form. No treatment is recommended.

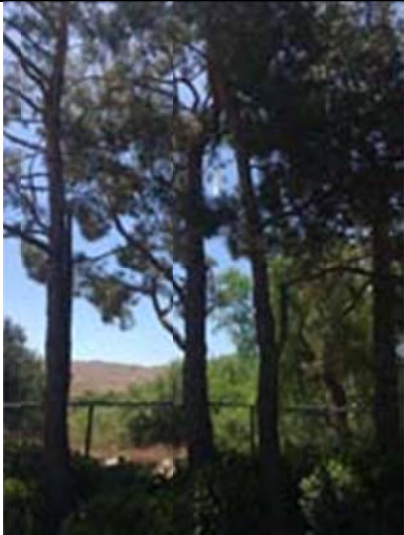
This tree has symptoms of drought stress. It has been partially suppressed by competition with its neighbors. This tree has good health and average form. I recommend supplying supplemental irrigation.

The proposed asphalt resurfacing will encroach within the critical root zone of this tree. All project activity within the drip line of this tree should be directly supervised by a Certified Arborist. This tree is intended to be retained in place throughout the project even though some of its roots may be impacted.

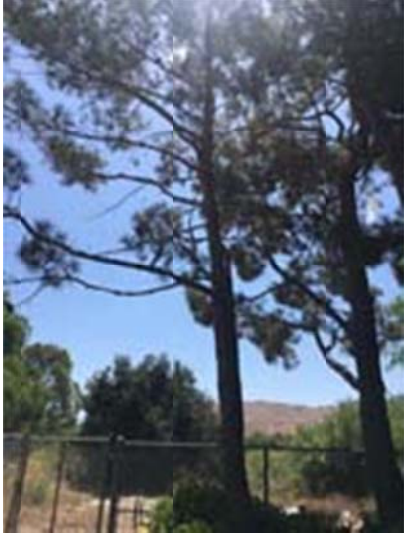
<p>Tree 122 <i>Pinus eldarica</i> – Mondell Pine</p> <p>This tree is a protected Mature Tree because it has a cumulative trunk area of more than 72 in². It will be retained in the landscape. It has an appraised value of \$5,424.29.</p> <p>This tree has symptoms of drought stress. It has been partially suppressed by competition with its neighbors. It has good health and average form. I recommend supplying supplemental irrigation.</p> <p>The proposed asphalt resurfacing will encroach within the critical root zone of this tree. All project activity within the drip line of this tree should be directly supervised by a Certified Arborist. This tree is intended to be retained in place throughout the project even though some of its roots may be impacted.</p>

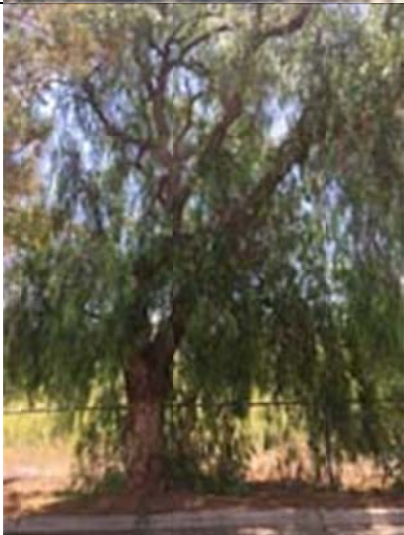
<p>Tree OP124 <i>Schinus molle</i> – California Pepper</p> <p>This tree is a prohibited species in Moorpark. It is growing on an adjacent property. It will be retained in the landscape.</p> <p>This tree has a multi-stem form. It has excellent health and good form. No treatment is recommended.</p>

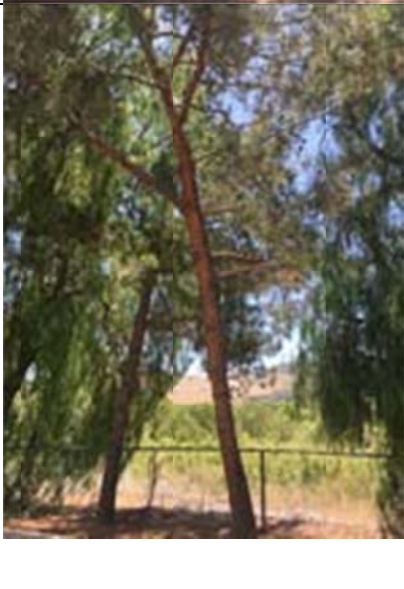
<p>Tree 125 <i>Schinus molle</i> – California Pepper</p> <p>This tree is a prohibited species in Moorpark. It will be removed.</p> <p>This tree has excellent health and good form.</p>

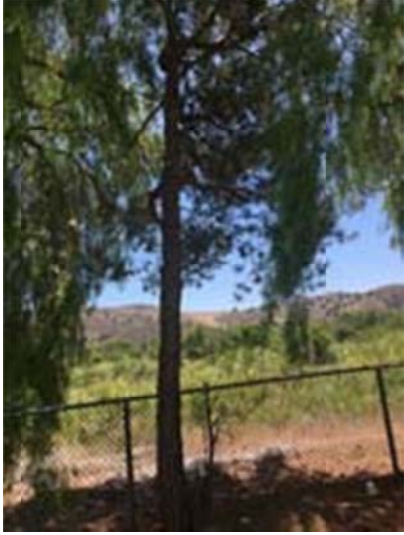
<p>Tree 126 <i>Pinus eldarica</i> – Mondell Pine</p> <p>This tree is a protected Mature Tree because it has a cumulative trunk area of more than 72 in². It will be retained in the landscape. It has an appraised value of \$3,096.68.</p> <p>This tree has been suppressed by competition with its neighbors. It also has symptoms of drought stress. It has good health and good form. I recommend supplying supplemental irrigation.</p> <p>The proposed parking lot demolition will encroach within the critical root zone of this tree. All project activity within the drip line of this tree should be directly supervised by a Certified Arborist. This tree is intended to be retained in place throughout the project even though some of its roots may be impacted.</p>

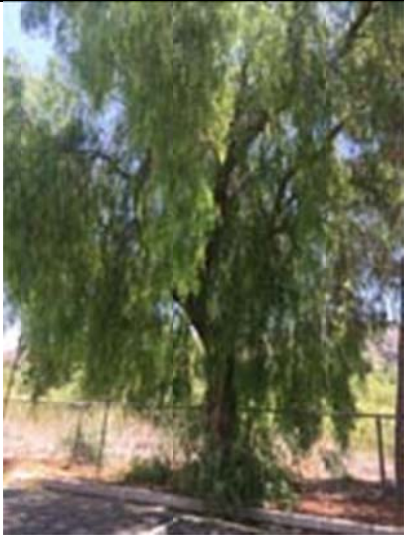
<p>Tree 127 <i>Pinus eldarica</i> – Mondell Pine</p> <p>This tree is too small to be protected by ordinance. It will be retained in the landscape. It has an appraised value of \$2,344.35.</p> <p>This tree has been suppressed by competition with its neighbors. It also has symptoms of drought stress. It has average health and average form. I recommend supplying supplemental irrigation.</p> <p>The proposed parking lot demolition will encroach within the critical root zone of this tree. All project activity within the drip line of this tree should be directly supervised by a Certified Arborist. This tree is intended to be retained in place throughout the project even though some of its roots may be impacted.</p>

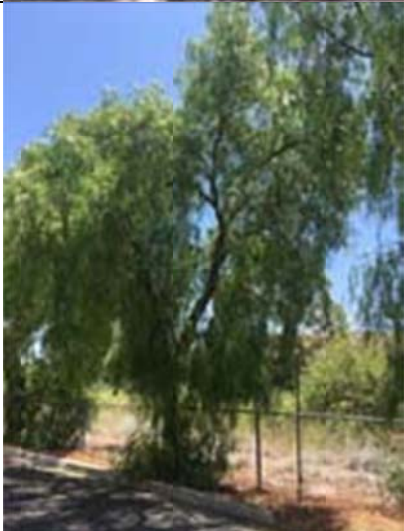
<p>Tree 128 <i>Schinus molle</i> – California Pepper</p> <p>This tree is a prohibited species in Moorpark. It will be removed.</p> <p>This tree has excellent health and good form.</p>

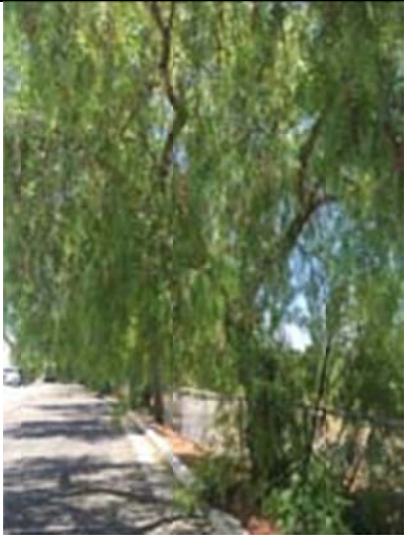
<p>Tree 129 <i>Schinus molle</i> – California Pepper</p> <p>This tree is a prohibited species in Moorpark. It will be removed.</p> <p>One of this tree's trunks was removed in the past, leaving a cavity at the base of the tree. The tree has good health and good form.</p>

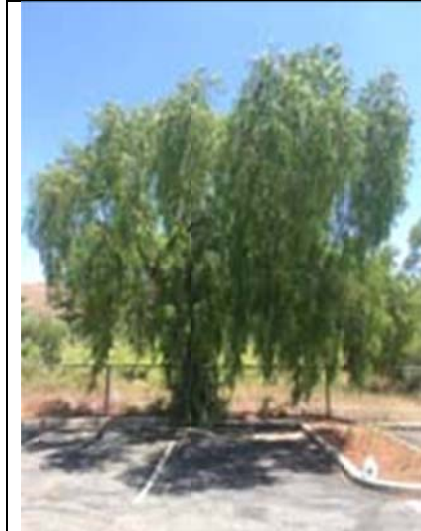
Tree 133

This tree has symptoms of heat and drought stress. It has good health and good form. I recommend supplying supplemental irrigation.

The proposed parking lot demolition will encroach within the critical root zone of this tree. All project activity within the drip line of this tree should be directly supervised by a Certified Arborist. This tree is intended to be retained in place throughout the project even though some of its roots may be impacted.

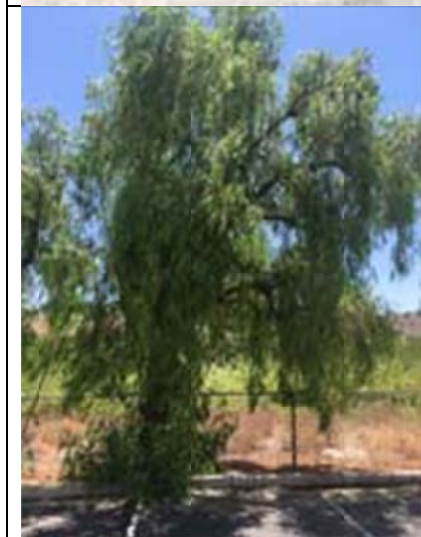
Tree 134

This tree is a prohibited species in Moorpark. It will be removed.

This tree has a trunk cavity. It has good health and excellent form.

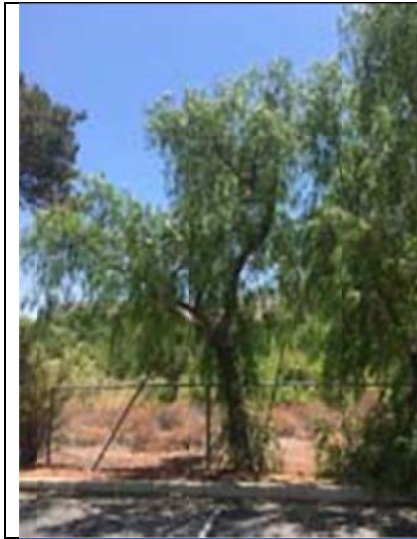
Tree 135

This tree is a prohibited species in Moorpark. It will be removed.

This tree has excellent health and good form.

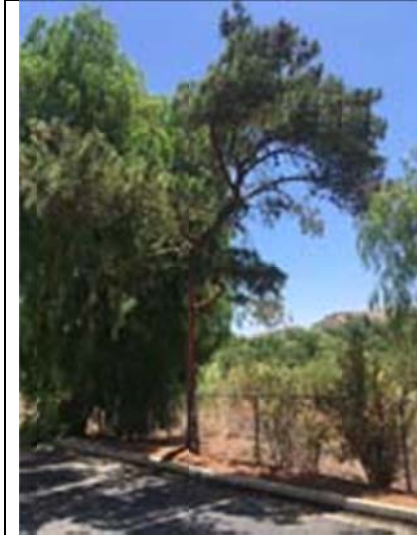
Tree 136

This tree is a prohibited species in Moorpark. It will be removed.

This tree is healthy. It has good health and excellent form.

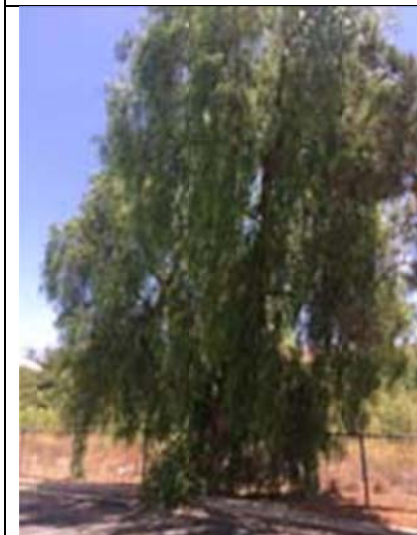
Tree 137

This tree has symptoms of heat and drought stress. It has good health and good form. No treatment is recommended.

The proposed parking lot demolition will encroach within the critical root zone of this tree. All project activity within the drip line of this tree should be directly supervised by a Certified Arborist. This tree is intended to be retained in place throughout the project even though some of its roots may be impacted.

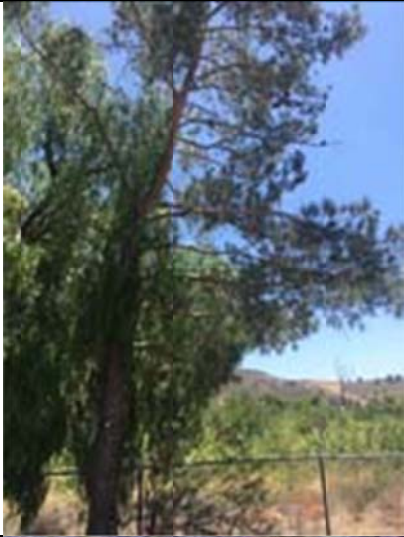
Tree 138

This tree is a prohibited species in Moorpark. It will be removed.

This tree has excellent health and excellent form.

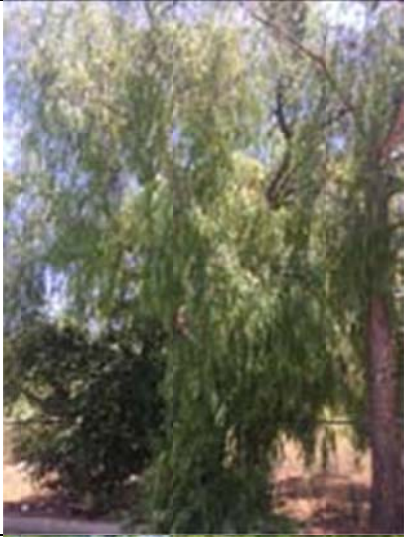
<p>Tree 139 <i>Pinus eldarica</i> – Mondell Pine</p> <p>This tree is a protected Mature Tree because it has a cumulative trunk area of more than 72 in². It will be removed because it is growing within the footprint of the proposed fire hydrant relocation. It has an appraised value of \$6,378.70.</p> <p>This tree has symptoms of heat and drought stress. It has good health and good form.</p>

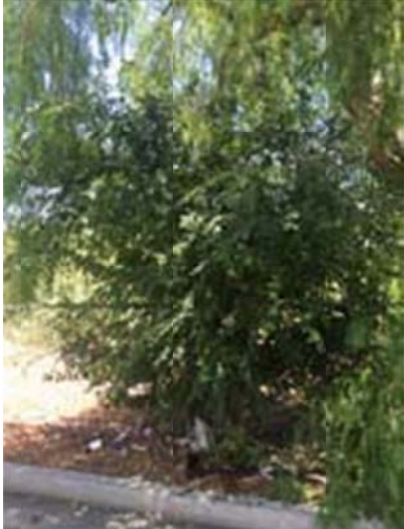
<p>Tree 140 <i>Schinus molle</i> – California Pepper</p> <p>This tree is a prohibited species in Moorpark. It will be removed.</p> <p>This tree has former trunk removed, cavity at base. It has good health and good form.</p>

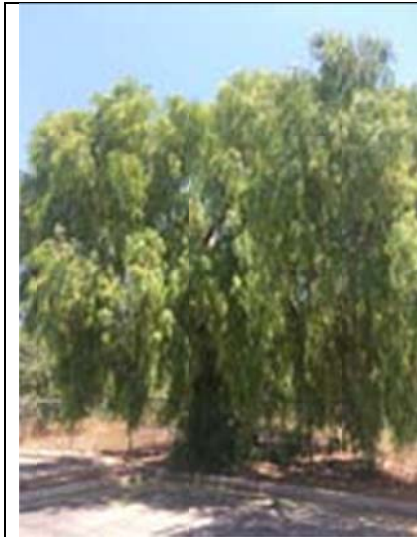
<p>Tree 141 <i>Ulmus parvifolia</i> – Chinese Elm</p> <p>This tree is too small to be protected by ordinance. It will be removed because it is growing within the footprint of the proposed fire hydrant relocation. It has an appraised value of \$856.73.</p> <p>This tree has partially impounded fence. It has excellent health and average form.</p>

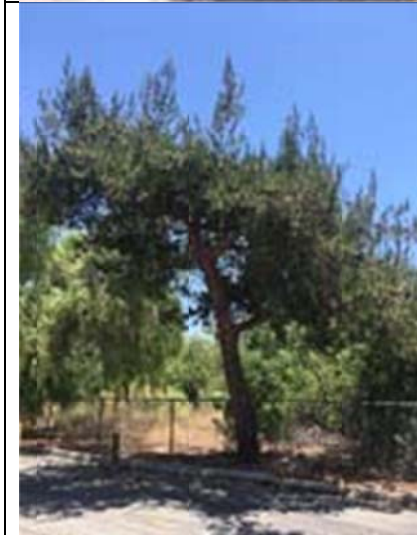
Tree 142

This tree is a prohibited species in Moorpark. It will be removed.

This tree has excellent health and excellent form.

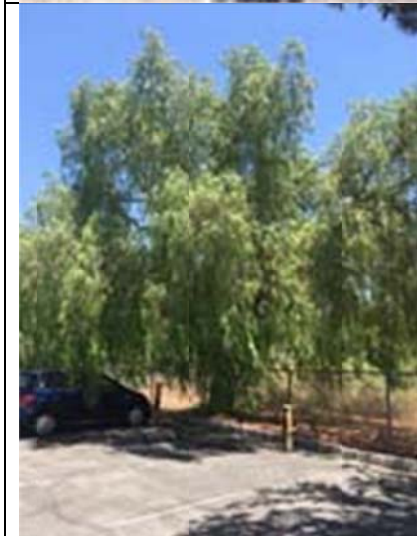
Tree 143

This tree is a protected Mature Tree because it has a cumulative trunk area of more than 72 in². It will be removed because it is growing within the footprint of the proposed parking lot expansion. It has an appraised value of \$13,809.51.

This tree has lower branches removed. It has excellent health and good form.

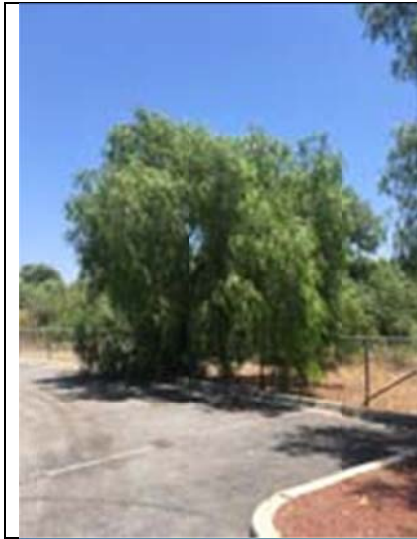
Tree 144

This tree is a prohibited species in Moorpark. It will be removed.

This tree has excellent health and excellent form.

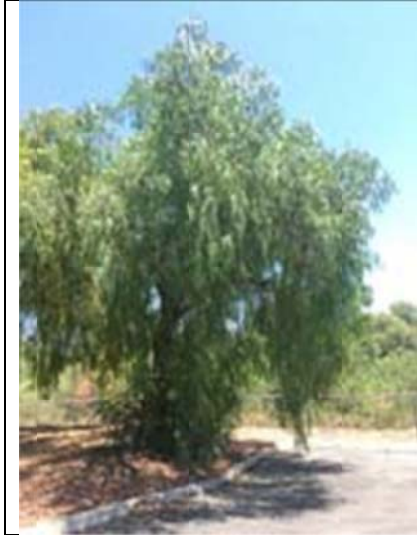
Tree 145

This tree is a prohibited species in Moorpark. It will be removed.

This tree has excellent health and excellent form.

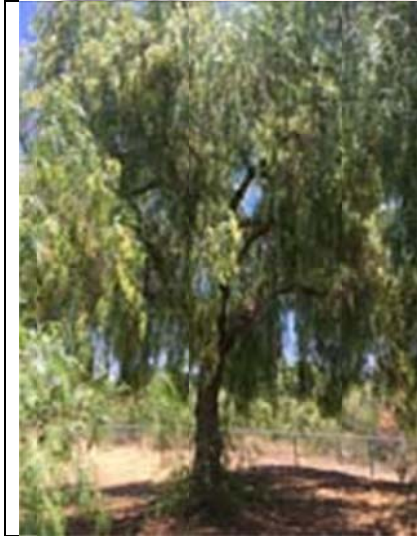
Tree 146

This tree is a prohibited species in Moorpark. It will be removed.

This tree has impounded its old nursery stake. It has excellent health and good form.

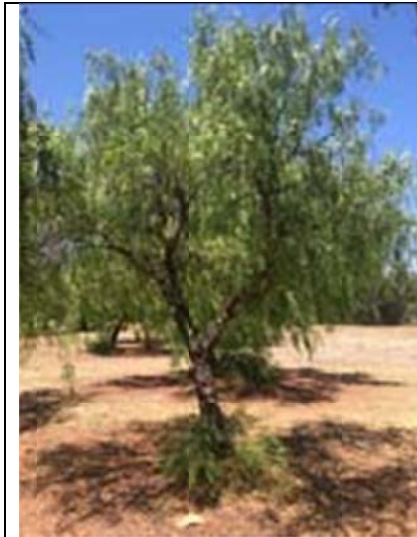
Tree 147

This tree is a prohibited species in Moorpark. It will be removed.

This tree has excellent health and excellent form.

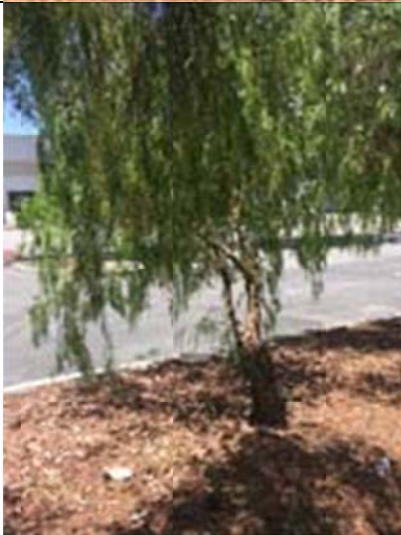
Tree 148

This tree is a prohibited species in Moorpark. It will be removed.

This tree has impounded its nursery stake. It has excellent health and good form.

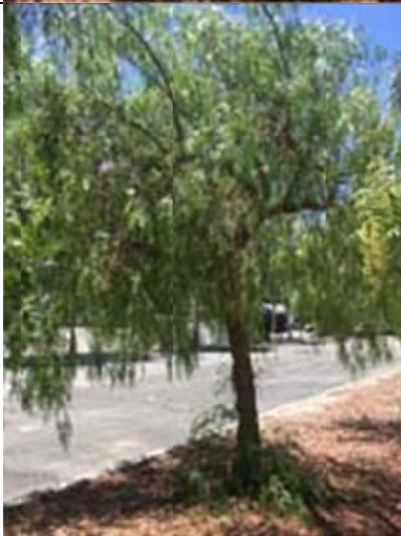
Tree 149

This tree is a prohibited species in Moorpark. It will be removed.

This tree is comprised of a stump sprout from a formerly removed tree. It has good health and average form.

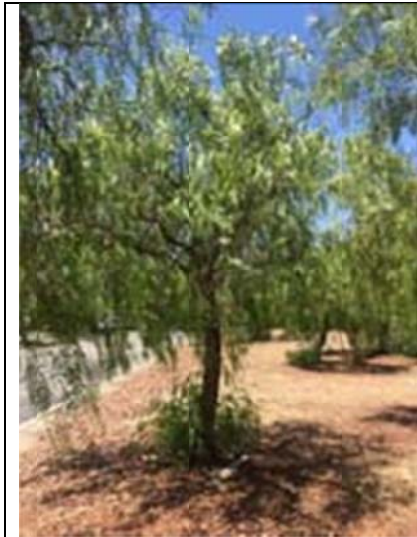
Tree 150

This tree is a prohibited species in Moorpark. It will be removed.

This tree has excellent health and excellent form.

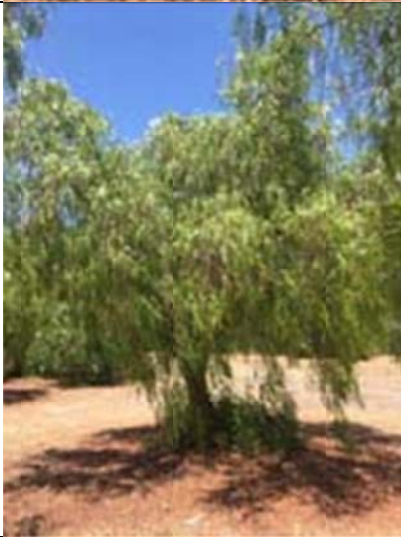
Tree 151

This tree is a prohibited species in Moorpark. It will be removed.

This tree has excellent health and excellent form.

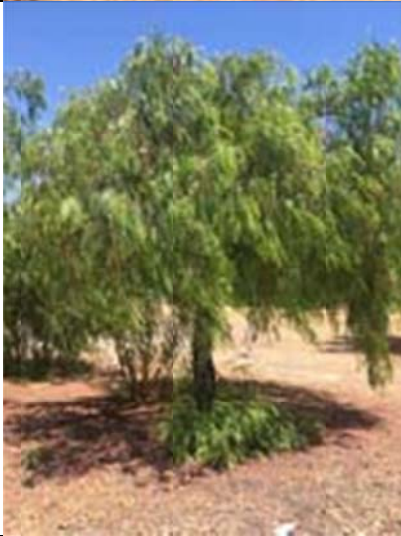
Tree 152

This tree is a prohibited species in Moorpark. It will be removed.

This tree has excellent health and excellent form.

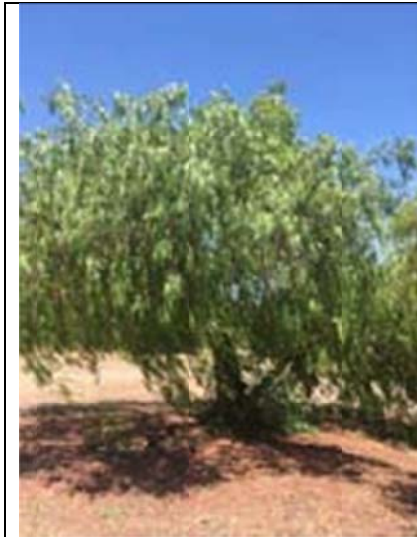
Tree 153

This tree is a prohibited species in Moorpark. It will be removed.

This tree has excellent health and excellent form.

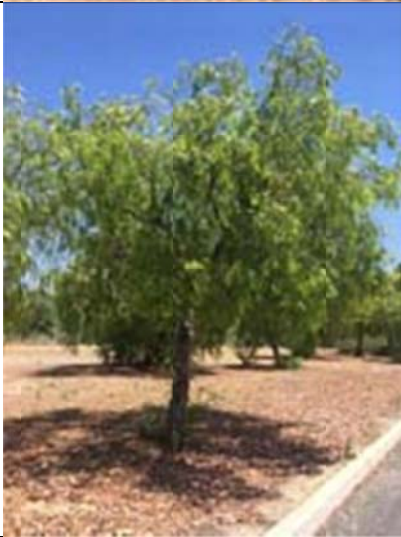
Tree 154

This tree is a prohibited species in Moorpark. It will be removed.

One of the trunks of this tree has a substantial lean. This tree has excellent health and good form.

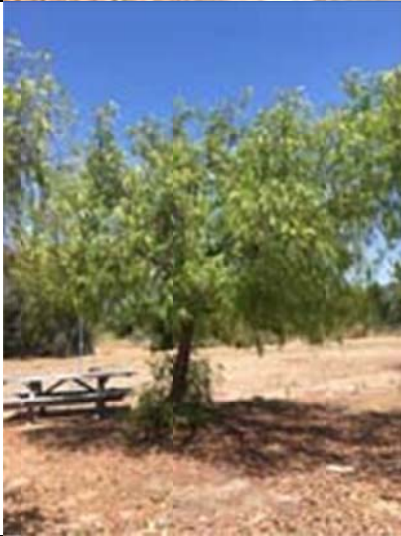
Tree 155

This tree is a prohibited species in Moorpark. It will be removed.

This tree has excellent health and excellent form.

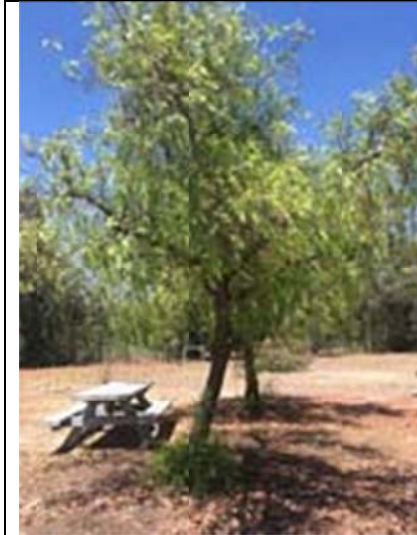
Tree 156

This tree is a prohibited species in Moorpark. It will be removed.

This tree has excellent health and excellent form.

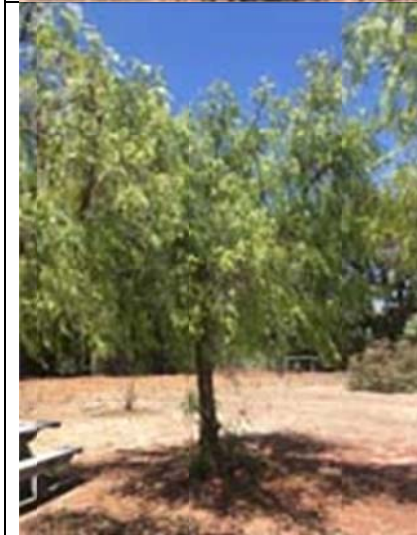
Tree 157

This tree is a prohibited species in Moorpark. It will be removed.

This tree has excellent health and excellent form.

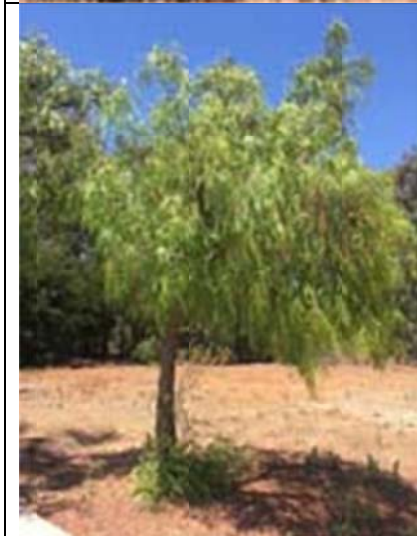
Tree 158

This tree is a prohibited species in Moorpark. It will be removed.

This tree has excellent health and excellent form.

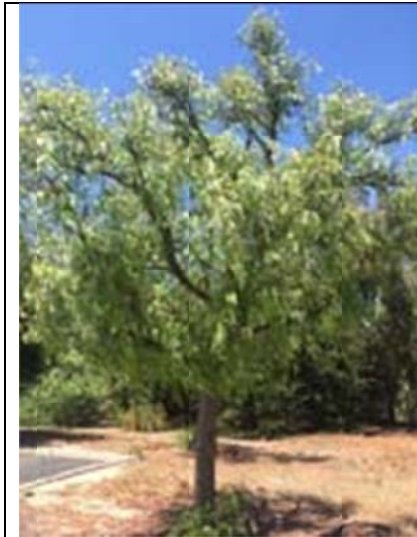
Tree 159

This tree is a prohibited species in Moorpark. It will be removed.

This tree has excellent health and excellent form.

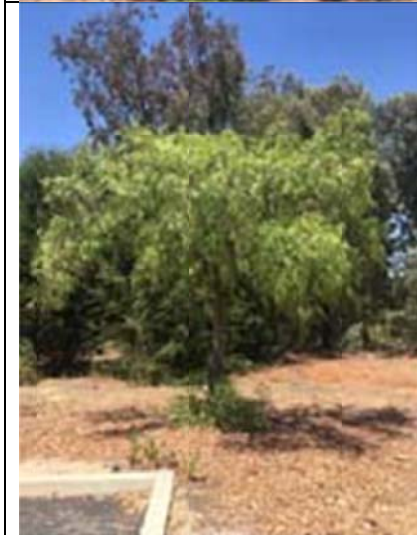
Tree 160

This tree is a prohibited species in Moorpark. It will be removed.

This tree has excellent health and excellent form.

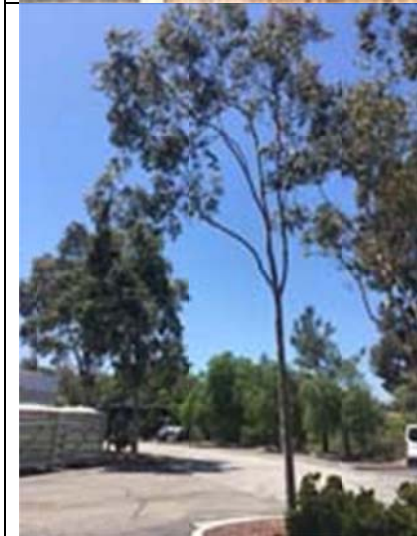
Tree 161

This tree is a prohibited species in Moorpark. It will be removed.

This tree has excellent health and excellent form.

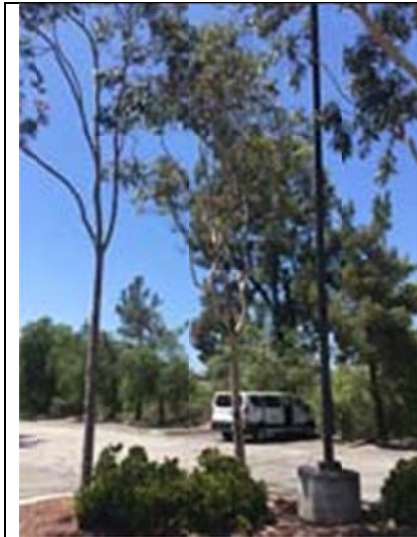
Tree 162

This tree is too small to be protected by ordinance. It will be removed because it is growing within the footprint of the proposed parking lot expansion. It has an appraised value of \$2,075.04.

This tree has symptoms of minor drought stress. It has good health and excellent form.

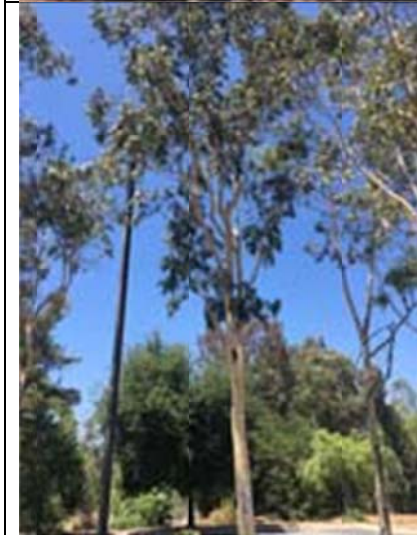
Tree 163

This tree is too small to be protected by ordinance. It will be removed because it is growing within the footprint of the proposed parking lot expansion. It has an appraised value of \$1,659.40.

This tree has symptoms of minor drought stress. It has good health and average form.

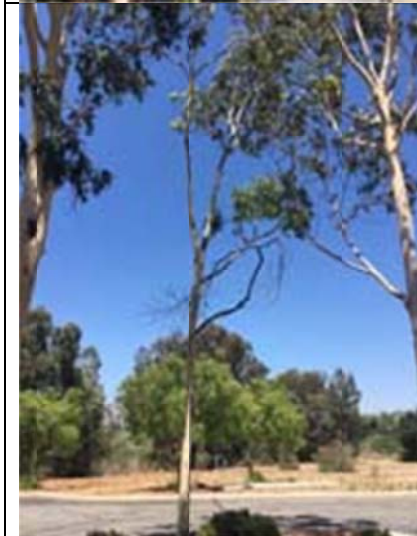
Tree 164

This tree is a protected Mature Tree because it has a cumulative trunk area of more than 72 in². It will be removed because it is growing within the footprint of the proposed parking lot expansion. It has an appraised value of \$4,964.67.

This tree has symptoms of minor drought stress. It also has co-dominant branches. It has good health and good form.

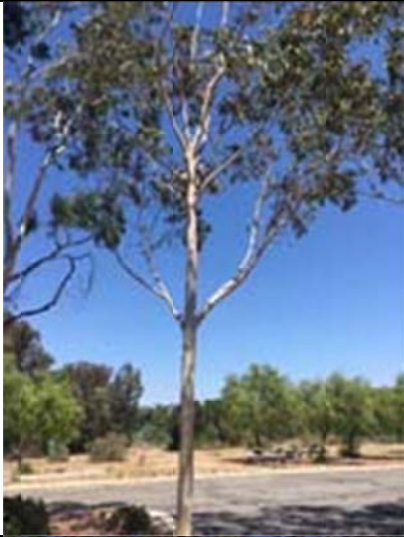
Tree 165

This tree is too small to be protected by ordinance. It will be removed because it is growing within the footprint of the proposed parking lot expansion. It has an appraised value of \$2,761.16.

This tree has symptoms of minor drought stress. It also has co-dominant branches. It has good health and excellent form.

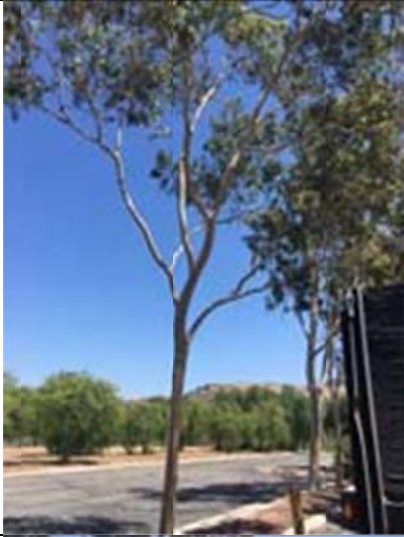
<p>Tree 166 <i>Corymbia citriodora</i> – Lemon Gum</p> <p>This tree is too small to be protected by ordinance. It will be removed because it is growing within the footprint of the proposed parking lot expansion. It has an appraised value of \$2,761.16.</p> <p>This tree has symptoms of minor drought stress. It has good health and excellent form.</p>

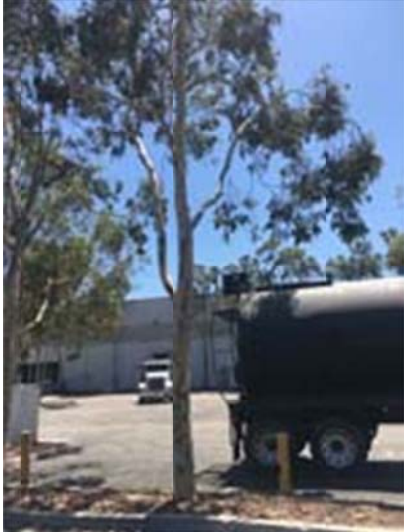
<p>Tree 167 <i>Corymbia citriodora</i> – Lemon Gum</p> <p>This tree is too small to be protected by ordinance. It will be removed because it is growing within the footprint of the proposed parking lot expansion. It has an appraised value of \$3,552.84.</p> <p>This tree has symptoms of minor drought stress. It has good health and excellent form.</p>

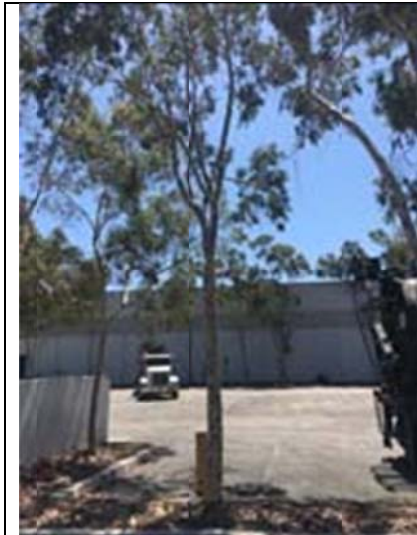
Tree 169

This tree has symptoms of minor drought stress. It has good health and excellent form.

This tree is too small to be protected by ordinance. It will be removed because it is growing within the footprint of the proposed parking lot expansion. It has an appraised value of \$3,552.84.

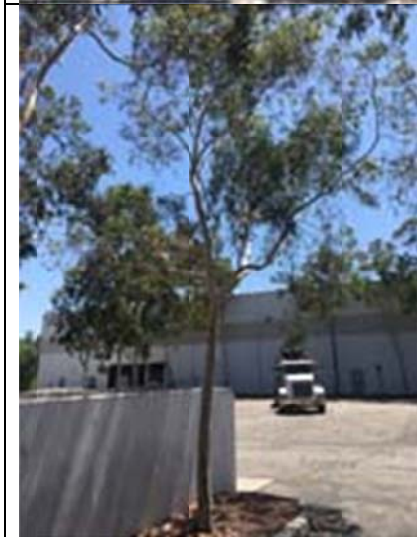
Tree 170

This tree has symptoms of minor drought stress. It has good health and excellent form.

This tree is too small to be protected by ordinance. It will be removed because it is growing within the footprint of the proposed parking lot expansion. It has an appraised value of \$2,075.04.

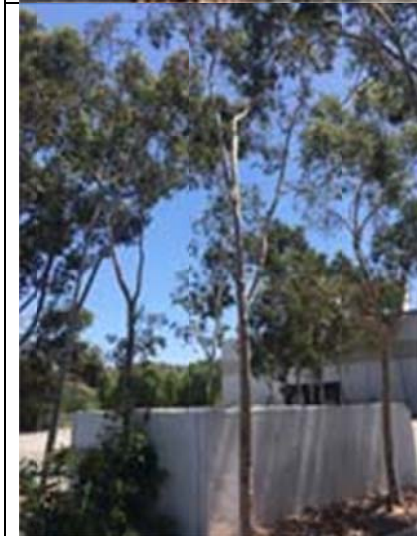
Tree 171

This tree has symptoms of minor drought stress. It has average health and good form.

This tree is too small to be protected by ordinance. It will be removed because it is growing within the footprint of the proposed parking lot expansion. It has an appraised value of \$1,362.52.

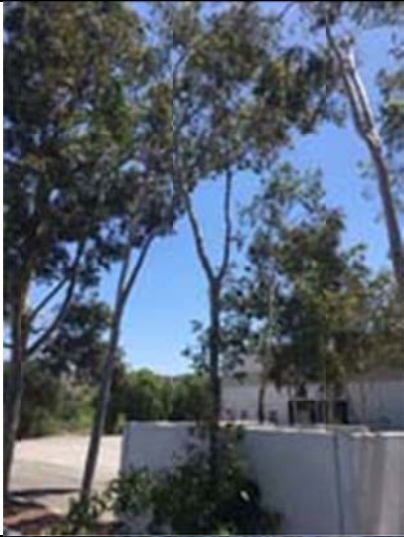
<p>Tree 172 <i>Corymbia citriodora</i> – Lemon Gum</p> <p>This tree is too small to be protected by ordinance. It will be removed because it is growing within the footprint of the proposed parking lot expansion. It has an appraised value of \$752.27.</p> <p>This tree has symptoms of minor drought stress. It is growing in a very small soil volume behind the existing trash enclosure. Despite its growing conditions, it has good health and good form.</p>

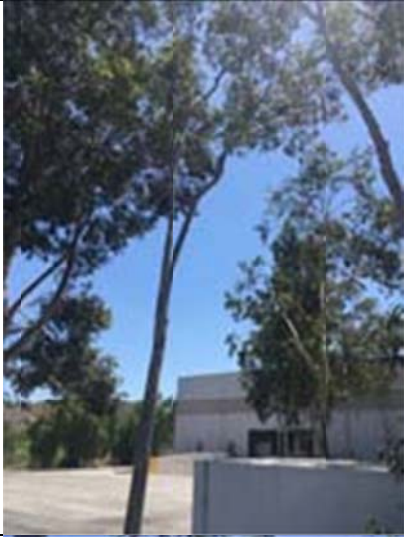
<p>Tree 173 <i>Corymbia citriodora</i> – Lemon Gum</p> <p>This tree is too small to be protected by ordinance. It will be removed because it is growing within the footprint of the proposed parking lot expansion. It has an appraised value of \$1,718.78.</p> <p>This tree has symptoms of minor drought stress. It has good health and good form.</p>

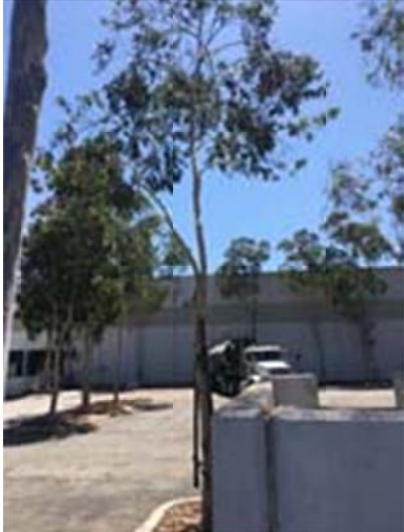
<p>Tree 174 <i>Corymbia citriodora</i> – Lemon Gum</p> <p>This tree is too small to be protected by ordinance. It will be removed because it is growing within the footprint of the proposed parking lot expansion. It has an appraised value of \$1,659.40.</p> <p>This tree has symptoms of minor drought stress. It still has its old nursery ties. It has excellent health and excellent form.</p>

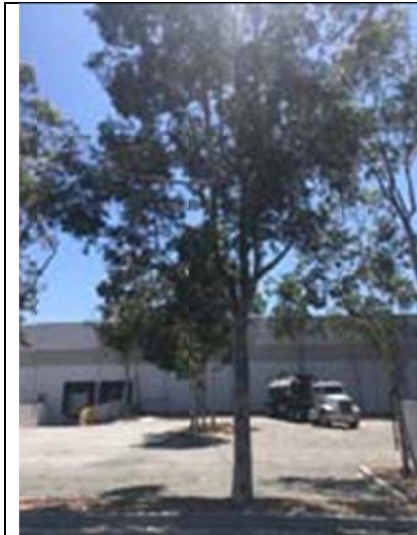
Tree 175

This tree is healthy. It has good health and excellent form.

This tree is a protected Mature Tree because it has a cumulative trunk area of more than 72 in². It will be removed because it is growing within the footprint of the proposed parking lot expansion. It has an appraised value of \$9,094.61.

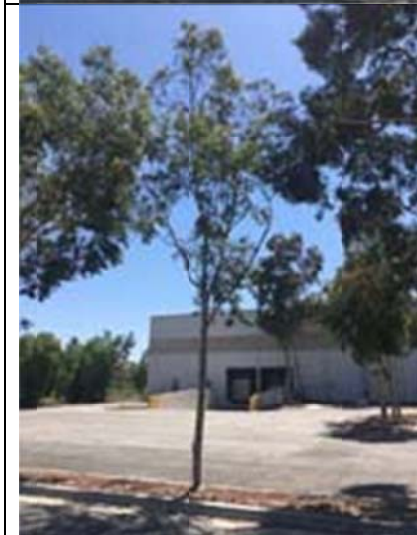
Tree 176

This tree has symptoms of minor drought stress. It has good health and excellent form.

This tree is too small to be protected by ordinance. It will be removed because it is growing within the footprint of the proposed parking lot expansion. It has an appraised value of \$2,075.04.
