6000 Condor Dr. Arborist Report

Prepared for HPA inc.
c/o Tammi Bailey
18831 Bardeen Ave. Suite 100
Irvine, CA 92612

Prepared by James Komen
BCMA WE-9909B
RCA #555

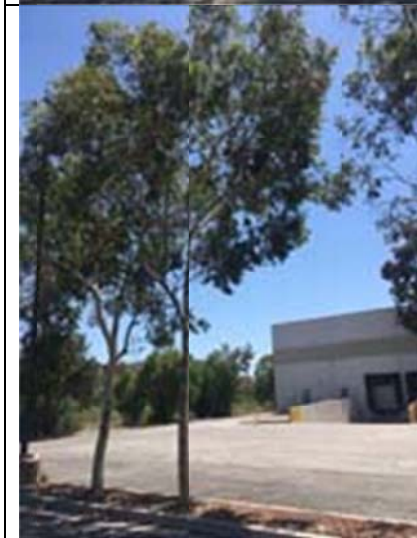
Tree 177

This tree has symptoms of minor drought stress. It has good health and excellent form.

This tree is too small to be protected by ordinance. It will be removed because it is growing within the footprint of the proposed parking lot expansion. It has an appraised value of \$3,552.84.

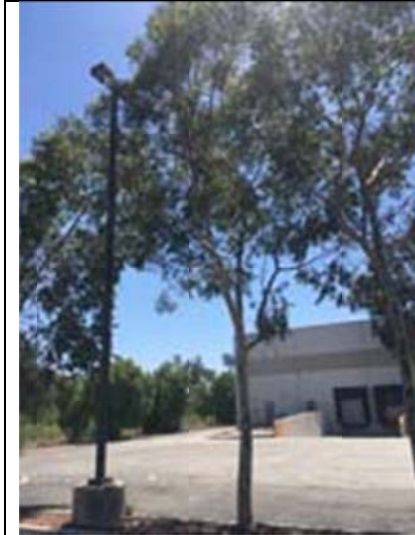
Tree 178

This tree has symptoms of minor drought stress. It has good health and excellent form.

This tree is too small to be protected by ordinance. It will be removed because it is growing within the footprint of the proposed parking lot expansion. It has an appraised value of \$3,341.73.

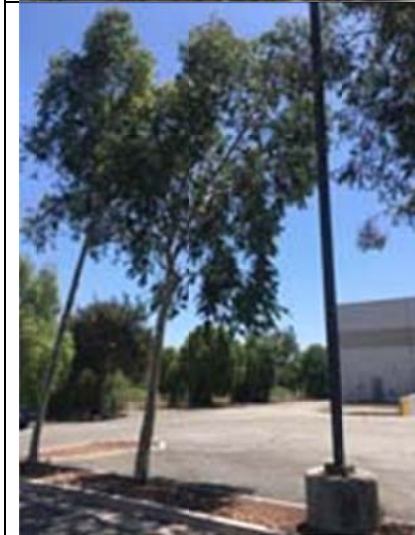
Tree 179

This tree has symptoms of minor drought stress. It has good health and excellent form.

This tree is too small to be protected by ordinance. It will be removed because it is growing within the footprint of the proposed parking lot expansion. It has an appraised value of \$3,341.73.

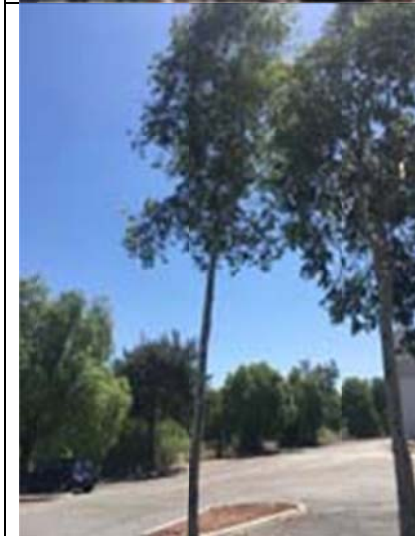
Tree 180

This tree has symptoms of minor drought stress. It has good health and excellent form.

This tree is too small to be protected by ordinance. It will be removed because it is growing within the footprint of the proposed parking lot expansion. It has an appraised value of \$2,761.16.

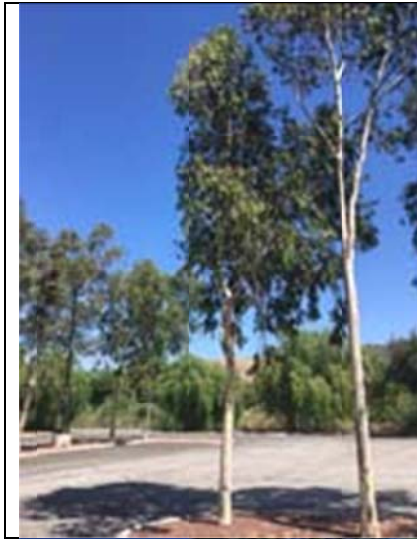
Tree 181

This tree has symptoms of minor drought stress. It has good health and good form.

This tree is too small to be protected by ordinance. It will be removed because it is growing within the footprint of the proposed parking lot expansion. It has an appraised value of \$1,718.78.

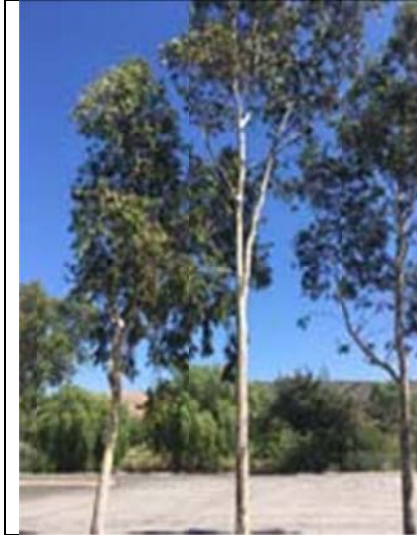
Tree 182

This tree has symptoms of minor drought stress. It also has co-dominant branches. It has good health and excellent form.

This tree is too small to be protected by ordinance. It will be removed because it is growing within the footprint of the proposed parking lot expansion. It has an appraised value of \$2,761.16.

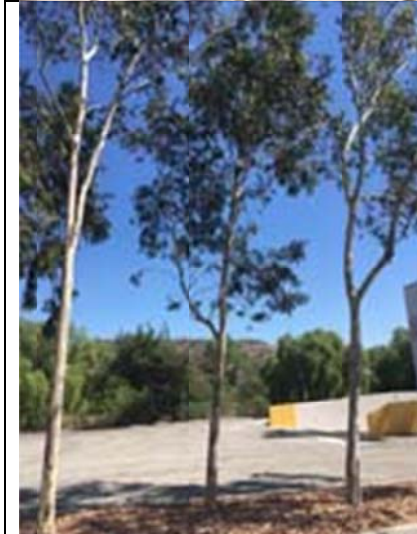
Tree 183

This tree has symptoms of minor drought stress. It has good health and excellent form.

This tree is too small to be protected by ordinance. It will be removed because it is growing within the footprint of the proposed parking lot expansion. It has an appraised value of \$2,075.04.

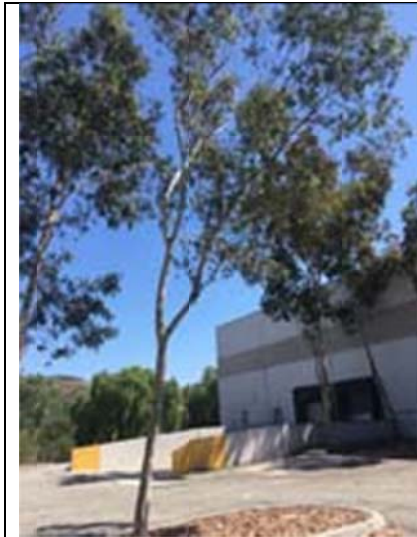
Tree 184

This tree has symptoms of minor drought stress. It has good health and good form.

This tree is too small to be protected by ordinance. It will be removed because it is growing within the footprint of the proposed parking lot expansion. It has an appraised value of \$2,437.89.

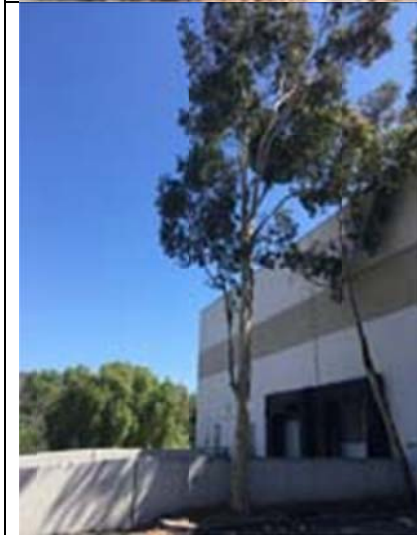
Tree 185

This tree has symptoms of minor drought stress. It has good health and good form.

This tree is a protected Mature Tree because it has a cumulative trunk area of more than 72 in². It will be removed because it is growing within the footprint of the proposed parking lot expansion. It has an appraised value of \$6,825.12.

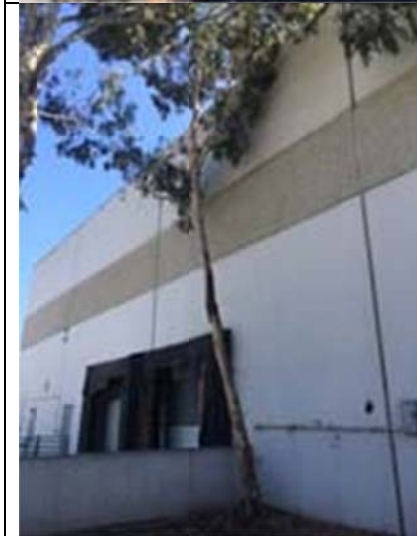
Tree 186

This tree has symptoms of minor drought stress. It has good health and good form.

This tree is too small to be protected by ordinance. It will be removed because it is growing within the footprint of the proposed parking lot expansion. It has an appraised value of \$3,915.69.

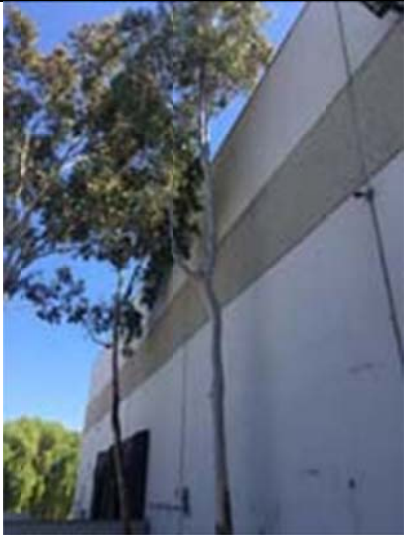
<p>Tree 187 <i>Corymbia citriodora</i> – Lemon Gum</p> <p>This tree is too small to be protected by ordinance. It will be removed because it is growing within the footprint of the proposed parking lot expansion. It has an appraised value of \$3,648.50.</p> <p>This tree has symptoms of minor drought stress. I observed a mechanical injury on its trunk. It has good health and good form.</p>

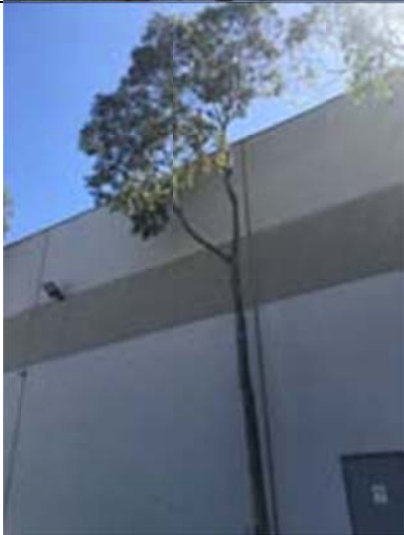
<p>Tree 188 <i>Corymbia citriodora</i> – Lemon Gum</p> <p>This tree is too small to be protected by ordinance. It will be removed because it is growing within the footprint of the proposed parking lot expansion. It has an appraised value of \$3,114.12.</p> <p>This tree has symptoms of minor drought stress. I observed a mechanical injury on its trunk. It has average health and good form.</p>

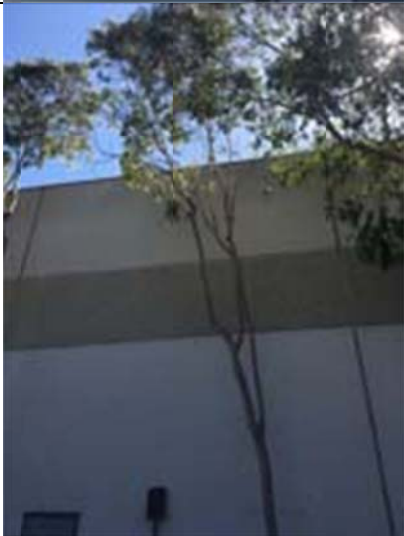
<p>Tree 189 <i>Corymbia citriodora</i> – Lemon Gum</p> <p>This tree is too small to be protected by ordinance. It will be removed because it is growing within the footprint of the proposed parking lot expansion. It has an appraised value of \$1,481.27.</p> <p>This tree has symptoms of minor drought stress. I observed a mechanical injury on its trunk. It has average health and good form.</p>

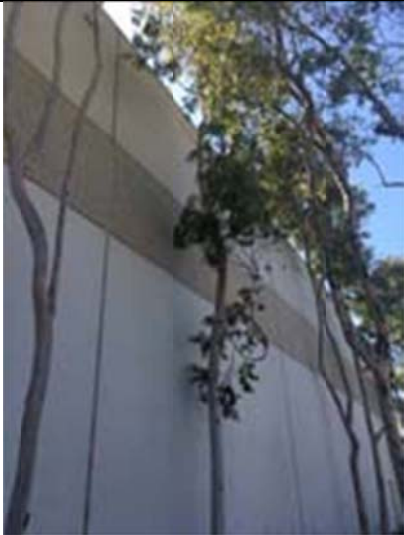
<p>Tree 190 <i>Corymbia citriodora</i> – Lemon Gum</p> <p>This tree is too small to be protected by ordinance. It will be removed because it is growing within the footprint of the proposed parking lot expansion. It has an appraised value of \$2,437.89.</p> <p>This tree has symptoms of minor drought stress. It has good health and good form.</p>

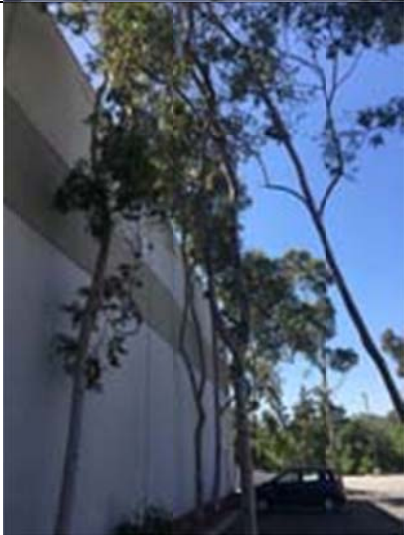
<p>Tree 191 <i>Corymbia citriodora</i> – Lemon Gum</p> <p>This tree is too small to be protected by ordinance. It will be removed because it is growing within the footprint of the proposed parking lot expansion. It has an appraised value of \$3,130.61.</p> <p>This tree has symptoms of minor drought stress. It has good health and good form.</p>

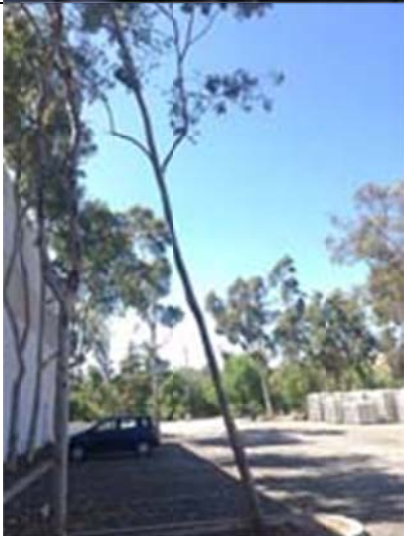
<p>Tree 192 <i>Corymbia citriodora</i> – Lemon Gum</p> <p>This tree is too small to be protected by ordinance. It will be removed because it is growing within the footprint of the proposed parking lot expansion. It has an appraised value of \$669.80.</p> <p>This tree has symptoms of minor drought stress. It has a prevailing lean. I observed a mechanical injury on its trunk. It has poor health and poor form.</p>

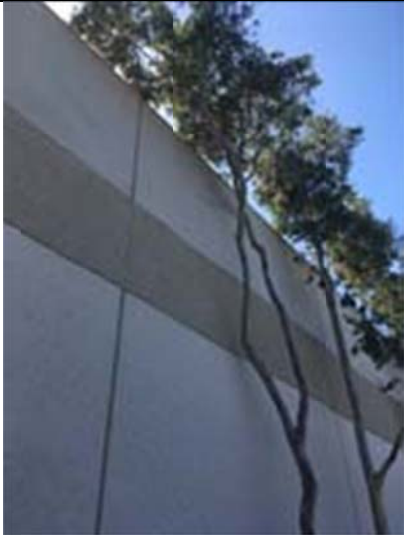
<p>Tree 193 <i>Corymbia citriodora</i> – Lemon Gum</p> <p>This tree is too small to be protected by ordinance. It will be removed because it is growing within the footprint of the proposed parking lot expansion. It has an appraised value of \$3,648.50.</p> <p>This tree has symptoms of minor drought stress. I observed a minor mechanical injury on its trunk. It has good health and good form.</p>

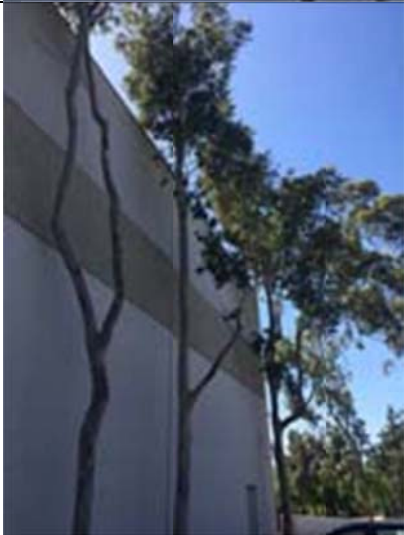
<p>Tree 194 <i>Corymbia citriodora</i> – Lemon Gum</p> <p>This tree is a protected Mature Tree because it has a cumulative trunk area of more than 72 in². It will be removed because it is growing within the footprint of the proposed parking lot expansion. It has an appraised value of \$4,793.14.</p> <p>This tree has symptoms of minor drought stress. It has good health and good form.</p>

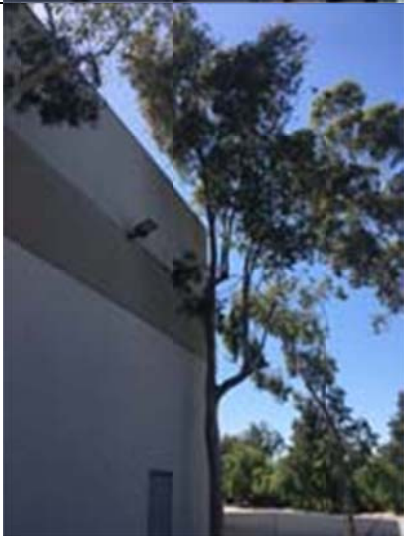
<p>Tree 195 <i>Corymbia citriodora</i> – Lemon Gum</p> <p>This tree is a protected Mature Tree because it has a cumulative trunk area of more than 72 in². It will be removed because it is growing within the footprint of the proposed parking lot expansion. It has an appraised value of \$7,979.66.</p> <p>This tree has symptoms of minor drought stress. It has good health and good form.</p>

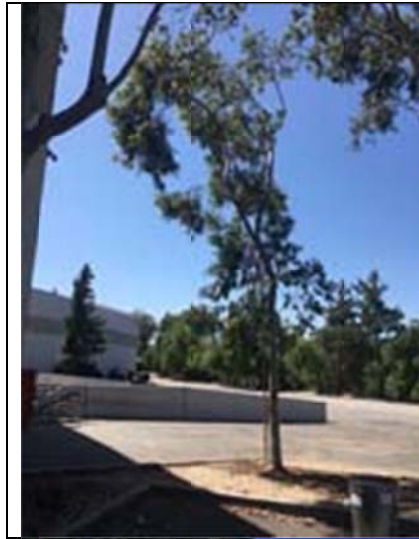
Tree 196

This tree has symptoms of minor drought stress. It has a prevailing lean. It has good health and average form.

This tree is too small to be protected by ordinance. It will be removed because it is growing within the footprint of the proposed parking lot expansion. It has an appraised value of \$1,758.36.

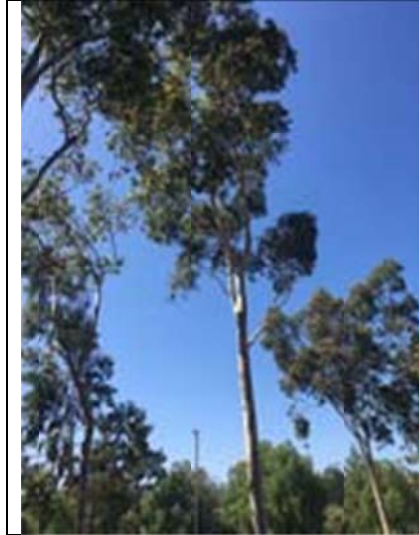
Tree 197

This tree has symptoms of minor drought stress. It has good health and excellent form.

This tree is too small to be protected by ordinance. It will be removed because it is growing within the footprint of the proposed parking lot expansion. It has an appraised value of \$4,450.08.

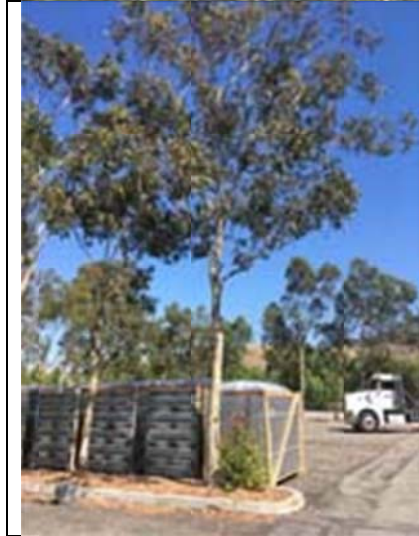
Tree 198

This tree has symptoms of minor drought stress. It has good health and excellent form.

This tree is too small to be protected by ordinance. It will be removed because it is growing within the footprint of the proposed parking lot expansion. It has an appraised value of \$3,552.84.

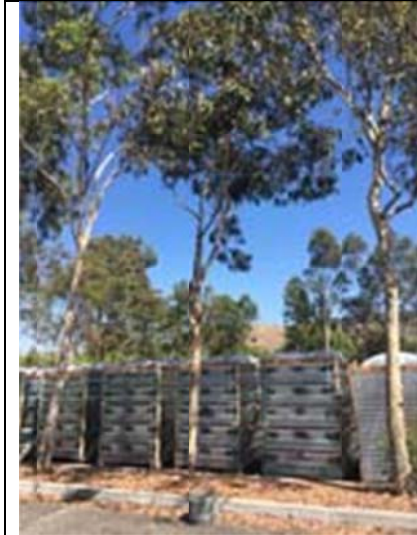
Tree 199

This tree has symptoms of minor drought stress. It has good health and excellent form.

This tree is too small to be protected by ordinance. It will be removed because it is growing within the footprint of the proposed parking lot expansion. It has an appraised value of \$2,075.04.

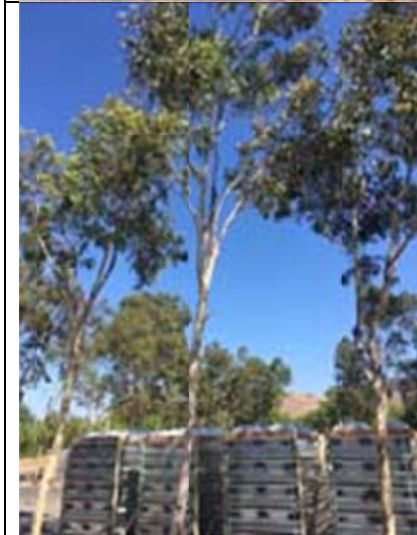
Tree 200

This tree has symptoms of minor drought stress. It has good health and good form.

This tree is too small to be protected by ordinance. It will be removed because it is growing within the footprint of the proposed parking lot expansion. It has an appraised value of \$2,437.89.

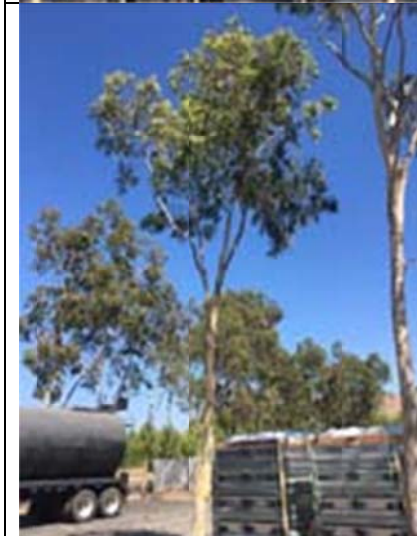
Tree 201

This tree has symptoms of minor drought stress. It has good health and good form.

This tree is too small to be protected by ordinance. It will be removed because it is growing within the footprint of the proposed parking lot expansion. It has an appraised value of \$2,437.89.

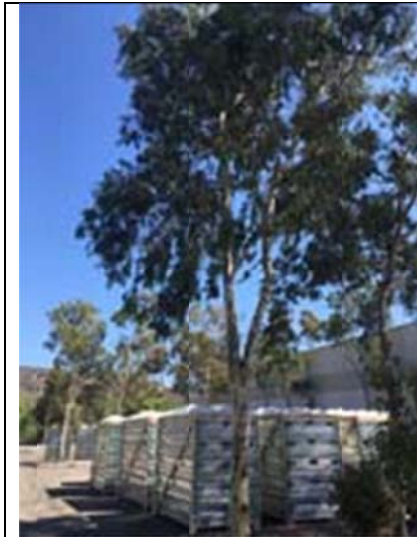
Tree 202

This tree has symptoms of minor drought stress. It has a co-dominant trunk defect. It has good health and average form.

This tree is a protected Mature Tree because it has a cumulative trunk area of more than 72 in². It will be removed because it is growing within the footprint of the proposed parking lot expansion. It has an appraised value of \$4,133.41.

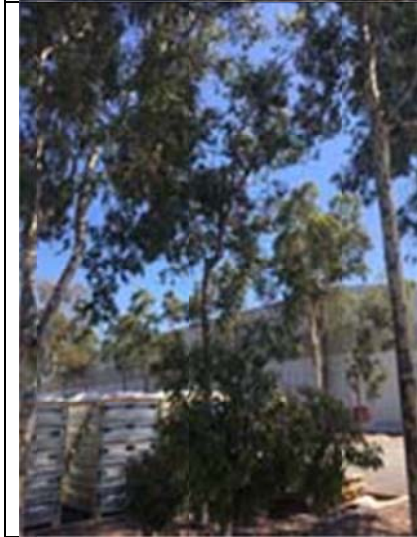
Tree 203

This tree has symptoms of minor drought stress. It has good health and good form.

This tree is too small to be protected by ordinance. It will be removed because it is growing within the footprint of the proposed parking lot expansion. It has an appraised value of \$1,837.53.

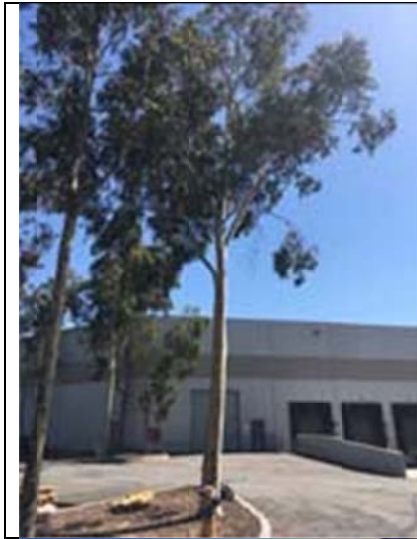
Tree 205

This tree is a protected Mature Tree because it has a cumulative trunk area of more than 72 in². It will be removed because it is growing within the footprint of the proposed parking lot expansion. It has an appraised value of \$7,979.66.

This tree has symptoms of minor drought stress. It has good health and good form.

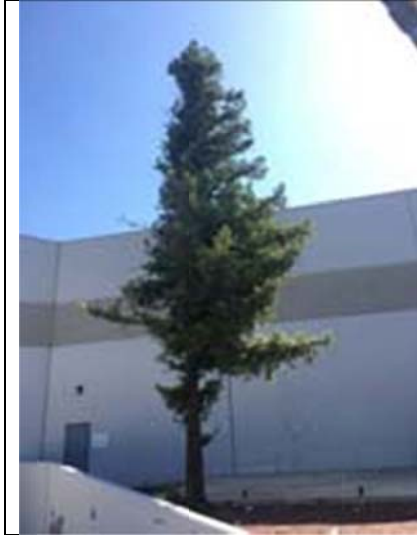
Tree 206

This tree is a protected Mature Tree because it has a cumulative trunk area of more than 72 in². It will be removed because it is growing within the footprint of the proposed parking lot expansion. It has an appraised value of \$798.45.

This tree has symptoms of drought stress. It has average health and average form.

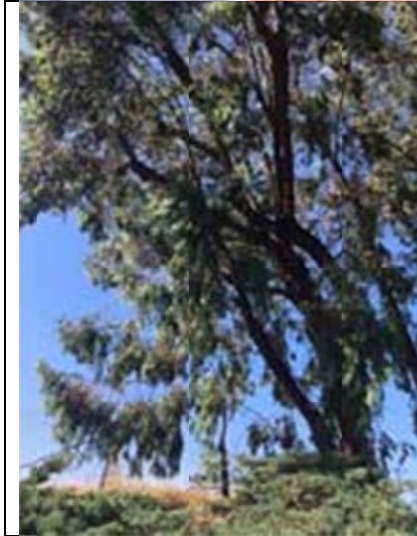
Tree 207

This tree is a prohibited species in Moorpark. It will be removed.

This tree has a prevailing lean, but it is still vigorous. It has excellent health and average form.

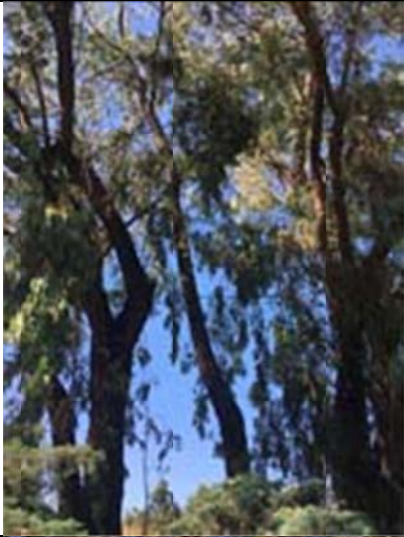
<p>Tree 208 <i>Eucalyptus sideroxylon</i> – Red Ironbark</p> <p>This tree is a prohibited species in Moorpark. It will be removed.</p> <p>This tree has been partially suppressed by competition with its neighbors. It has good health and good form.</p>

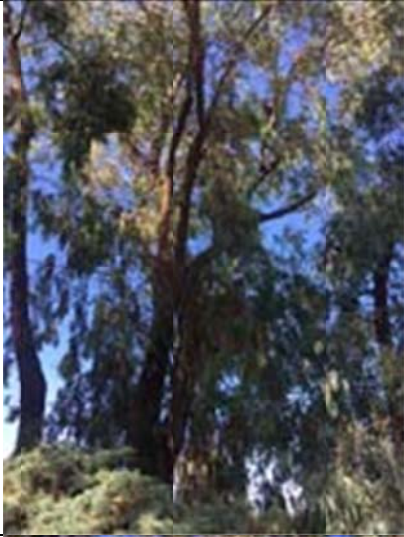
<p>Tree 209 <i>Eucalyptus sideroxylon</i> – Red Ironbark</p> <p>This tree is a prohibited species in Moorpark. It will be removed.</p> <p>This tree has excellent health and excellent form.</p>

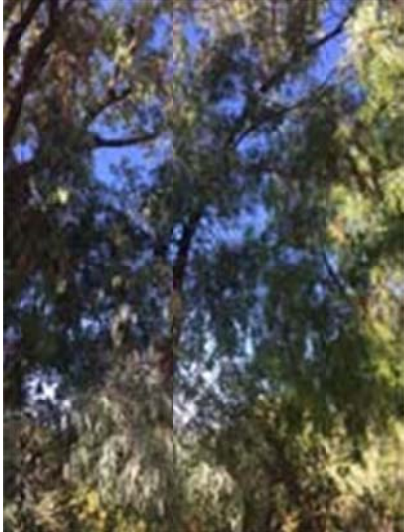
<p>Tree 210 <i>Eucalyptus sideroxylon</i> – Red Ironbark</p> <p>This tree is a prohibited species in Moorpark. It will be removed.</p> <p>This tree has been partially suppressed by competition. It has good health and average form.</p>

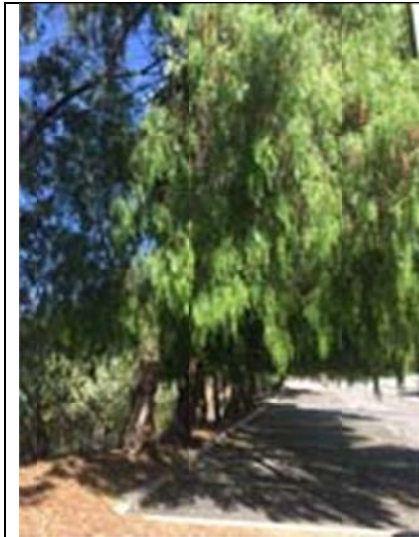
Tree 211

This tree is a prohibited species in Moorpark. It will be removed.

This tree has a prevailing lean. It has excellent health and good form.

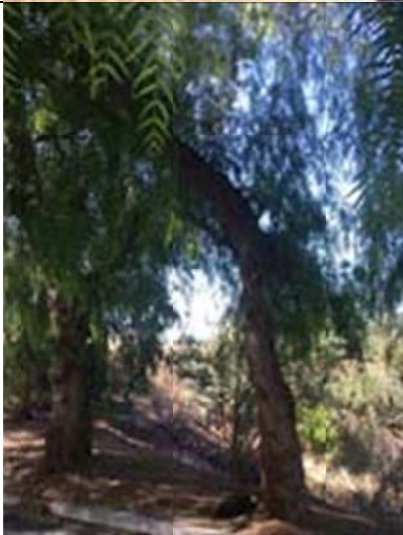
Tree 212

This tree is a prohibited species in Moorpark. It will be removed.

This tree has a prevailing lean. It has excellent health and good form.

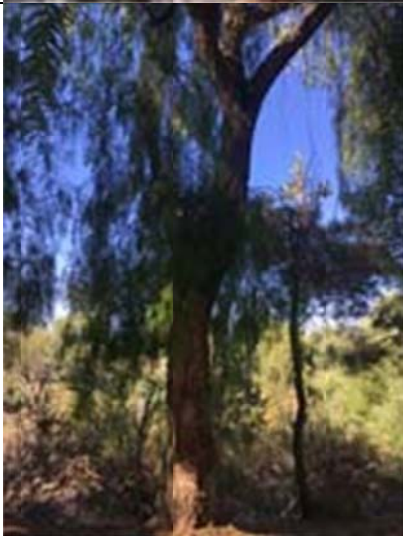
Tree 213

This tree is a prohibited species in Moorpark. It will be removed.

This tree has excellent health and excellent form.

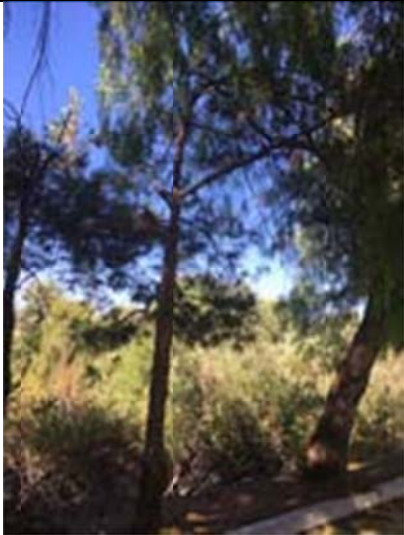
<p>Tree 214 <i>Pinus eldarica</i> – Mondell Pine</p> <p>This tree is too small to be protected by ordinance. It will be removed because it is growing within the footprint of the proposed grading. It has an appraised value of \$1,129.42.</p> <p>This tree has been suppressed by competition with its neighbors. It has average health and average form.</p>

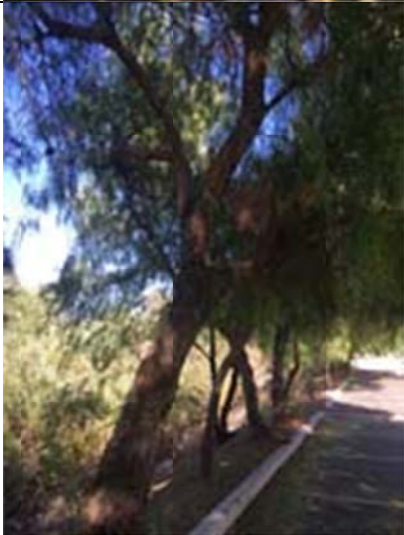
<p>Tree 215 <i>Schinus molle</i> – California Pepper</p> <p>This tree is a prohibited species in Moorpark. It will be removed.</p> <p>This tree has excellent health and excellent form.</p>

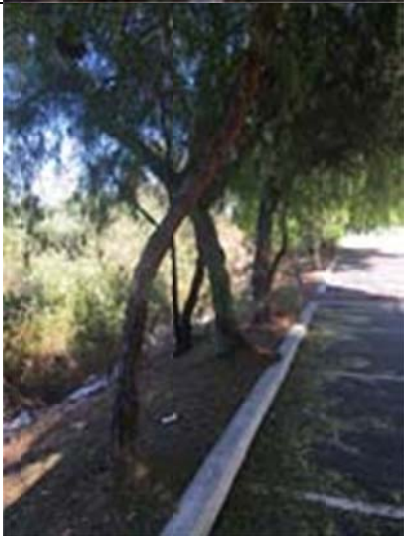
<p>Tree 216 <i>Pinus eldarica</i> – Mondell Pine</p> <p>This tree is too small to be protected by ordinance. It will be removed because it is growing within the footprint of the proposed grading. It has an appraised value of \$540.21.</p> <p>This tree has been suppressed by competition with its neighbors. It has poor health and poor form.</p>

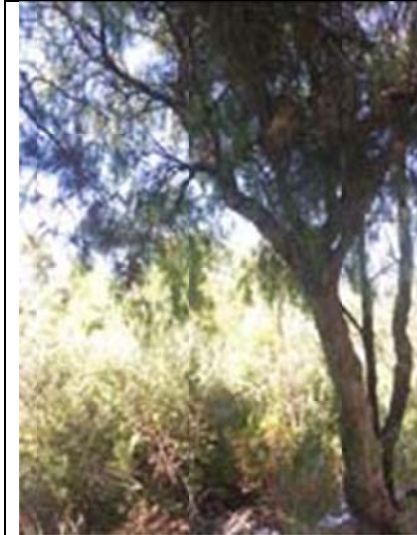
Tree 217

This tree is a prohibited species in Moorpark. It will be removed.

This tree has excellent health and good form.

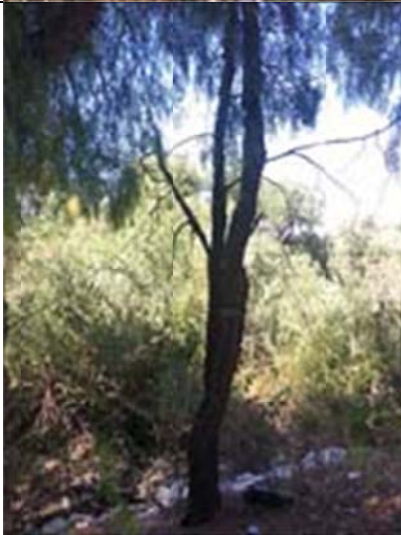
Tree 218

This tree is a prohibited species in Moorpark. It will be removed.

It is nearly dead.

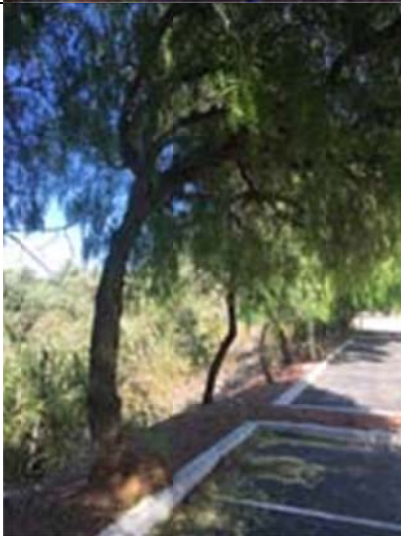
Tree 219

This tree is a prohibited species in Moorpark. It will be removed.

This tree has excellent health and excellent form.

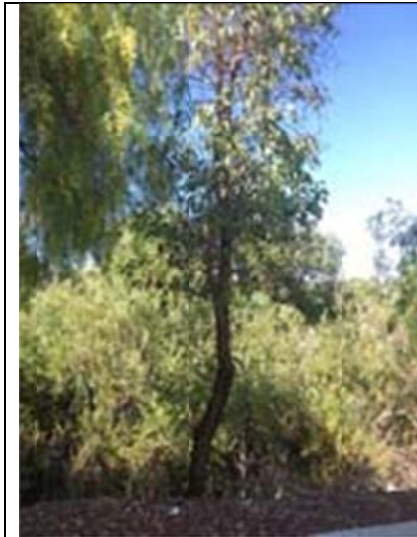
Tree 220

This tree is a prohibited species in Moorpark. It will be removed.

This tree has excellent health and excellent form.

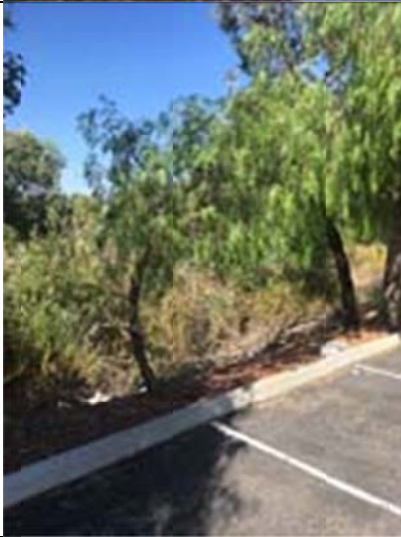
Tree 221

This tree is a prohibited species in Moorpark. It will be removed.

This tree has a bent trunk. It has excellent health and average form.

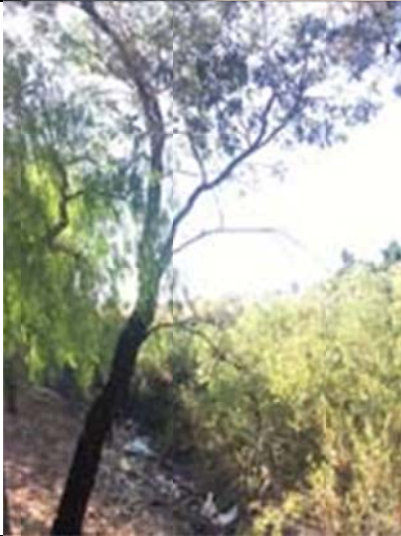
Tree 222

This tree is a prohibited species in Moorpark. It will be removed.

This tree has symptoms of drought stress, and there is deadwood in its canopy. It has average health and average form.

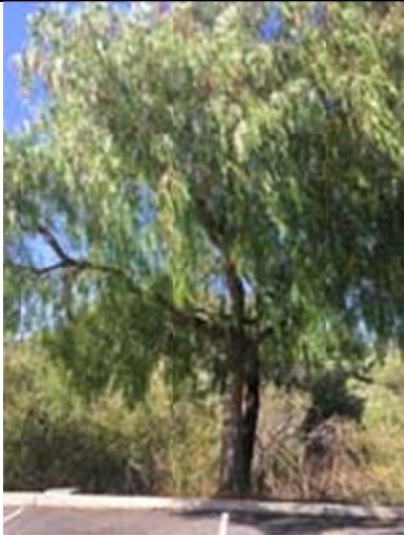
<p>Tree 223 <i>Schinus molle</i> – California Pepper</p> <p>This tree is a prohibited species in Moorpark. It will be removed.</p> <p>This tree has excellent health and excellent form.</p>

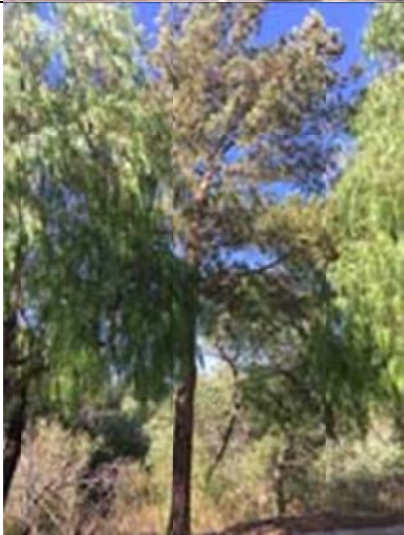
<p>Tree 224 <i>Pinus eldarica</i> – Mondell Pine</p> <p>This tree is a protected Mature Tree because it has a cumulative trunk area of more than 72 in². It will be removed because it is growing within the footprint of the proposed grading. It has an appraised value of \$4,206.92.</p> <p>This tree has symptoms of heat and drought stress. It has average health and good form.</p>

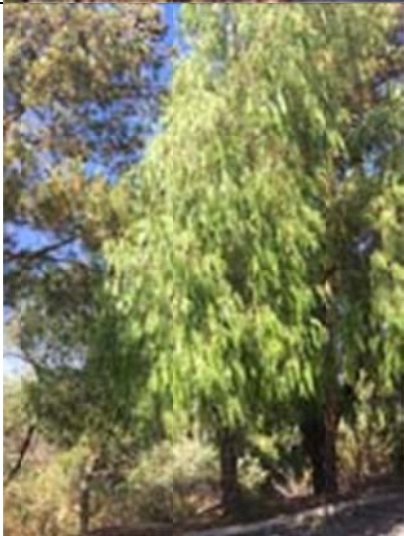
<p>Tree 225 <i>Schinus molle</i> – California Pepper</p> <p>This tree is a prohibited species in Moorpark. It will be removed.</p> <p>This tree has excellent health and excellent form.</p>

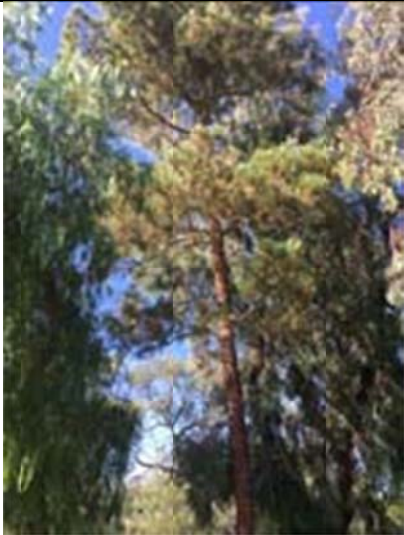
<p>Tree 226 <i>Pinus eldarica</i> – Mondell Pine</p> <p>This tree is a protected Mature Tree because it has a cumulative trunk area of more than 72 in². It will be removed because it is growing within the footprint of the proposed grading. It has an appraised value of \$3,340.15.</p> <p>This tree has symptoms of heat and drought stress. It has good health and good form.</p>

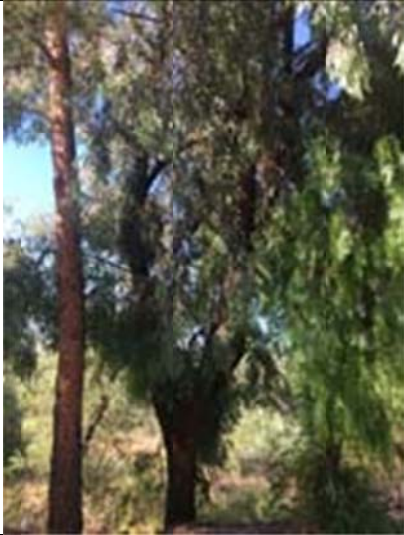
<p>Tree 227 <i>Eucalyptus sideroxylon</i> – Red Ironbark</p> <p>This tree is a prohibited species in Moorpark. It will be removed.</p> <p>This tree has excellent health and good form.</p>

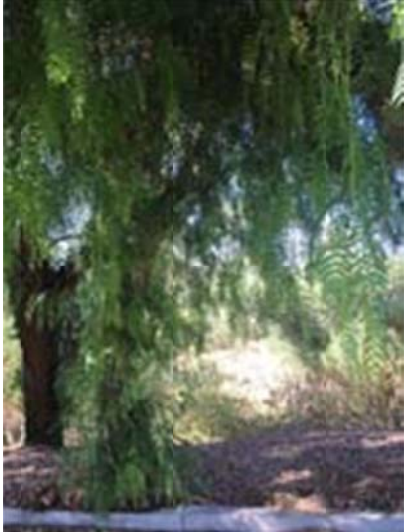
<p>Tree 228 <i>Schinus molle</i> – California Pepper</p> <p>This tree is a prohibited species in Moorpark. It will be removed.</p> <p>This tree has a prevailing lean. It has excellent health and good form.</p>

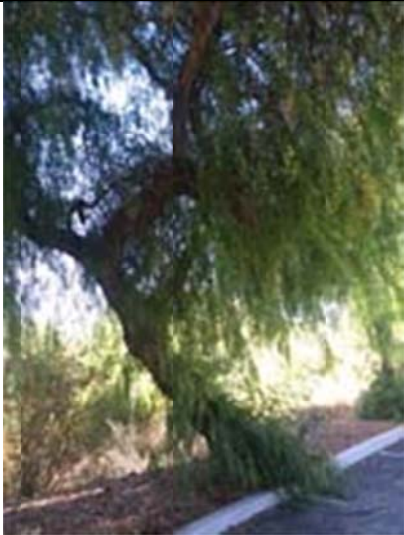
<p>Tree 229 <i>Schinus molle</i> – California Pepper</p> <p>This tree is a prohibited species in Moorpark. It will be removed.</p> <p>This tree has strong lean, but it is still healthy. It has excellent health and average form.</p>

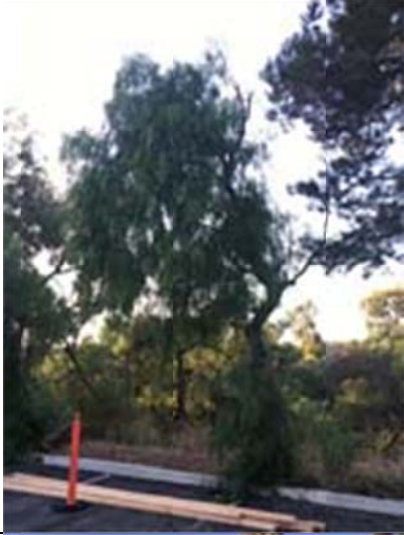
<p>Tree 230 <i>Schinus molle</i> – California Pepper</p> <p>This tree is a prohibited species in Moorpark. It will be removed.</p> <p>This tree has bark loss, but it is still vigorous. It has good health and good form.</p>

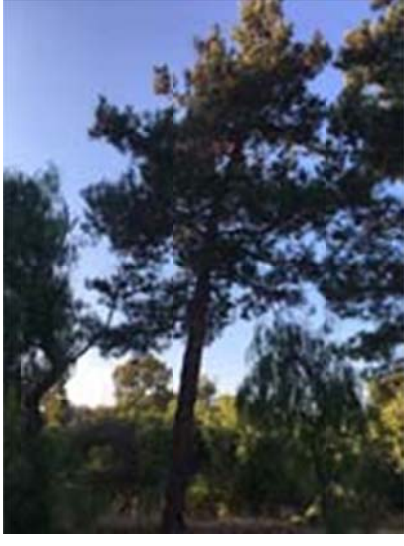
<p>Tree 231 <i>Pinus eldarica</i> – Mondell Pine</p> <p>This tree is a protected Mature Tree because it has a cumulative trunk area of more than 72 in². It will be retained in the landscape. It has an appraised value of \$6,855.91.</p> <p>This tree has symptoms of heat and drought stress. It has good health and excellent form. I recommend supplying supplemental irrigation.</p> <p>The proposed asphalt resurfacing will encroach within the critical root zone of this tree. All project activity within the drip line of this tree should be directly supervised by a Certified Arborist. This tree is intended to be retained in place throughout the project even though some of its roots may be impacted.</p>

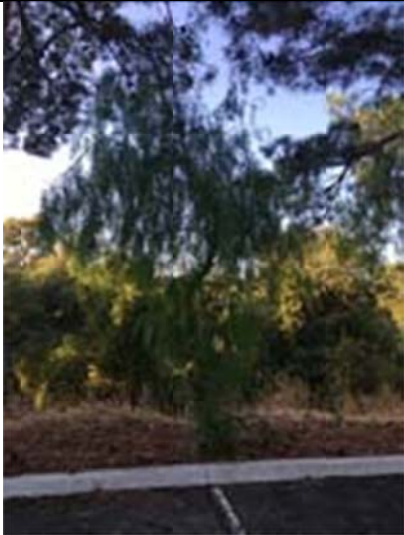
<p>Tree 232 <i>Schinus molle</i> – California Pepper</p> <p>This tree is a prohibited species in Moorpark. It will be removed.</p> <p>This tree has excellent health and excellent form.</p>

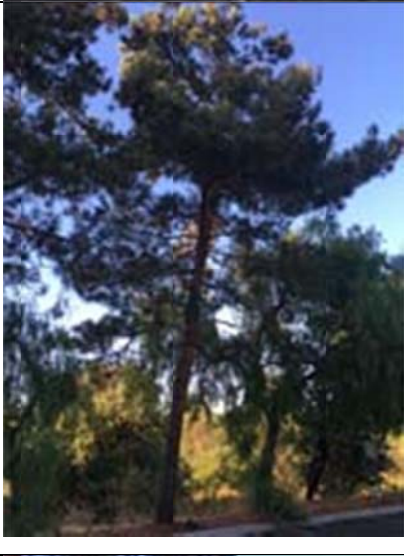
<p>Tree 233 <i>Pinus eldarica</i> – Mondell Pine</p> <p>This tree is a protected Mature Tree because it has a cumulative trunk area of more than 72 in². It will be retained in the landscape. It has an appraised value of \$5,935.58.</p> <p>This tree has symptoms of heat and drought stress. It has good health and excellent form. I recommend supplying supplemental irrigation.</p> <p>The proposed asphalt resurfacing will encroach within the critical root zone of this tree. All project activity within the drip line of this tree should be directly supervised by a Certified Arborist. This tree is intended to be retained in place throughout the project even though some of its roots may be impacted.</p>

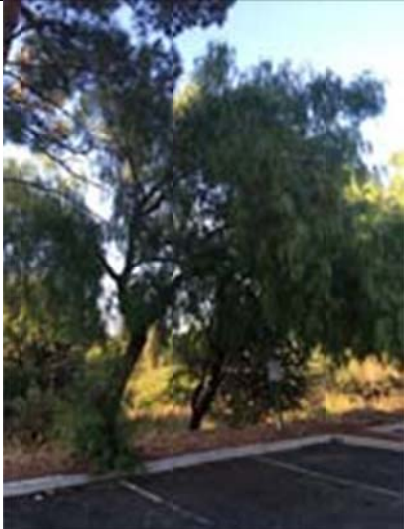
<p>Tree 234 <i>Schinus molle</i> – California Pepper</p> <p>This tree is a prohibited species in Moorpark. It will be removed.</p> <p>This tree has excellent health and excellent form.</p>

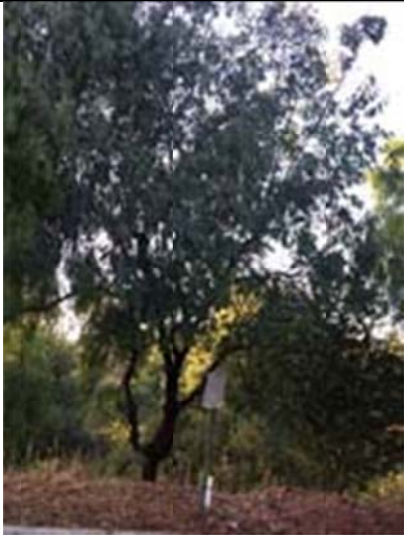
<p>Tree 235 <i>Eucalyptus sideroxylon</i> – Red Ironbark</p> <p>This tree is a prohibited species in Moorpark. It will be removed.</p> <p>This tree has been partially suppressed by competition with its neighbors. It has good health and good form.</p>

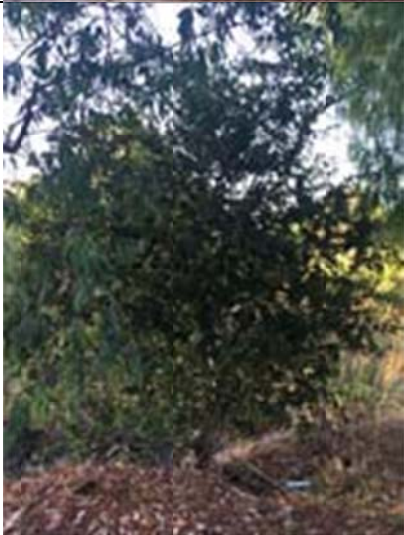
<p>Tree 236 <i>Quercus agrifolia</i> – Coast Live Oak</p> <p>This is a protected Native Oak Tree. It will be retained in the landscape. It has an appraised value of \$759.34.</p> <p>This tree has a healthy canopy and a twisted trunk. It has excellent health and good form. No treatment is recommended.</p>

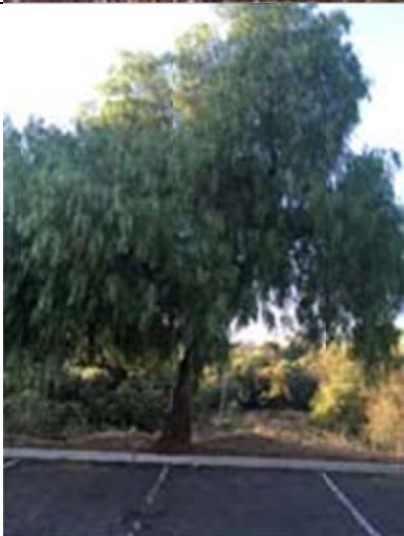
<p>Tree 237 <i>Schinus molle</i> – California Pepper</p> <p>This tree is a prohibited species in Moorpark. It will be removed.</p> <p>This tree has excellent health and good form.</p>

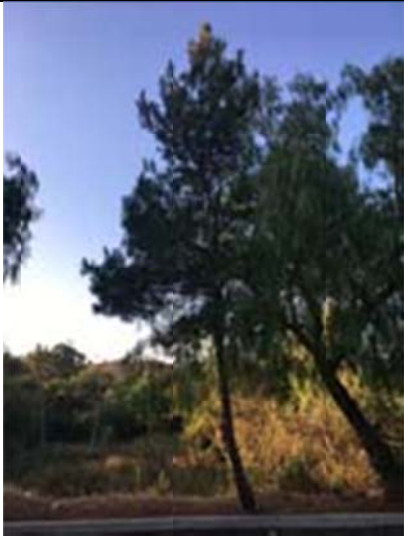
<p>Tree 238 <i>Pinus eldarica</i> – Mondell Pine</p> <p>This tree is too small to be protected by ordinance. It will be retained in the landscape. It has an appraised value of \$905.42.</p> <p>This tree has symptoms of heat and drought stress. It also has a corrected lean. It has good health and good form. I recommend supplying supplemental irrigation.</p> <p>The proposed asphalt resurfacing will encroach within the critical root zone of this tree. All project activity within the drip line of this tree should be directly supervised by a Certified Arborist. This tree is intended to be retained in place throughout the project even though some of its roots may be impacted.</p>

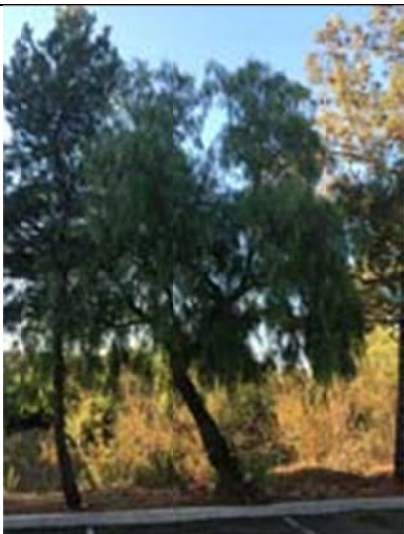
<p>Tree 239 <i>Schinus molle</i> – California Pepper</p> <p>This tree is a prohibited species in Moorpark. It will be removed.</p> <p>This tree has excellent health and good form.</p>

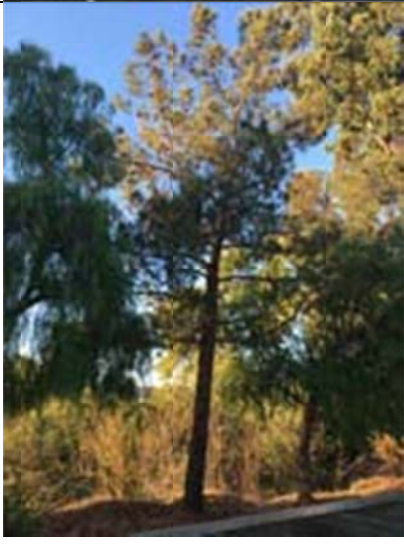
<p>Tree 240 <i>Pinus eldarica</i> – Mondell Pine</p> <p>This tree is a protected Mature Tree because it has a cumulative trunk area of more than 72 in². It will be retained in the landscape. It has an appraised value of \$4,152.14.</p> <p>This tree has symptoms of heat and drought stress. It has good health and good form. I recommend supplying supplemental irrigation.</p> <p>The proposed asphalt resurfacing will encroach within the critical root zone of this tree. All project activity within the drip line of this tree should be directly supervised by a Certified Arborist. This tree is intended to be retained in place throughout the project even though some of its roots may be impacted.</p>

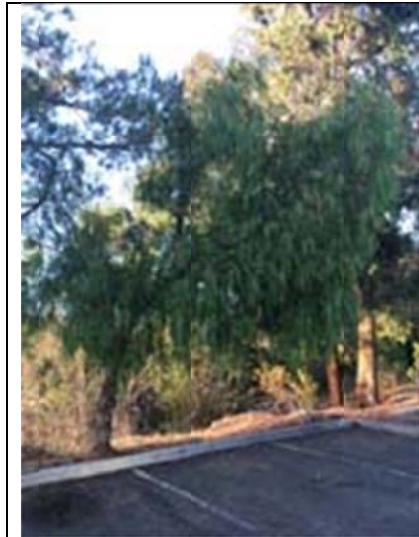
Tree 241

This tree is a prohibited species in Moorpark. It will be removed.

This tree has excellent health and good form.

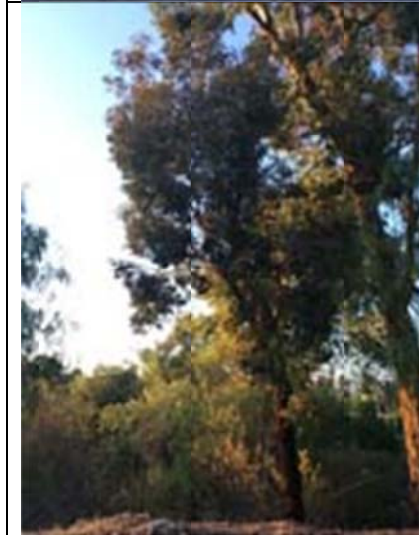
Tree 242

This tree is a prohibited species in Moorpark. It will be removed.

This tree has been partially suppressed by competition. It has excellent health and good form.

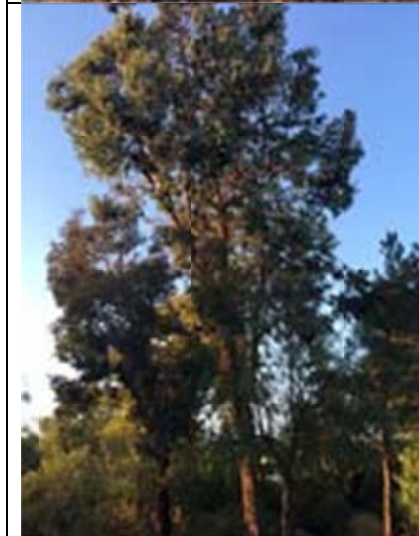
Tree 243

This tree is a prohibited species in Moorpark. It will be removed.

This tree has some co-dominant branches. It has excellent health and good form.

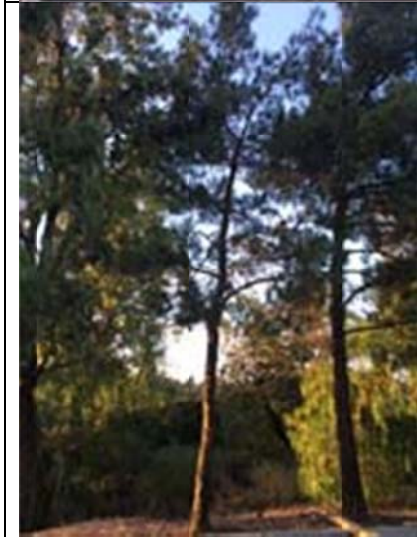
Tree 245

This tree has symptoms of heat and drought stress, and it is leaning. It has good health and good form. I recommend supplying supplemental irrigation.

The proposed landscaped area expansion will encroach within the critical root zone of this tree. All project activity within the drip line of this tree should be directly supervised by a Certified Arborist. This tree is intended to be retained in place throughout the project even though some of its roots may be impacted.

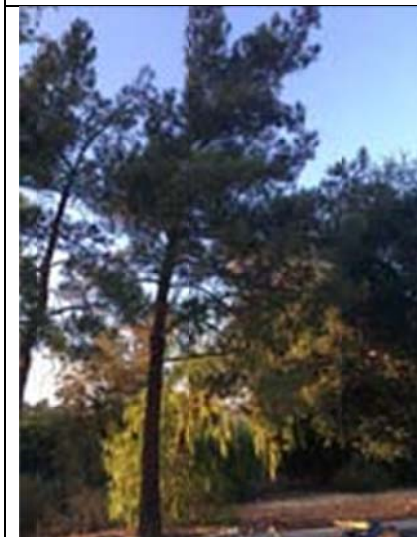
Tree 246

This tree has symptoms of heat and drought stress, and it is leaning. It has good health and good form. I recommend supplying supplemental irrigation.

The proposed landscaped area expansion will encroach within the critical root zone of this tree. All project activity within the drip line of this tree should be directly supervised by a Certified Arborist. This tree is intended to be retained in place throughout the project even though some of its roots may be impacted.

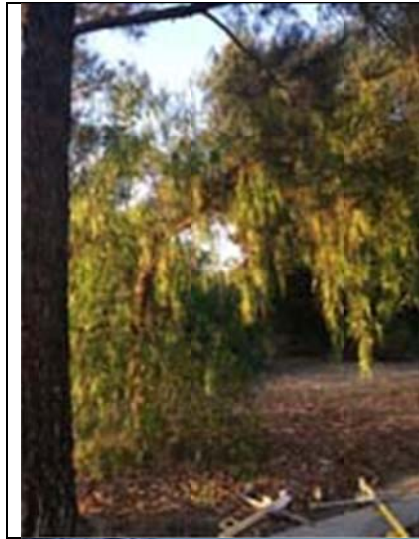
Tree 247

This tree is a prohibited species in Moorpark. It will be removed.

This tree has been partially suppressed by competition. It has good health and good form.

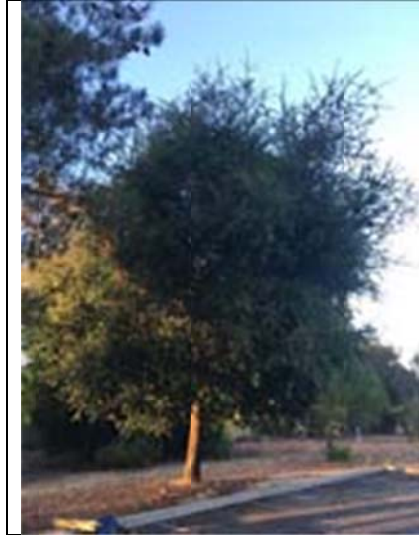
Tree 248

This is a protected Native Oak Tree. It will be removed because it is growing within the footprint of the proposed parking lot expansion. It has an appraised value of \$7,581.46.

This tree has excellent health and excellent form.

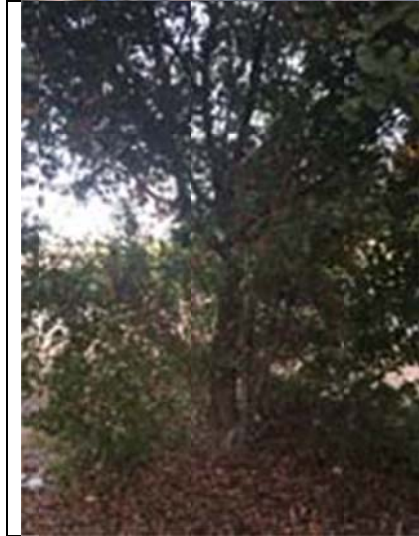
Tree 249

This is a protected Native Oak Tree. It will be removed because it is growing within the footprint of the proposed parking lot expansion. It has an appraised value of \$2,044.88.

This tree has substantial trunk bark loss. It also has a secondary trunk that is competing with its central leader. This tree has good health and good form.

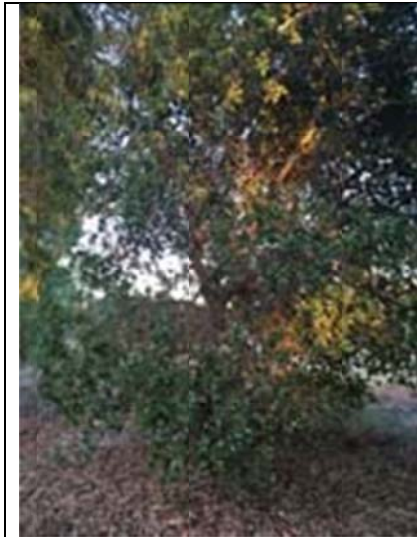
Tree 250

This is a protected Native Oak Tree. It will be removed because it is growing within the footprint of the proposed parking lot expansion. It has an appraised value of \$2,979.81.

This tree has excellent health and excellent form.

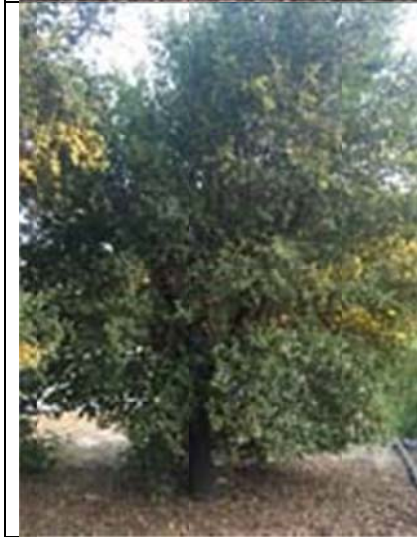
Tree 251

This is a protected Native Oak Tree. It will be removed because it is growing within the footprint of the proposed parking lot expansion. It has an appraised value of \$5,477.85.

This tree has excellent health and excellent form.

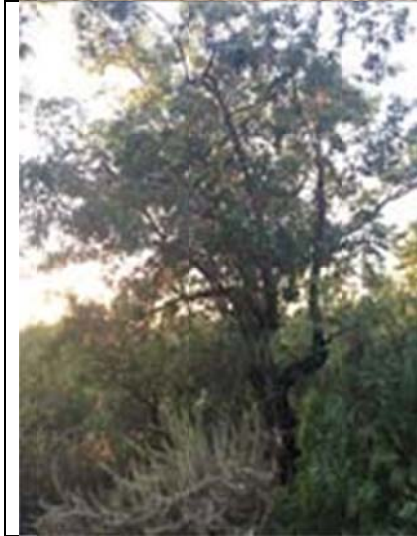
Tree 252

This tree is a prohibited species in Moorpark. It will be removed.

This tree has bark loss, drought stress, and tip dieback. It has average health and good form.

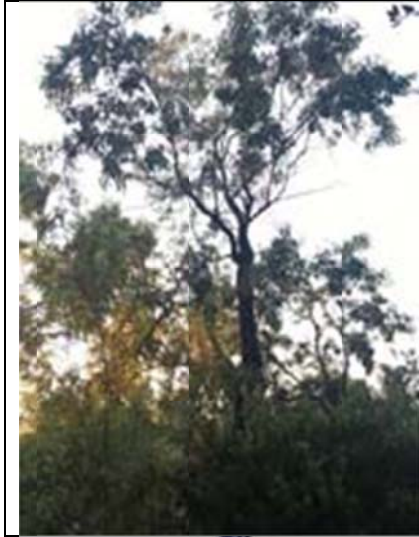
Tree 253

This tree is a prohibited species in Moorpark. It will be removed.

This tree has symptoms of drought stress, and there is deadwood in its canopy. It has average health and good form.
