6000 Condor Dr. Arborist Report

Prepared for HPA inc.
c/o Tammi Bailey
18831 Bardeen Ave. Suite 100
Irvine, CA 92612

Prepared by James Komen
BCMA WE-9909B
RCA #555

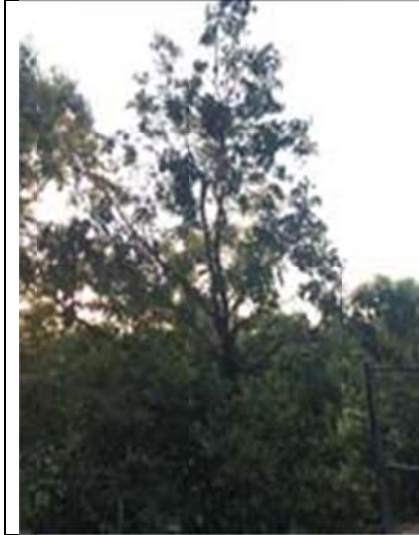
Tree 254

This tree is a prohibited species in Moorpark. It will be removed.

This tree has drought stress and co-dominant trunks. It has good health and good form.

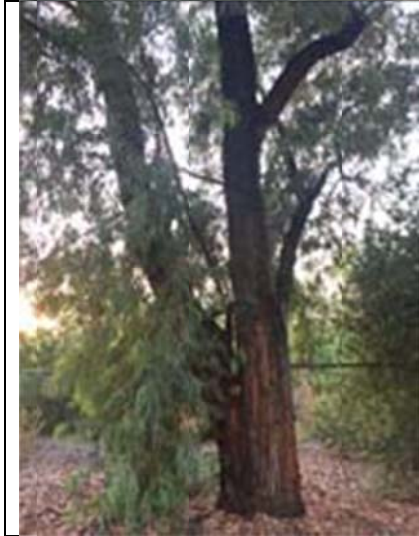
Tree 255

This tree is a prohibited species in Moorpark. It will be removed.

This tree has co-dominant trunks. It has excellent health and good form.

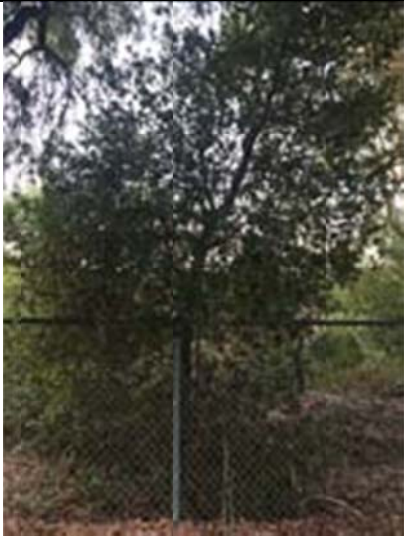
<p>Tree OP256 <i>Quercus agrifolia</i> – Coast Live Oak</p> <p>This is a protected Native Oak Tree. It is growing on an adjacent property. It will be retained in the landscape. It has an appraised value of \$1,752.71.</p> <p>This tree has excellent health and excellent form. No treatment is recommended.</p> <p>The proposed parking lot expansion will encroach within the critical root zone of this tree. All project activity within the drip line of this tree should be directly supervised by a Certified Arborist. This tree is intended to be retained in place throughout the project even though some of its roots may be impacted.</p>

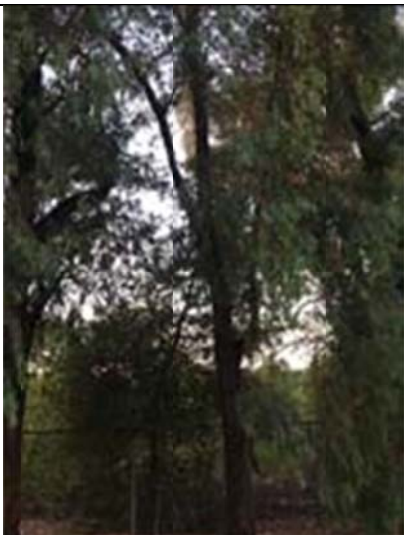
<p>Tree 257 <i>Eucalyptus sideroxylon</i> – Red Ironbark</p> <p>This tree is a prohibited species in Moorpark. It will be removed.</p> <p>This tree has co-dominant branches, and it has a history of suppression by competition with its neighbors. Despite this, it has good health and good form.</p>

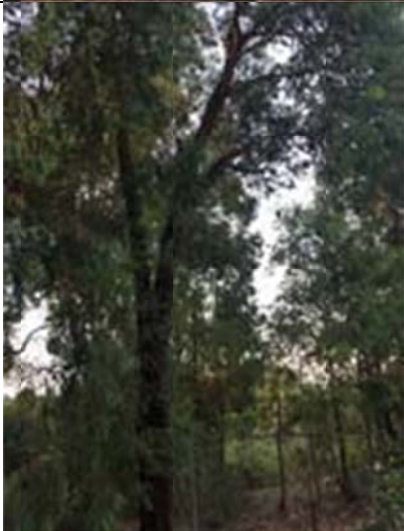
<p>Tree 258 <i>Eucalyptus sideroxylon</i> – Red Ironbark</p> <p>This tree is a prohibited species in Moorpark. It will be removed.</p> <p>This tree has co-dominant trunks. It has excellent health and average form.</p>

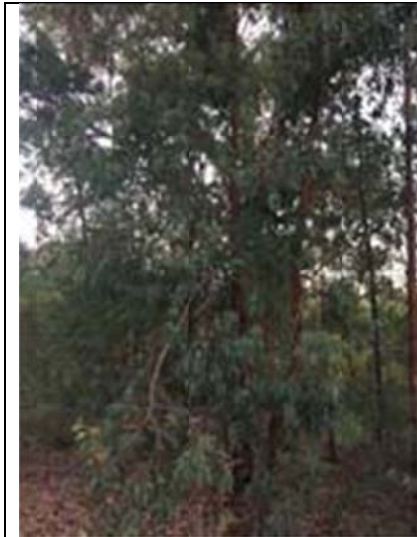
Tree 259

This tree is a prohibited species in Moorpark. It will be removed.

This tree has co-dominant trunks. It has good health and average form.

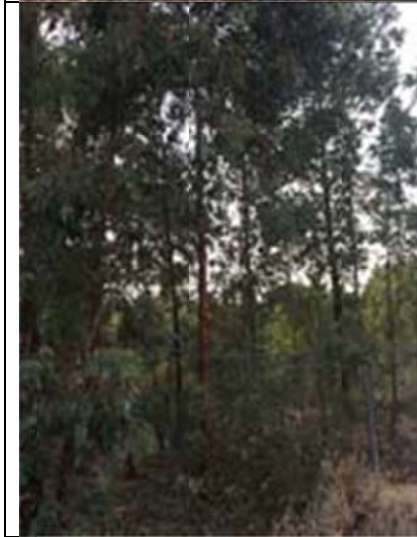
Tree 260

This tree is a prohibited species in Moorpark. It will be removed.

This tree has been partially suppressed by competition. It has average health and average form.

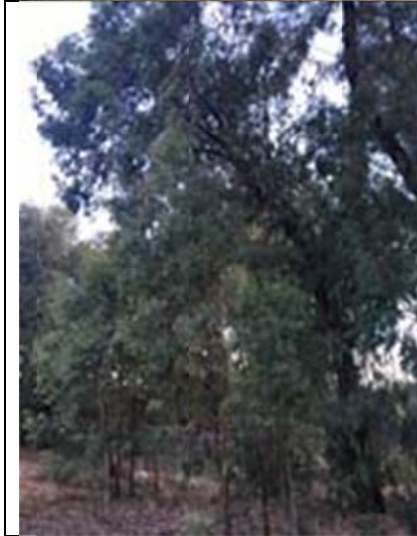
Tree 261

This tree is a prohibited species in Moorpark. It will be removed.

This tree has excellent health and good form.

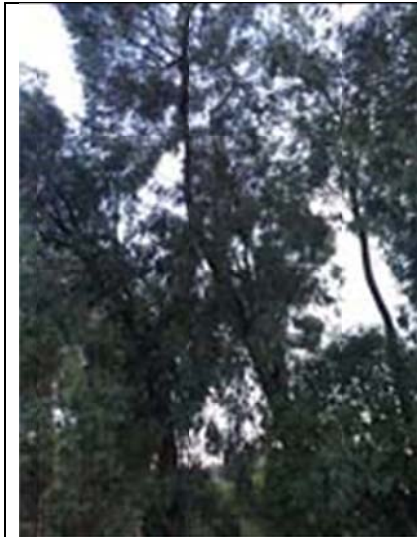
Tree 262

This tree is a prohibited species in Moorpark. It will be removed.

This tree has had a recent co-dominant branch failure. Despite this, it has excellent health and good form.

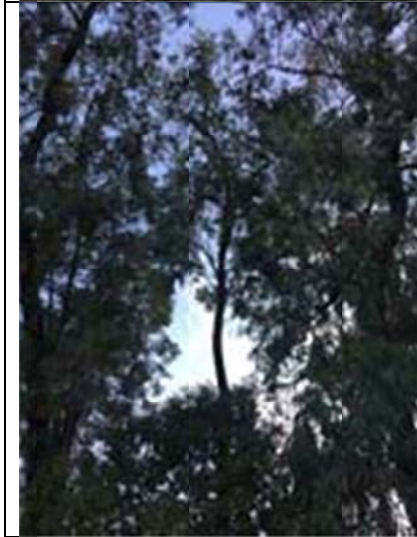
Tree 263

This tree is a prohibited species in Moorpark. It will be removed.

This tree has been suppressed by competition with its neighbors. It has good health and average form.

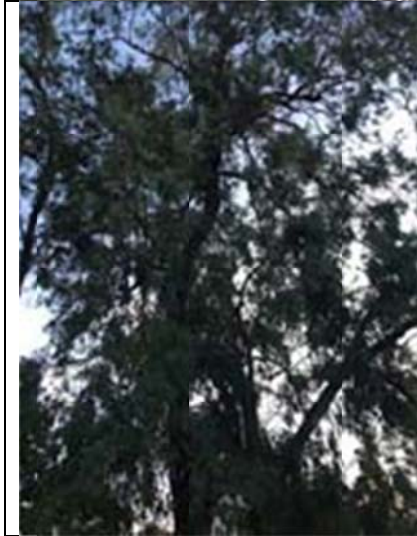
Tree 264

This tree is a prohibited species in Moorpark. It will be removed.

This tree has excellent health and excellent form.

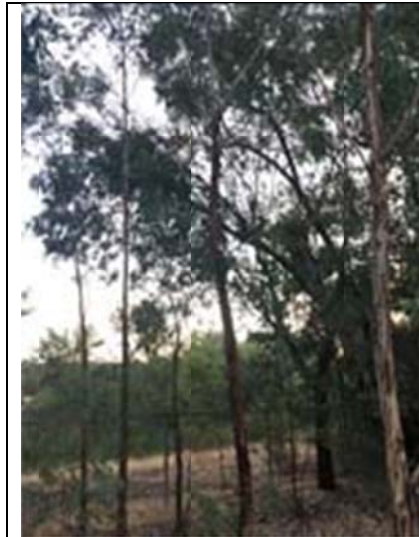
Tree 265

This tree is a prohibited species in Moorpark. It will be removed.

This tree has sap exudation, stressed. It has poor health and average form.

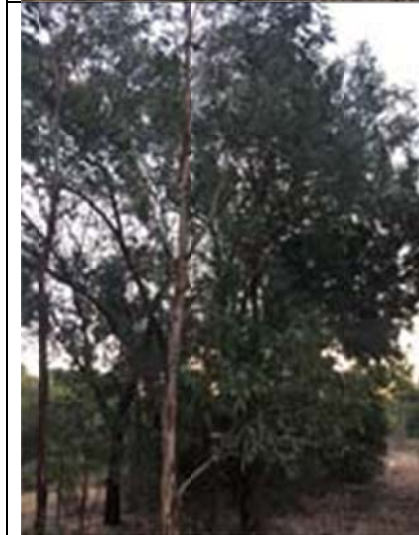
Tree 266

This tree is a prohibited species in Moorpark. It will be removed.

This tree has symptoms of drought stress, and there is deadwood in its canopy. It has average health and average form.

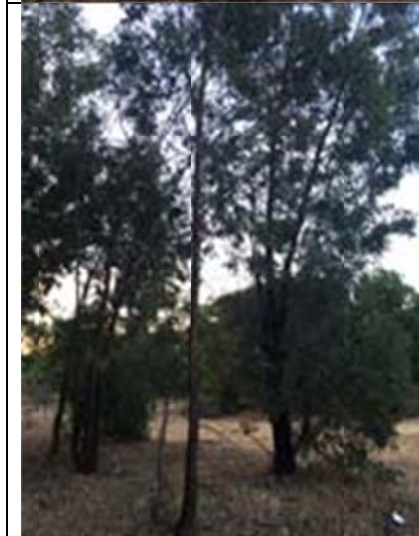
Tree 267

This tree is a prohibited species in Moorpark. It will be removed.

This tree has symptoms of drought stress, and there is deadwood in its canopy. It has good health and good form.

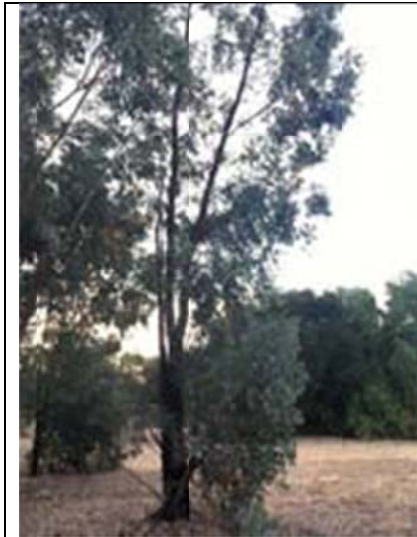
Tree 268

This tree is a prohibited species in Moorpark. It will be removed.

This tree has co-dominant trunks. It has good health and average form.

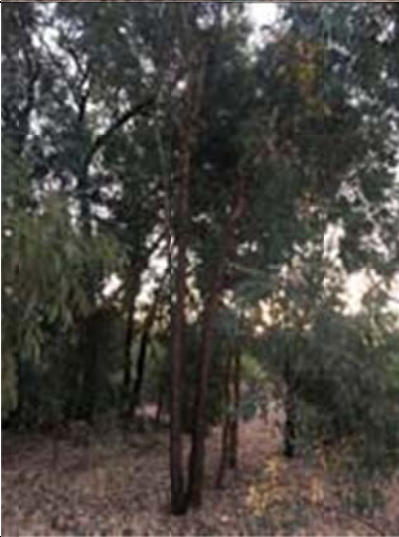
Tree 269

This tree is a prohibited species in Moorpark. It will be removed.

This tree has co-dominant trunks. It has good health and average form.

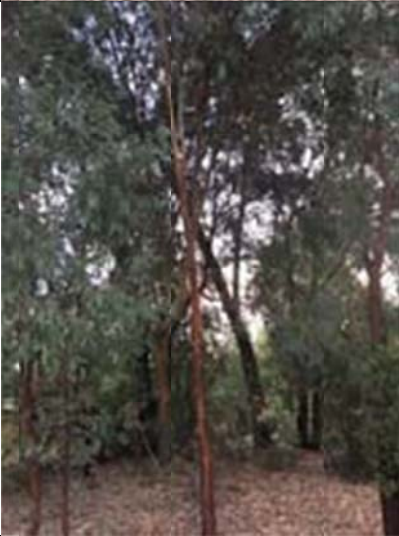
Tree 270

This tree is a prohibited species in Moorpark. It will be removed.

This tree has been suppressed by competition with its neighbors. It has average health and good form.

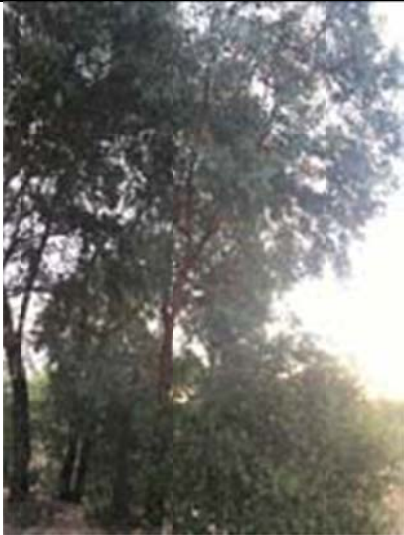
<p>Tree 271 <i>Eucalyptus sideroxylon</i> – Red Ironbark</p> <p>This tree is a prohibited species in Moorpark. It will be removed.</p> <p>This tree has co-dominant trunks. It has good health and average form.</p>

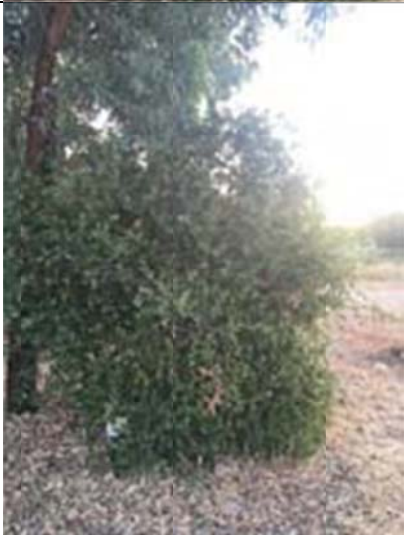
<p>Tree 272 <i>Quercus agrifolia</i> – Coast Live Oak</p> <p>This is a protected Native Oak Tree. It will be removed because it is growing within the footprint of the proposed parking lot expansion. It has an appraised value of \$1,270.63.</p> <p>This tree has excellent health and excellent form.</p>

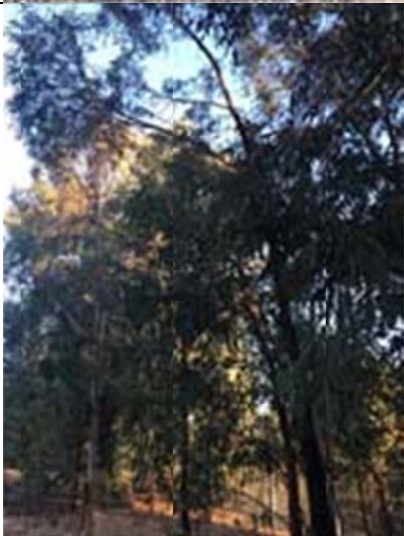
<p>Tree 273 <i>Eucalyptus sideroxylon</i> – Red Ironbark</p> <p>This tree is a prohibited species in Moorpark. It will be removed.</p> <p>This tree has co-dominant trunks. It has good health and average form.</p>

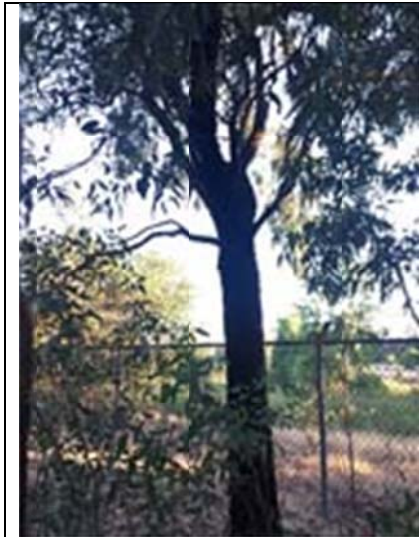
Tree 274

This tree is a prohibited species in Moorpark. It will be removed.

This tree has been partially suppressed by competition with its neighbors. It has good health and good form.

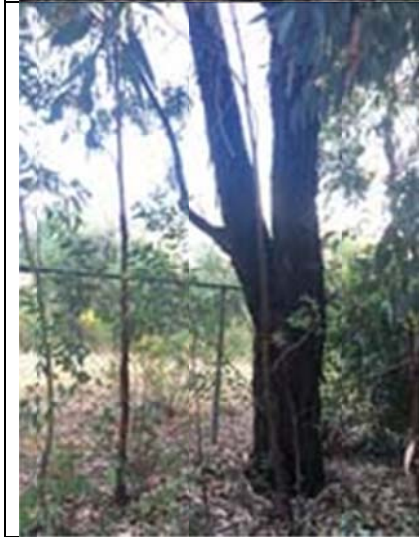
Tree 275

This tree is a prohibited species in Moorpark. It will be removed.

This tree has co-dominant trunks. It has good health and average form.

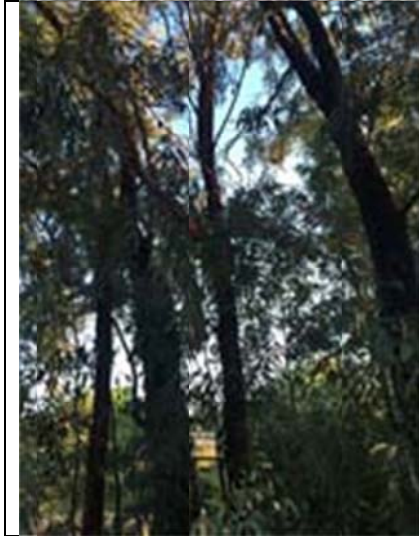
Tree 276

This tree is a prohibited species in Moorpark. It will be removed.

This tree has symptoms of heat and drought stress. It has average health and excellent form.

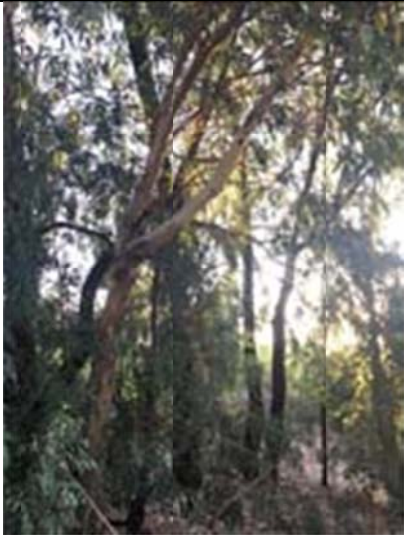
<p>Tree 277 <i>Eucalyptus leucoxylon</i> – White Ironbark</p> <p>This tree is a prohibited species in Moorpark. It will be removed.</p> <p>This tree has a prevailing lean. It has excellent health and average form.</p>

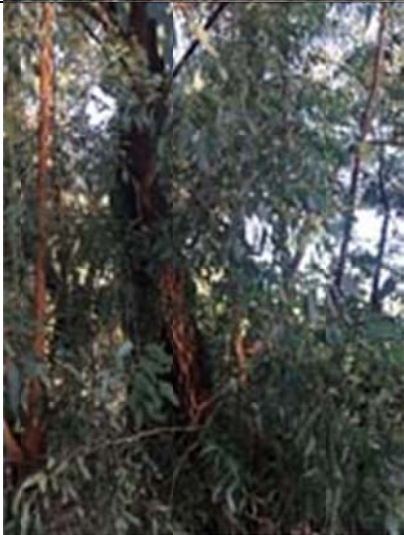
<p>Tree 278 <i>Eucalyptus sideroxylon</i> – Red Ironbark</p> <p>This tree is a prohibited species in Moorpark. It will be removed.</p> <p>This tree has excellent health and good form.</p>

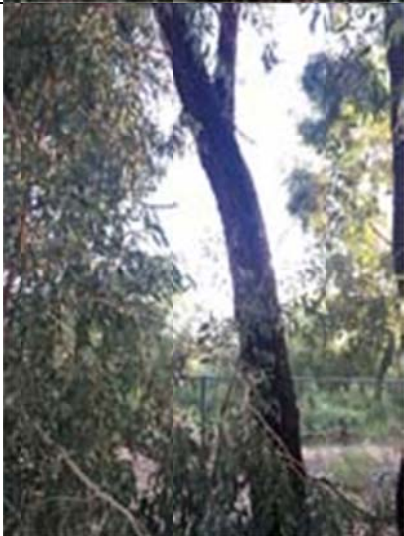
<p>Tree 279 <i>Eucalyptus sideroxylon</i> – Red Ironbark</p> <p>This tree is a prohibited species in Moorpark. It will be removed.</p> <p>This tree has excellent health and good form.</p>

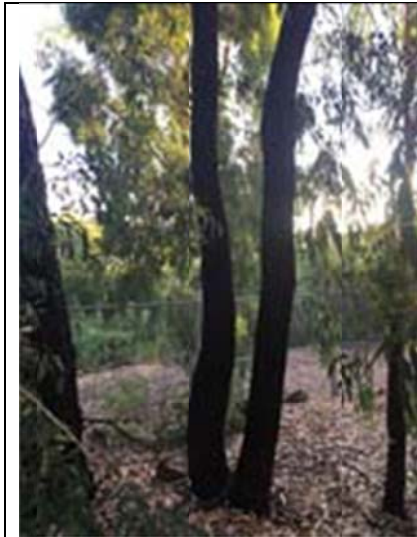
Tree 280

This tree is a prohibited species in Moorpark. It will be removed.

This tree has co-dominant trunks. It has excellent health and good form.

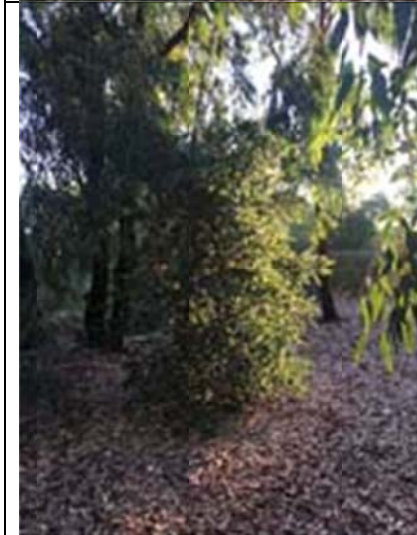
Tree 281

This tree has excellent health and excellent form. No treatment is recommended.

The proposed parking lot expansion will encroach within the critical root zone of this tree. All project activity within the drip line of this tree should be directly supervised by a Certified Arborist. This tree is intended to be retained in place throughout the project even though some of its roots may be impacted.

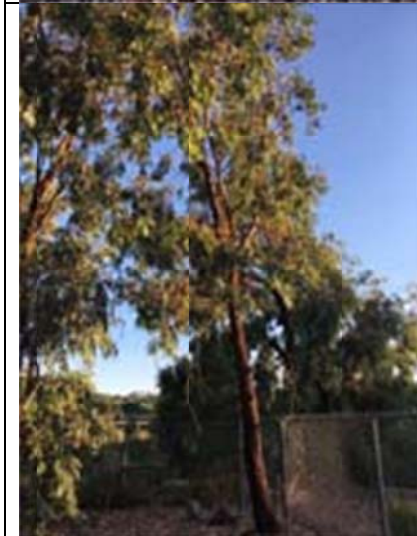
Tree 282

This tree is a prohibited species in Moorpark. It will be removed.

This tree has symptoms of heat and drought stress. It has good health and excellent form.

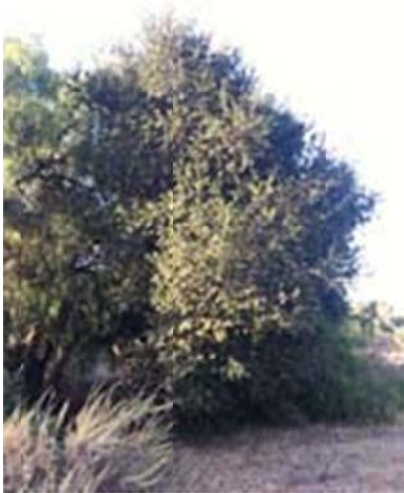
<p>Tree 283 <i>Quercus agrifolia</i> – Coast Live Oak</p> <p>This is a protected Native Oak Tree. It will be removed because it is growing within the footprint of the proposed parking lot expansion. It has an appraised value of \$5,784.63.</p> <p>This tree is still attached to its nursery stake. It has excellent health and excellent form.</p>

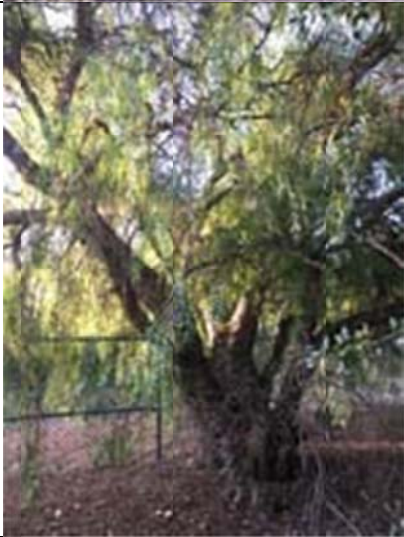
<p>Tree 284 <i>Schinus molle</i> – California Pepper</p> <p>This tree is a prohibited species in Moorpark. It will be removed.</p> <p>This tree has an accumulation of deadwood, but it is still healthy. It has excellent health and good form.</p>

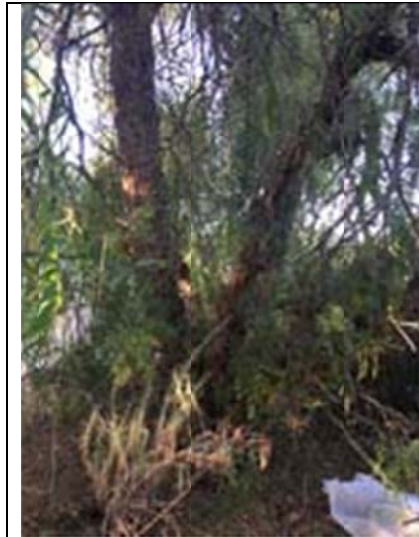
<p>Tree 285 <i>Schinus molle</i> – California Pepper</p> <p>This tree is a prohibited species in Moorpark. It will be removed.</p> <p>This tree has an accumulation of deadwood, but it is still healthy. It has excellent health and good form.</p>

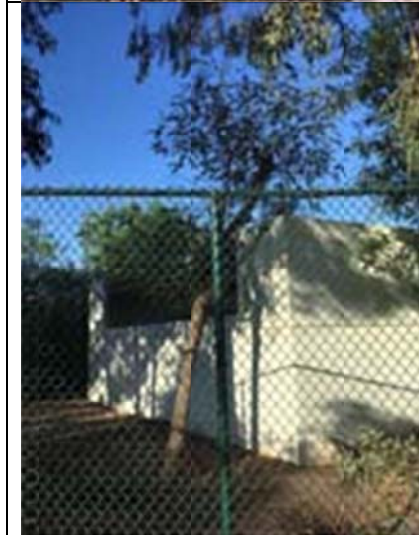
Tree 286

This tree has an accumulation of deadwood, but it is still healthy. It has excellent health and good form.

This tree is a prohibited species in Moorpark. It will be removed.

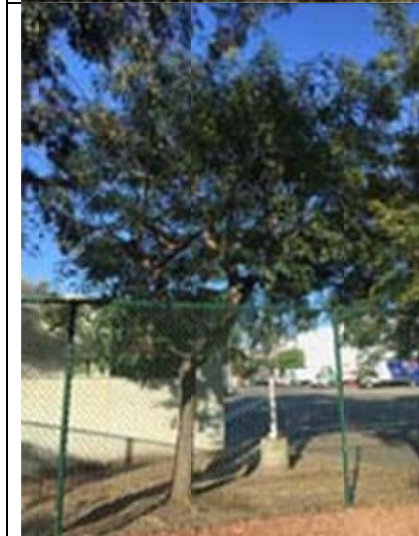
Tree OP287

This tree has had past topping, and it is stressed. It has average health and poor form. No treatment is recommended.

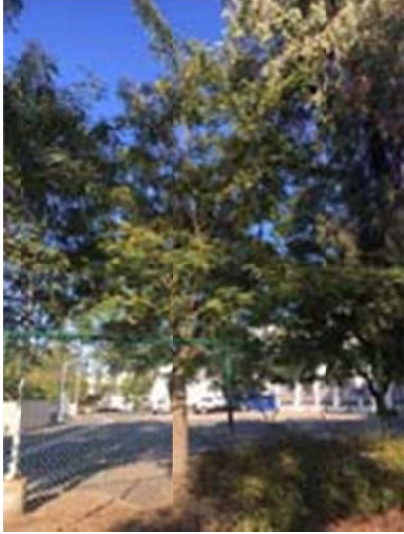
Tree OP288

This tree has excellent health and good form. No treatment is recommended.

The proposed asphalt resurfacing will encroach within the critical root zone of this tree. All project activity within the drip line of this tree should be directly supervised by a Certified Arborist. This tree is intended to be retained in place throughout the project even though some of its roots may be impacted.

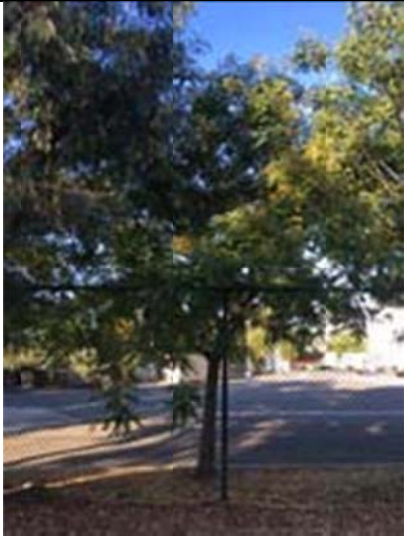
<p>Tree OP289 <i>Tipuana tipu</i> – Tipu Tree</p> <p>This tree is too small to be protected by ordinance. It is growing on an adjacent property. It will be retained in the landscape. It has an appraised value of \$3,330.42.</p> <p>This tree has excellent health and good form. No treatment is recommended.</p> <p>The proposed asphalt resurfacing will encroach within the critical root zone of this tree. All project activity within the drip line of this tree should be directly supervised by a Certified Arborist. This tree is intended to be retained in place throughout the project even though some of its roots may be impacted.</p>

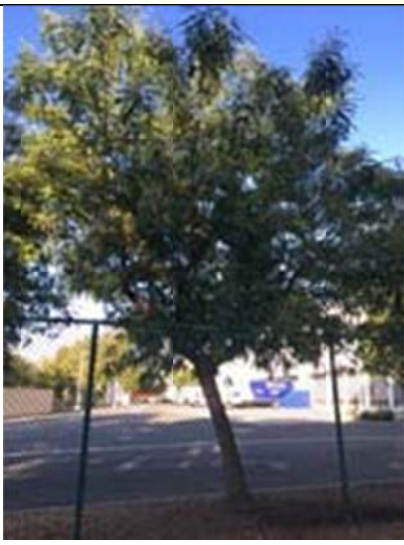
<p>Tree OP290 <i>Tipuana tipu</i> – Tipu Tree</p> <p>This tree is too small to be protected by ordinance. It is growing on an adjacent property. It will be retained in the landscape. It has an appraised value of \$1,402.11.</p> <p>This tree has minor suppression. It has good health and good form. No treatment is recommended.</p> <p>The proposed asphalt resurfacing will encroach within the critical root zone of this tree. All project activity within the drip line of this tree should be directly supervised by a Certified Arborist. This tree is intended to be retained in place throughout the project even though some of its roots may be impacted.</p>

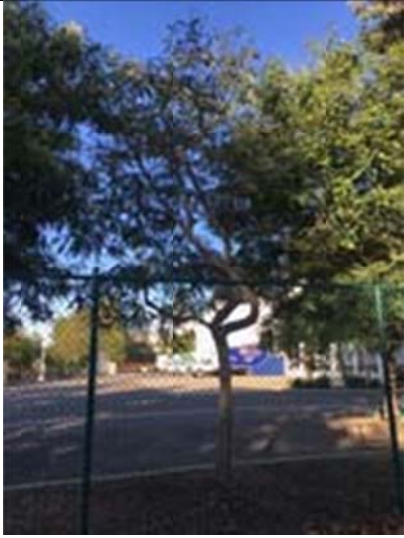
<p>Tree OP291 <i>Tipuana tipu</i> – Tipu Tree</p> <p>This tree is too small to be protected by ordinance. It is growing on an adjacent property. It will be retained in the landscape. It has an appraised value of \$2,668.17.</p> <p>This tree has excellent health and good form. No treatment is recommended.</p> <p>The proposed asphalt resurfacing will encroach within the critical root zone of this tree. All project activity within the drip line of this tree should be directly supervised by a Certified Arborist. This tree is intended to be retained in place throughout the project even though some of its roots may be impacted.</p>

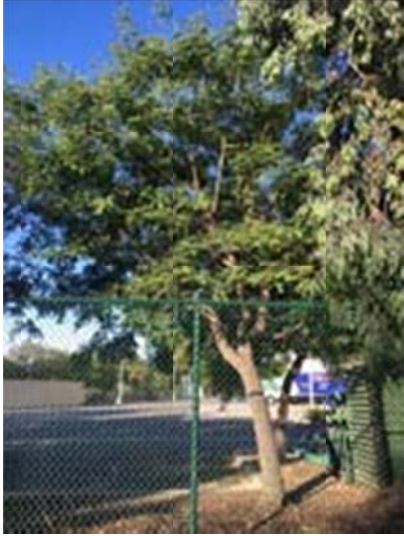
<p>Tree OP292 <i>Tipuana tipu</i> – Tipu Tree</p> <p>This tree is too small to be protected by ordinance. It is growing on an adjacent property. It will be retained in the landscape. It has an appraised value of \$1,402.11.</p> <p>This tree has been partially suppressed by competition with its neighbors. It has good health and good form. No treatment is recommended.</p> <p>The proposed asphalt resurfacing will encroach within the critical root zone of this tree. All project activity within the drip line of this tree should be directly supervised by a Certified Arborist. This tree is intended to be retained in place throughout the project even though some of its roots may be impacted.</p>

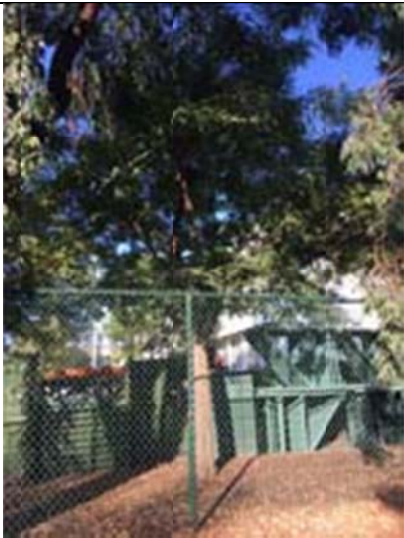
<p>Tree OP293 <i>Tipuana tipu</i> – Tipu Tree</p> <p>This tree is too small to be protected by ordinance. It is growing on an adjacent property. It will be retained in the landscape. It has an appraised value of \$2,823.99.</p> <p>This tree has excellent health and excellent form. No treatment is recommended.</p> <p>The proposed asphalt resurfacing will encroach within the critical root zone of this tree. All project activity within the drip line of this tree should be directly supervised by a Certified Arborist. This tree is intended to be retained in place throughout the project even though some of its roots may be impacted.</p>

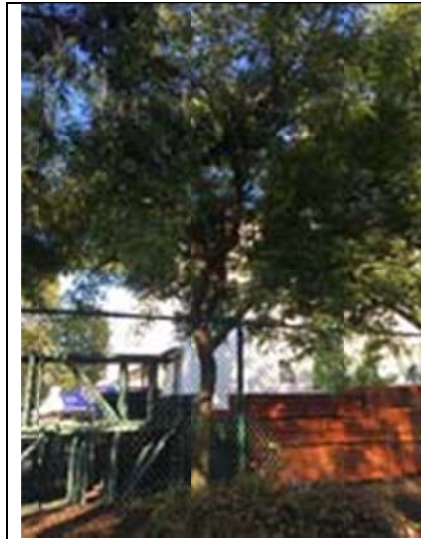
<p>Tree OP294 <i>Tipuana tipu</i> – Tipu Tree</p> <p>This tree is too small to be protected by ordinance. It is growing on an adjacent property. It will be retained in the landscape. It has an appraised value of \$2,823.99.</p> <p>This tree has excellent health and excellent form. No treatment is recommended.</p> <p>The proposed asphalt resurfacing will encroach within the critical root zone of this tree. All project activity within the drip line of this tree should be directly supervised by a Certified Arborist. This tree is intended to be retained in place throughout the project even though some of its roots may be impacted.</p>

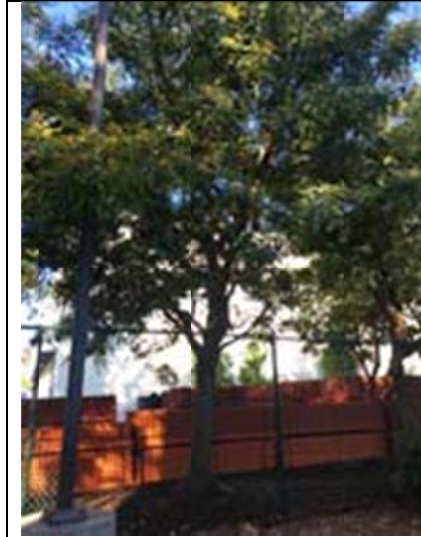
Tree OP295

This tree has excellent health and excellent form. No treatment is recommended.

The proposed asphalt resurfacing will encroach within the critical root zone of this tree. All project activity within the drip line of this tree should be directly supervised by a Certified Arborist. This tree is intended to be retained in place throughout the project even though some of its roots may be impacted.

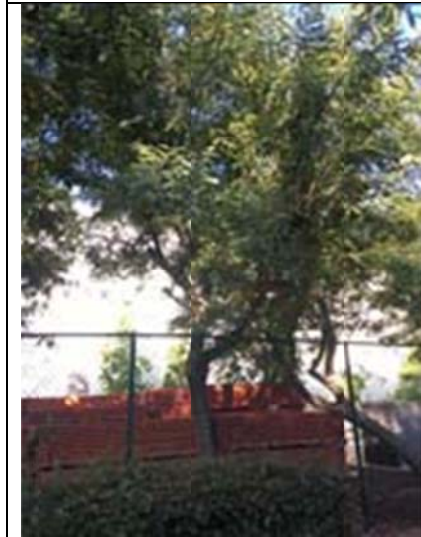
Tree OP296

This tree has excellent health and excellent form. No treatment is recommended.

The proposed asphalt resurfacing will encroach within the critical root zone of this tree. All project activity within the drip line of this tree should be directly supervised by a Certified Arborist. This tree is intended to be retained in place throughout the project even though some of its roots may be impacted.

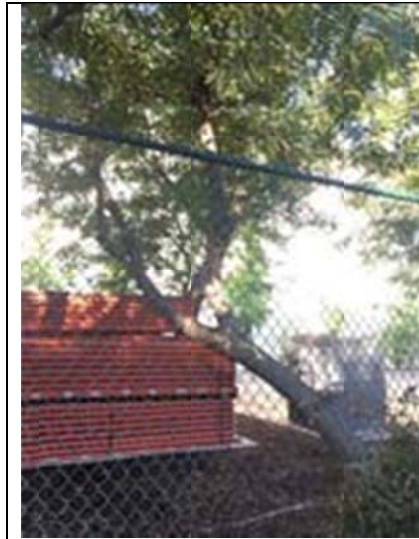
Tree OP297

This tree has excellent health and excellent form. No treatment is recommended.

The proposed asphalt resurfacing will encroach within the critical root zone of this tree. All project activity within the drip line of this tree should be directly supervised by a Certified Arborist. This tree is intended to be retained in place throughout the project even though some of its roots may be impacted.

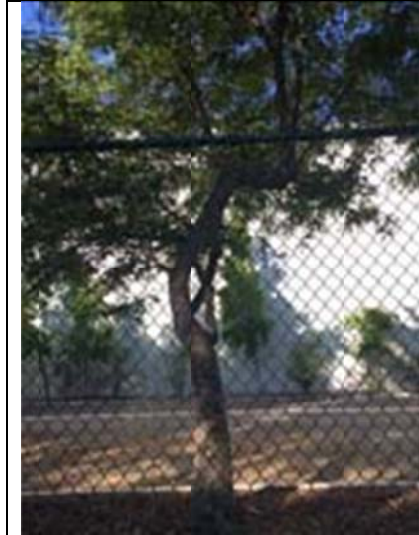
Tree OP298

This tree has a strong prevailing lean. It has excellent health and average form. No treatment is recommended.

The proposed asphalt resurfacing will encroach within the critical root zone of this tree. All project activity within the drip line of this tree should be directly supervised by a Certified Arborist. This tree is intended to be retained in place throughout the project even though some of its roots may be impacted.

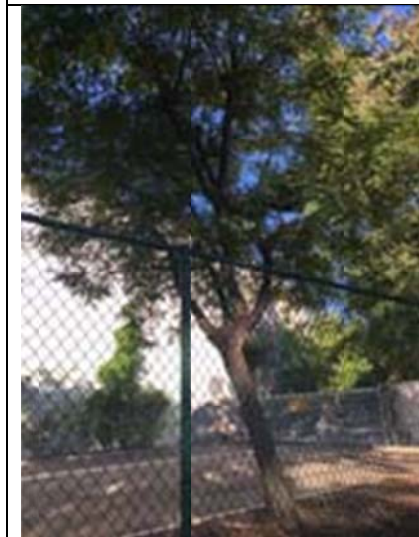
Tree OP299

This tree has a minor lean. It has excellent health and good form. No treatment is recommended.

The proposed asphalt resurfacing will encroach within the critical root zone of this tree. All project activity within the drip line of this tree should be directly supervised by a Certified Arborist. This tree is intended to be retained in place throughout the project even though some of its roots may be impacted.

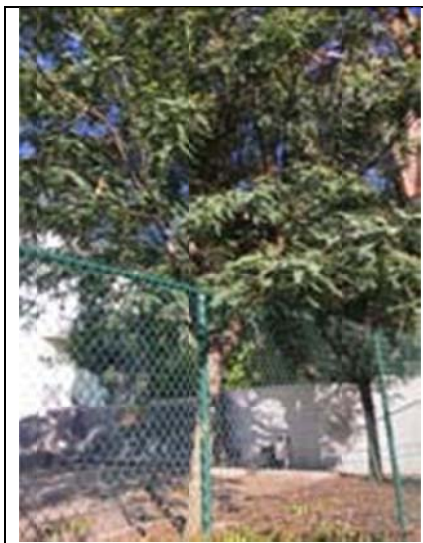
Tree OP300

This tree has excellent health and excellent form. No treatment is recommended.

The proposed asphalt resurfacing will encroach within the critical root zone of this tree. All project activity within the drip line of this tree should be directly supervised by a Certified Arborist. This tree is intended to be retained in place throughout the project even though some of its roots may be impacted.

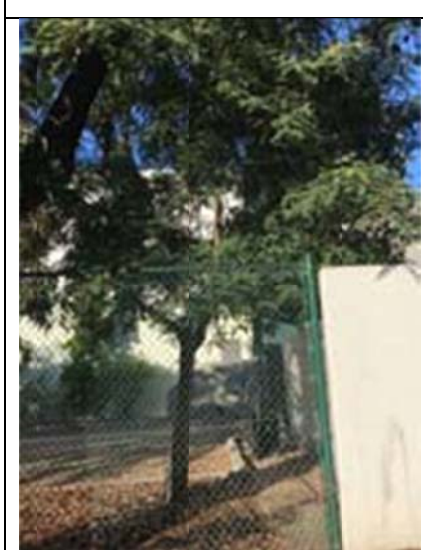
<p>Tree OP301 <i>Tipuana tipu</i> – Tipu Tree</p> <p>This tree is too small to be protected by ordinance. It is growing on an adjacent property. It will be retained in the landscape. It has an appraised value of \$2,823.99.</p> <p>This tree has excellent health and excellent form. No treatment is recommended.</p> <p>The proposed asphalt resurfacing will encroach within the critical root zone of this tree. All project activity within the drip line of this tree should be directly supervised by a Certified Arborist. This tree is intended to be retained in place throughout the project even though some of its roots may be impacted.</p>

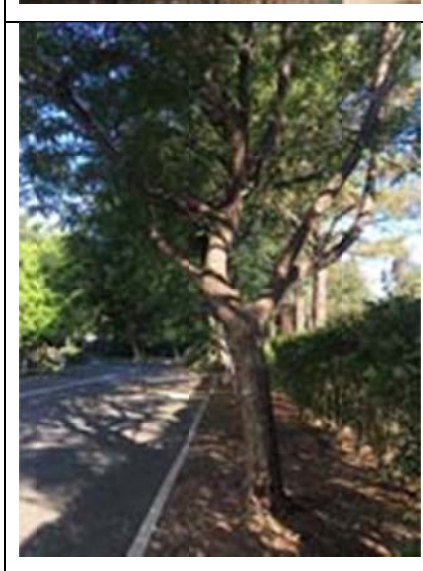
<p>Tree OP302 <i>Tipuana tipu</i> – Tipu Tree</p> <p>This tree is too small to be protected by ordinance. It is growing on an adjacent property. It will be retained in the landscape. It has an appraised value of \$2,322.44.</p> <p>This tree has excellent health and excellent form. No treatment is recommended.</p> <p>The proposed asphalt resurfacing will encroach within the critical root zone of this tree. All project activity within the drip line of this tree should be directly supervised by a Certified Arborist. This tree is intended to be retained in place throughout the project even though some of its roots may be impacted.</p>

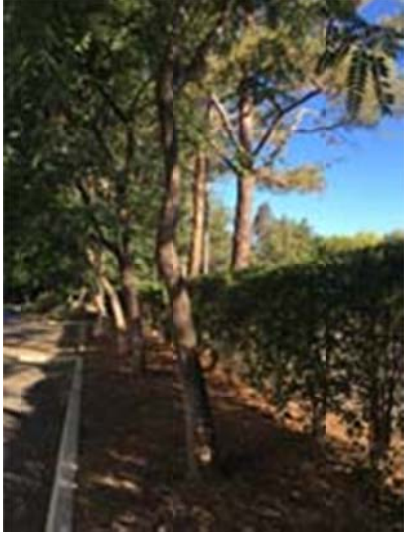
<p>Tree OP303 <i>Tipuana tipu</i> – Tipu Tree</p> <p>This tree is a protected Mature Tree because it has a cumulative trunk area of more than 72 in². It is growing on an adjacent property. It will be retained in the landscape. It has an appraised value of \$4,732.82.</p> <p>This tree has a history of past topping, but it is still vigorous. It has good health and good form. No treatment is recommended.</p> <p>The proposed parking lot demolition will encroach within the critical root zone of this tree. All project activity within the drip line of this tree should be directly supervised by a Certified Arborist. This tree is intended to be retained in place throughout the project even though some of its roots may be impacted.</p>

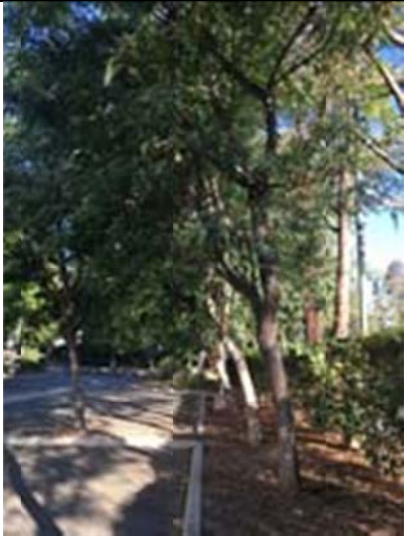
<p>Tree OP304 <i>Tipuana tipu</i> – Tipu Tree</p> <p>This tree is too small to be protected by ordinance. It is growing on an adjacent property. It will be retained in the landscape. It has an appraised value of \$2,738.78.</p> <p>This tree has a history of past topping, but it is still vigorous. It has good health and good form. No treatment is recommended.</p> <p>The proposed parking lot demolition will encroach within the critical root zone of this tree. All project activity within the drip line of this tree should be directly supervised by a Certified Arborist. This tree is intended to be retained in place throughout the project even though some of its roots may be impacted.</p>

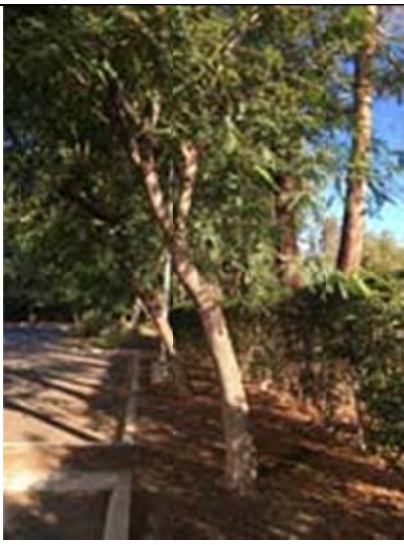
<p>Tree OP305 <i>Tipuana tipu</i> – Tipu Tree</p> <p>This tree is too small to be protected by ordinance. It is growing on an adjacent property. It will be retained in the landscape. It has an appraised value of \$2,738.78.</p> <p>This tree has a history of past topping, but it is still vigorous. It has good health and good form. No treatment is recommended.</p> <p>The proposed parking lot demolition will encroach within the critical root zone of this tree. All project activity within the drip line of this tree should be directly supervised by a Certified Arborist. This tree is intended to be retained in place throughout the project even though some of its roots may be impacted.</p>

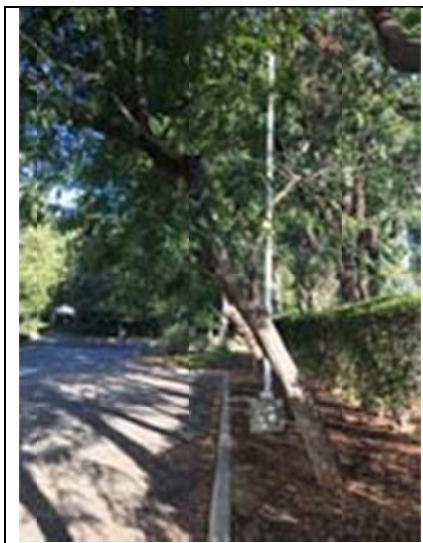
<p>Tree OP306 <i>Tipuana tipu</i> – Tipu Tree</p> <p>This tree is too small to be protected by ordinance. It is growing on an adjacent property. It will be retained in the landscape. It has an appraised value of \$2,738.78.</p> <p>This tree has a history of past topping, but it is still vigorous. It has good health and good form. No treatment is recommended.</p> <p>The proposed parking lot demolition will encroach within the critical root zone of this tree. All project activity within the drip line of this tree should be directly supervised by a Certified Arborist. This tree is intended to be retained in place throughout the project even though some of its roots may be impacted.</p>

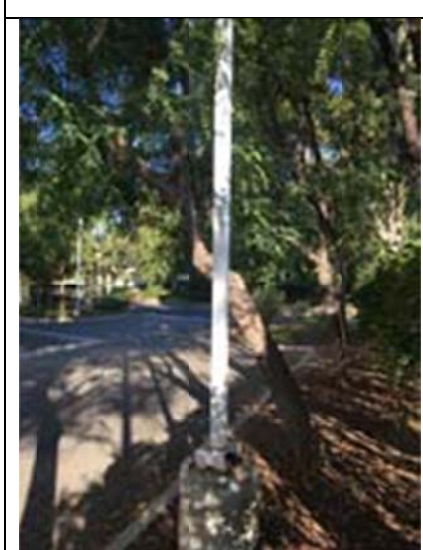
<p>Tree OP307 <i>Tipuana tipu</i> – Tipu Tree</p> <p>This tree is a protected Mature Tree because it has a cumulative trunk area of more than 72 in². It is growing on an adjacent property. It will be retained in the landscape. It has an appraised value of \$3,857.54.</p> <p>This tree has a history of past topping. It also has a prevailing lean. It has good health and average form. No treatment is recommended.</p> <p>The proposed parking lot demolition will encroach within the critical root zone of this tree. All project activity within the drip line of this tree should be directly supervised by a Certified Arborist. This tree is intended to be retained in place throughout the project even though some of its roots may be impacted.</p>

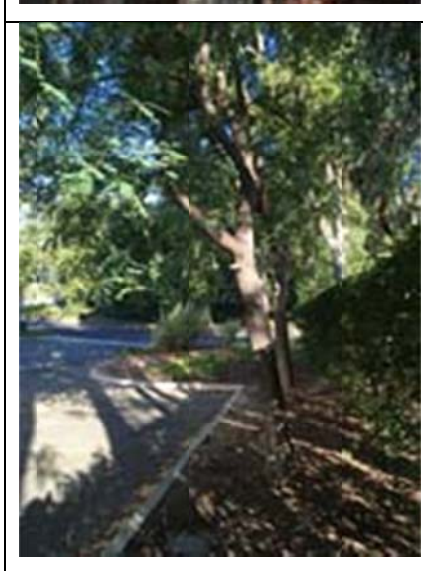
<p>Tree OP308 <i>Tipuana tipu</i> – Tipu Tree</p> <p>This tree is a protected Mature Tree because it has a cumulative trunk area of more than 72 in². It is growing on an adjacent property. It will be retained in the landscape. It has an appraised value of \$3,218.42.</p> <p>This tree has a history of past topping. It also has a prevailing lean. It has good health and average form. No treatment is recommended.</p> <p>The proposed parking lot demolition will encroach within the critical root zone of this tree. All project activity within the drip line of this tree should be directly supervised by a Certified Arborist. This tree is intended to be retained in place throughout the project even though some of its roots may be impacted.</p>

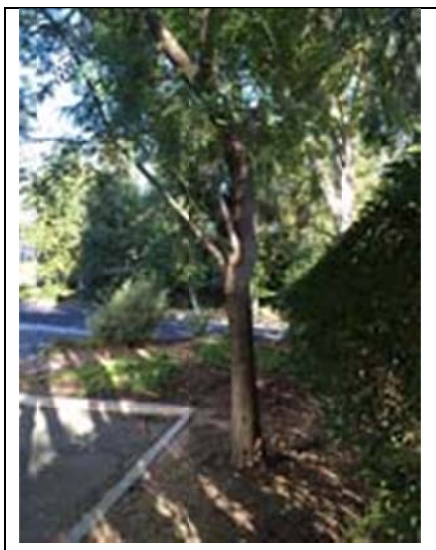
<p>Tree OP309 <i>Tipuana tipu</i> – Tipu Tree</p> <p>This tree is a protected Mature Tree because it has a cumulative trunk area of more than 72 in². It is growing on an adjacent property. It will be retained in the landscape. It has an appraised value of \$3,340.15.</p> <p>This tree has a history of past topping, but it is still vigorous. It has good health and good form. No treatment is recommended.</p> <p>The proposed parking lot demolition will encroach within the critical root zone of this tree. All project activity within the drip line of this tree should be directly supervised by a Certified Arborist. This tree is intended to be retained in place throughout the project even though some of its roots may be impacted.</p>

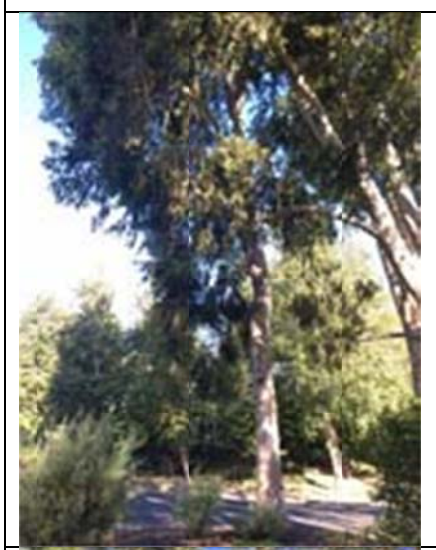
<p>Tree OP310 <i>Tipuana tipu</i> – Tipu Tree</p> <p>This tree is a protected Mature Tree because it has a cumulative trunk area of more than 72 in². It is growing on an adjacent property. It will be retained in the landscape. It has an appraised value of \$3,340.15.</p> <p>This tree has a history of past topping, but it is still vigorous. It has good health and good form. No treatment is recommended.</p> <p>The proposed parking lot demolition will encroach within the critical root zone of this tree. All project activity within the drip line of this tree should be directly supervised by a Certified Arborist. This tree is intended to be retained in place throughout the project even though some of its roots may be impacted.</p>

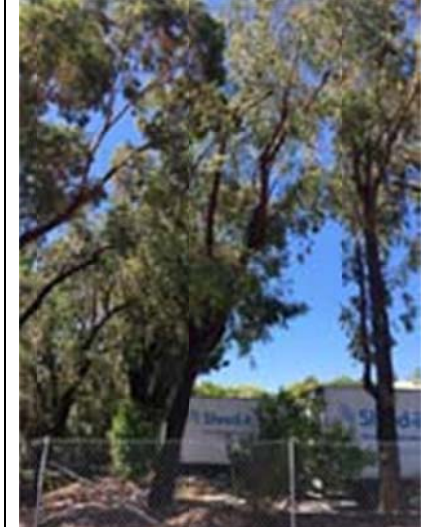
<p>Tree OP311 <i>Corymbia citriodora</i> – Lemon Gum</p> <p>This tree is a protected Mature Tree because it has a cumulative trunk area of more than 72 in². It is growing within the public right of way. It will be retained in the landscape. It has an appraised value of \$24,123.36.</p> <p>This tree has a co-dominant branch defect. It has excellent health and good form. No treatment is recommended.</p>

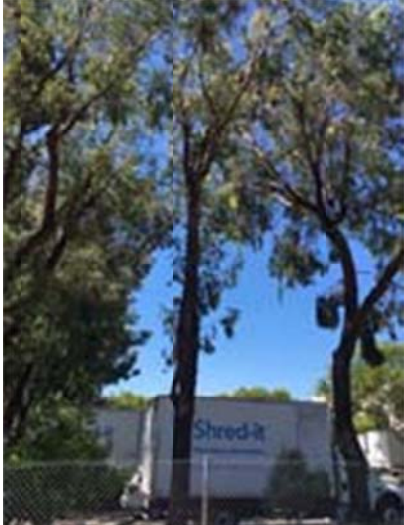
<p>Tree OP312 <i>Eucalyptus sideroxylon</i> – Red Ironbark</p> <p>This tree is a prohibited species in Moorpark. It is growing on the adjacent property.</p> <p>The proposed new parking lot will encroach within the critical root zone of this tree. This tree is intended to be retained in place throughout the project even though some of its roots may be impacted.</p> <p>This tree has co-dominant trunks. It has good health and average form. No treatment is recommended.</p>

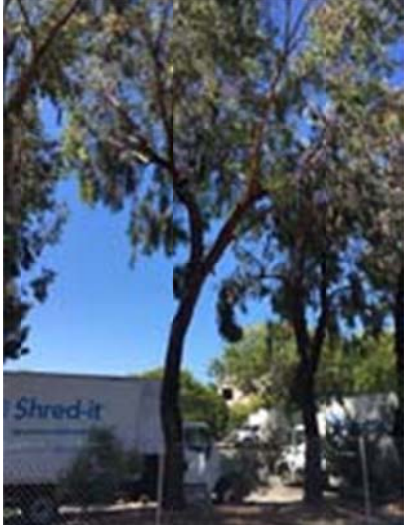
<p>Tree OP313 <i>Eucalyptus sideroxylon</i> – Red Ironbark</p> <p>This tree is a prohibited species in Moorpark. It is growing on the adjacent property.</p> <p>The proposed new parking lot will encroach within the critical root zone of this tree. This tree is intended to be retained in place throughout the project even though some of its roots may be impacted.</p> <p>This tree has been partially suppressed by competition with its neighbors. It has good health and good form.</p>

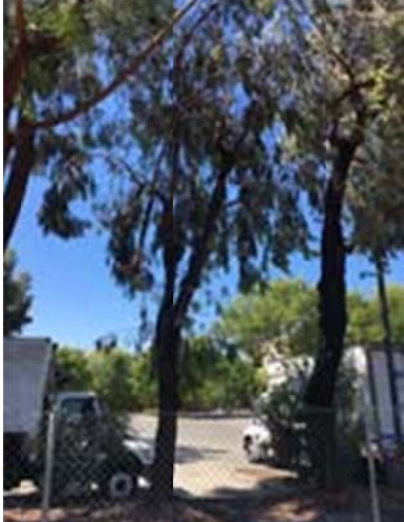
<p>Tree OP314 <i>Eucalyptus sideroxylon</i> – Red Ironbark</p> <p>This tree is a prohibited species in Moorpark. It is growing on the adjacent property.</p> <p>The proposed new parking lot will encroach within the critical root zone of this tree. This tree is intended to be retained in place throughout the project even though some of its roots may be impacted.</p> <p>This tree has a history of past topping, but it is still vigorous. It has good health and good form.</p>

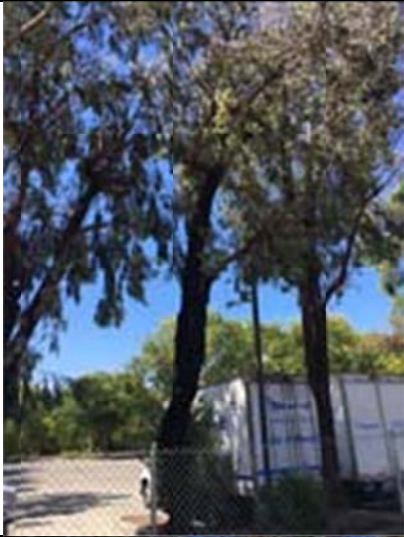
<p>Tree OP315 <i>Eucalyptus sideroxylon</i> – Red Ironbark</p> <p>This tree is a prohibited species in Moorpark. It is growing on the adjacent property.</p> <p>The proposed new parking lot will encroach within the critical root zone of this tree. This tree is intended to be retained in place throughout the project even though some of its roots may be impacted.</p> <p>This tree has co-dominant trunks. It also has a history of past topping. It has good health and average form.</p>

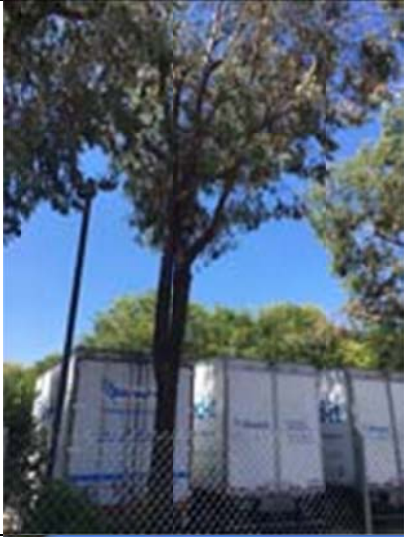
<p>Tree OP316 <i>Eucalyptus sideroxylon</i> – Red Ironbark</p> <p>This tree is a prohibited species in Moorpark. It is growing on the adjacent property.</p> <p>The proposed new parking lot will encroach within the critical root zone of this tree. This tree is intended to be retained in place throughout the project even though some of its roots may be impacted.</p> <p>This tree has symptoms of heat and drought stress. It has good health and good form.</p>

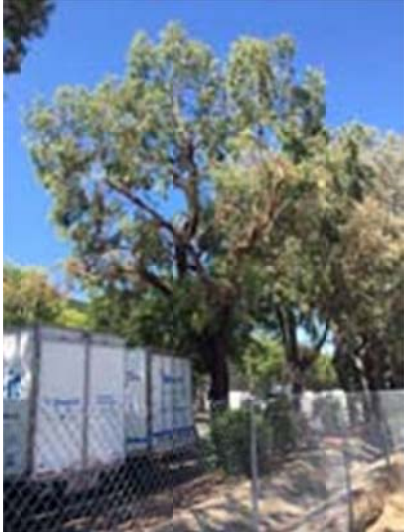
<p>Tree OP317 <i>Eucalyptus sideroxylon</i> – Red Ironbark</p> <p>This tree is a prohibited species in Moorpark. It is growing on the adjacent property.</p> <p>The proposed new parking lot will encroach within the critical root zone of this tree. This tree is intended to be retained in place throughout the project even though some of its roots may be impacted.</p> <p>This tree has co-dominant trunks. It has good health and average form.</p>

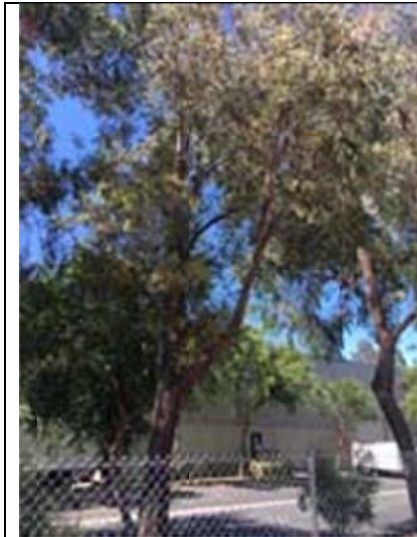
<p>Tree OP318 <i>Eucalyptus sideroxylon</i> – Red Ironbark</p> <p>This tree is a prohibited species in Moorpark. It is growing on the adjacent property.</p> <p>The proposed new parking lot will encroach within the critical root zone of this tree. This tree is intended to be retained in place throughout the project even though some of its roots may be impacted.</p> <p>This tree has co-dominant branches. It has excellent health and good form.</p>

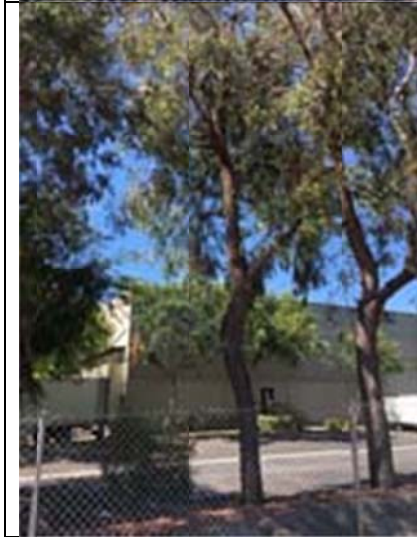
Tree OP319

The proposed new parking lot will encroach within the critical root zone of this tree. This tree is intended to be retained in place throughout the project even though some of its roots may be impacted.

This tree has co-dominant branches. It has excellent health and good form.

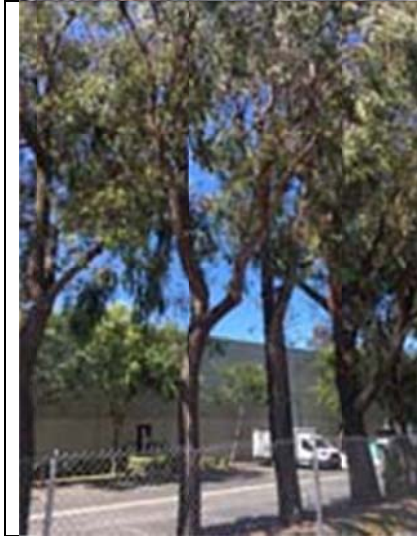
Tree OP320

The proposed new parking lot will encroach within the critical root zone of this tree. This tree is intended to be retained in place throughout the project even though some of its roots may be impacted.

This tree has excellent health and good form.

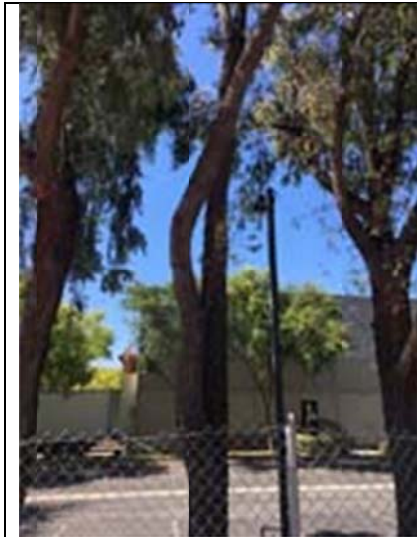
Tree OP321

The proposed new parking lot will encroach within the critical root zone of this tree. This tree is intended to be retained in place throughout the project even though some of its roots may be impacted.

This tree has excellent health and good form.

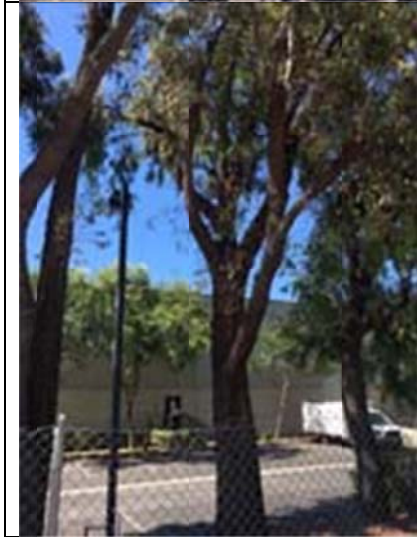
Tree OP322

The proposed new parking lot will encroach within the critical root zone of this tree. This tree is intended to be retained in place throughout the project even though some of its roots may be impacted.

This tree has co-dominant trunks. It has excellent health and average form.
