6000 Condor Dr. Arborist Report

Prepared for HPA inc.
c/o Tammi Bailey
18831 Bardeen Ave. Suite 100
Irvine, CA 92612

Prepared by James Komen
BCMA WE-9909B
RCA #555

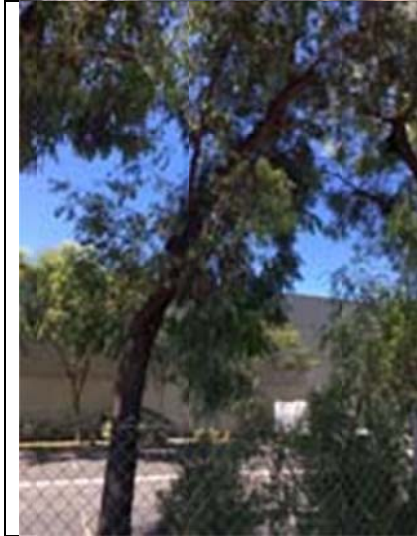
Tree OP323

The proposed new parking lot will encroach within the critical root zone of this tree. This tree is intended to be retained in place throughout the project even though some of its roots may be impacted.

This tree has a history of past topping, but it is still vigorous. It has excellent health and good form.

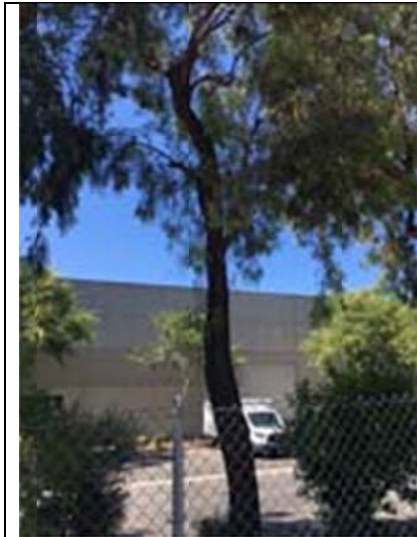
Tree OP324

The proposed new parking lot will encroach within the critical root zone of this tree. This tree is intended to be retained in place throughout the project even though some of its roots may be impacted.

This tree has a minor lean. It has excellent health and good form.

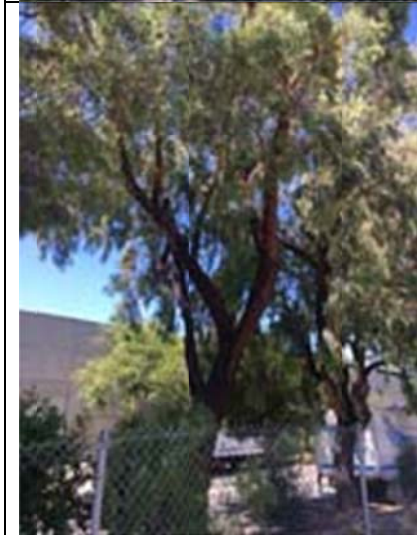
Tree OP325

The proposed new parking lot will encroach within the critical root zone of this tree. This tree is intended to be retained in place throughout the project even though some of its roots may be impacted.

This tree has excellent health and good form.

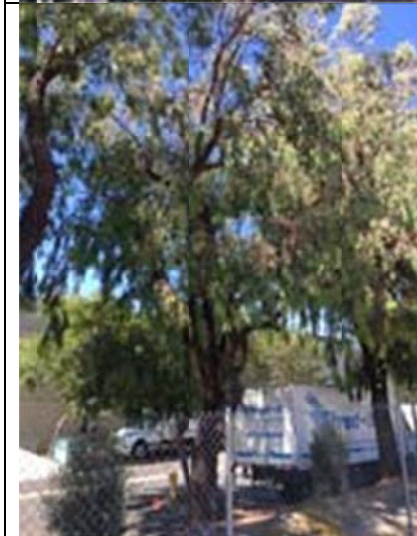
Tree OP326

The proposed new parking lot will encroach within the critical root zone of this tree. This tree is intended to be retained in place throughout the project even though some of its roots may be impacted.

This tree has excellent health and excellent form.

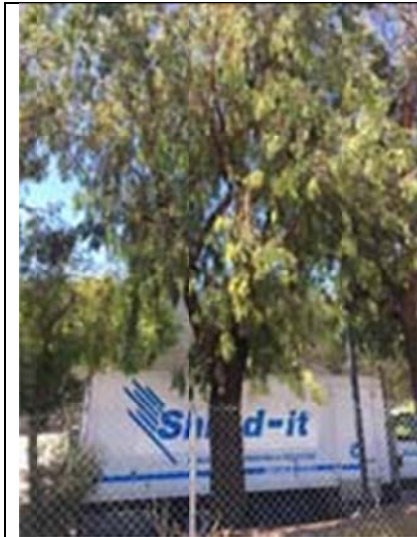
Tree OP327

The proposed new parking lot will encroach within the critical root zone of this tree. This tree is intended to be retained in place throughout the project even though some of its roots may be impacted.

This tree has co-dominant branches. It has excellent health and average form.

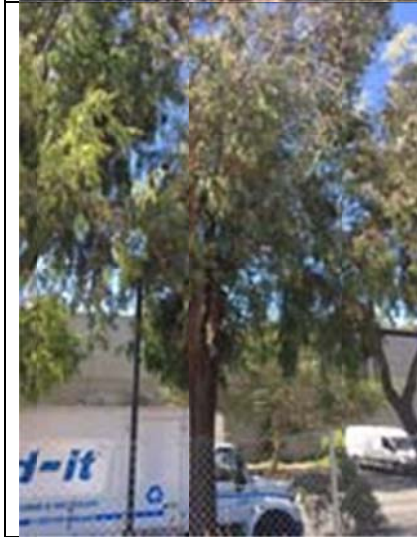
Tree OP328

The proposed new parking lot will encroach within the critical root zone of this tree. This tree is intended to be retained in place throughout the project even though some of its roots may be impacted.

This tree has excellent health and good form.

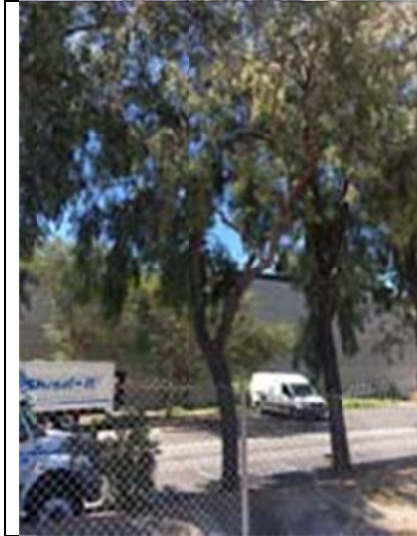
Tree OP329

The proposed new parking lot will encroach within the critical root zone of this tree. This tree is intended to be retained in place throughout the project even though some of its roots may be impacted.

This tree has co-dominant branches. I observed a recent branch failure from its canopy. This tree has excellent health and average form.

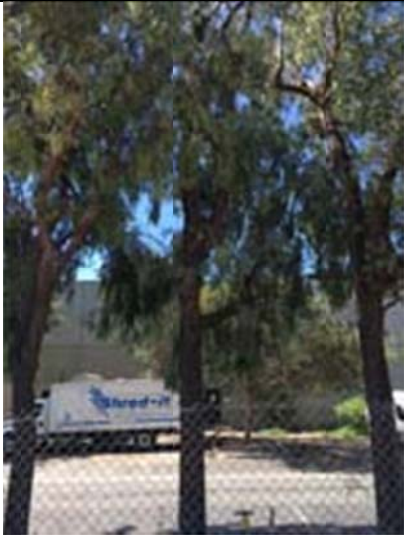
Tree OP330

The proposed new parking lot will encroach within the critical root zone of this tree. This tree is intended to be retained in place throughout the project even though some of its roots may be impacted.

This tree has an impounded nursery tie from when it was first planted. It has good health and good form.

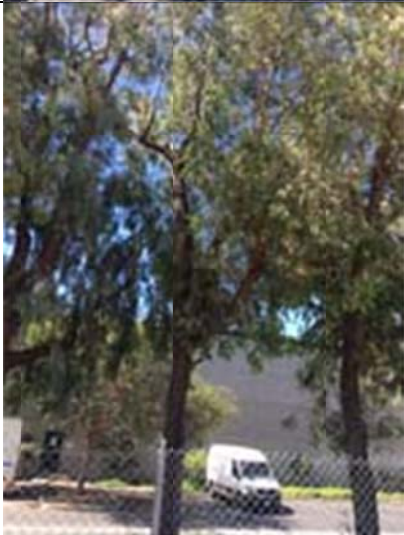
<p>Tree OP331 <i>Eucalyptus sideroxylon</i> – Red Ironbark</p> <p>This tree is a prohibited species in Moorpark. It is growing on the adjacent property.</p> <p>The proposed new parking lot will encroach within the critical root zone of this tree. This tree is intended to be retained in place throughout the project even though some of its roots may be impacted.</p> <p>This tree has excellent health and good form.</p>

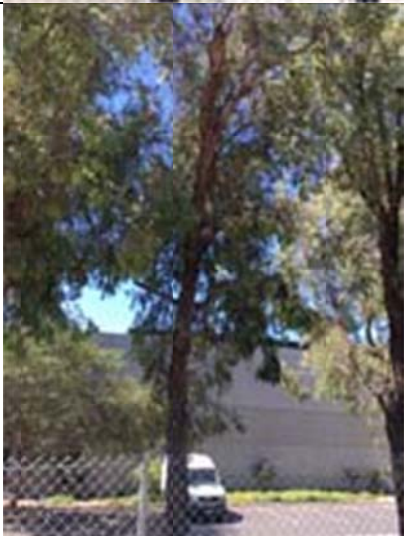
<p>Tree OP332 <i>Eucalyptus sideroxylon</i> – Red Ironbark</p> <p>This tree is a prohibited species in Moorpark. It is growing on the adjacent property.</p> <p>The proposed new parking lot will encroach within the critical root zone of this tree. This tree is intended to be retained in place throughout the project even though some of its roots may be impacted.</p> <p>This tree has a history of past topping, but it is still vigorous. It has excellent health and good form.</p>

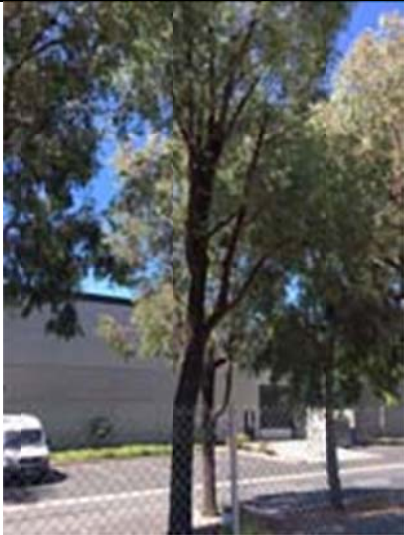
<p>Tree OP333 <i>Eucalyptus sideroxylon</i> – Red Ironbark</p> <p>This tree is a prohibited species in Moorpark. It is growing on the adjacent property.</p> <p>The proposed new parking lot will encroach within the critical root zone of this tree. This tree is intended to be retained in place throughout the project even though some of its roots may be impacted.</p> <p>This tree has excellent health and good form.</p>

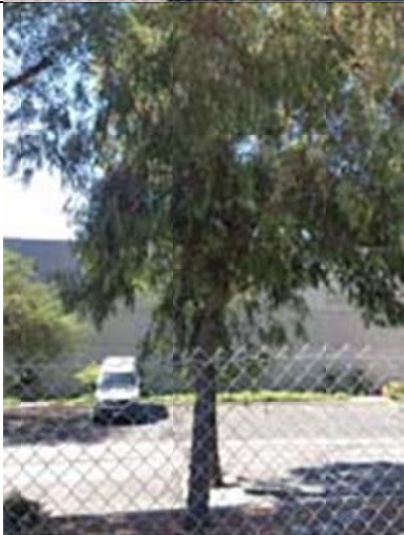
<p>Tree OP334 <i>Eucalyptus sideroxylon</i> – Red Ironbark</p> <p>This tree is a prohibited species in Moorpark. It is growing on the adjacent property.</p> <p>The proposed new parking lot will encroach within the critical root zone of this tree. This tree is intended to be retained in place throughout the project even though some of its roots may be impacted.</p> <p>This tree has co-dominant branches. It has excellent health and good form.</p>

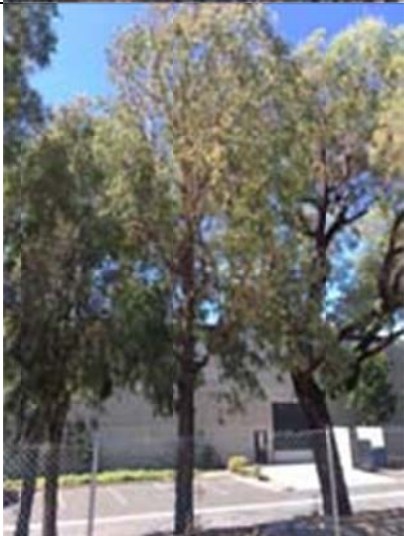
<p>Tree OP335 <i>Eucalyptus sideroxylon</i> – Red Ironbark</p> <p>This tree is a prohibited species in Moorpark. It is growing on the adjacent property.</p> <p>The proposed new parking lot will encroach within the critical root zone of this tree. This tree is intended to be retained in place throughout the project even though some of its roots may be impacted.</p> <p>This tree has been suppressed by competition with its neighbors. It has good health and good form.</p>

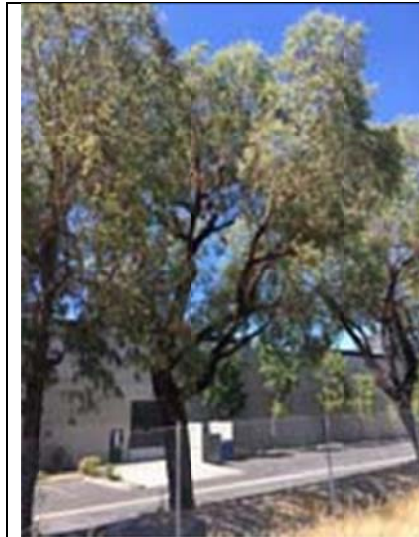
<p>Tree OP336 <i>Eucalyptus sideroxylon</i> – Red Ironbark</p> <p>This tree is a prohibited species in Moorpark. It is growing on the adjacent property.</p> <p>The proposed new parking lot will encroach within the critical root zone of this tree. This tree is intended to be retained in place throughout the project even though some of its roots may be impacted.</p> <p>This tree has co-dominant branches. It has excellent health and good form.</p>

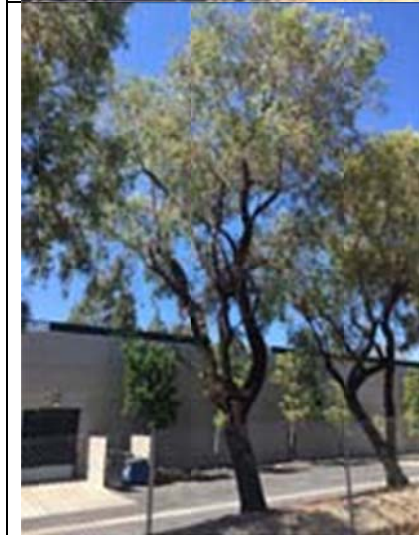
Tree OP337

The proposed new parking lot will encroach within the critical root zone of this tree. This tree is intended to be retained in place throughout the project even though some of its roots may be impacted.

This tree has excellent health and good form.

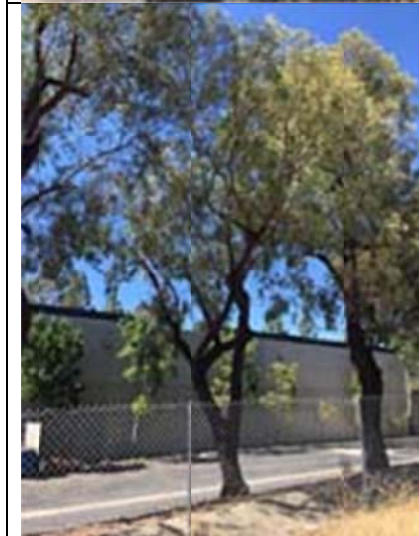
Tree OP338

The proposed new parking lot will encroach within the critical root zone of this tree. This tree is intended to be retained in place throughout the project even though some of its roots may be impacted.

This tree has symptoms of drought stress, and there is deadwood in its canopy. It has good health and good form.

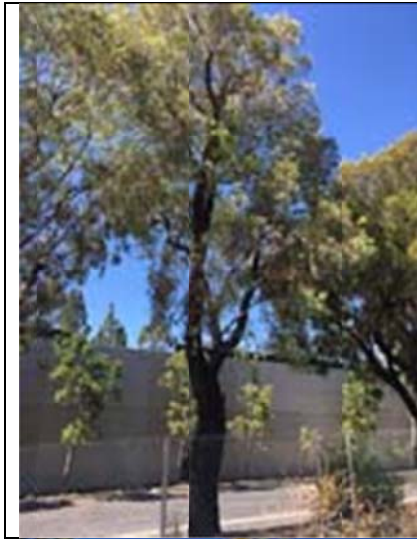
Tree OP339

The proposed new parking lot will encroach within the critical root zone of this tree. This tree is intended to be retained in place throughout the project even though some of its roots may be impacted.

This tree has co-dominant trunks. It has excellent health and average form.

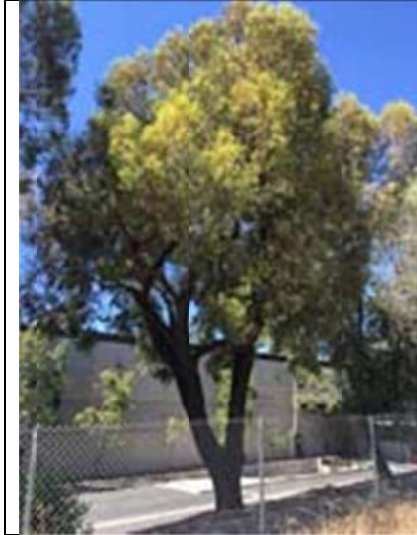
Tree OP340

The proposed new parking lot will encroach within the critical root zone of this tree. This tree is intended to be retained in place throughout the project even though some of its roots may be impacted.

This tree has excellent health and good form.

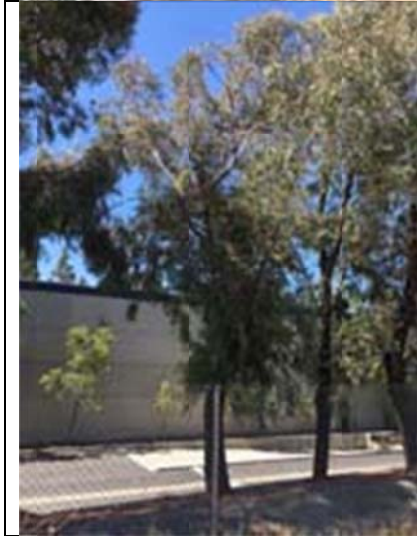
Tree OP341

The proposed new parking lot will encroach within the critical root zone of this tree. This tree is intended to be retained in place throughout the project even though some of its roots may be impacted.

This tree has excellent health and excellent form.

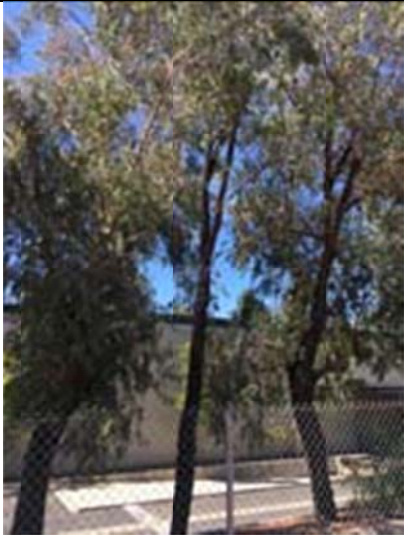
Tree OP342

The proposed new parking lot will encroach within the critical root zone of this tree. This tree is intended to be retained in place throughout the project even though some of its roots may be impacted.

This tree is leaning. It has excellent health and good form.

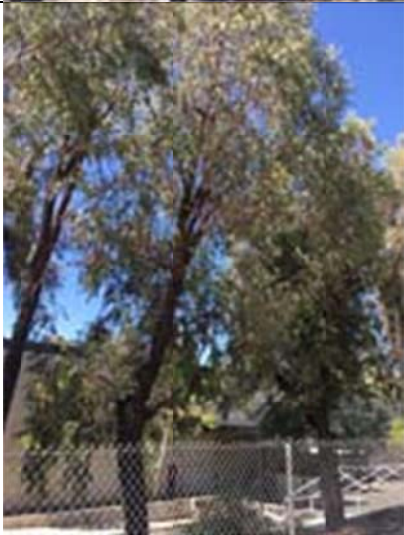
<p>Tree OP343 <i>Eucalyptus sideroxylon</i> – Red Ironbark</p> <p>This tree is a prohibited species in Moorpark. It is growing on the adjacent property.</p> <p>The proposed new parking lot will encroach within the critical root zone of this tree. This tree is intended to be retained in place throughout the project even though some of its roots may be impacted.</p> <p>This tree has been partially suppressed by competition with its neighbors. It has good health and good form.</p>

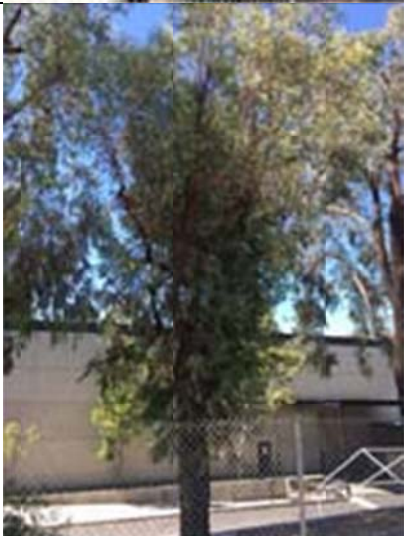
<p>Tree OP344 <i>Eucalyptus sideroxylon</i> – Red Ironbark</p> <p>This tree is a prohibited species in Moorpark. It is growing on the adjacent property.</p> <p>The proposed new parking lot will encroach within the critical root zone of this tree. This tree is intended to be retained in place throughout the project even though some of its roots may be impacted.</p> <p>This tree has excellent health and good form.</p>

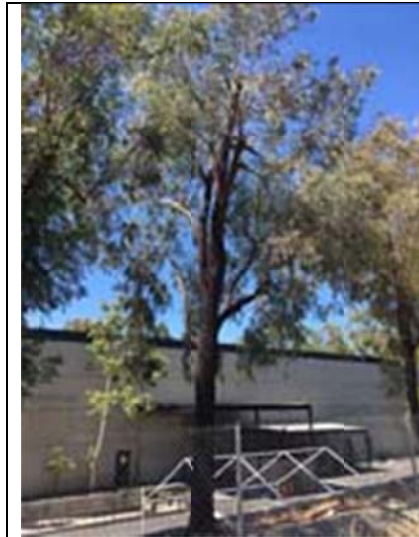
<p>Tree OP345 <i>Eucalyptus sideroxylon</i> – Red Ironbark</p> <p>This tree is a prohibited species in Moorpark. It is growing on the adjacent property.</p> <p>The proposed new parking lot will encroach within the critical root zone of this tree. This tree is intended to be retained in place throughout the project even though some of its roots may be impacted.</p> <p>This tree has excellent health and good form.</p>

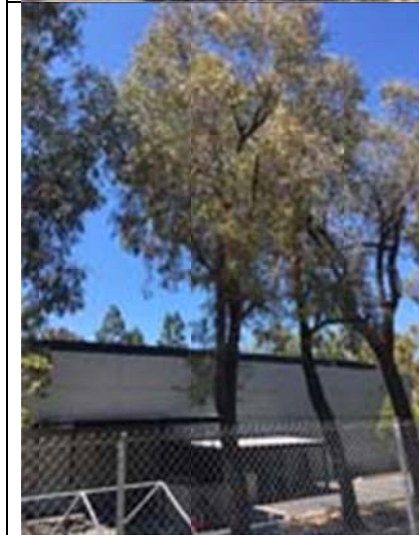
Tree OP346

The proposed new parking lot will encroach within the critical root zone of this tree. This tree is intended to be retained in place throughout the project even though some of its roots may be impacted.

This tree has trunk bark sloughing off. It has good health and good form.

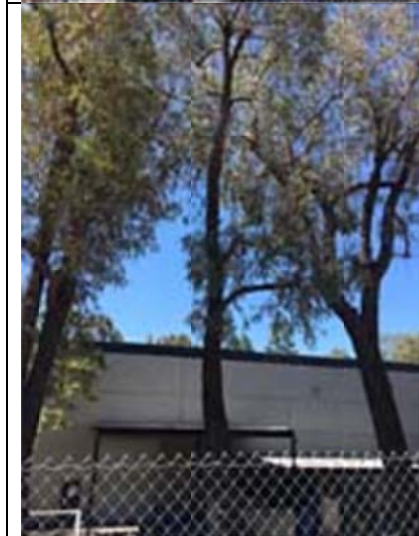
Tree OP347

The proposed new parking lot will encroach within the critical root zone of this tree. This tree is intended to be retained in place throughout the project even though some of its roots may be impacted.

This tree has co-dominant trunks. It has good health and average form.

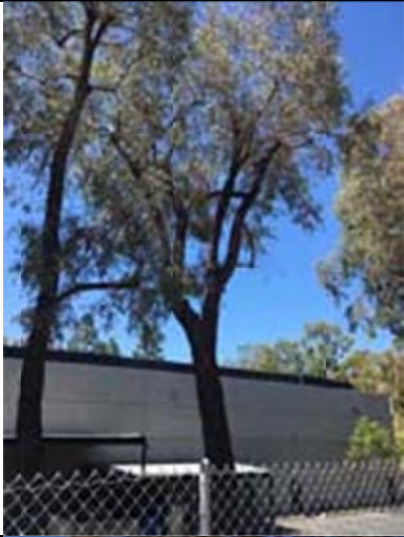
Tree OP348

The proposed new parking lot will encroach within the critical root zone of this tree. This tree is intended to be retained in place throughout the project even though some of its roots may be impacted.

This tree has symptoms of heat and drought stress. It has good health and good form.

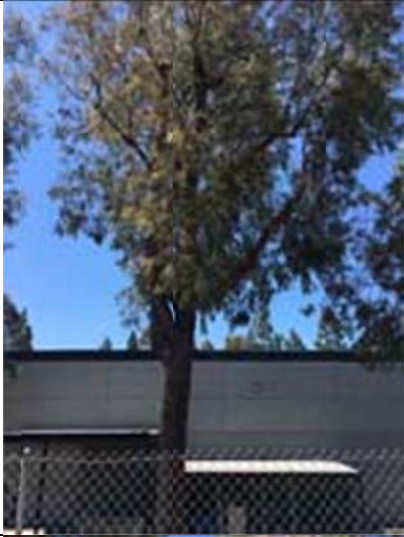
<p>Tree OP349 <i>Eucalyptus sideroxylon</i> – Red Ironbark</p> <p>This tree is a prohibited species in Moorpark. It is growing on the adjacent property.</p> <p>The proposed new parking lot will encroach within the critical root zone of this tree. This tree is intended to be retained in place throughout the project even though some of its roots may be impacted.</p> <p>This tree has symptoms of heat and drought stress. It has good health and good form.</p>

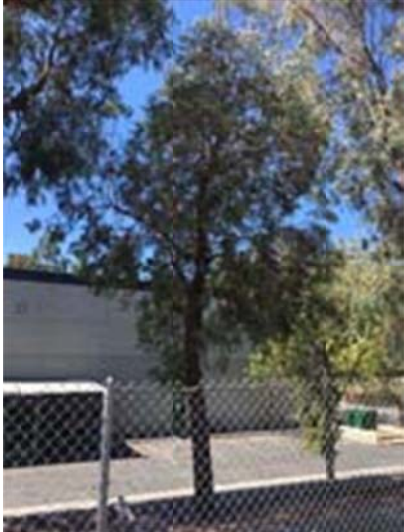
<p>Tree OP350 <i>Eucalyptus sideroxylon</i> – Red Ironbark</p> <p>This tree is a prohibited species in Moorpark. It is growing on the adjacent property.</p> <p>The proposed new parking lot will encroach within the critical root zone of this tree. This tree is intended to be retained in place throughout the project even though some of its roots may be impacted.</p> <p>This tree has symptoms of heat and drought stress. It has good health and good form.</p>

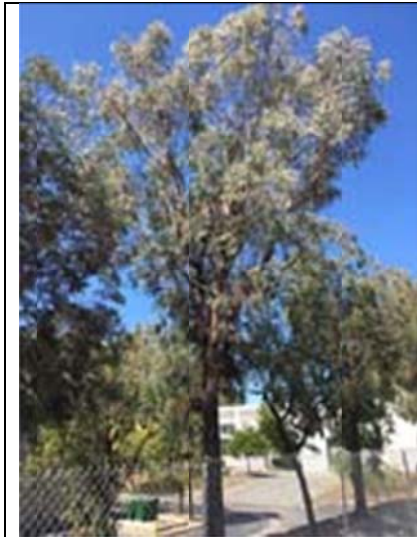
<p>Tree OP351 <i>Eucalyptus sideroxylon</i> – Red Ironbark</p> <p>This tree is a prohibited species in Moorpark. It is growing on the adjacent property.</p> <p>The proposed new parking lot will encroach within the critical root zone of this tree. This tree is intended to be retained in place throughout the project even though some of its roots may be impacted.</p> <p>This tree has been suppressed by competition with its neighbors. It has good health and excellent form.</p>

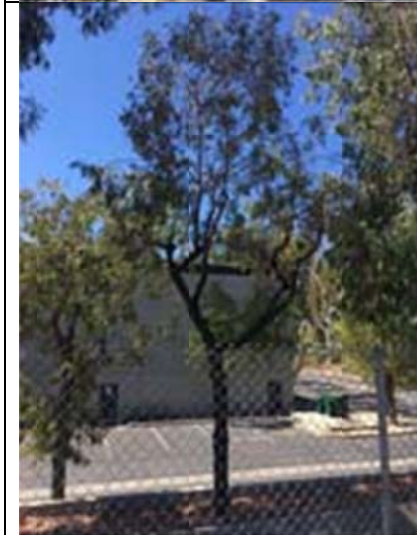
Tree OP352

This tree is a prohibited species in Moorpark. It is growing on the adjacent property. This tree is intended to be retained in place.

This tree has co-dominant trunks. It has good health and average form.

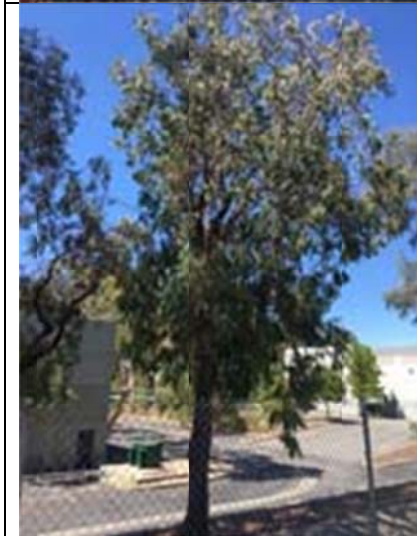
Tree OP353

This tree is a prohibited species in Moorpark. It is growing on the adjacent property. This tree is intended to be retained in place.

This tree has been suppressed by competition with its neighbors. It has good health and excellent form.

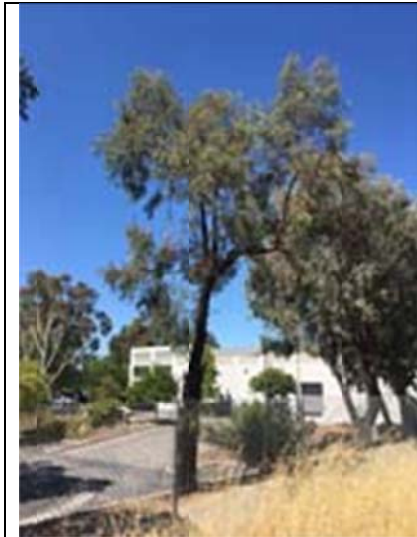
Tree OP354

This tree is a prohibited species in Moorpark. It is growing on the adjacent property. This tree is intended to be retained in place.

This tree has excellent health and excellent form.

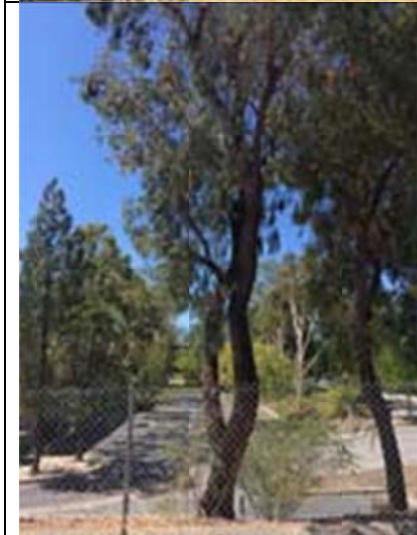
Tree OP355

This tree is a prohibited species in Moorpark. It is growing on the adjacent property. This tree is intended to be retained in place.

This tree has had a co-dominant trunk failure in the past. Despite this, it still has good health and average form.

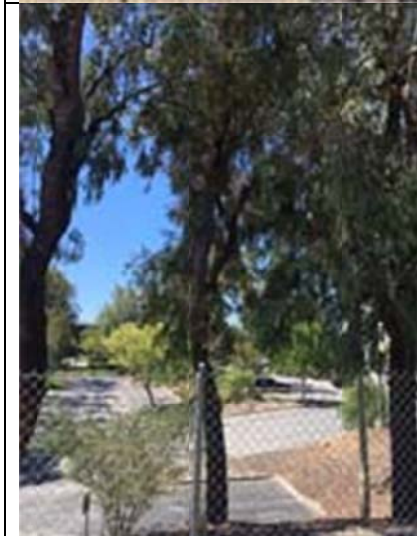
Tree OP356

This tree is a prohibited species in Moorpark. It is growing on the adjacent property. This tree is intended to be retained in place.

This tree has co-dominant trunks. It has excellent health and average form.

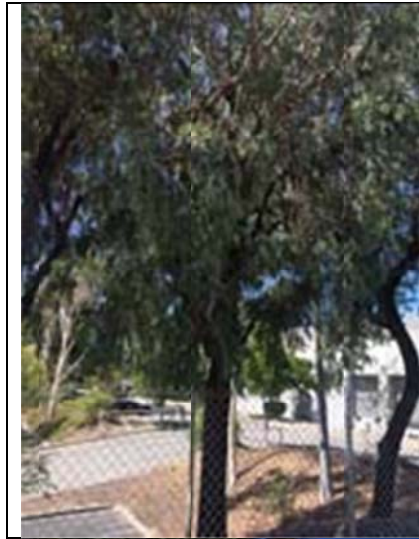
Tree OP357

This tree is a prohibited species in Moorpark. It is growing on the adjacent property. This tree is intended to be retained in place.

This tree has been suppressed by competition with its neighbors. It has good health and good form.

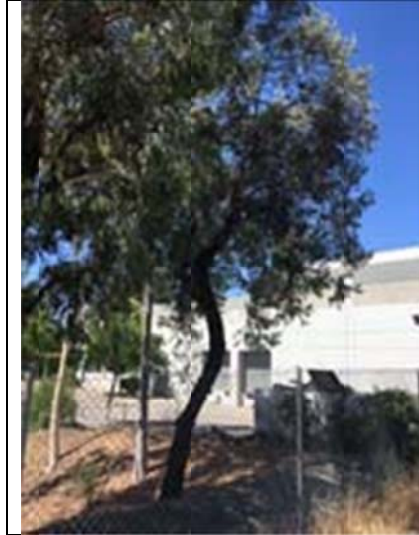
Tree OP358

This tree is a prohibited species in Moorpark. It is growing on the adjacent property. This tree is intended to be retained in place.

This tree has co-dominant branches. It has excellent health and good form.

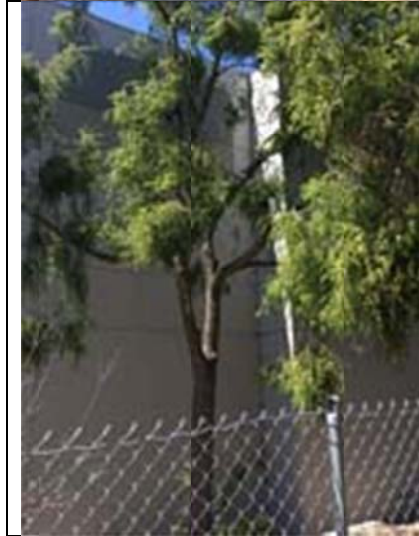
Tree OP359

This tree is a prohibited species in Moorpark. It is growing on the adjacent property. This tree is intended to be retained in place.

This tree has a twisted trunk. It has good health and average form.

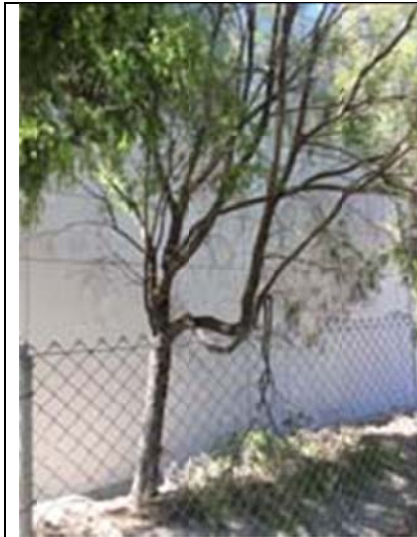
Tree OP360

This tree is a protected Mature Tree because it has a cumulative trunk area of more than 72 in². It is growing on an adjacent property. It will be retained in the landscape. It has an appraised value of \$5,123.01.

This tree has co-dominant trunks. It has excellent health and good form. No treatment is recommended.

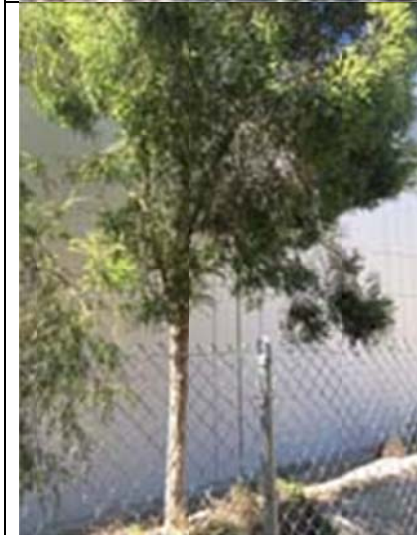
Tree OP361

This tree is too small to be protected by ordinance. It is growing on an adjacent property. It will be retained in the landscape. It has an appraised value of \$2,919.50.

This tree has a one-sided canopy. However, it has good health and good form. No treatment is recommended.

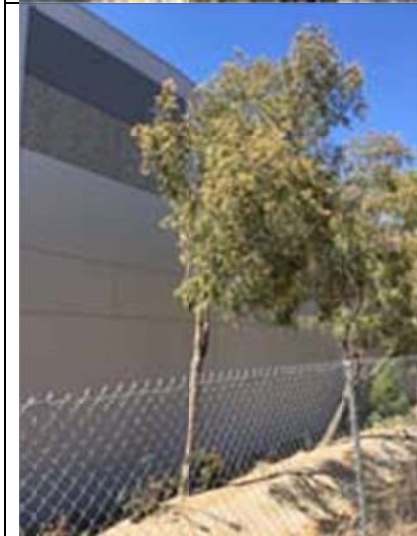
Tree OP362

This tree is too small to be protected by ordinance. It is growing on an adjacent property. It will be retained in the landscape. It has an appraised value of \$2,599.52.

This tree has excellent health and good form. No treatment is recommended.

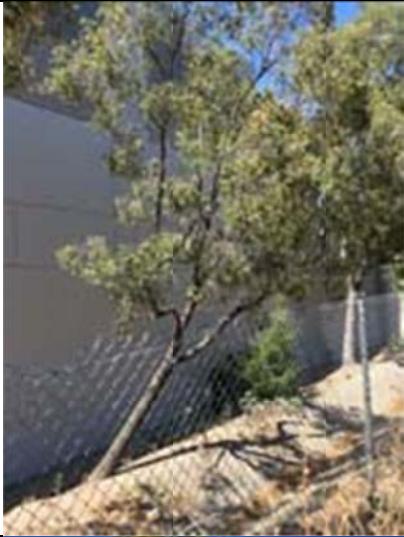
Tree OP363

This tree is too small to be protected by ordinance. It is growing on an adjacent property. It will be retained in the landscape. It has an appraised value of \$1,362.52.

This tree has co-dominant trunks. It has average health and average form. No treatment is recommended.

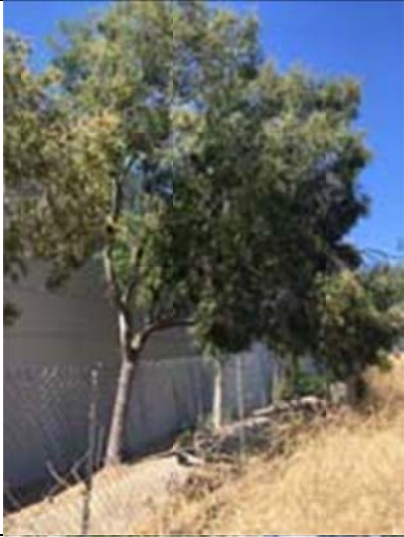
<p>Tree OP364 <i>Melaleuca linariifolia</i> – Narrow Leaf Paperbark</p> <p>This tree is too small to be protected by ordinance. It is growing on an adjacent property. It will be retained in the landscape. It has an appraised value of \$1,952.98.</p> <p>This tree is leaning. It has good health and average form. No treatment is recommended.</p>

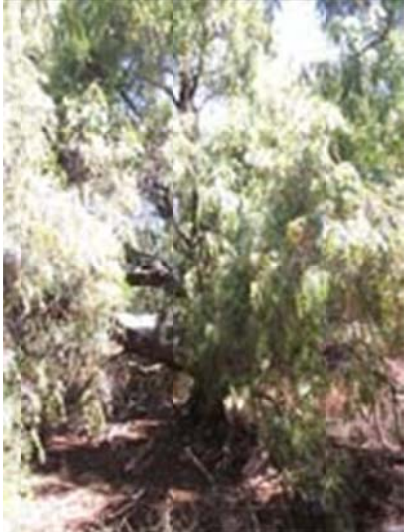
<p>Tree OP365 <i>Melaleuca linariifolia</i> – Narrow Leaf Paperbark</p> <p>This tree is too small to be protected by ordinance. It is growing on an adjacent property. It will be retained in the landscape. It has an appraised value of \$4,182.89.</p> <p>This tree has excellent health and good form. No treatment is recommended.</p>

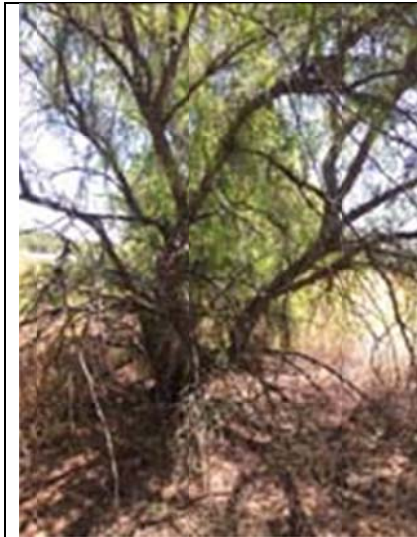
<p>Tree OP366 <i>Schinus molle</i> – California Pepper</p> <p>This tree is a prohibited species in Moorpark. It is growing on the adjacent property. This tree is intended to be retained in place.</p> <p>This tree has an accumulation of deadwood, but it is still healthy. It has excellent health and excellent form. No treatment is recommended.</p>

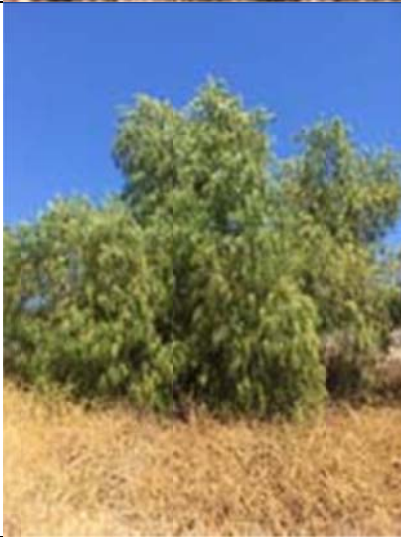
Tree OP367

This tree is a prohibited species in Moorpark. It is growing on the adjacent property. This tree is intended to be retained in place.

This tree has symptoms of drought stress, and there is deadwood in its canopy. It has good health and excellent form. No treatment is recommended.

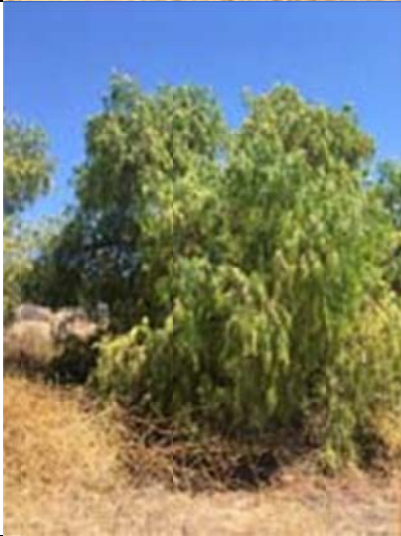
Tree OP368

This tree is a prohibited species in Moorpark. It is growing on the adjacent property. This tree is intended to be retained in place.

This tree has an accumulation of deadwood, but it is still healthy. It has excellent health and excellent form. No treatment is recommended.

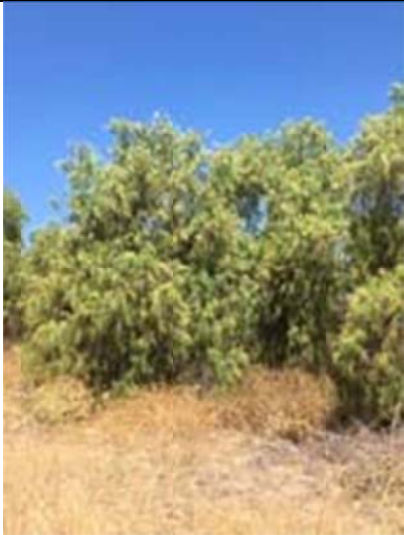
Tree OP369

This tree is a prohibited species in Moorpark. It is growing on the adjacent property. This tree is intended to be retained in place.

This tree has an accumulation of deadwood, but it is still healthy. It has excellent health and excellent form. No treatment is recommended.

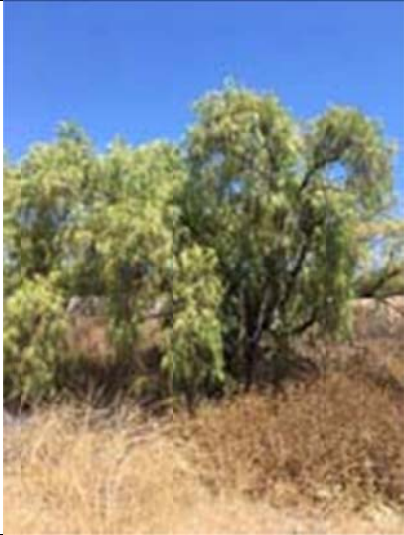
<p>Tree OP370 <i>Schinus molle</i> – California Pepper</p> <p>This tree is a prohibited species in Moorpark. It is growing on the adjacent property. This tree is intended to be retained in place.</p> <p>This tree has an accumulation of deadwood, but it is still healthy. It has excellent health and excellent form. No treatment is recommended.</p>

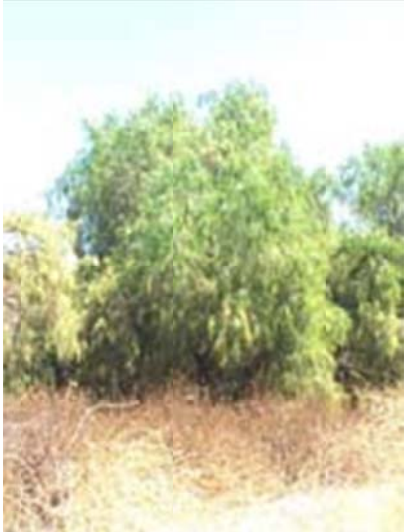
<p>Tree OP371 <i>Schinus molle</i> – California Pepper</p> <p>This tree is a prohibited species in Moorpark. It is growing on the adjacent property. This tree is intended to be retained in place.</p> <p>This tree has an accumulation of deadwood, but it is still healthy. It has excellent health and excellent form. No treatment is recommended.</p>

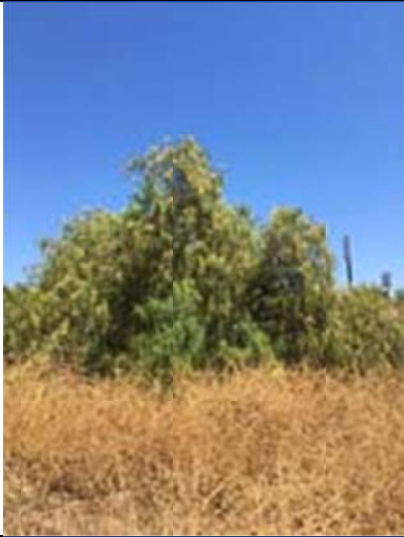
<p>Tree OP372 <i>Schinus molle</i> – California Pepper</p> <p>This tree is a prohibited species in Moorpark. It is growing on the adjacent property.</p> <p>The proposed new parking lot will encroach within the critical root zone of this tree. This tree is intended to be retained in place throughout the project even though some of its roots may be impacted.</p> <p>This tree has an accumulation of deadwood, but it is still healthy. It has excellent health and good form.</p>

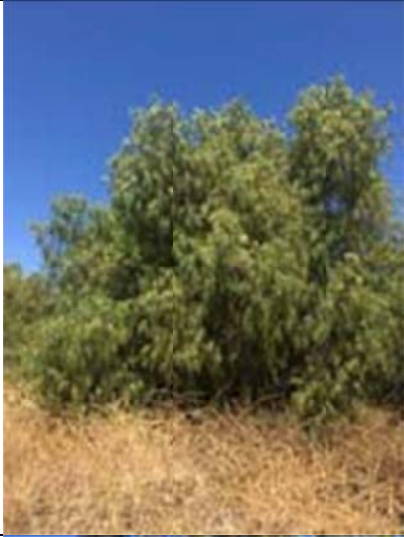
<p>Tree OP373 <i>Schinus molle</i> – California Pepper</p> <p>This tree is a prohibited species in Moorpark. It is growing on the adjacent property.</p> <p>The proposed new parking lot will encroach within the critical root zone of this tree. This tree is intended to be retained in place throughout the project even though some of its roots may be impacted.</p> <p>This tree has an accumulation of deadwood, but it is still healthy. It has excellent health and excellent form.</p>

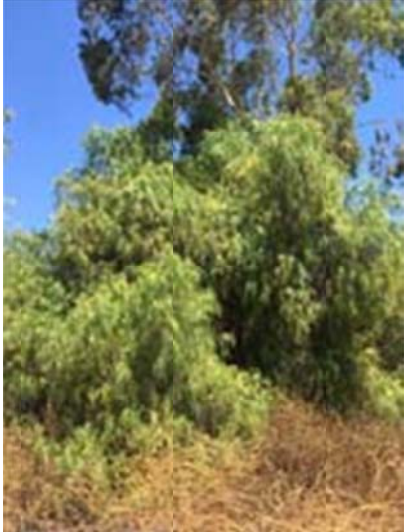
<p>Tree OP374 <i>Schinus molle</i> – California Pepper</p> <p>This tree is a prohibited species in Moorpark. It is growing on the adjacent property.</p> <p>The proposed new parking lot will encroach within the critical root zone of this tree. This tree is intended to be retained in place throughout the project even though some of its roots may be impacted.</p> <p>This tree has an accumulation of deadwood, but it is still healthy. It has excellent health and excellent form.</p>

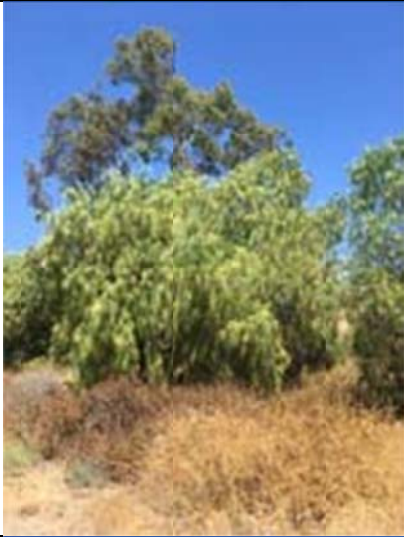
<p>Tree OP375 <i>Schinus molle</i> – California Pepper</p> <p>This tree is a prohibited species in Moorpark. It is growing on the adjacent property.</p> <p>The proposed new parking lot will encroach within the critical root zone of this tree. This tree is intended to be retained in place throughout the project even though some of its roots may be impacted.</p> <p>This tree has an accumulation of deadwood, but it is still healthy. It has excellent health and excellent form.</p>

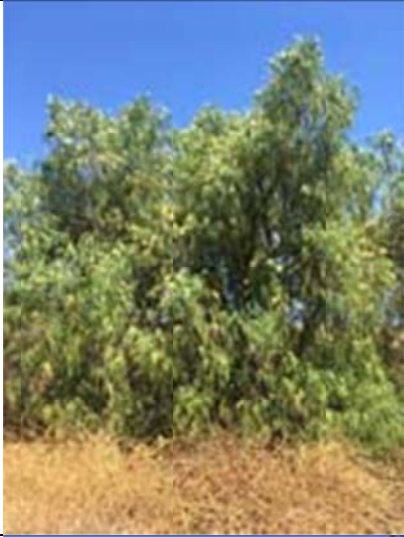
<p>Tree OP376 <i>Schinus molle</i> – California Pepper</p> <p>This tree is a prohibited species in Moorpark. It is growing on the adjacent property.</p> <p>The proposed new parking lot will encroach within the critical root zone of this tree. This tree is intended to be retained in place throughout the project even though some of its roots may be impacted.</p> <p>This tree has an accumulation of deadwood, but it is still healthy. It has excellent health and excellent form.</p>

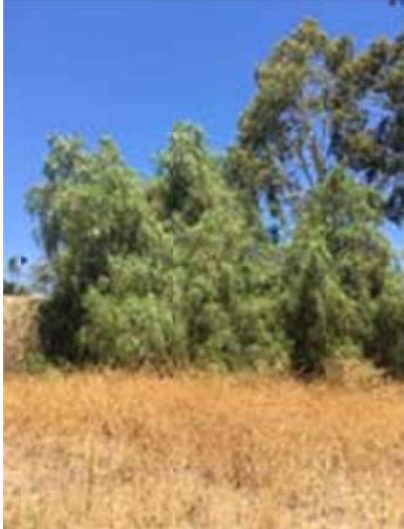
<p>Tree OP377 <i>Schinus molle</i> – California Pepper</p> <p>This tree is a prohibited species in Moorpark. It is growing on the adjacent property.</p> <p>The proposed new parking lot will encroach within the critical root zone of this tree. This tree is intended to be retained in place throughout the project even though some of its roots may be impacted.</p> <p>This tree has an accumulation of deadwood, but it is still healthy. It has excellent health and excellent form.</p>

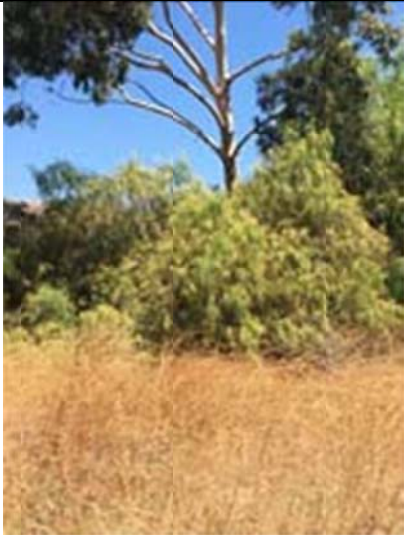
<p>Tree OP378 <i>Schinus molle</i> – California Pepper</p> <p>This tree is a prohibited species in Moorpark. It is growing on the adjacent property.</p> <p>The proposed new parking lot will encroach within the critical root zone of this tree. This tree is intended to be retained in place throughout the project even though some of its roots may be impacted.</p> <p>This tree has an accumulation of deadwood, but it is still healthy. It has excellent health and excellent form.</p>

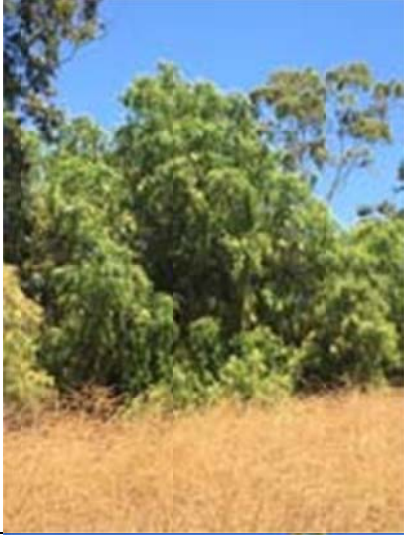
<p>Tree OP379 <i>Schinus molle</i> – California Pepper</p> <p>This tree is a prohibited species in Moorpark. It is growing on the adjacent property.</p> <p>The proposed new parking lot will encroach within the critical root zone of this tree. This tree is intended to be retained in place throughout the project even though some of its roots may be impacted.</p> <p>This tree has symptoms of drought stress and a history of being suppressed by competition with its neighbors. Despite this, it still has good health and excellent form.</p>

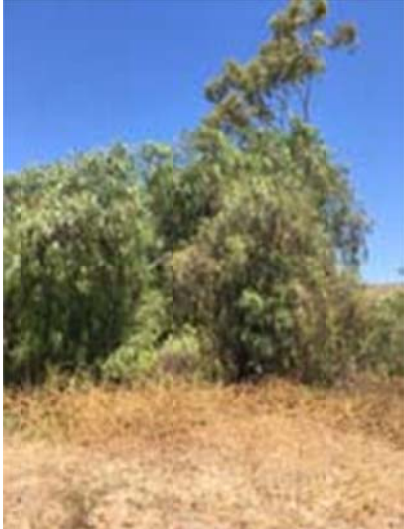
<p>Tree OP380 <i>Schinus molle</i> – California Pepper</p> <p>This tree is a prohibited species in Moorpark. It is growing on the adjacent property.</p> <p>The proposed new parking lot will encroach within the critical root zone of this tree. This tree is intended to be retained in place throughout the project even though some of its roots may be impacted.</p> <p>This tree has an accumulation of deadwood, but it is still healthy. It has excellent health and excellent form.</p>

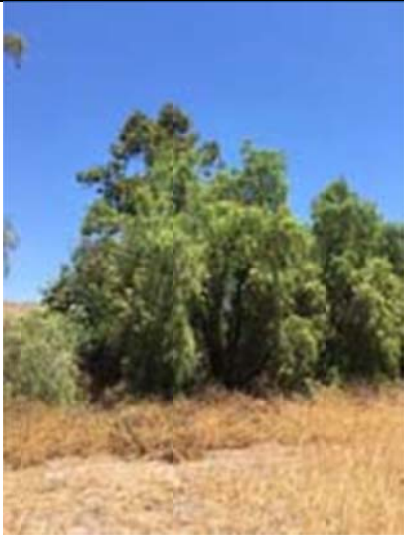
<p>Tree OP381 <i>Schinus molle</i> – California Pepper</p> <p>This tree is a prohibited species in Moorpark. It is growing on the adjacent property.</p> <p>The proposed new parking lot will encroach within the critical root zone of this tree. This tree is intended to be retained in place throughout the project even though some of its roots may be impacted.</p> <p>This tree has multi-stem co-dominant trunks. It has excellent health and good form.</p>

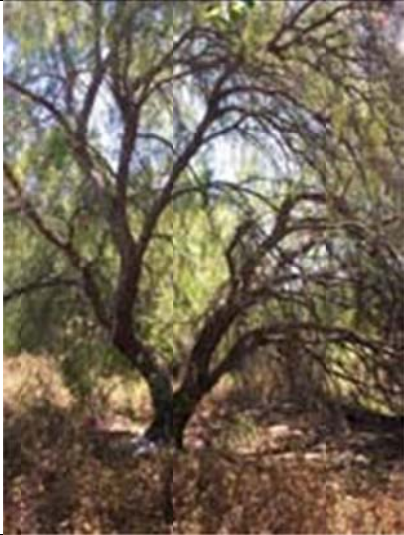
<p>Tree OP382 <i>Schinus molle</i> – California Pepper</p> <p>This tree is a prohibited species in Moorpark. It is growing on the adjacent property.</p> <p>The proposed new parking lot will encroach within the critical root zone of this tree. This tree is intended to be retained in place throughout the project even though some of its roots may be impacted.</p> <p>This tree has an accumulation of deadwood, but it is still healthy. It has excellent health and excellent form.</p>

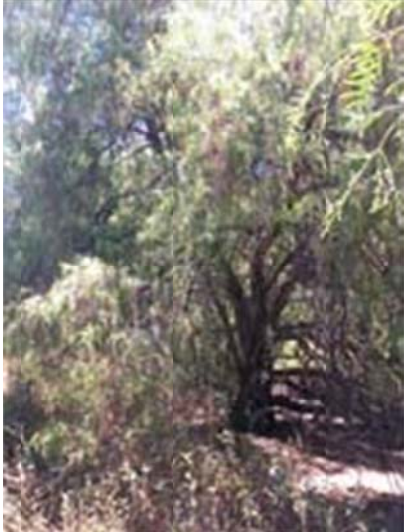
<p>Tree OP383 <i>Schinus molle</i> – California Pepper</p> <p>This tree is a prohibited species in Moorpark. It is growing on the adjacent property.</p> <p>The proposed new parking lot will encroach within the critical root zone of this tree. This tree is intended to be retained in place throughout the project even though some of its roots may be impacted.</p> <p>This tree has an accumulation of deadwood, but it is still healthy. It has excellent health and excellent form.</p>

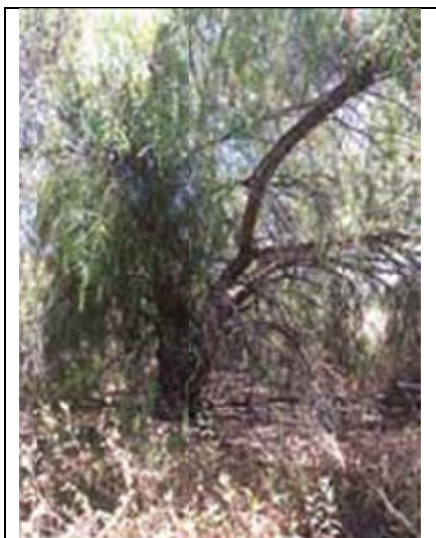
<p>Tree OP385 <i>Schinus molle</i> – California Pepper</p> <p>This tree is a prohibited species in Moorpark. It is growing on the adjacent property.</p> <p>The proposed new parking lot will encroach within the critical root zone of this tree. This tree is intended to be retained in place throughout the project even though some of its roots may be impacted.</p> <p>This tree has an accumulation of deadwood, but it is still healthy. It has excellent health and excellent form.</p>
---	---

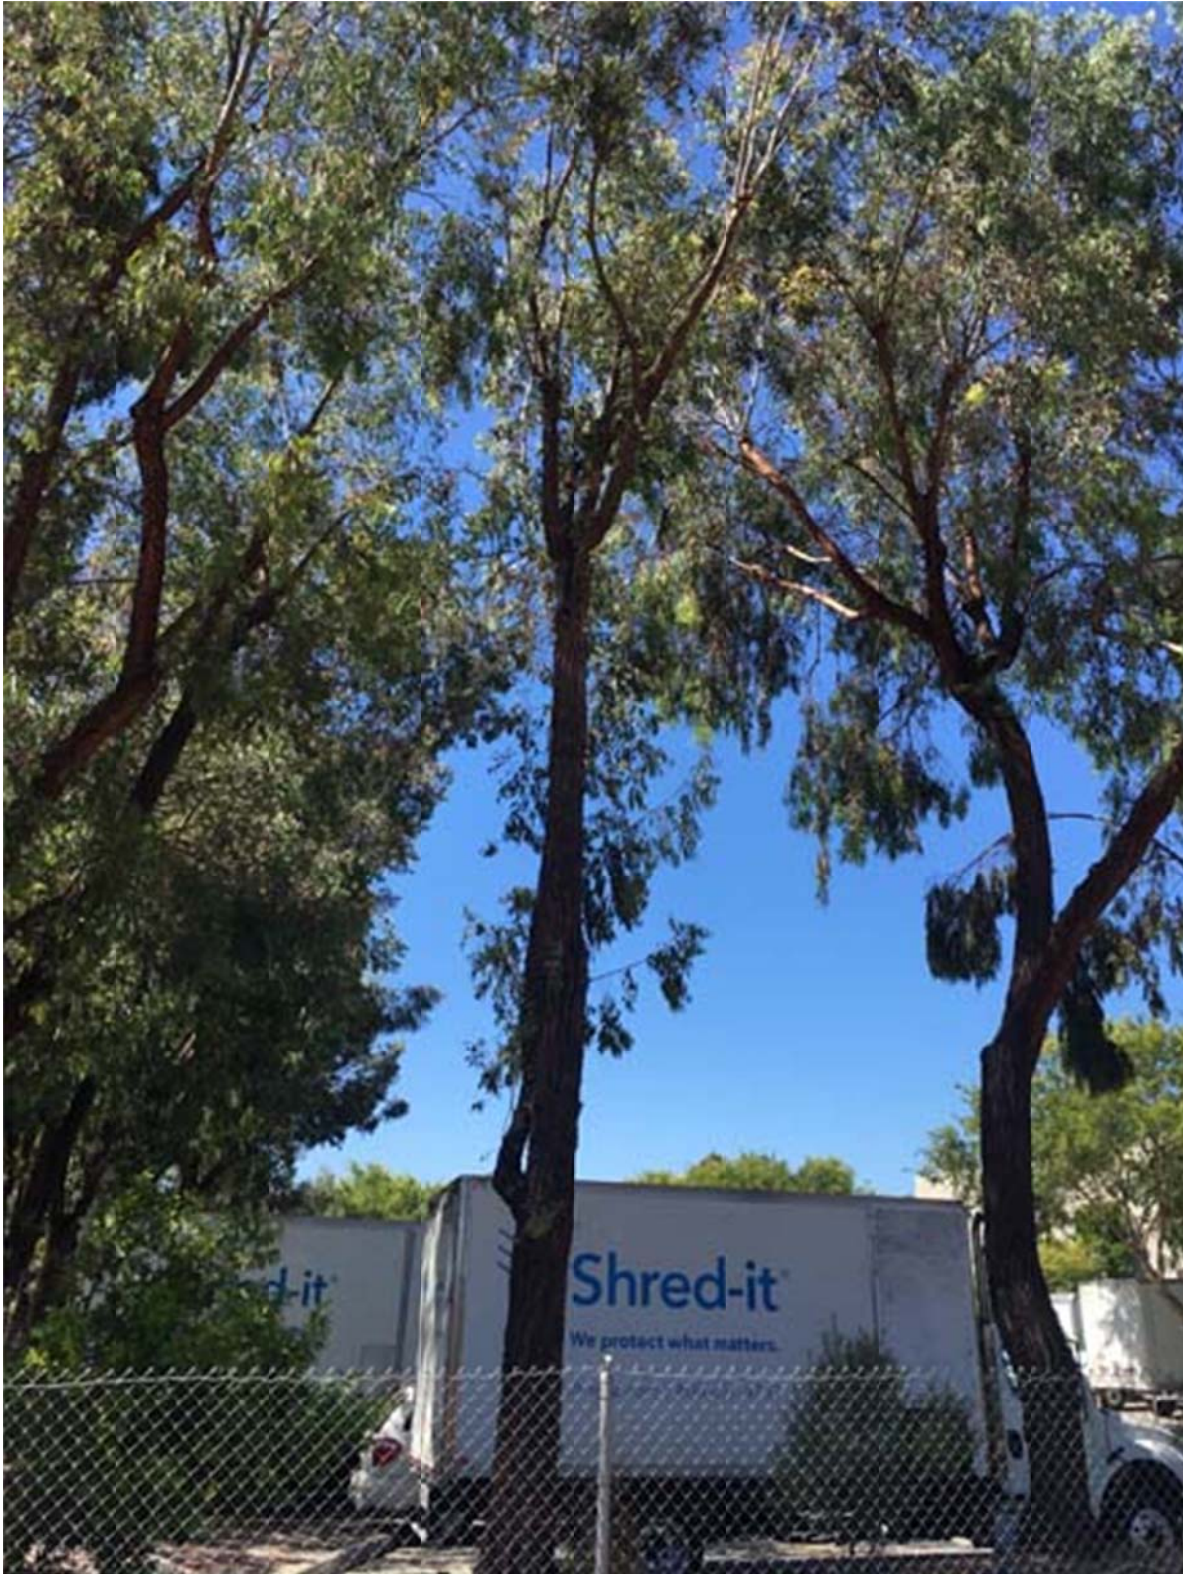
Figure 312: Tree OP312

<p>Tree OP312 <i>Eucalyptus sideroxylon</i> – Red Ironbark</p> <p>This tree is a prohibited species in Moorpark. It is growing on the adjacent property.</p> <p>The proposed new parking lot will encroach within the critical root zone of this tree. This tree is intended to be retained in place throughout the project even though some of its roots may be impacted.</p> <p>This tree has co-dominant trunks. It has good health and average form. No treatment is recommended.</p>
