6000 Condor Dr. Arborist Report

Prepared for HPA inc.
c/o Tammi Bailey
18831 Bardeen Ave. Suite 100
Irvine, CA 92612

Prepared by James Komen
BCMA WE-9909B
RCA #555

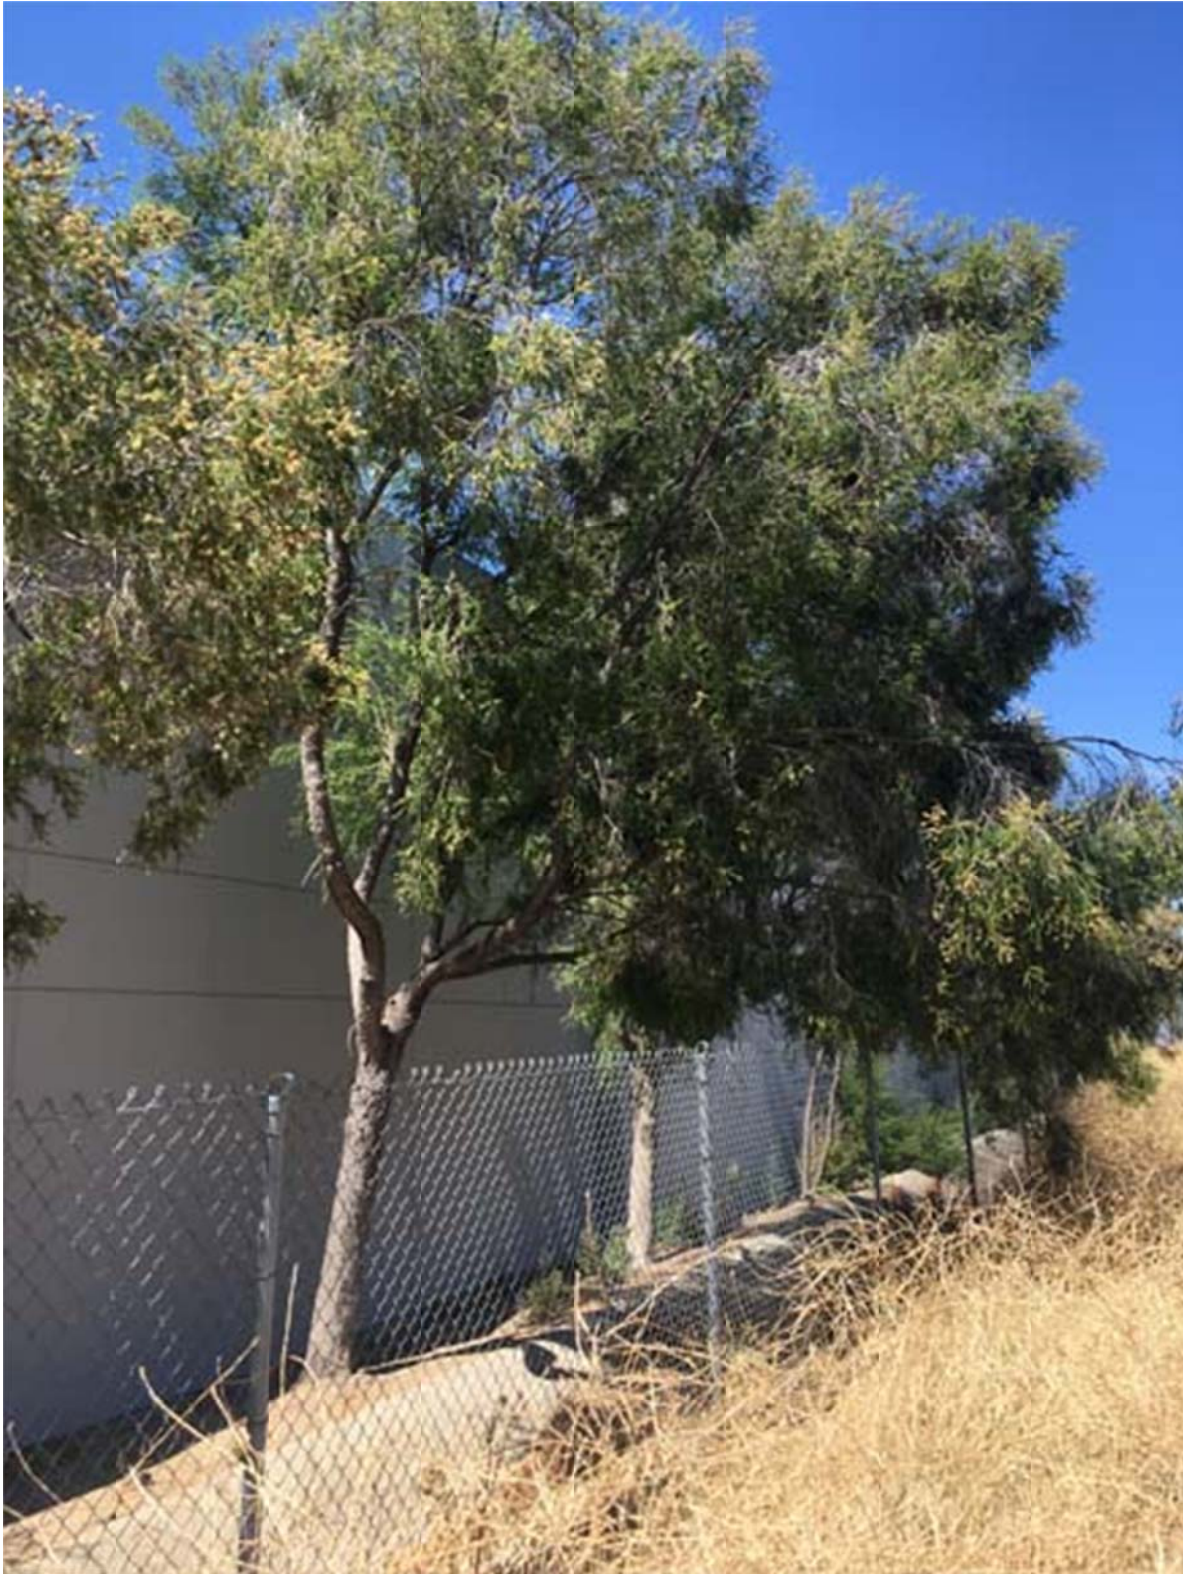
Figure 364: Tree OP364

<p>Tree OP364 <i>Melaleuca linariifolia</i> – Narrow Leaf Paperbark</p> <p>This tree is too small to be protected by ordinance. It is growing on an adjacent property. It will be retained in the landscape. It has an appraised value of \$1,952.98.</p> <p>This tree is leaning. It has good health and average form. No treatment is recommended.</p>

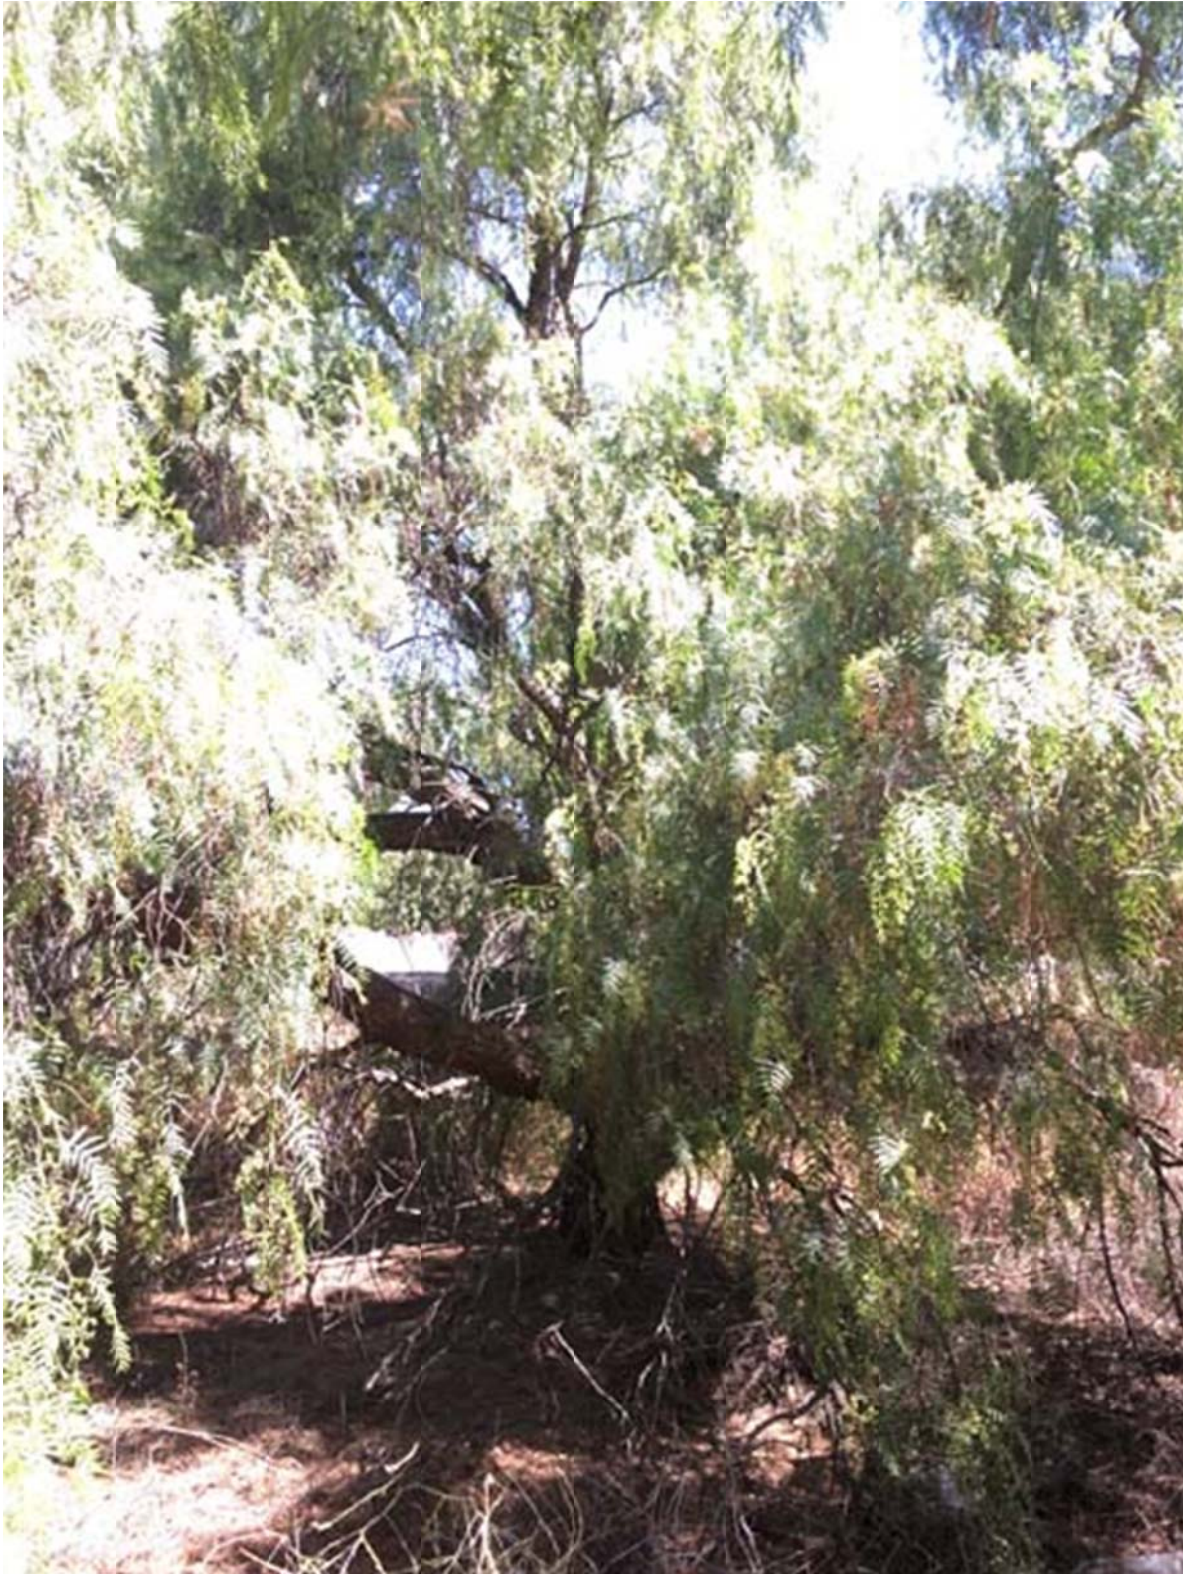
Figure 365: Tree OP365

<p>Tree OP365 <i>Melaleuca linariifolia</i> – Narrow Leaf Paperbark</p> <p>This tree is too small to be protected by ordinance. It is growing on an adjacent property. It will be retained in the landscape. It has an appraised value of \$4,182.89.</p> <p>This tree has excellent health and good form. No treatment is recommended.</p>

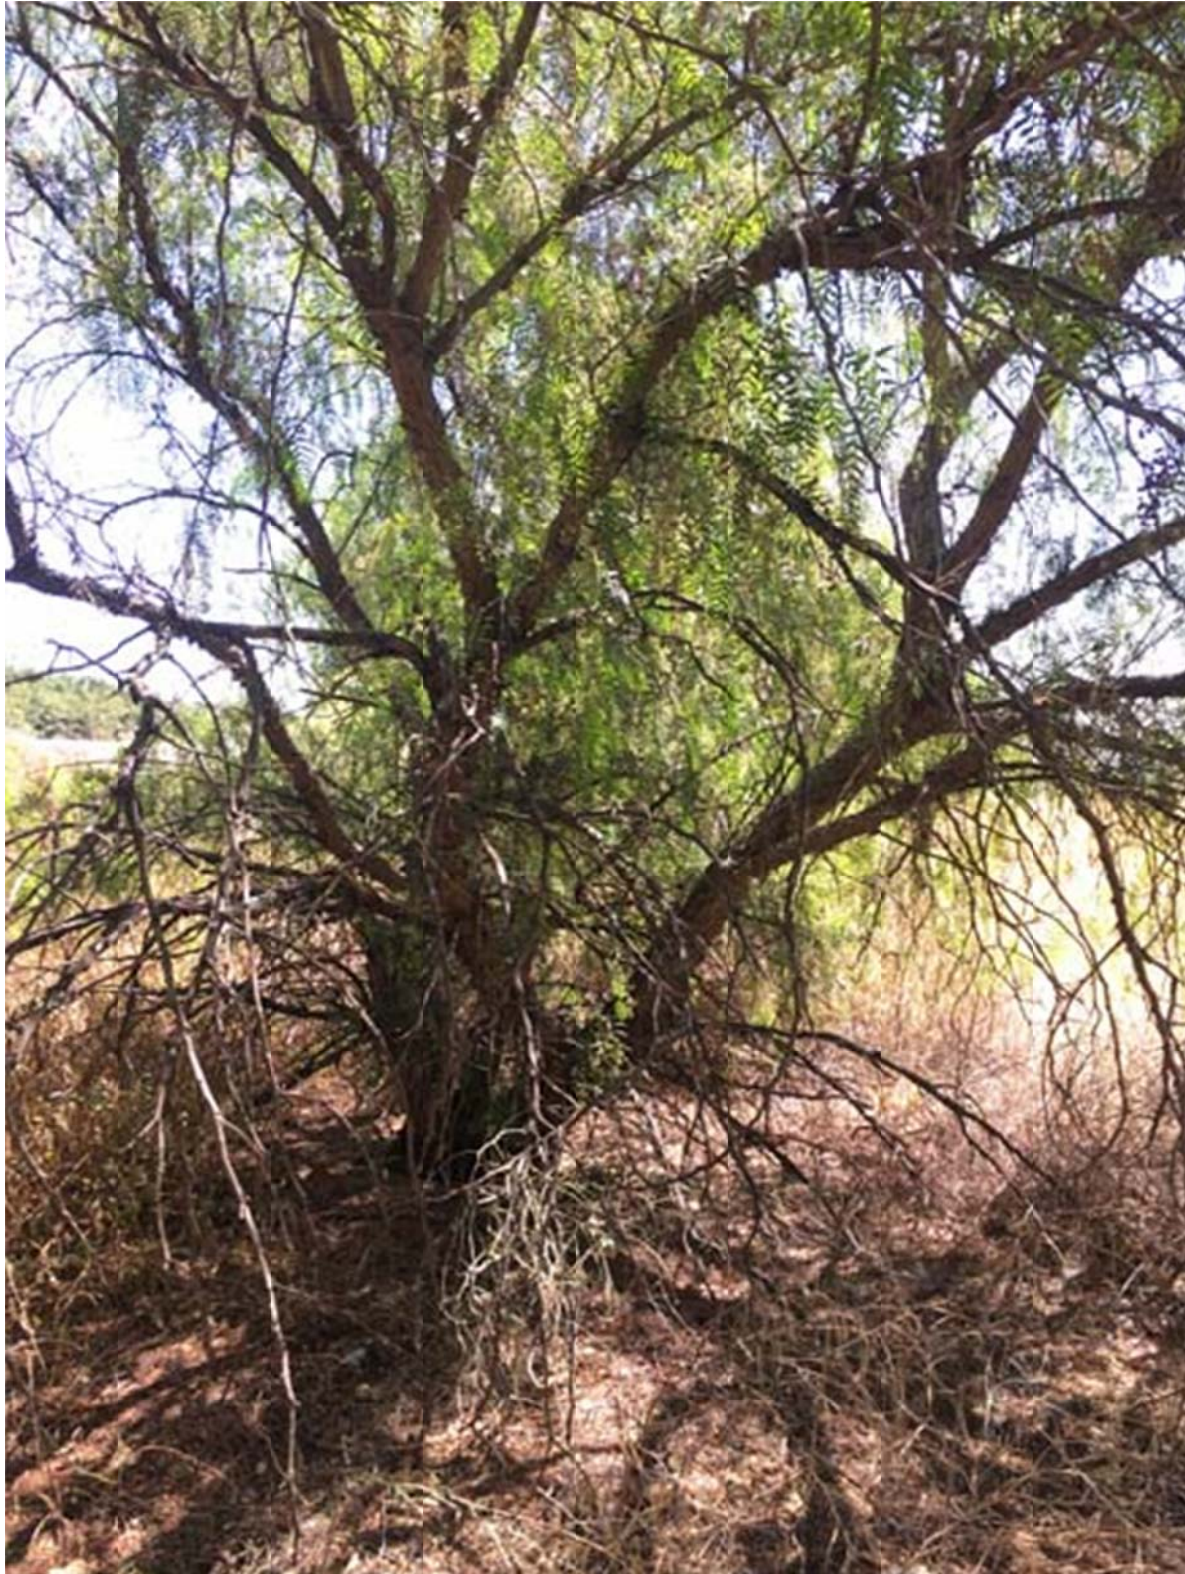
Figure 366: Tree OP366

<p>Tree OP366 <i>Schinus molle</i> – California Pepper</p> <p>This tree is a prohibited species in Moorpark. It is growing on the adjacent property. This tree is intended to be retained in place.</p> <p>This tree has an accumulation of deadwood, but it is still healthy. It has excellent health and excellent form. No treatment is recommended.</p>

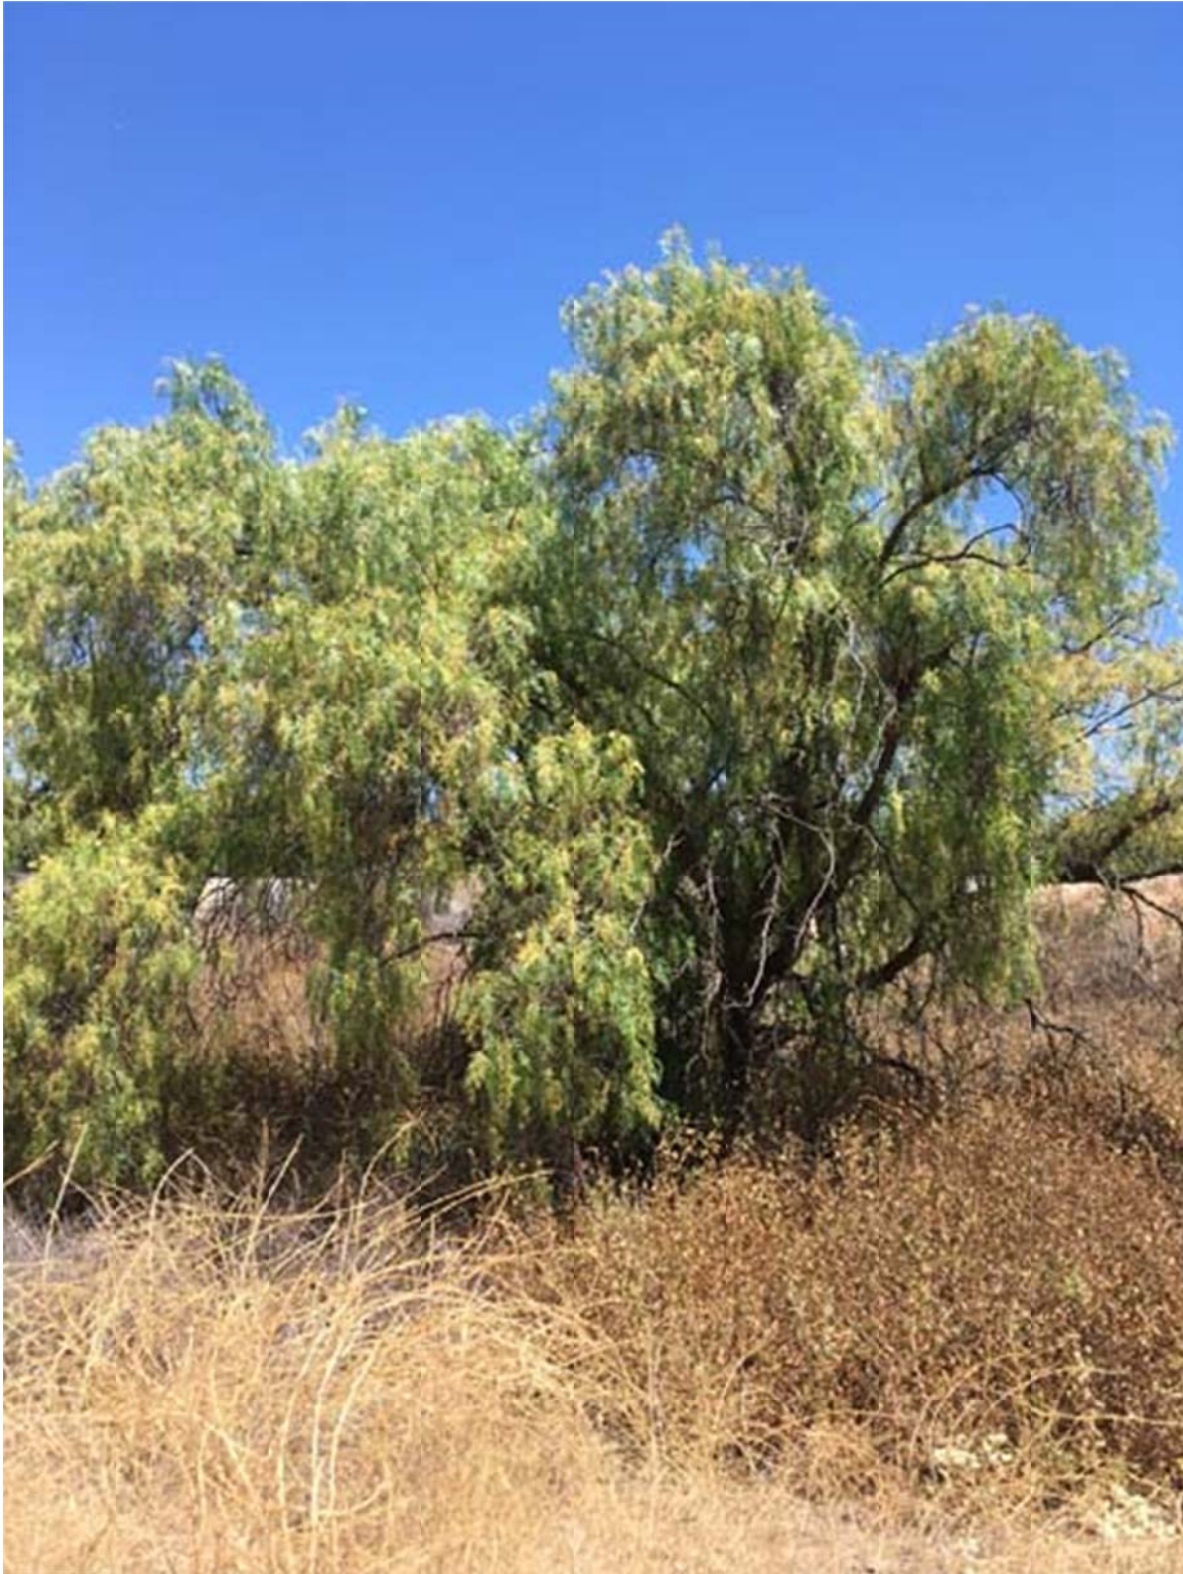
Figure 370: Tree OP370

<p>Tree OP370 <i>Schinus molle</i> – California Pepper</p> <p>This tree is a prohibited species in Moorpark. It is growing on the adjacent property. This tree is intended to be retained in place.</p> <p>This tree has an accumulation of deadwood, but it is still healthy. It has excellent health and excellent form. No treatment is recommended.</p>

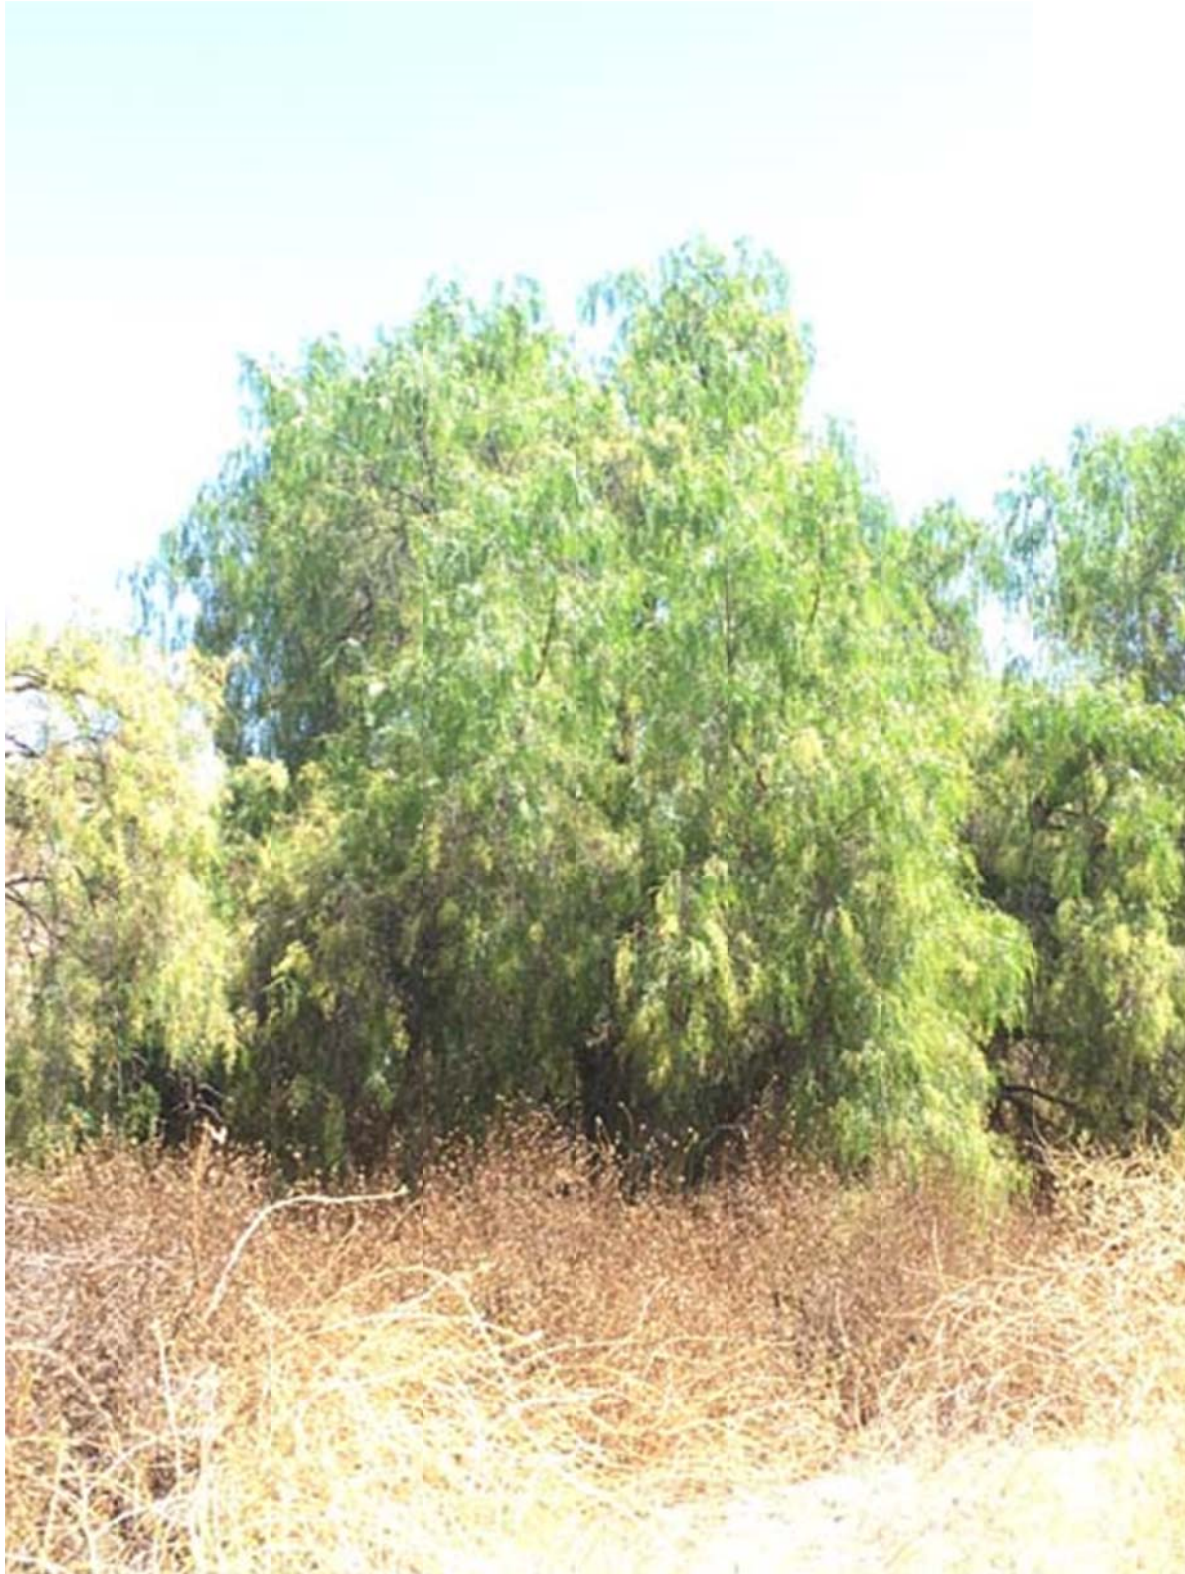
Figure 371: Tree OP371

<p>Tree OP371 <i>Schinus molle</i> – California Pepper</p> <p>This tree is a prohibited species in Moorpark. It is growing on the adjacent property. This tree is intended to be retained in place.</p> <p>This tree has an accumulation of deadwood, but it is still healthy. It has excellent health and excellent form. No treatment is recommended.</p>

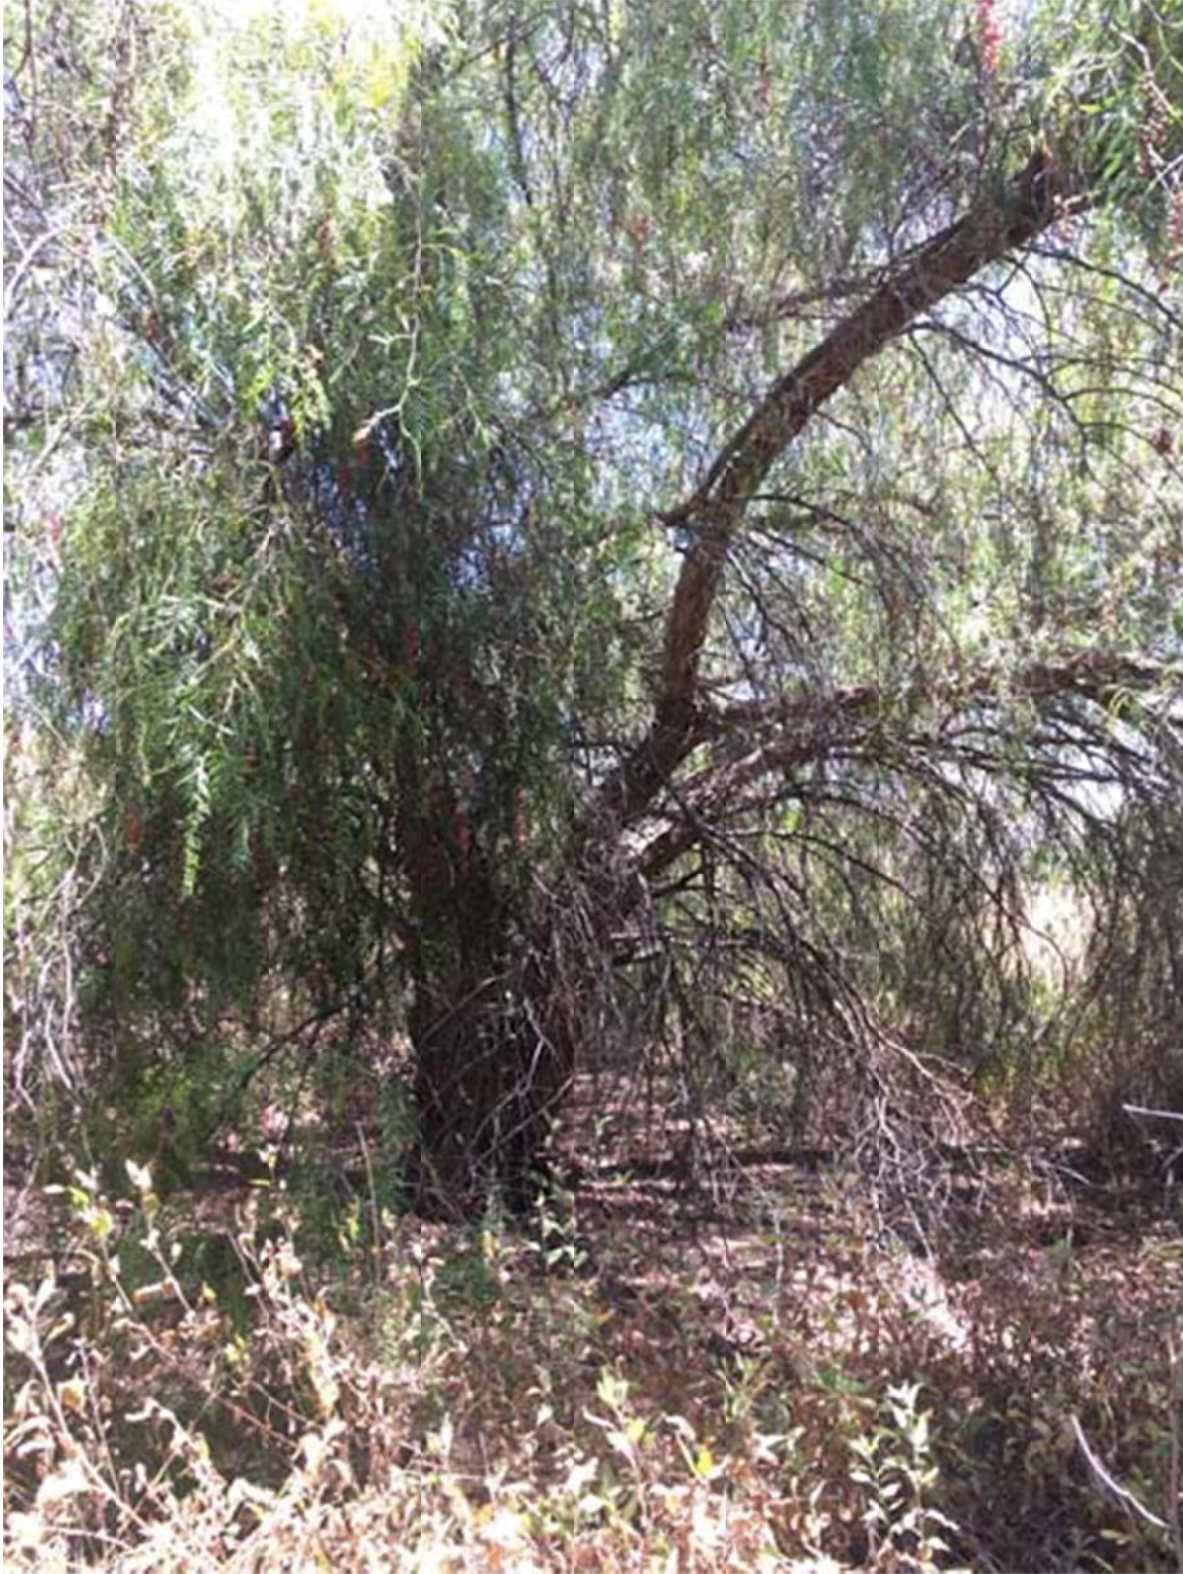
Figure 384: Tree OP384

<p>Tree OP384 <i>Schinus molle</i> – California Pepper</p> <p>This tree is a prohibited species in Moorpark. It is growing on the adjacent property.</p> <p>The proposed new parking lot will encroach within the critical root zone of this tree. This tree is intended to be retained in place throughout the project even though some of its roots may be impacted.</p> <p>This tree has co-dominant trunk defects. It has excellent health and average form.</p>
