**GEOTECHNICAL REPLY TO PEER REVIEW,  
PRELIMINARY CITY STORM DRAIN OUTFALL  
SLOPE RETREAT ASSESSMENT,  
& GEOTECHNICAL REPORT UPDATE STUDY**  
Proposed Glenview Terrace Residential Subdivision  
2880 San Bruno Avenue  
San Bruno, California

February 7, 2020  
GEO Project No. 91-04747-A  
2172.01.00

**RE: GEOTECHNICAL REPLY TO PEER REVIEW,  
PRELIMINARY CITY STORM DRAIN OUTFALL  
SLOPE RETREAT ASSESSMENT,  
& GEOTECHNICAL REPORT UPDATE STUDY**  
Proposed Glenview Terrace Residential Subdivision  
2880 San Bruno Avenue  
San Bruno, California  
GEO #91-04747-A (2172)

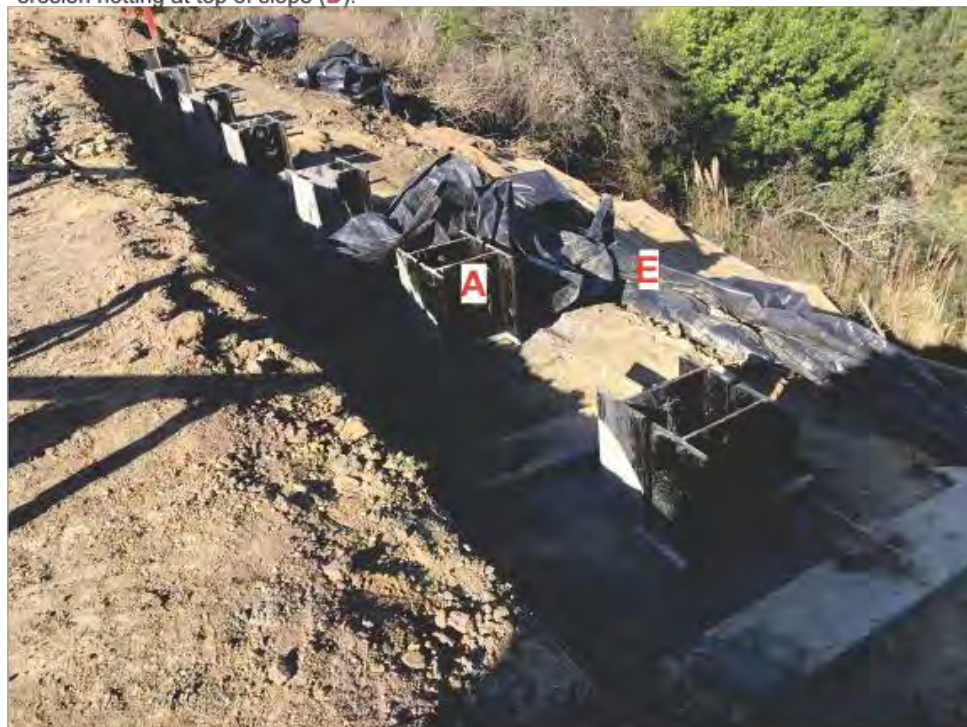
Photo 2. Westerly view along top of slope line of double I-beam reinforced concrete stitch piers (A). Edge of west-bound lane of San Bruno Avenue on left of view. Temporary plastic tarp (E).

Fig. 2. February 2, 2020 observation of storm drain and slope retreat mitigation.

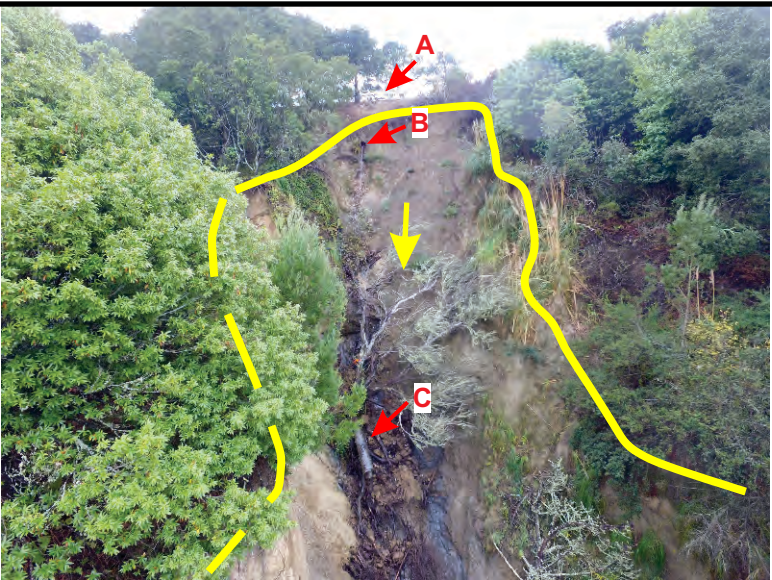
Image 1. South view of 12/04/19 erosional gorge & escarpment from storm drain pipe. **A** is edge of roadway; **B** is current CMP outfall; **C** is detached pipe segment.

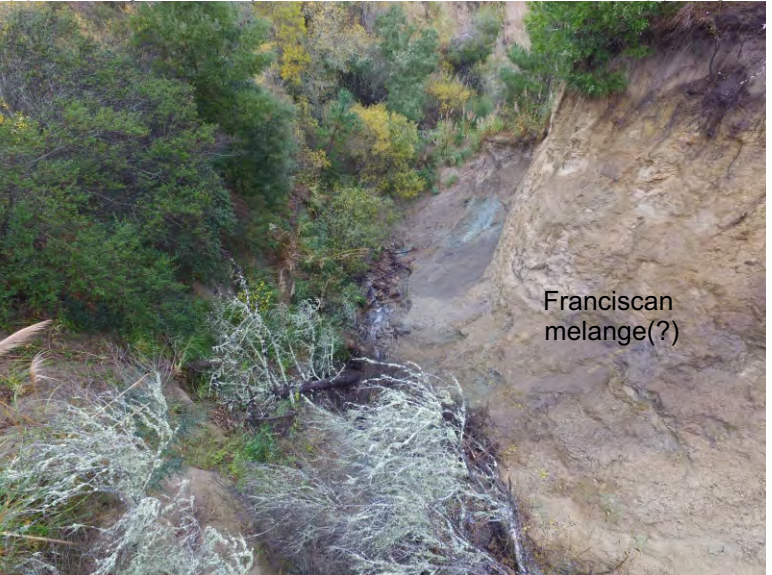
Image 2. North downstream view of confluence of gorge with San Bruno Creek.

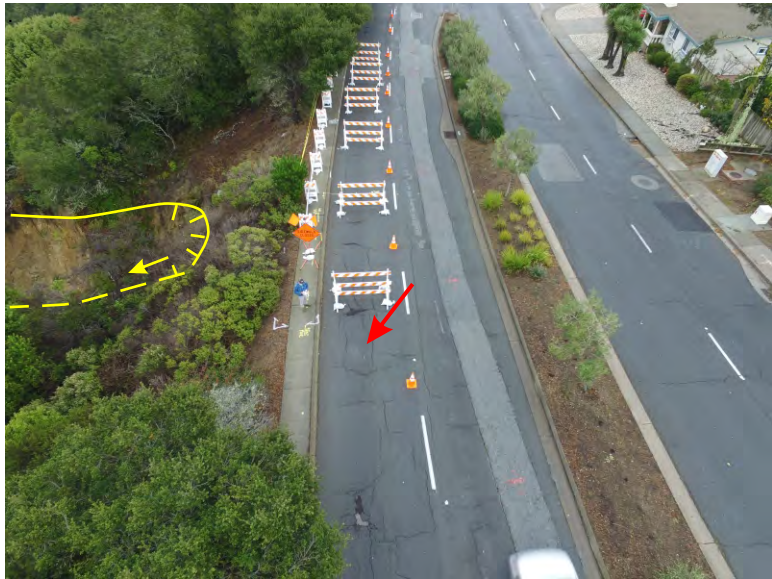
Image 3. East view of headward erosion toward San Bruno Avenue. Arrow points to dilapidated asphalt roadway.

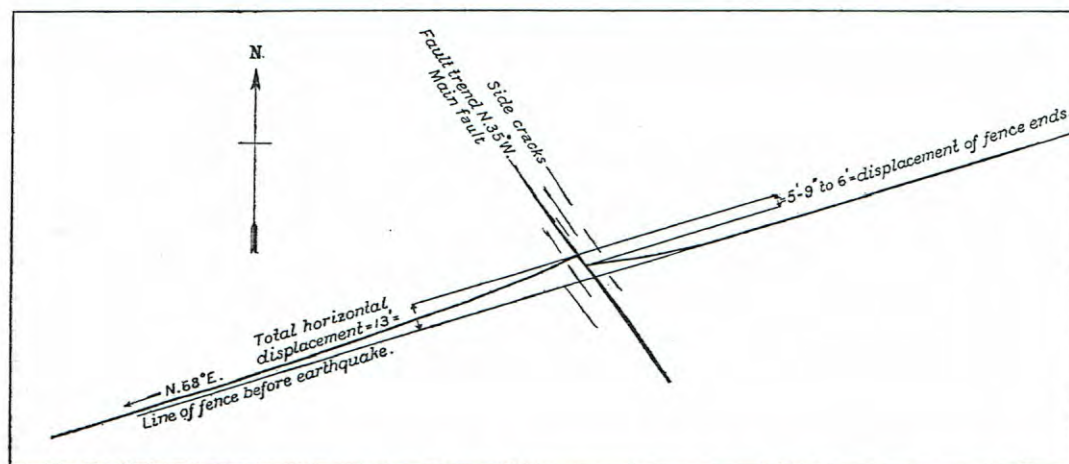
FIG. 29. — Offset fence southeast of Mussel Rock, showing distribution of deformation on either side of fault.

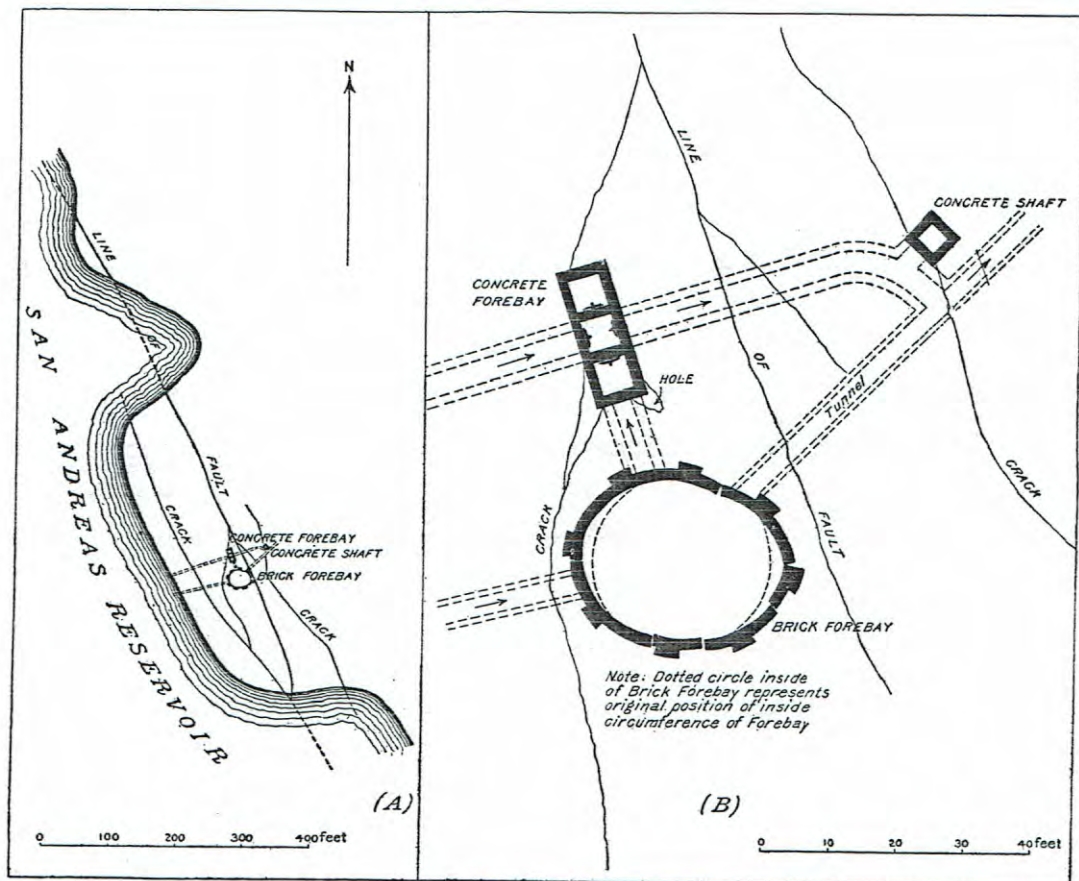
FIG. 35. — Main and auxiliary faults, San Andreas Lake. A. General Plan. B. Detail. After H. Schussler.

The walls are about a foot thick, and are strongly buttressed. As a result of the shock this gate-well was shattered and deformed so that it became oval in cross-section, the east and west diameter becoming 30 feet and the north and south diameter about 21 or 22 feet, as shown in the accompanying figure. A new concrete gate-well a few feet to the north, rectangular in cross-section and having three compartments, each  $2.5 \times 2.5$  feet, was uninjured, altho on the line of the same branching crack. A concrete manhole 45 feet northeast of the damaged gate-well, also on an auxiliary crack, was similarly unaffected. (See fig. 35.)

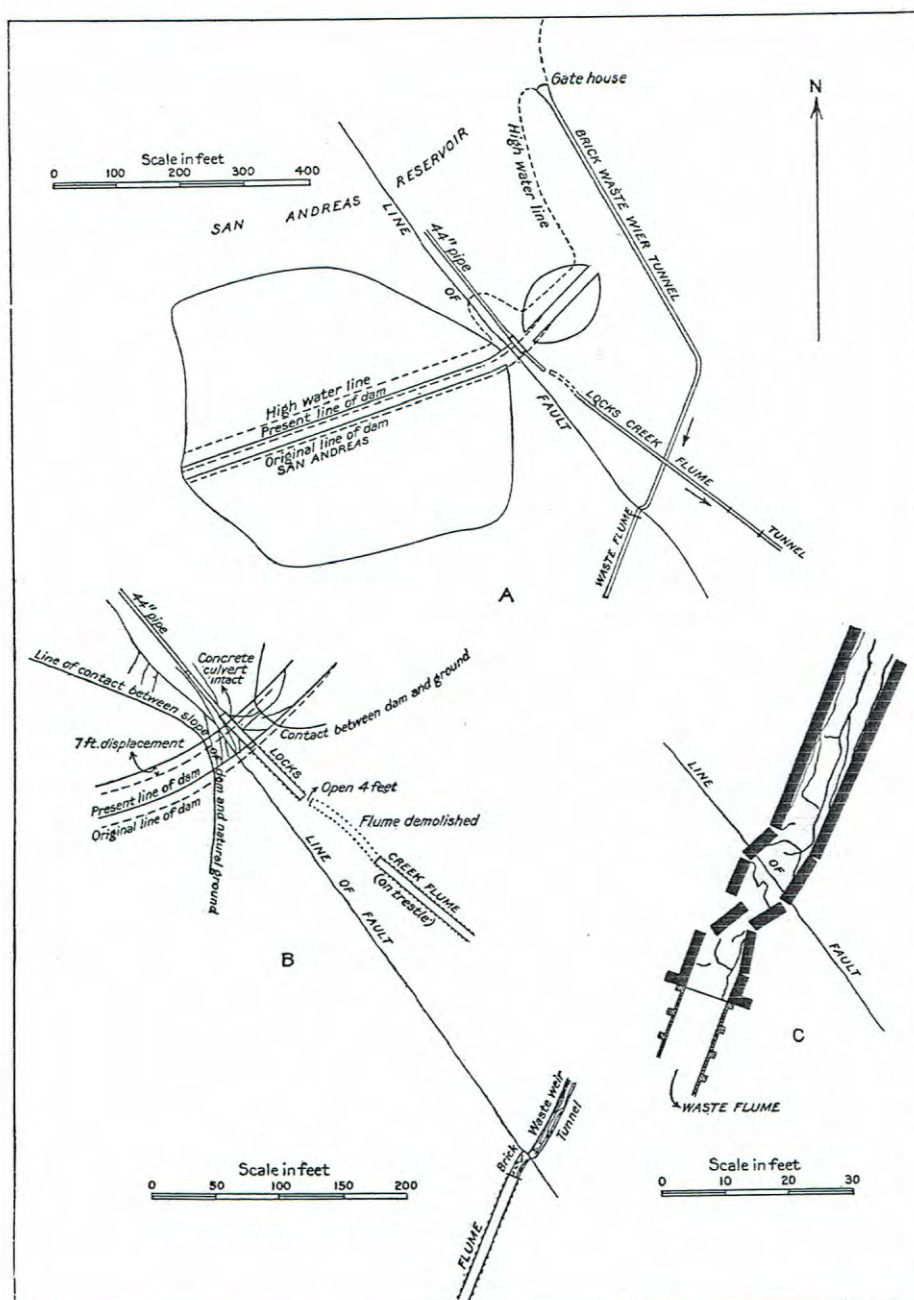
FIG. 36.—Intersection of San Andreas dam by fault. A. Plan of dam in two parts, with rock between. B. Relation of dam to waste weir tunnel. C. Detail of waste weir tunnel.

About 125 yards below the dam the fault past thru the lower end of a massively built brick and cement waste weir tunnel. The inside diameter of the tunnel was about 7 or 8 feet and the walls were 17 inches thick. At the intersection of the fault within this structure, the latter was stove in and smashed in pieces for a distance of about 28 feet. The tunnel was offset about 5 feet. In the shattering of the brick work, the cracks and ruptures in no case followed the cement between the bricks, but broke across the latter; the cement and its adhesion to the bricks being stronger than the bricks themselves, altho the bricks were evidently carefully selected and of good quality. Several cracks traversed the tunnel longitudinally and obliquely to the northeast of the part that was demolished. (See fig. 36.)

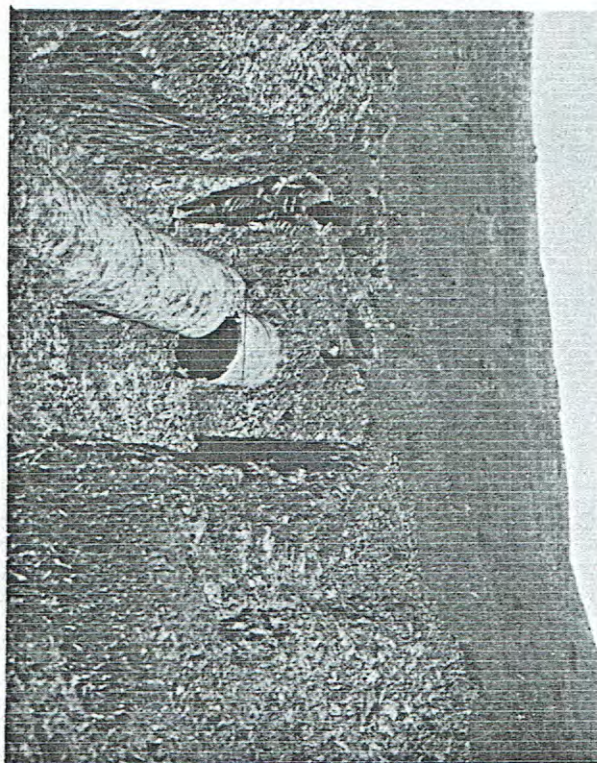
A. Offset in 30-inch water-pipe by fault, Northwest of San Andreas Lake, A. O. L.

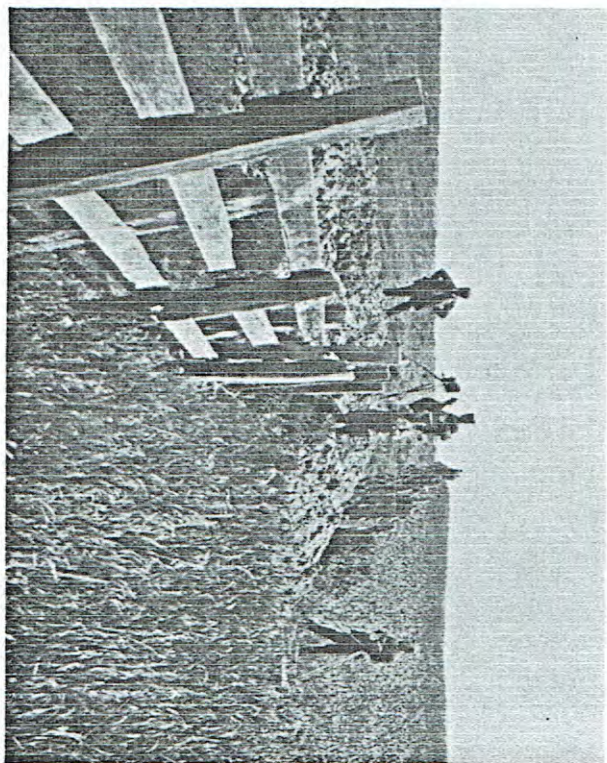
yards, due doubtless to the establishment of a partial vacuum within the pipe by the sudden withdrawal of the water from the arch in the pipe at the time of the shock, owing either to the leakage below, or the propulsion of the water induced by the shock. (See plate 60B.)

B. Collapse of 30-inch water-pipe northwest of San Andreas Lake, R. L. H.

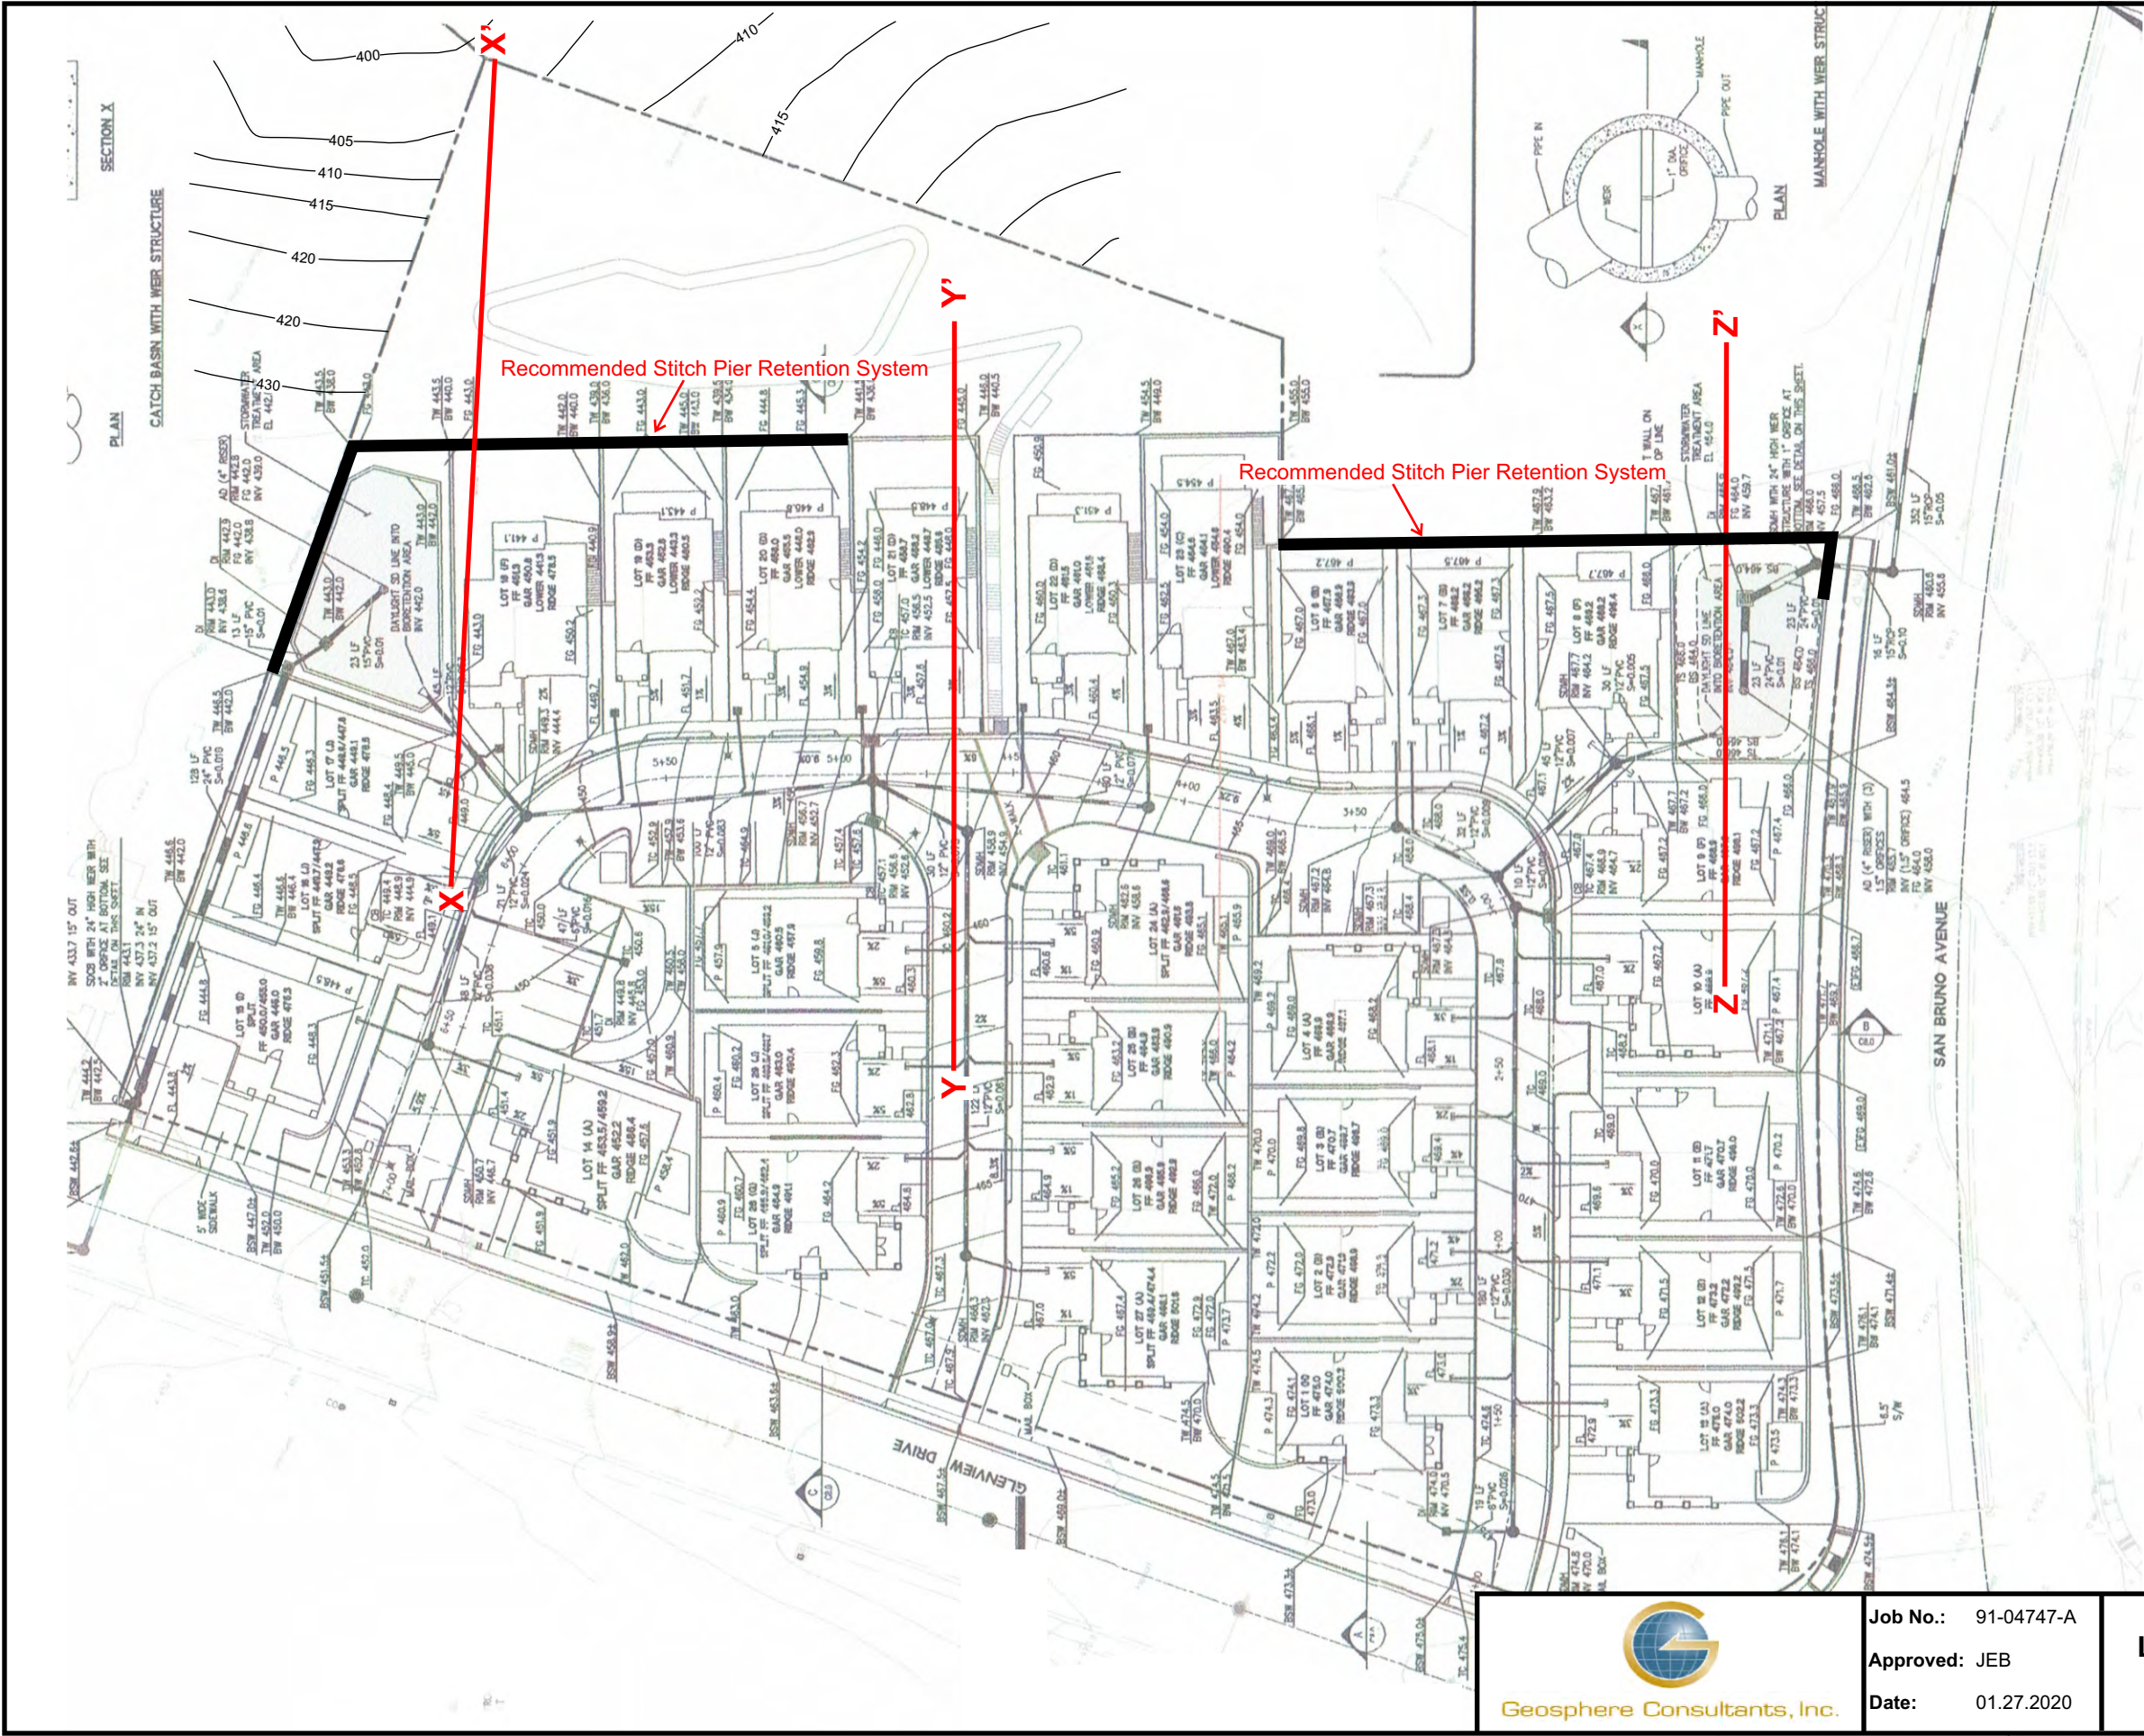
Based on the results of our analyses, we judge that the proposed development is feasible, with an acceptable FoS for slope stability under both static and seismic loading conditions provided that our recommendations are followed. We judge the northeastern and southeastern portions of the property, typically where a slope of steeper than approximately 3:1 H:V exists, would benefit from a stitch pier retention system to mitigate potential encroachment into the proposed bio-retention basin locations by perceived off-site surficial slope instability (Plate G6). Geotechnical parameters for stitch pier design are presented in Appendix B.

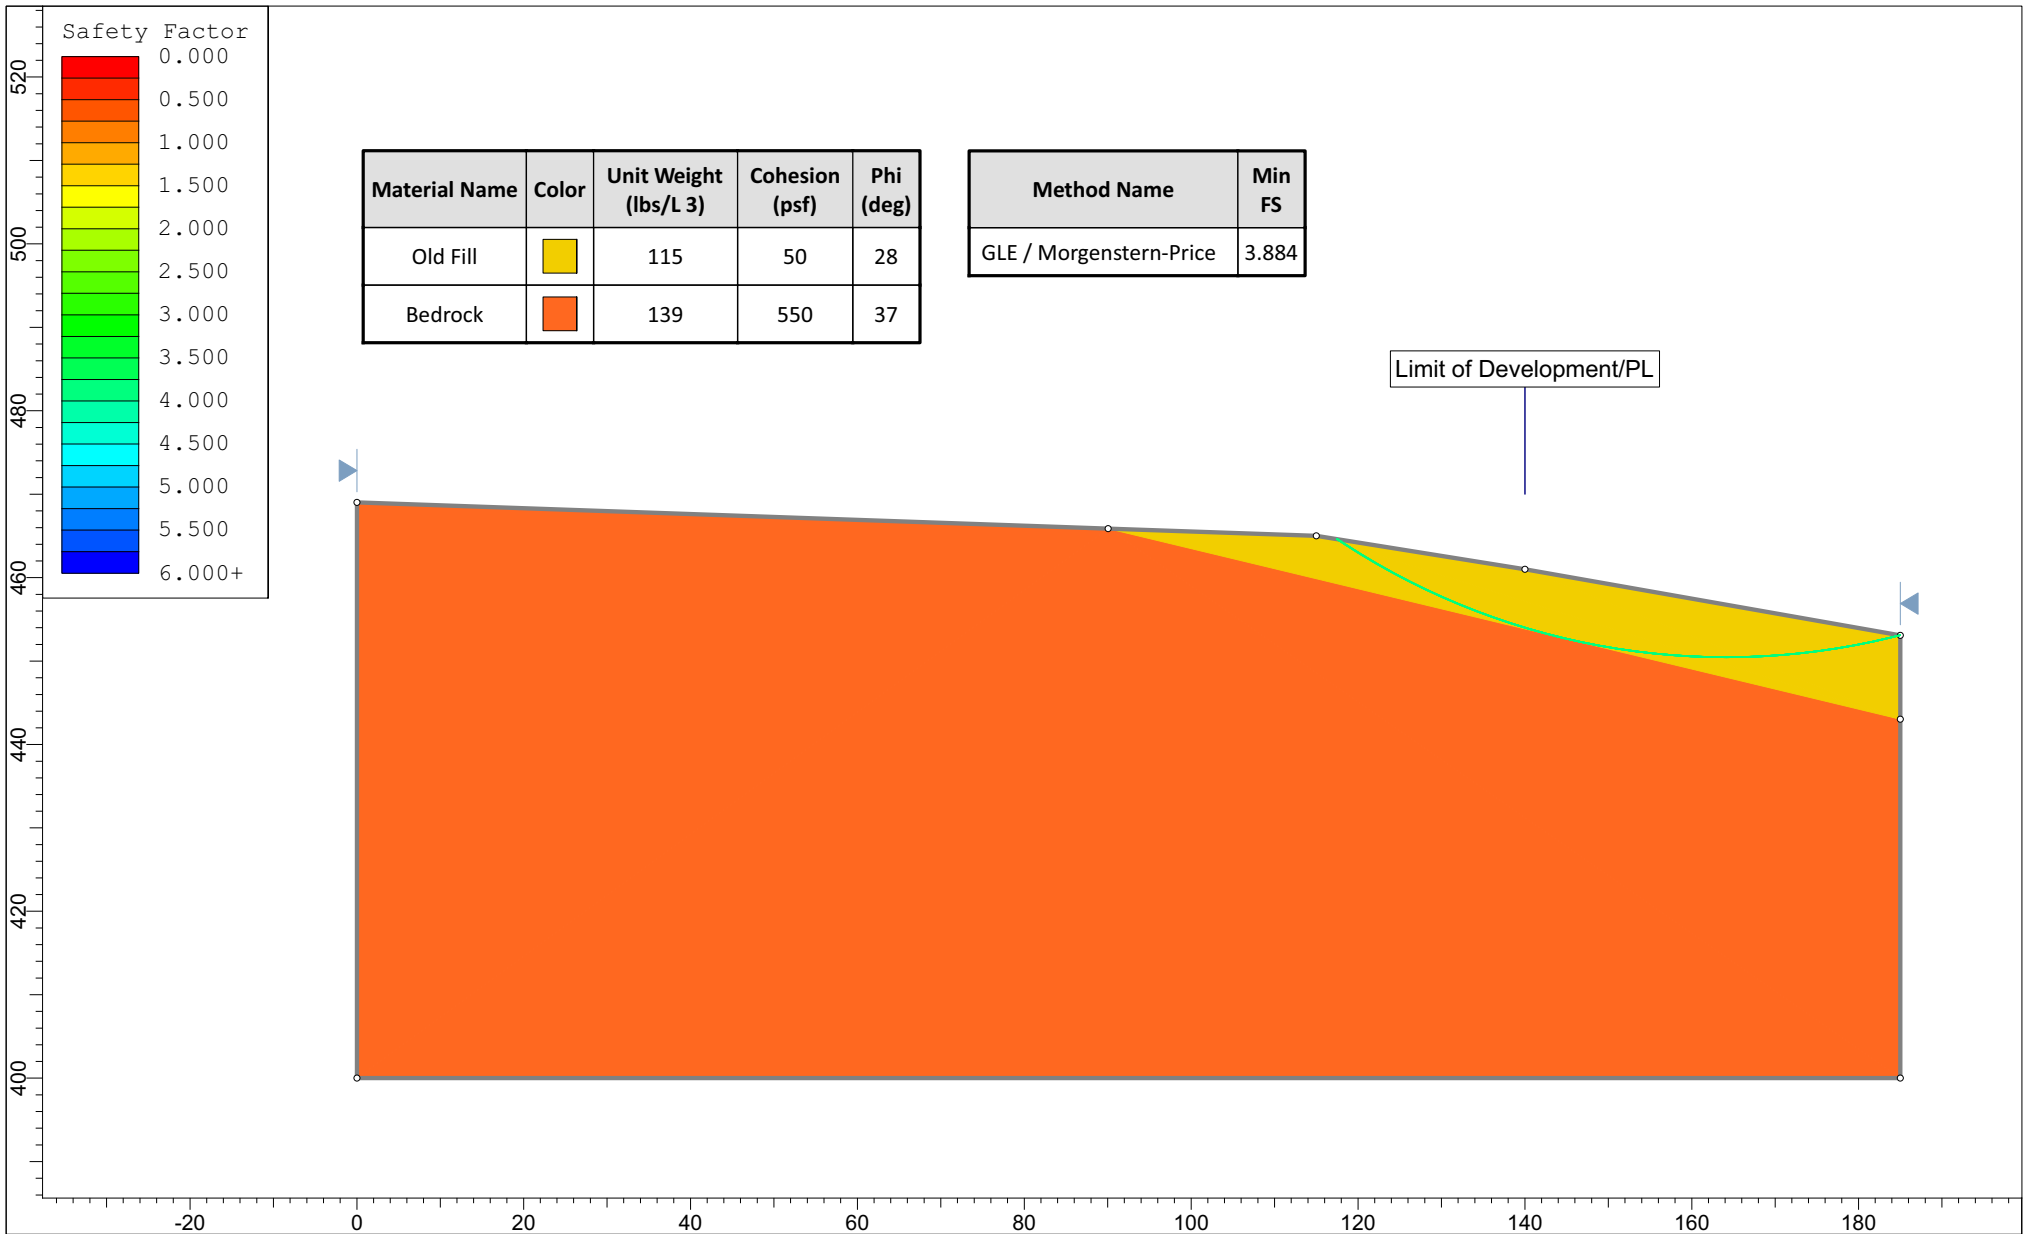
Section Z-Z' transects the southeastern corner of the project area where the second bio-retention basin is sited. Boring data from this area indicates there is up to 6½ feet of artificial fill on mélange (Appendix E). The grading plan suggests the finished grade will be approximately 6 feet higher than existing condition on the eastern side. Our analysis indicates that subsurface materials are generally stable under current conditions and under pseudo-static load (Plates G11, G12). They also indicate that proposed slope has acceptable static and pseudo-static FoS when constructed in accordance with our remedial grading and drainage recommendations (Plates G17, G18; Appendices A and B). However, due to potential encroachment from retrogression of surficial landsliding on the slope below the proposed bio-retention basin in the southeast corner of the site, we have recommend seismic slope stability be enhanced from installation of a stitch pier retention system as depicted on Plate G6. Provided our remedial grading and drainage recommendations in Appendices A and B are followed, we anticipate a low risk for adverse impact to the eastern side of the project area by surficial soil creep.

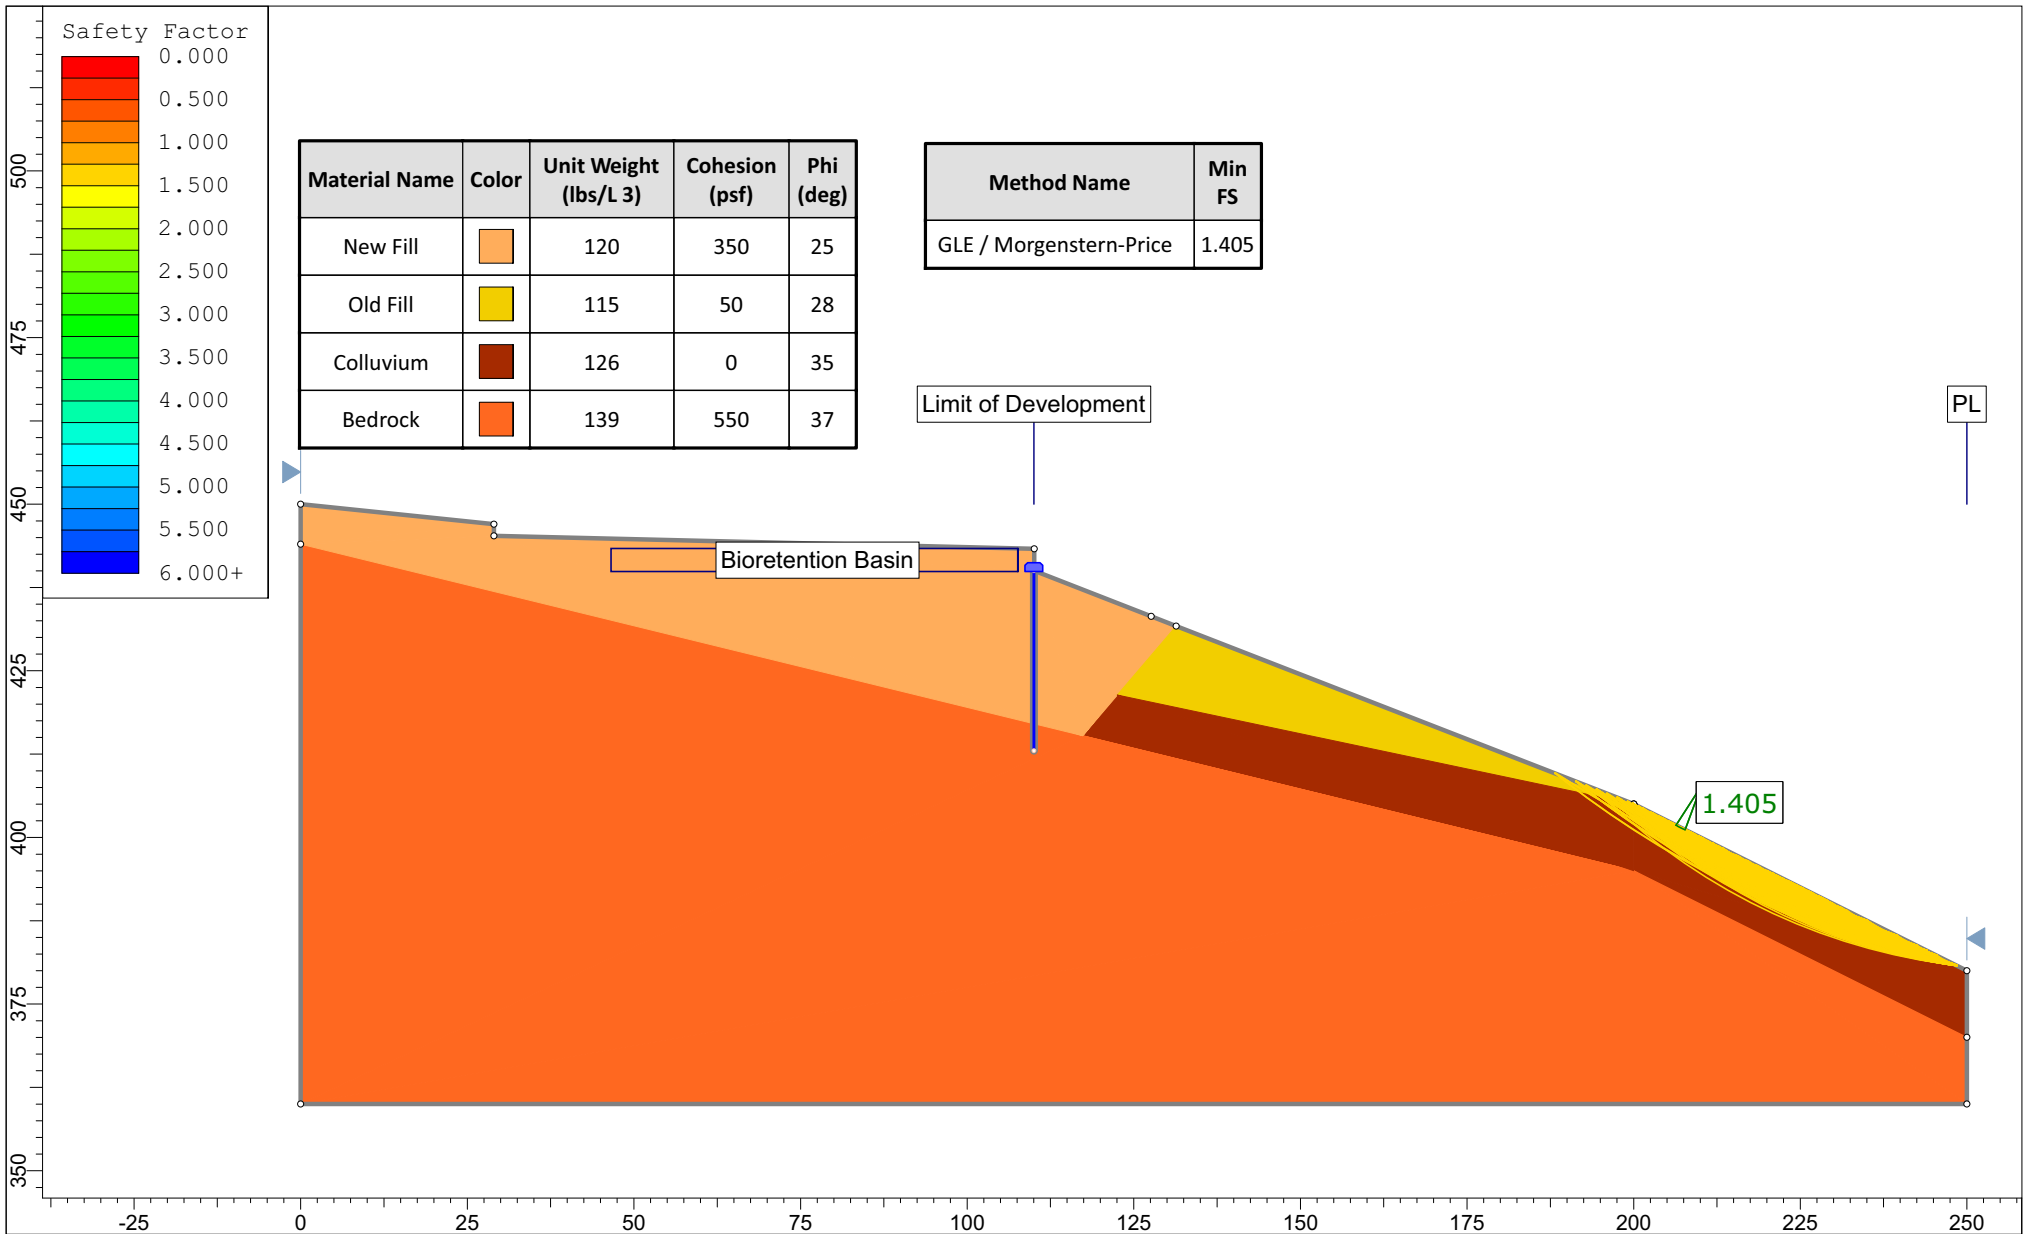
**Plate**  
**G13**

Based on our analysis, proposed grading within the actual limits of the development has acceptable static and pseudo-static FoS (Plates G13, G14), as all potential failure surfaces had computed FoS exceeding 1.5 and 1.1, respectively. However, as previously indicated for existing conditions and shown on Plates G13 and G14, minimum FoS for static and seismic conditions downslope of the development remain at 1.4 and 0.7, respectively. Since these conditions present potential for encroachment of shallow landsliding in the eastern margin of the development, in Appendix B we recommend seismic slope stability be enhanced by installing a stitch pier system on the property line in the northeastern part of the property (Plate G6). Provided our remedial grading and drainage recommendations in Appendices A and B are followed, we anticipate a low risk for adverse impact to the eastern side of the project area by surficial soil creep.
