4057 N HAYVENHURST AVENUE, ENCINO

Protected Tree Report

Permits #21010-30000-02481, 21010-30000-02484, and 21010-30000-03246

September 2021

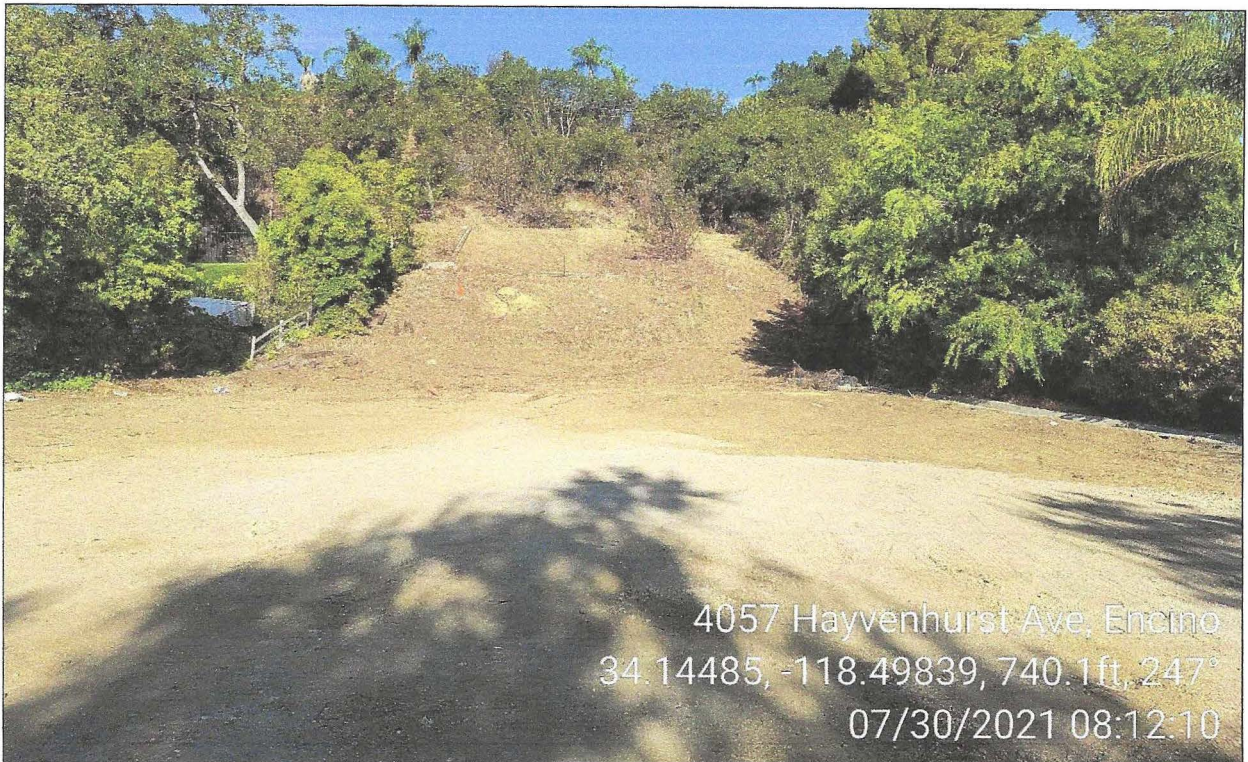
Photo 1: View of property as viewed from the east, facing west. Photo depicts developed concrete pad in foreground, disturbed lands in the center of the site, and landscaped/ornamental vegetation along the left and right portions of the photo.

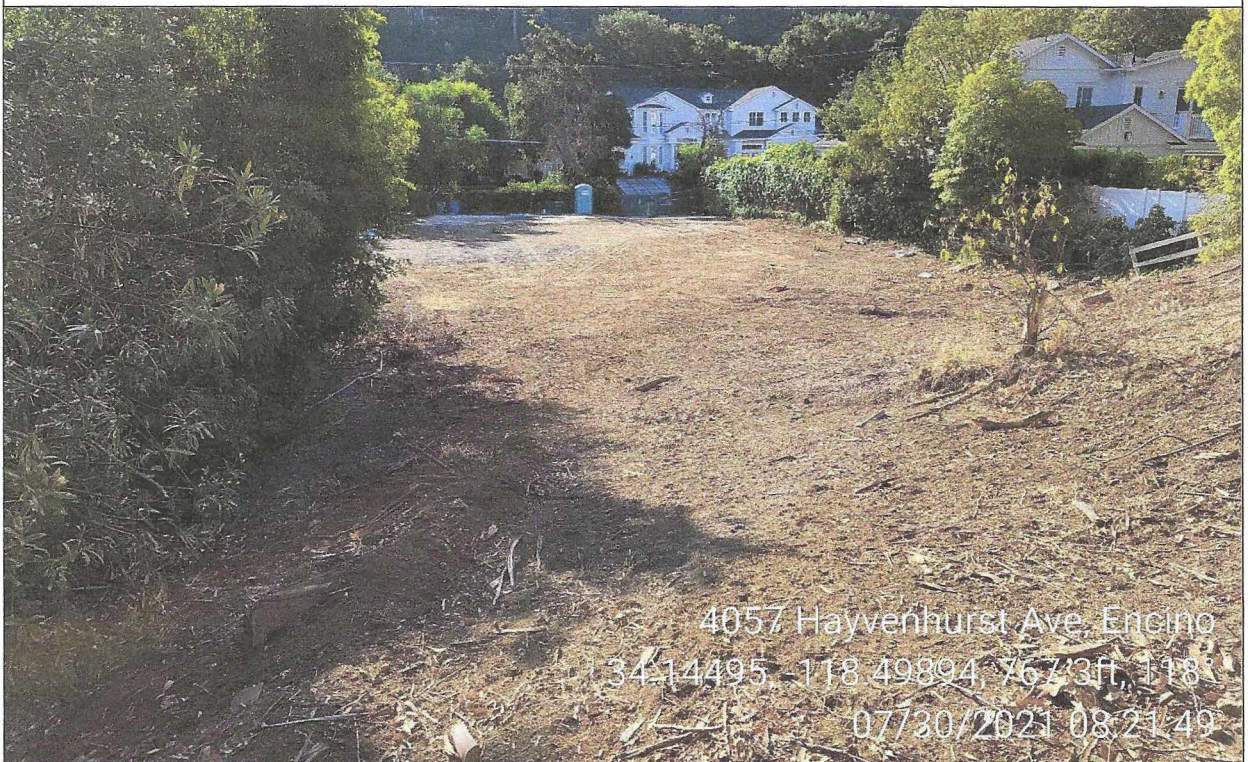
Photo 2: View of property from the northwest corner, facing southeast. Photo depicts disturbed land in the foreground and neighboring properties.

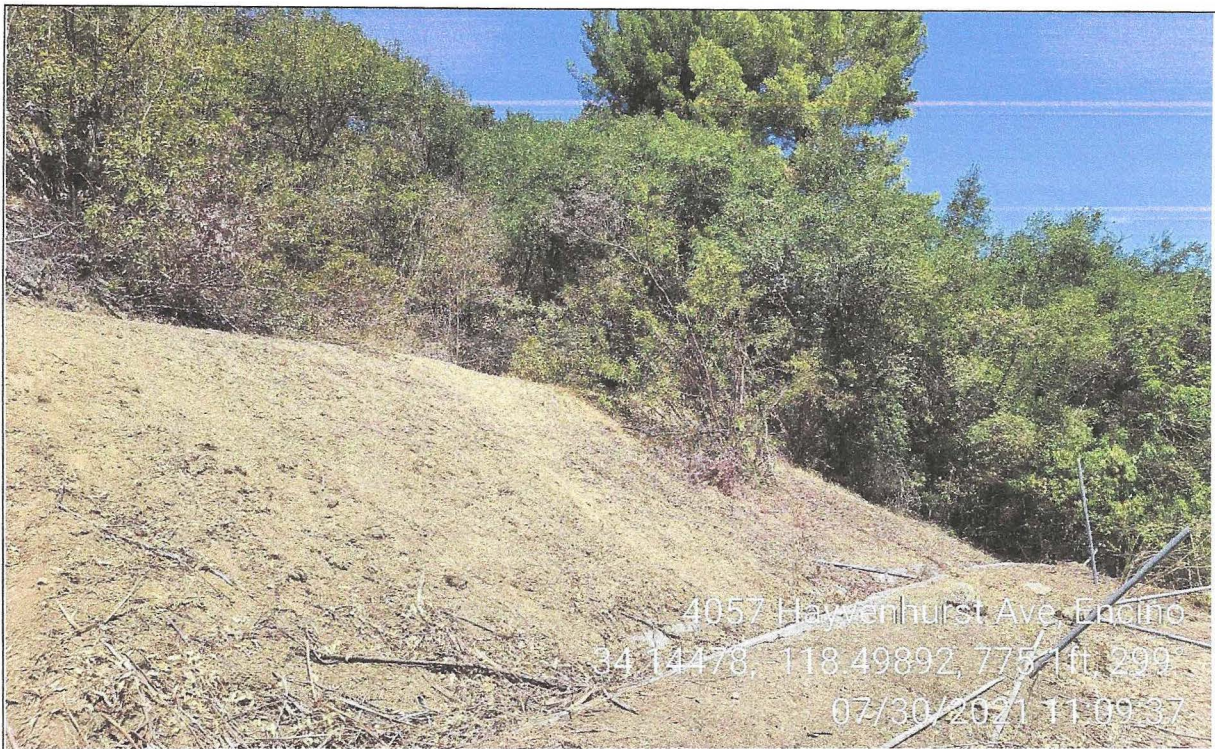
Photo 5: View of cleared slope in western portion of property and eastern boundary of coast live oak south coastal woodland/forest association. Photo depicts disturbed slope.

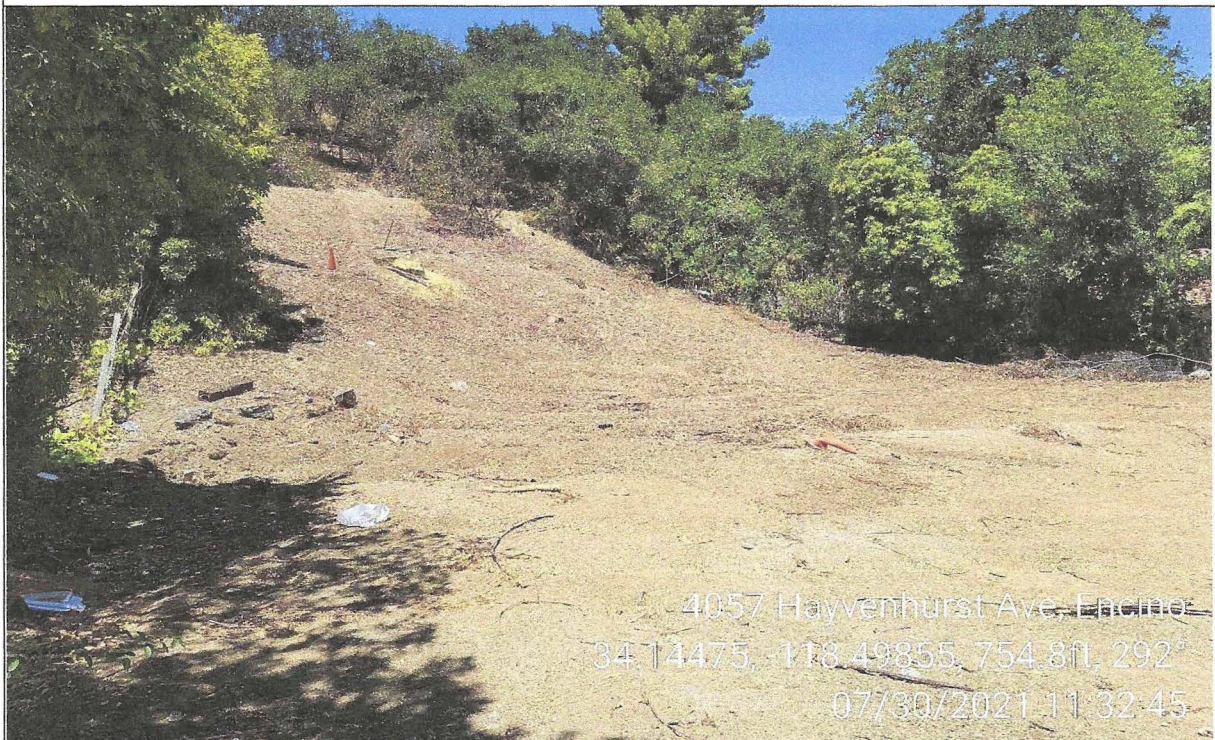
Photo 6: View of disturbed land and slope from southeast corner of property, facing northwest.

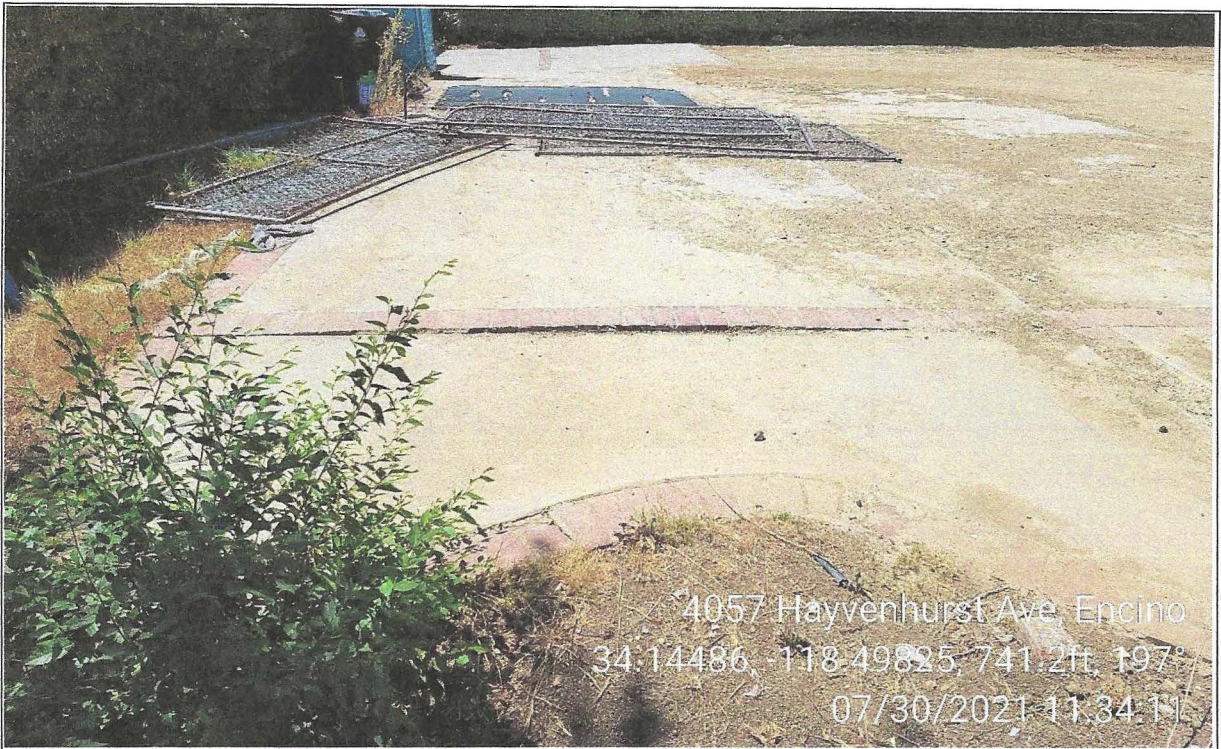
Photo 7: View of developed area in east portion of property, facing south. Concrete pad is a remainder from old property.

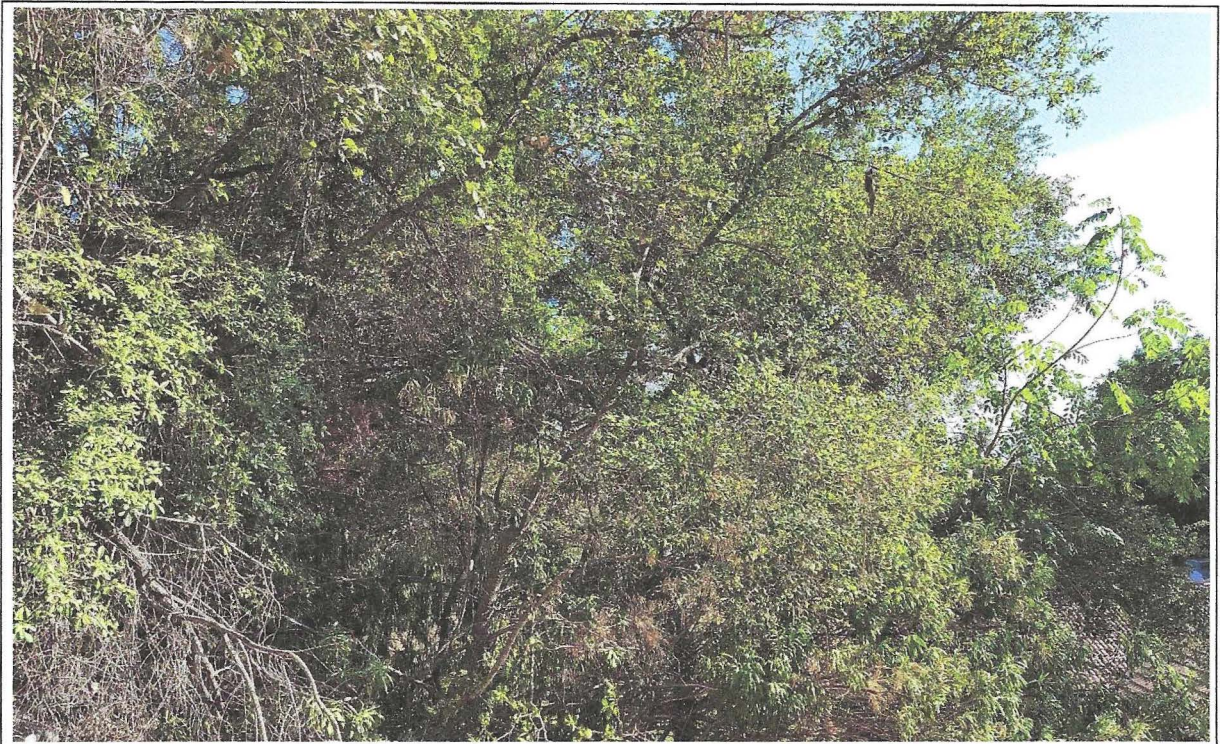
Photo 11: View of tree #2 – coast live oak, facing north. Photo depicts tree in center of photo.

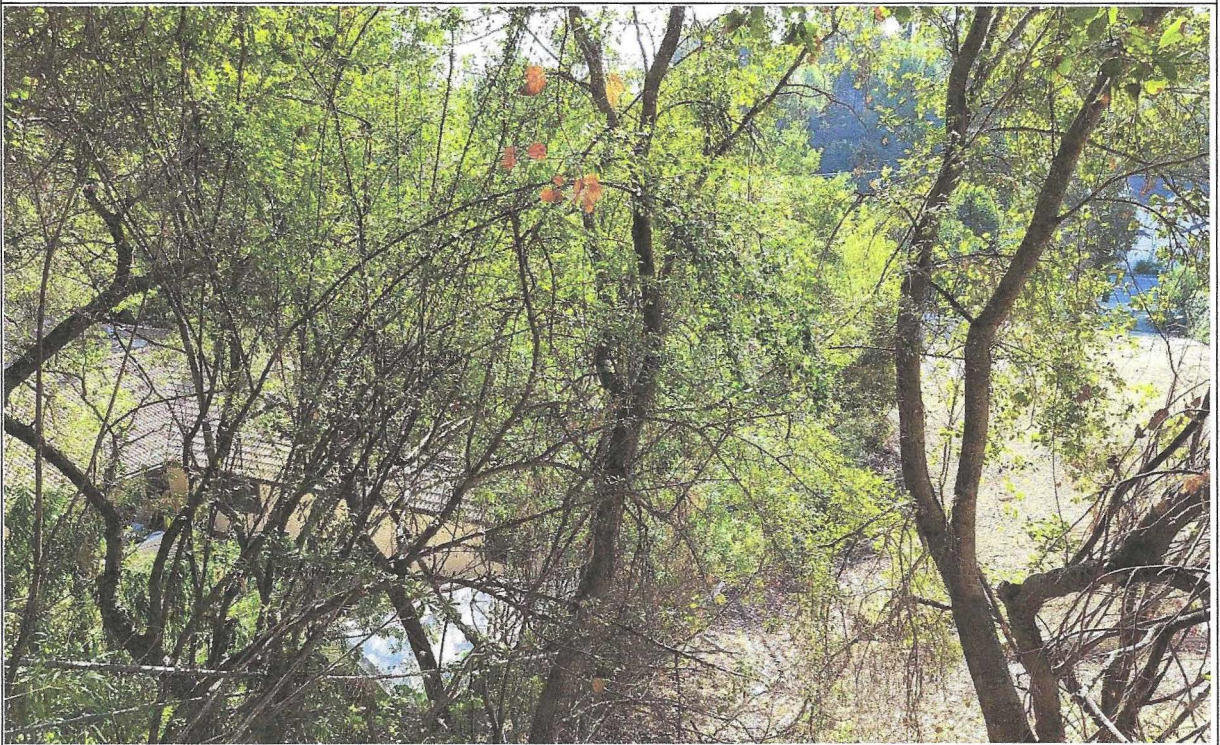
Photo 12: View of tree #3 – coast live oak, facing northeast. Photo depicts tree in center of the photo and neighboring fence.
