Tree Evaluation Report

For: Proposed Palmyra Cemetery Site

741 Palmyra Street, Orange

Prepared by: **Greg Applegate, RCA #365
Arborgate Consulting, Inc.
1131 Lucinda Way
Tustin, CA 92780
714/ 731-6240**

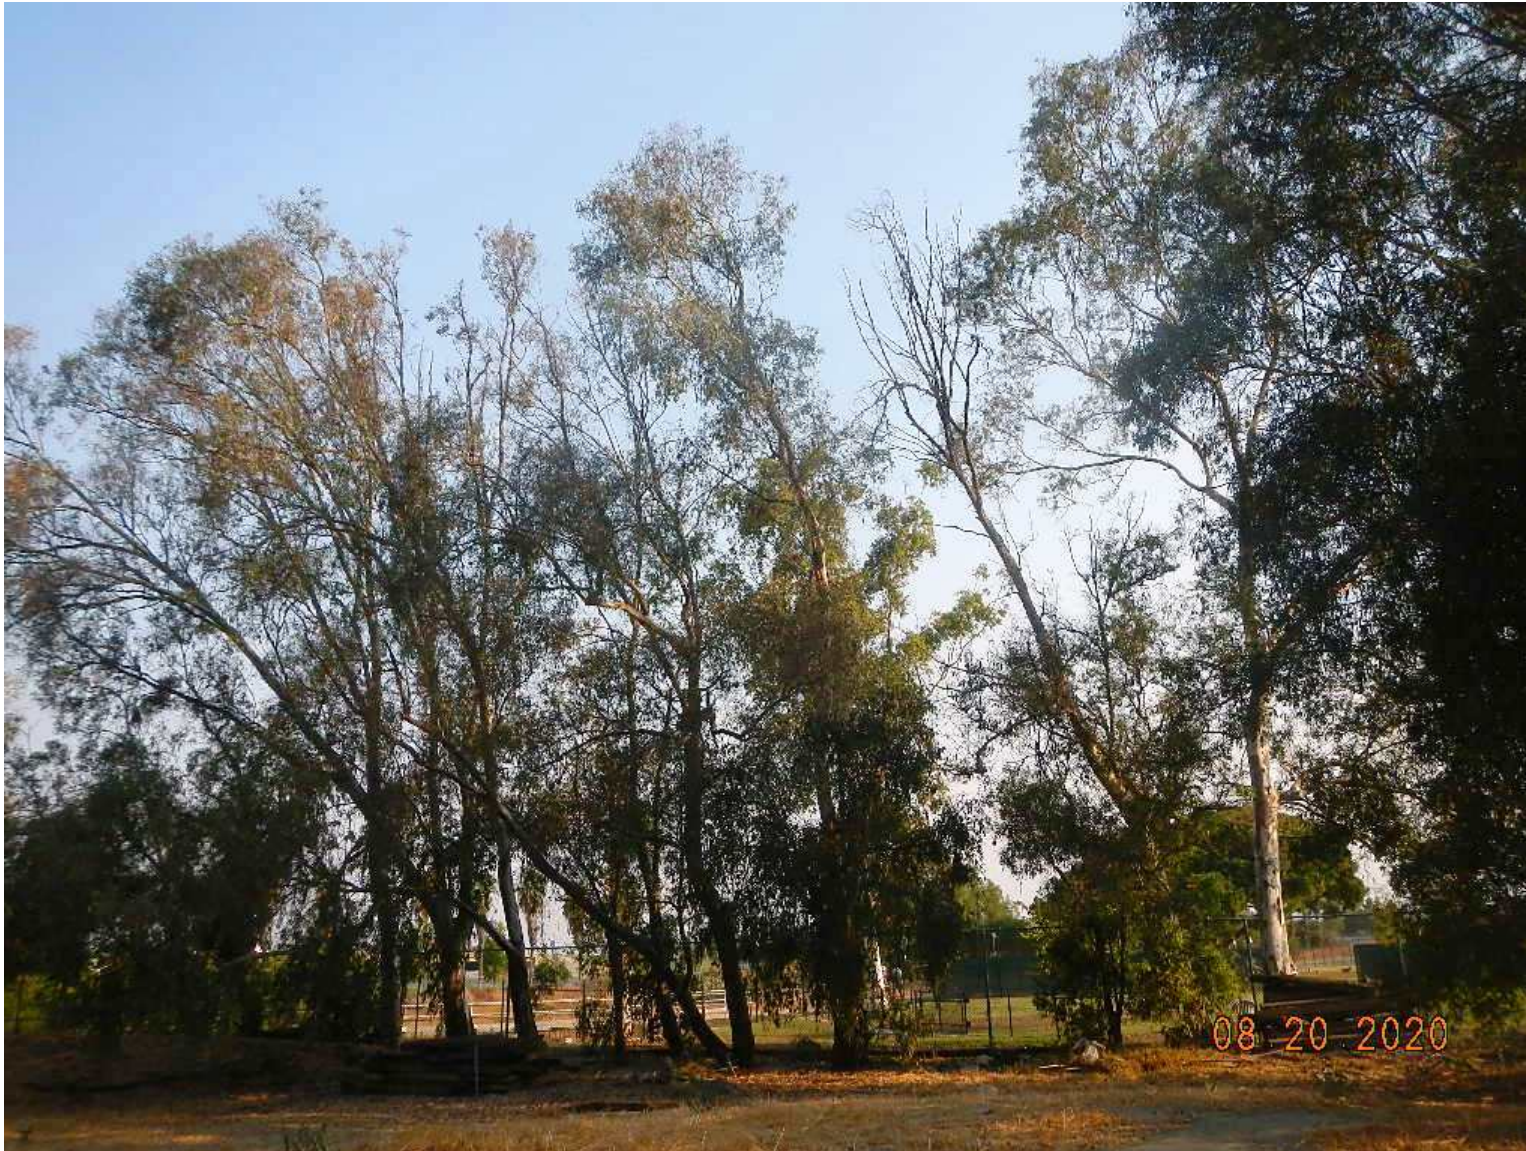
North edge of the site.

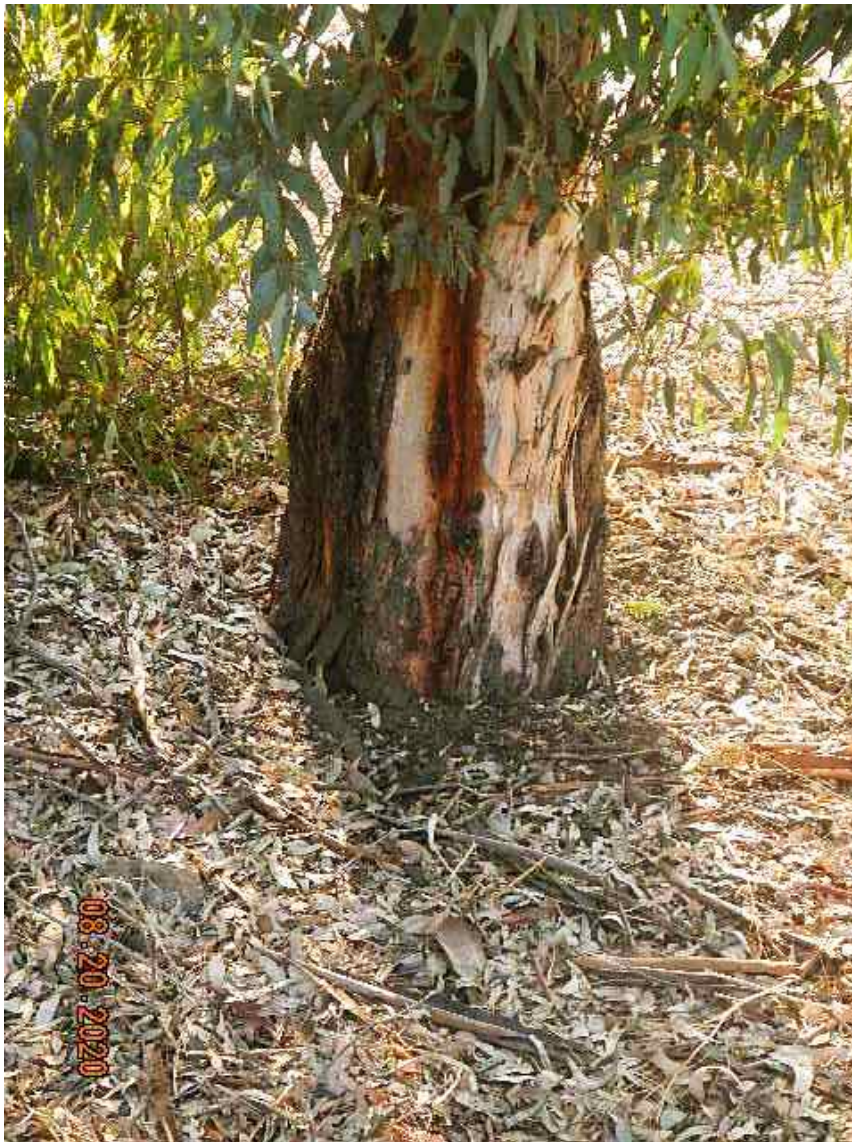
Note split and lack of normal root flare.

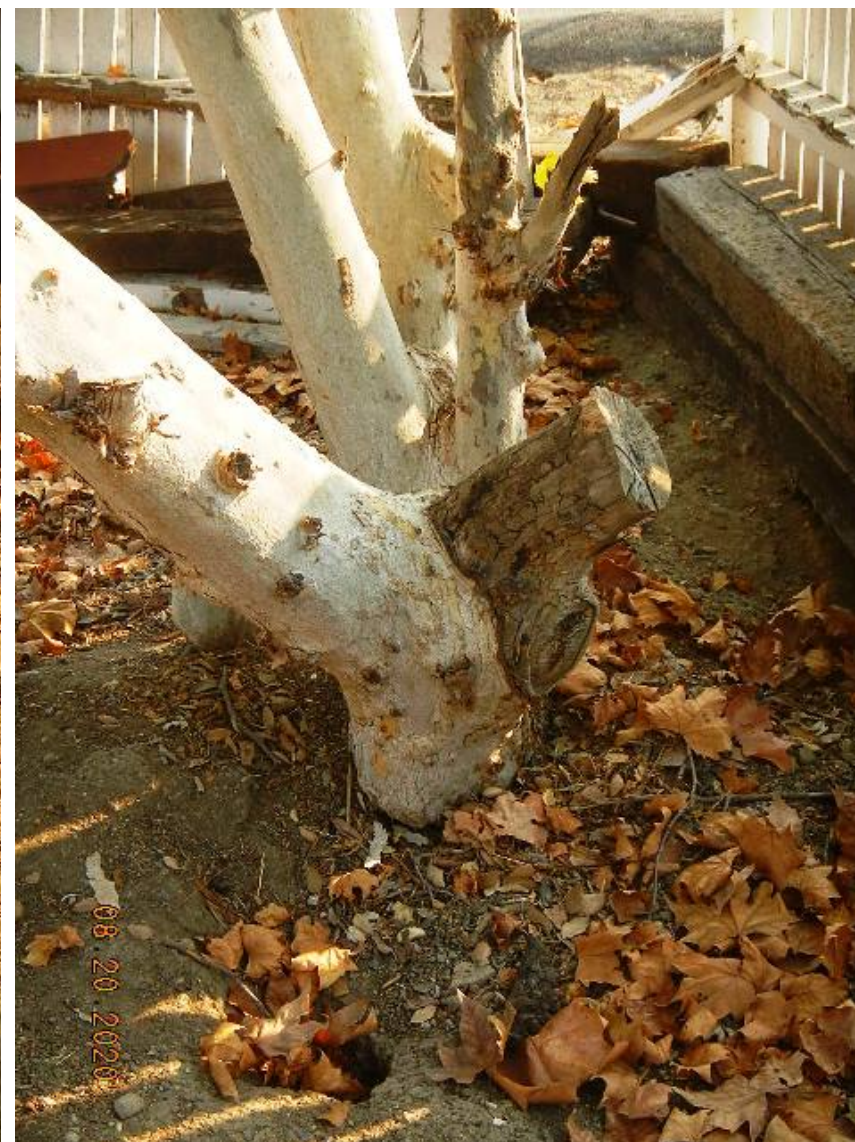
London plane tree #55

The sycamores, European and California, are in declining health. They both need more water than they have been getting recently. Despite the dry conditions, their health is generally better than their structure.

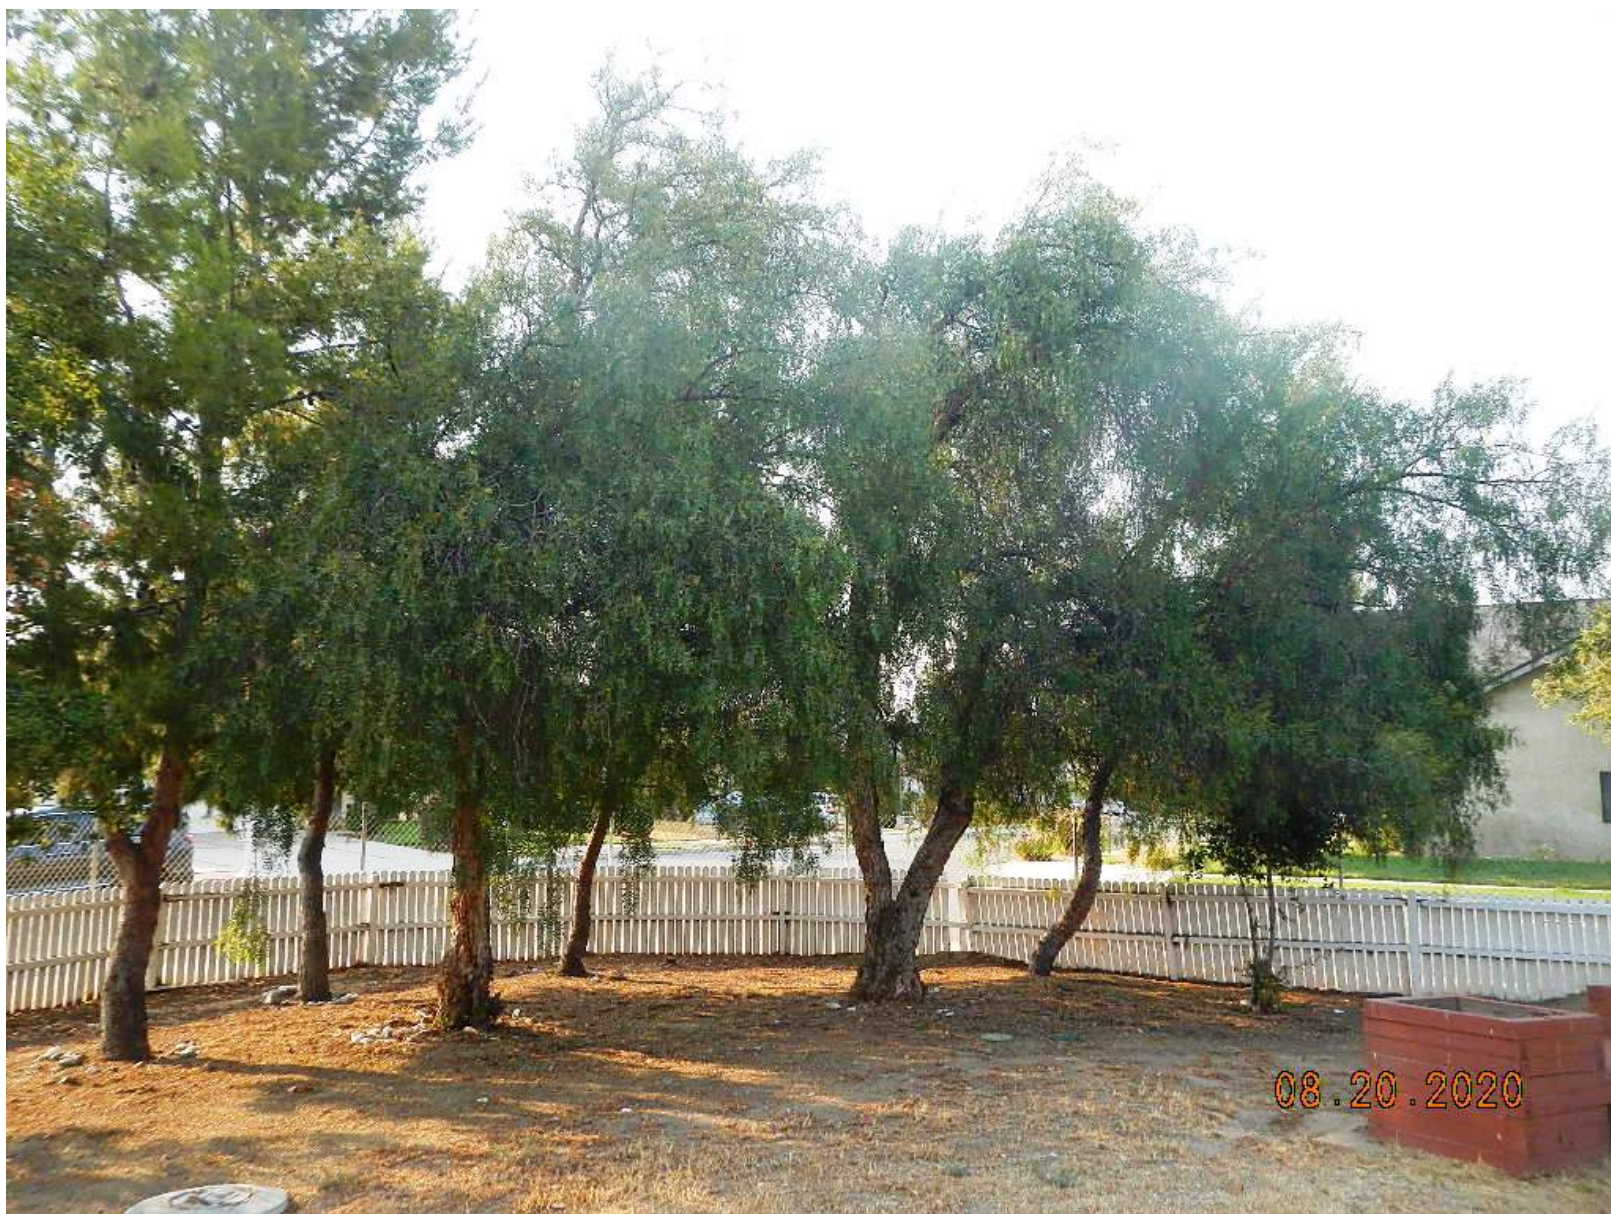
California peppers #130 & 131. Aleppo pines behind.

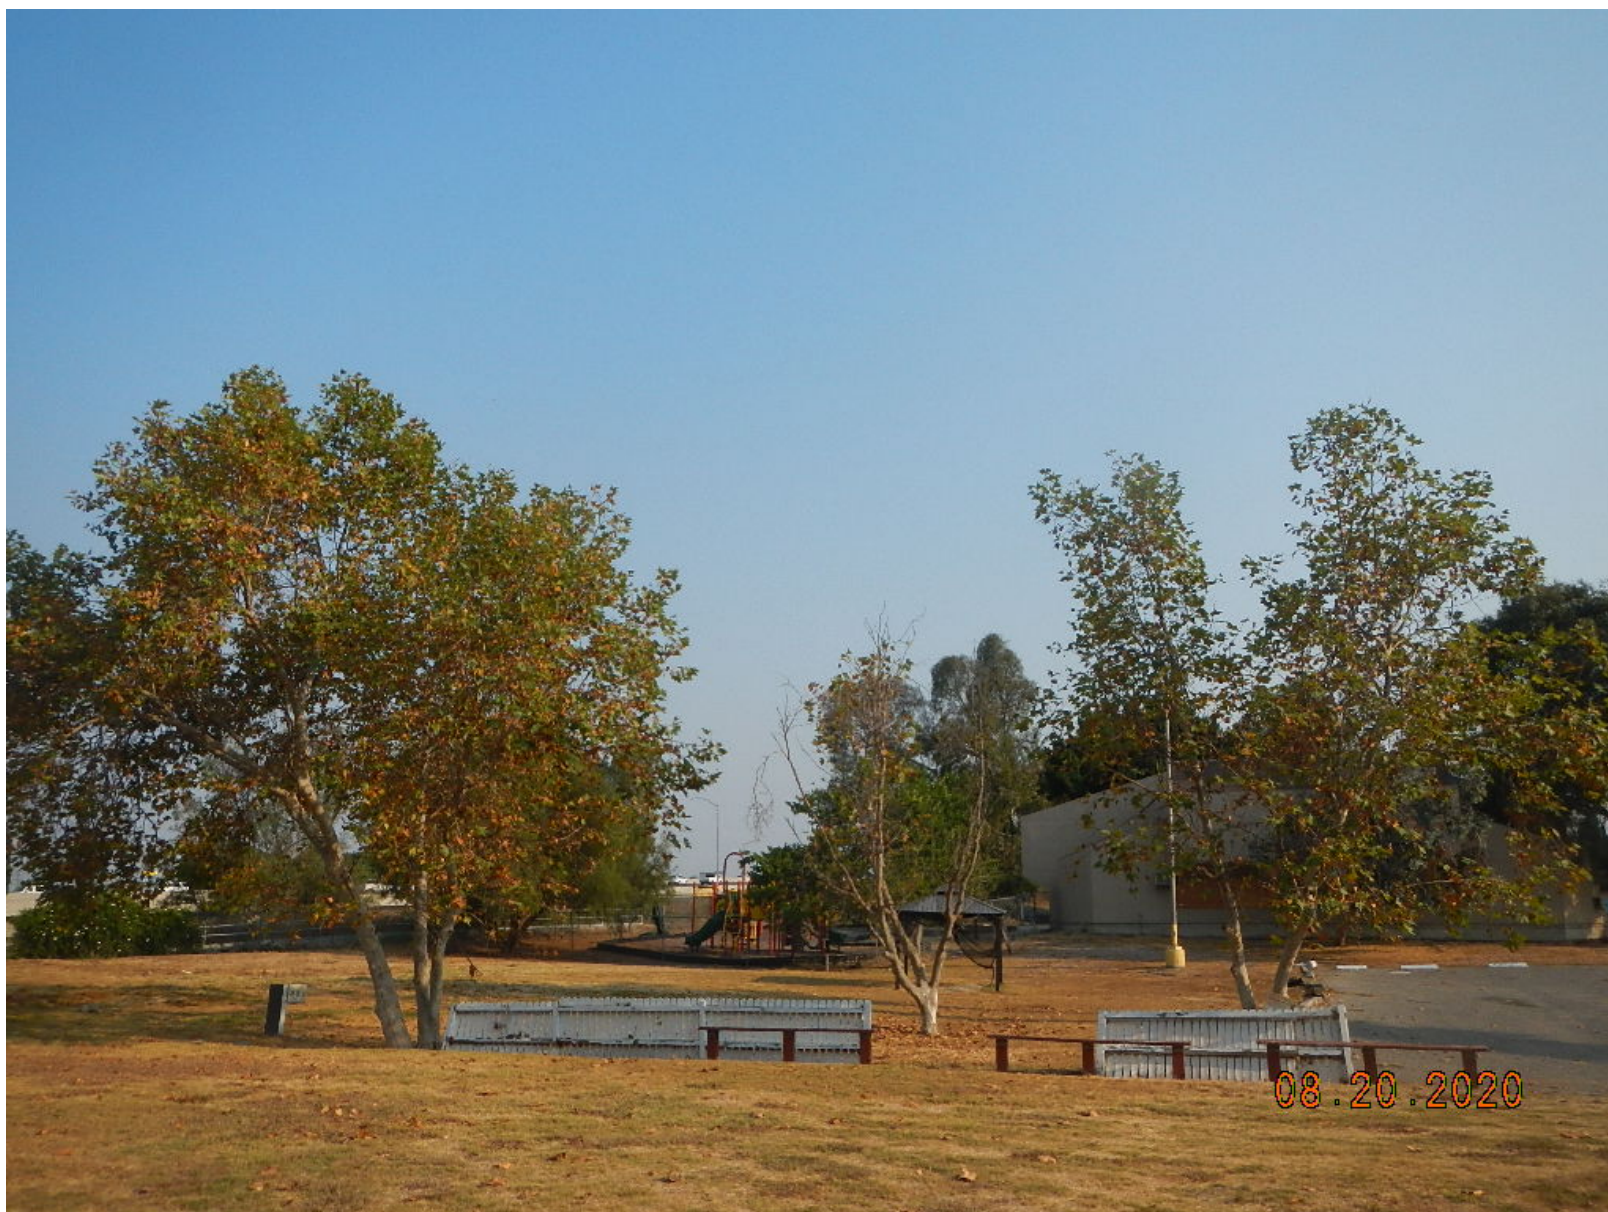
London planes #92, 93 and 94, left to right.

Tag#	Species	DBH	Ht	Spr	Health	Structure	Comments
77	Pinus eldarica	9	40	20	C-	C-	Cod Cr#78 Sp
78	Pinus eldarica	12	50	24	B	B	Deep Cr#77
79	Platanus x acerifolia	17	60	35	B	C	1s cut of cod base
80	Pinus halepensis	9	24	22	B	D	1s pale Sh crk@B 45°lean
81	Quercus agrifolia	13 @ 2'	24	24	B	C-	Cod <u>inc</u> CrS fill
82	Quercus agrifolia	9 @ 3'	24	22	B	C	Cod inc
83	Platanus x Acerifolia	15	40	40	C-	C	2long Sp mDb
84	Schinus molle	14	60	35	A	B	1sRF leans
85	Schinus molle	18	60	40	B	D	Root sprung, wall damage, cod inc
86	Quercus lobata	1	50	35	B	C-	Leans Xing cod
87	Quercus lobata	4	20	18	B	C	Cod inc 1s leans Cr#88
88	Quercus agrifolia	8	24	20	B	C-	Cod Xing Cr#87
89	Jacaranda mimosifolia	4	14	14	B	C-	Cod inc CrS fill
90	Quercus agrifolia	10	20	30	A	C	Cod inc, CalTrans'?
91	Schinus molle	18+20	40	55	B	C	1T on ground, 2long
92	Platanus x Acerifolia	13+13	50	50	C	C	2long cod Sp
93	Platanus x Acerifolia	11 @ 1'	28	24	C-	D	FC Dk Db cod deep Sp

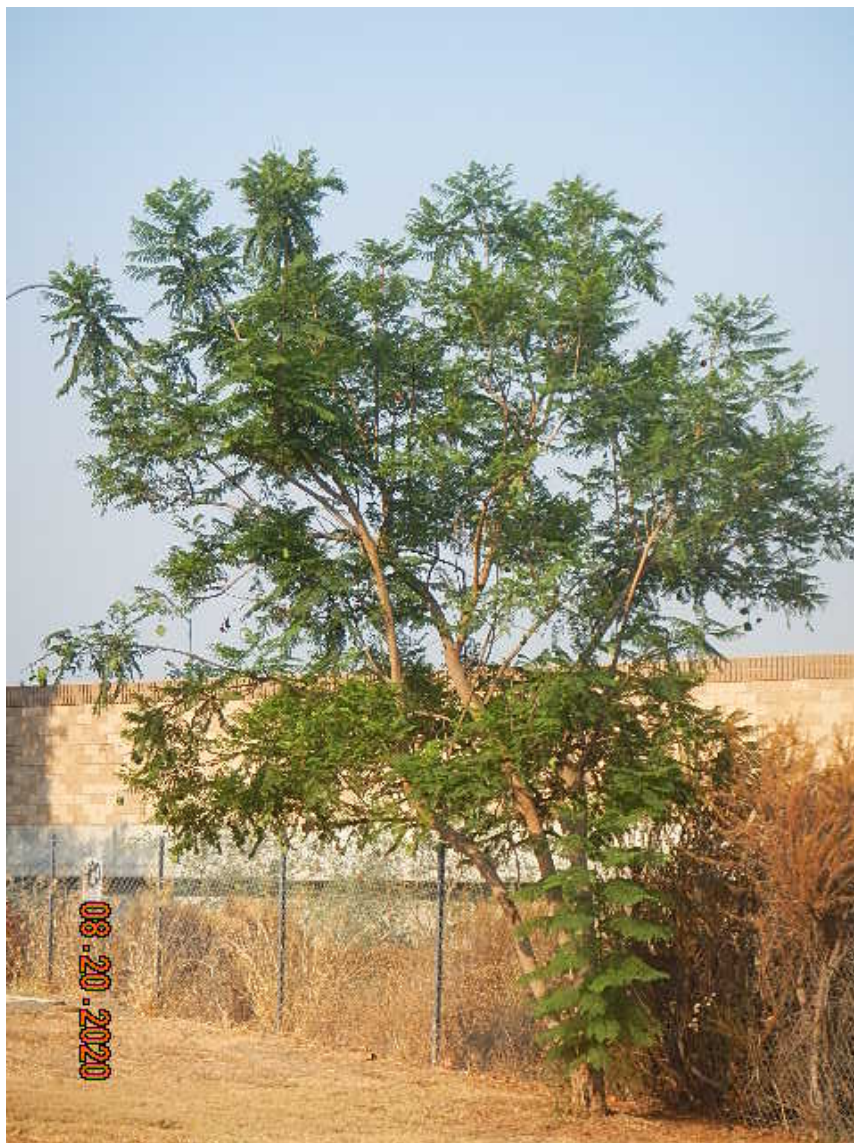
Jacaranda #129

There are two jacarandas, *Jacaranda mimosifolia*,. Both are young and have good health, but they are one-sided and codominant. They could be trained into better structural condition over 2 to 3 years of time.

129	Jacaranda mimosifolia	4+4+4	16	12	8	B	C-	Remain
130	Schinus molle	11	28	20	8	B	C	Remain
131	Schinus molle	9+9	28	32	10	B	C	Remain

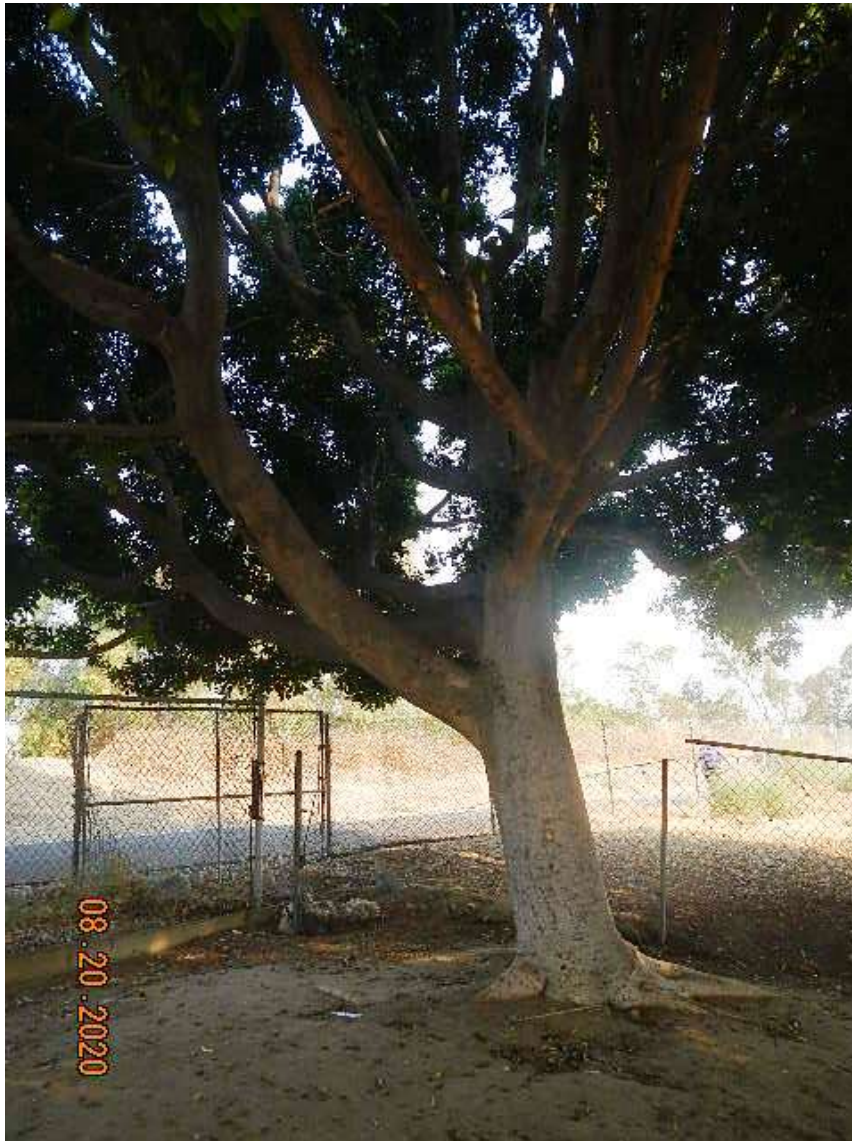
Ficus #125

There are two rubber trees and two Indian laurels. Both species have handled the drought conditions well. The Indian laurels are behind the building. Their health is good, but it looks like they were pruned to facilitate climbing by lion-tail pruning, i.e. stripping out the inner branch work and foliage. The rubber trees are both healthy, but poor pruning has left them less than attractive.

Indian laurel, *Ficus microcarpa 'Nitida'*, - this is a large growing species with large aggressive roots, especially in turf. It is subject to Cuban laurel thrip, gall wasps, Ficus eye-spot midge, Ficus psyllid and Ficus leaf-rolling psyllid. Recently the number of pests have increased significantly. We will see how long Indian laurel remains a popular landscape tree. Not recommended for turf here, unless it is well away from hardscape and utilities.

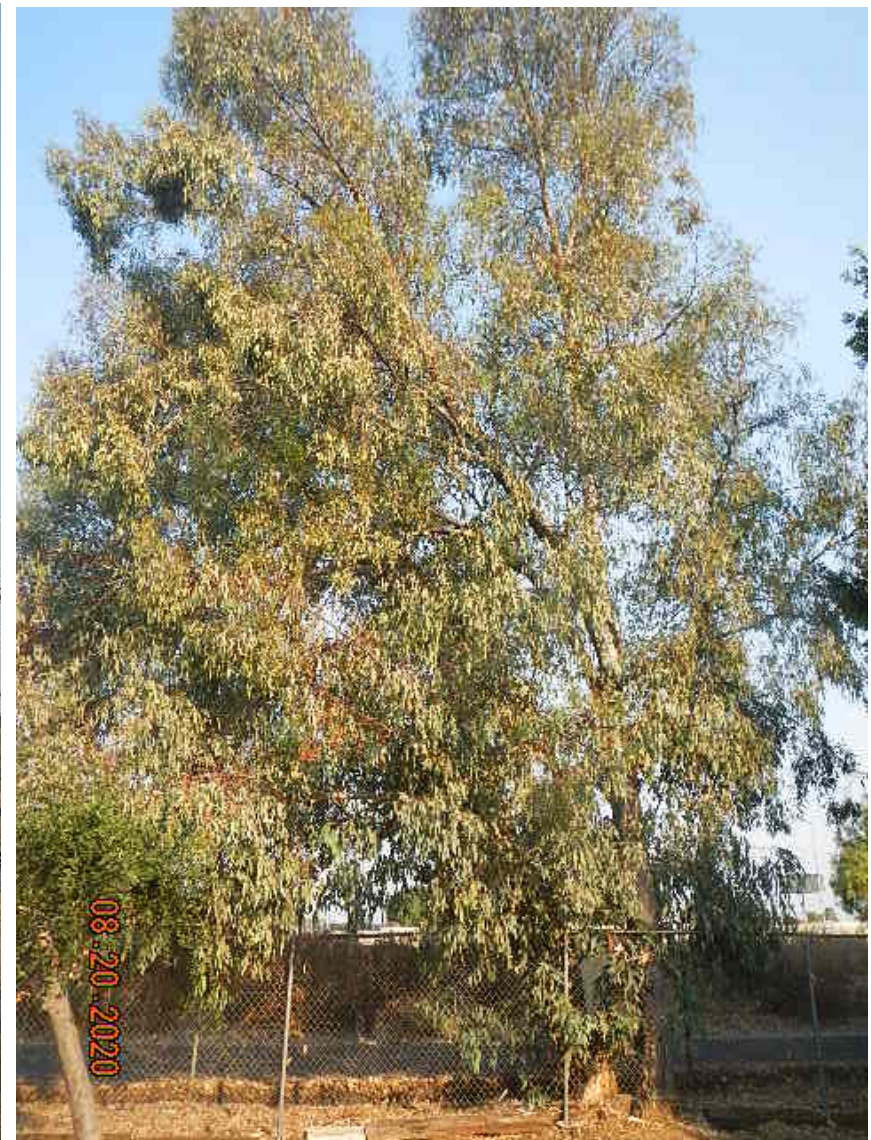
Red gum #124

Two different species of eucalypts occur on the property, though only one is found in the north portion, the red gum, *Eucalyptus camaldulensis*. There are 71 red gums, nearly all of which are in the windrow that wraps around the north and east sides. Due to crowding and pest infestation, none were really healthy or structurally good specimens. Being crowded together in a windrow, they reach out in odd directions for light. Windrow trees have their roots intertwined and depend on each other for protection and support. Also, all the red gums are infested by redgum lerp psyllids, and have been chewed up by tortoise beetles.

Red gum, *Eucalyptus camaldulensis*,— tolerates turf conditions well, but honey dew dripping by lerp psyllids may be a long-term issue. Removal of intermediate trees can sacrifice the stability of the adjoining trees. Will require large amounts of pruning to remove dead limbs and shorten overly long limbs. Removal is recommended.
