**SUPPLEMENTAL ENGINEERING GEOLOGIC STUDY**  
***Onsite Wastewater Treatment System (OWTS)***  
Proposed Single-Family Residential Development  
634 Palomar Drive  
Redwood City, California

October 4, 2021  
ATLAS Project No. 91-55905-C  
(3067)

**RE: SUPPLEMENTAL ENGINEERING GEOLOGIC STUDY**  
***Onsite Wastewater Treatment System (OWTS)***  
Proposed Single-Family Residential Development  
634 Palomar Drive  
Redwood City, California  
**ATLAS #91-55905-C (3067)**

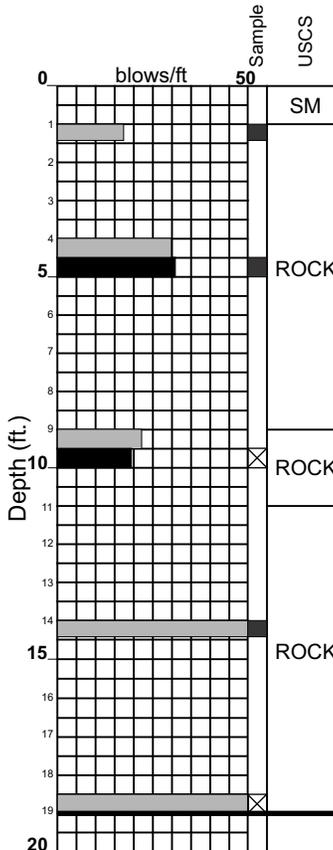
USCS	Description
SM	Yellow brown Silty SAND with Gravel, moist, very dense (af)
ROCK	Very dark brown GRAYWACKE, slight to moderately weathered, closely fractured, hard (Franciscan Bedrock)
ROCK	Brown yellow brown SILTY, Clayey SANDSTONE w/ hard, angular SHALE fragments to 1/2", very weathered, closely fractured, soft (Franciscan Bedrock)
ROCK	Very dark brown GRAYWACKE, very weathered, closely fractured, moderately hard to hard (Franciscan Bedrock)
Terminated @ 19'

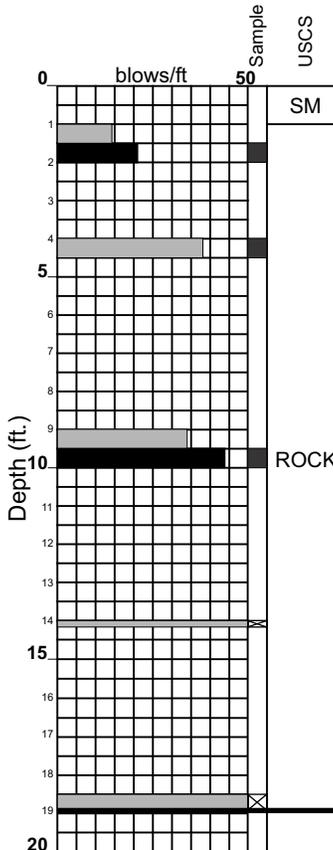
SM Yellow brown Silty SAND with Gravel, moist, dense (af)

Very dark brown GRAYWACKE, slight to moderately weathered, closely fractured, moderately hard to hard (Franciscan Bedrock)

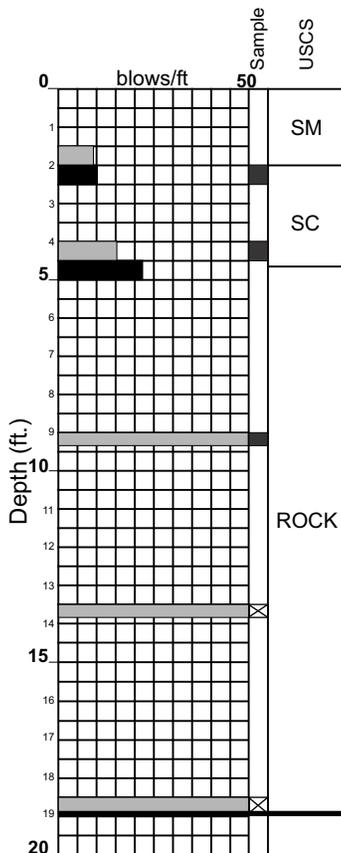
Yellow brown Silty SAND with Gravel, moist, medium dense (af)

Dark brown Clayey SAND with Gravel, medium dense to dense moist (Qc)

Very dark brown GRAYWACKE, slight to moderately weathered, closely fractured, hard (Franciscan Bedrock)

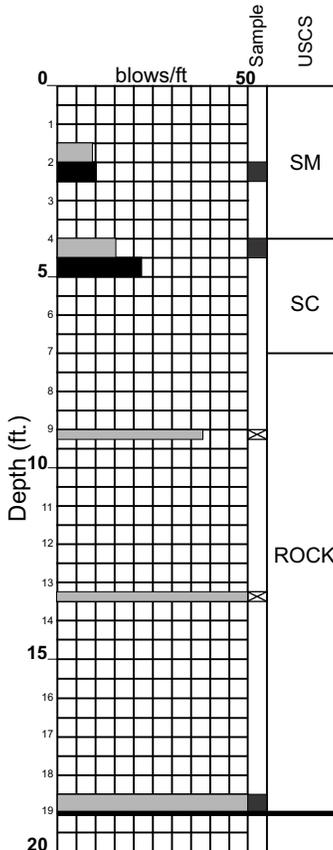
Yellow brown Gravelly SAND, moist, very dense (af)  
concrete fragments

Dark brown Clayey SAND with Gravel, moist, medium dense (Qc)

Very dark brown GRAYWACKE, slight to moderately weathered, closely fractured, hard (Franciscan Bedrock)

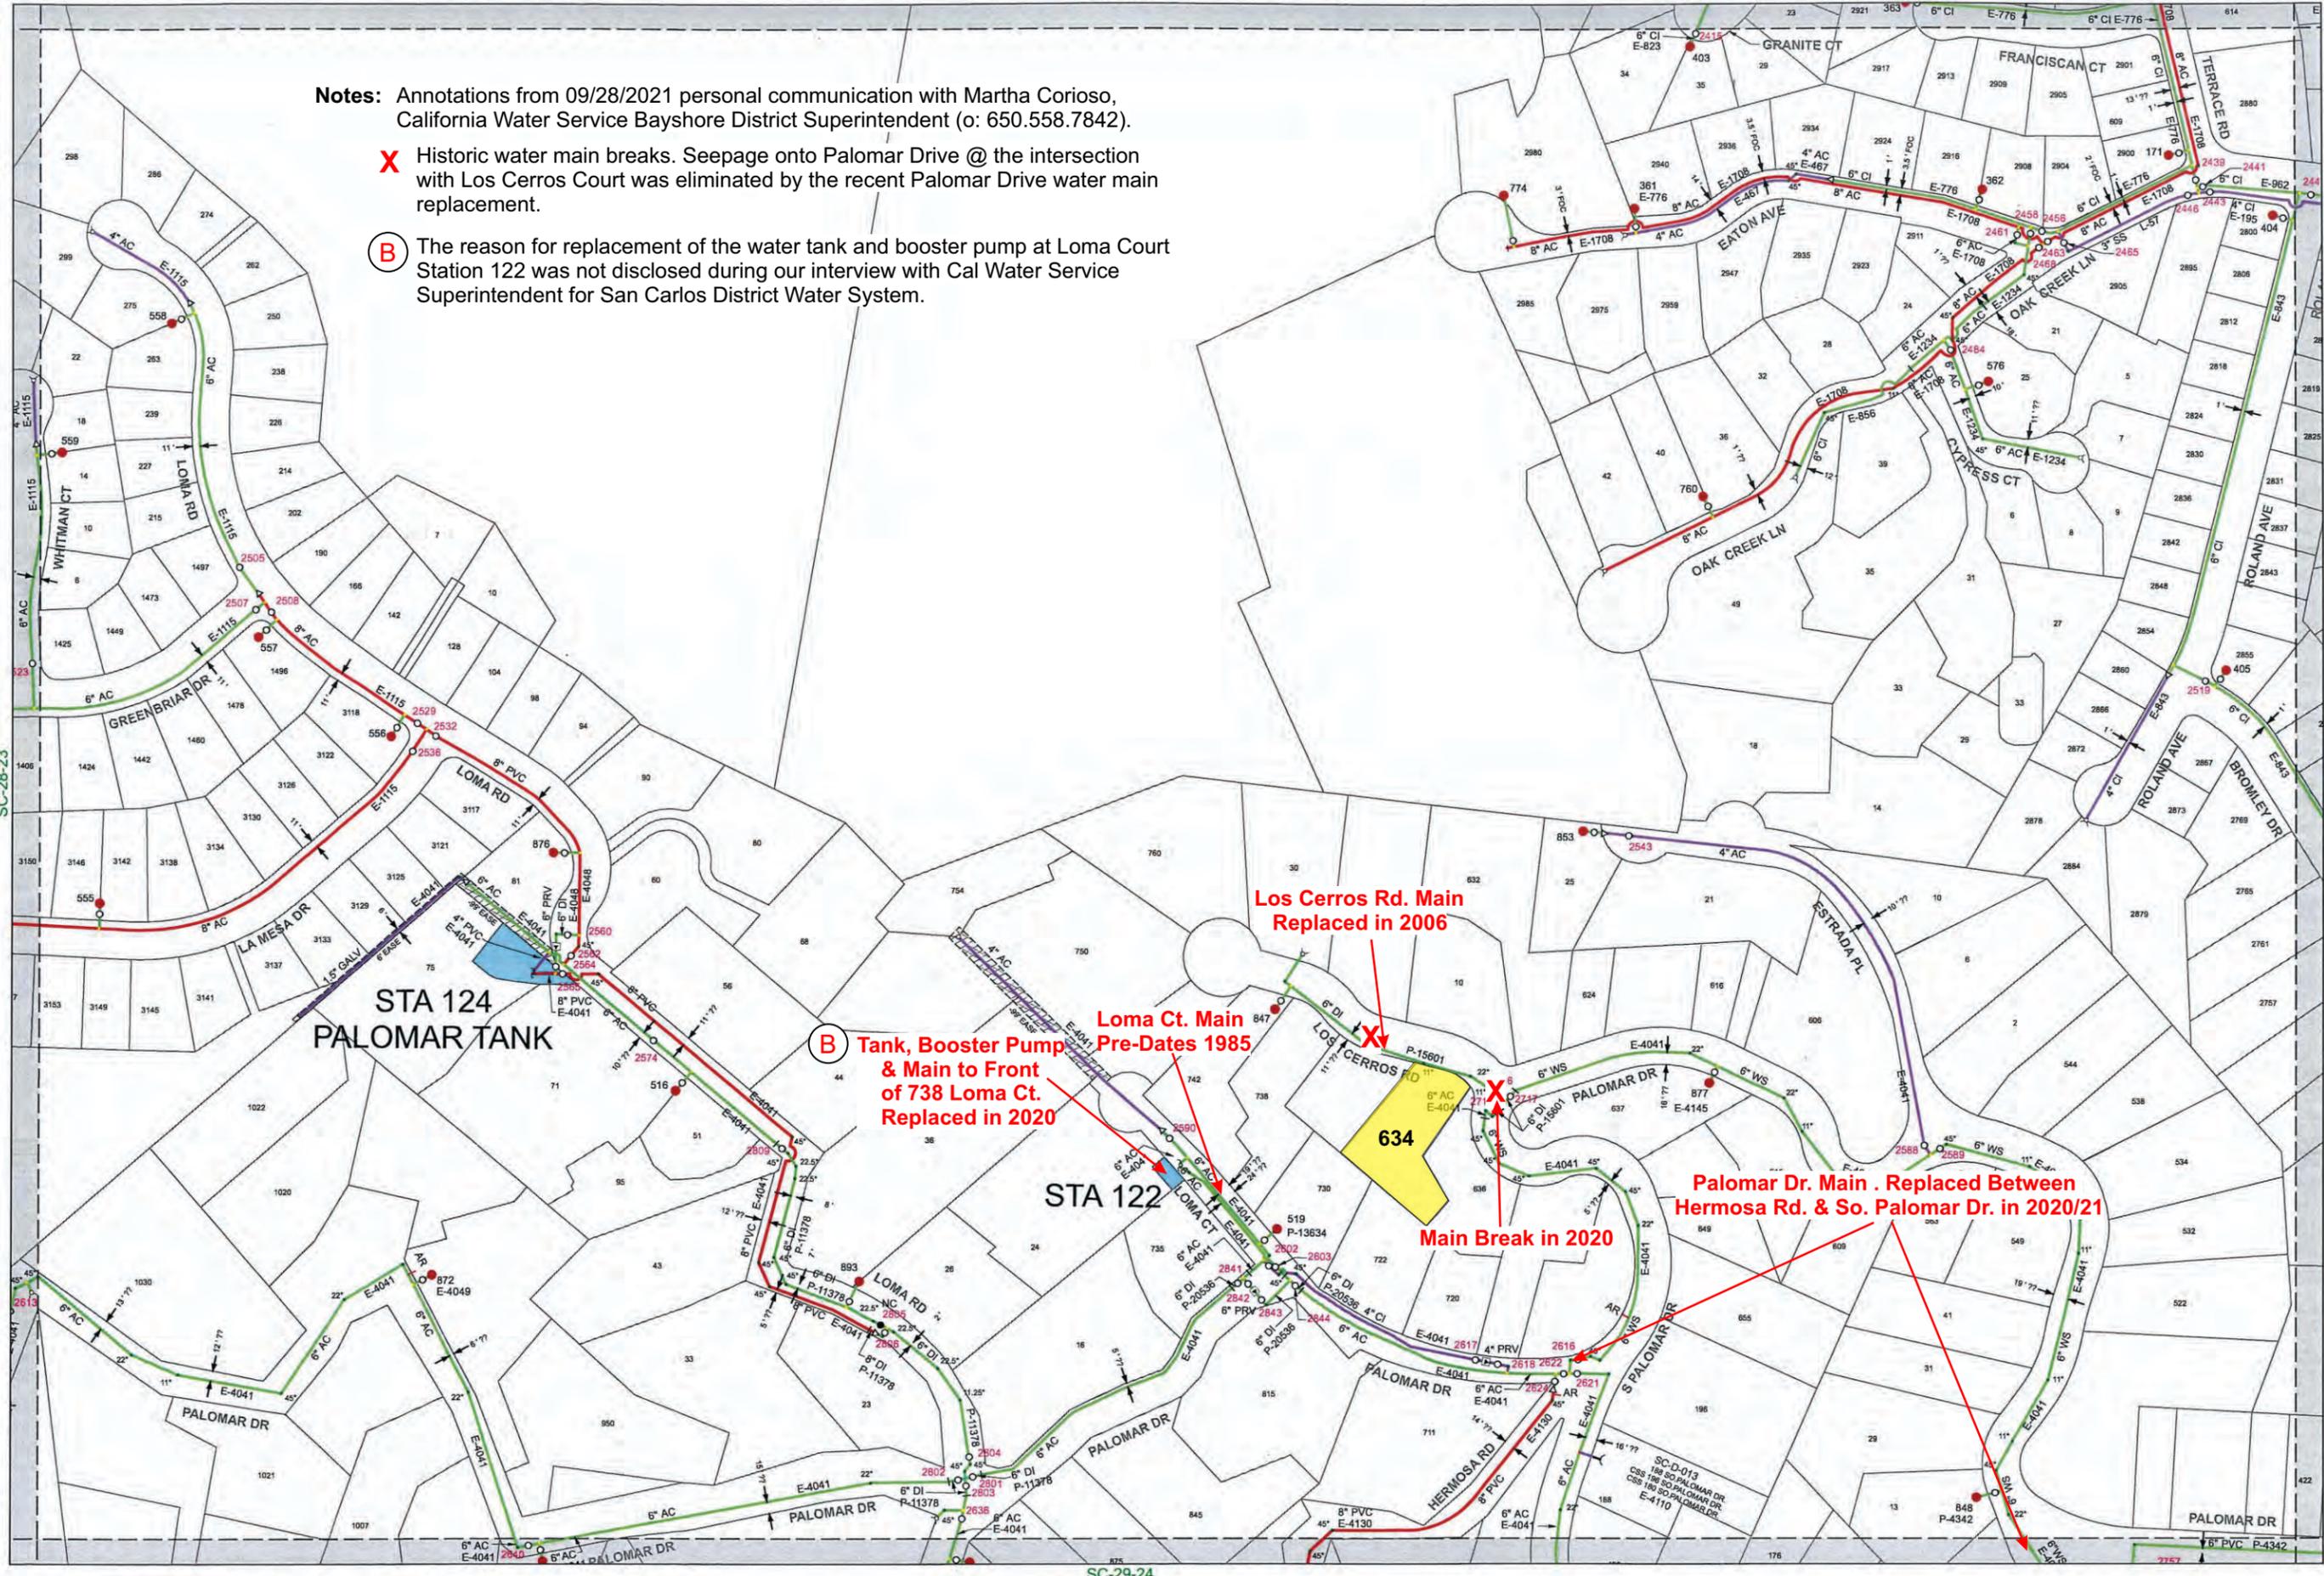
- X** Historic water main breaks. Seepage onto Palomar Drive @ the intersection with Los Cerros Court was eliminated by the recent Palomar Drive water main replacement.
- B** The reason for replacement of the water tank and booster pump at Loma Court Station 122 was not disclosed during our interview with Cal Water Service Superintendent for San Carlos District Water System.

Los Cerros Rd. Main Replaced in 2006

**B** Tank, Booster Pump & Main to Front of 738 Loma Ct. Replaced in 2020

Palomar Dr. Main . Replaced Between Hermosa Rd. & So. Palomar Dr. in 2020/21

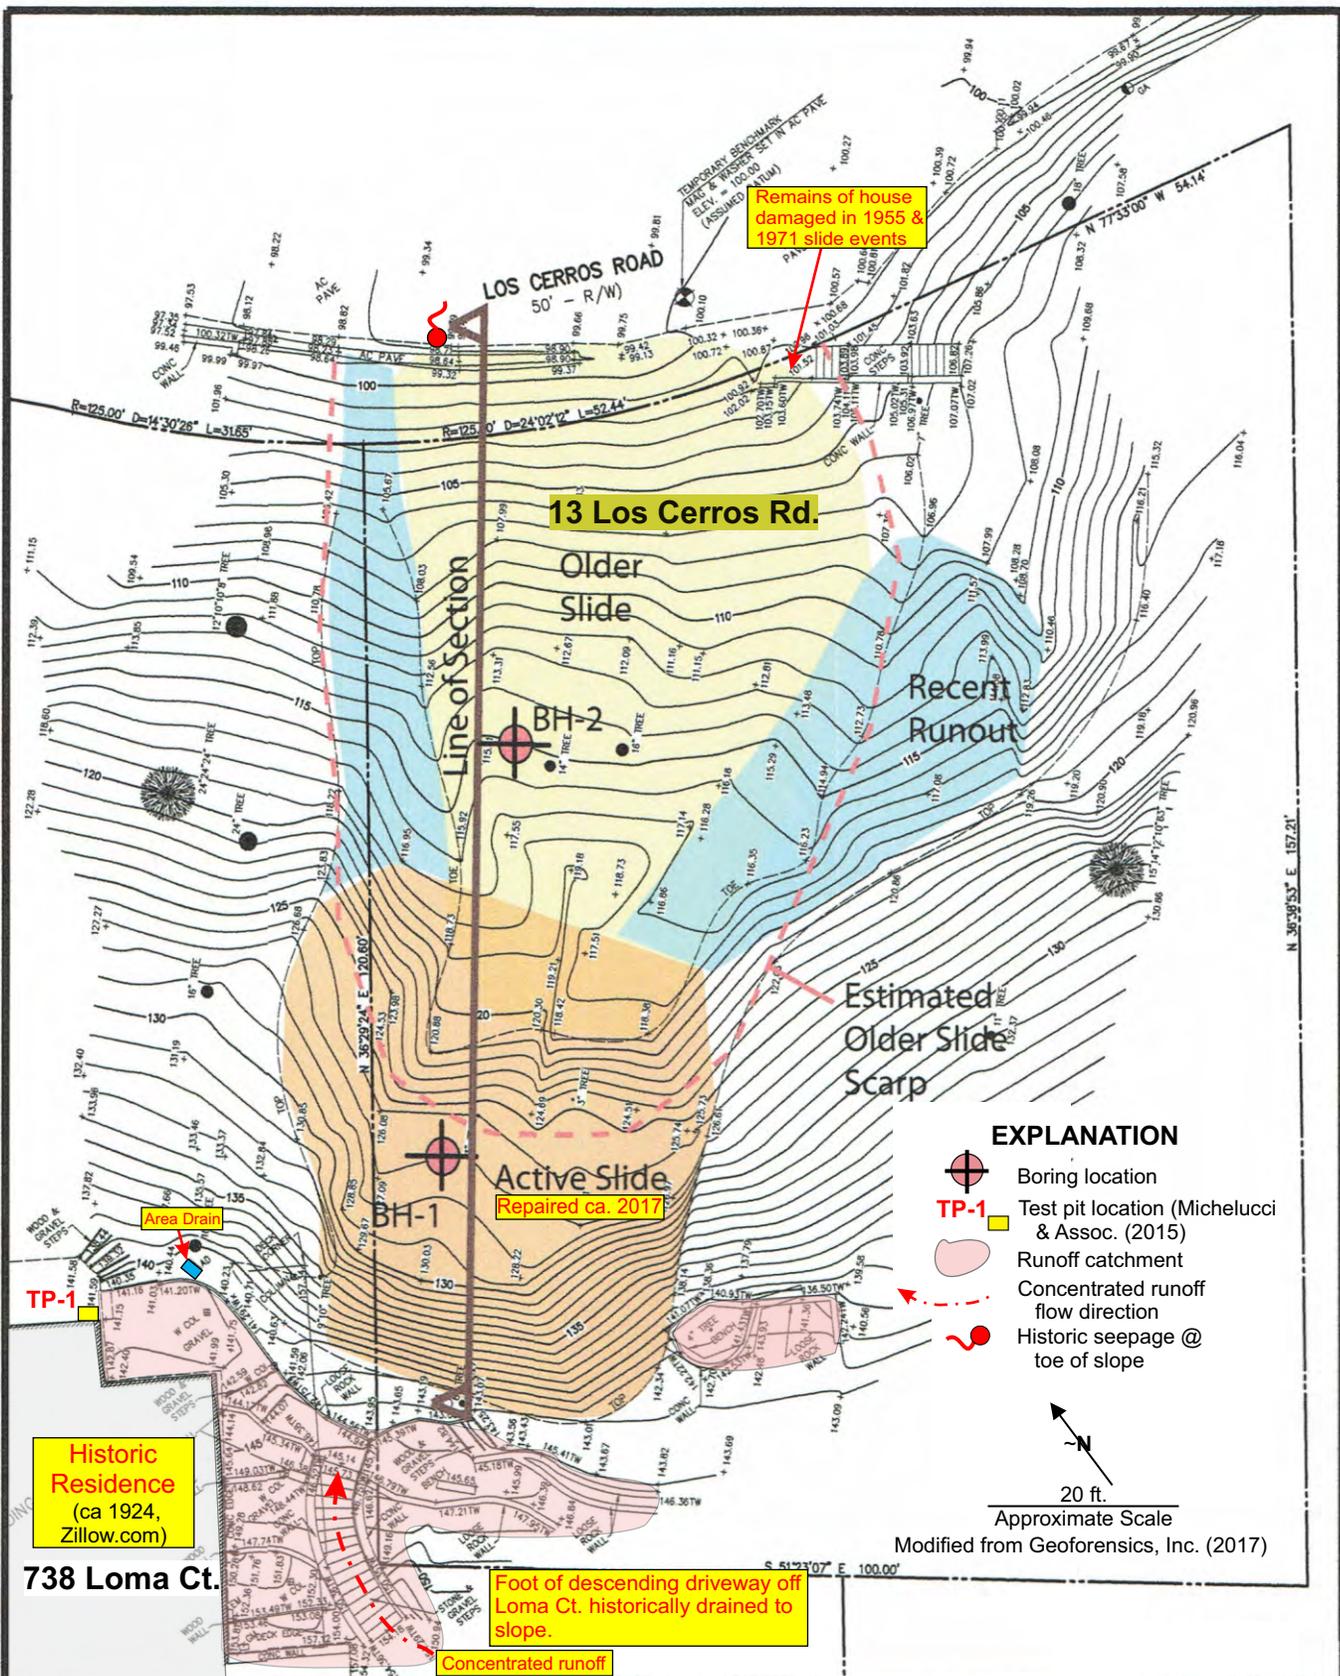
This appendix presents illustrations of adverse drainage conditions at the head of a retrogressive landslide that has persisted for decades without pursuit of characterizing the source and mitigation for causative perched ground water. Seepage was inferred from Geoforensics, Inc. (2017) boring data and cross section, and an earlier reconnaissance study by Michelucci & Associates (2015) to evaluate seepage and deflection of the nearly century-old residence. Neither report presented a characterization of the drainage conditions at the head of the landslide scarp.

Remains of house damaged in 1955 & 1971 slide events

Active Slide  
Repaired ca. 2017
