Appendix E
Mission Canyon Stream Habitat
Restoration Project Jurisdictional
Delineation Report

MISSION CANYON STREAM HABITAT RESTORATION PROJECT

SOUTHERN CALIFORNIA EDISON, SANTA BARBARA COUNTY, CALIFORNIA

Delineation of State and Federal Jurisdictional Waters

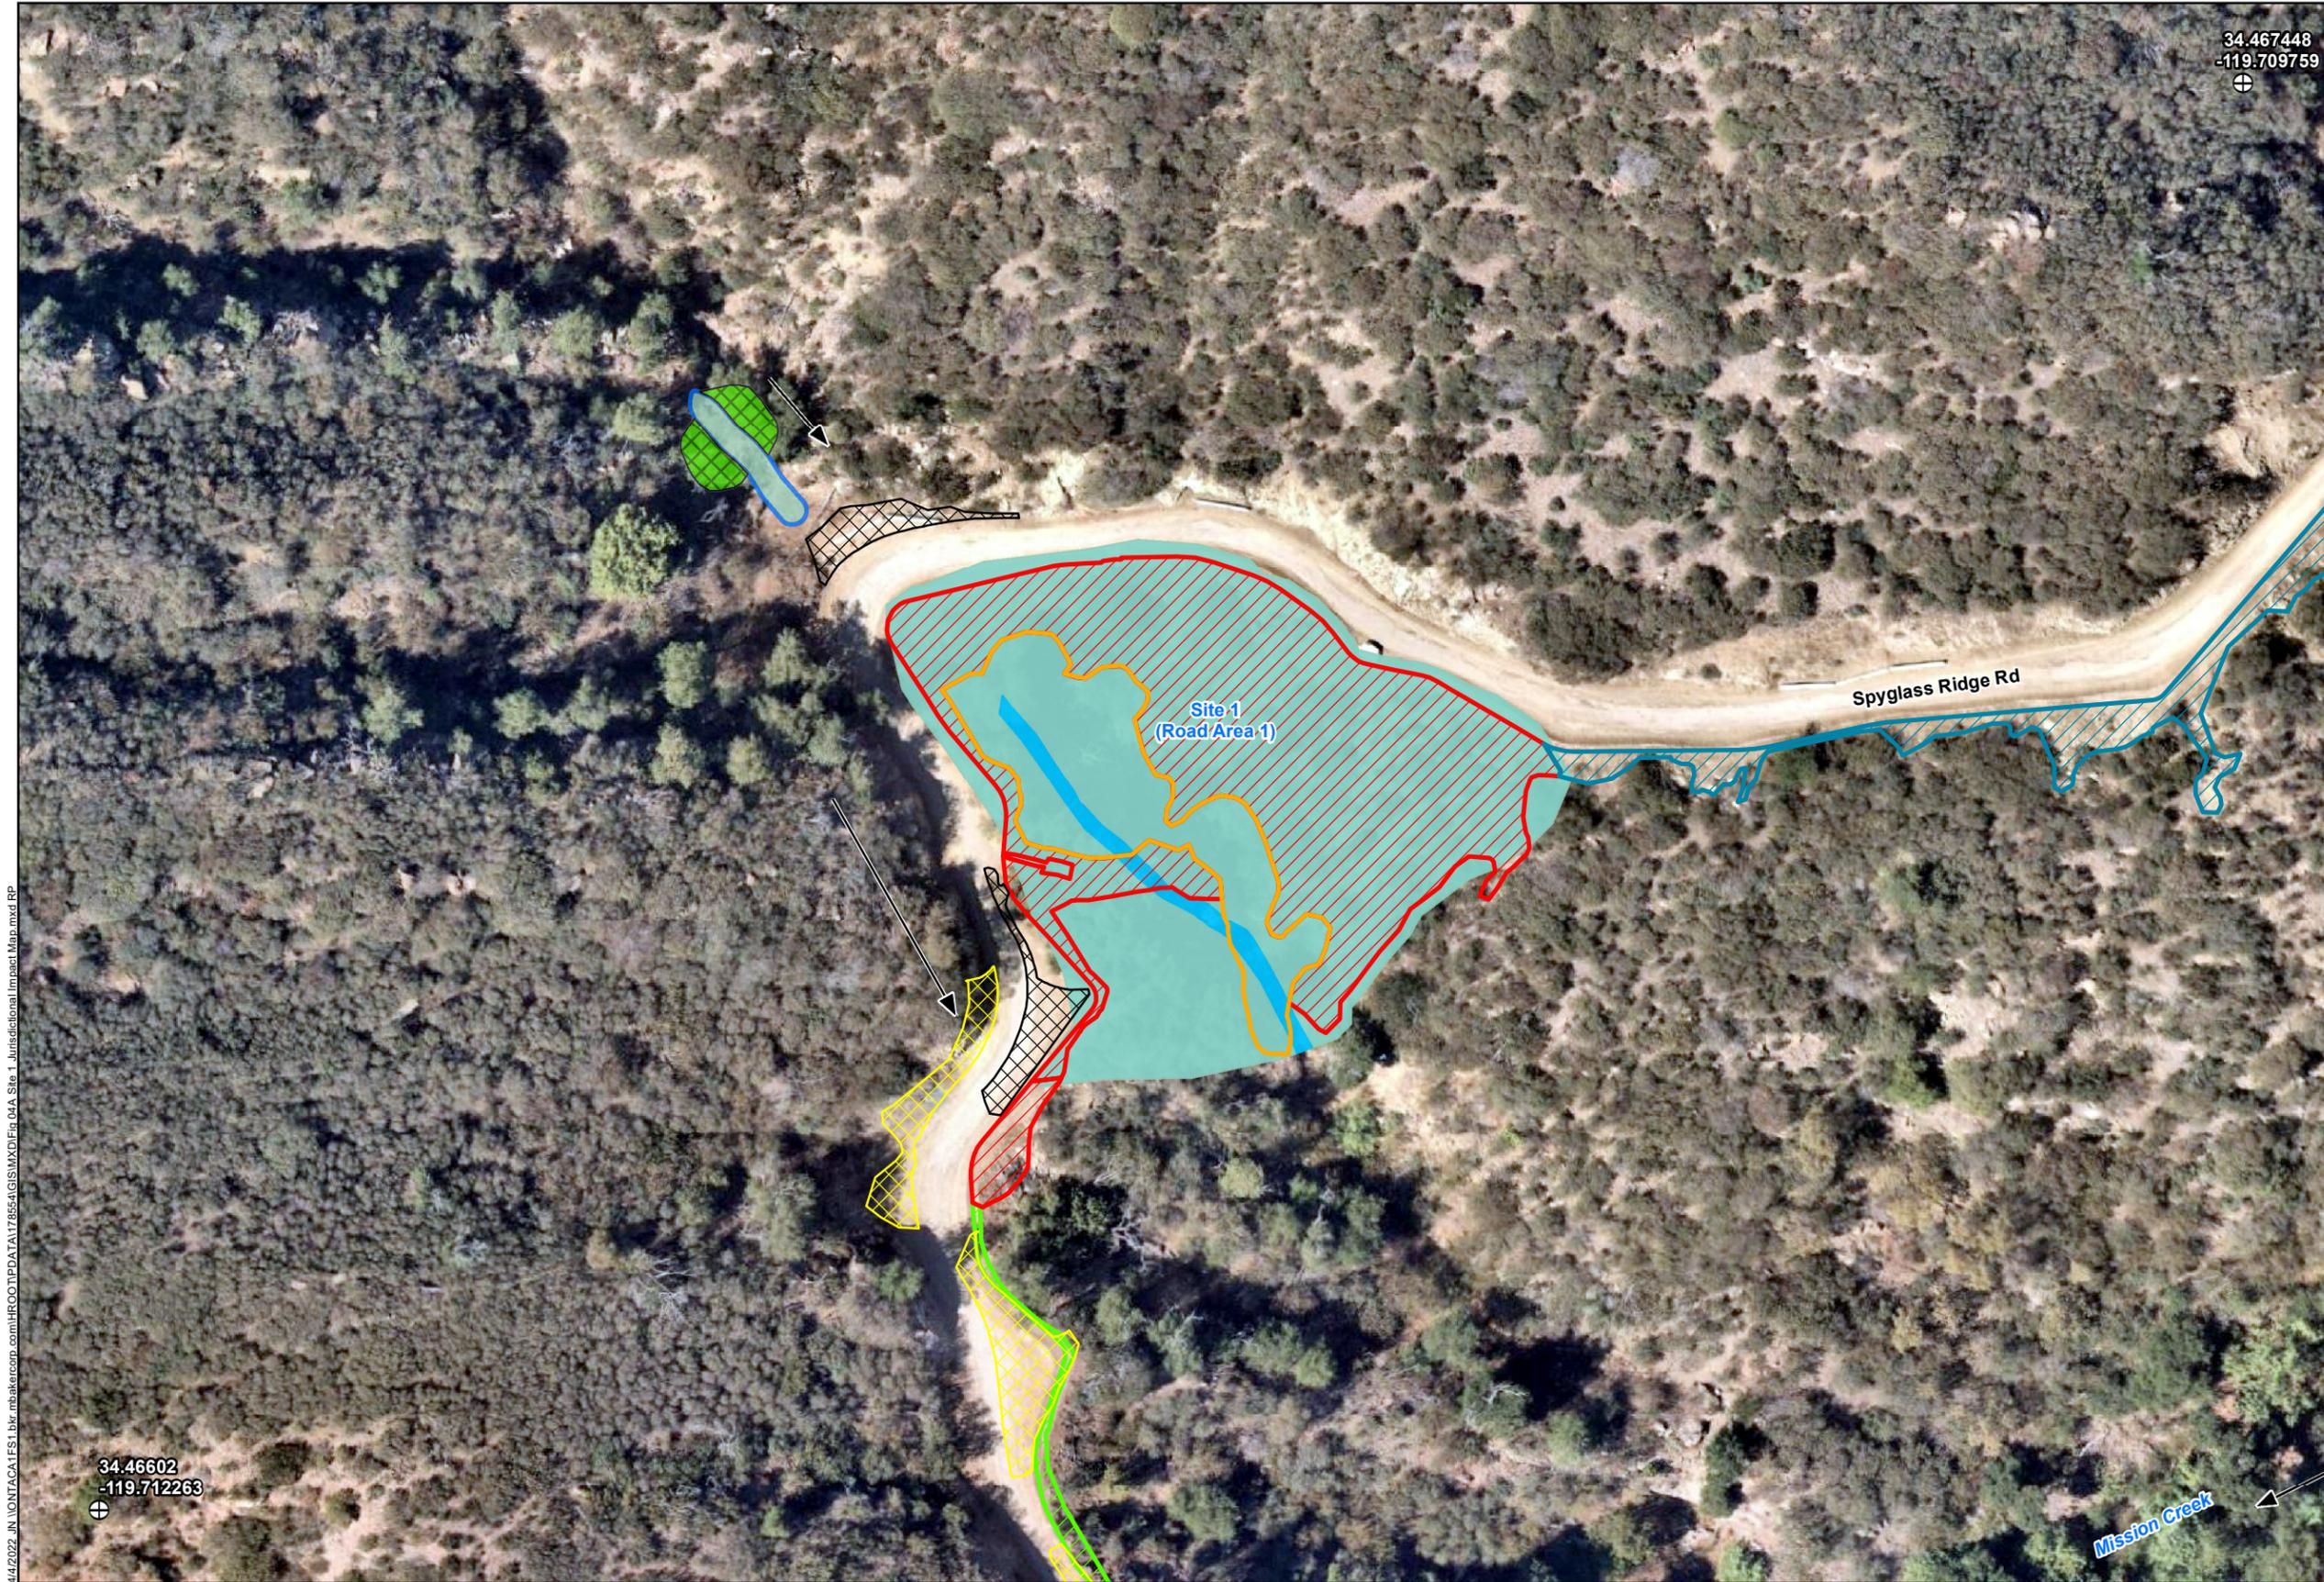
One area along an unnamed drainage, west of Mission Creek, was identified where soil was observed spilling into potentially jurisdictional resources. As depicted in Tables 3A and 3B, temporary impacts to USACE jurisdiction at Site 1 total to 0.002 acre of proposed sidecast removal and 0.01 acre within the contingency disturbance buffer (0.8 cubic yards). RWQCB/CDFW jurisdiction totals to 0.39 acre resulting from sidecast removal and 0.14 acre within the contingency disturbance buffer (184.9 cubic yards). Proposed impacts to Site 1 are depicted on Figure 4a.

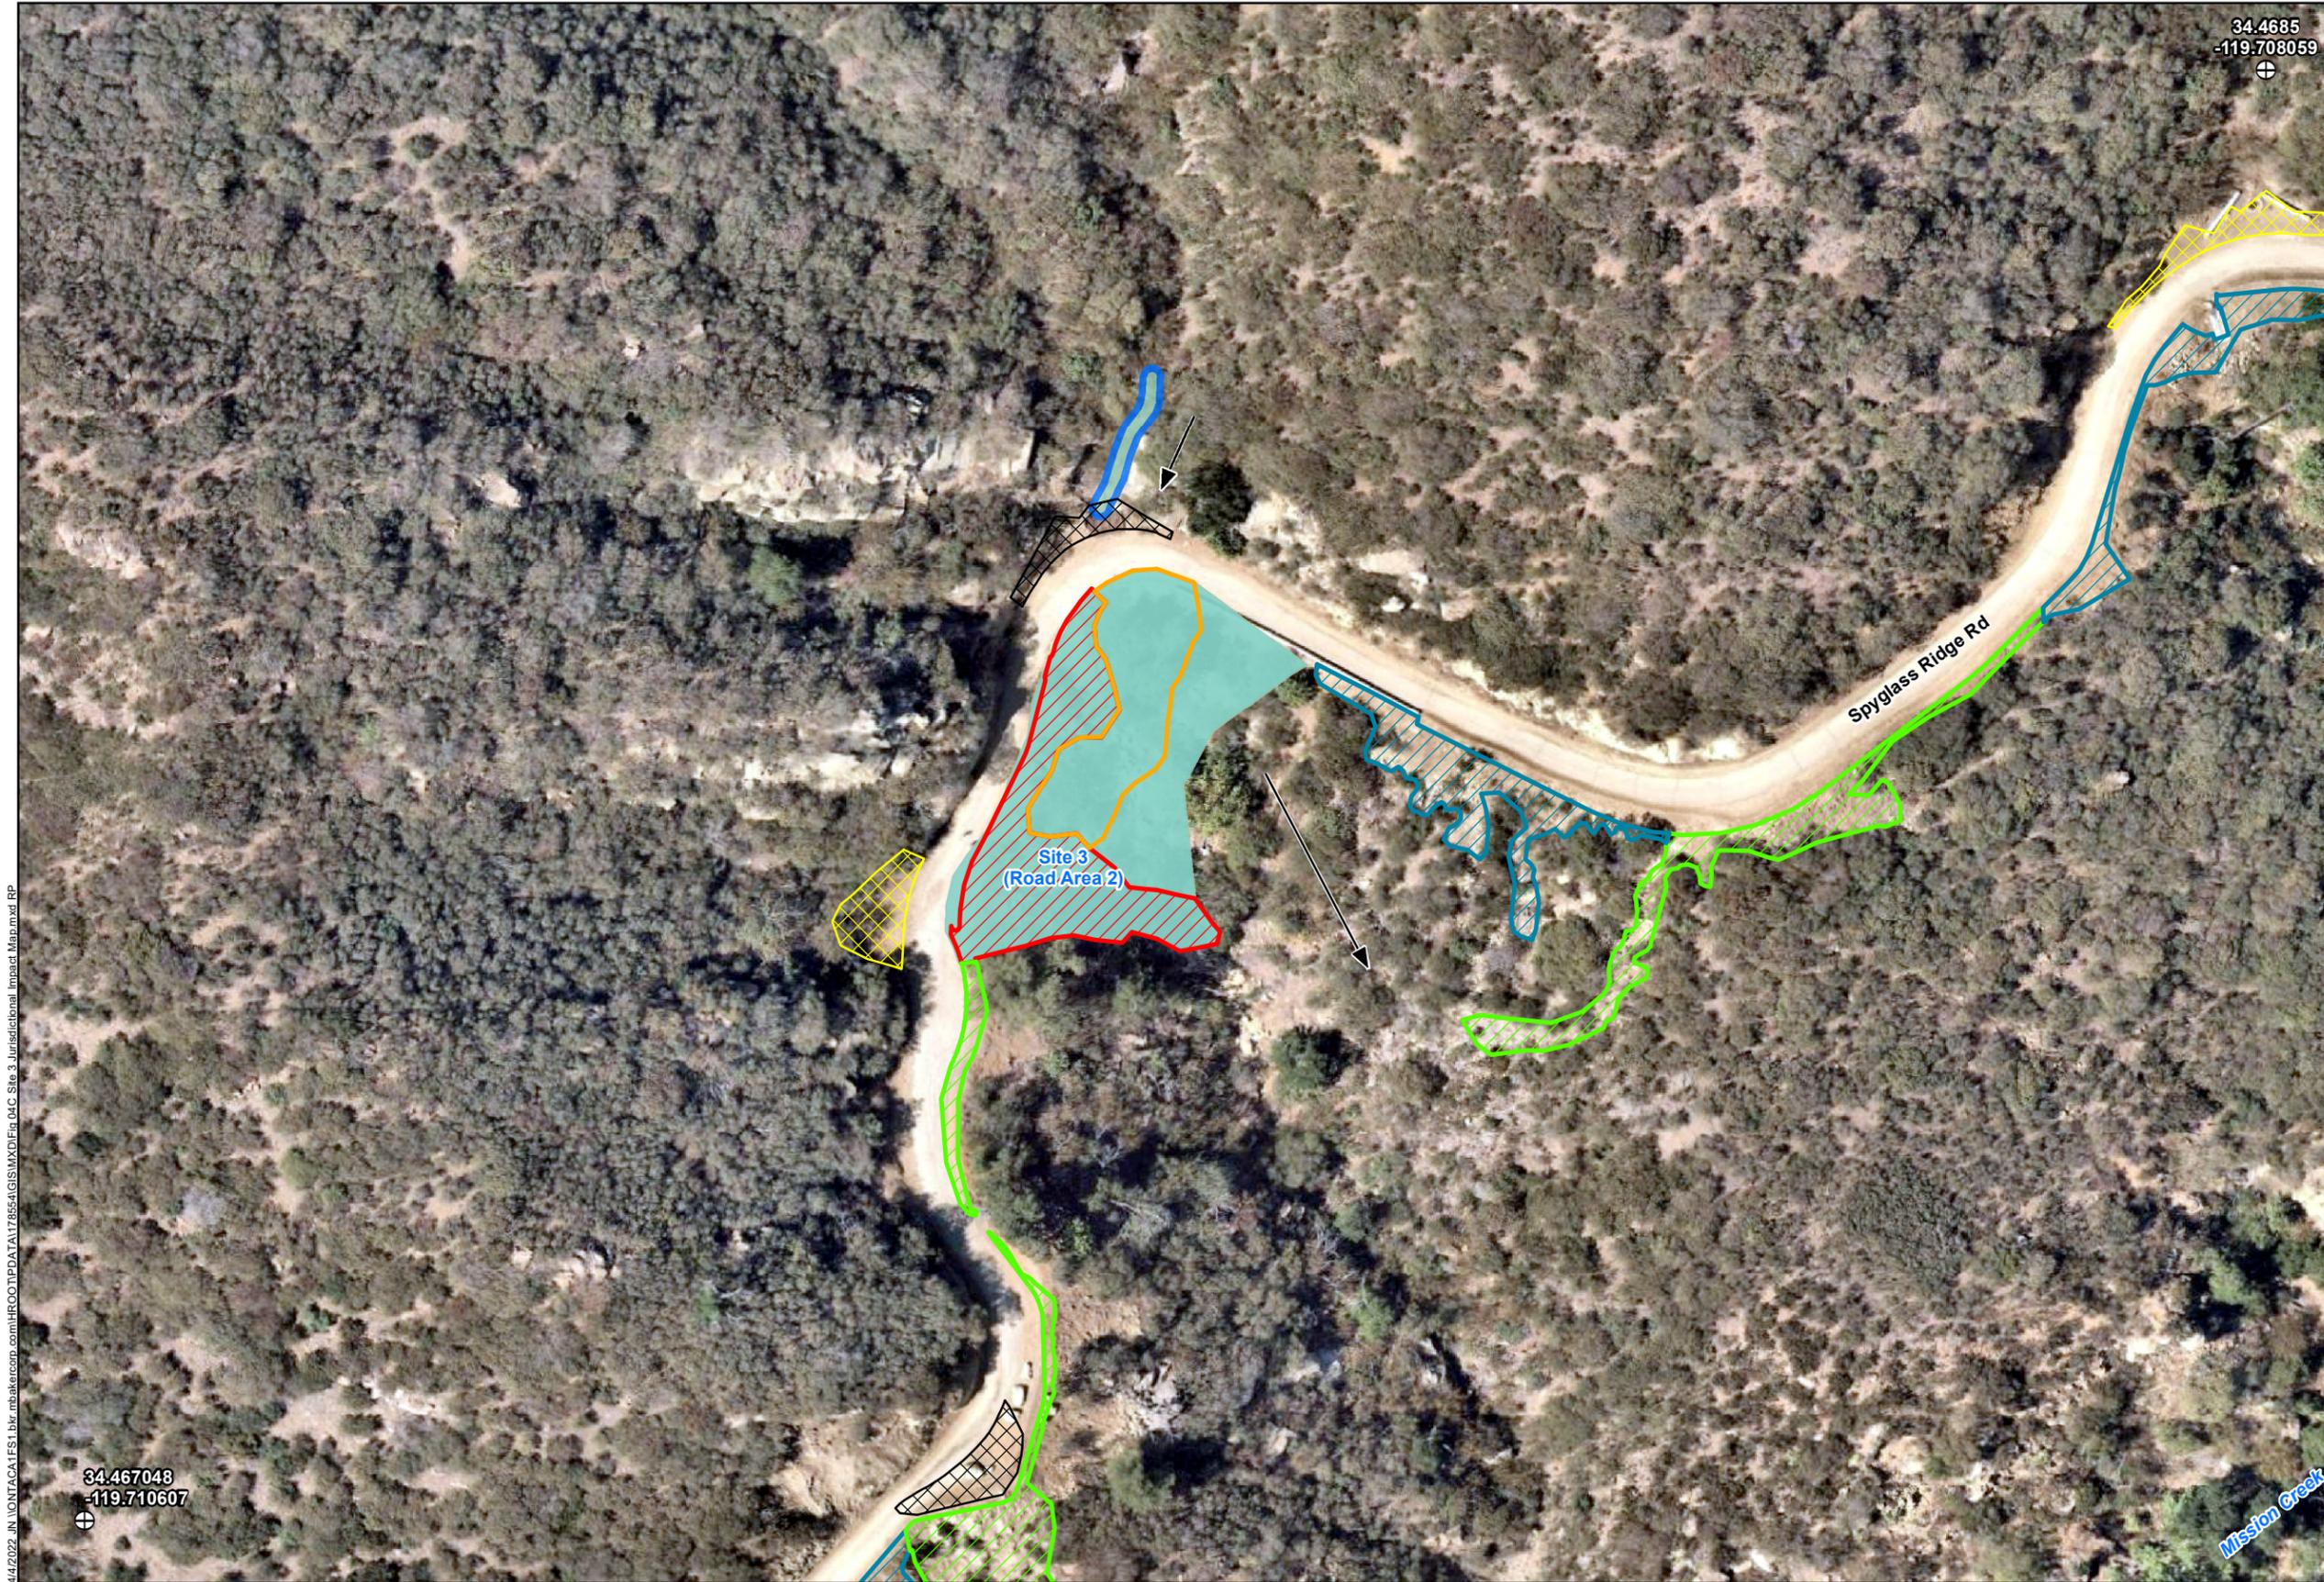
One area along another unnamed drainage, west of the Mission Creek mainstem, was identified where soil was observed spilling into potentially jurisdictional resources, specifically within CDFW/RWQCB jurisdiction. As depicted in Tables 3A and 3B, proposed temporary impacts to RWQCB/CDFW jurisdiction at Site 3 totals approximately 0.09 acre of sidecast removal (70.5 cubic yards) and 0.06 acre within the contingency disturbance buffer (225.0 cubic yards). The limits of the tributary were conservatively assumed to be equivalent to the jurisdictional stream and riparian habitat boundaries discussed below. No defined OWHM or channel was identified within the Study Area for this area, therefore no USACE jurisdiction was defined. Proposed impacts to Site 3 are depicted on Figure 4c.

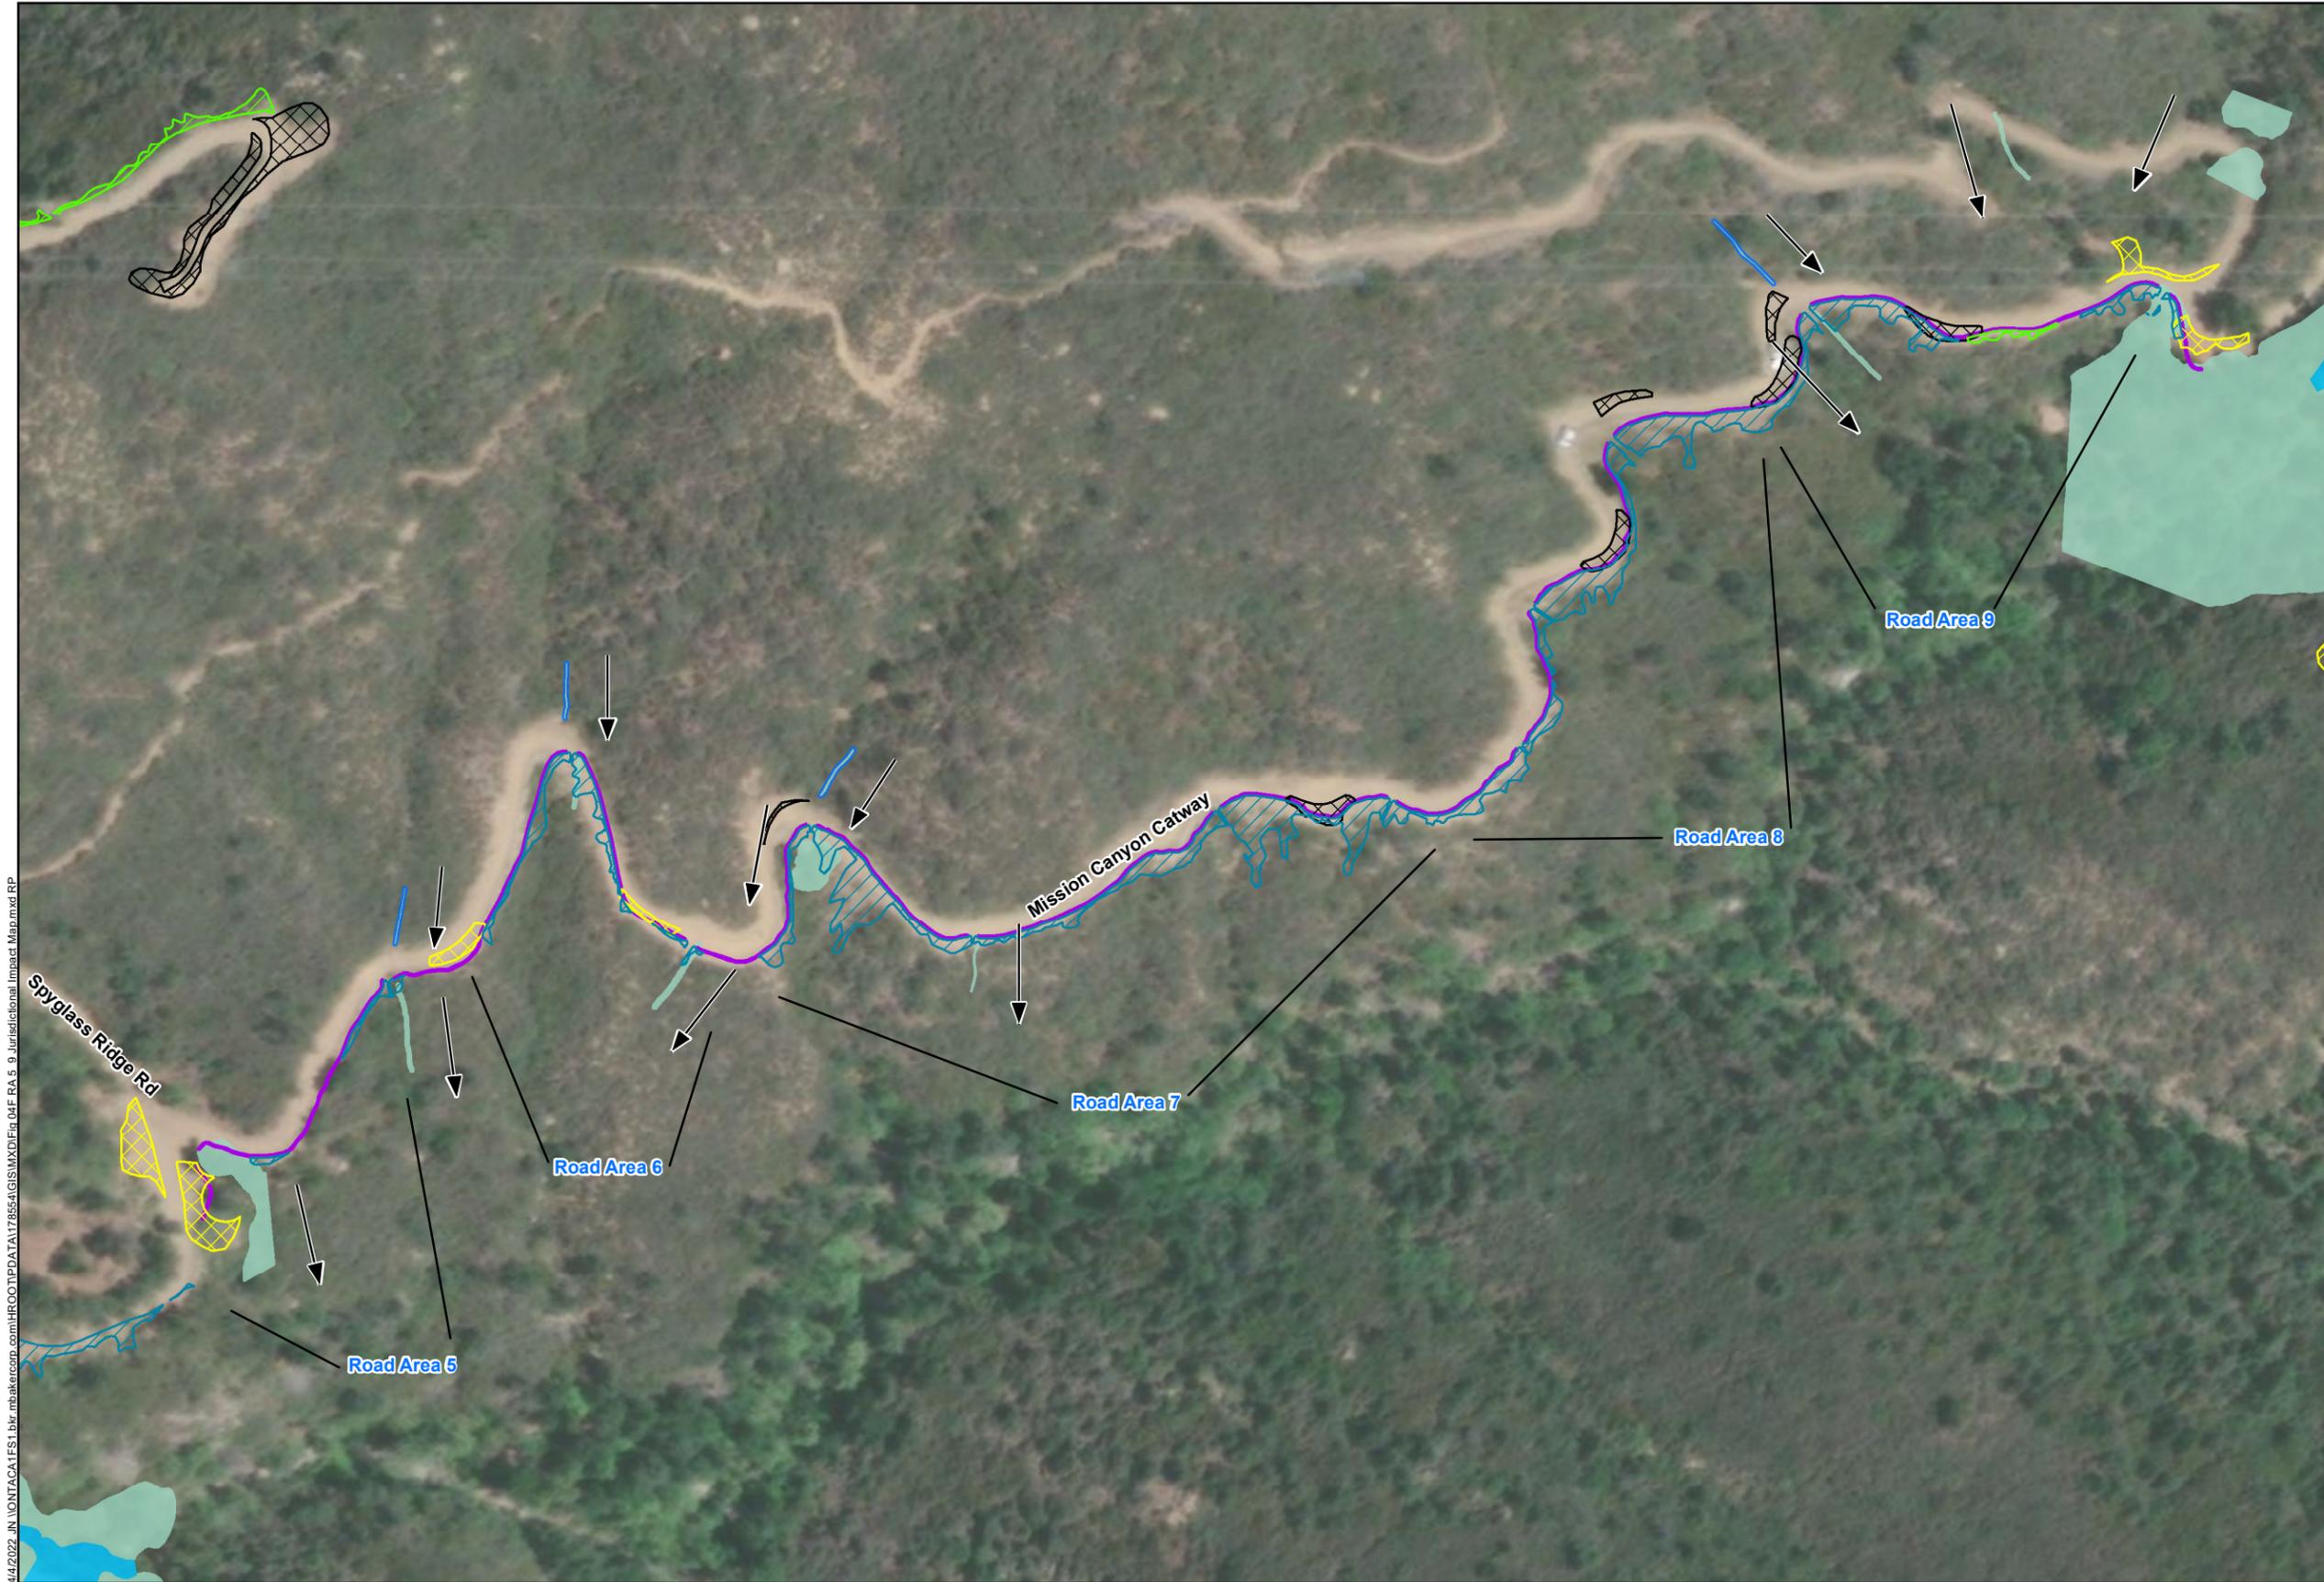
Temporary impacts to RWQCB/CDFW jurisdiction occur in Road Areas 5-9, totaling 0.02 acre of proposed sidecast removals (Table 3A). Proposed impacts to Road Areas 5-9 are depicted on Figure 4f.

Jurisdictional areas were documented by Rincon and MBI along the road in Road Areas 5-9. Sidecast in Road Areas 5-9 is proposed to be removed by hand with hand tools where necessary within jurisdictional areas. Sidecast will also be removed by hand in one small section of Road Area 1 and a small area of Site 5 (Creek Site 7), Jurisdictional areas documented at Site 5 are depicted on Figure 4e. Jurisdictional areas documented adjacent to or within Road Areas 5-9 are depicted on Figure 4f.

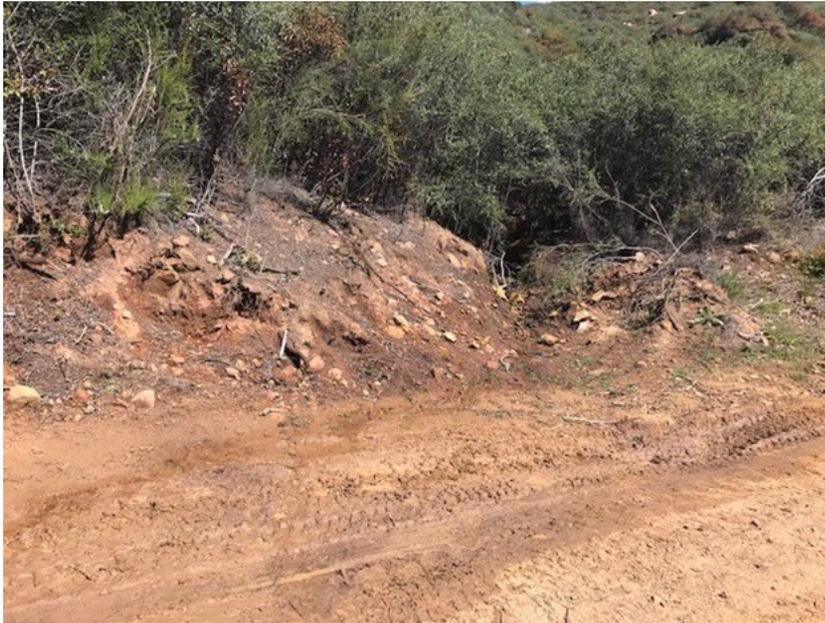
Photograph 15. Other non-jurisdictional drainage features observed within Study Area (March 27, 2020; aspect: north).

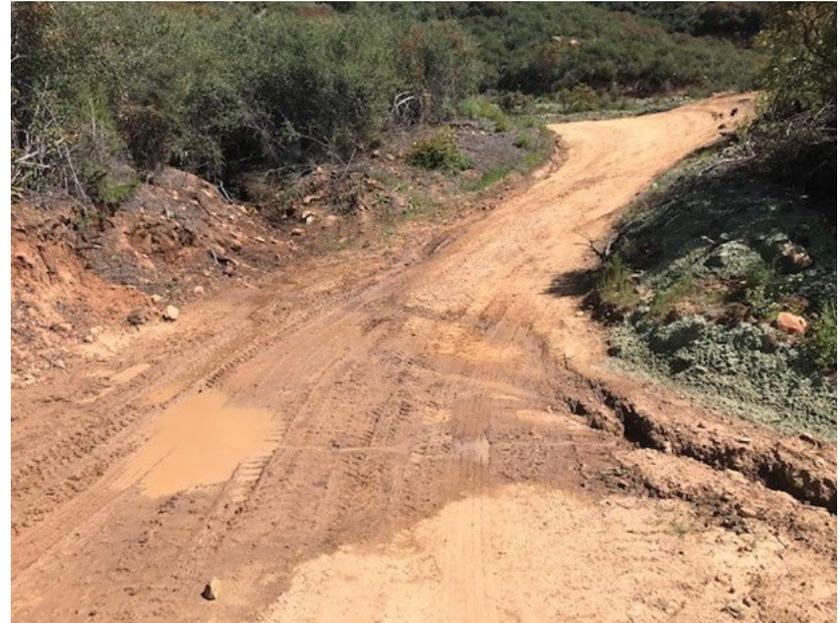
Photograph 16. Other non-jurisdictional drainage features observed within Study Area (March 27, 2020; aspect: northeast).

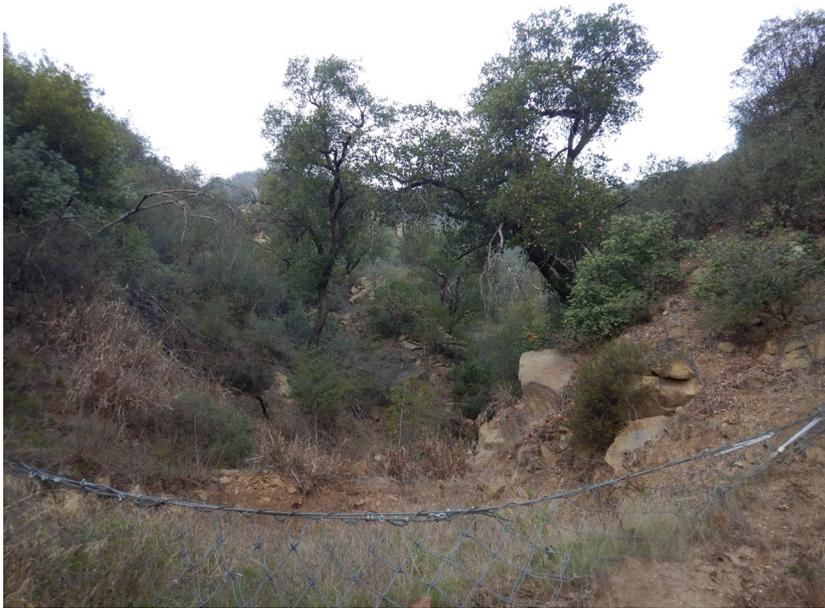
Photograph 17. Looking upstream from Tunnel Trail at Drainage 1, no impacts from road grading activities observed (November 11, 2021; aspect: northwest).

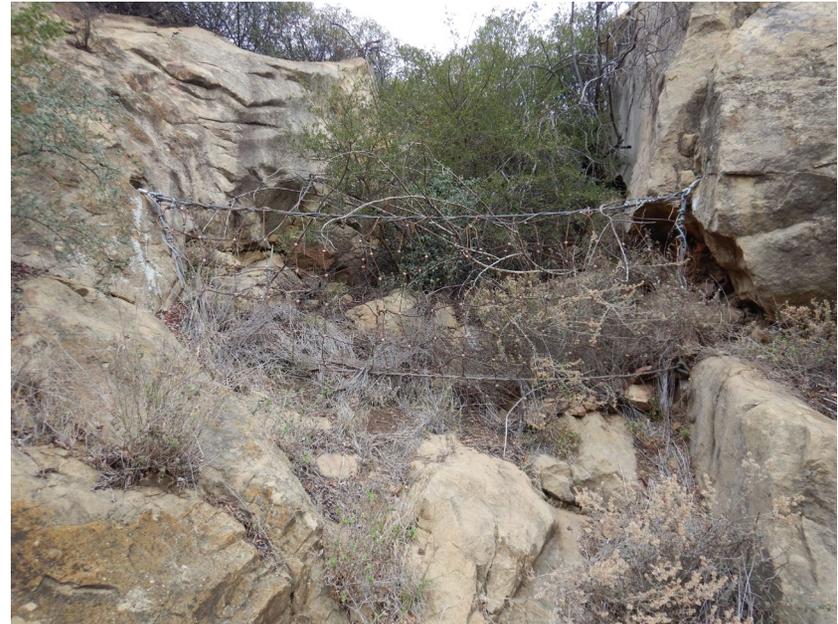
Photograph 18. Looking upstream from Tunnel Trail at Drainage 2, no impacts from road grading activities observed (November 11, 2021; aspect: northeast).

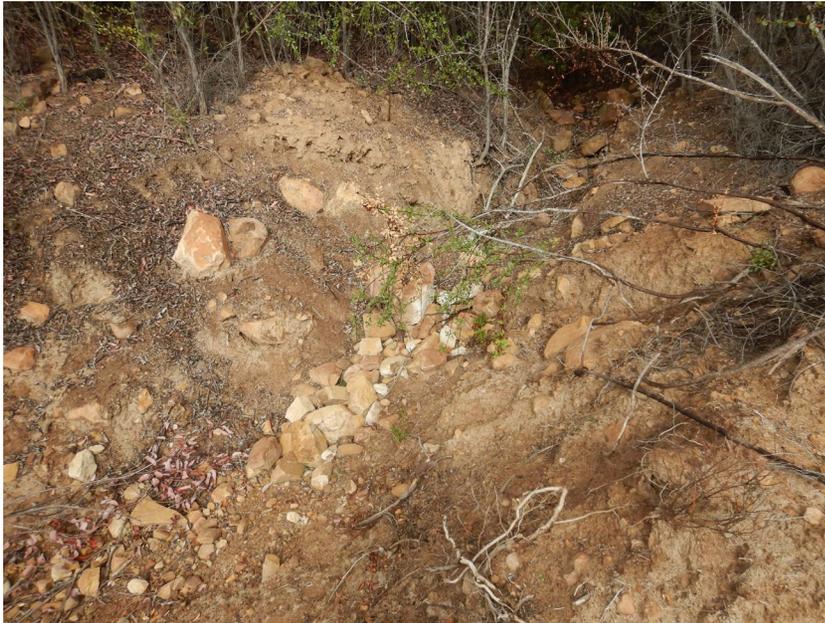
Photograph 23. Looking upstream from Mission Canyon Catway at Drainage 3, no impacts from road grading activities observed (November 11, 2021; aspect: north).

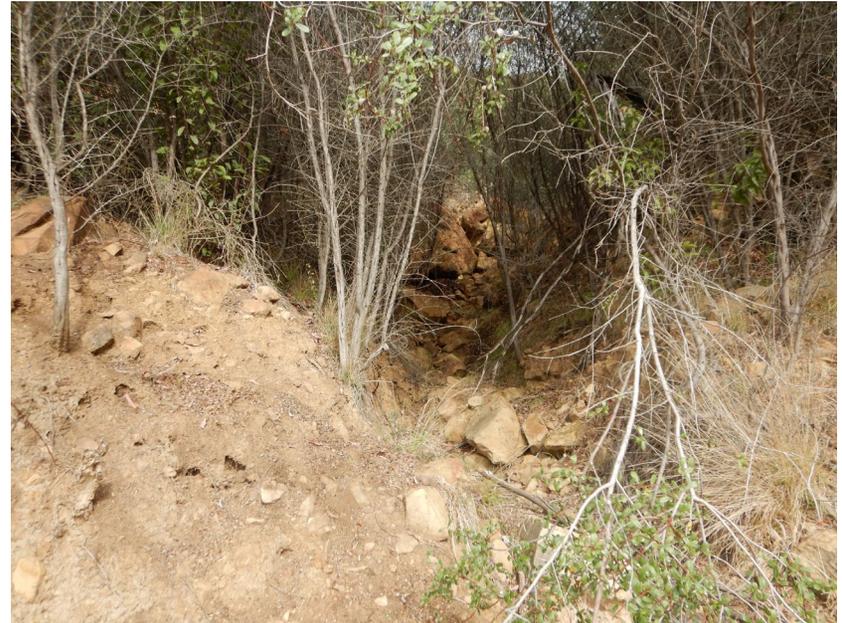
Photograph 24. Looking upstream from Mission Canyon Catway at Drainage 4, no impacts from road grading activities observed (November 11, 2021; aspect: north).

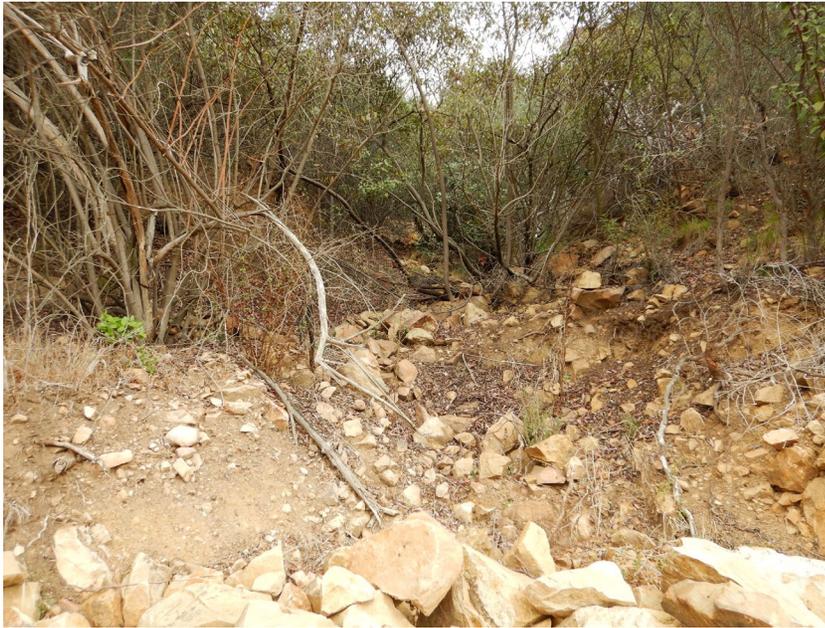
Photograph 25. Photograph 24. Looking upstream from Mission Canyon Catway at Drainage 5, (upstream of rockpile depicted in photograph) no impacts from road grading activities observed (November 11, 2021; aspect: northeast).

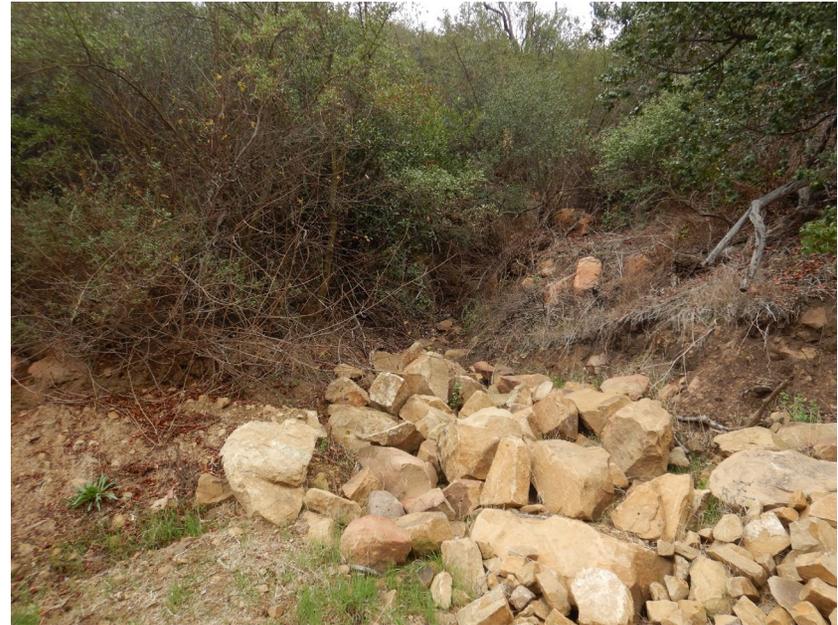
Photograph 26. Looking upstream from Mission Canyon Catway at Drainage 6 (upstream of rockpile depicted in photograph) no impacts from road grading activities observed (November 11, 2021; aspect: northwest)
