Project No. 6103.200.000

Subject: Spotorno Property Pleasanton, California

## **GEOTECHNICAL FEASIBILITY REPORT**

We prepared this geotechnical feasibility report for the proposed residential development at the approximately 112-acre site referred to as the Spotorno Property. The subject property is located at 1000 Minnie Street in Pleasanton, California and is identified as Assessor Parcel Number (APN) 949-16-6. This report is prepared as outlined in our proposal dated December 29, 2014.

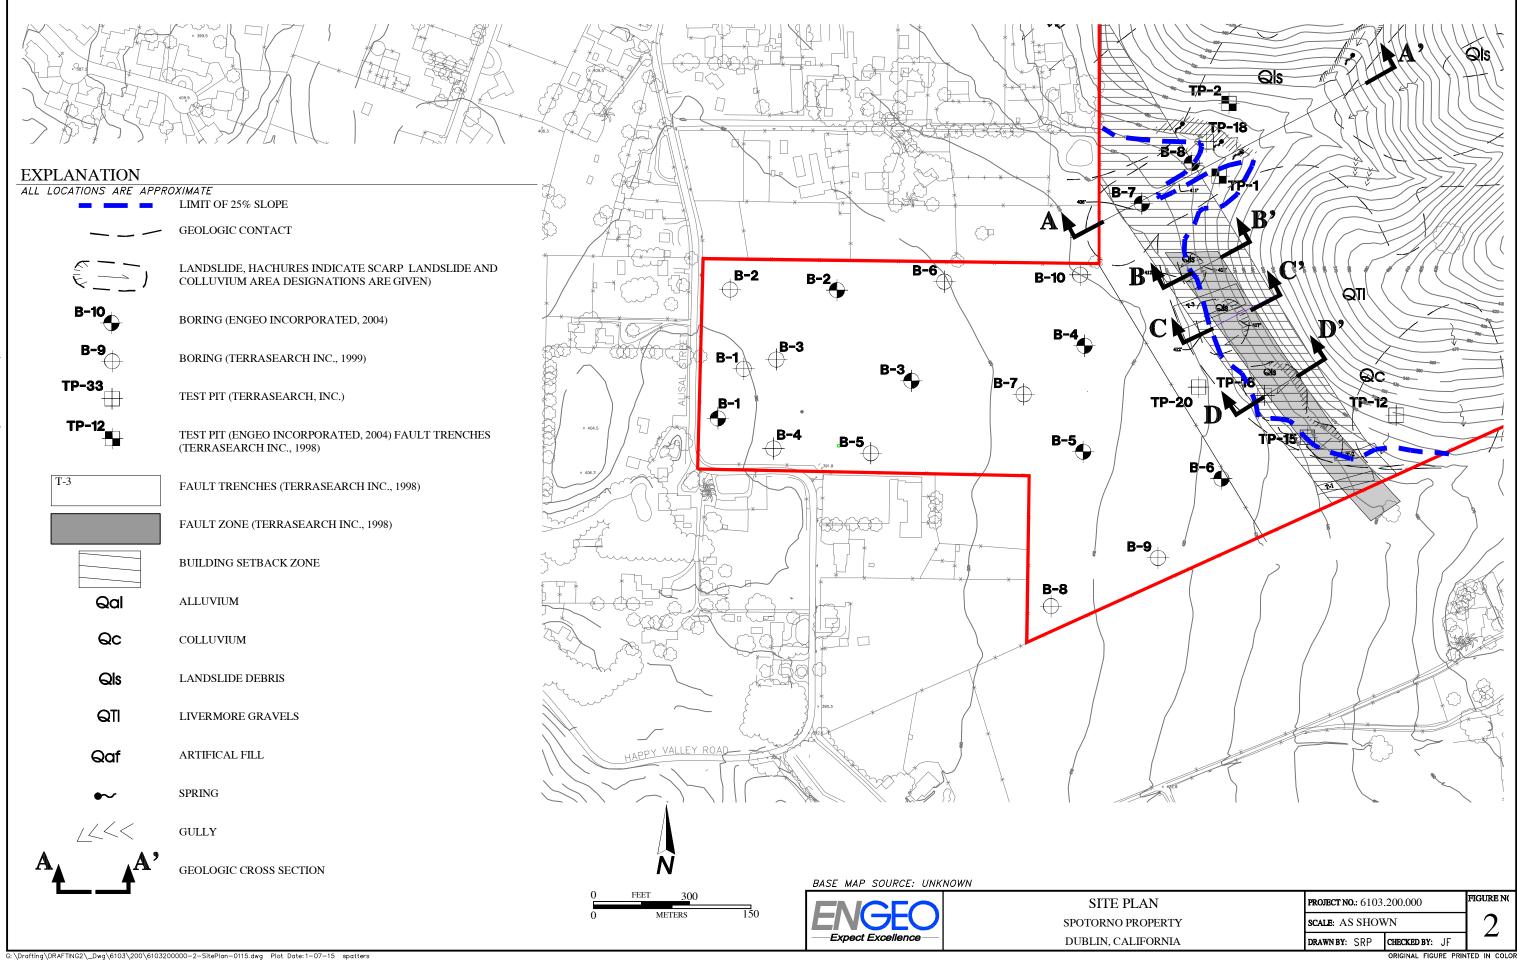
PROPERTY	SCALE: AS SHOWN		2
ALIFORNIA	DRAWN BY: SRP	CHECKED BY: JF	
			TED IN AGLOD

Known previous explorations located near and within the proposed area to be developed are shown in Figure 2.

slope limit (identified as "L-1" through "L-4" on Figure 2). The four possible landslides were identified based on relatively subtle breaks in slope along spur ridges that may be indicative of landslides.

As previously discussed, landslides have been mapped throughout the study area. It is our understanding that the improvements are proposed on the western relatively flat portion of the property as delineated by the 25-percent. Four landslides have been identified along the eastern boundary of the proposed improvement area as shown on Figure 2. It does not appear that structures will be located on slide areas, however, structures could be located near the toe of the landslides risking damage to the structure. Recommendations for mitigation of this hazard should be provided in a design-level exploration for the proposed project pending the site plan. We provide the preliminary mitigation option of removal and replacement as engineered fill in

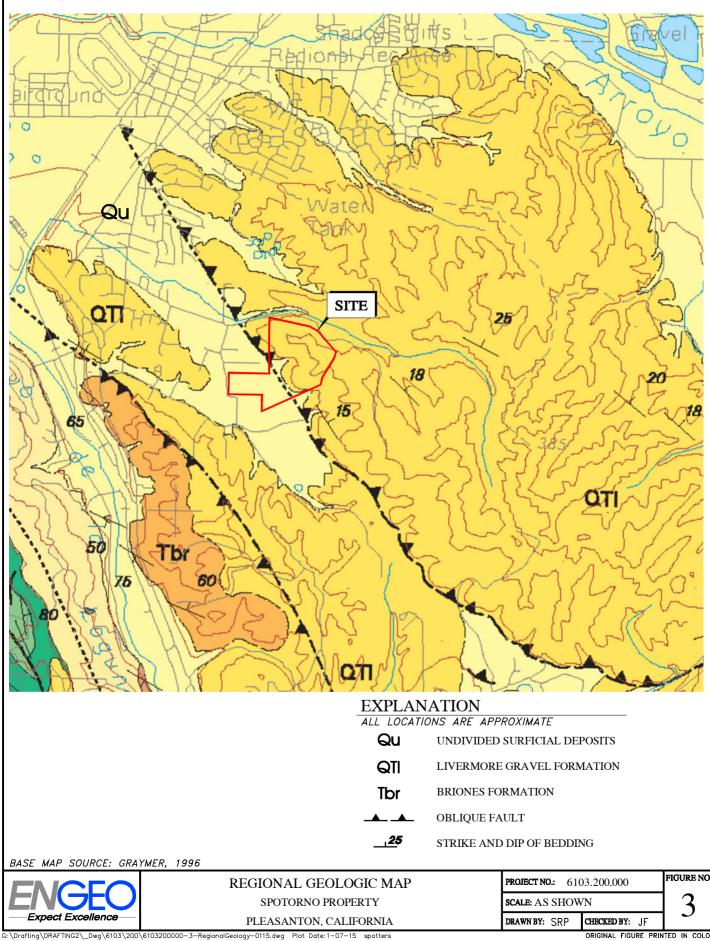
Portions of the study area underlain by Livermore Gravels at relatively shallow depths are indicated on the Geologic Map (Figure 3) using the symbol QTI. Where encountered in test pits and borings, the Livermore gravels were found to consist predominantly of light olive-gray and olive-brown siltstone and sandstone with some interbedded light olive-gray conglomerate. The bedrock encountered was friable to weak, and varied from thinly to thickly bedded. A few test pits encountered slightly cemented siltstone that was moderately difficult to excavate with the small excavator used for our exploration.

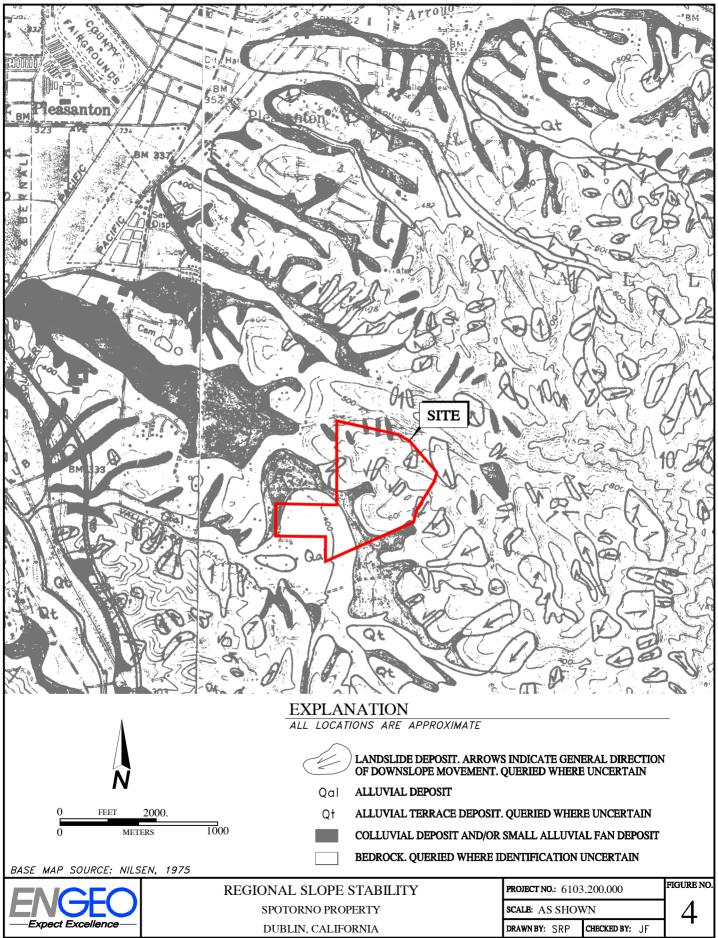
G:\Drafting\DRAFTING2\\_Dwg\6103\200\6103200000-4-SlopeStabilityMap-0115.dwg Plot Date:1-07-15 spatters

Regional landslide mapping of the vicinity by Nilsen (1975) (Figure 4) and by Majmundar (1991) shows numerous landslides within the study area.

Regional mapping of surficial deposits in the vicinity by Nilsen (1975) shows much of the base of the west facing slope near the center of the study area to be underlain by colluvium (Figure 4). Colluvial deposits were found to range from silty clay to sandy clay with some fine gravel. The colluvial deposits were typically dark brown, very stiff to hard and varied from dry to moist. Based on the findings of our exploration and data by others, the colluvium appears to range up to about 16 feet in thickness (Terrasearch, 1998, TP-19).

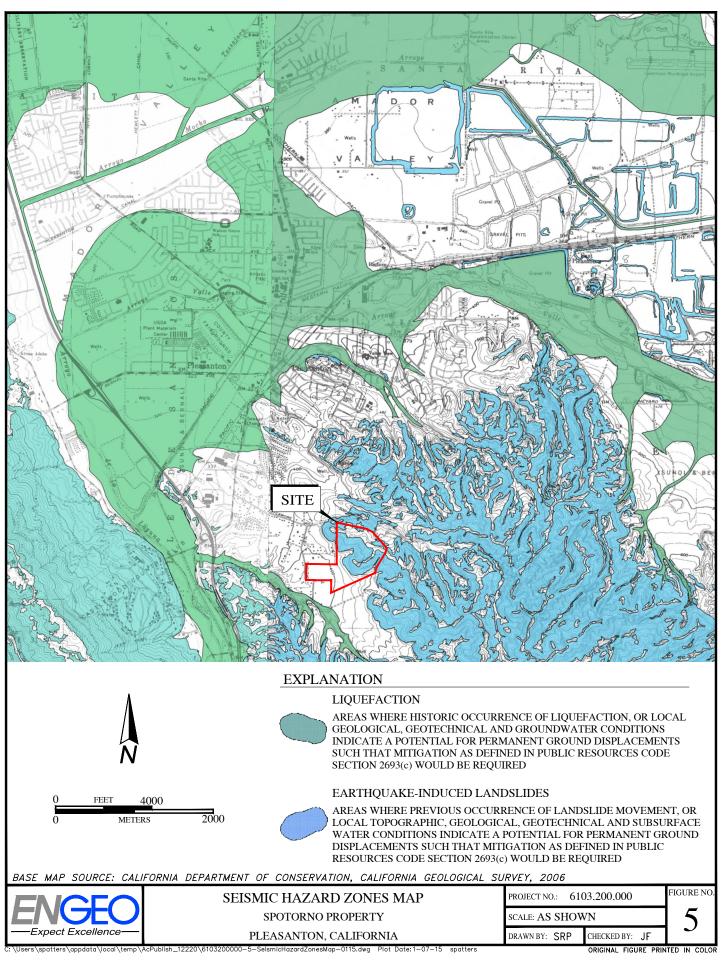
The site is not located within a State of California Seismic Hazard Zone (CGS, 2008) for areas that may be susceptible to liquefaction (Figure 5). In addition, the United States Geological Survey (USGS) has mapped the area to have low susceptibility for liquefaction. Soil liquefaction results from loss of strength during cyclic loading, such as imposed by earthquakes. Soils most susceptible to liquefaction are clean, loose, saturated, uniformly graded, sand. Empirical evidence indicates that loose to medium dense gravel, silty sand, low-plasticity silt, and some low-plasticity clay are also potentially liquefiable.
