UPDATED GEOTECHNICAL REPORT

THE HOMES AT DEER HILL LAFAYETTE, CALIFORNIA

> Prepared by: ENGEO Incorporated

> > April 3, 2014

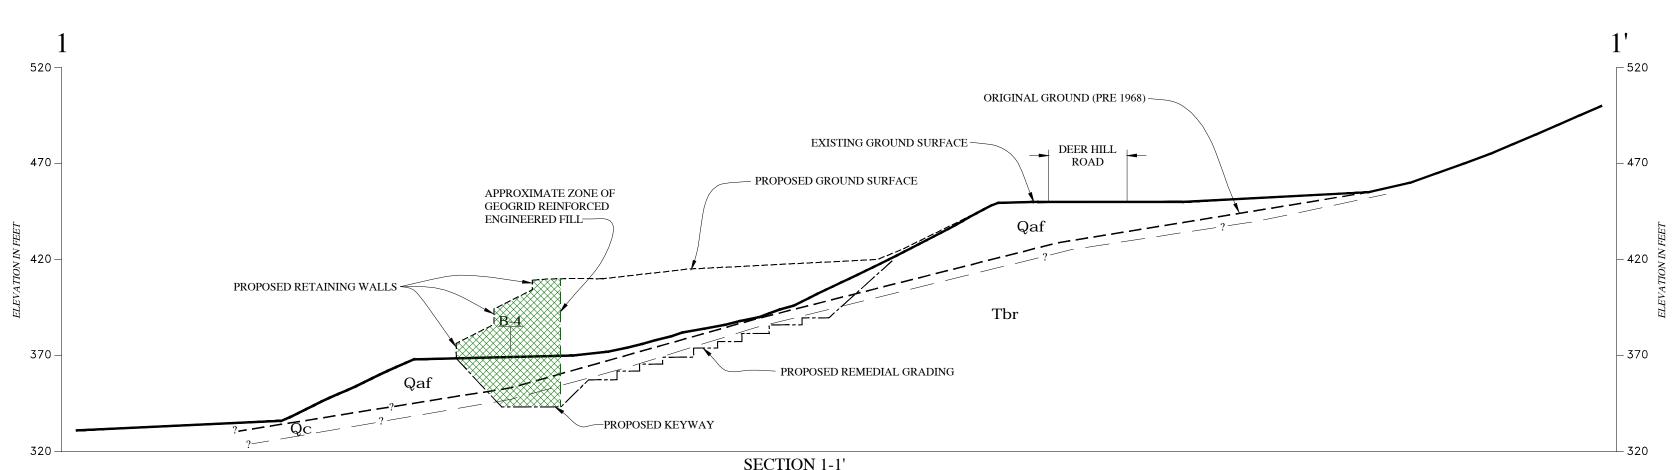
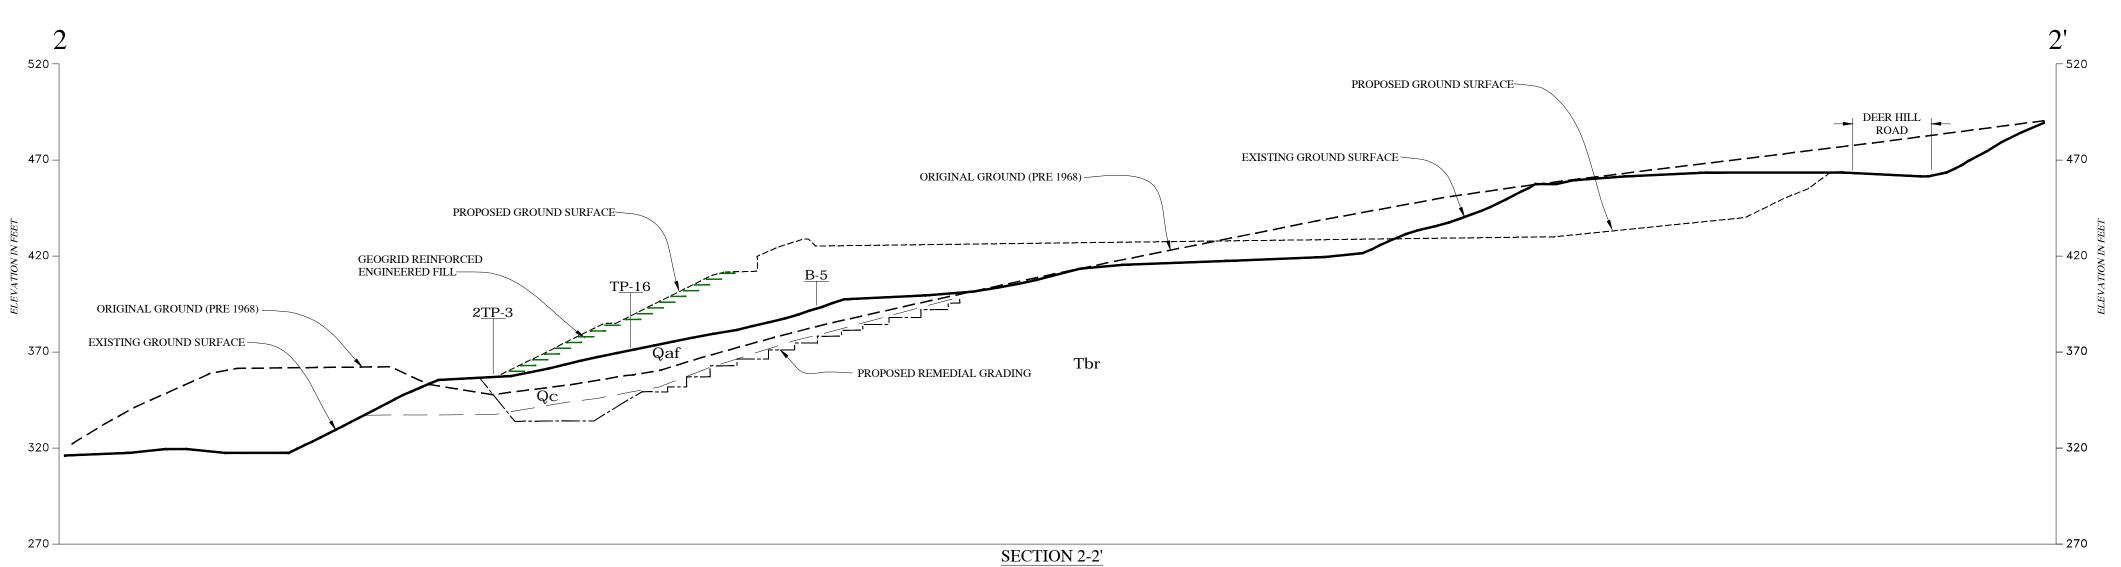
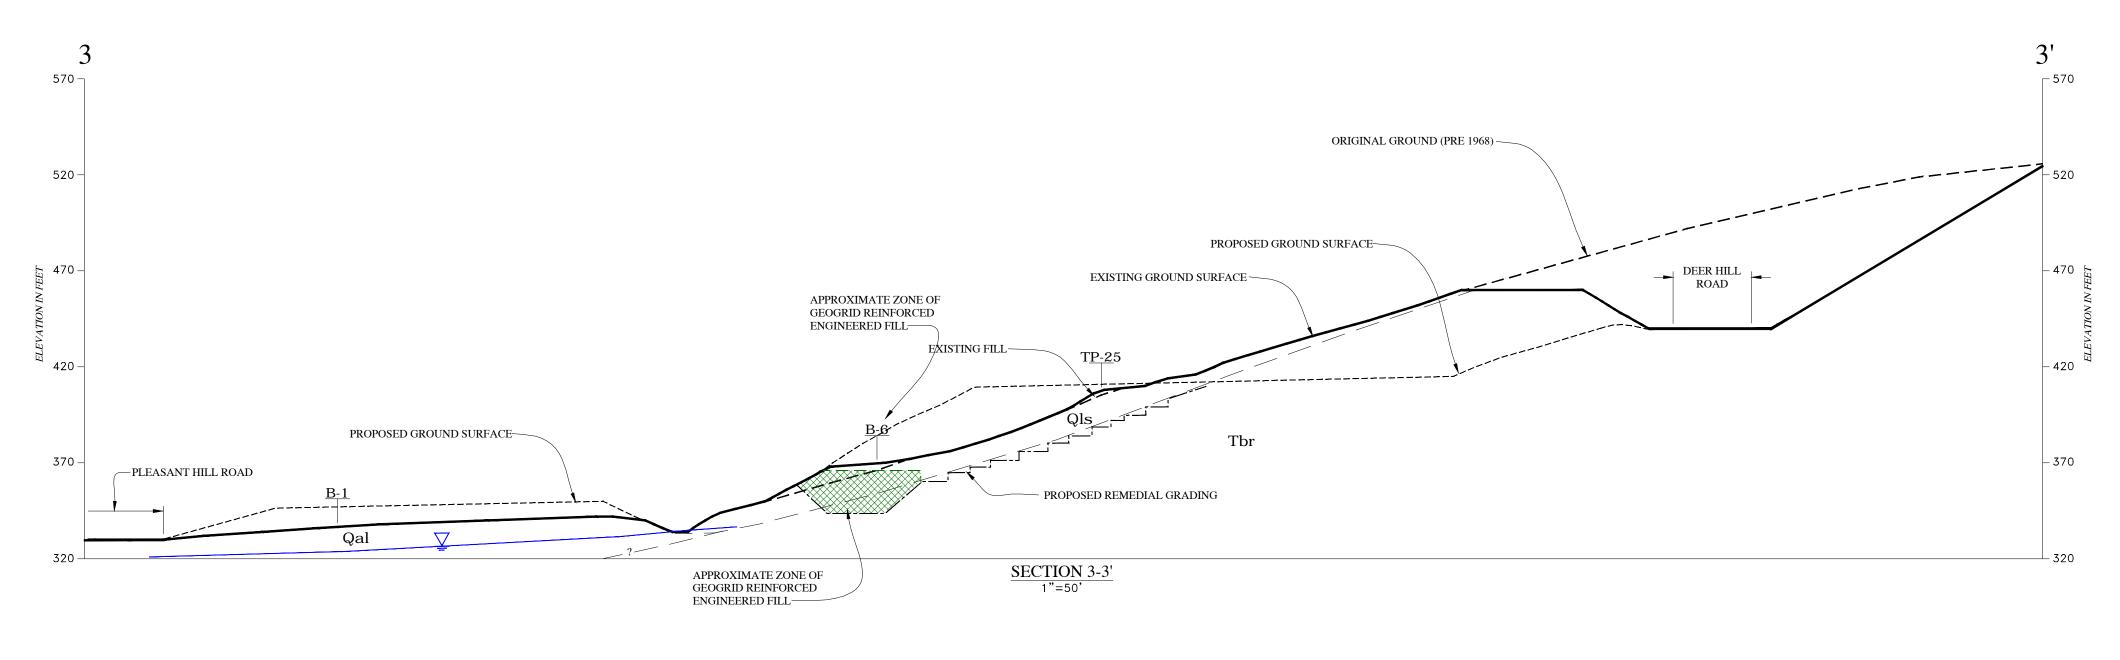
CROSS SECTIONS THE TERRACES OF LAFAYETTE LAFAYETTE, CALIFORNIA

<u>SECTION 2-2'</u> 1"=50'

We performed two-dimensional limit-equilibrium slope stability analyses of critical slopes with the computer slope stability software Slide Version 6.0 using Spencer's method (Spencer, 1967). We selected critical slopes for slope stability analyses (Cross Sections 1-1', 2-2', and 3-3'). Cross Section 1-1 is at the location of a proposed 2:1 (horizontal to vertical) slope with terraced retaining walls at the southwestern portion of the site. Figure 3 shows the locations of Cross Sections 1-1, 2-2, and 3-3 and the profiles of the Cross Sections are included on Figure 5. A conservative groundwater table was assumed at roughly 5 to 20 feet below existing grade depending on location. For pseudostatic stability analyses, we used ground motions corresponding to a seismic event with a probability of exceedance of 10 percent in 50 years based on the United States Geological Survey 2008 Seismic Hazard Map.

Actual subsurface mitigation configurations (including size and depths of keyways) will be shown on the final 40-scale remedial grading plans and after additional detailed slope stability analyses have been performed where necessary. Fills should be adequately keyed and benched into competent material or bedrock materials as evaluated by the Geotechnical Engineer during fill slope construction. Observation and evaluation of exposed conditions by the Geotechnical Engineer in the field will allow for modifications to the actual depth and location of the keyways, subexcavated benches, and locations of subdrains on actual field conditions and geometry exposed during grading. Figure 5 includes conceptual remedial grading measures for Cross Sections 1-1', 2-2', and 3-3'.

Where slopes higher or steeper than those recommended above are desired, or based upon final grading plan slope stability analysis, supplemental slope stabilization techniques such as slope rebuilding or incorporation of geogrid-reinforcing materials may be required. For example, the proposed fill slope shown on Cross Section 2-2' of Figure 5, which is situated below Lots 35 and 36, is shown on the grading plan at an inclination of 2:1 and a height greater than 50 feet. Therefore, we recommend the use of biaxial geogrid within the outer portion of the slope at this location to reduce the risk of surficial failures. Additionally, cut-fill transition slopes should be overexcavated and reconstructed as engineered fill slopes.
