**GEOTECHNICAL REPORT
THE INN AT SUNSET CLIFFS
SAN DIEGO, CALIFORNIA**

Prepared for
PROJECT DESIGN CONSULTANTS
San Diego, California

Prepared by
TERRACOSTA CONSULTING GROUP, INC.
San Diego, California

Project No. 2317-01
December 24, 2020

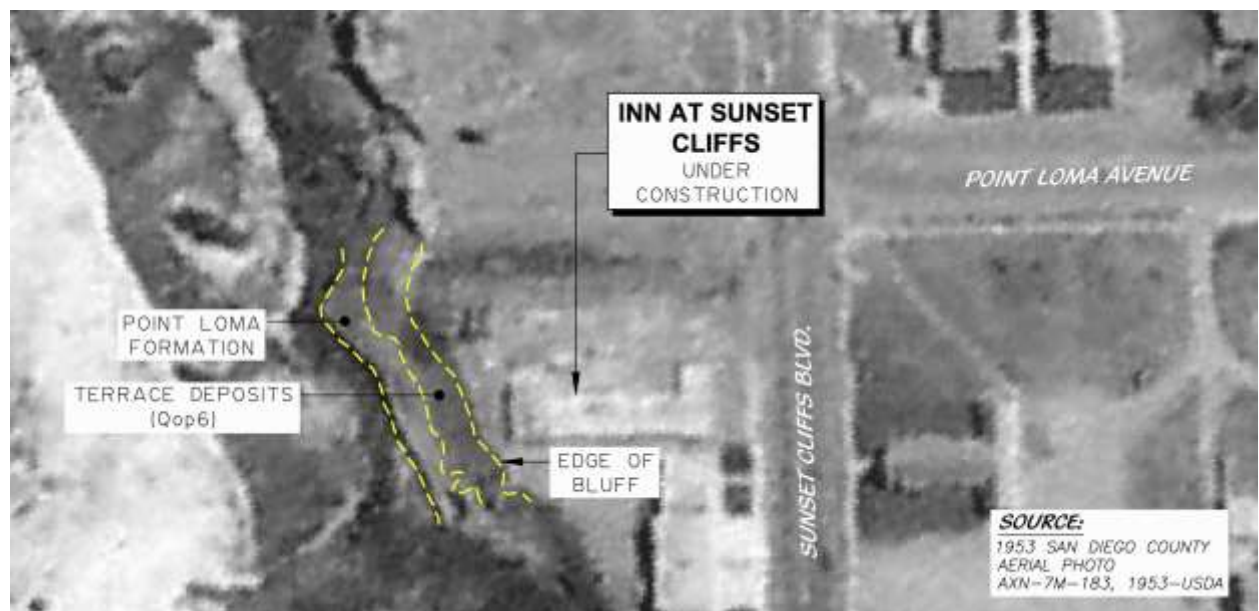
Photo 1

We have reviewed several historical photos dating back to 1939. The below 1953 aerial photo shows The Inn under construction and the seawall and lower viewing area constructed concurrently (Photo 1). Thus, all of the existing improvements pre-date the California Coastal Act.

1953 Aerial

In examining Figure 2, which shows the existing top-of-bluff from both GEI's and TerraCosta's measurements, the minimum distance from the top-of-bluff to the southwestern corner of the southern building is approximately 13 feet measured from GEI's reported top-of bluff, and only 8 feet measured from the 1953 aerial photograph (Photo 1).

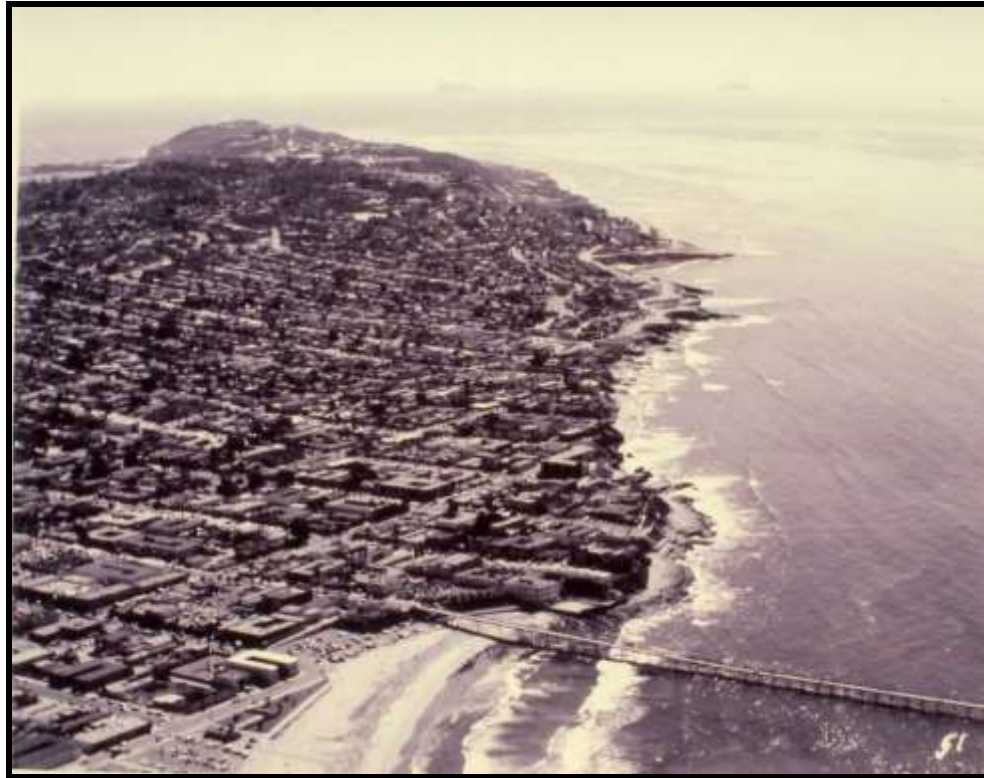
Photo 4

Point Loma is a 6-mile-long peninsular promontory (Photo 4), extending southerly from the low land adjacent to the mouth of the San Diego River. The Point Loma coastal bluffs are bordered by a narrow wave-abraded Quaternary-age terrace or bench, with elevations ranging from 25 to 95 feet MSL. Wave impact erosion has etched out the less resistant rock along faults and fractures in the coastal bluff, creating the shallow coves and sea caves that punctuate the Point Loma coastline. The more resistant rocks of the Point Loma Formation form the lower cliffed section of the coastal bluff and shore platform, which extends seaward. The relatively flat surface of the modern-day abrasion platform is interrupted by isolated remnants of more erosion-resistant rock, which have formed “sea stacks” and topographic highs. Further seaward, the abrasion platform becomes progressively deeper, and is locally incised by surge channels formed along the trends of major joint sets or faults.

Photo Date: 1974

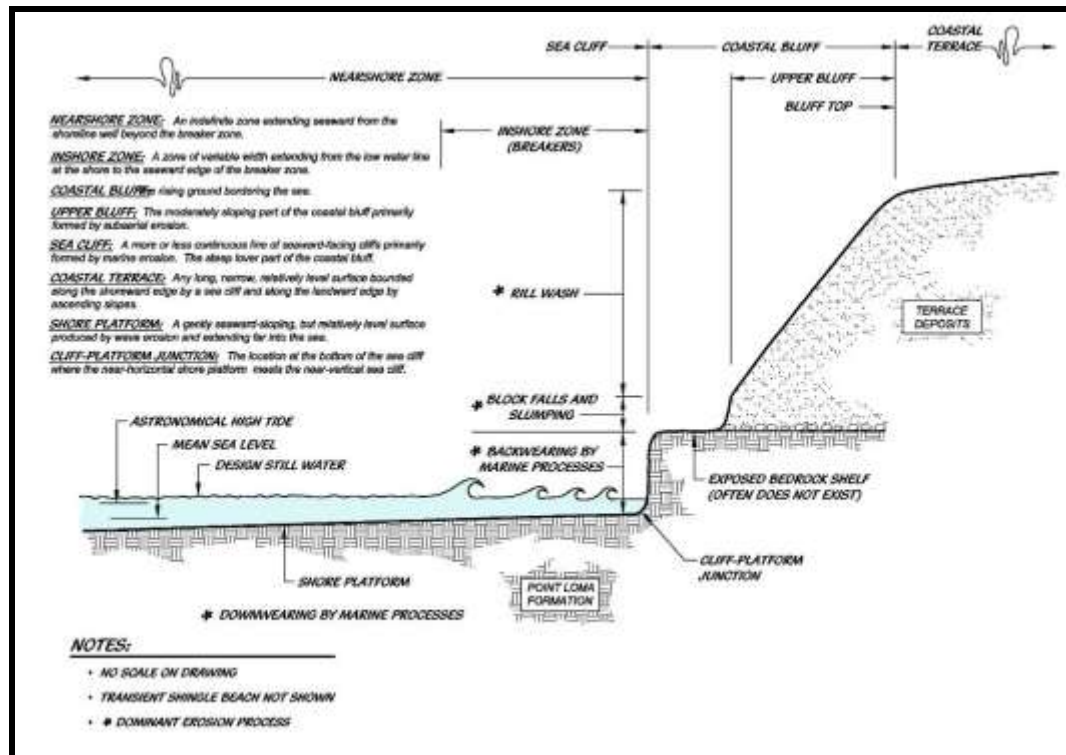
The geomorphology of a typical Point Loma sea cliff is shown in Figure 8. Depicted on Figure 8 are the shore platform, a lower, near-vertical cliffed surface called the sea cliff, and an upper-bluff slope generally ranging in inclination between 35 and 80 degrees (measured from the horizontal). Little or no flat area is exposed above sea level at the base of the cliff, even at very low tides. The sea cliff is bounded at its landward edge by the coastal terrace deposits.

Figure 8. Typical Coastal Bluff Profile (Looking North up the Coast).

Offshore from the sea cliff is an area of indefinite extent called the nearshore zone (see Figure 8). The bedrock surface in the nearshore zone, which extends out to sea from the base of the sea cliff, is the shore platform. Worldwide, the shore platform may vary in inclination from horizontal to a gradient of 3 horizontal to 1 vertical, or $33^{1/3}$ percent (Trenhaile, 1987). Offshore, the gradient of the shore platform is approximated at 1 to 2 percent. The boundary between the sea cliff (the lower near-vertical section of the bluff) and the shore platform is designated as the cliff-platform junction.

Within the nearshore zone is a subdivision designated as the inshore zone, beginning where the waves begin to break (Figure 8). This boundary varies with time because the point at

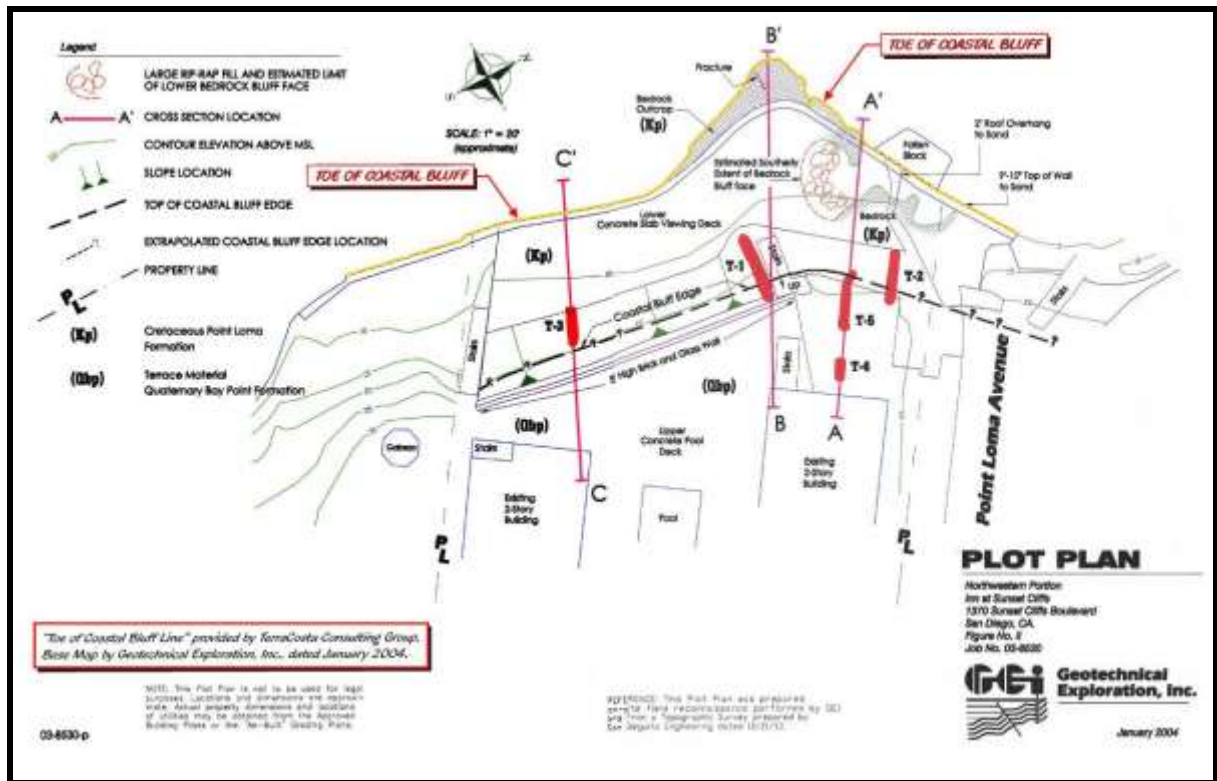
Three representative geologic cross sections are contained in the attached February 2004 geotechnical report prepared by GEI, which in part form the basis for the location of the coastal bluff edge shown on Figure 9. It is our opinion that the GEI test pits most accurately located the top of the coastal bluff that has been reproduced from GEI's report and shown below as Figure 9.

Figure 9. GEI Plot Plan.

The location of the coastal bluff edge was addressed in some detail by GEI and reported in their February 2, 2004, geotechnical report (Appendix A). As indicated in GEI's February 2004 report, a variable thickness veneer of fill mantles the entire westerly surface of the site, obscuring the geologic boundary between the coastal terrace and the landward extent of increased subaerial erosion due to the presence of the coastal bluff. Five hand-dug test excavations were advanced by GEI within the slope separating the lower and upper concrete slabs in December 2003 to locate the edge of the coastal bluff and to facilitate the mapping of the bluff edge in plan view. The plot plan presented in GEI's February 2004 geotechnical report (Appendix A) has been reproduced below as Figure 9, as it shows the location of the coastal bluff edge, determined by the excavation of five test pits specifically excavated to delineate the location of the coastal bluff edge, along with the toe of the coastal bluff as it existed in February 2004, predominantly coincident with the foundation of the existing seawall. Figure 2 also shows the coastal bluff edge as estimated by our review of 1953 aerial photographs. As noted previously, the formational Point Loma shelf rock on which the seawall was constructed almost 70 years ago is continuing to slowly erode, occasionally breaching the foundation of the wall, necessitating the repairs designed by our predecessor firm, Group Delta Consultants-San Diego, in 1991, and by TerraCosta in 2005, 2015, and 2018.

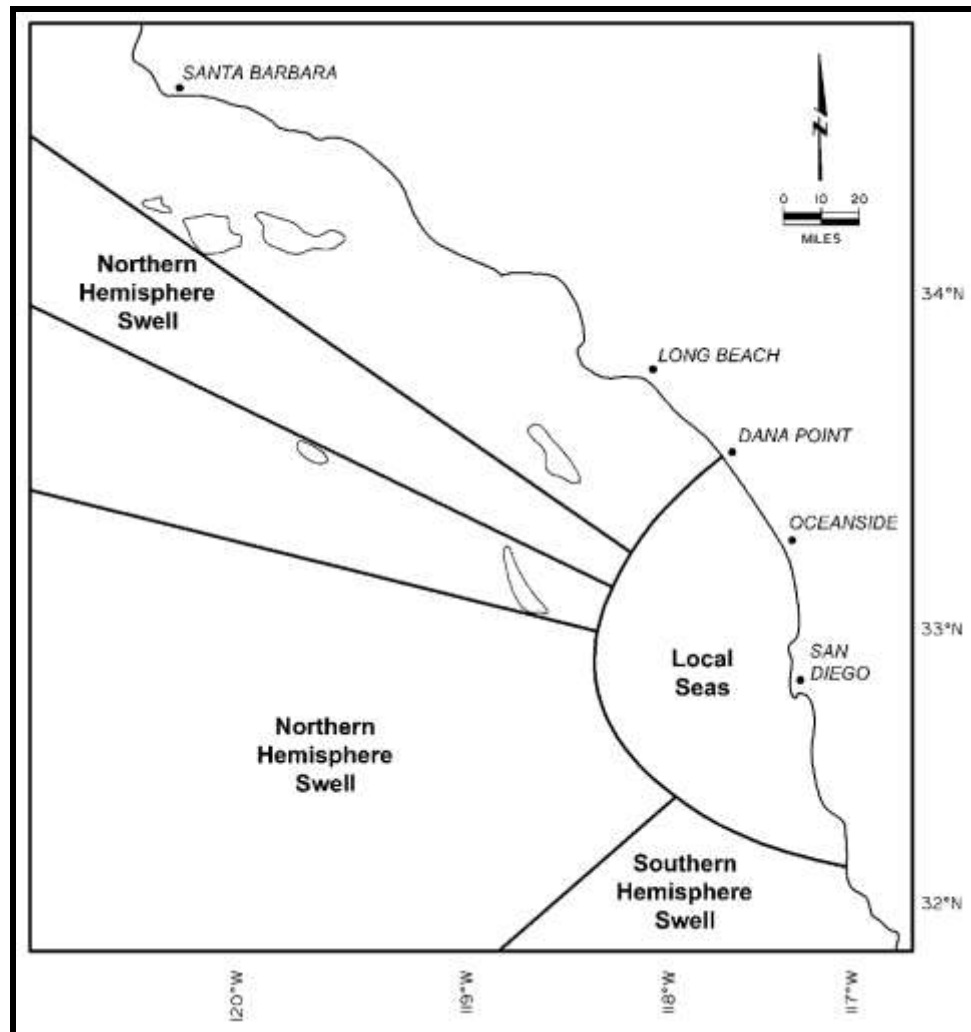
Waves provide nearly all of the energy input that drives shoreline processes along the California coast. As illustrated in Figure 10, incoming waves along the southern California coast fall into three main categories: Longer period northern and southern hemisphere swell, and locally short-period generated seas. North hemisphere swell from the North Pacific Ocean dominate the winter wave conditions off California, while southern hemisphere swell is more important in the summer. Short-period seas are produced by storms sweeping through the area. The offshore islands, shallow banks, submarine canyons and generally complex bathymetry of southern California greatly complicate the wave climate at the coast (Figure 11).

Figure 10. Map Showing Generalized Wave Exposure for Southern California.

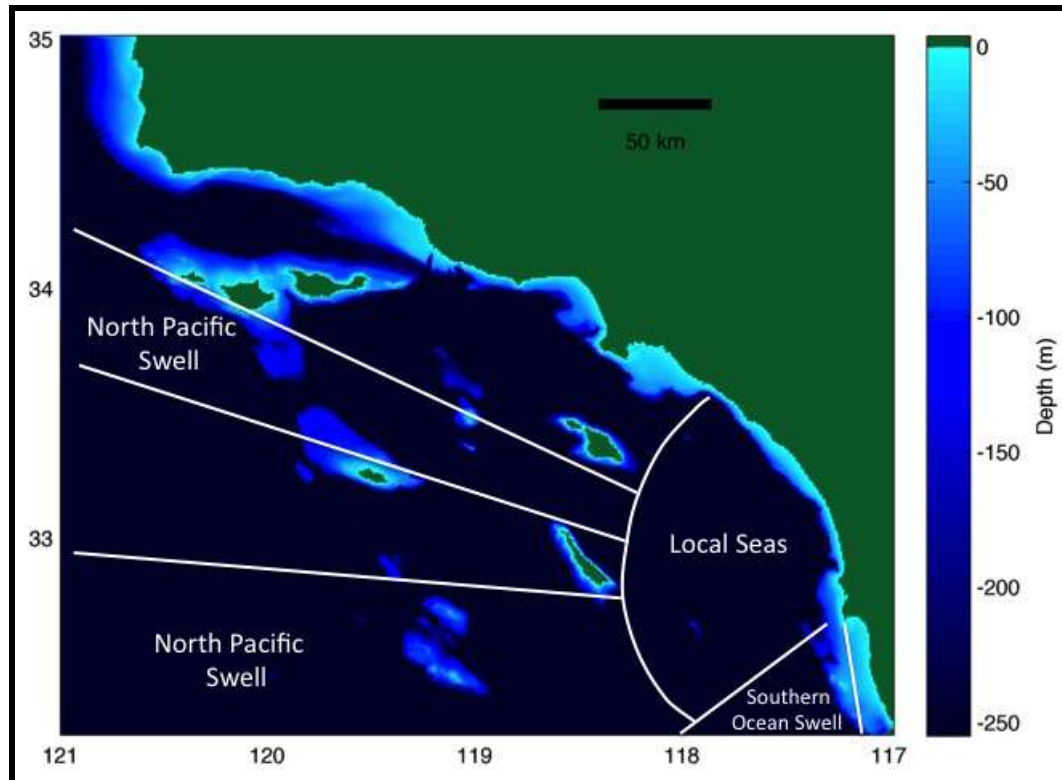
Coastal orientation, and the islands and banks greatly influence the swell propagating toward shore by partially sheltering southern California, including Point Loma, especially from directions north of west. Figure 11 shows the approximate directions from which incoming swell is blocked by the islands. The Point Loma coastline faces west and is therefore also relatively exposed to southern hemisphere swell. Because of the complicated effects of bathymetry and island shadowing, the wave height at the shoreline is sensitive to relatively small changes in the incoming direction of the deep ocean waves.

Figure 11. Map Showing Generalized Bathymetry in the Southern California Bight and Wave Exposure Windows at Oceanside.

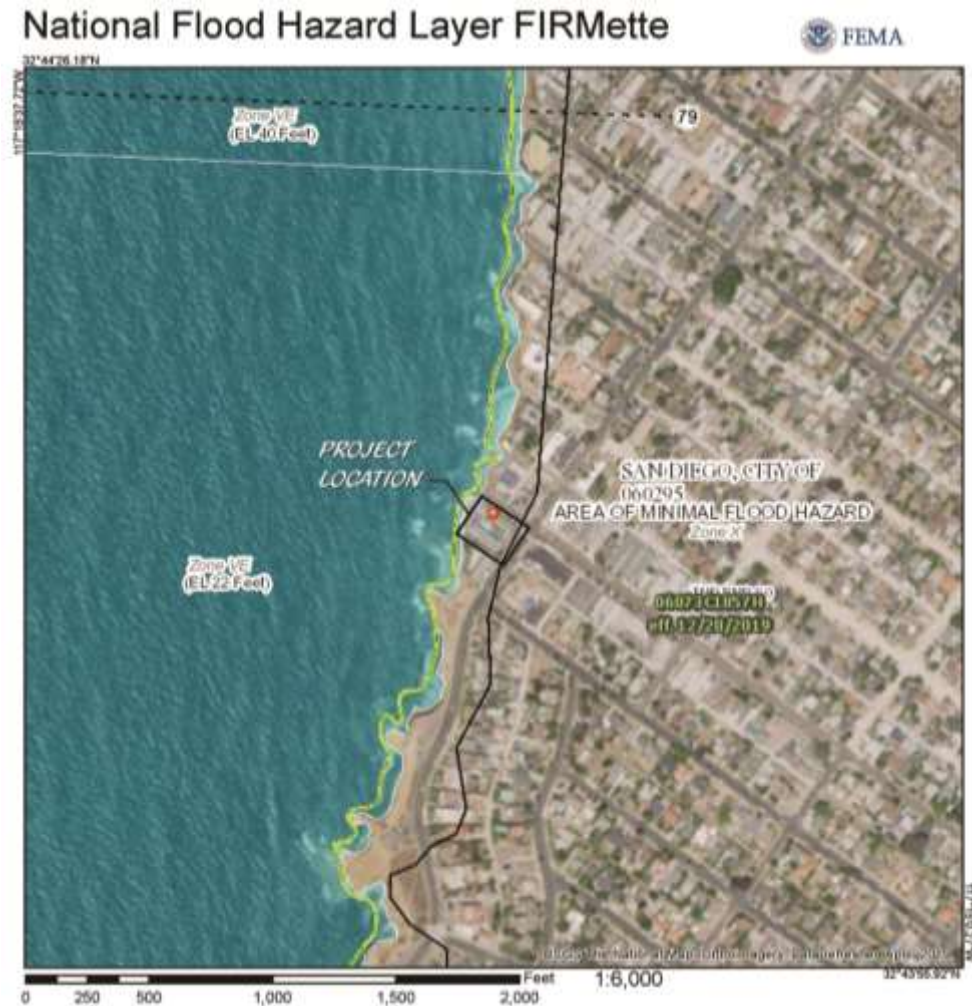
Figure 12A. FEMA Map.

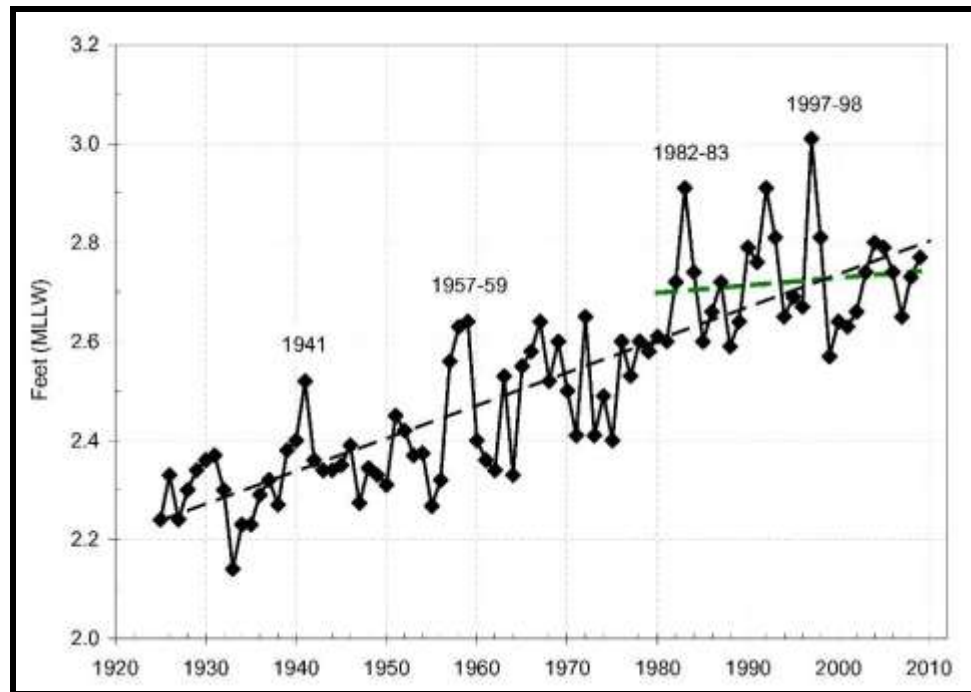
Figure 13. Annual Average Sea Level History at La Jolla, 1925-2007. Broken Line Shows Linear Trend of 0.7 Feet/Century Rise.

Figure 13 is a plot of the annual mean sea levels measured at the La Jolla tide gauge starting in 1925. The linear trend indicates the approximate 0.7 foot per century sea level rise. Also noticeable are the enhanced sea levels during the El Niño episodes of 1941, 1957-59, 1982-83, and 1997-98 (respectively labeled).

A notable feature of the sea level history at La Jolla is the leveling-off of sea level rise since about 1980 (Figure 13). The green broken line shows a much reduced trend of about 0.15 foot per century between 1980 and 2009, or about 4.5 times smaller than the overall trend of 0.67 foot per century. A similar reduction in the rate of sea level rise has been noted at San Francisco, which has a similar overall appearance as the La Jolla record, but is a much longer record extending back to 1856.

the eastern Pacific, extending from Central America north to Washington State, have fallen at a rate of 0-3 mm per year (0-30 cm per century, or 0-1 foot per century). This may explain the coastal tide gauge observations (La Jolla sea level history; Figure 13) described above.

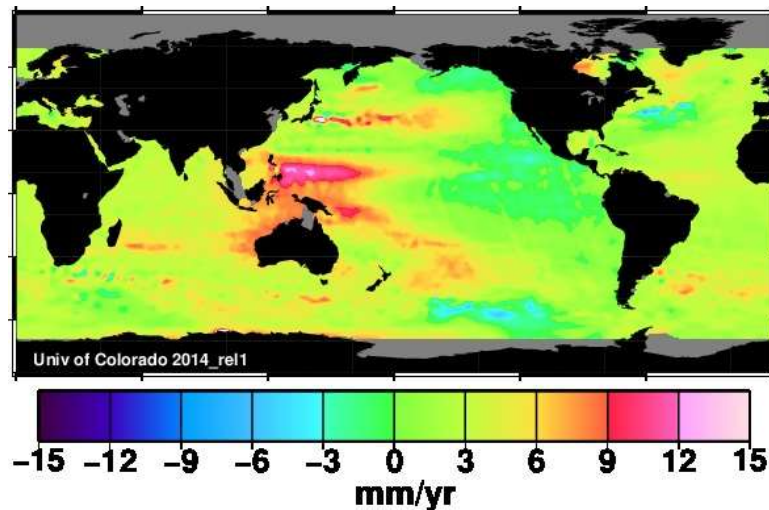
Figure 14 shows the global distribution of the rate of sea level change for the period of 1993-2012 (University of Colorado, 2012). Note that warm colors (yellow-orange-red) show areas of sea level rise (positive rates), while cool colors (green-blue) indicate falling sea level (negative rates) over the record. Inspection of the North Pacific reveals that sea levels in the western Pacific, especially in the lower latitudes, have risen at a rate of 3-9 mm/year (equivalent to 30-90 cm per century, or about 1-3 feet per century). Conversely, sea levels in

Figure 14. Global Sea Level Change Rates 1993-2012 as derived from satellite altimetry measurements, following University of Colorado (2012).

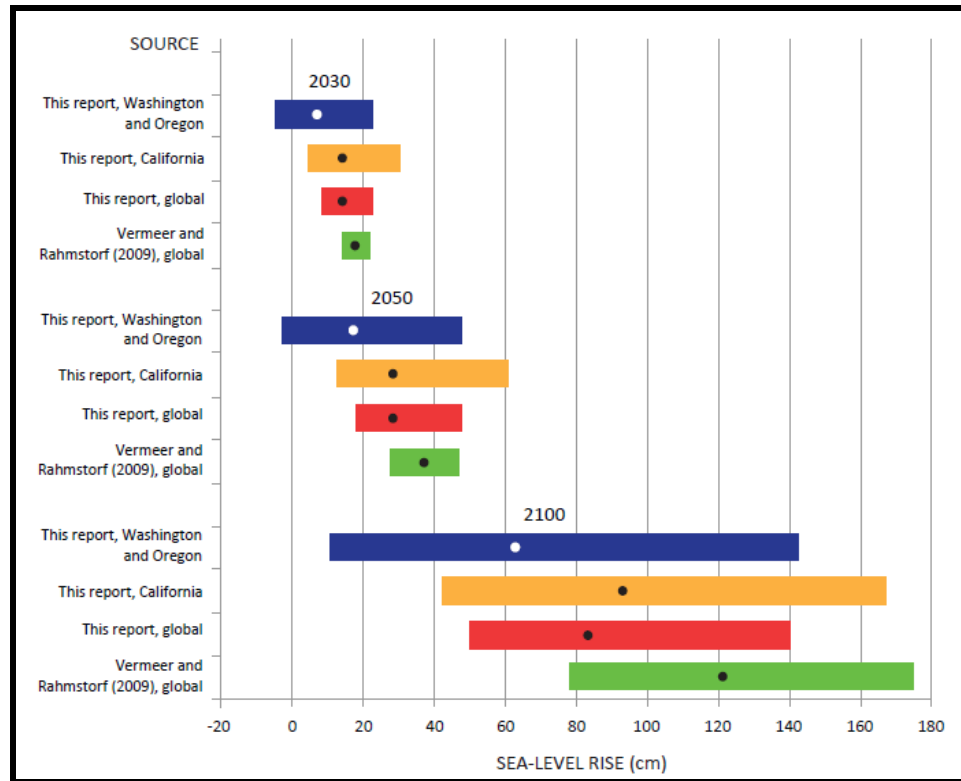
When considering the effects of future sea level rise, the National Academy of Sciences (NAS, 2012) presents a possible global, west-coast, and state-wide future Mean Sea Level Rise (MSLR) for California, Oregon, and Washington (Figure 15, dots) and its range (Figure 15, bars). These are based on the IPCC (2007) mid-range Green House Gas emissions scenarios for the ocean steric (warming) expansion component added to the results of new research projecting the likely contributions of future ice-melt. The resulting projected *global* MSLR relative to 2000 ranged from 0.08-0.23 m (0.26-0.75 ft) by 2030; 0.18-0.48 m (0.59-1.6 ft) by 2050; and 0.50-1.4 m (1.6-4.6 ft) by 2100 (Figure 15, red bars). The global estimates were adjusted for vertical crustal movement (uplift north of Cape Mendocino and

down-drop in the south) resulting in the orange bars, also shown in Figure 15. The State of California (2013) used these results of NAS (2012) shown as the updated MSLR guidance in Table 2.

Figure 15. NAS (2012) summary of global, Washington, Oregon, and California (south of Cape Mendocino) MSLR projections for 2030, 2050, and 2100 relative to 2000.

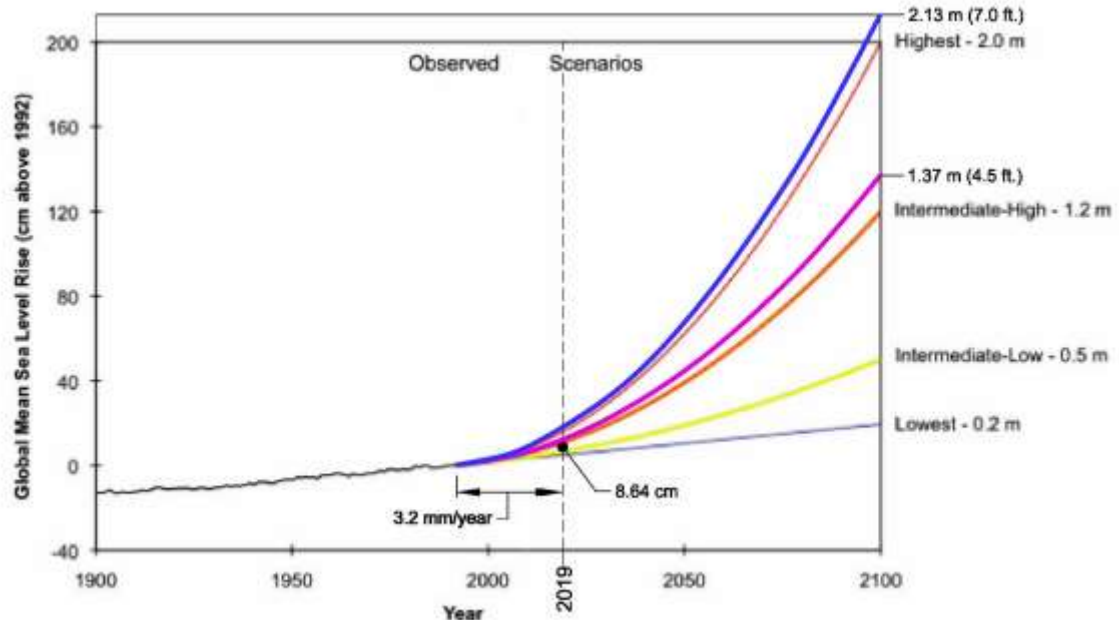
FIGURE 16

We have reproduced as Figure 16 the Coastal Commission’s four suggested sea level rise scenarios through the year 2100 from the Coastal Commission’s 2015 Sea Level Rise Policy Guidance Document, ranging from the Lowest at 0.2 meter, to the Highest at 2.0 meters, measured from the 1992 baseline. Based on recent discussions with Dr. Reinhard Flick, the State Oceanographer with the California Department of Boating and Waterways and a Research Scientist at Scripps Institution of Oceanography, global sea level has risen from 1992 through 2019 at a relatively uniform rate of 32 centimeters per century, or at the same trajectory as previously reported by Nerem (2005) and illustrated below in Figure 17. While Nerem’s data extended from 1993 to 2005, the more recent recorded global sea level elevation change from 1993 to 2019 provides essentially the same data. This information is also shown on Figure 16, which from 1992 through 2019 has resulted in 8.64 centimeters of relatively uniform sea level rise in the past 27 years. If this uniform rate of sea level rise (consistent with that shown on Figure 16) were to extend out to the year 2100, this would be equivalent to a future mean sea level of 0.35 meter (1.13 feet) above the 1992 datum, and slightly above the Coastal Commission’s 2015 suggested Lowest SLR scenario. Notably, and while we appreciate the Coastal Commission’s 2018 Sea Level Rise Policy Guidance Update requiring adaptive strategies to accommodate worst-case SLR scenarios, the OPC’s 2018 Sea-Level Rise Guidance also acknowledges that there is a 17 percent probability of sea level rise by the year 2100 being lower than 1.8 feet, as shown on Table 3.

Modified from Figure 5 of the California Coastal Commission Sea Level Rise Policy Guidance document adopted August 12, 2015.

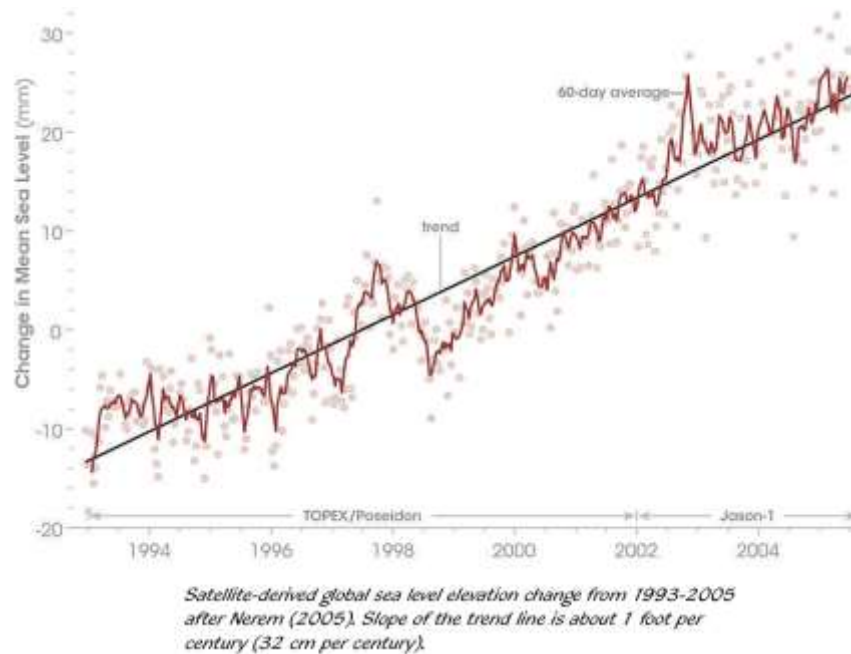
FIGURE 17

Global mean sea level rise rate over the past two decades has increased over the rate observed for the past century, and has reached about 1 foot per century (32 cm per century). This is indicated from satellite data reporting and trend analysis shown in Figure 17 (Nerem, 2005).

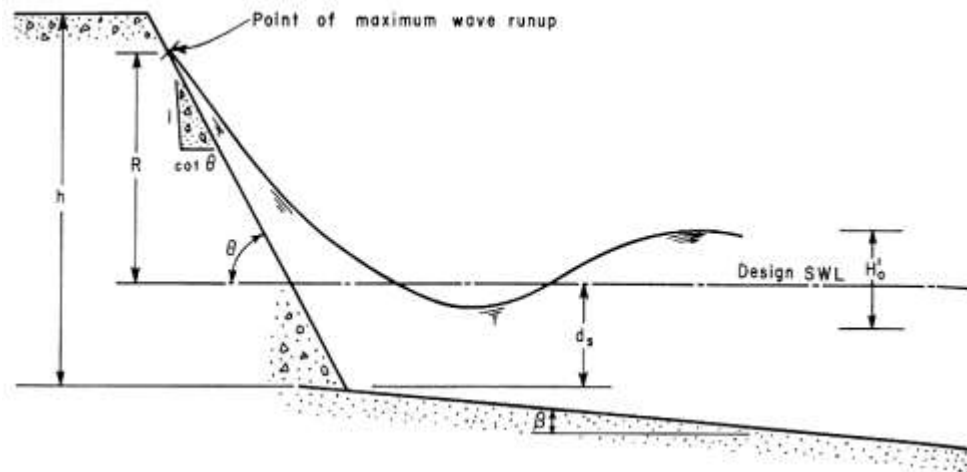
The following definition sketch for both wave runup and overtopping, reproduced from the 1984 SPM, graphically illustrates the point of maximum wave runup for a particular design condition.

Definition sketch: wave runup and overtopping

It should also be clear from the sketch that any wave runup exceeding the height of the structure then represents overtopping.

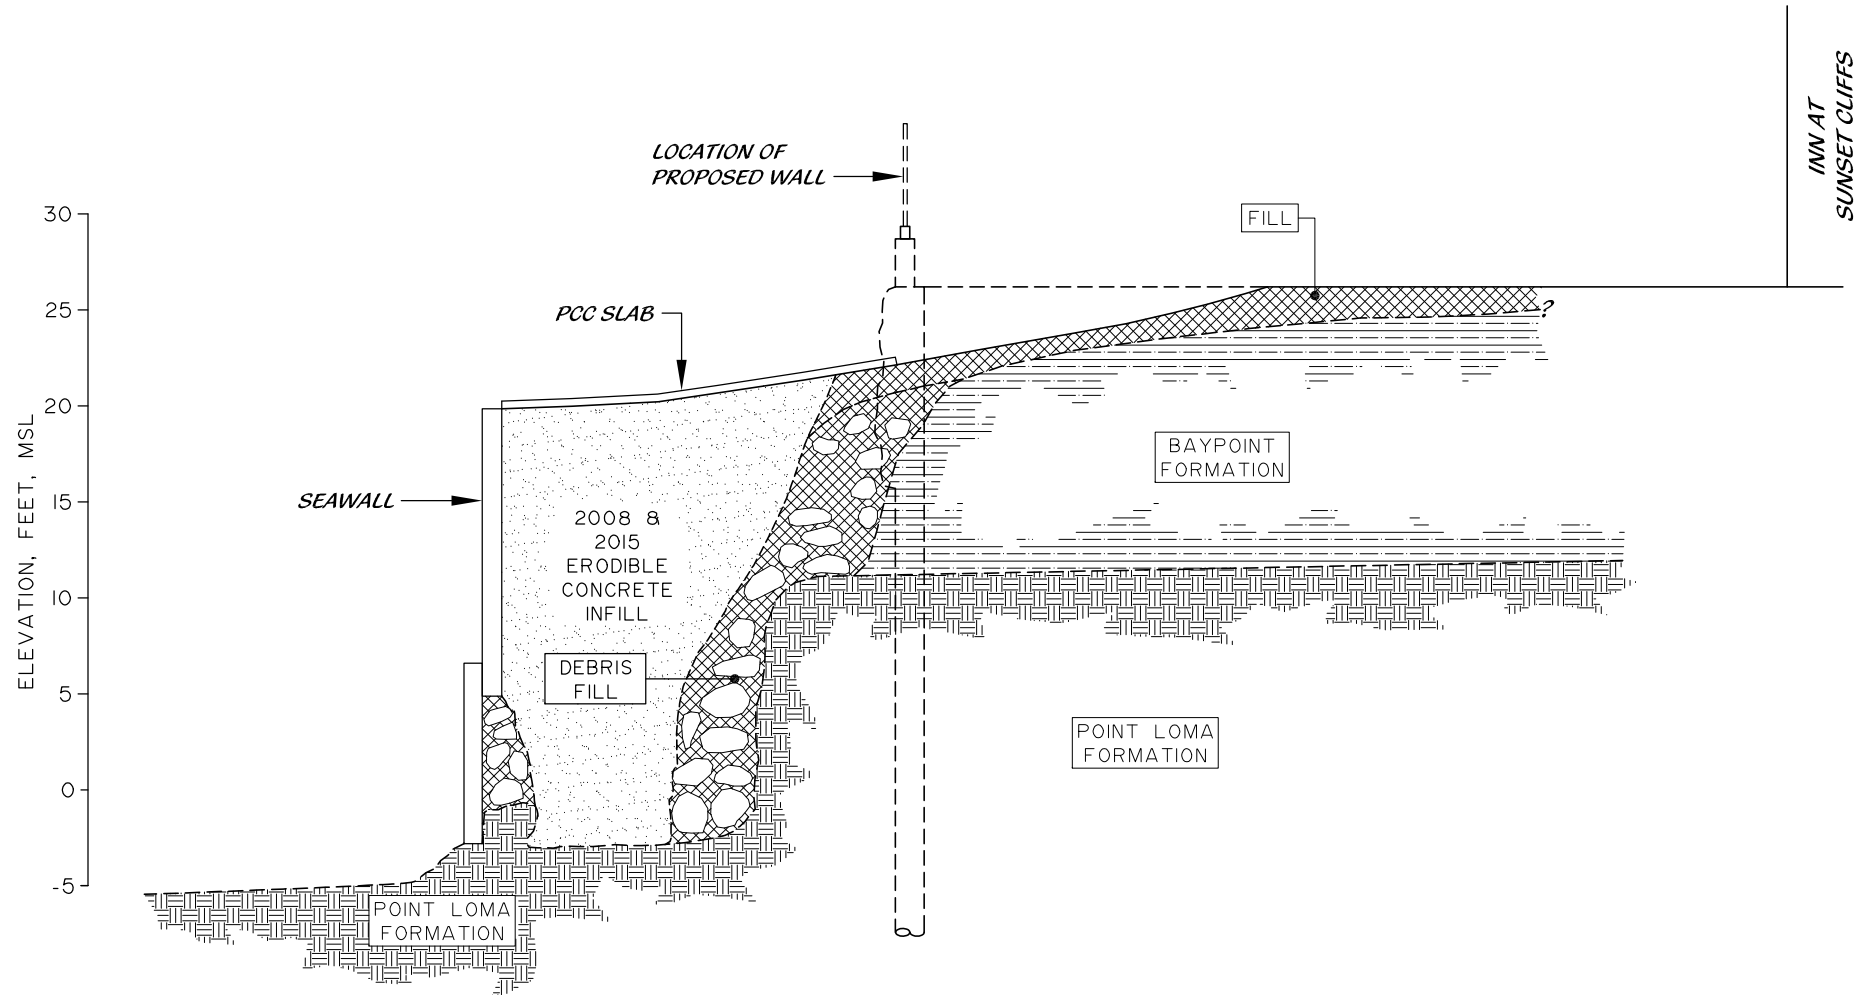
EXISTING CROSS SECTION

SCALE: 1"=10'

The proposed shoreline stabilization project shown on Figure 18 is necessary to prevent the continued erosion of the lower bluff threatening the bluff-top structures and to prevent flanking of the adjacent walls to the north and south. Cross Sections A, B, and C (Figures 3, 4, and 5) show the existing and proposed improvements. Absent the proposed improvements, both the bluff-top structures and the adjacent improvements would be compromised.

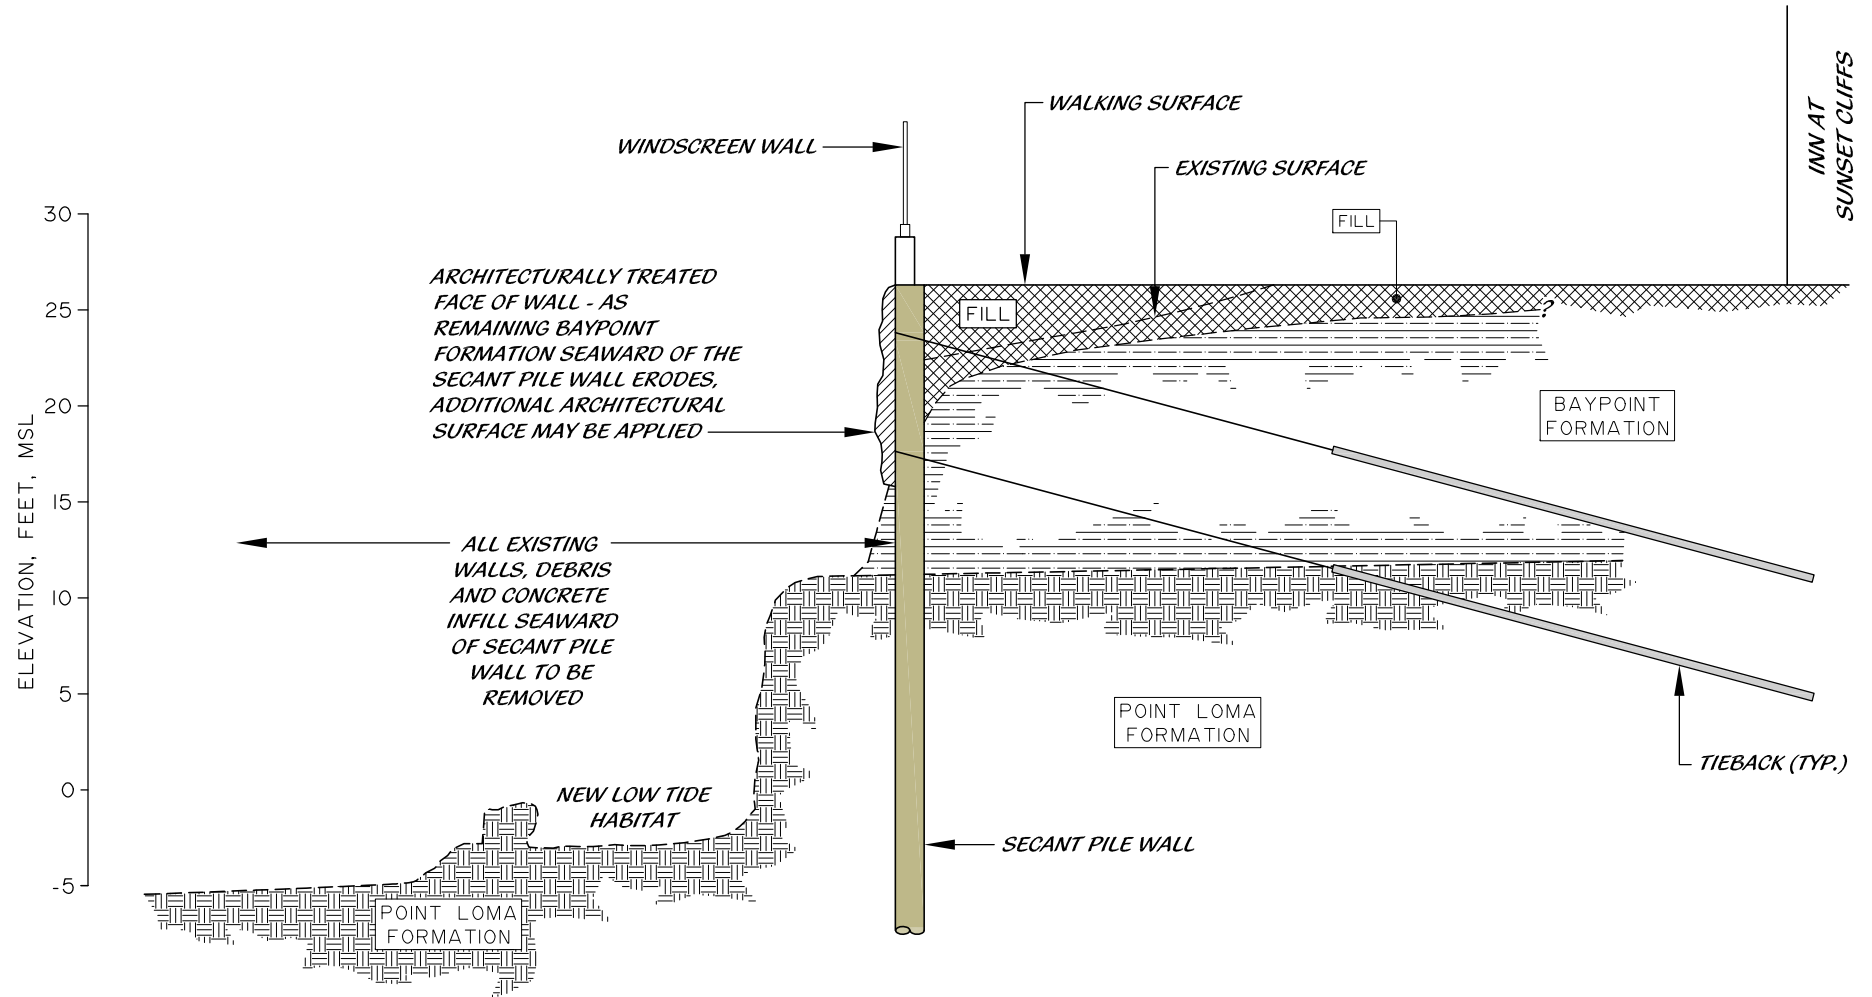
PROPOSED CROSS SECTION

SCALE: 1"=10'

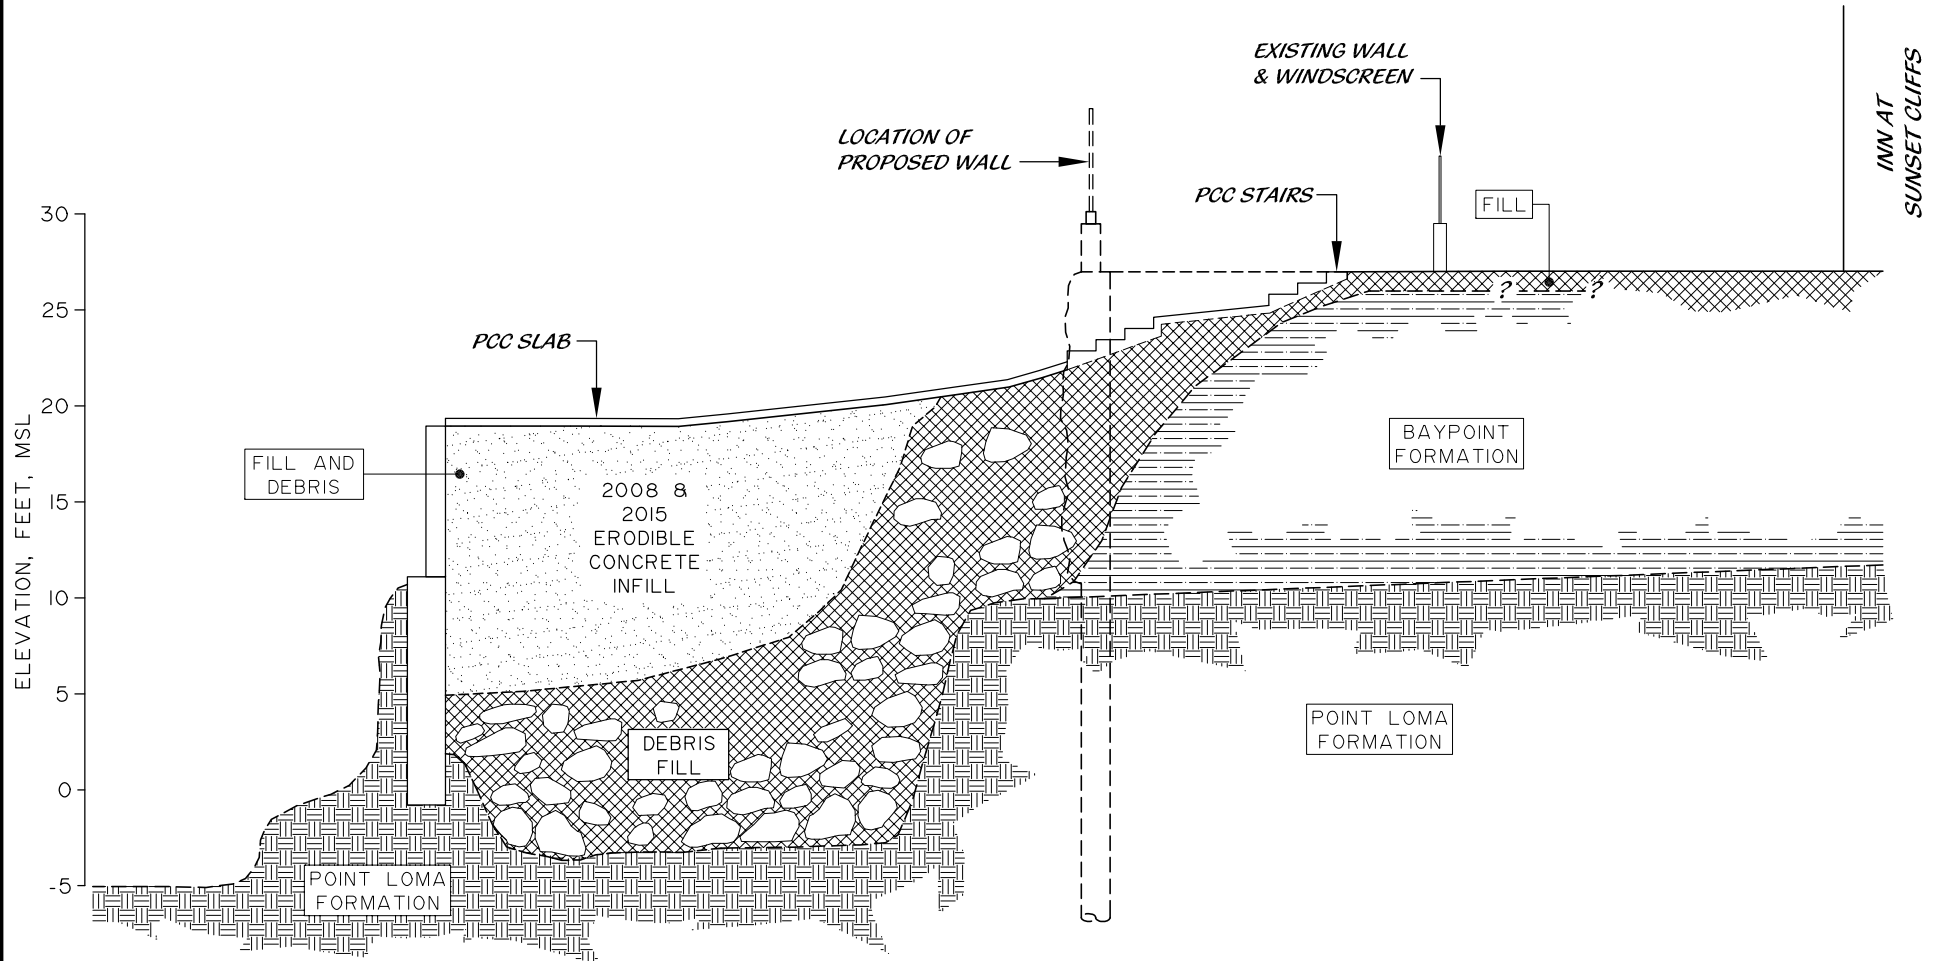
EXISTING CROSS SECTION

SCALE: 1"=10'

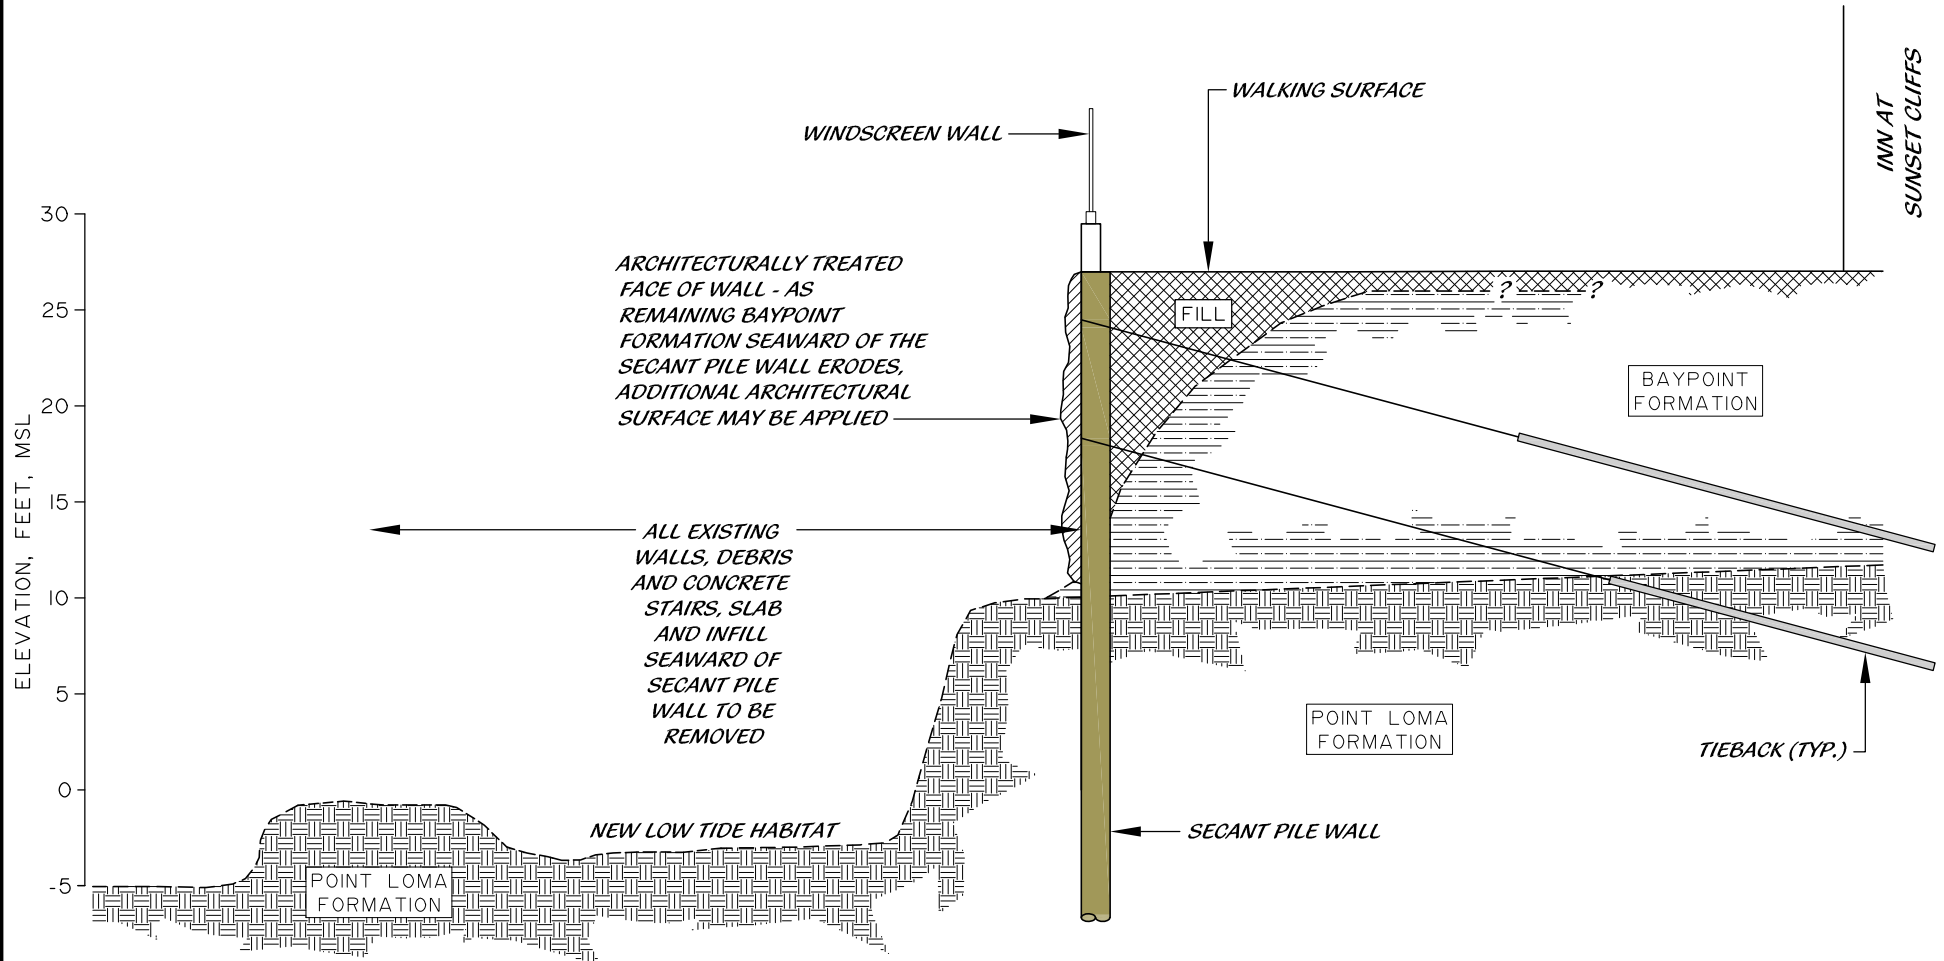
PROPOSED CROSS SECTION

SCALE: 1"=10'

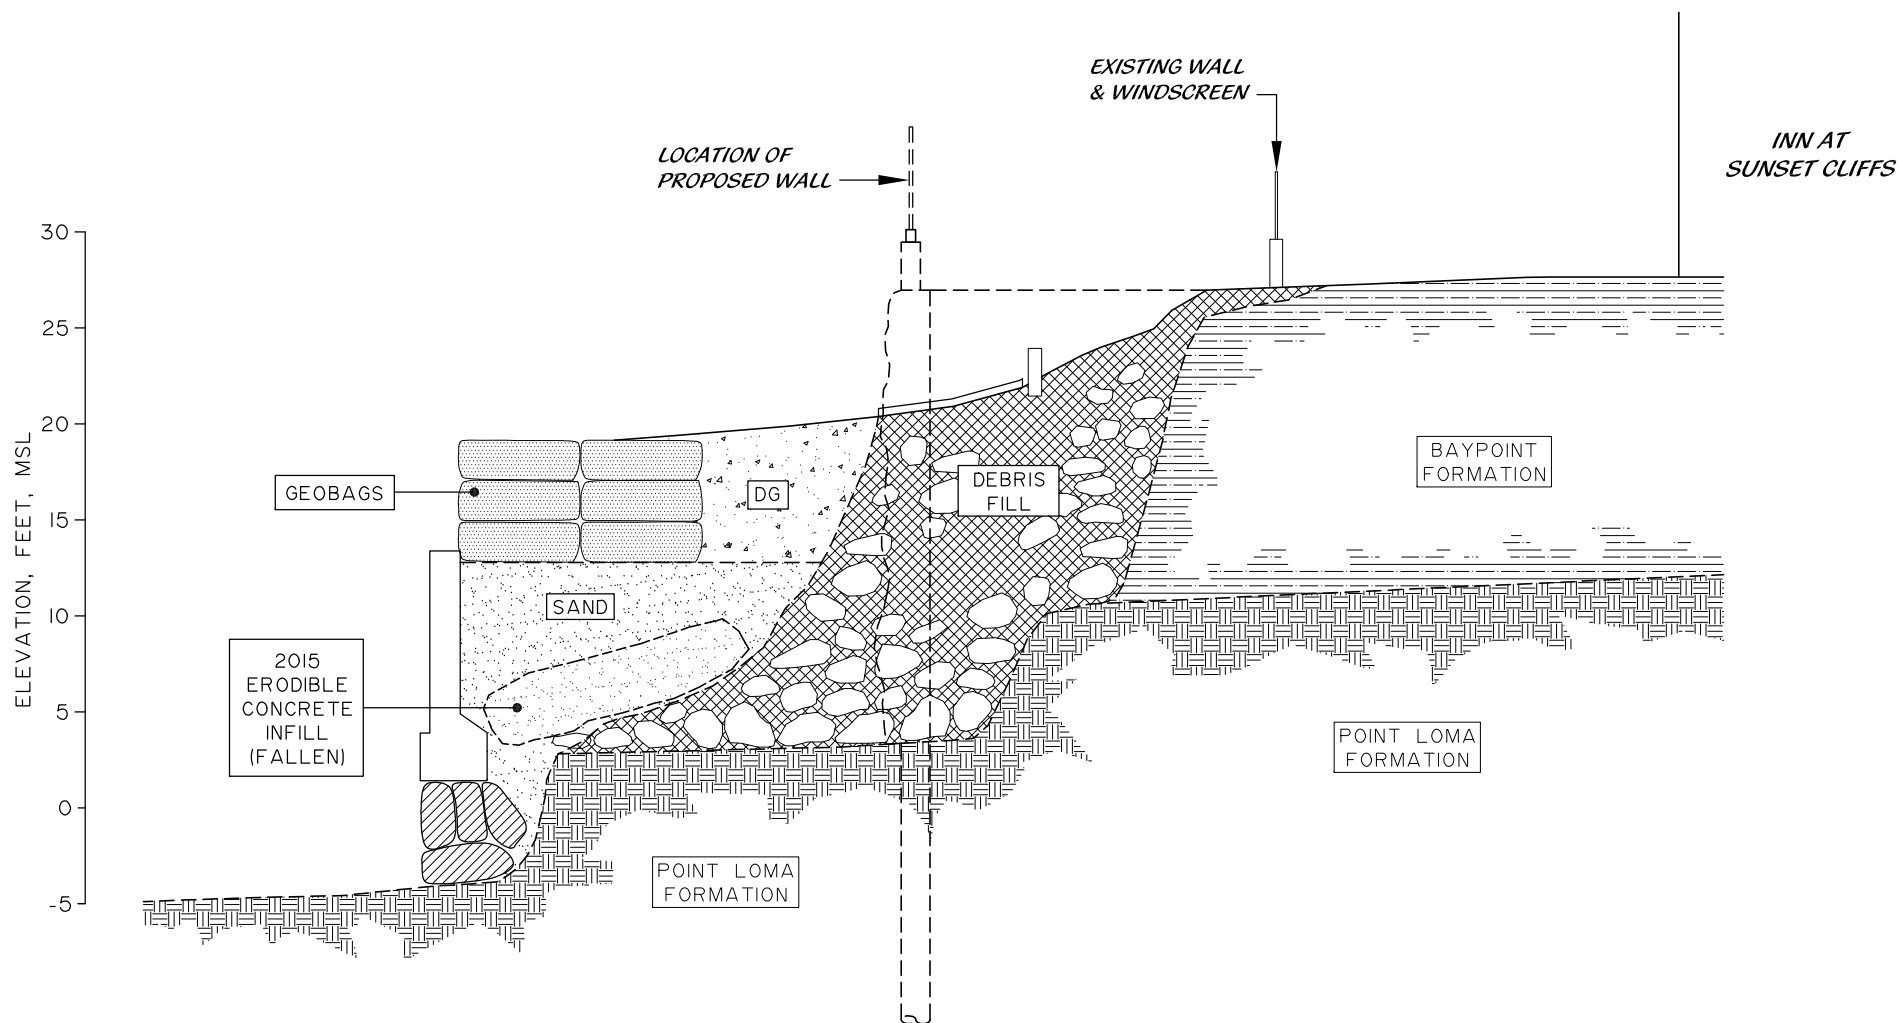
EXISTING CROSS SECTION

SCALE: 1"=10'

In examining Figure 5, and in the absence of the proposed seawall (or the existing seawall, for that matter), the elevation of the Point Loma shelf rock is around +3 feet MSL, which means that on a daily basis, waves will break over the low elevation shelf rock up to the back step, and then up the steeply inclined Bay Point terrace deposits. If all of the existing fill soils shown on Figure 5 were removed (along with the seawall), a severe storm season similar to the 2015-16, 1997-98, or 1982-83 storm seasons could easily cause over 10 feet of bluff-top erosion. With the building only 8 feet back from the top-of-bluff and a low elevation shelf rock that allows waves to run up the upper sloping terrace deposits on a daily basis, the steeply inclined terrace deposits will quickly erode, damaging the southerly building during the first storm season. It is for this reason that the seawall remains critical to the protection of the southern building at the project.
