**GEOTECHNICAL REPORT
THE INN AT SUNSET CLIFFS
SAN DIEGO, CALIFORNIA**

Prepared for
PROJECT DESIGN CONSULTANTS
San Diego, California

Prepared by
TERRACOSTA CONSULTING GROUP, INC.
San Diego, California

Project No. 2317-01
December 24, 2020

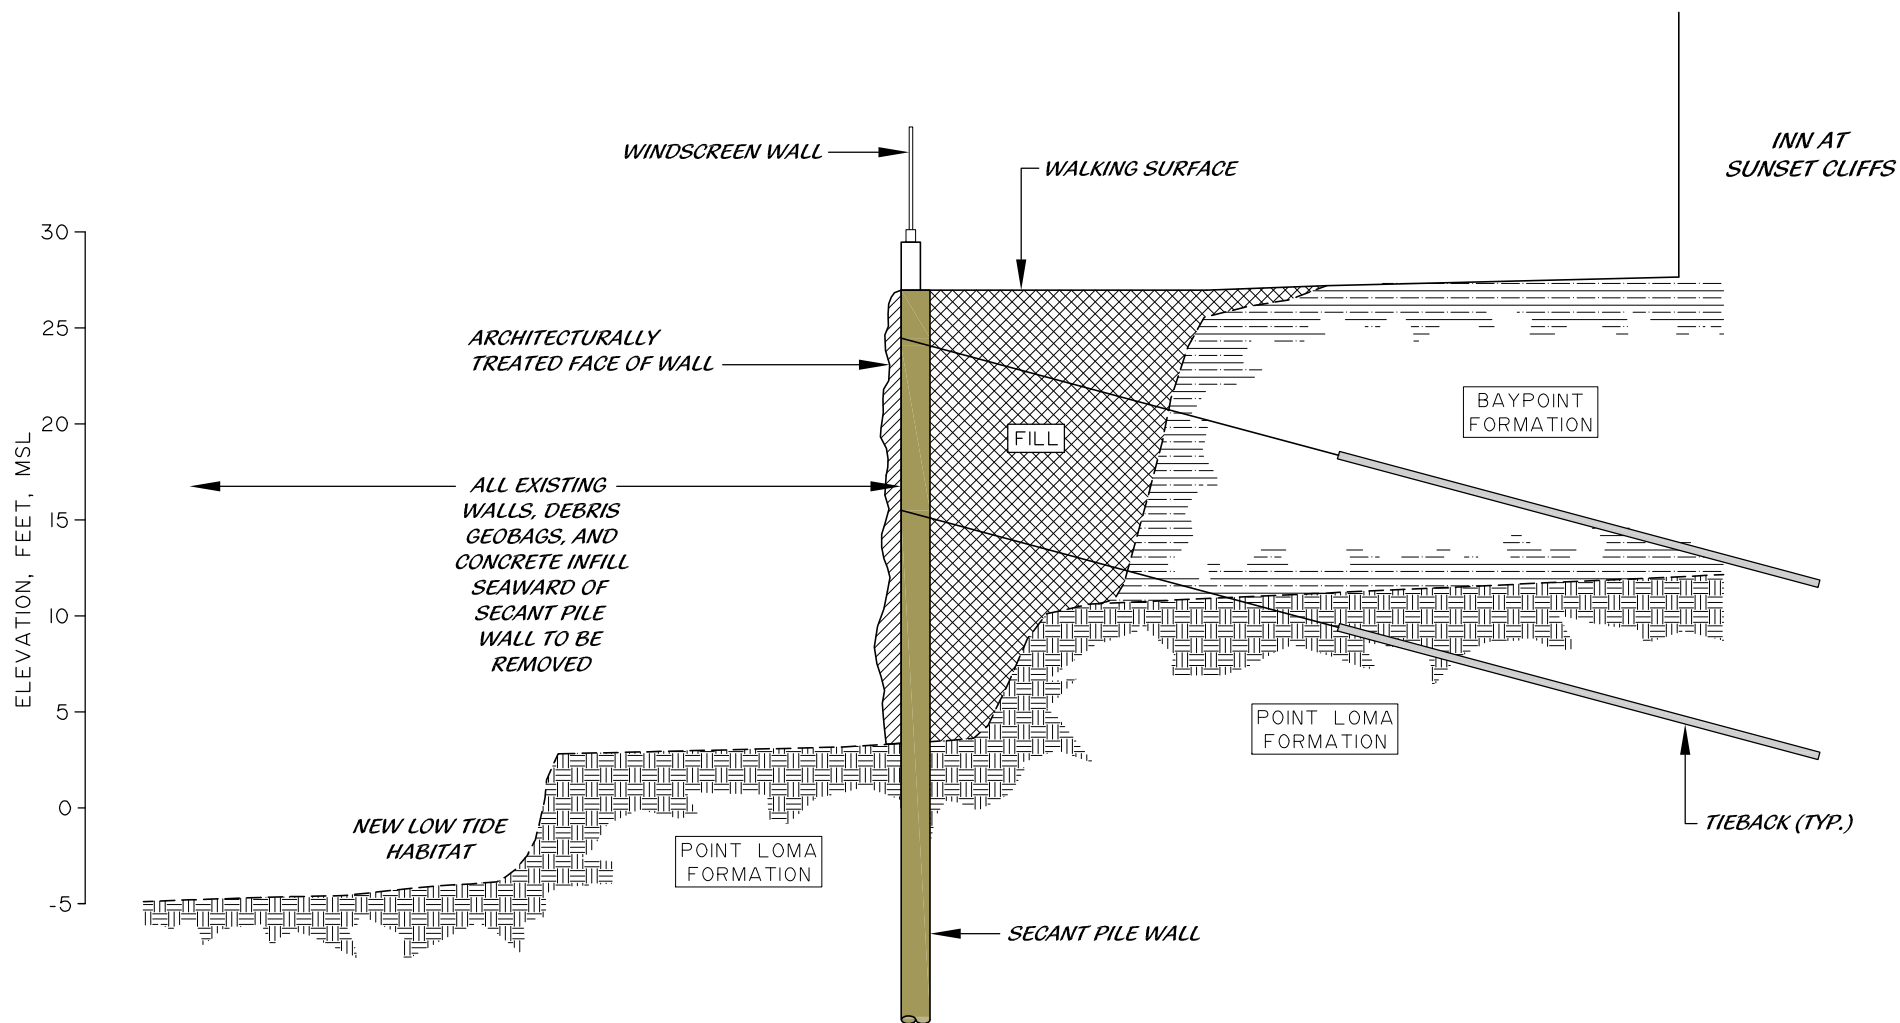
PROPOSED CROSS SECTION

SCALE: 1"=10'

In examining Figure 5, and in the absence of the proposed seawall (or the existing seawall, for that matter), the elevation of the Point Loma shelf rock is around +3 feet MSL, which means that on a daily basis, waves will break over the low elevation shelf rock up to the back step, and then up the steeply inclined Bay Point terrace deposits. If all of the existing fill soils shown on Figure 5 were removed (along with the seawall), a severe storm season similar to the 2015-16, 1997-98, or 1982-83 storm seasons could easily cause over 10 feet of bluff-top erosion. With the building only 8 feet back from the top-of-bluff and a low elevation shelf rock that allows waves to run up the upper sloping terrace deposits on a daily basis, the steeply inclined terrace deposits will quickly erode, damaging the southerly building during the first storm season. It is for this reason that the seawall remains critical to the protection of the southern building at the project.

The proposed shoreline stabilization project shown on Figure 18 is necessary to prevent the continued erosion of the lower bluff threatening the bluff-top structures and to prevent flanking of the adjacent walls to the north and south. Cross Sections A, B, and C (Figures 3, 4, and 5) show the existing and proposed improvements. Absent the proposed improvements, both the bluff-top structures and the adjacent improvements would be compromised.

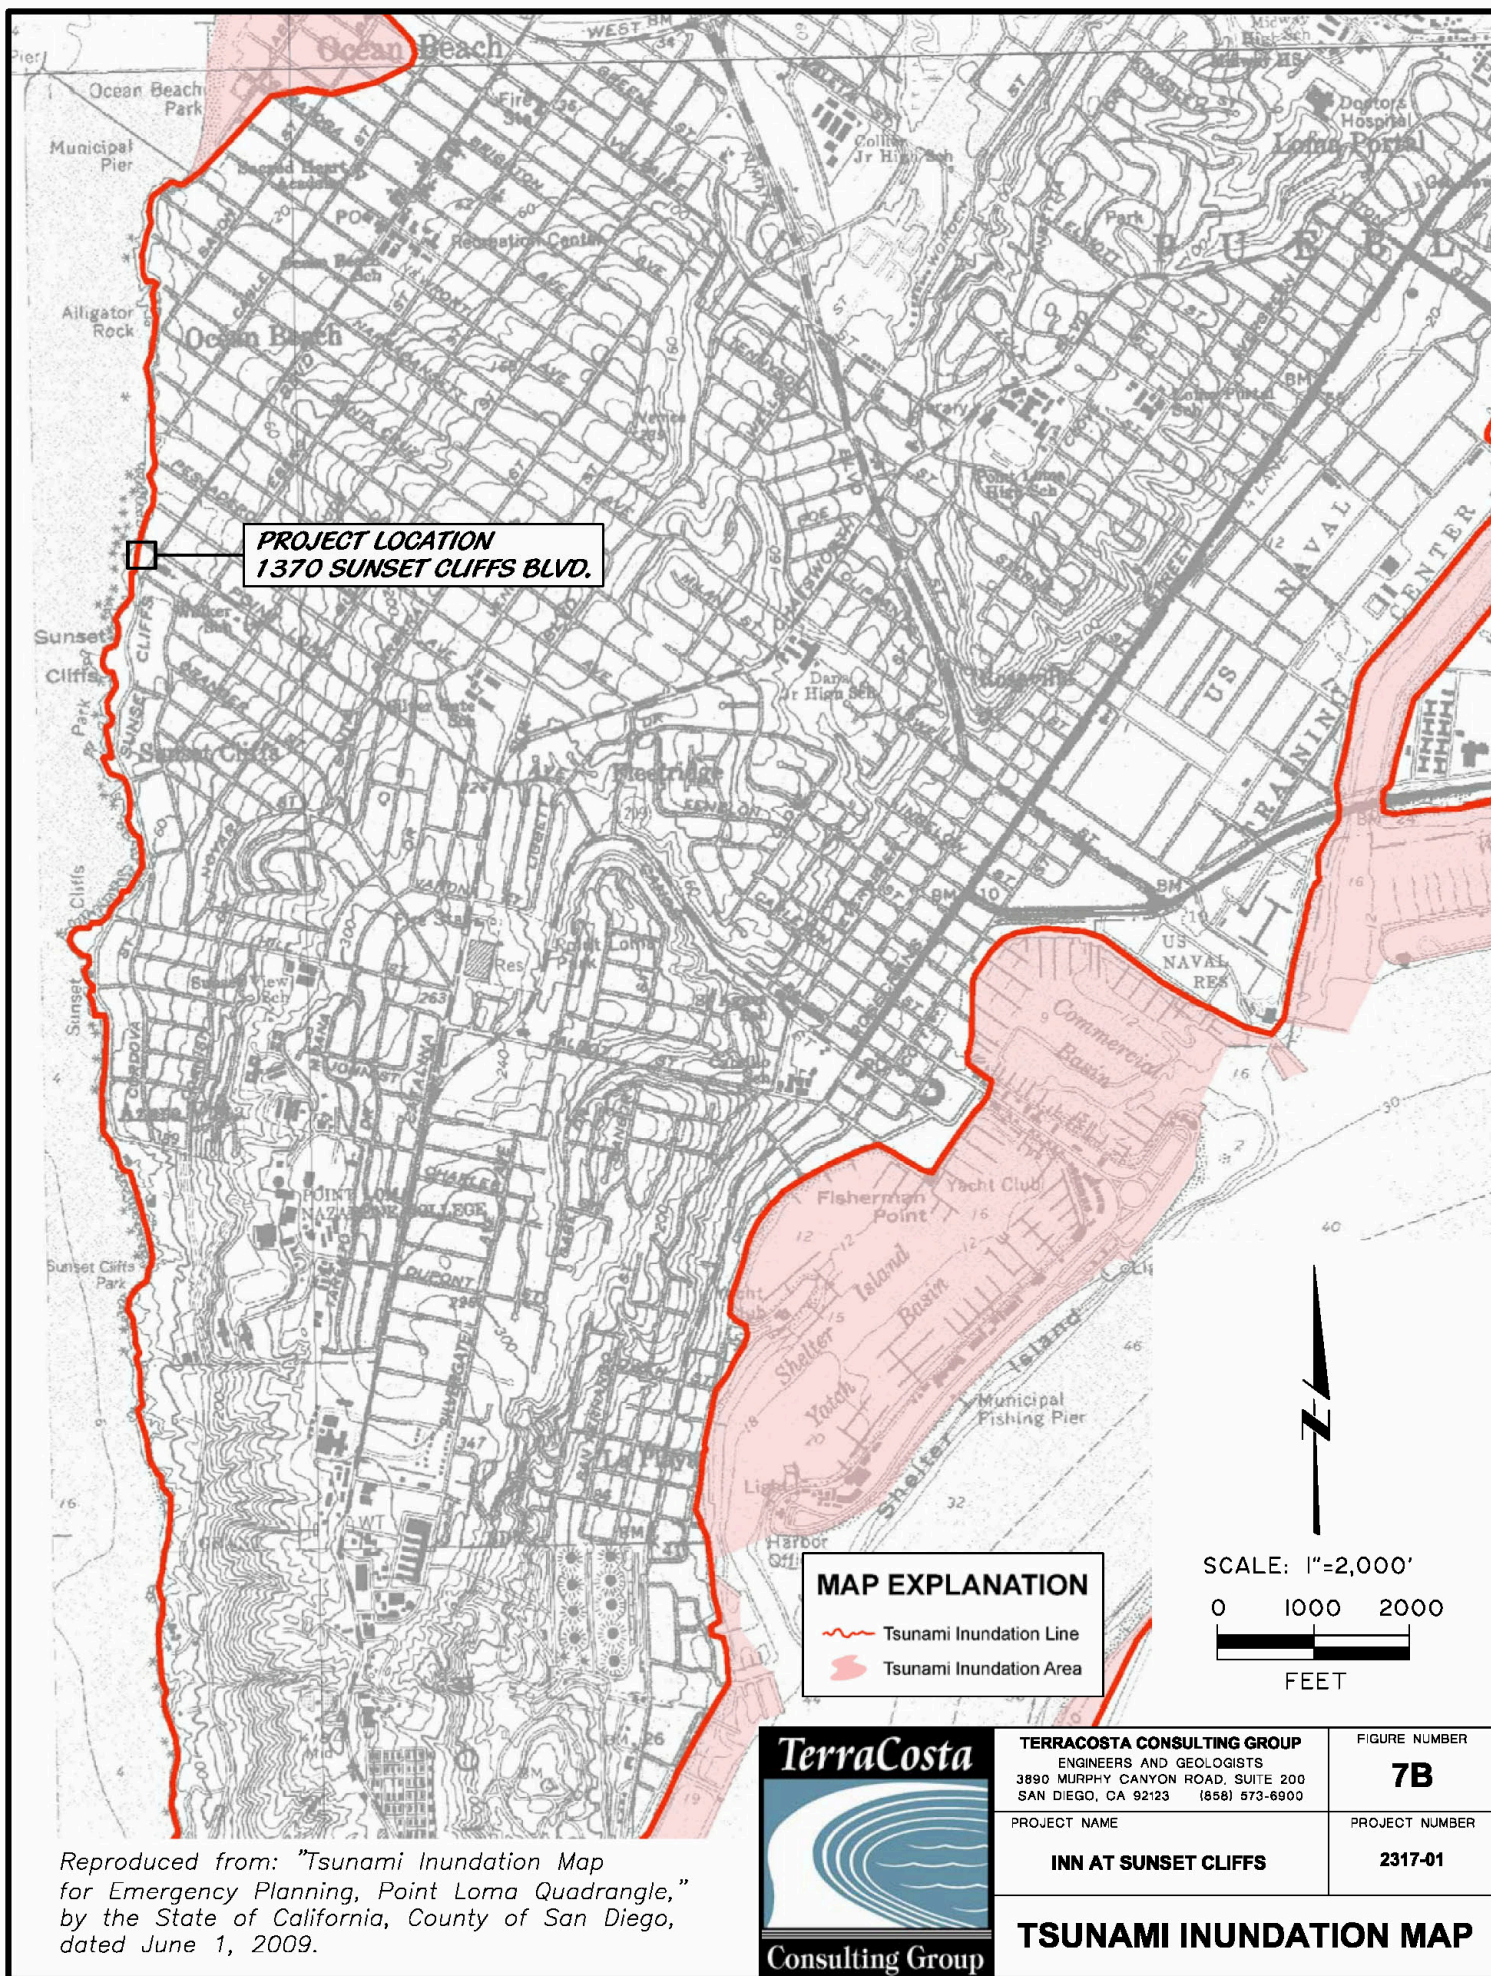
Reproduced from: "Tsunami Inundation Map for Emergency Planning, Point Loma Quadrangle," by the State of California, County of San Diego, dated June 1, 2009.

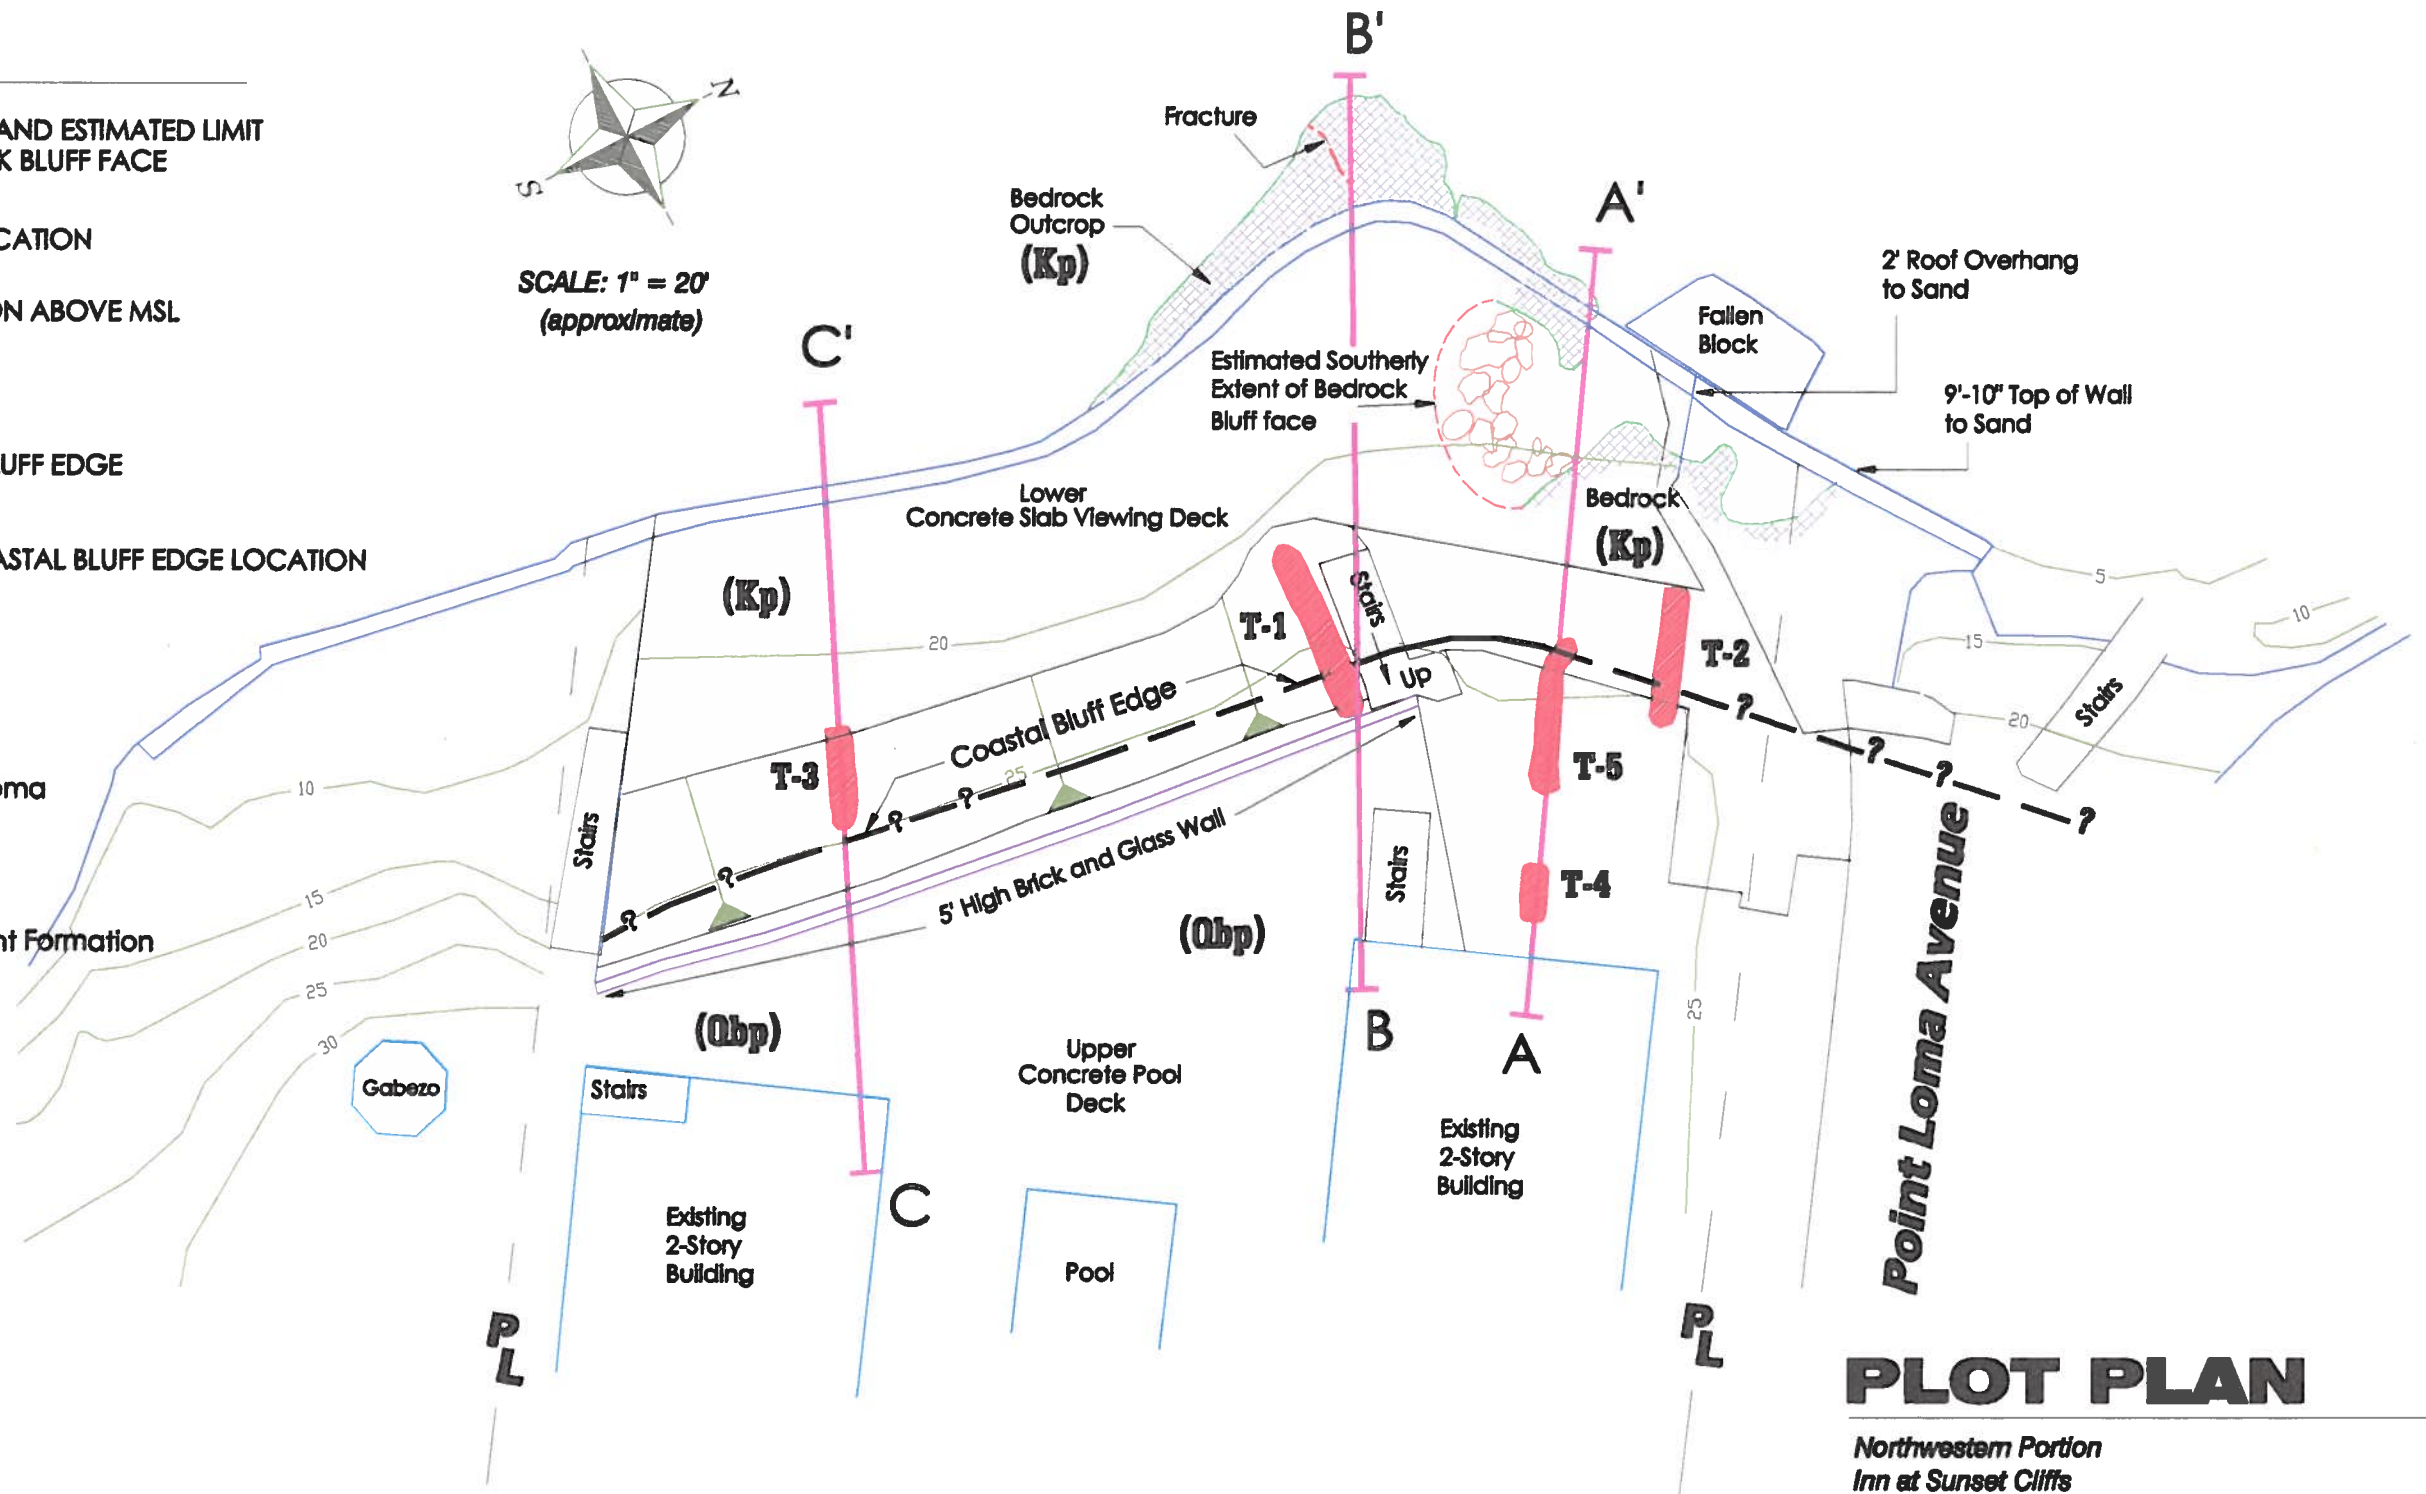
PLOT PLAN

Northwestern Portion
Inn at Sunset Cliffs
1370 Sunset Cliffs Boulevard
San Diego, CA.
Figure No. II
Job No. 03-8530

REFERENCE: This Plot Plan was prepared on-site field reconnaissance performed by GEI and from a Topographic Survey prepared by San Dieguito Engineering dated 10/21/03

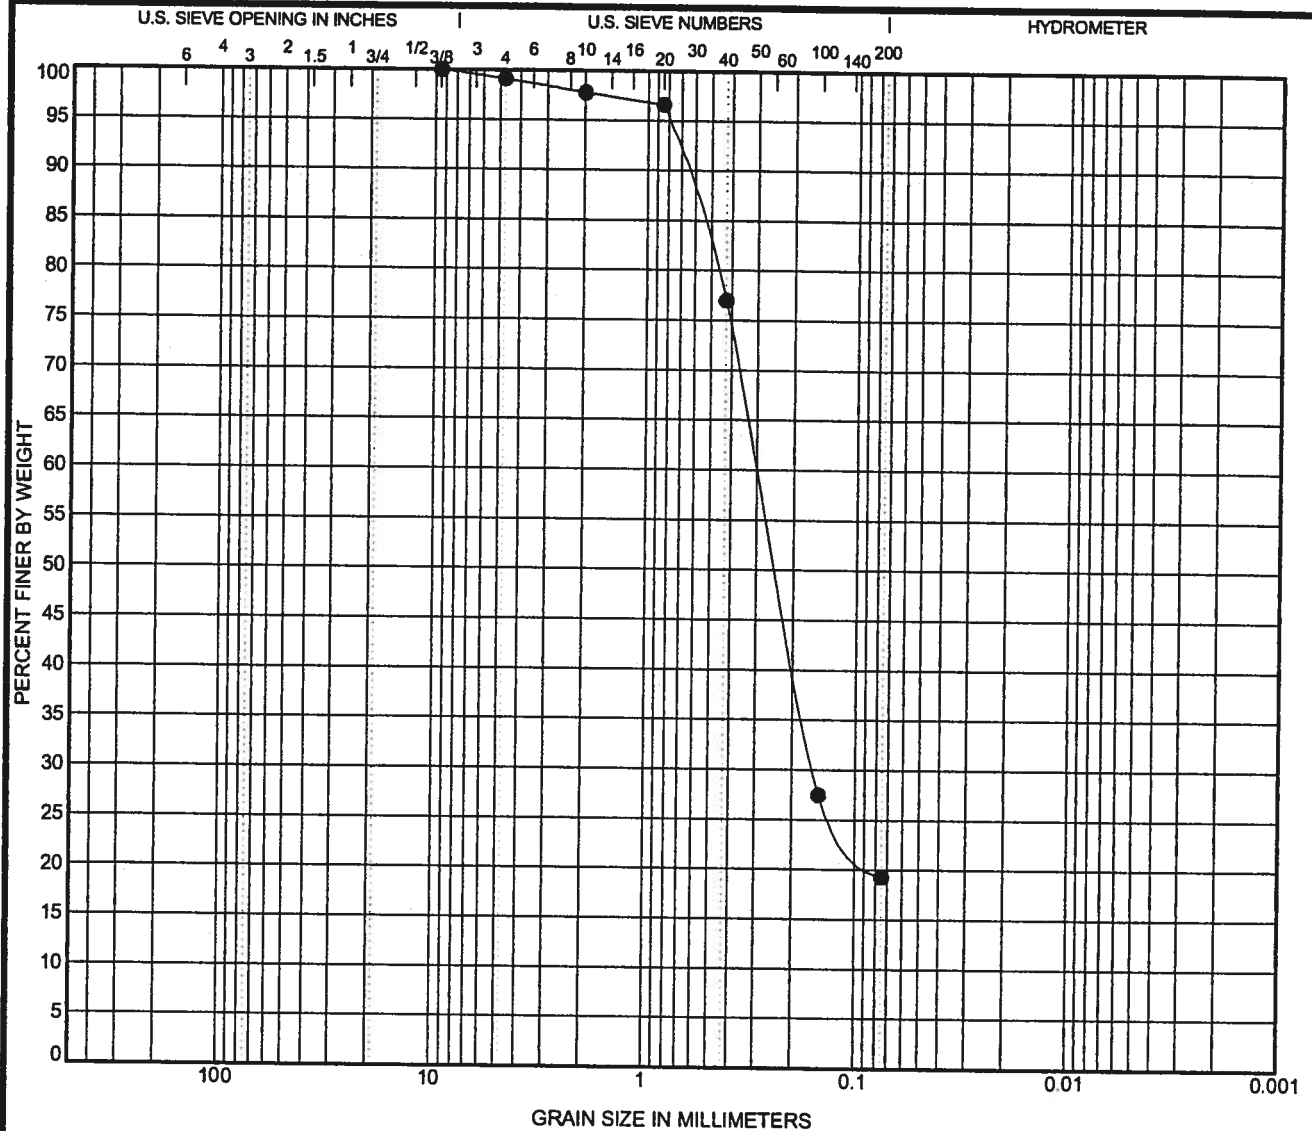
GRAIN SIZE DISTRIBUTION

COBBLES	GRAVEL		SAND			SILT OR CLAY
	coarse	fine	coarse	medium	fine

Specimen Identification		Classification				LL	PL	PI	Cc	Cu
●	T-1 @ 3.5'	Red-brown Fine Sand w/ some silt								
Specimen Identification		D100	D60	D30	D10	%Gravel	%Sand	%Silt	%Clay	
●	T-1 @ 3.5'	9.5	0.297	0.158		0.9	79.8	19.3

Figure Number: IIIb
 Job Name: The Inn at Sunset Cliffs
 Site Location: 1370 Sunset Cliffs Blvd., San Diego, California
 Job Number: 03-8530

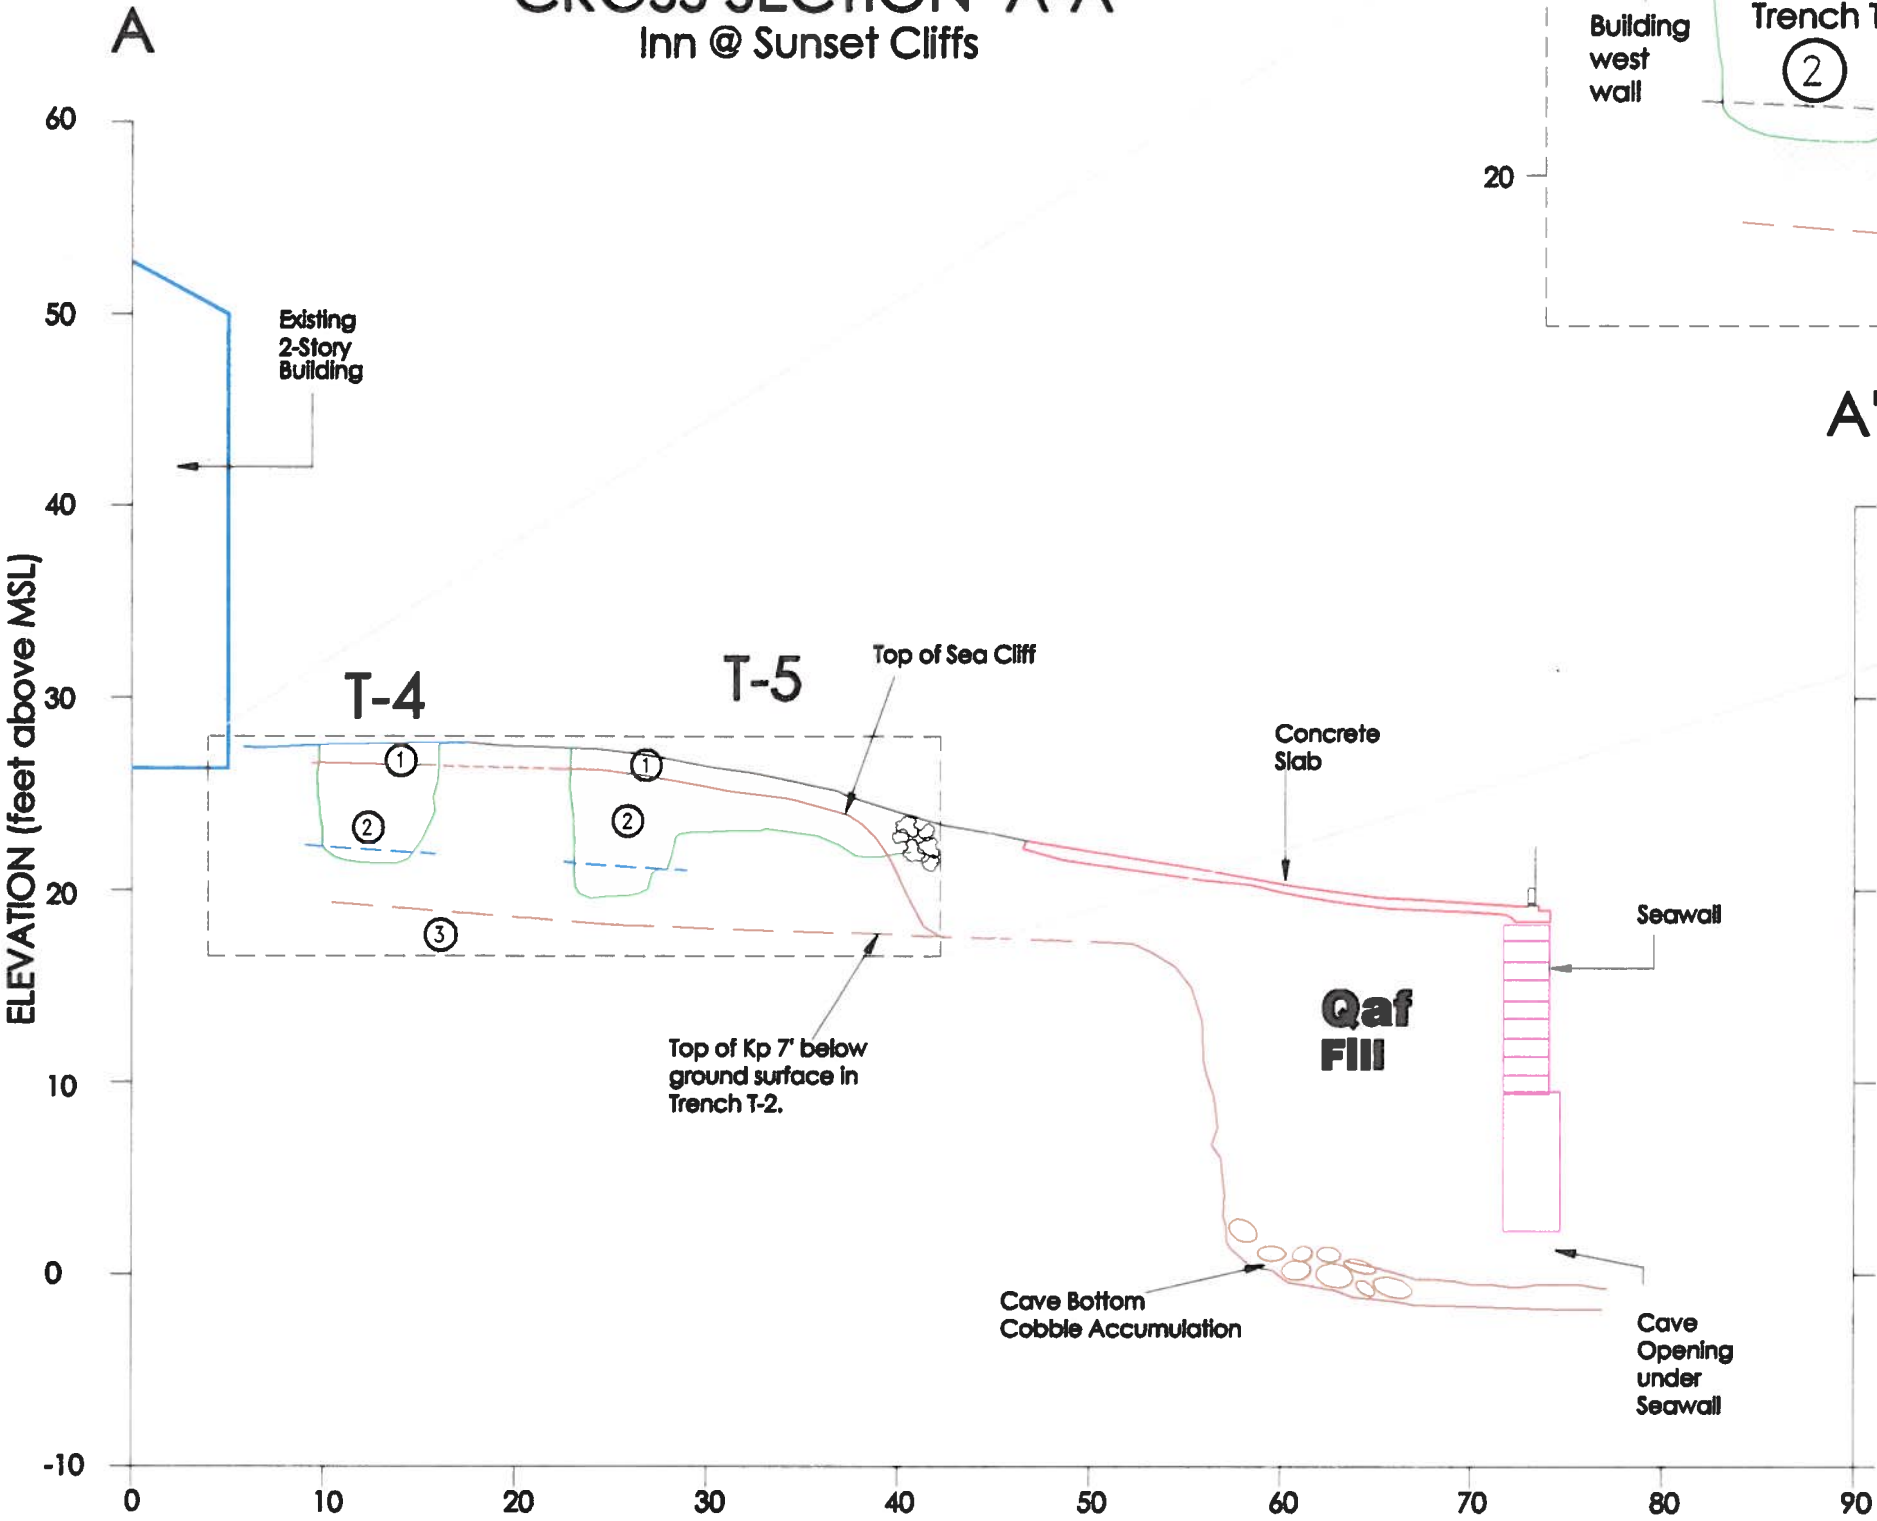
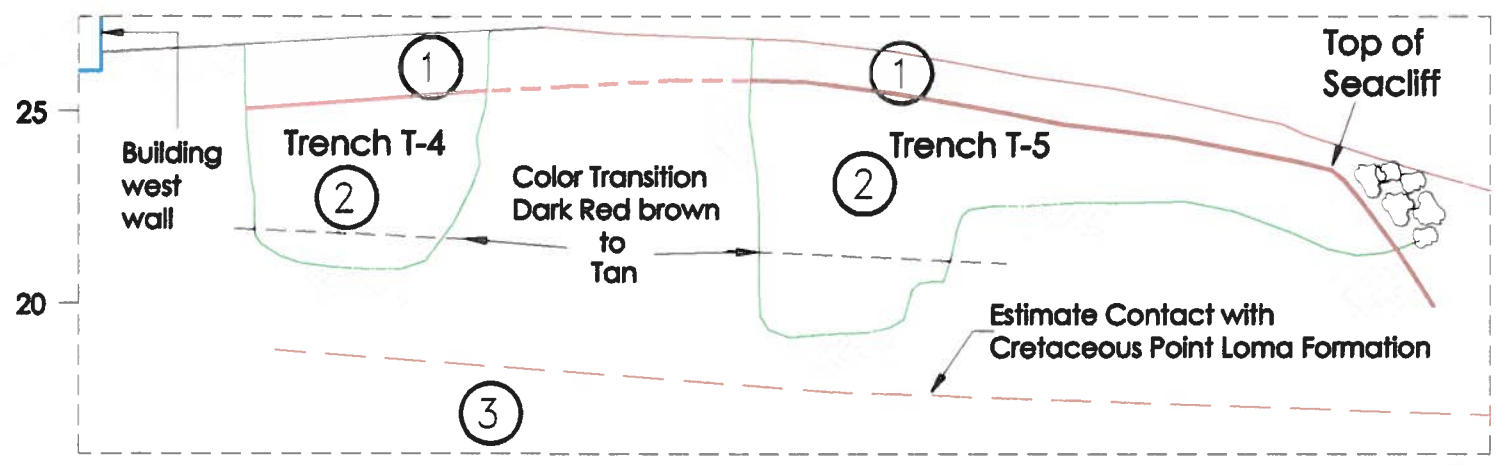
CROSS SECTION A-A' Inn @ Sunset Cliffs

SCALE 1" = 5'

UNIT #	LOCATION	UNIT DESCRIPTION
1	Fill	ARTIFICIAL FILL (Qaf) 0 to 4"/6" 4"/6" to 12"/15" Silty Sand and Gravel. Loose, dry, very light brown Silty Fine to Medium Sand and Mixed Angular Cobble-Boulder size Concrete Debris. Loose, damp, brown Buried Concrete Rubble Debris placed on sea cliff face. Angular, cobble to boulder size.
2	Bay Point Formation	Terrace Materials (Qbp) 12"/15" to 5'-6" Slightly Silty Fine to Medium Sand. Highly bioturbated. Medium dense, damp-moist, dark reddish brown, subvertical black linear manganese/iron mineral accumulations. 7" to 9" long. Color transition to tan at approximate elev: 21' to 22' MSL.
3	Point Loma Formation	Cretaceous Point Loma Formation Kp Estimated contact between Qbp/Kp 18' to 19' feet above Mean Sea Level.

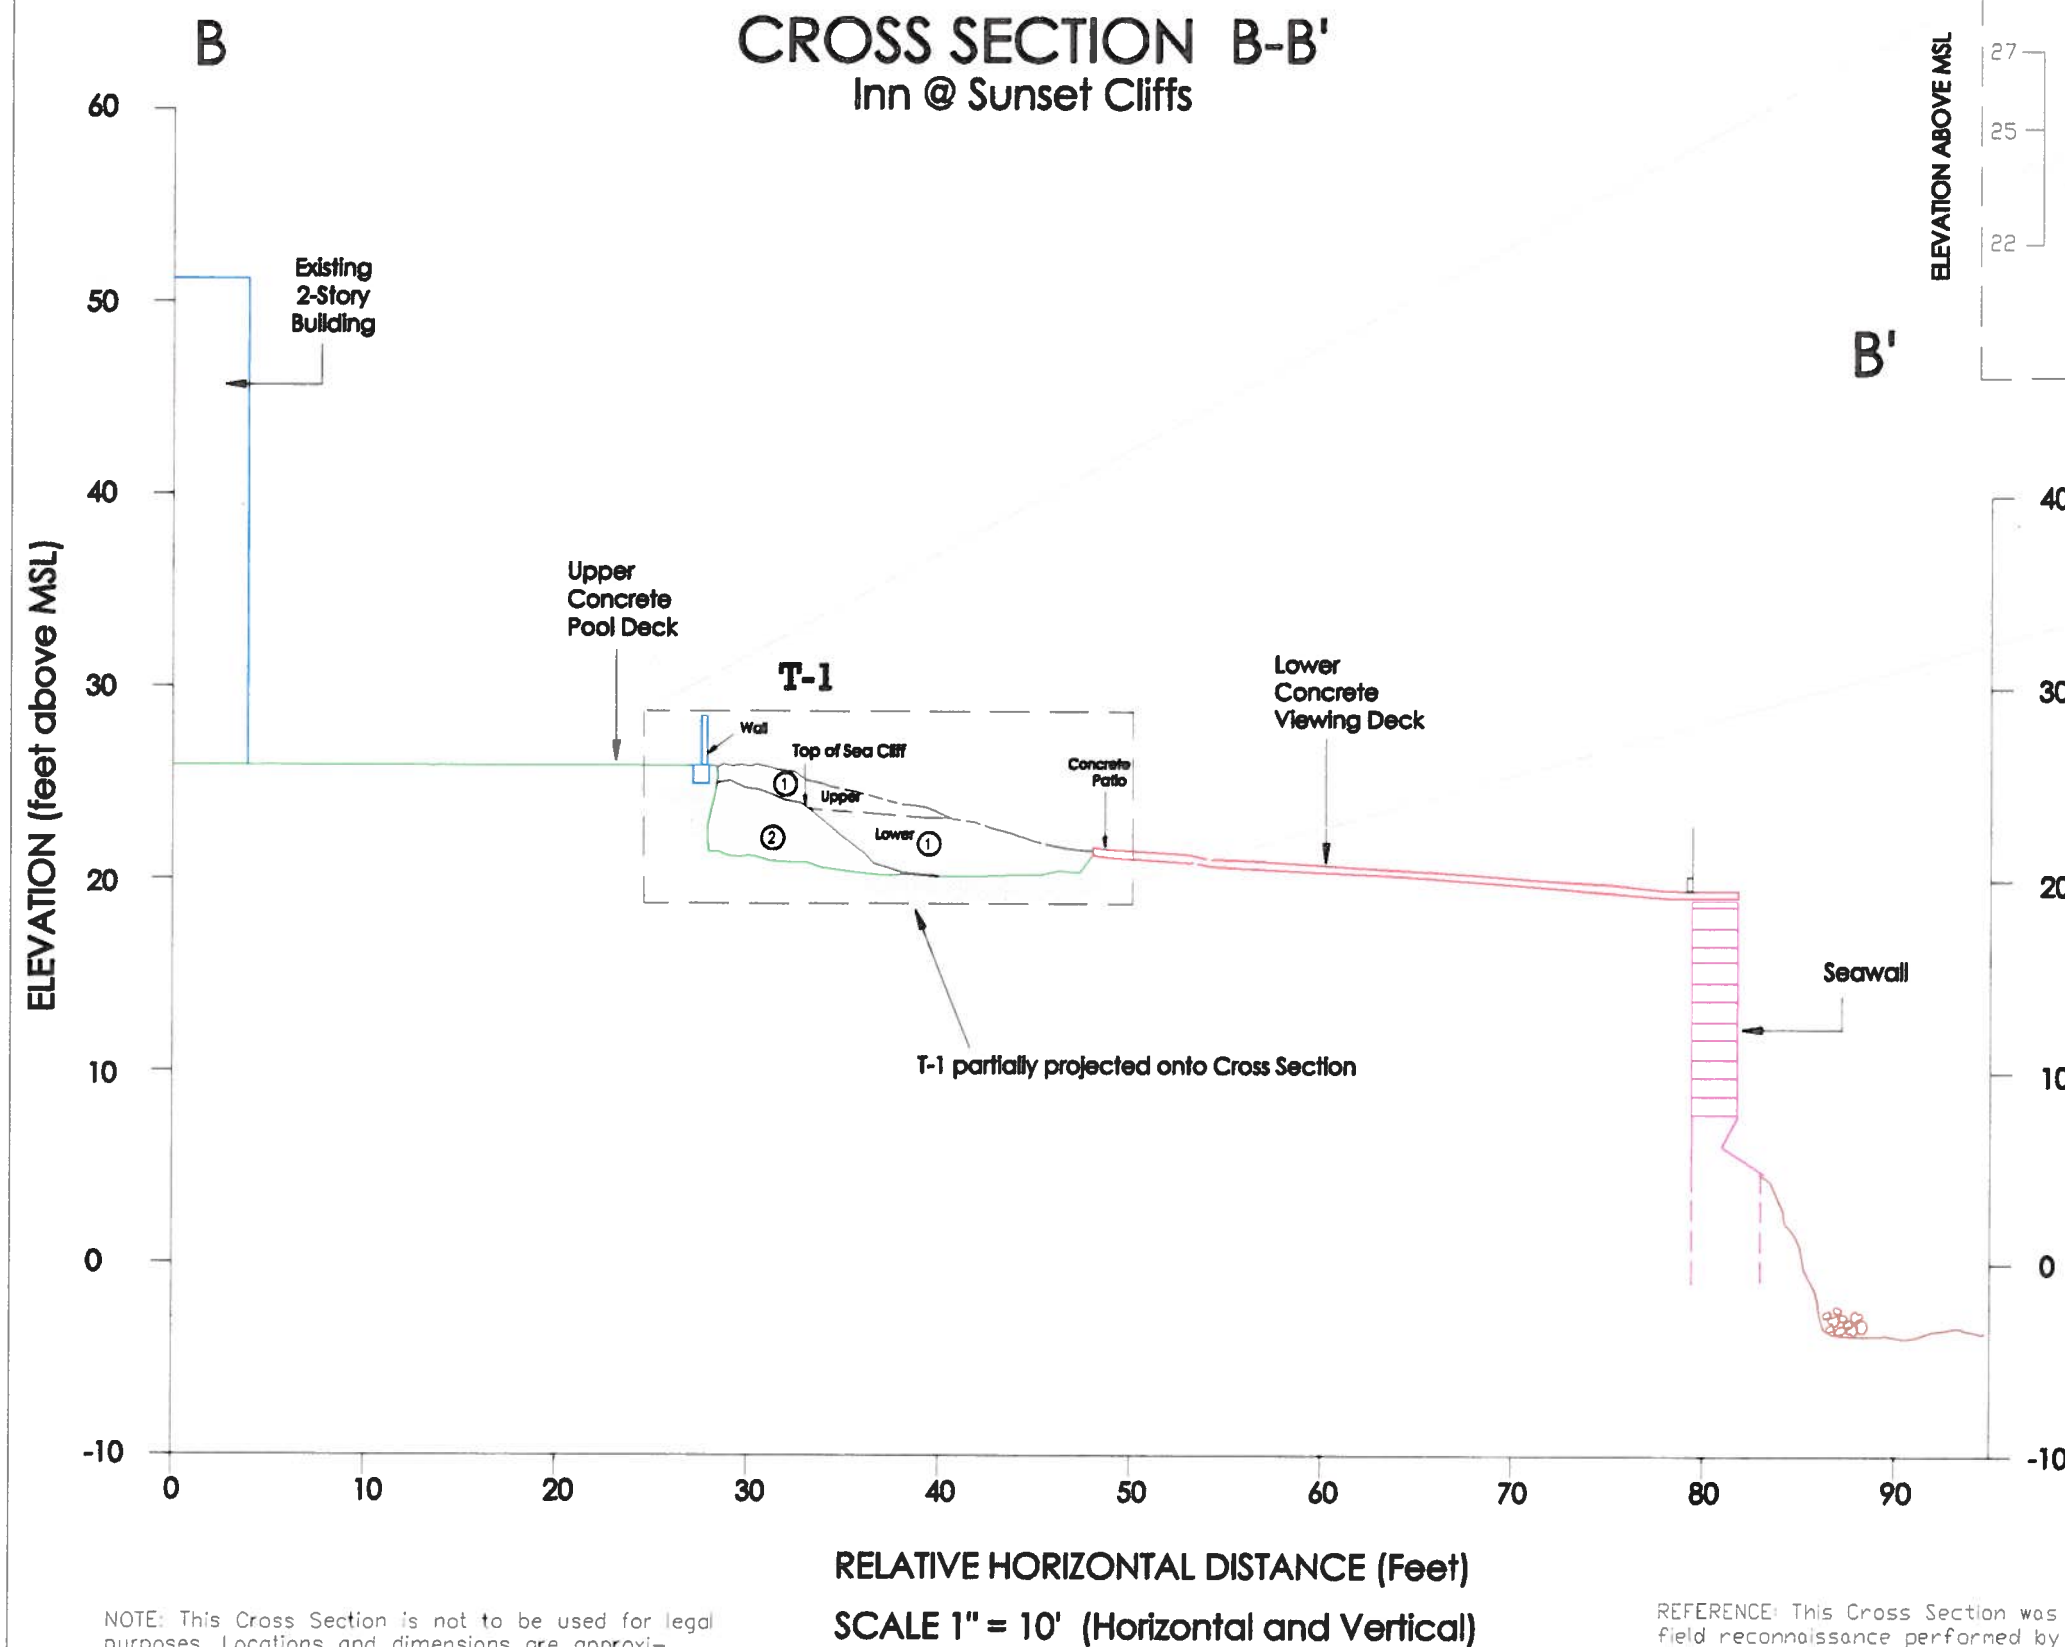
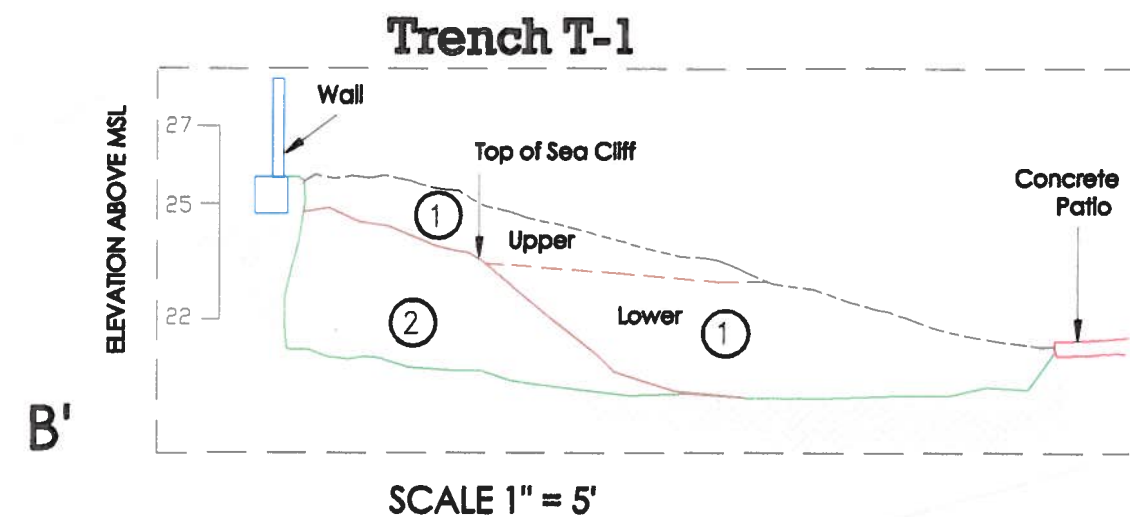
UNIT #	LOCATION	UNIT DESCRIPTION
ARTIFICIAL FILL (Qaf)		
①	Upper Fill	Gravelly Sand, loose, dry-damp, gray/brown/tan with mixed cobble-size angular concrete debris.
	Lower Fill	Fine to Medium Sand, Loose-medium dense, damp-moist, buff/pale brown/yellow white, "beach sand derived"
②	Bay Point Formation	TERRACE MATERIALS (Qbp) Slightly Silty fine to medium sand, Medium dense, moist, brown/dark brown.

Inn at Sunset Cliffs
1370 Sunset Cliffs Boulevard
San Diego, CA.
Figure No. IVb
Job No. 03-8530

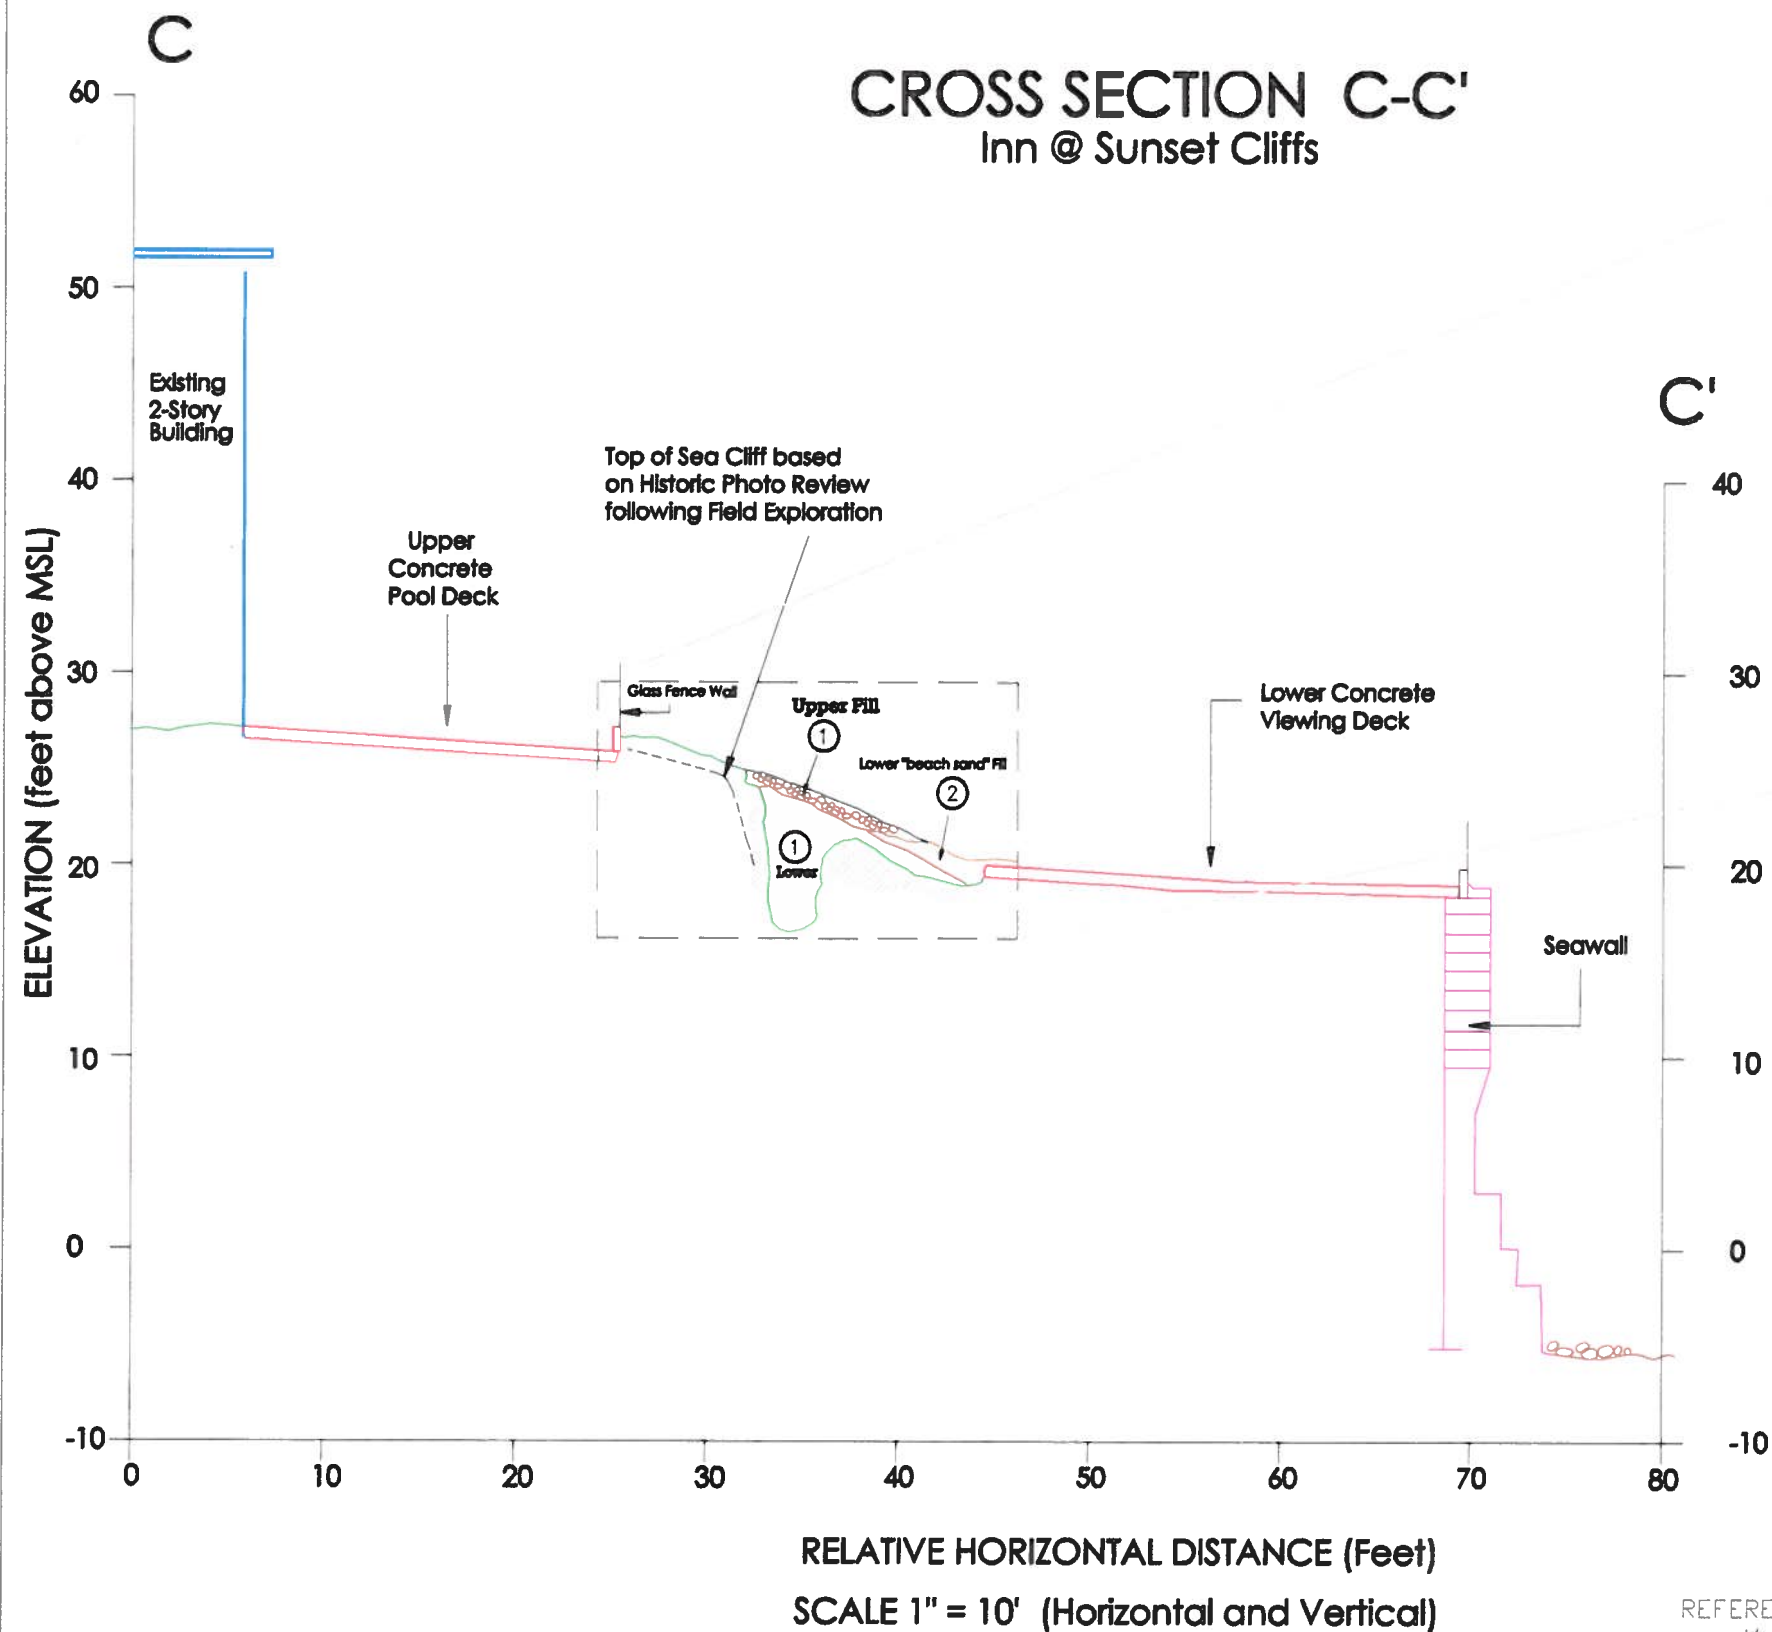
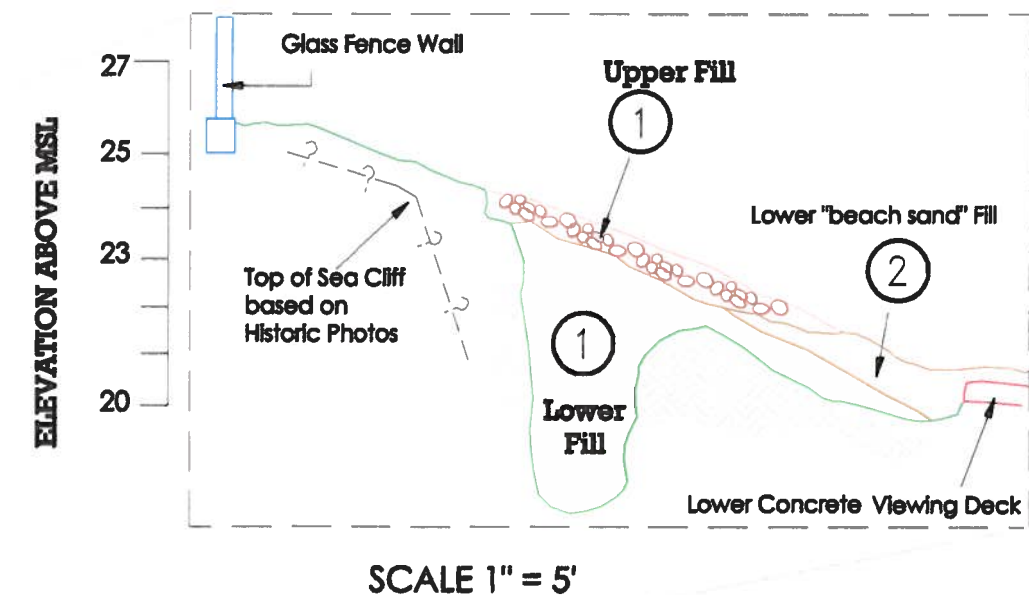
UNIT #	LOCATION	UNIT DESCRIPTION
ARTIFICIAL FILL (Qaf)		
①	Upper Fill	Silty Fine to Medium Sand. Loose-medium dense, damp, tan/brown/gray with angular gravel and angular cobble-boulder size, concrete debris.
②	Lower Fill	Fine to medium sand. Loose-medium dense, damp, brown with scattered angular concrete and brick debris.
	Lower "beach sand fill"	Fine to Medium Sand, Loose-medium dense, damp, pale tan/white/gold brown, "beach sand derived".

Inn at Sunset Cliffs
1370 Sunset Cliffs Boulevard
San Diego, CA.
Figure No. IVc
Job No. 03-8530
