**GEOTECHNICAL REPORT
THE INN AT SUNSET CLIFFS
SAN DIEGO, CALIFORNIA**

Prepared for
PROJECT DESIGN CONSULTANTS
San Diego, California

Prepared by
TERRACOSTA CONSULTING GROUP, INC.
San Diego, California

Project No. 2317-01
December 24, 2020

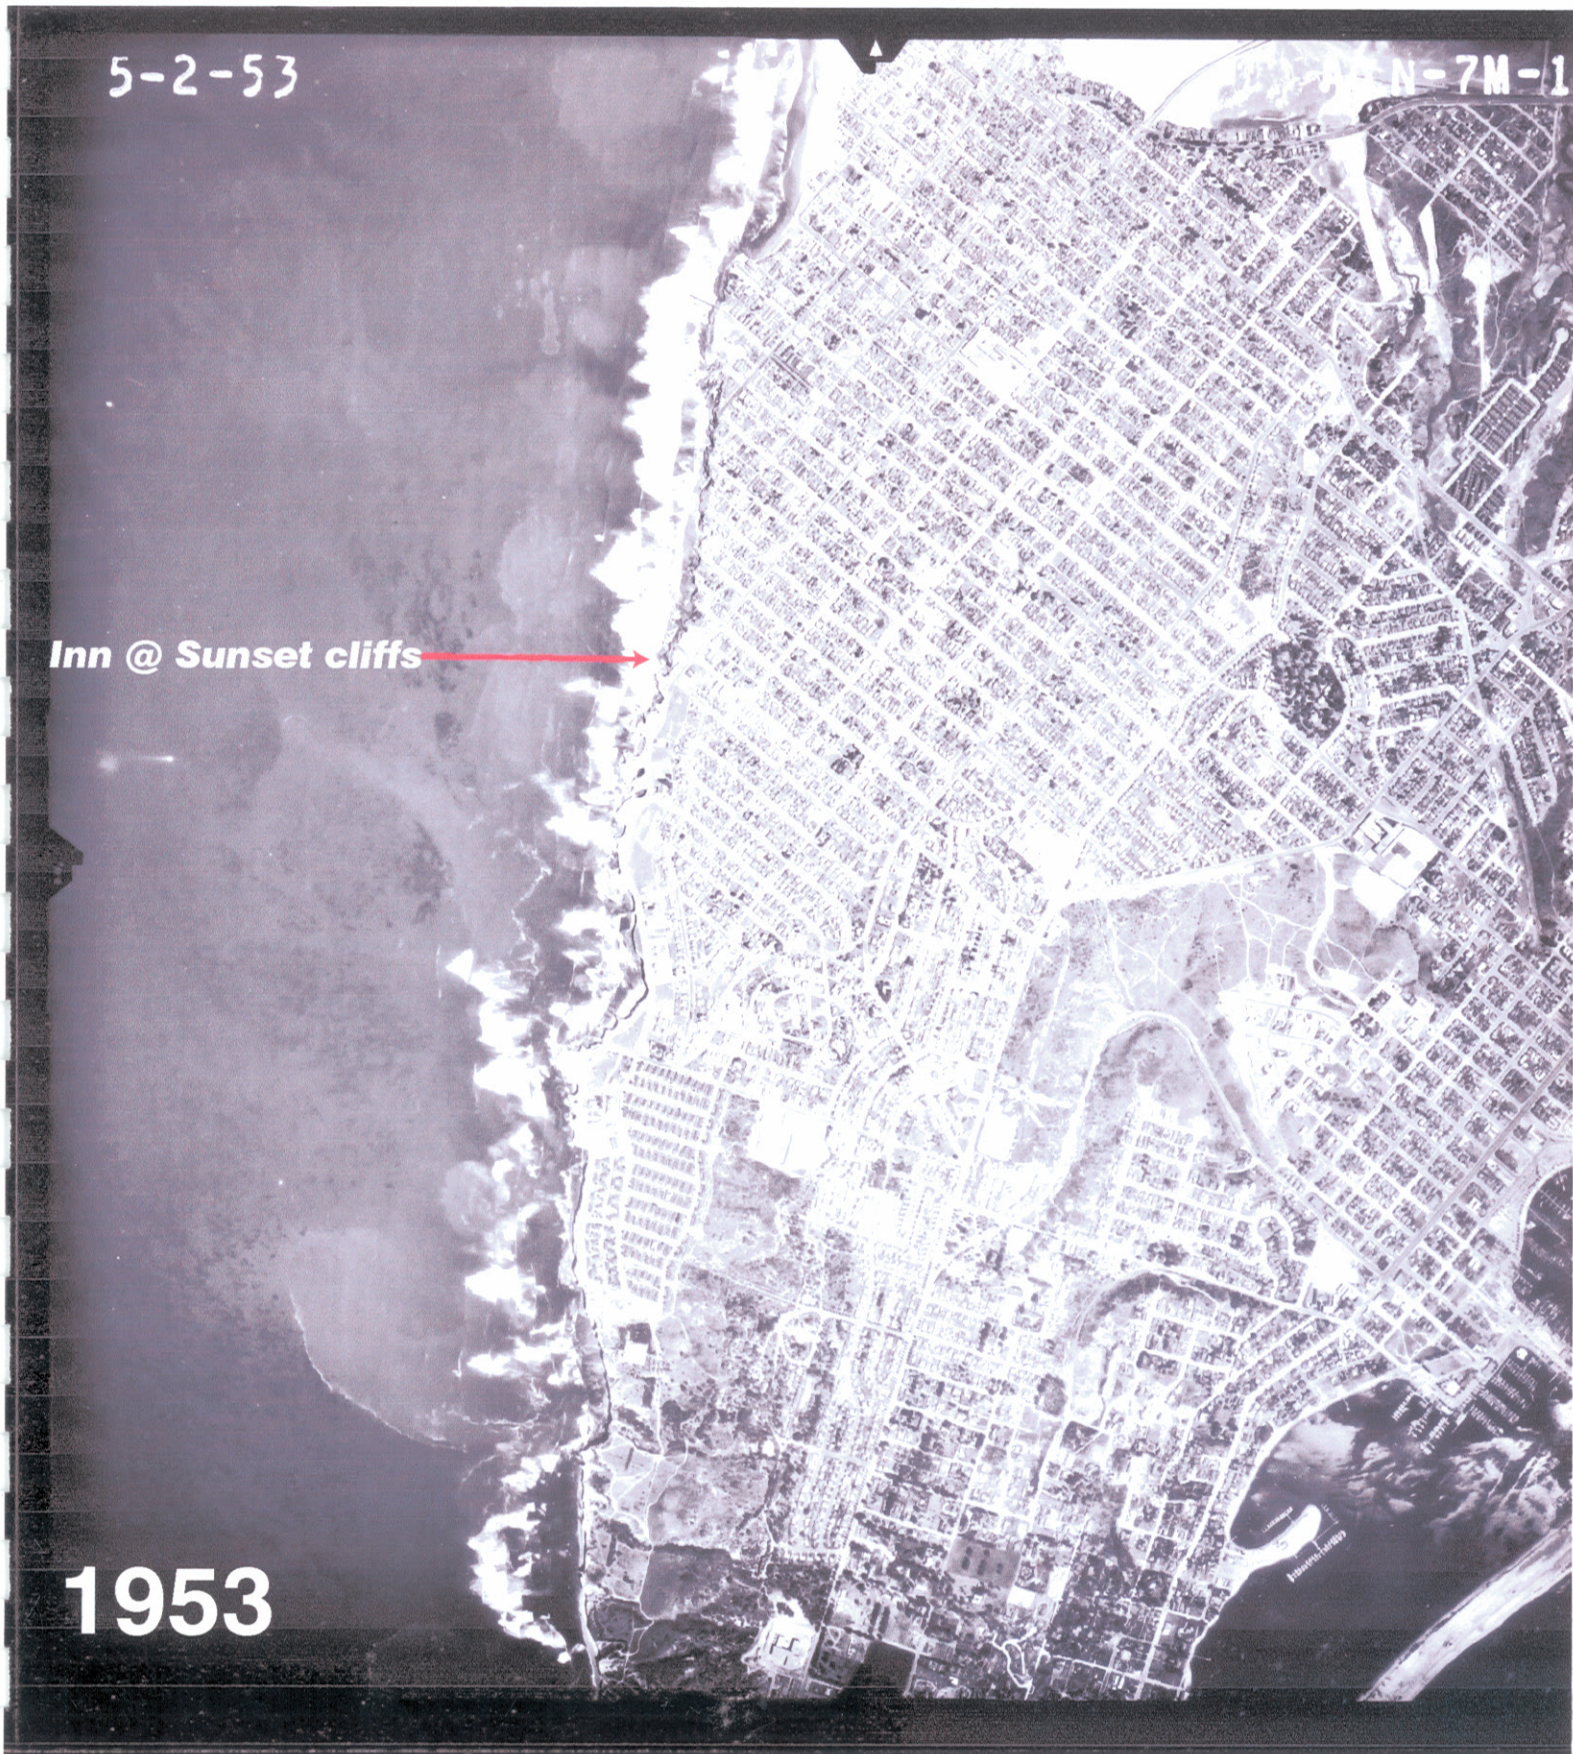
5-2-53

1953

We have reviewed several historical photos dating back to 1939. The below 1953 aerial photo shows The Inn under construction and the seawall and lower viewing area constructed concurrently (Photo 1). Thus, all of the existing improvements pre-date the California Coastal Act.

In examining Figure 2, which shows the existing top-of-bluff from both GEI's and TerraCosta's measurements, the minimum distance from the top-of-bluff to the southwestern corner of the southern building is approximately 13 feet measured from GEI's reported top-of bluff, and only 8 feet measured from the 1953 aerial photograph (Photo 1).

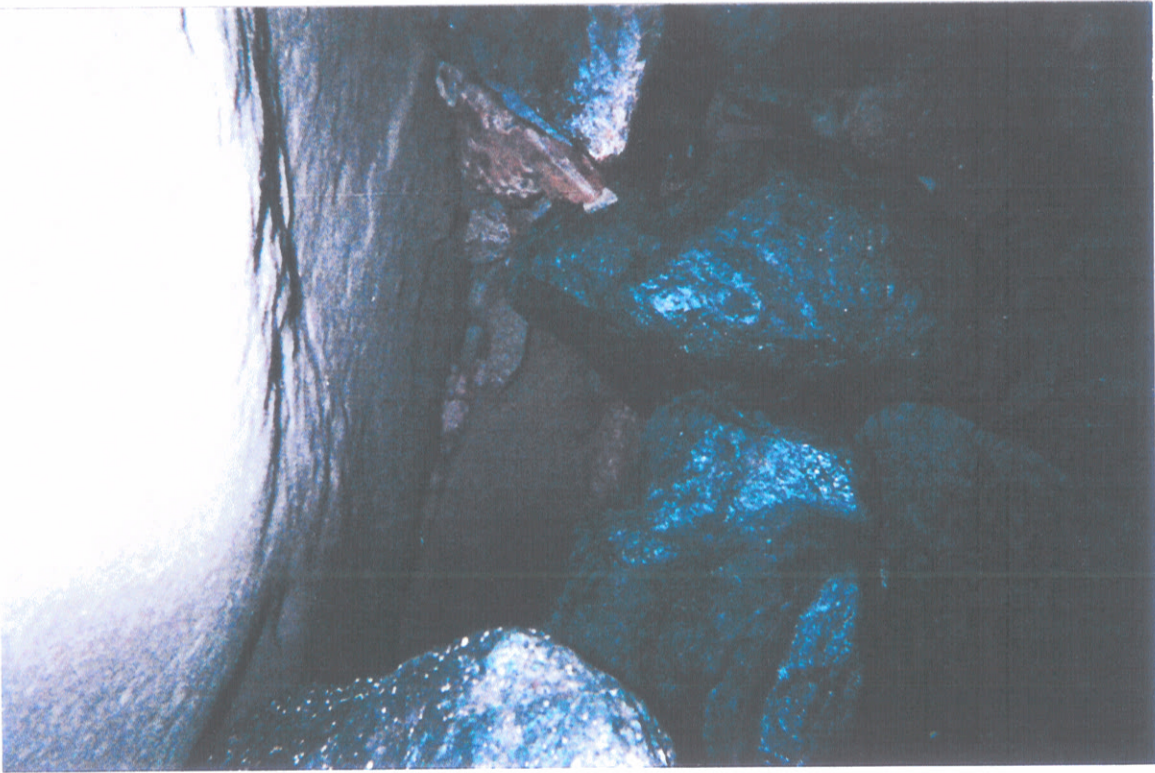
1

1. Point Loma Formation and rock infill observed below lower deck.
2. Shallow fill soils over Bay Point Formation in Trench T-5.
3. Concrete debris in fill soils, east end of Trench T-3.
4. Bioturbation in Bay Point Formation in Trench T-5.
- 5 & 6 Sublinear iron/manganese accumulations in Bay Point Formation in Trench T-5.
