**Update Geotechnical Feasibility Report
Proposed High-Rise Residential Development
6220 West Yucca Street
Hollywood District
Los Angeles, California**

**July 10, 2020
GDC Project No. LA-1461**

Subject: Updated Geotechnical Feasibility Report
Proposed High-Rise Residential Development
6220 West Yucca Street, Hollywood District, Los Angeles, California

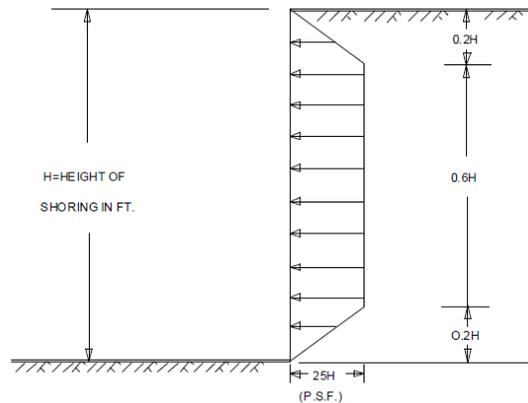
For the design of cantilevered temporary, where the surface of the backfill is level, it can be assumed that drained soils will exert a lateral pressure equal to that developed by a fluid with a density of 30 pounds per cubic foot. If tiebacks are planned to support the shoring, we recommend the use of a trapezoidal distribution of earth pressure. The recommended pressure distribution, for the case where the grade is level behind the shoring, is illustrated in the following diagram with the maximum pressure equal to $25H$ in pounds per square foot, where H is the height of the shoring in feet.

The recommended earth pressure provided above is a preliminary value. The final earth pressure for design of soldier piles and anchors will be provided in the during the design-level geotechnical investigation. Surcharge loads from equipment or stockpiled material should be kept behind the top of the temporary excavations a horizontal distance of at least twice the depth of the excavation.

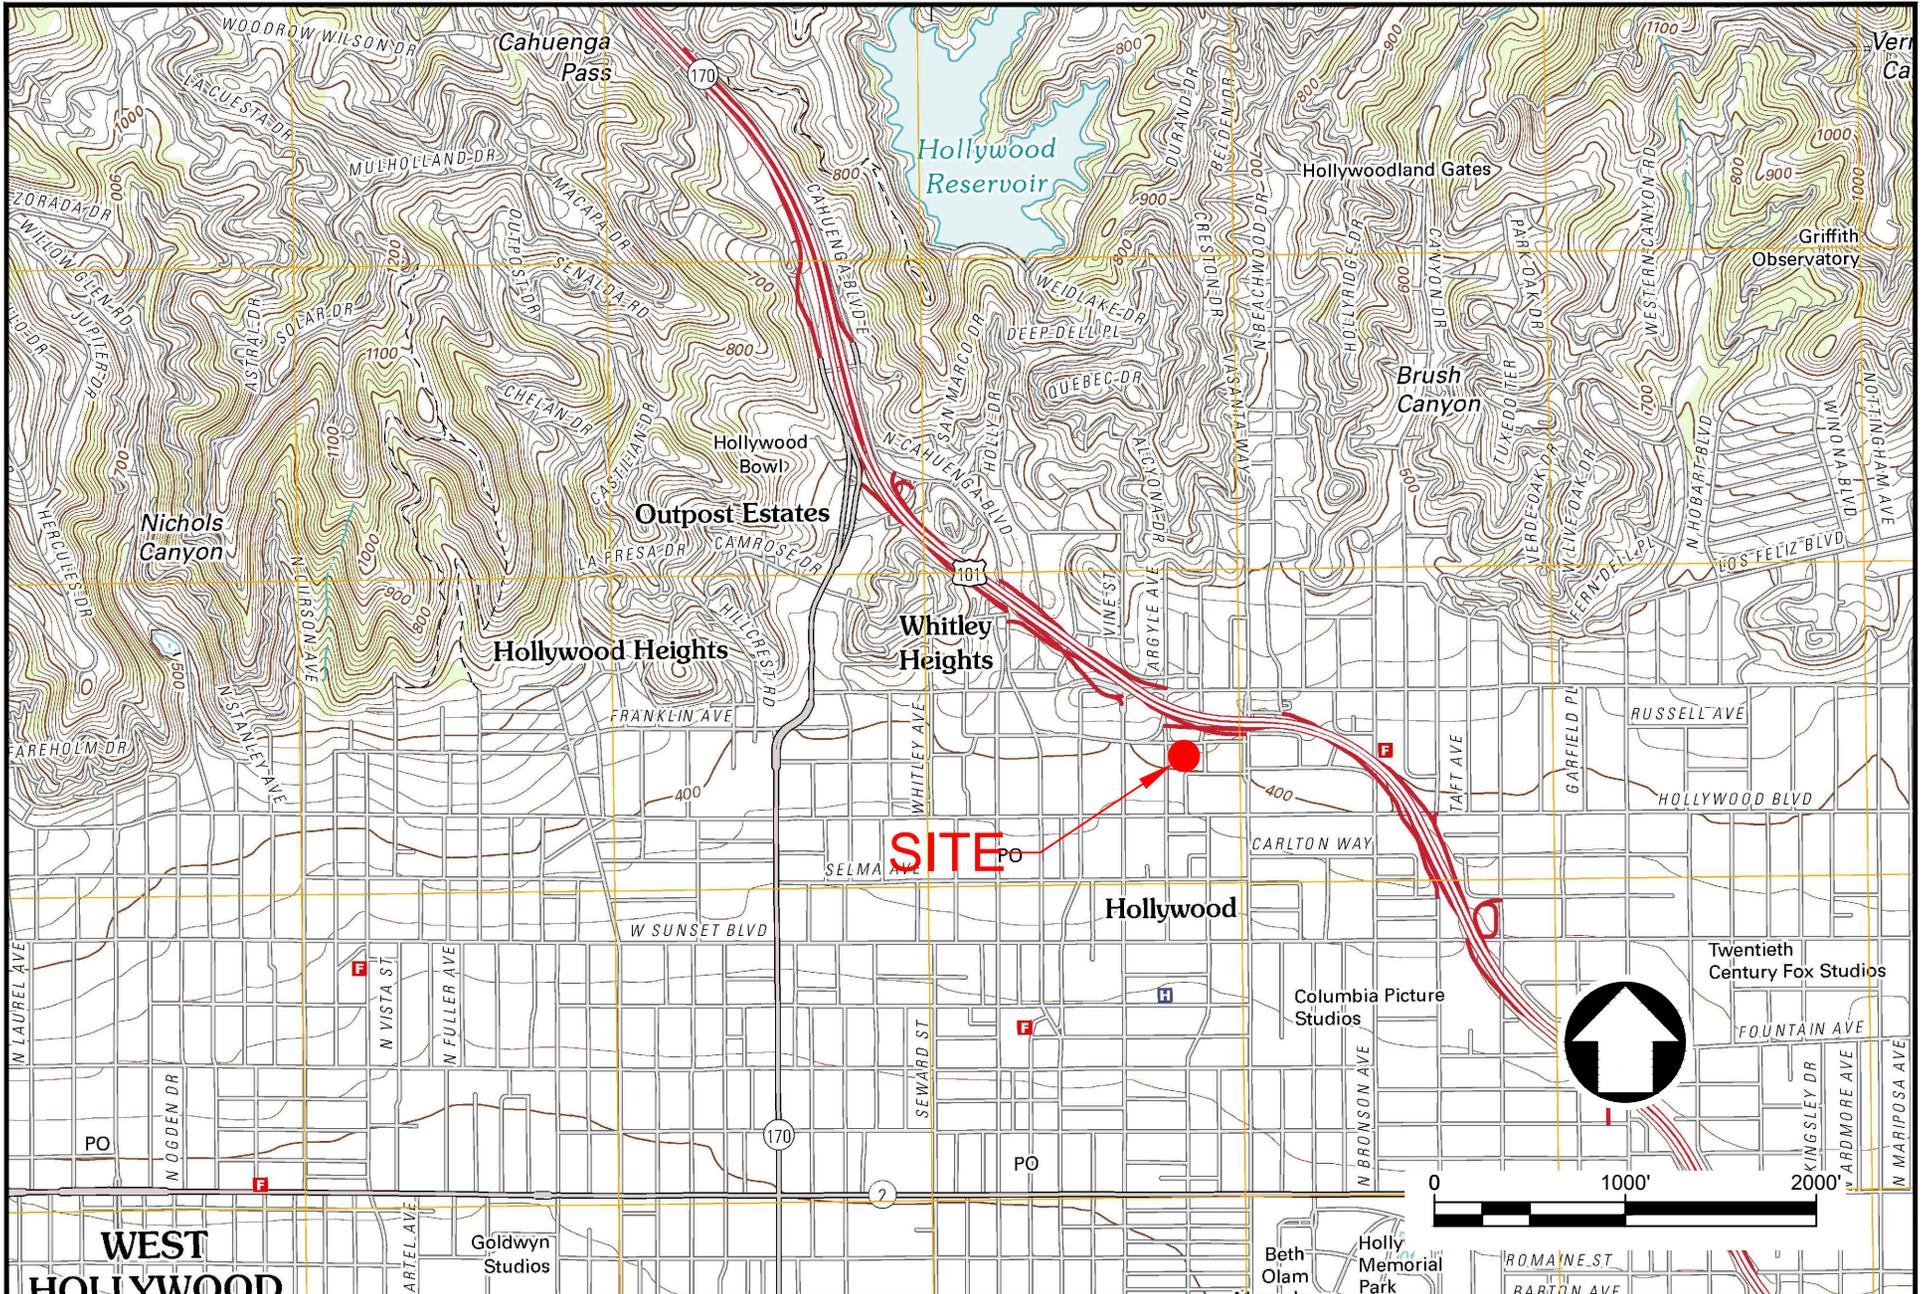
PROJECT NUMBER: LA-1461
SCALE: AS SHOWN
FIGURE NUMBER: 1

WEST HOLLYWOOD
 REFERENCE: USGS 2012, HOLLYWOOD QUADRANGLE
 7.5 MINUTE SERIES

This report was prepared to address the feasibility of the proposed high-rise residential development from a geotechnical standpoint and to provide preliminary geotechnical recommendations for Project Entitlements or planning purposes. The project site is located at 6220 West Yucca Street in the Hollywood District of Los Angeles City, California. A Vicinity Map is presented in Figure 1.

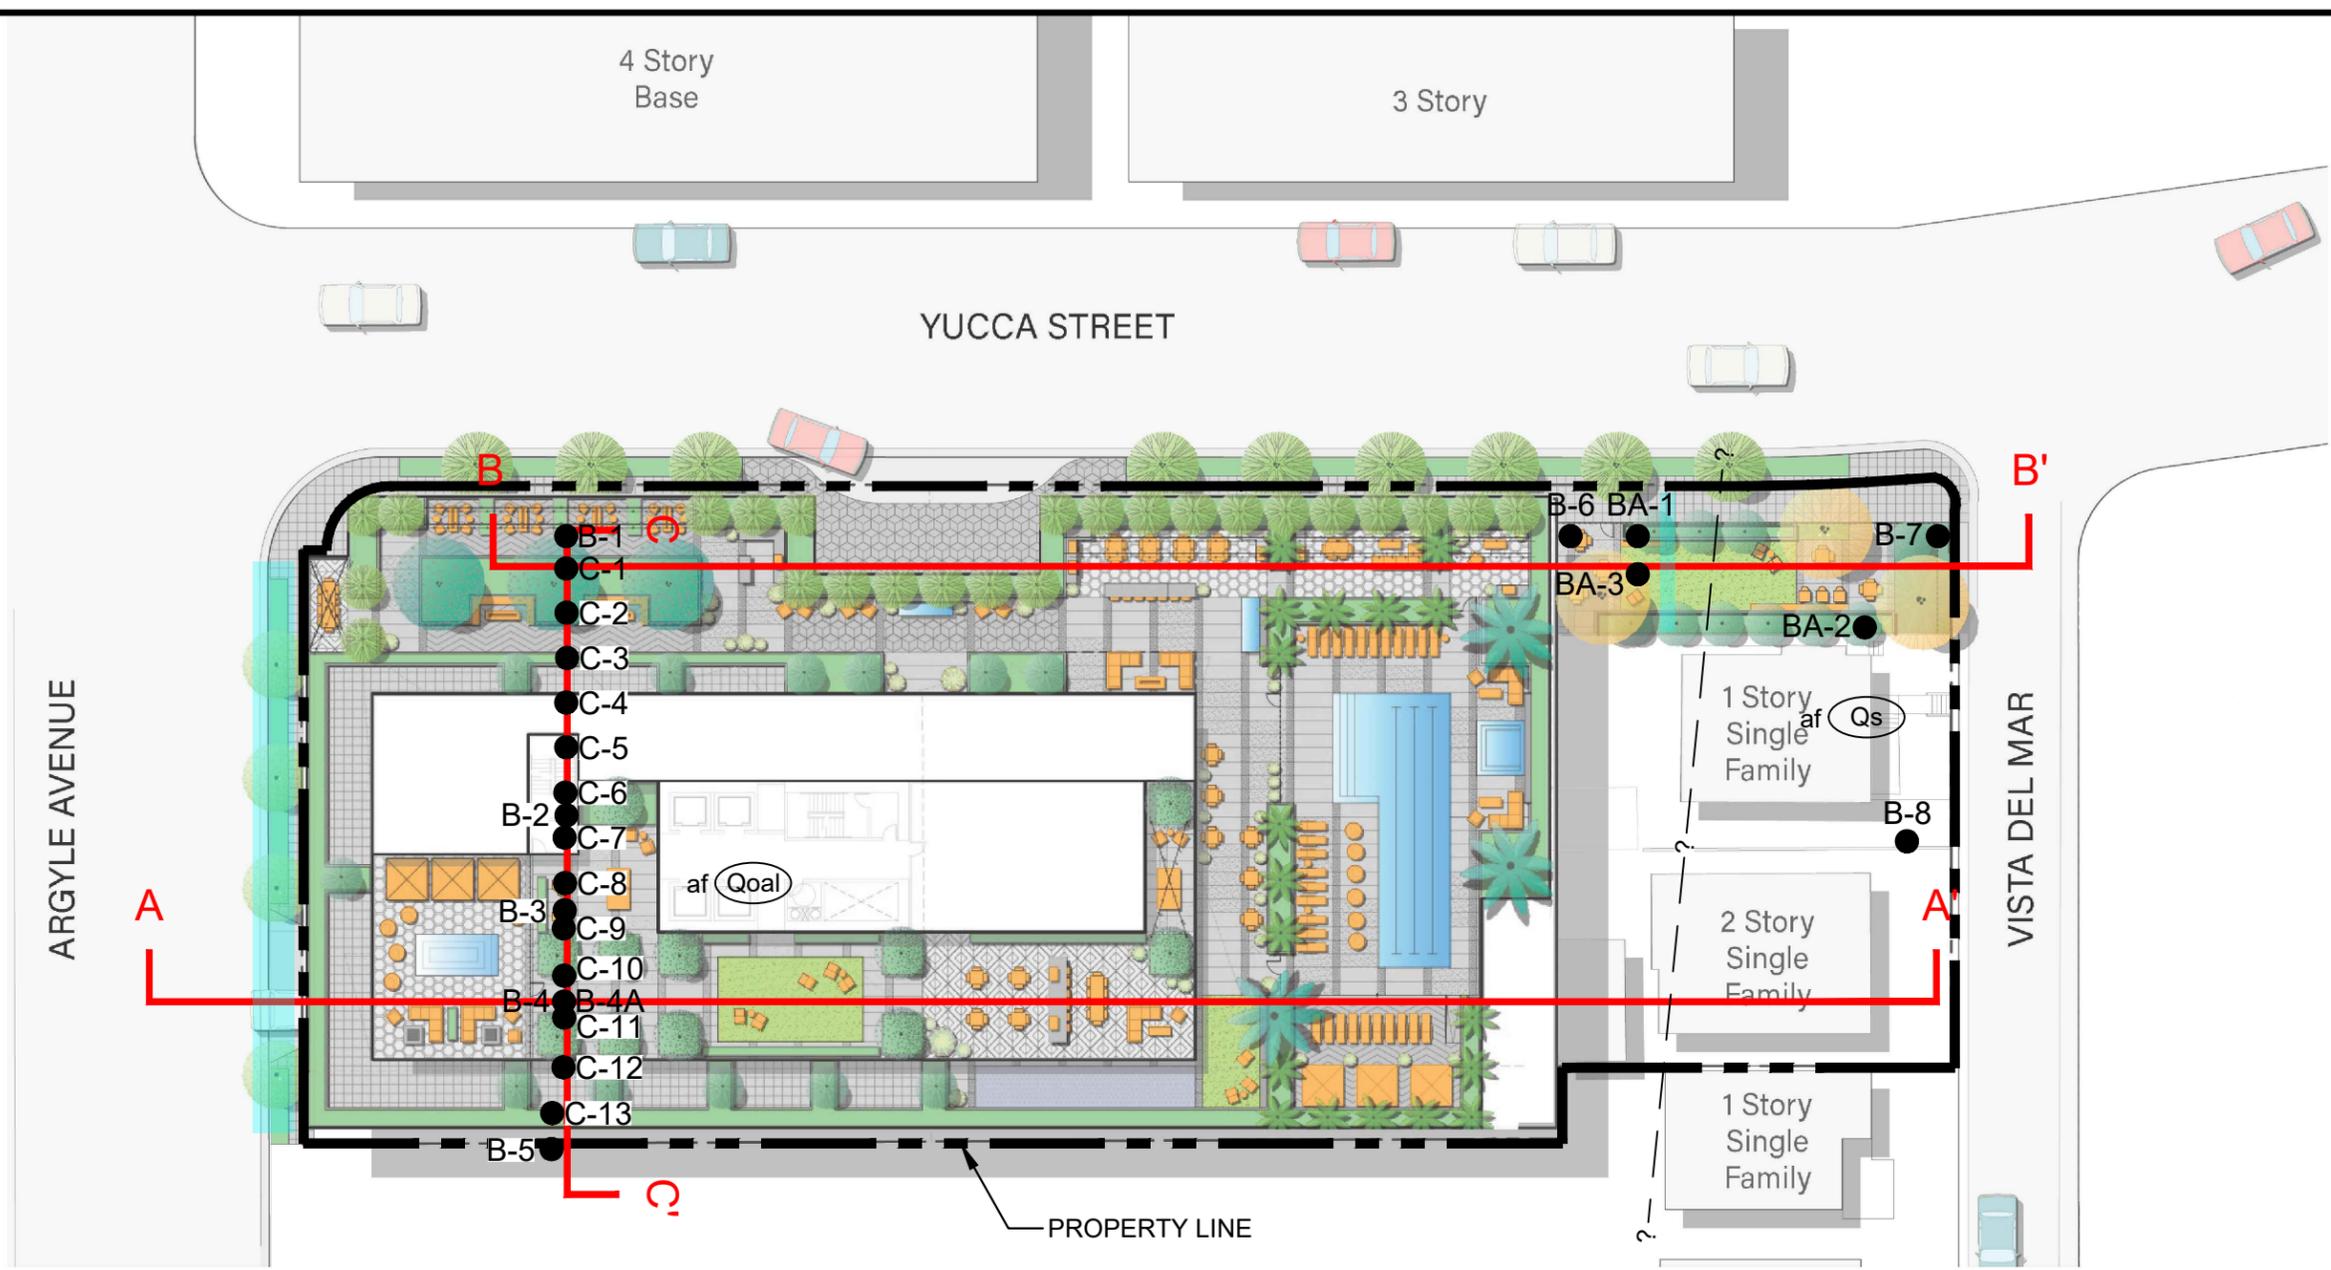
PROJECT NUMBER: LA-1461
SCALE: AS SHOWN
FIGURE NUMBER: 2

SITE PLAN & PRIOR EXPLORATION MAP
PROPOSED MIXED USE HIGH-RISE DEVELOPMENT
 6220 W. YUCCA STREET LOS ANGELES, CA.

The topography of the site is a graded level pad positioned in the middle of a slope, descending approximately 10 degrees to the south. Locally the slope descends from Elevation 430 feet at the northeast corner of the site down to about Elevation 408 feet at the southwest portion of the site, shown in Figure 2. Regionally the slope is an anomalous steepened landform within gentle, south-sloping, alluvial fan deposits near the border of south trending ridgelines and canyons along the south limb of the Santa Monica Mountains, illustrated on the Historical Geologic Map presented in Figure 3.

Subsurface conditions were evaluated through review of our prior fault investigation field exploration data (GDC, 2014), which included 8 continuous core borings, 13 CPTs, 3 bucket auger borings, and two fault trenches. The locations of explorations are shown on Figure 2 and the subsurface data is summarized on Figures 4.1 through 4.3. Detailed logs are presented in Appendix B. A soil-stratigraphic age assessment and paleo-environmental reconstruction of the subsurface geology was performed for the site by Roy Shlemon & Associates, Inc. and is also presented in the GDC 2014 fault report.

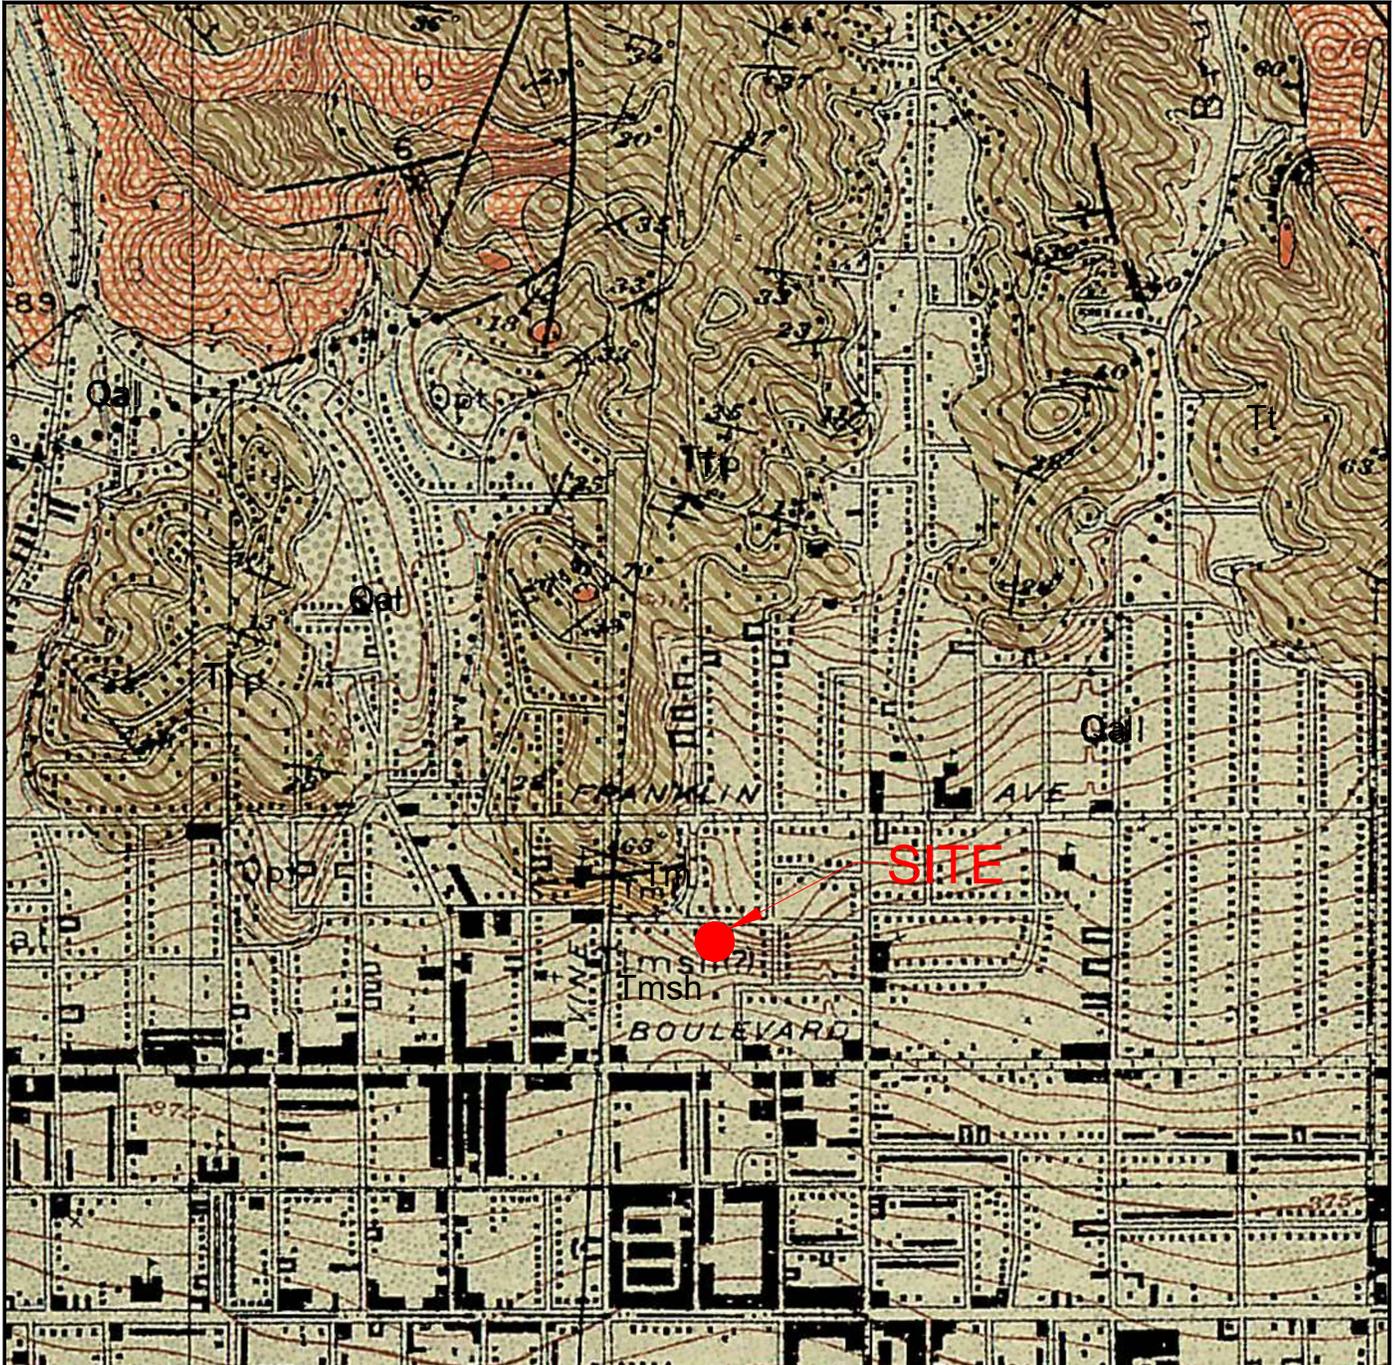
GROUP DELTA CONSULTANTS, INC 370 Amapola Ave. Suite 212 Torrance, CA. 90501	HISTORICAL GEOLOGIC MAP PROPOSED MIXED USE HIGH-RISE DEVELOPMENT 6220 W. YUCCA STREET LOS ANGELES, CA	PROJECT NUMBER: LA-1461
REVIEW:	APPROVED BY:			SCALE: AS SHOWN
PREPARED BY:			FIGURE NUMBER: 3

Figure 3: Geologic map Site and Vicinity (Hoots and Kew, 1931) showing inferred trace of a Hollywood Fault separating Modelo (T_m / T_{msh}), and Topanga (T_t) Formations, granite rocks (gr), and alluvium (Q_{a1}).

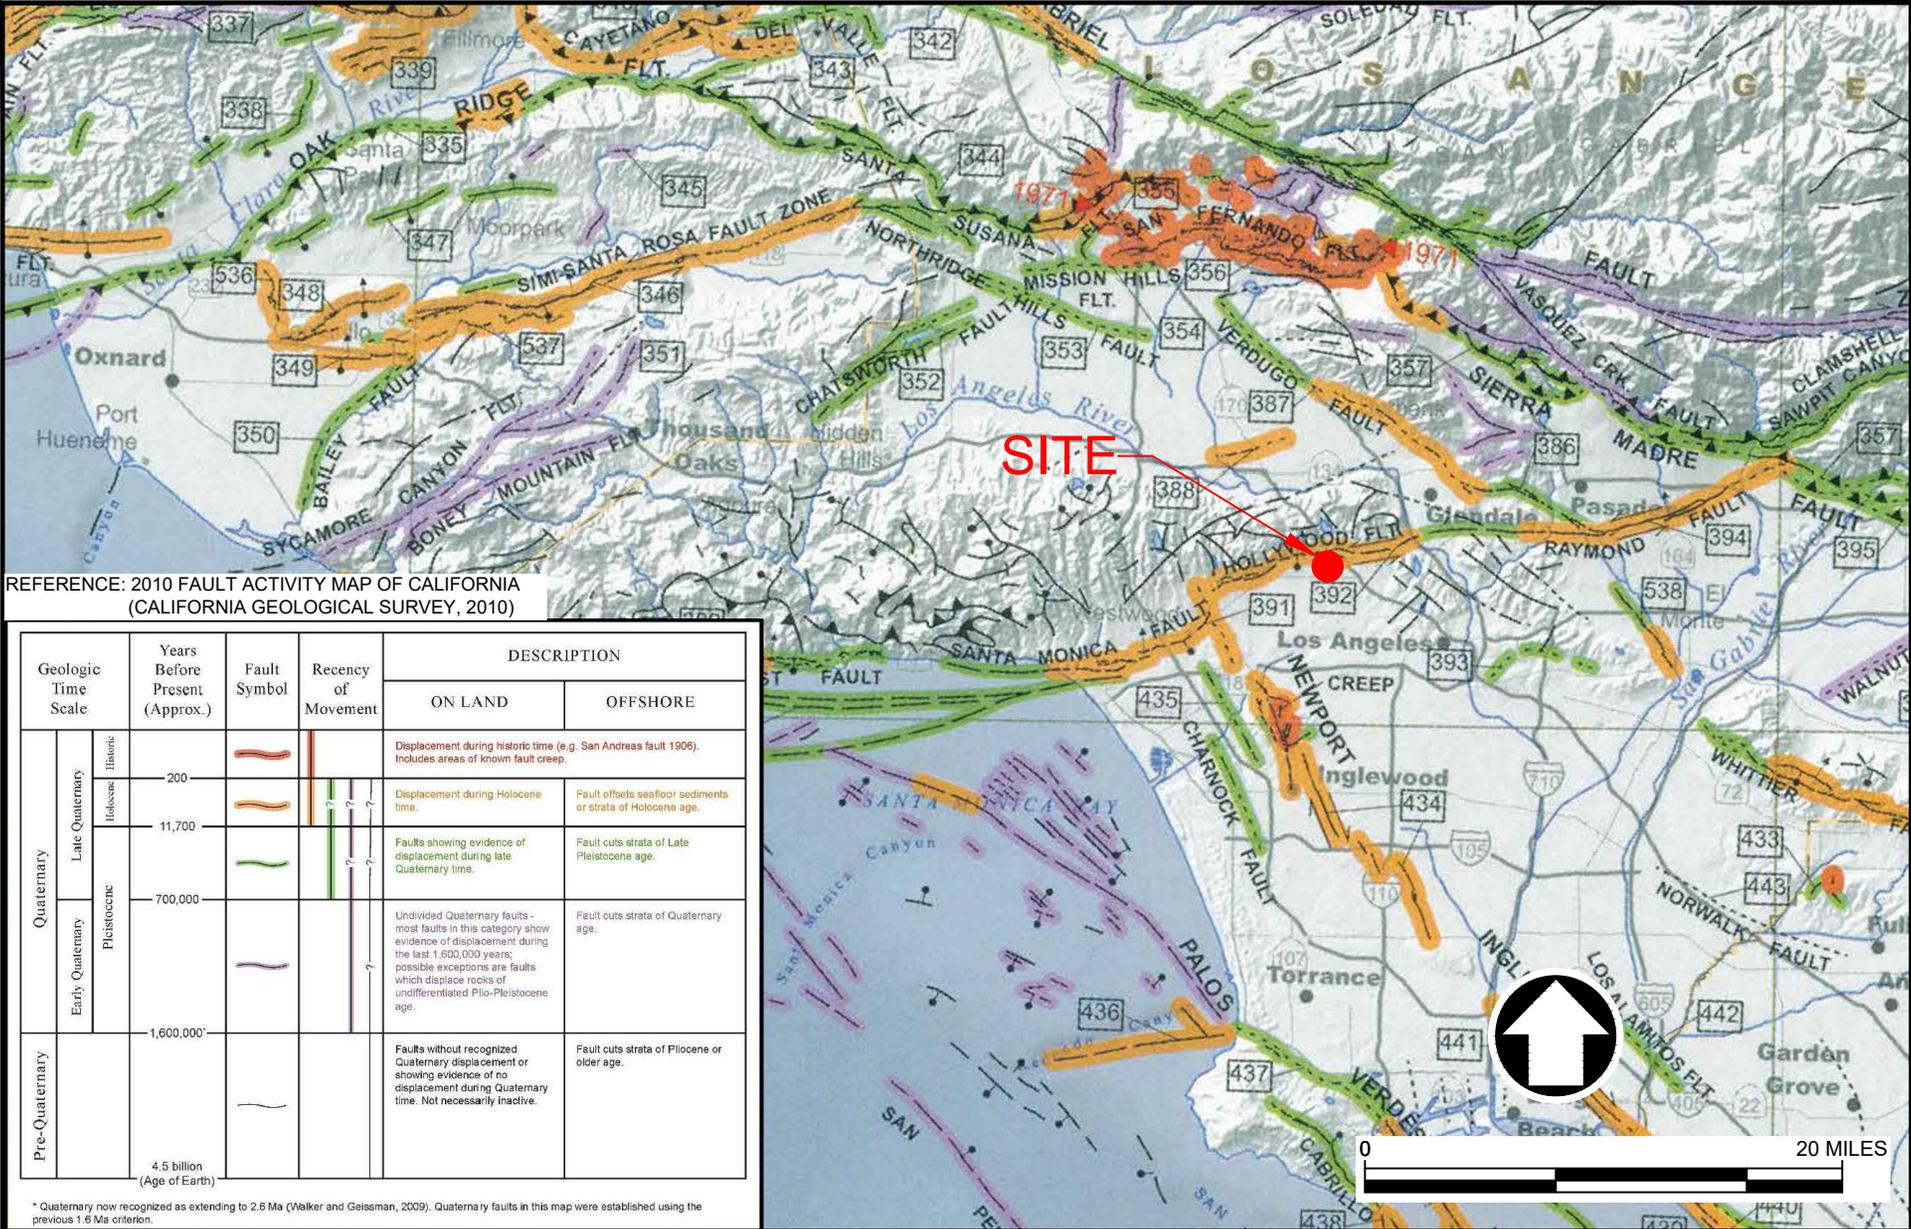
REFERENCE: 2010 FAULT ACTIVITY MAP OF CALIFORNIA (CALIFORNIA GEOLOGICAL SURVEY, 2010)

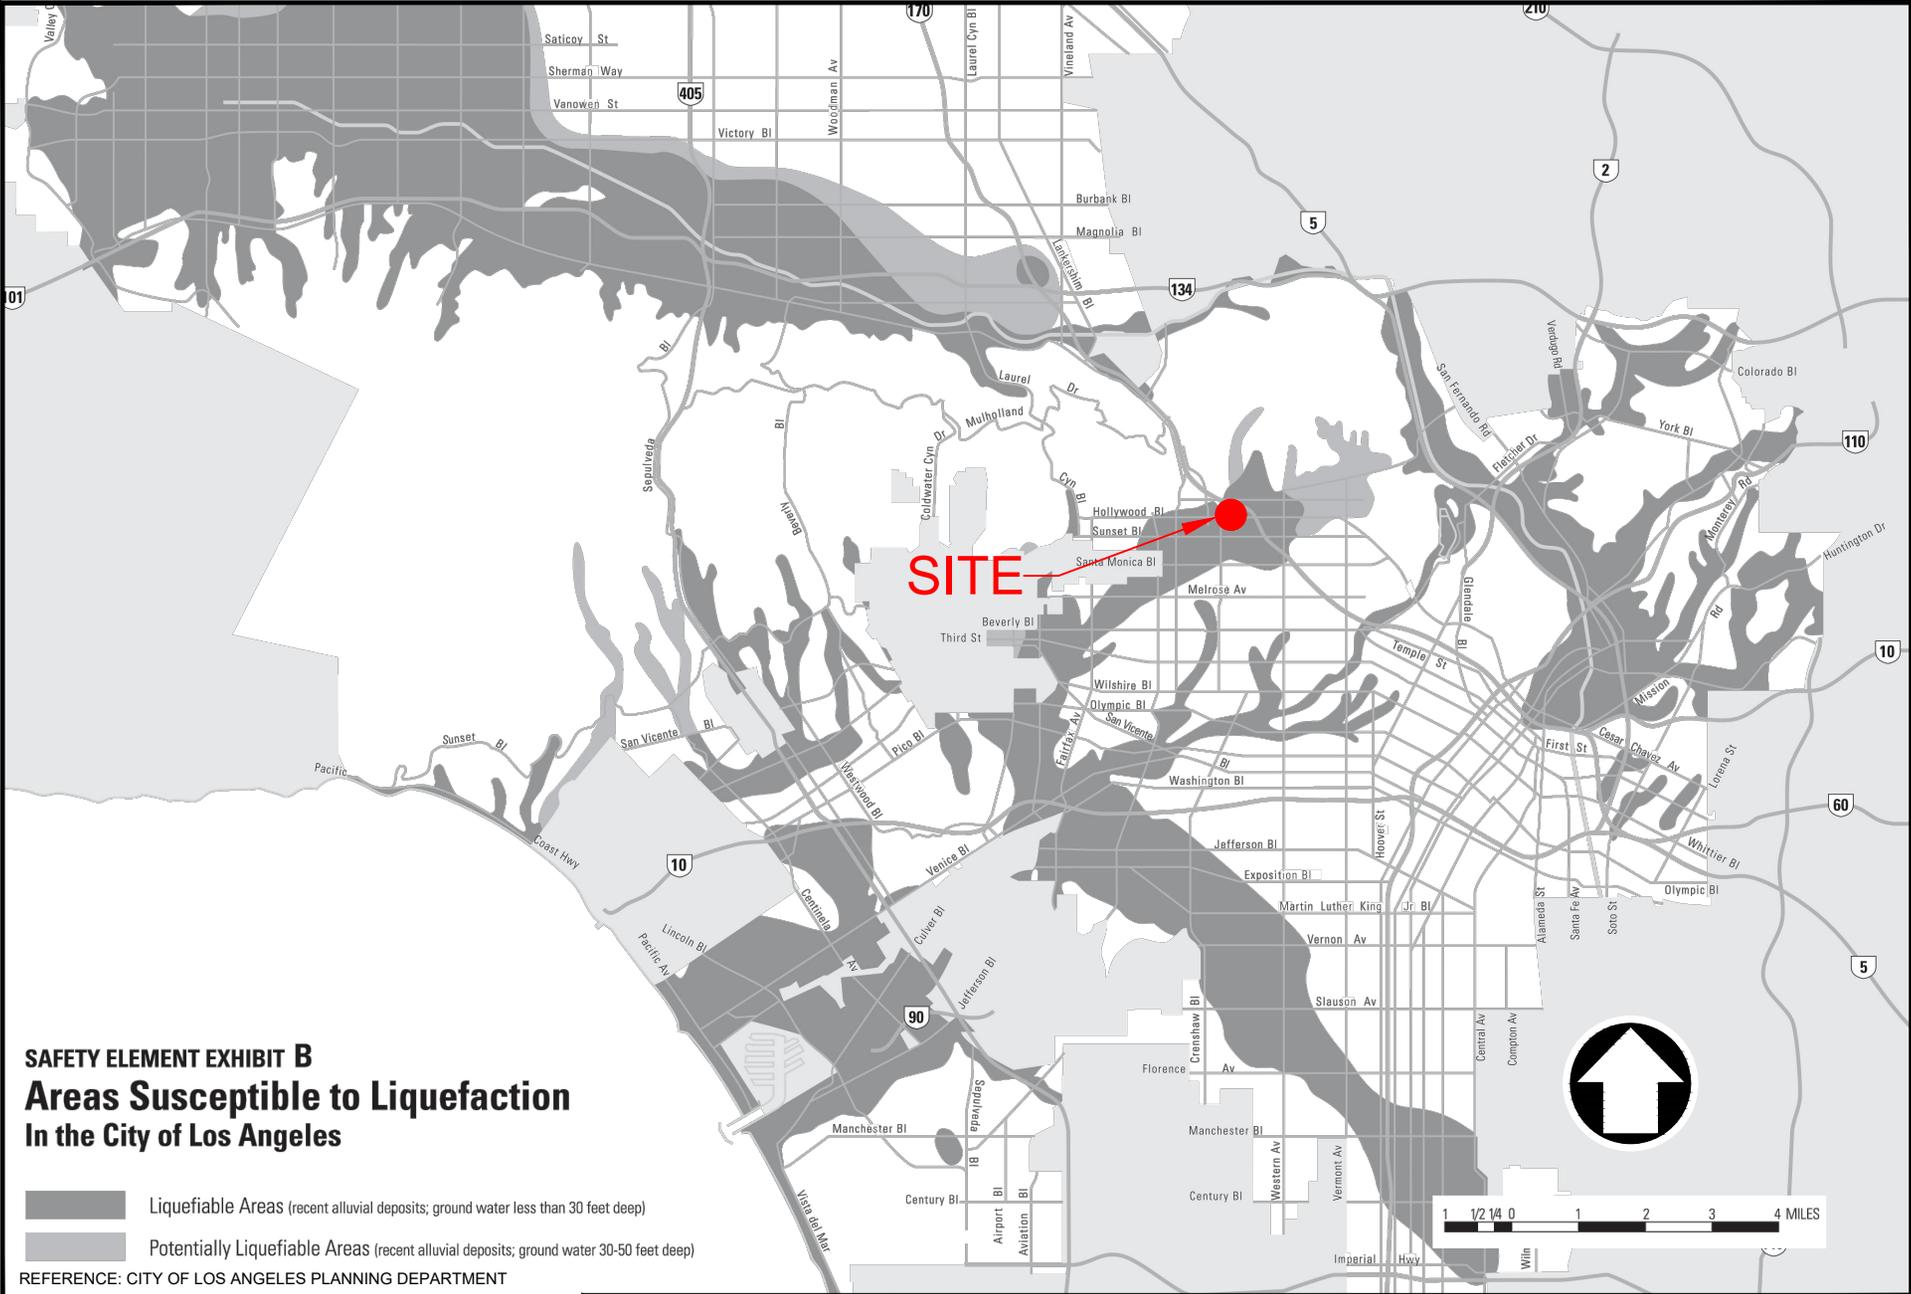
SAFETY ELEMENT EXHIBIT B
Areas Susceptible to Liquefaction
In the City of Los Angeles

The State of California Seismic Hazard Zones map of the Hollywood Quadrangle and the Safety Element of the Los Angeles City General Plan - Areas Susceptible to Liquefaction. The site is not located within a State of California Seismic Hazard Liquefaction zone as shown in Figure 7; however, the site is located within an area susceptible to liquefaction based on the Los Angeles Safety Element, shown on Figure 9.

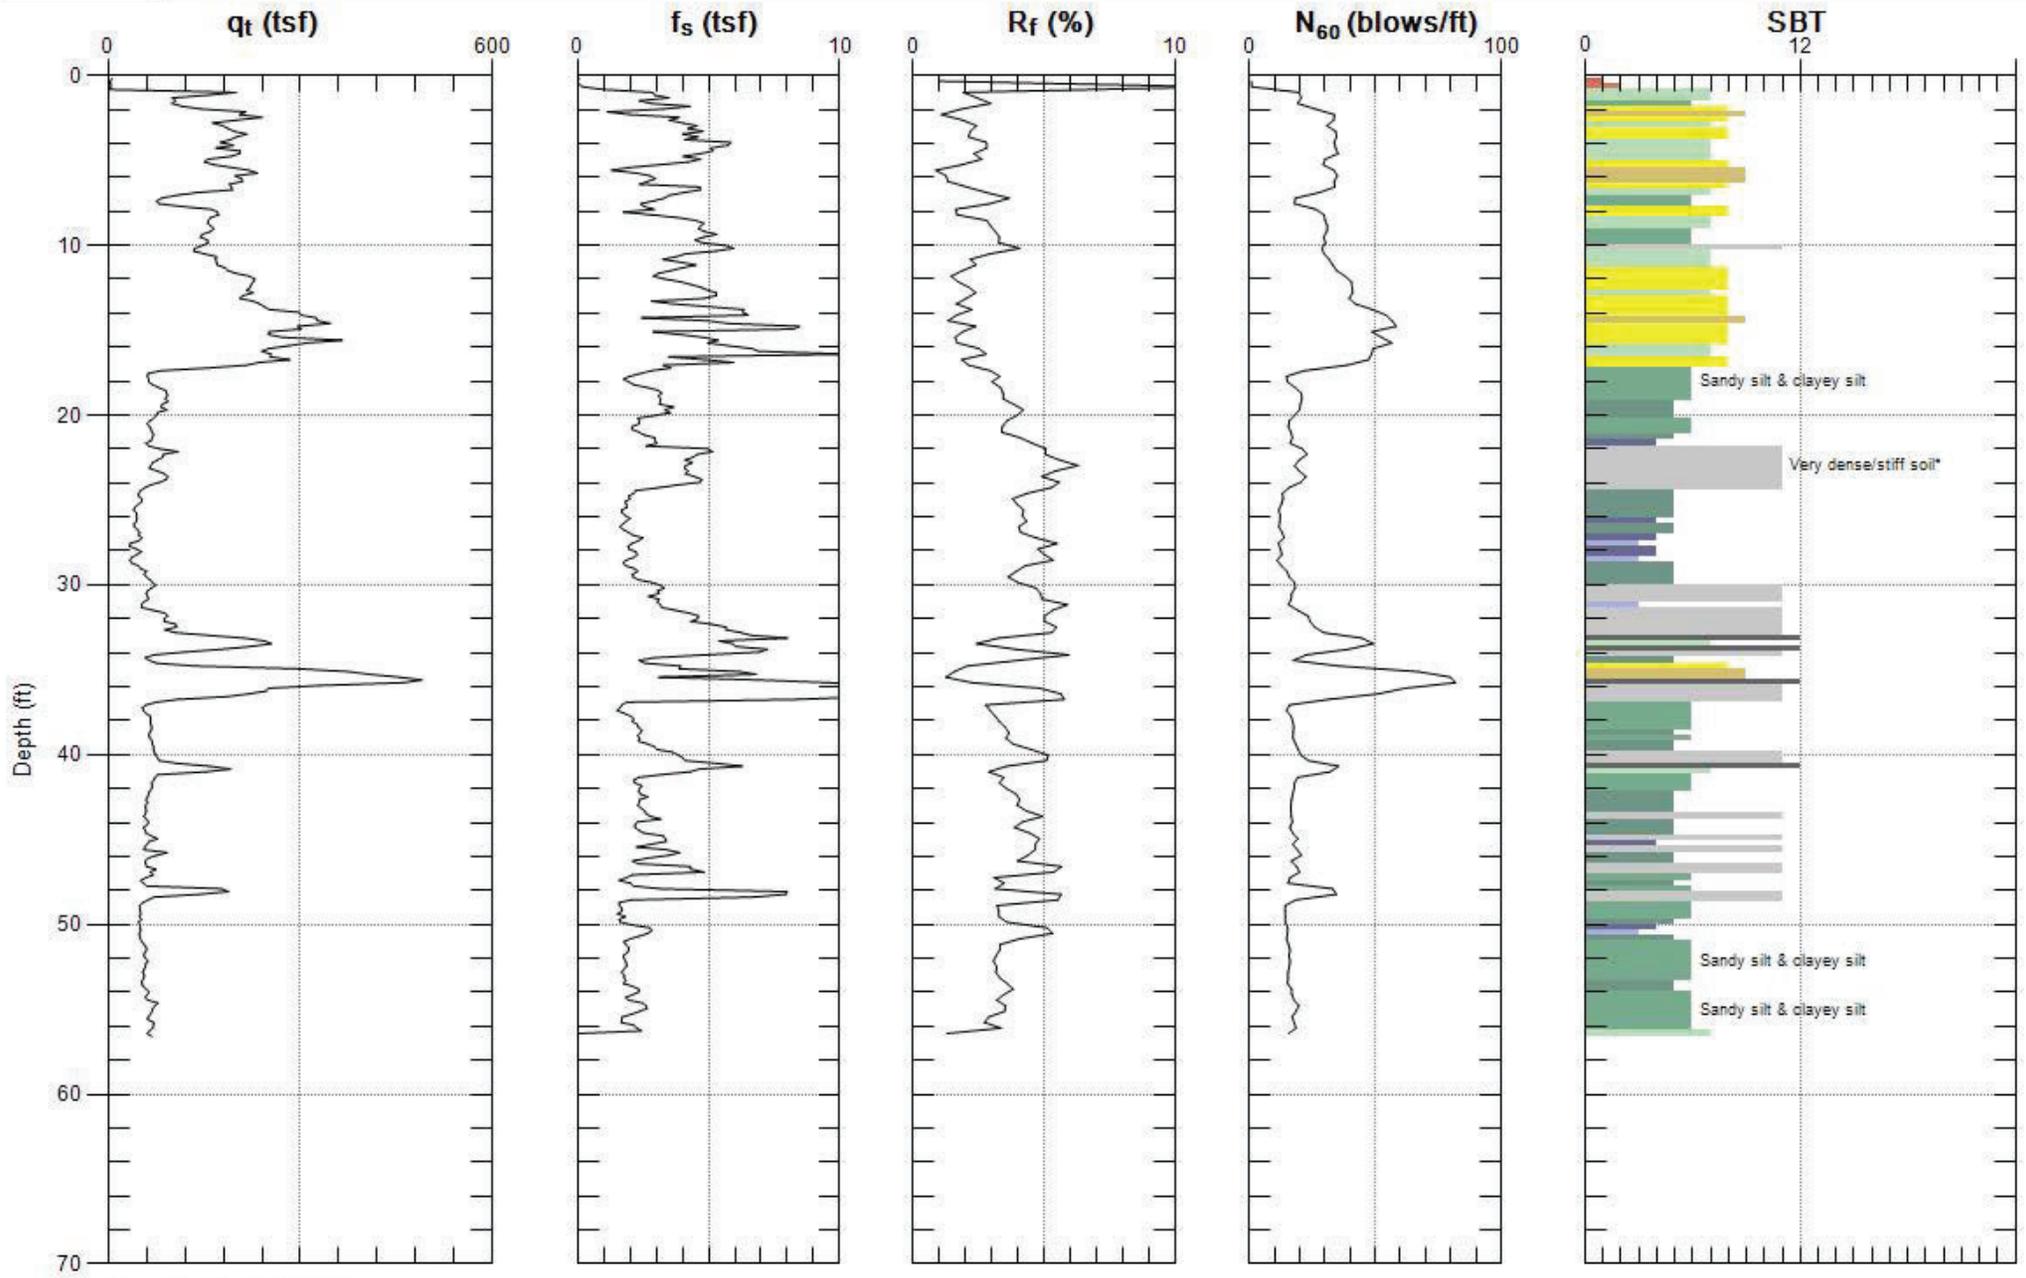
Figure A - 25

Max. Depth: 56.594 (ft)
Avg. Interval: 0.328 (ft)

SBT: Soil Behavior Type (Robertson 1990)

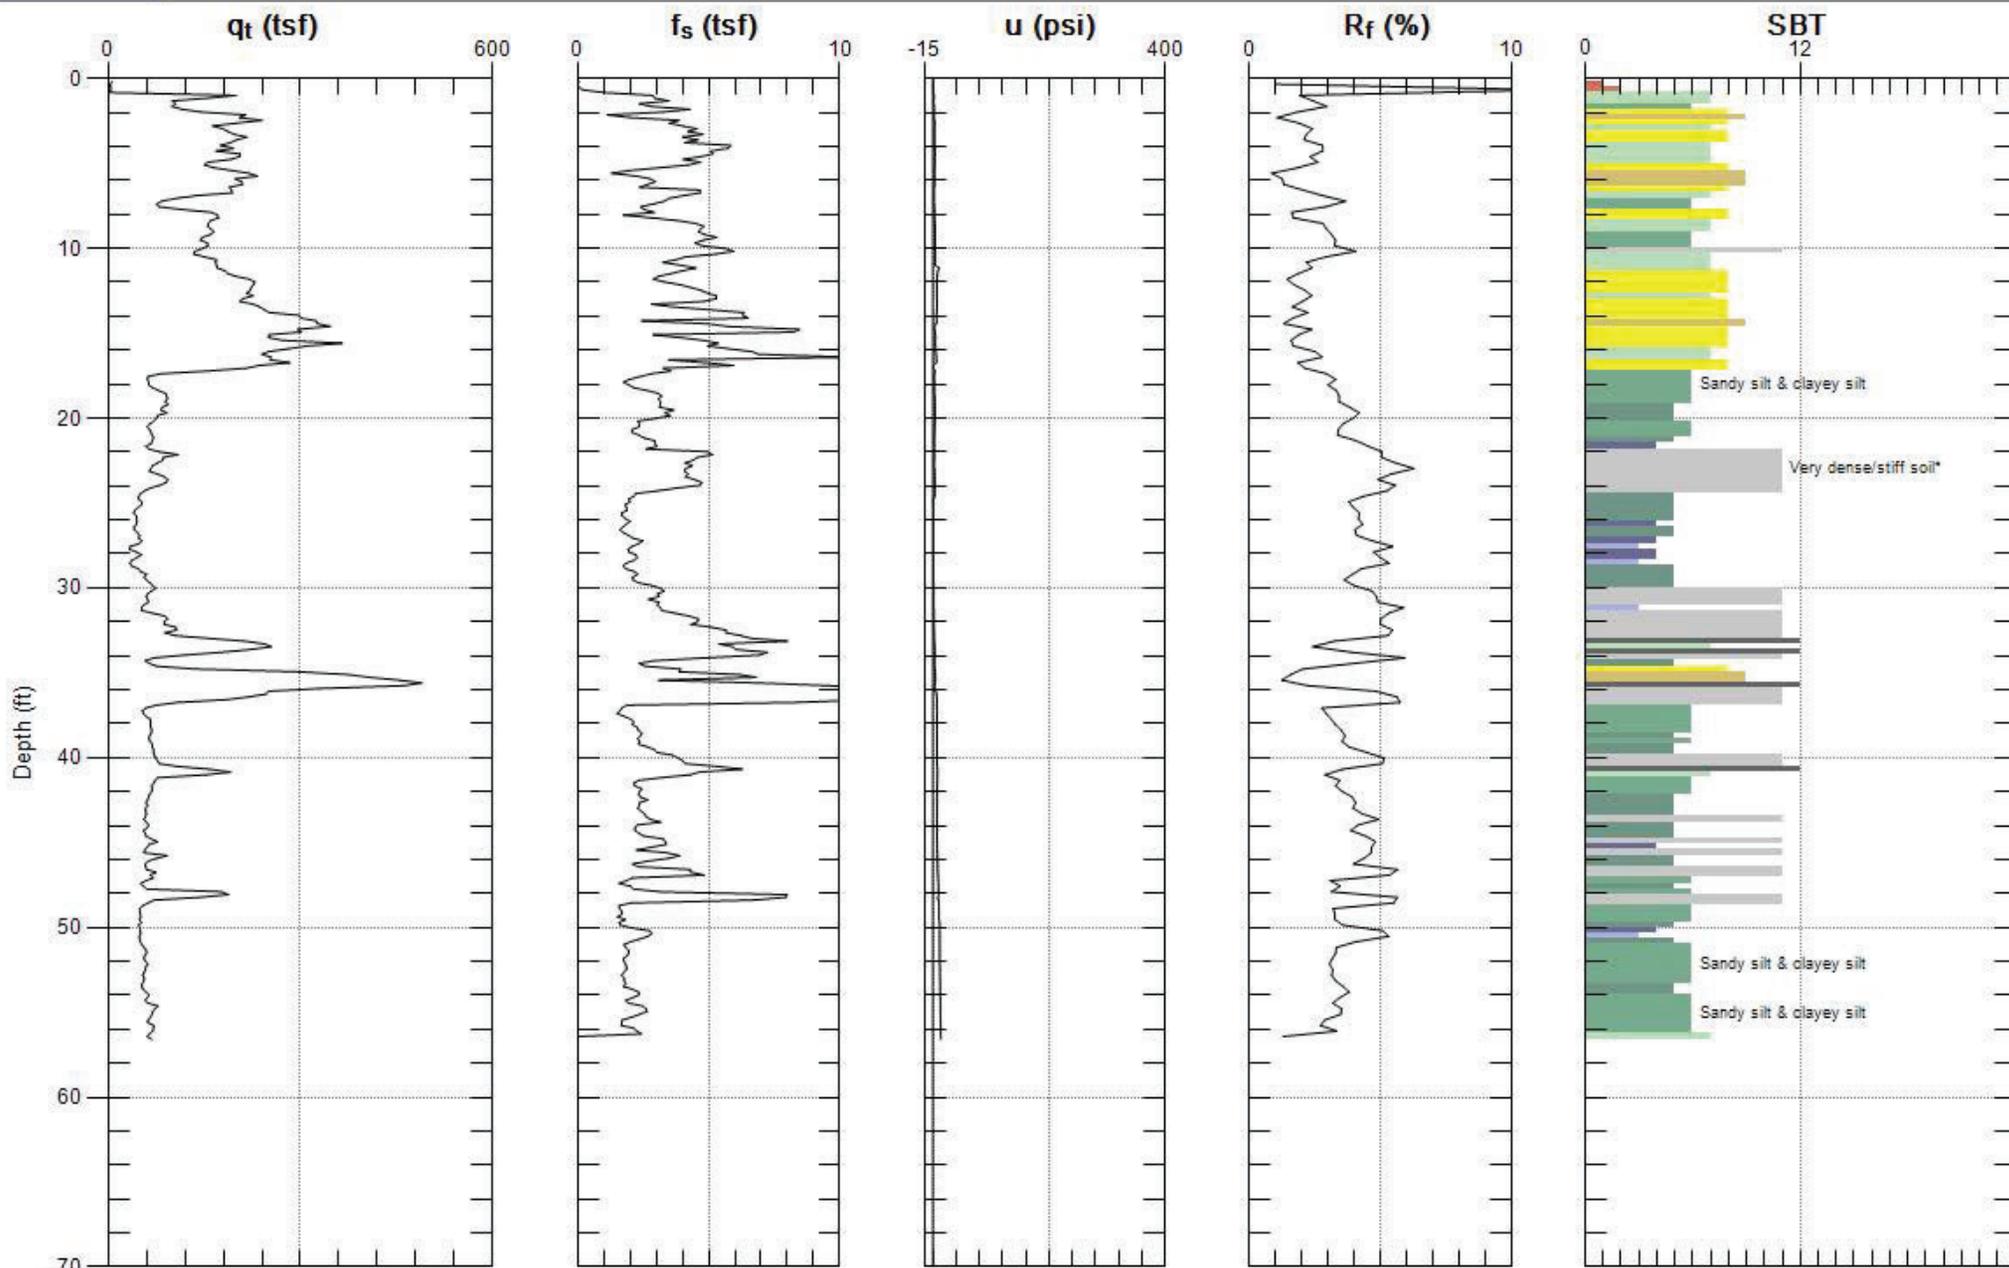
Figure A - 26

Max. Depth: 56.594 (ft)
Avg. Interval: 0.328 (ft)

SBT: Soil Behavior Type (Robertson 1990)

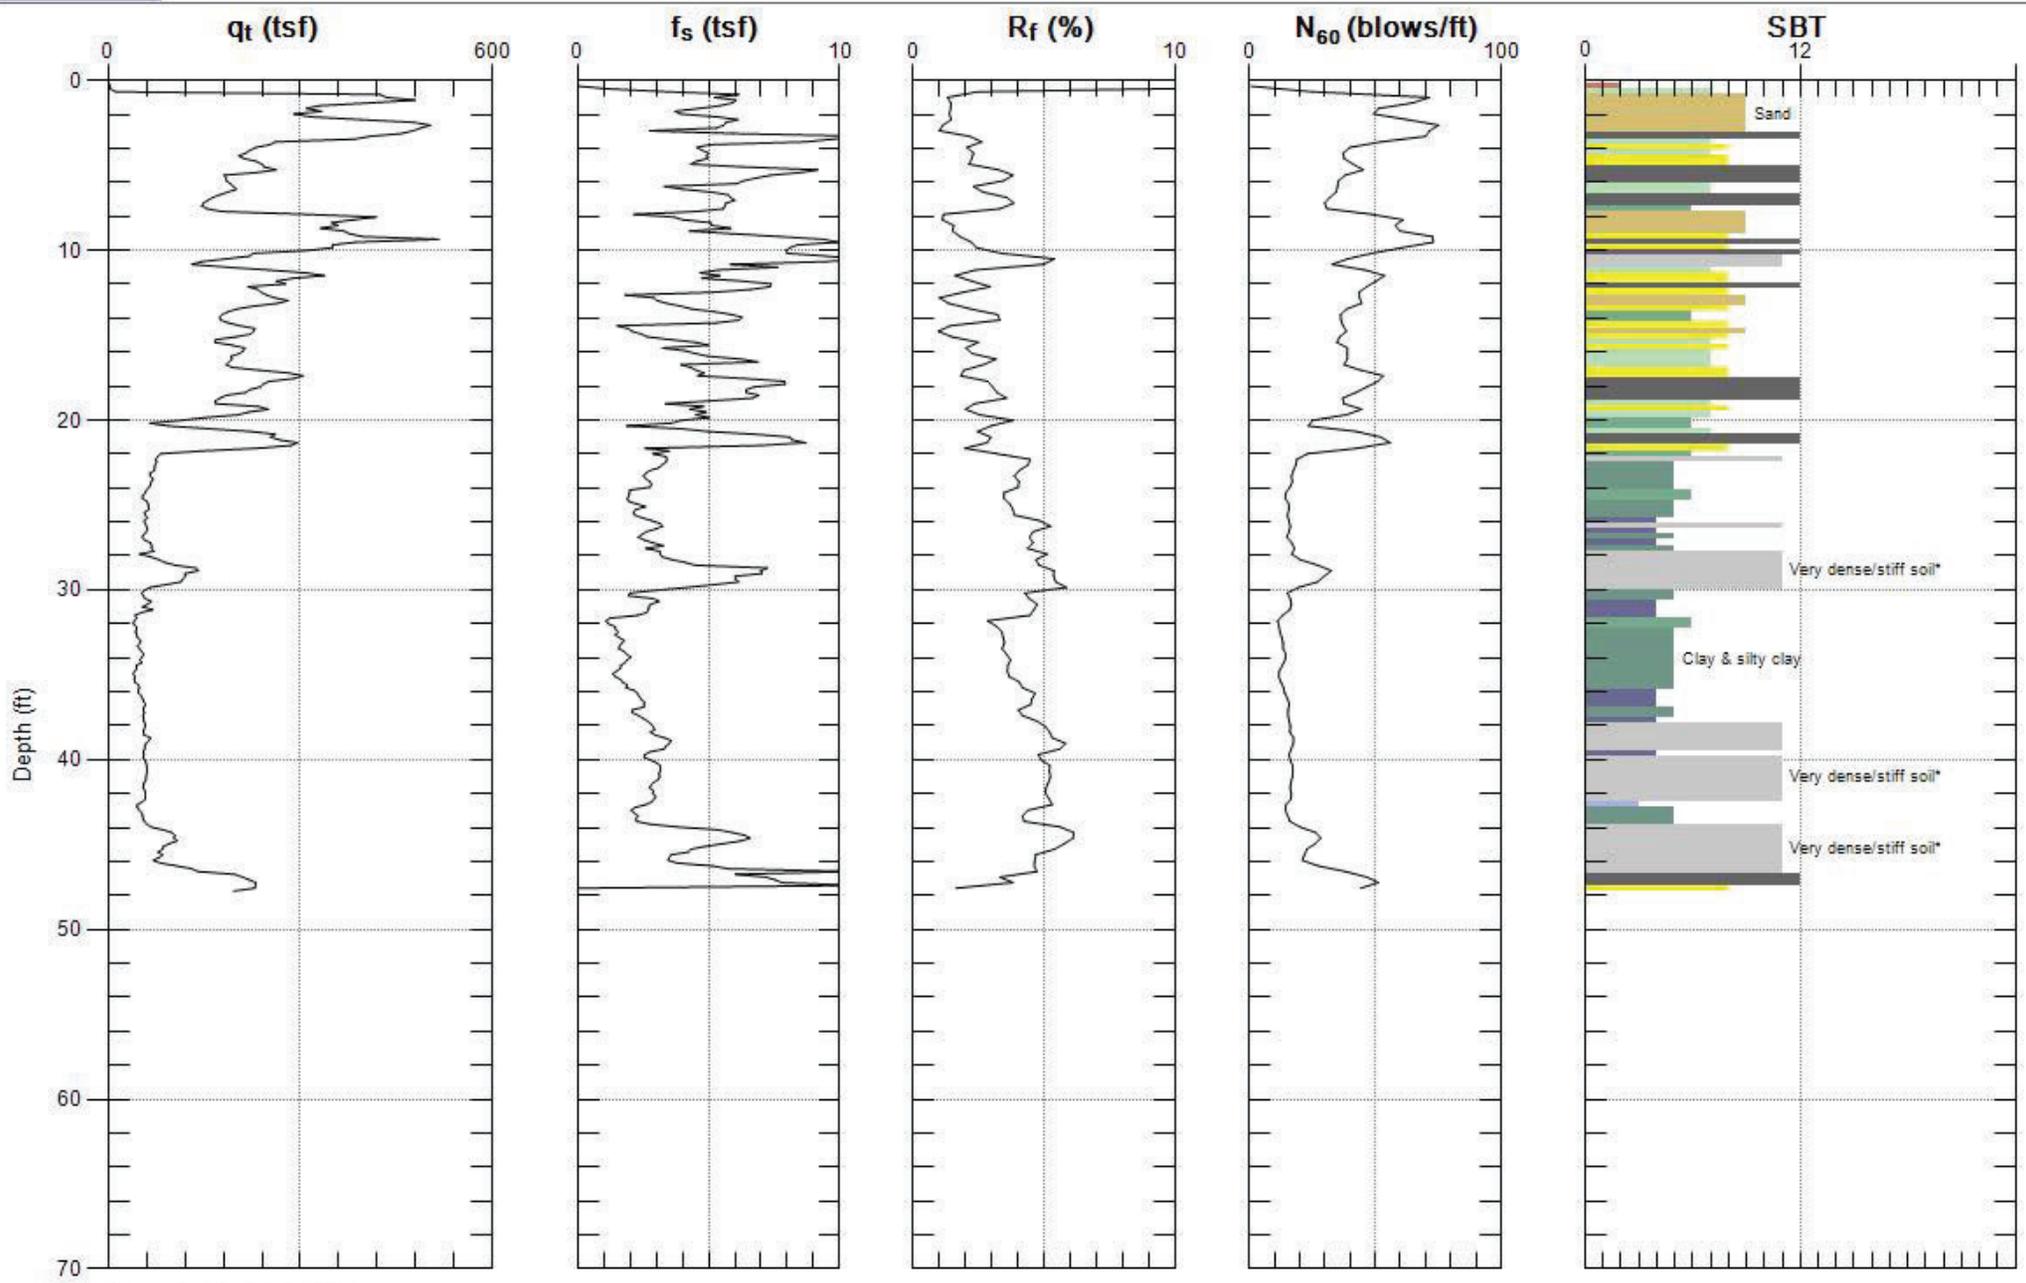
Figure A - 27

Max. Depth: 47.736 (ft)
Avg. Interval: 0.328 (ft)

SBT: Soil Behavior Type (Robertson 1990)
