**Update Geotechnical Feasibility Report
Proposed High-Rise Residential Development
6220 West Yucca Street
Hollywood District
Los Angeles, California**

**July 10, 2020
GDC Project No. LA-1461**

Subject: Updated Geotechnical Feasibility Report
Proposed High-Rise Residential Development
6220 West Yucca Street, Hollywood District, Los Angeles, California

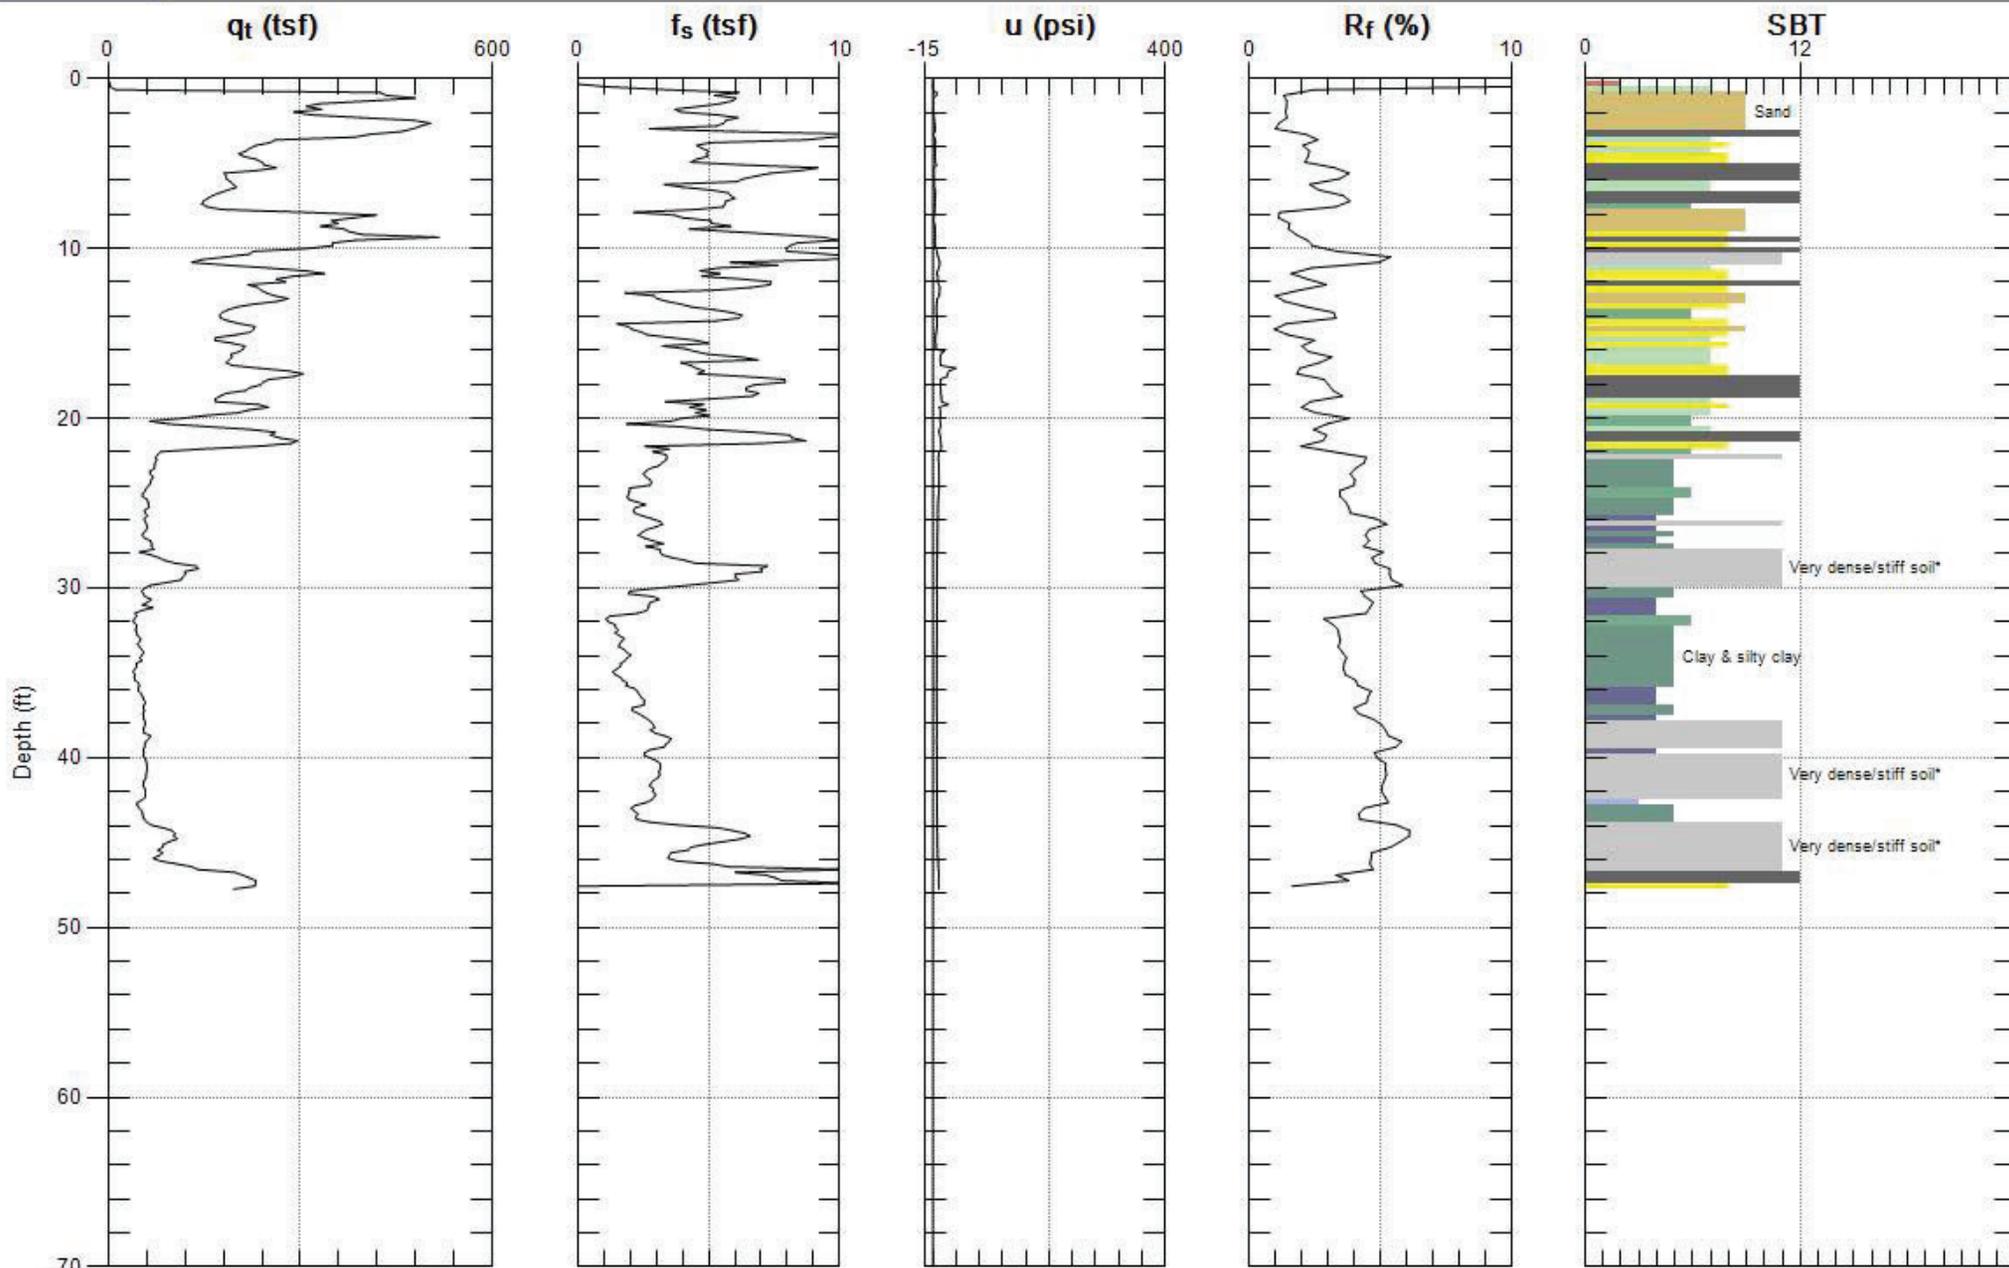
Figure A - 28

Max. Depth: 47.736 (ft)
Avg. Interval: 0.328 (ft)

SBT: Soil Behavior Type (Robertson 1990)
