# 88 Sunnyside Lane Residential Project, City of Orinda

## Alameda Whipsnake Habitat Assessment

# Geotechnical Investigation 88 Sunnyside Lane

88 Sunnyside Lane, Orinda, California

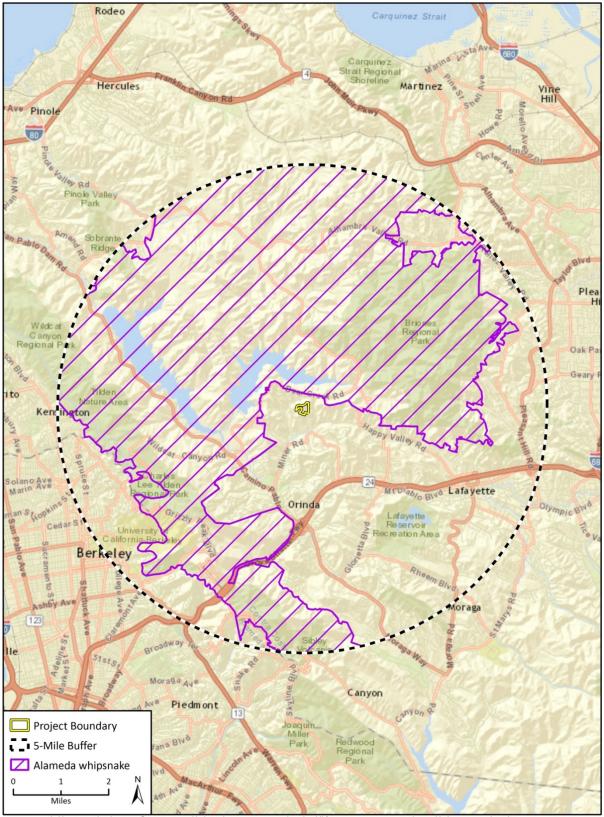
Figure 3 Alameda Whipsnake Critical Habitat

Imagery provided by ESRI and its licensors © 2017. Critical habitat data source: U.S. Fish and Wildlife Service, May, 2017. Final critical habitat acquired via the USFWS Critical Habitat Portal. It is only a general representation of the data and does not include all designated critical habitat. Contact USFWS for more specific data.

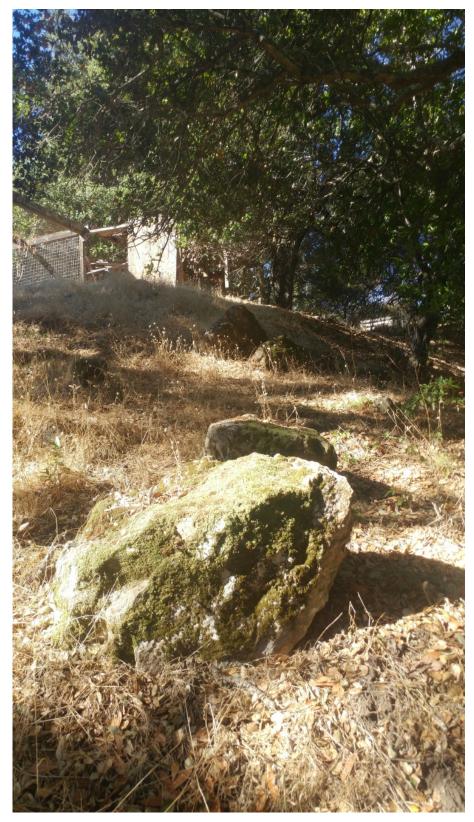
**Photograph 7.** Rock outcrop #1 southeast of former chicken coop, one with small mammal burrow at base. This rock outcrop is within an area determined to be suitable habitat.

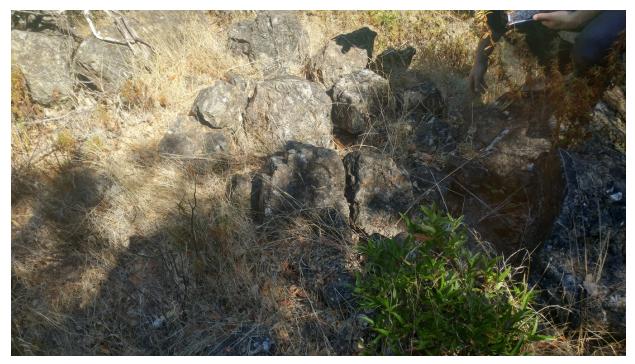
**Photograph 8.** Rock outcropping #2 located along ridge extending southeast from residence. Mixed oak woodland and non-native annual grasses predominate. This rock outcropping provides some refuge and crevices and a norther Pacific rattlesnake was observed here. This area was determined to provide suitable habitat.

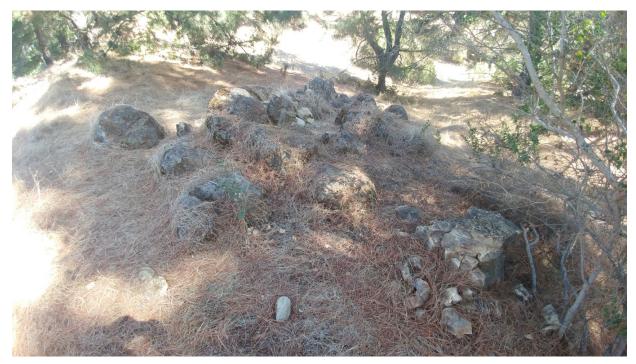
**Photograph 9.** Rock outcrop #3 located southwest of residence along edge of non-native annual grassland and oak woodland vegetation community area of the project site. No crevices or small mammal burrows present; however, this rock outcrop occurs in an area determined to be suitable habitat.

Toward the very southern edge of the property, a rocky outcrop stretches approximately 250 feet along the length of the top of a steeply sloped south-facing ridgeline (Attachment A, Photos 9 and 10; see Figure 4). The rock ridge offers deep crevices and connects shaded woodland areas with open grassland areas (Attachment A, Photos 11 and 12). Three other isolated rock outcrops were identified on the project site (Attachment A, Photos 7, 8 and 9; see Figure 4). Rock outcrop #1 consists of a collection of two small boulders (< 2 feet diameter or smaller). A small mammal burrow was present at the base of the larger rock, but no sign of mammal or reptile activity was observed. Rocks are located individually and no crevices are present. Rock outcrop #2 occurs at the top of a steep grassy slope and is surrounded by scrub brush and grassy vegetation. Crevices are present within the outcrop deep enough to provide suitable refugia for snakes and lizards. A single western fence lizard was observed at rock outcrop #2, which disappeared into a crevice upon detection. Rock outcrop #3 consists of small collection of rocks deeply embedded in the ground and partially covered in pine needle leaf litter. No crevices or small mammal burrows were observed.

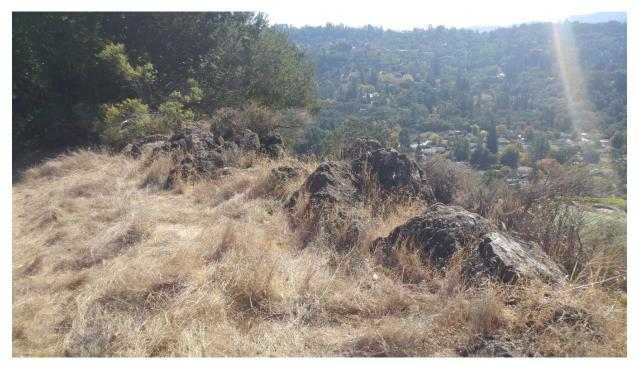
**Photograph 11.** Rock outcrop atop cliff edge at south-most end of project site. Western fence lizard sighted. Rock out cropping provides best available habitat potential for Alameda whipsnake.

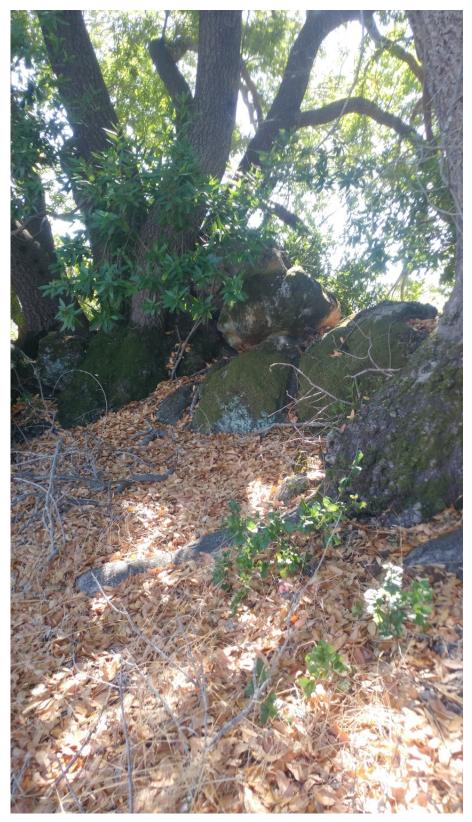
**Photograph 12.** View of rock outcrop (same as photo 9) taken from southeastern end of ridgeline and showing larger rocks and deeper crevices with opportunity for Alameda whipsnake refugia. Northern Pacific rattlesnake observed in this area.

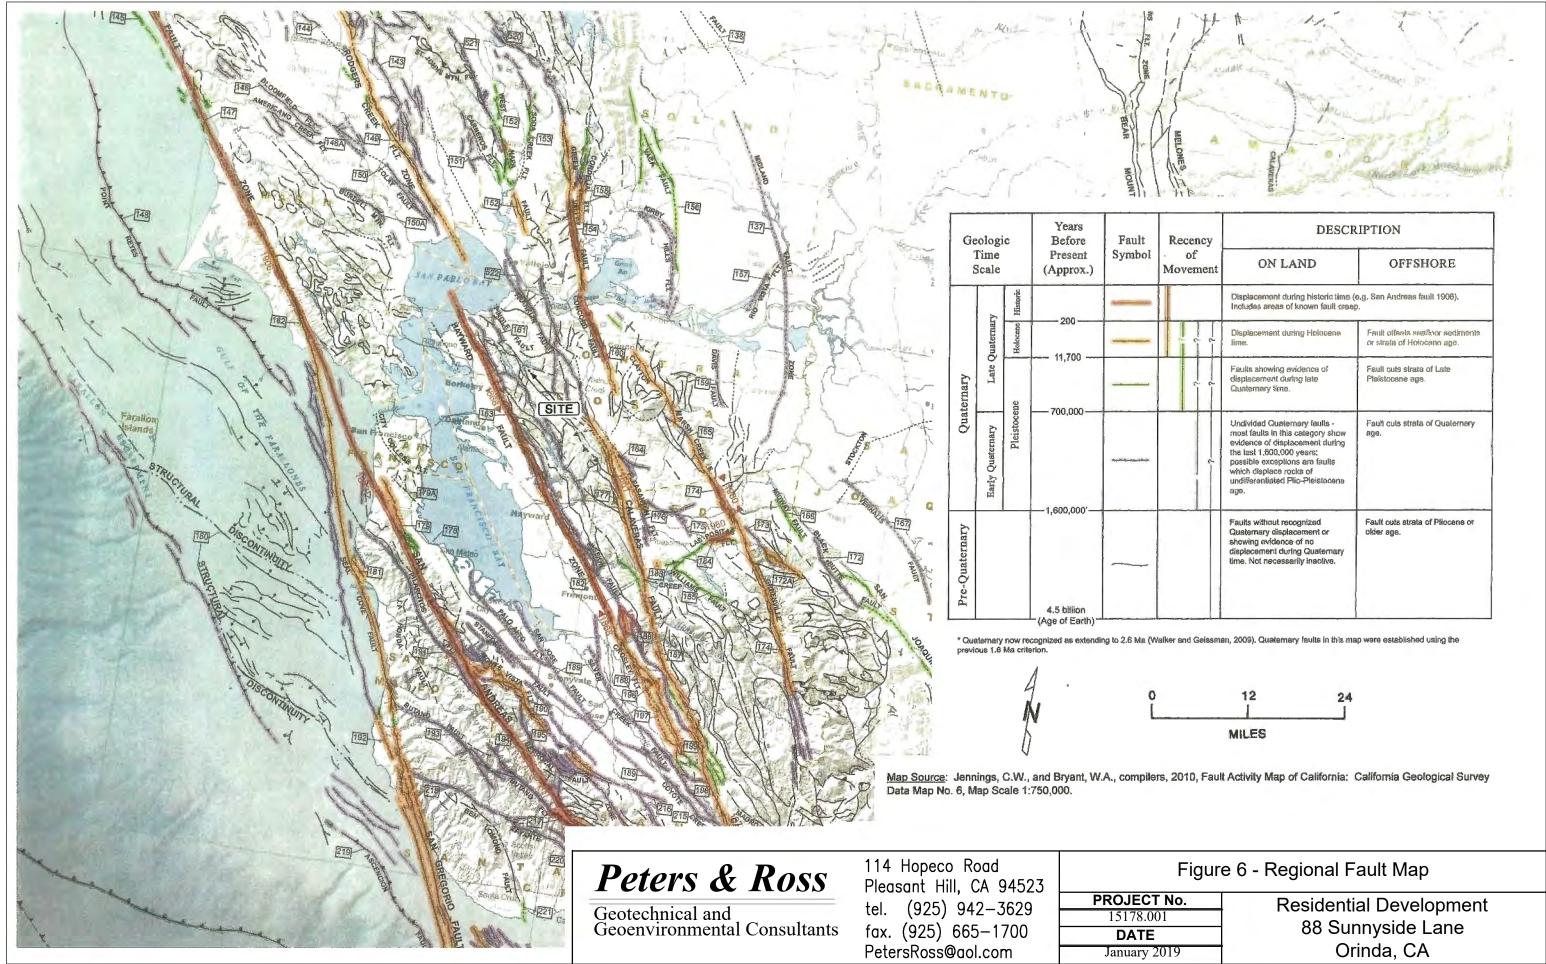
Figure 6 - Regional Fault Map

Recency		DESCRIPTION		
o Move	f	ON LAND	OFFSHORE	
ľ		Displacement during historic time (e.g. San Audreas fault 1906). Includes areas of known fault creep.		
Î	1 - 2	Displacement during Holocene Jime.	Fault offents seafloor addimenta or strate of Holocano age.	
	2	Faults showing evidence of displacement during late Quatemary time.	Fault cuts strate of Late Plaistocene age.	
	6	Undivided Quatemary faults - most faults in this category show evidence of displacement during the last 1,600,000 years; possible exceptions ara faults which displace rocks of undifferentiated Plic-Pleistocene age.	Fault cuis strate of Qualemery age.	
		Faults without recognized Quatemary displacement or showing evidence of no displacement during Quatemary time. Not necessarily inactive.	Fault cuts strata of Pliocene or older age.

The San Francisco Bay area is dominated by the northwest-striking, strike-slip San Andreas fault and related seismically active faults, such as the Calaveras, Concord – Green Valley, Greenville – Marsh Creek – Clayton, Hayward – Rodgers Creek, and Seal Cove – San Gregorio fault zones as shown on Figure 6 (Jennings and Bryant, 2010). The site is not within an Alquist-Priolo Earthquake Fault Zone as designated by the State of California for faults that have been active in Holocene time (Hart and Bryant, 1997). No faults have been mapped as passing through the property (Dibblee, 1980 and 2005; and Haydon, 1995). The closest State of California Alquist-Priolo Earthquake Fault Zone is located approximately 4.5 miles to the west for the Holocene active Hayward fault (Jennings and Bryant, 2010). The closest major non-Holocene active fault to the property is the Pinole fault, located approximately 0.75 miles to the southwest (Dibblee, 1980 and 2005; and Haydon, 1995).

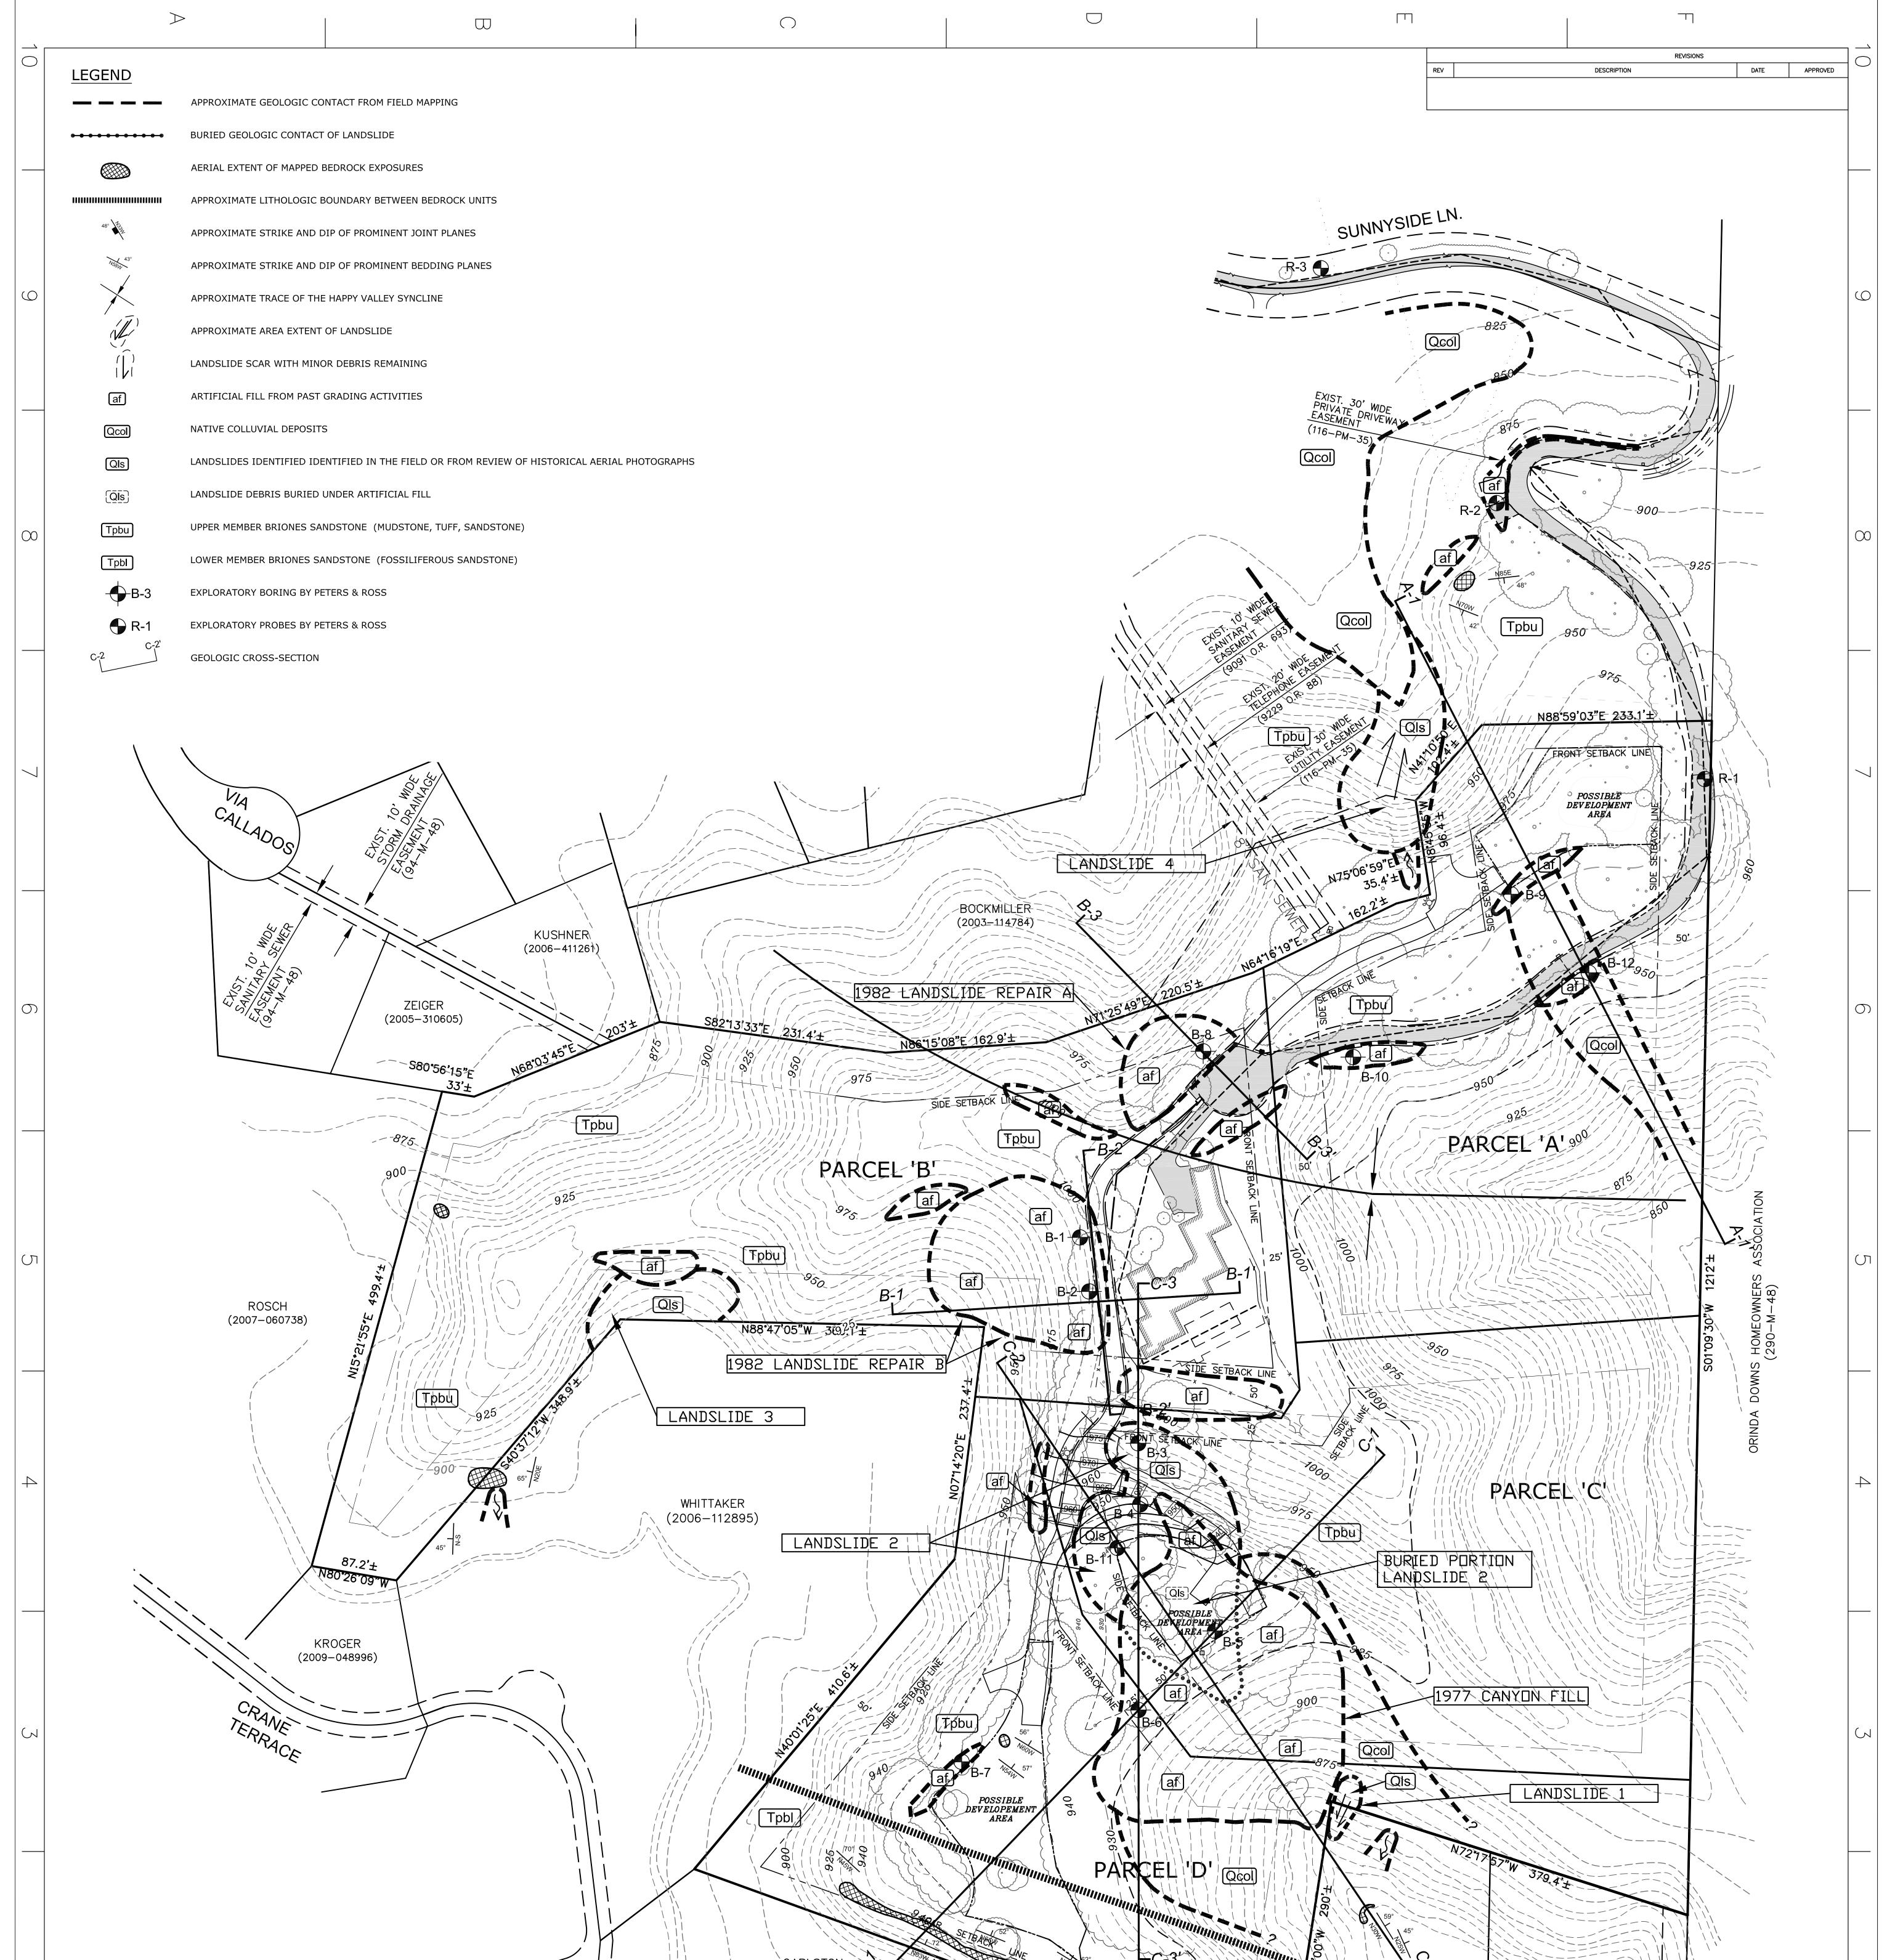
10°05′13°W 640 640 Tpbl 48° 48°	MAGNUSSEN (2003-436616)	AGNUSSEN
				Peters & Ross	PLATE 1
GRAPHIC SCALE 60 0 30 60 120 ( IN FEET ) 1 inch = 60 ft.	240			Geotechnical and Geoenvironmental Consultants 114 Hopeco Road Pleasant Hill, CA 94523 tel. (925) 942-3629 fax. (925) 655-1700 PetersRoss@aol.com	SITE GEOLOGIC MAP 88 SUNNYSIDE LANE, ORINDA CA 94563
1  inch = 60  ft.				Drawn By: C. Flores	Project No.: 15178.001Prepared For:Mr. Keith B. Stone Diamond Construction, IncScale: AS NOTEDDate: 1/25/19Sheet: 1 of
$\geq$	$\square$	$\cap$

Landslide 4 shown on Plate 1 lies outside of the proposed development area and is mostly offsite. The existence of this landslide has not been confirmed by subsurface investigations because it is located offsite. To mitigate this landslide, we recommend that the northwest side of the driveway hammer head be supported by a row of stitch piers as described below for the recommended 1982 Landslide Repair A mitigation. In addition, we recommend that all drainage for the development area and driveway be directed toward the major east-flowing drainage as shown in Figure 5.

Peters & Ross recommends that the 1982 Landslide Repair B Area shown on Plate 1 be removed down to Elevation 965 and rebuilt with geogrid reinforced engineered fill. The engineered fill should be keyed and benched into the underlying bedrock with subsurface drainage as part of the project grading. A typical key and bench detail is included on the attached Figure 7.

Peters & Ross explored subsurface conditions at the site by drilling twelve exploratory test borings to a maximum depth of 43 feet and three 5-foot-deep auger probes. The locations of the exploratory test borings are shown on Plate 1.

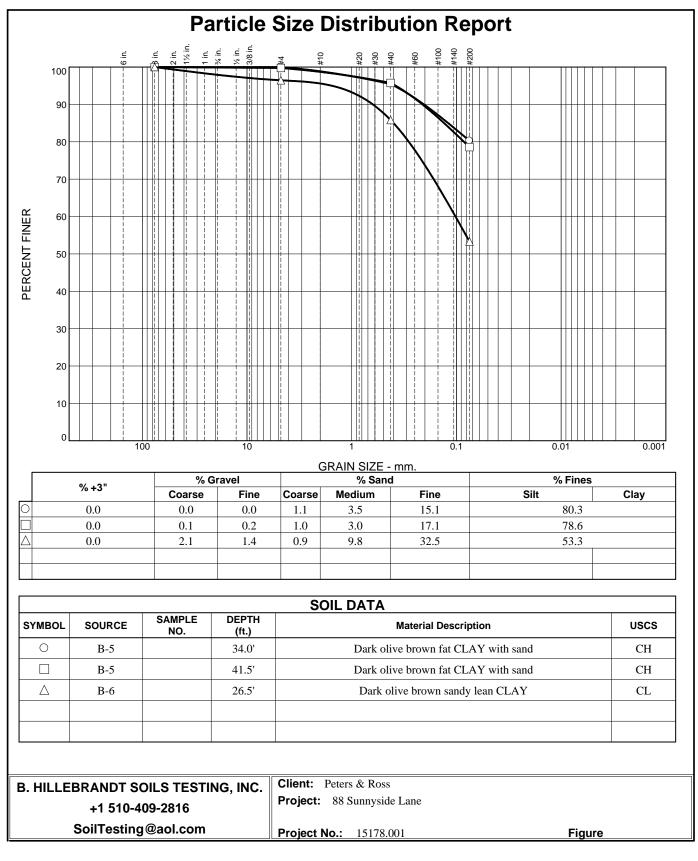
Client: Peters & Ross Project: 88 Sunnyside Lane Project Number: 15178.001 Location: B-5 Depth: 34.0' Material Description: Dark olive brown fat CLAY with sand USCS: CH Tested by: BH

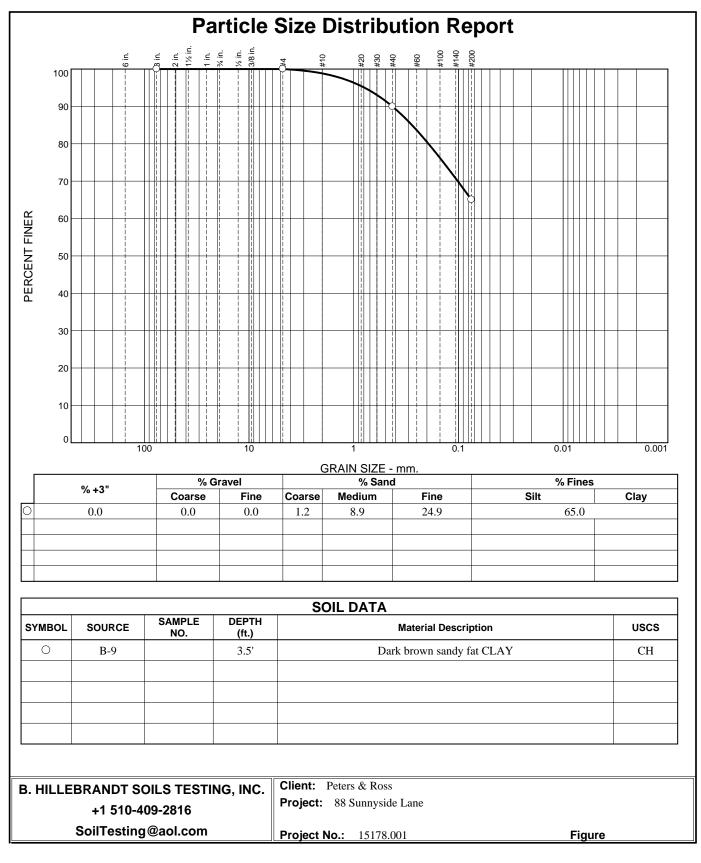
#### LIQUID AND PLASTIC LIMIT TEST DATA 12/19/2018 Client: Peters & Ross Project: 88 Sunnyside Lane Project Number: 15178.001 Location: B-9 **Depth:** 3.5' Material Description: Dark brown sandy fat CLAY **%<#40:** 89.9 **%<#200:** 65.0 USCS: CH **AASHTO:** A-7-6(25) Tested by: BH Liquid Limit Data Run No. 1 2 3 4 5 6 Wet+Tare 27.54 24.16 29.05 Dry+Tare 21.32 19.09 22.10 Tare 11.22 11.04 11.26 # Blows 32 25 19 Moisture 64.1 61.6 63.0 64.8 63 Liquid Limit= \_ 64.4 22 Plastic Limit= \_\_\_\_ 3 41 Plasticity Index= \_ 64 16.4 Natural Moisture= \_ 63.6 Liquidity Index= \_ -0.1 63.2 63.2 Woisture 62.4 62 61.6 61.2 60.8 9 10 8 20 25 30 40 6 Blows Plastic Limit Data Run No. 1 2 3 4 Wet+Tare 18.59 17.69 Dry+Tare 17.26 16.57 Tare 11.32 11.26 Moisture 22.4 21.1 Natural Moisture Data Wet+Tare Dry+Tare Tare Moisture 259.9 229.1 41.1 16.4 \_ B. Hillebrandt Soils Testing, Inc. \_

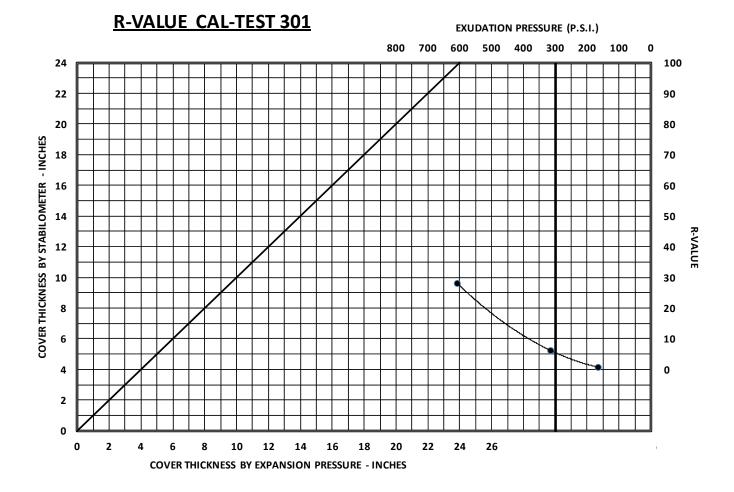
Job Name: <u>88 Sunnyside Lane</u>	Job No: <u>10089</u>
Sample Description: <u>Very dark brown silty clay</u>	Sample No: <u>R-3</u>
Source:	Date: <u>2018.11.19</u>
Client Name: <u>Peters &amp; Ross, Project No. 15178.001</u>	Sampled: <u>client</u> Tested: <u>BR/MR</u>

Exudation psi	Compaction (psi)	Expansion (0.0001")	Expansion (psf)	Moisture %	Dry Density	Resistance Value
608	196	5	22	18.9	108.4	28
315	112	0	0	22.3	99.6	6
166	103	0	0	27.8	91.0	1

Remarks:	Resistance Value
-	5

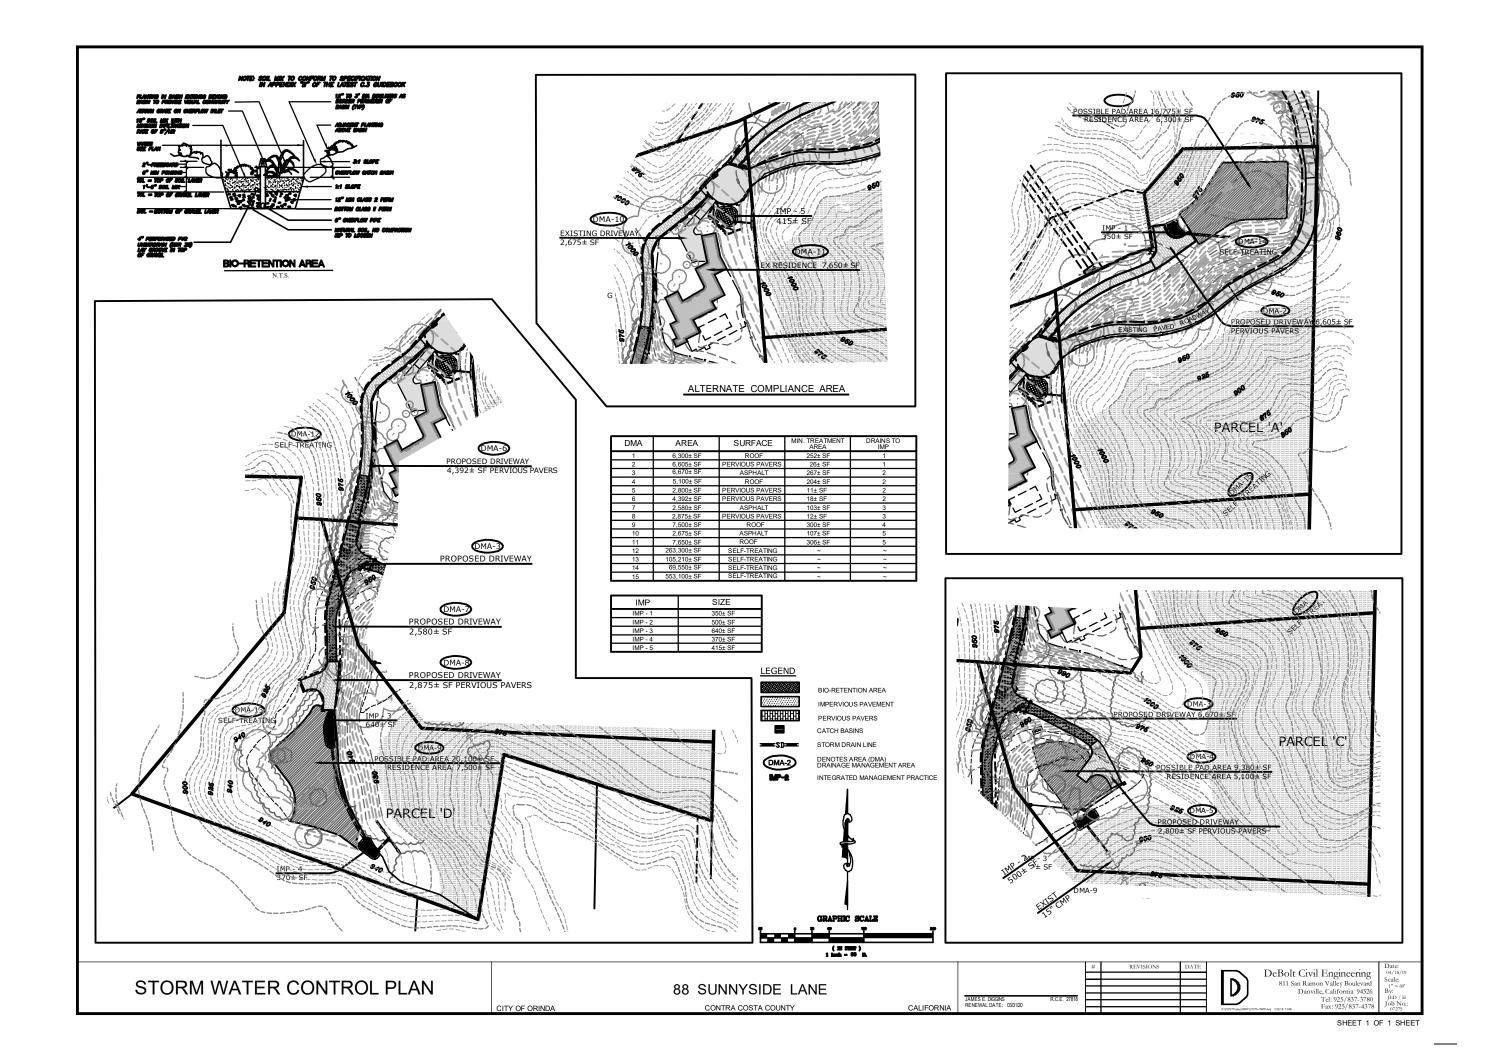
#### NOTE: SOIL MIX TO CONFORM TO SPECIFICATION IN APPENDIX "B" OF THE LATEST C.3 GUIDEBOOK
