## **Appendix G: Geotechnical For**

## WESTMINSTER, EAST GARDEN GROVE FLOOD RISK MANAGEMENT STUDY

## September 2019

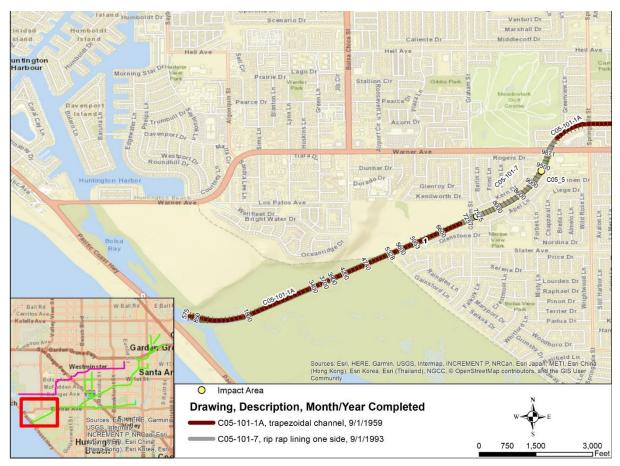
Figure 2. Pre-project impact area locations, reach 1

As shown in Figure 2, Channel 05 was initially completed in September of 1959 and consisted mainly of earth trapezoidal channels lined with rip rap. In Sep 1993 a portion of reach 1 rip rap was repaired.

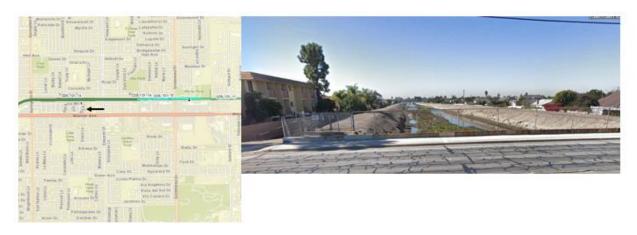
Figure 6. C05, Reach 1, Edwards looking west, example without project.

Though the levee is now with project south and west of Warner Avenue, an example of the levees for Channel 05, which would be how the levees south and west of Warner would have looked prior to project, are shown in Figure 6.

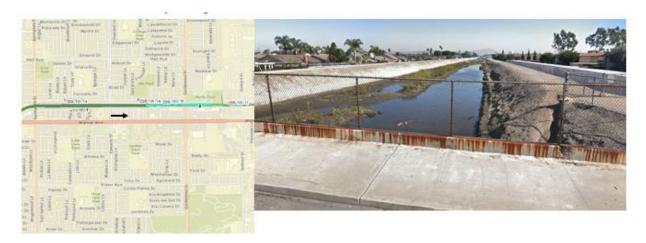
Figure 7. C05, Reach 1, Edwards looking east, example without project.

Figure 7 shows another view of the levees without project. In this case there is considerable erosion of the levee. Though analyses in this report will show that the gradients are low, there were no inspection reports available as part of this study. This adds to the uncertainty regarding the resilience of the levee system. There is, however, a history of repairs to the levees due to sloughing that coincides with flooding events.

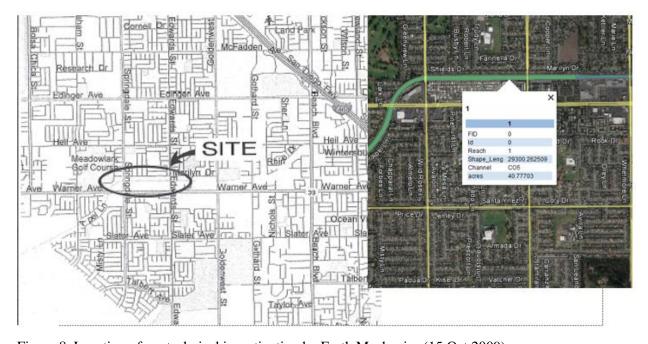
Figure 8. Location of geotechnical investigation by Earth Mechanics (15 Oct 2009)

Figure 8 shows the location of an investigation by Earth Mechanics (15 Oct 2009). This is from Station 101+00 to 151+25. Station 151+25 is very close to the end of reach 1. These investigations are used to evaluate the condition of the levees and foundations.

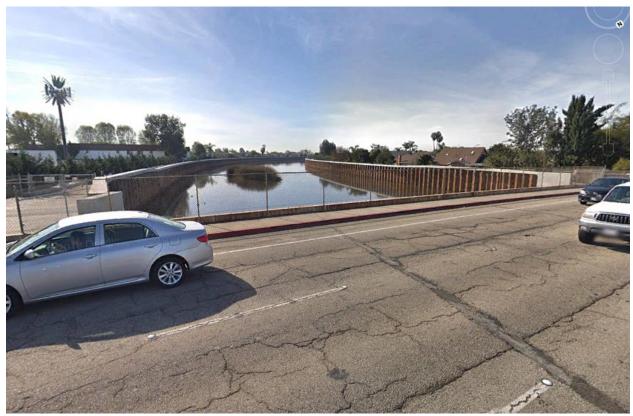
Figure 11. Warner looking southwest, example with project

Figure 11 shows the project condition. From Warner Avenue and the C05 Channel (Reach 1), there is adequate protection against breach because of the double sheetpile walls on both sides of the channel. However, this is a portion of the channel system that is with project.

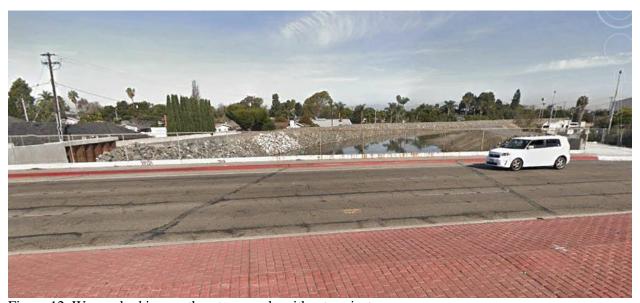
Figure 12. Warner looking northeast, example without project.

Figure 12 shows upstream of Warner on the C05 channel there are stone lined trapezoidal channels, which represents the case without project. Plans to improve this channel are located in drawing C05-101-14, which are dated Apr 2010. However these plans have yet to be implemented.

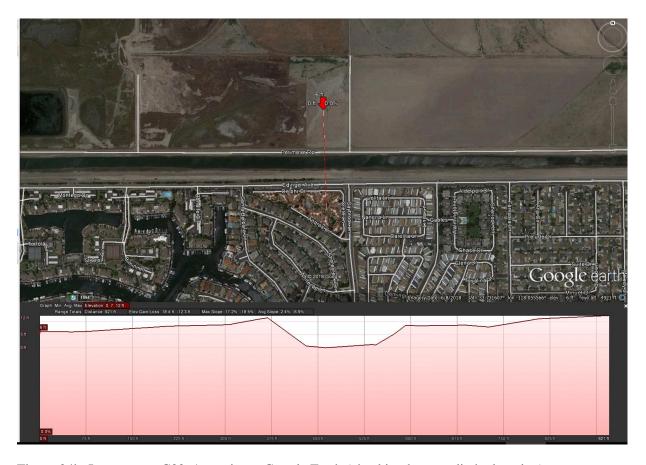
Figure 24b. Impact area C02\_1, section – Google Earth (checking bottom ditch elevation)
