Appendix E
Geotechnical Investigation Report, Fault Rupture Hazard
Investigation Report

Appendix E.1
Geotechnical Investigation Report

**FAULT RUPTURE HAZARD INVESTIGATION
PROPOSED I-15 LOGISTICS CENTER
LYTLE CREEK ROAD
FONTANA AREA
SAN BERNARDINO COUNTY, CALIFORNIA
PREPARED FOR
CAPROCK PARTNERS
JOB NO. 14176-8**

FAULT RUPTURE HAZARD INVESTIGATION
PROPOSED I-15 LOGISTICS CENTER PROJECT
LYTLE CREEK ROAD
FONTANA AREA
SAN BERNARDINO COUNTY, CALIFORNIA
PREPARED FOR
CAPROCK PARTNERS
JOB NO. 14176-8

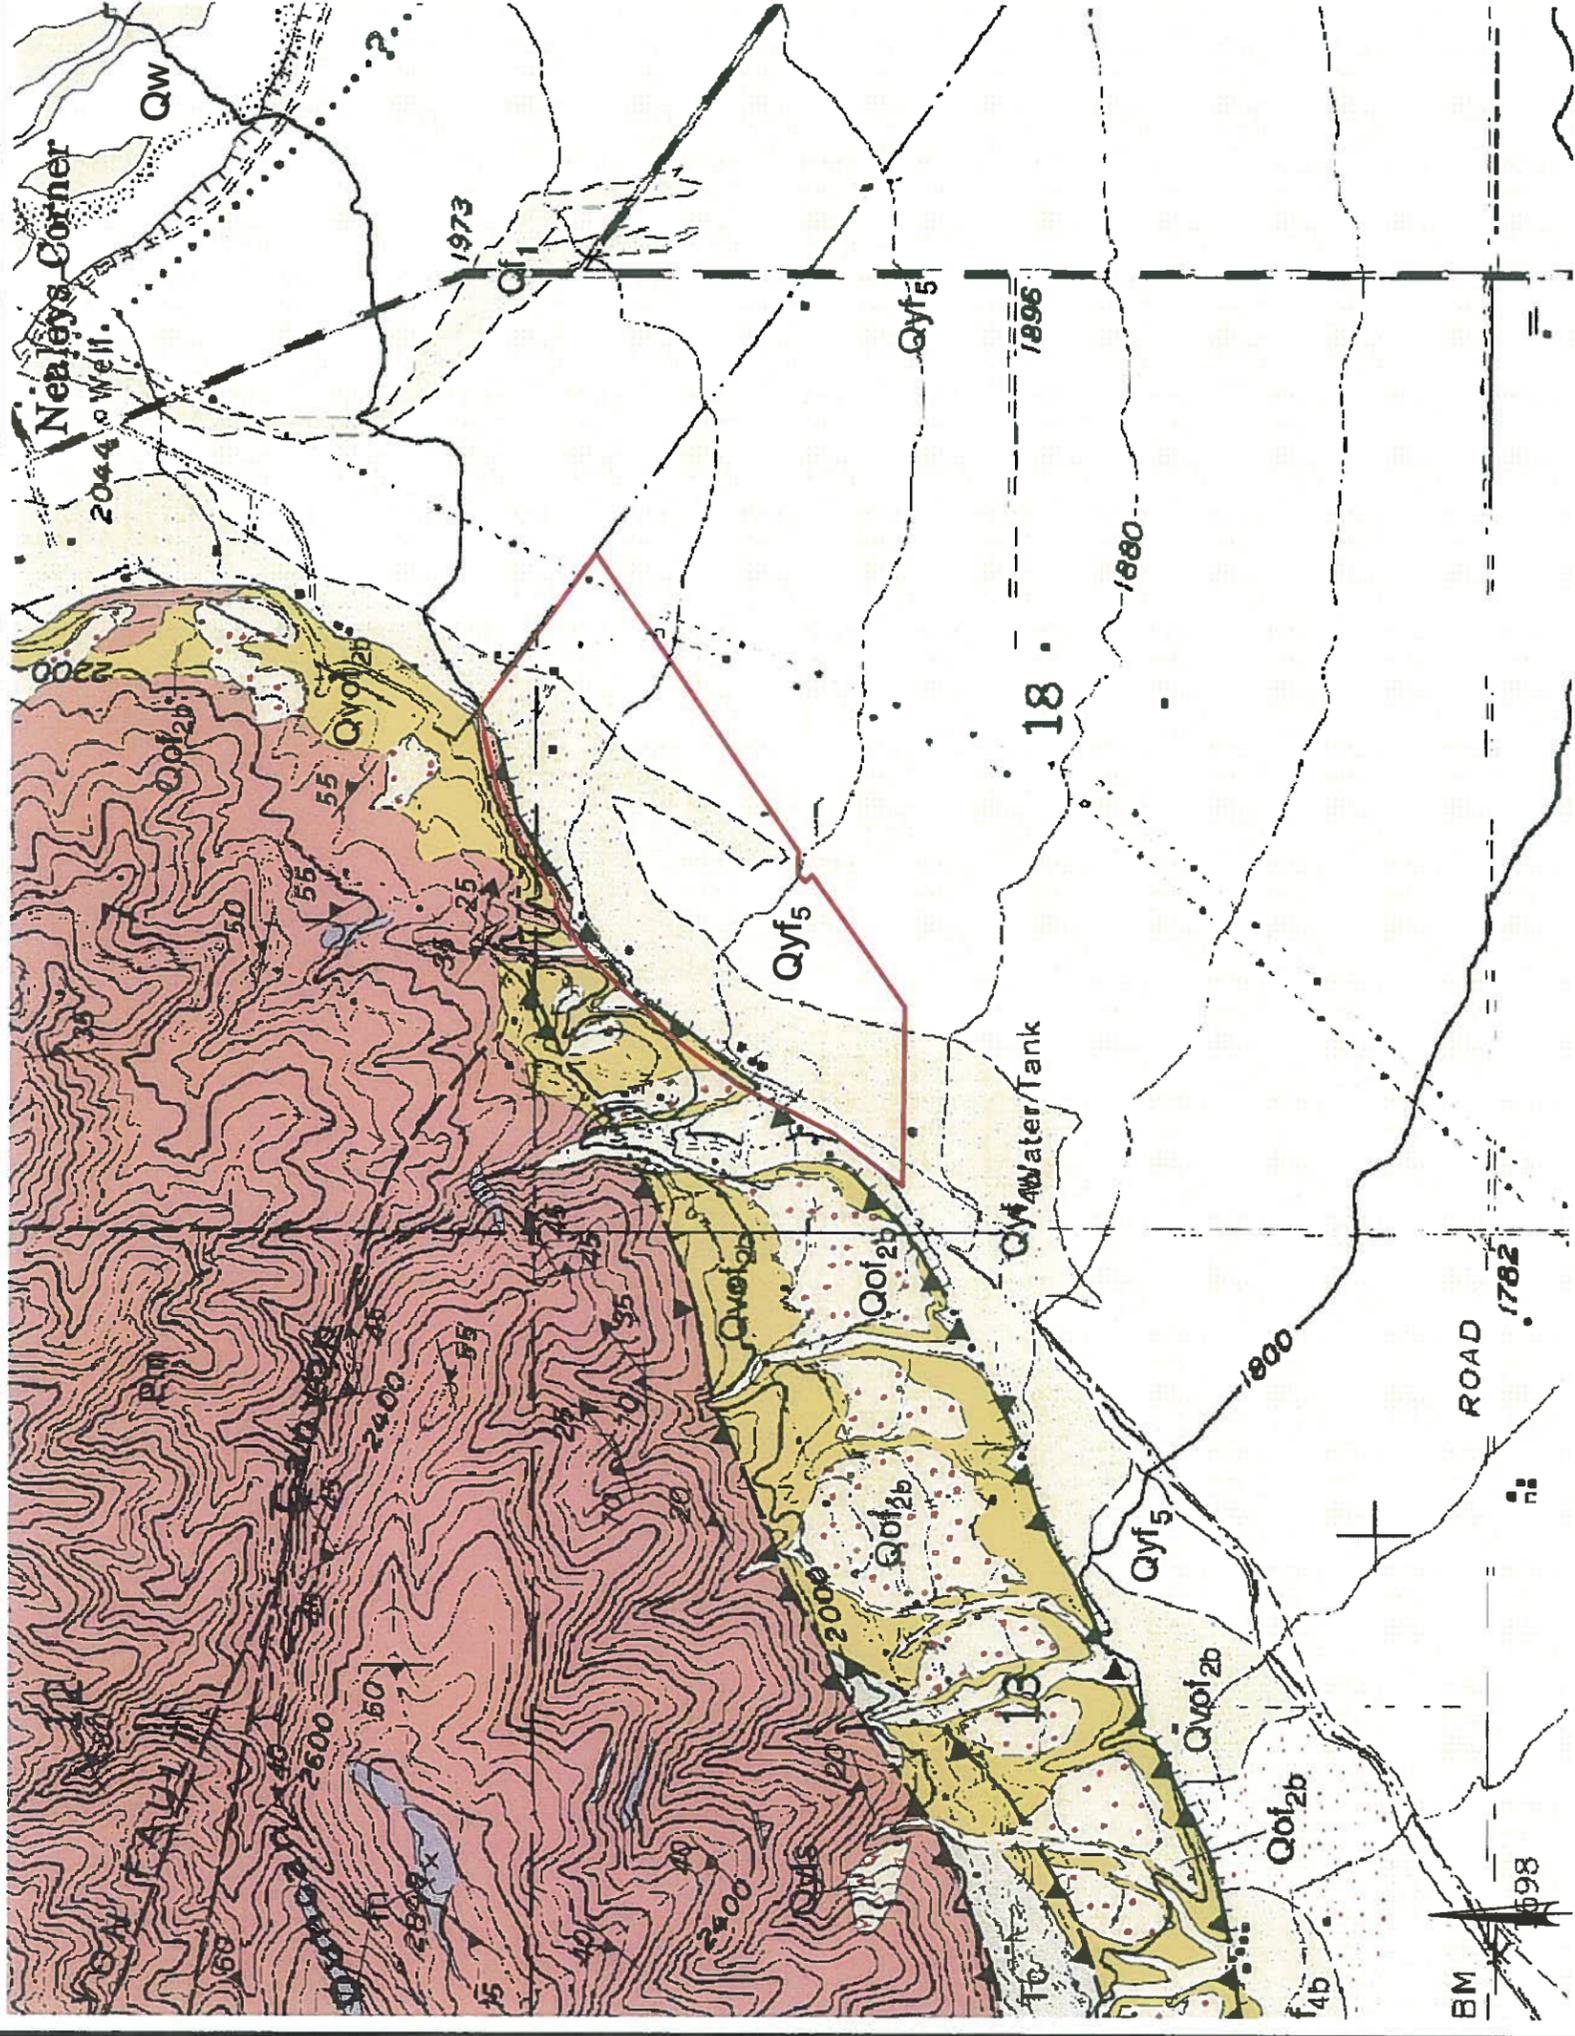
GEOLOGIC INDEX MAP

(Base Map: Morton, D.M. and Matti, J.C., 2001)

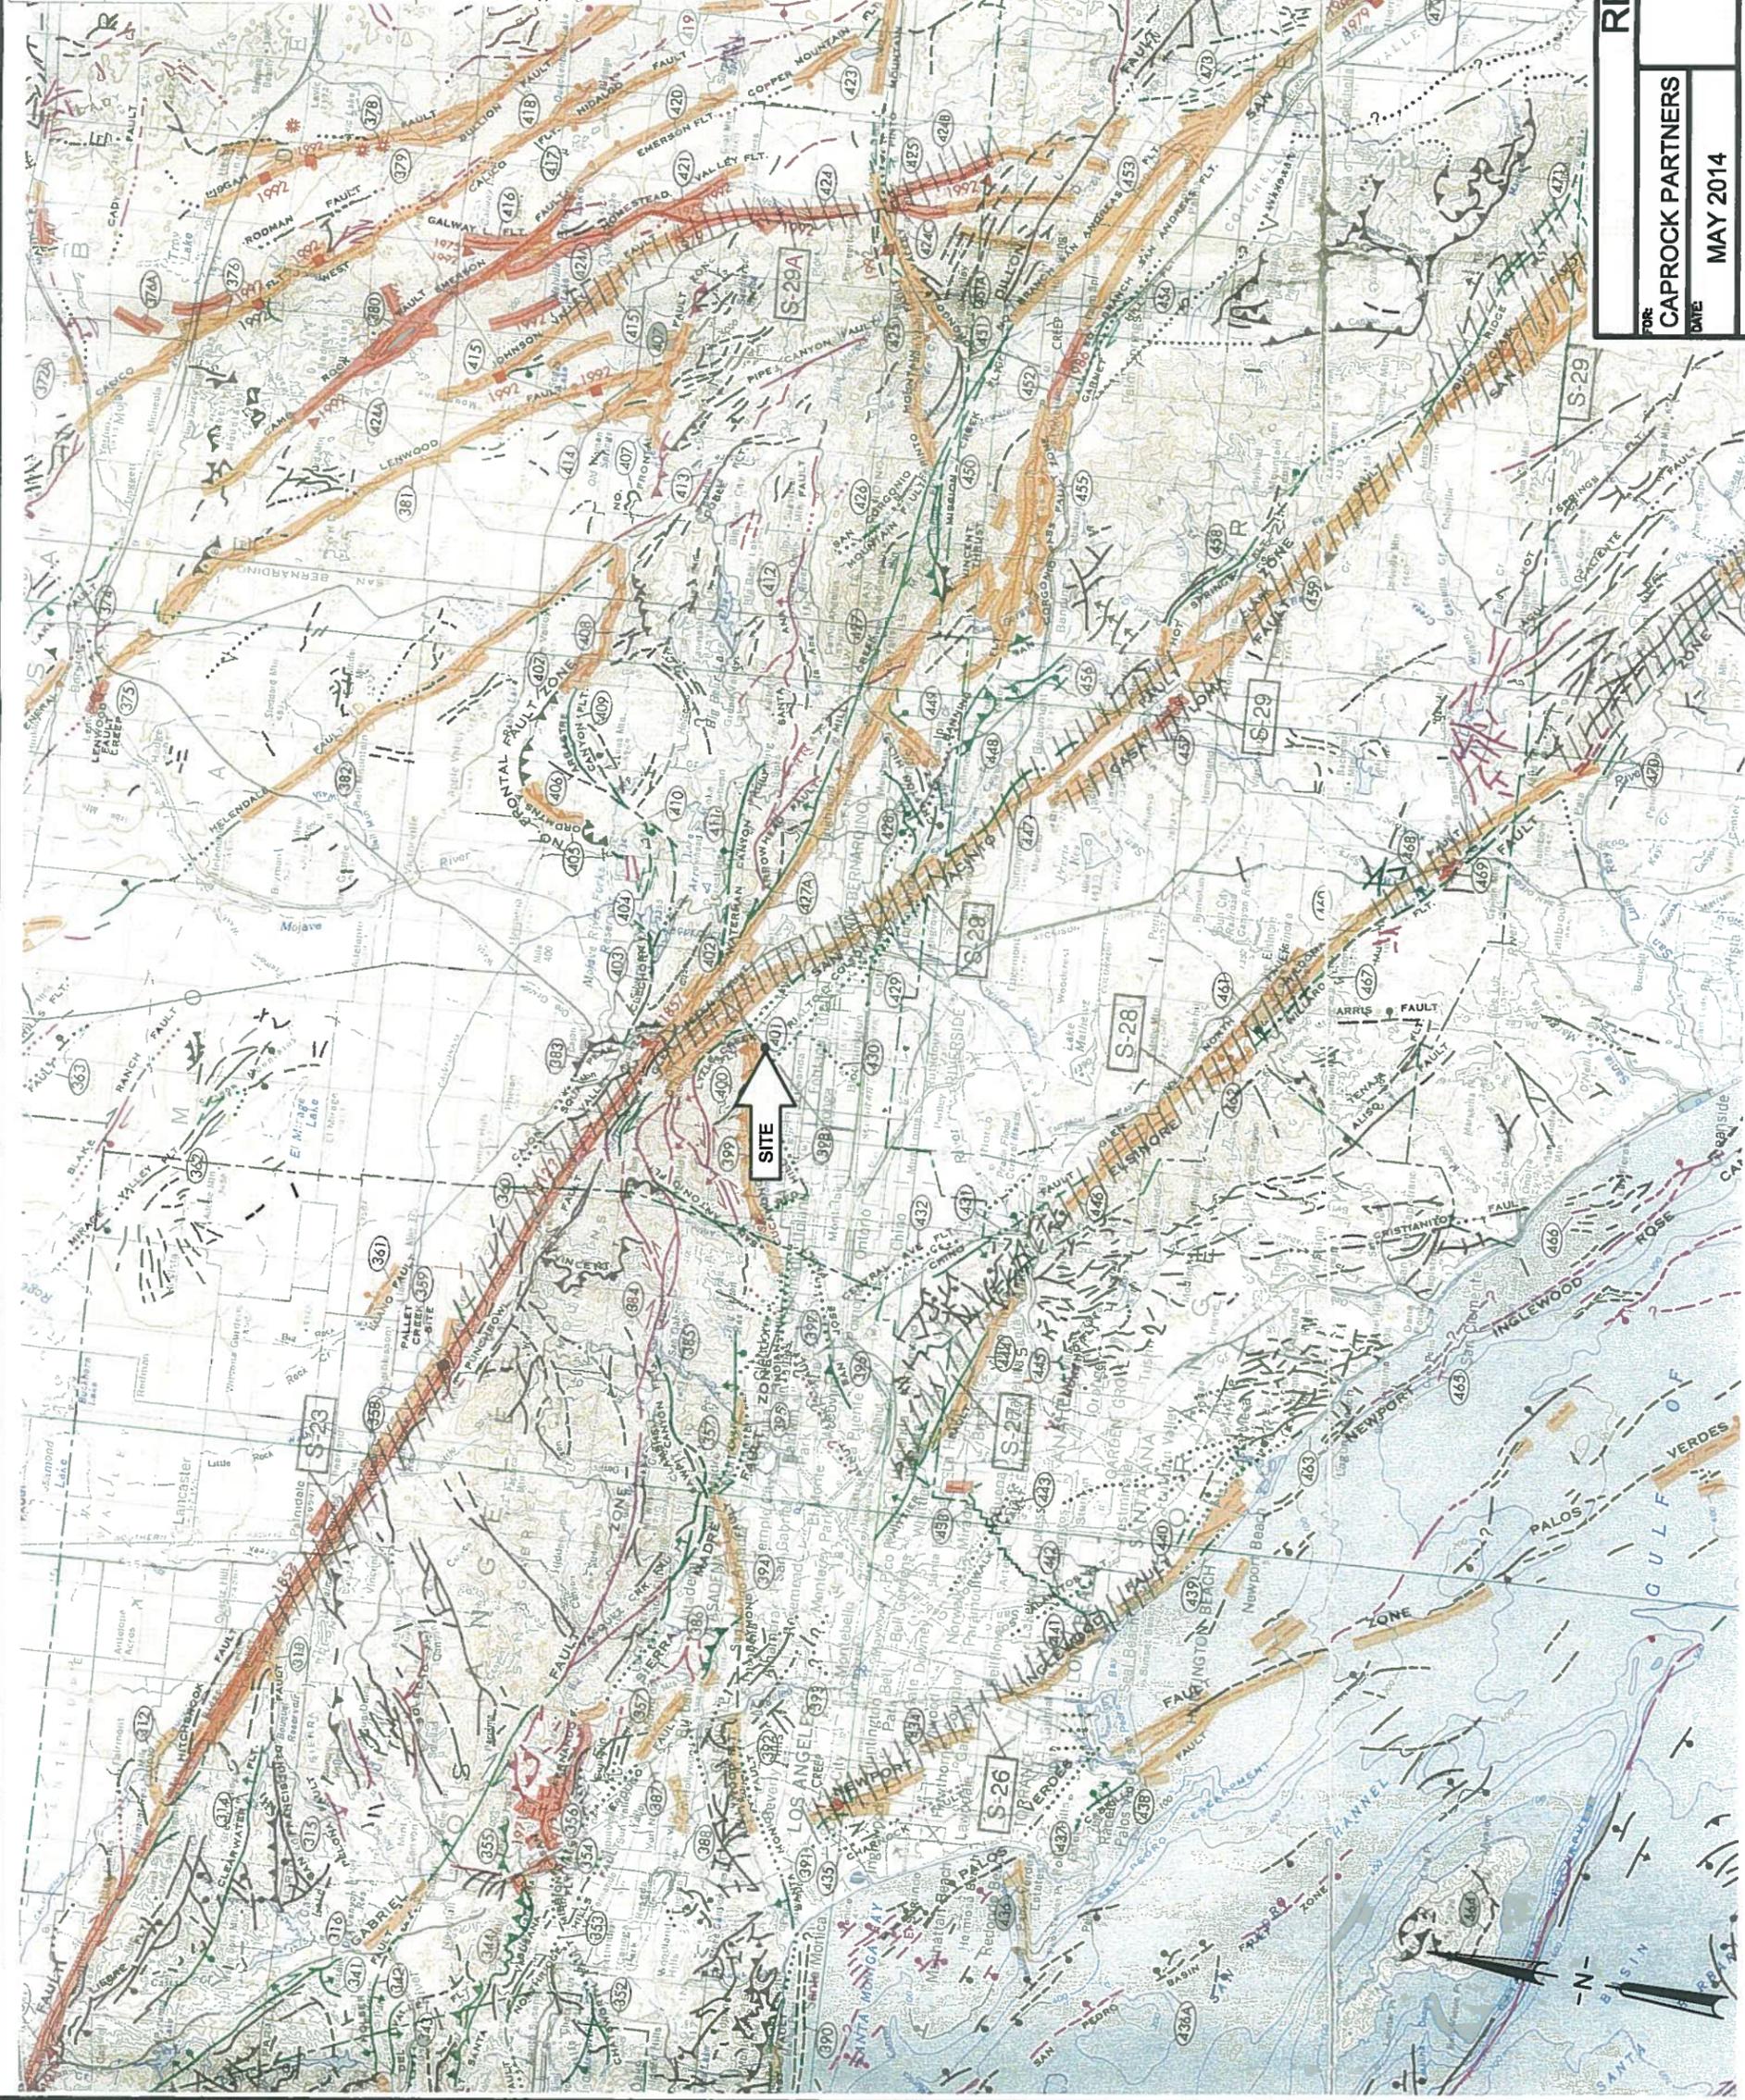
REGIONAL FAULT MAP

Geologic Time Scale	Years Before Present (Approx)	Fault Symbol	Recency of Movement	DESCRIPTION	
				ON LAND	OFFSHORE
4-billion (Age of Earth)				Displacement during tectonic time (e.g. San Andreas fault 196).	Offshore
Quaternary				Displacement during Holocene time	
	700,000			Faults showing evidence of displacement during late Quaternary time	
	10,000			Individual Quaternary faults - most faults in this category show evidence of displacement during the last 10,000 years, possible exceptions are faults which displace blocks of undifferentiated Pleistocene age	
	100,000			Faults showing evidence of displacement during late Quaternary time	
	1,000,000			Faults showing evidence of displacement during late Quaternary time	
	10,000,000			Faults showing evidence of displacement during late Quaternary time	
	100,000,000			Faults showing evidence of displacement during late Quaternary time	
	1,000,000,000			Faults showing evidence of displacement during late Quaternary time

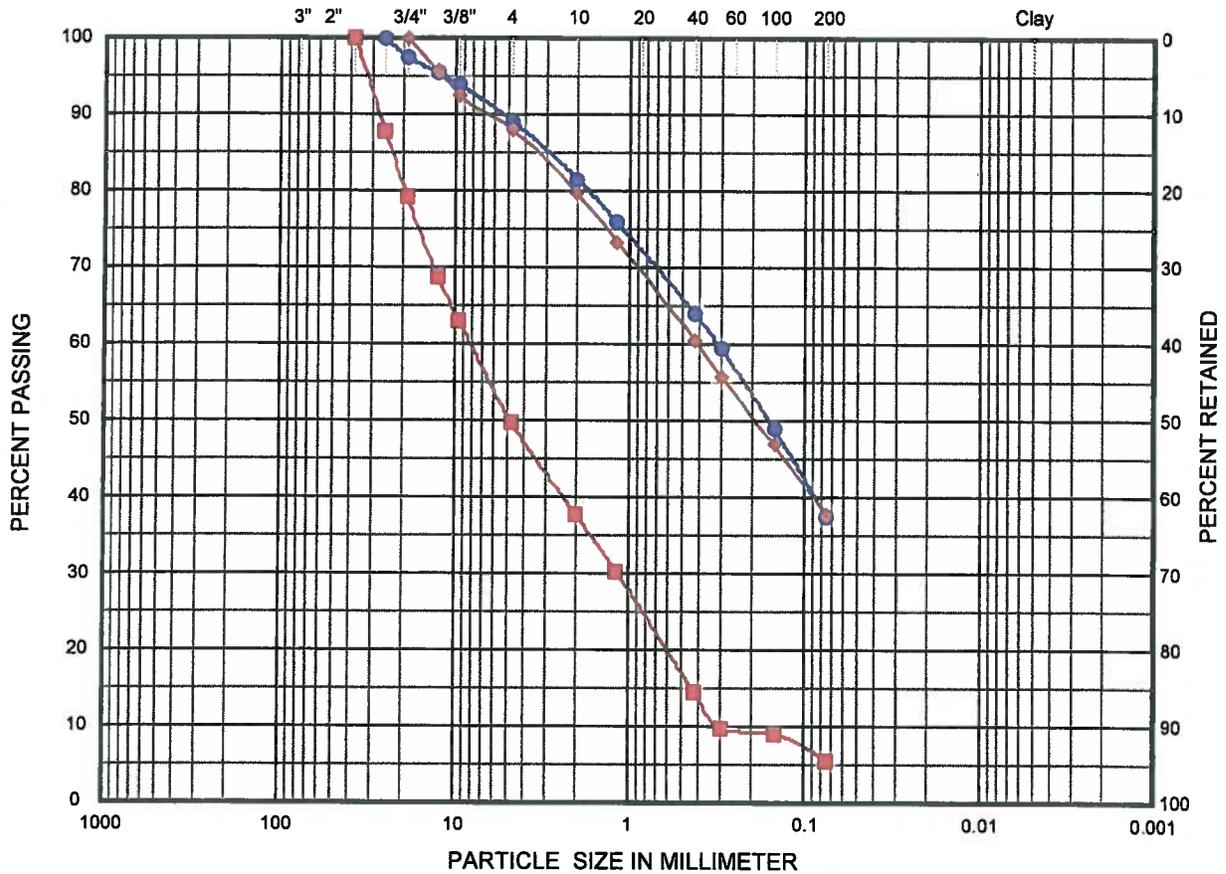
Project:	Proposed I-15 Logistics Center				
Location:	Lytle Creek Road, Fontana Area, San Bernardino County, CA				
Job Number:	14176-3	Engineer:	JFC	Enclosure:	C-1

Boring No.	Depth	Gravel	Sand	Fines	Clay	D ₁₀	D ₃₀	D ₅₀	D ₆₀	C _u	C _c
●	1A		10.9	51.6	37.6			0.048	0.159	0.314		
	(SM) Silty sand, fine to coarse											
■	2A		50.2	44.2	5.6		0.3130	1.154	4.819	8.162	26.1	0.5
	(GP-GM) Poorly-graded gravel with silt and sand											
◆	3A		11.9	50.3	37.8			0.042	0.191	0.410		
	(SM) Silty sand, fine to coarse

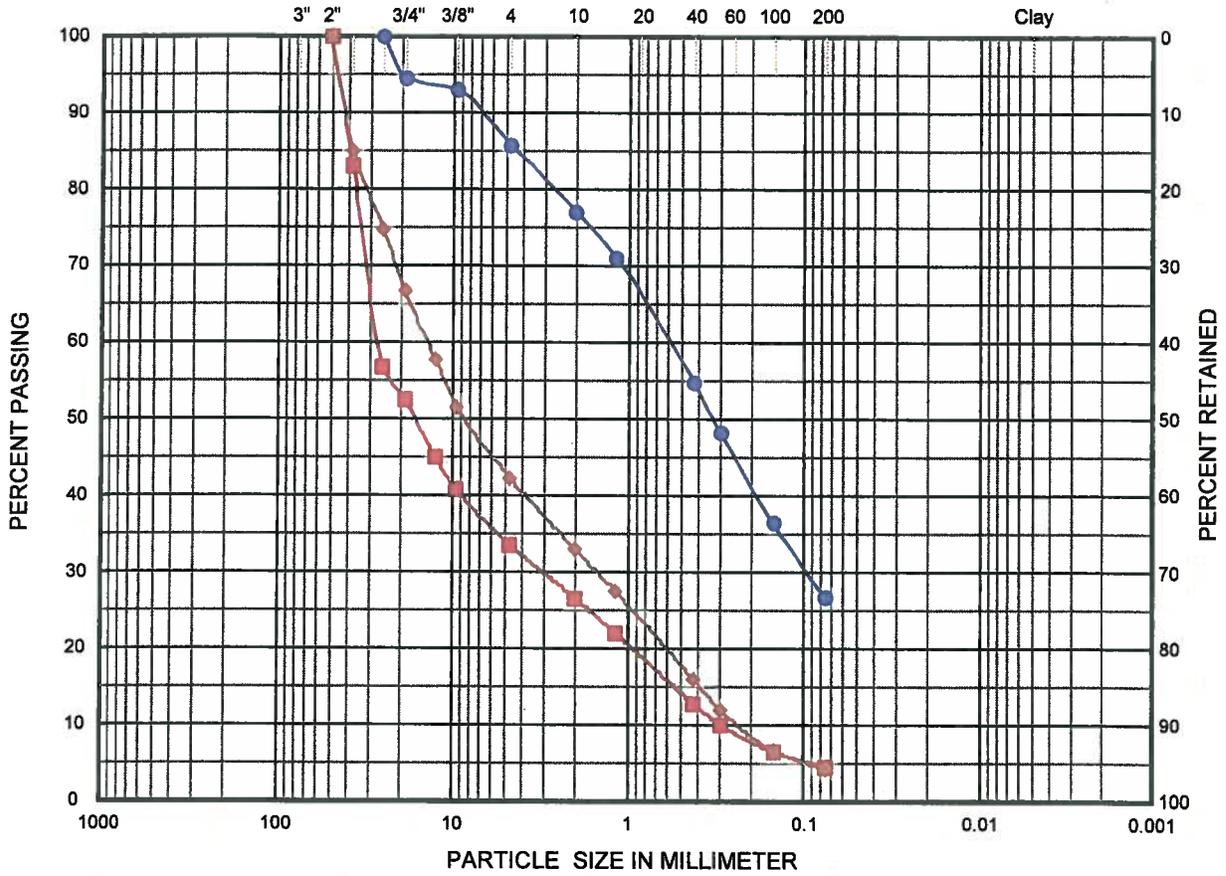
PARTICLE SIZE DISTRIBUTION (ASTM D422)

Boring No.	Depth	Gravel	Sand	Fines	Clay	D ₁₀	D ₃₀	D ₅₀	D ₆₀	C _u	C _c
●	4A		14.2	59.2	26.6			0.096	0.331	0.577		
	(SM) Silty sand, fine to coarse											
■	5A		66.4	29.0	4.6		0.2977	3.074	16.510	27.413	92.1	1.2
	(GW) Well-graded gravel with sand											
◆	6A		57.6	38.1	4.3		0.2408	1.511	8.692	14.089	58.5	0.7
	(GP) Poorly-graded gravel with sand

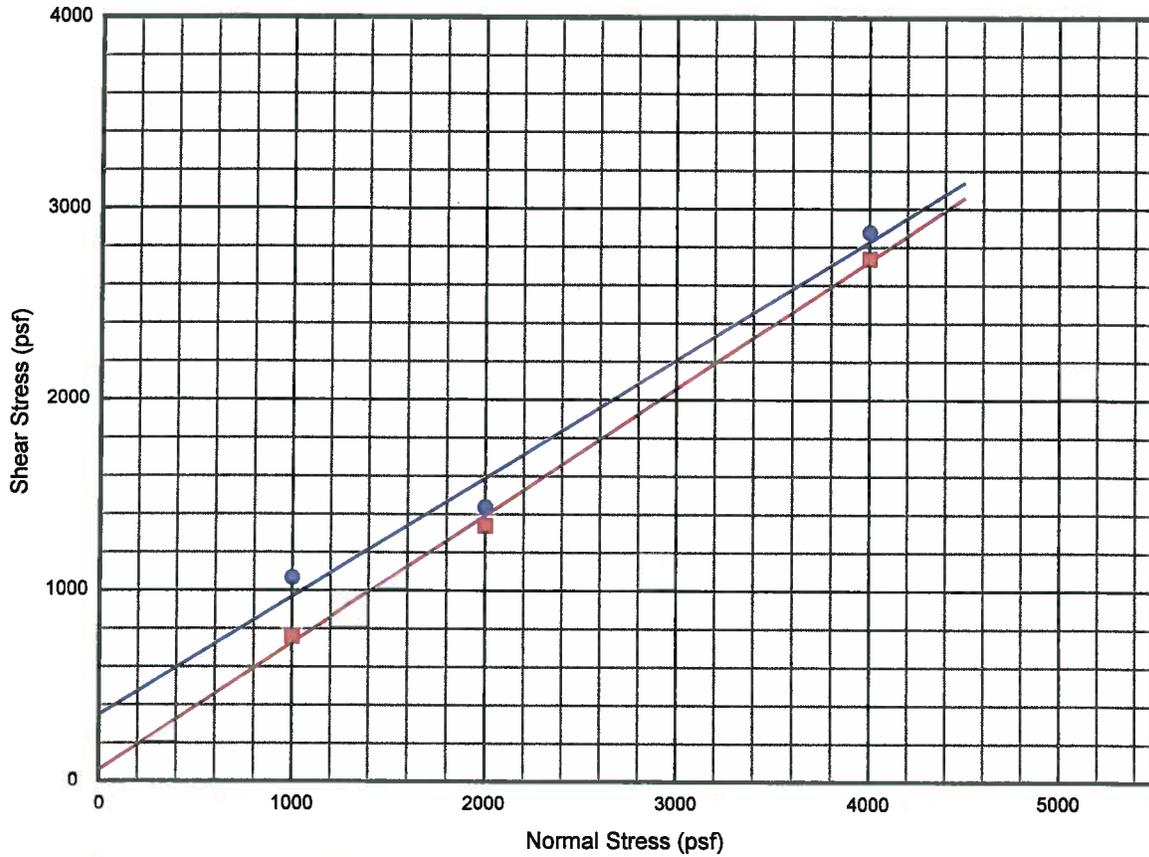
DIRECT SHEAR TESTS (ASTM D3080)

Boring No.	Depth (ft)	γ_d (pcf)	w (%)	C_{pk} (psf)	ϕ_{pk} (°)	C_{rs} (psf)	ϕ_{rs} (°)
●	2A	0	0.0	0.0	355.0	34.1	348.1	31.8
	(GP-GM) Poorly-graded gravel with silt and sand, gray brown / Undisturbed							
■	4A	0	0.0	0.0	59.9	33.8	57.9	33.7
	(SM) Silty Sand, fine to coarse / Undisturbed

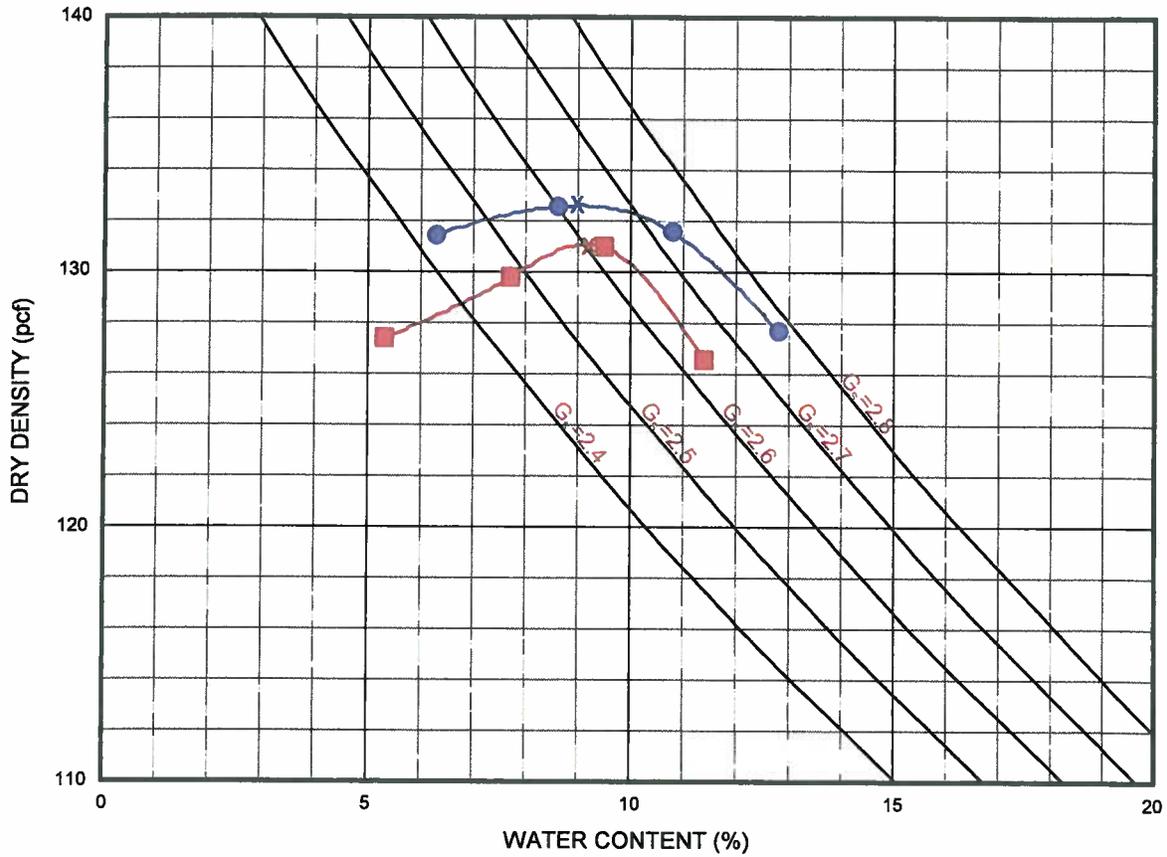
Boring No.	Depth (ft)	USCS Classification	γ_{dmax} (pcf)	w_o (%)
●	2A/6A	0	(GP-GM) Poorly Graded Gravel with Sand and Silt, mixture of 2A and 6A	132.6	9.0
■	4A	0	(SM) Silty Sand, fine to coarse	131.1	9.2

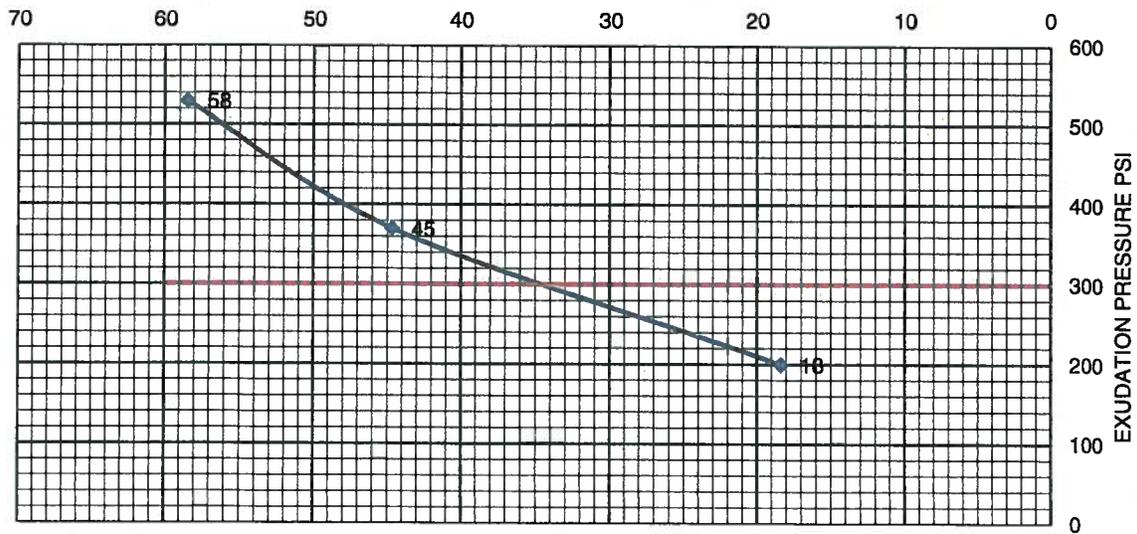
EXUDATION CHART
R-VALUE

Traffic Index (T.I.)	5.0	A	B	C	D
COMPACTOR AIR PRESSURE P.S.I.	250	350	350		
INITIAL MOISTURE %	6.9	6.9	6.9		
WATER ADDED, ML	55	45	35		
WATER ADDED %	5.2	4.3	3.3		
MOISTURE AT COMPACTION %	12.1	11.2	10.2		
HEIGHT OF BRIQUETTE	2.50	2.45	2.46		
WET WEIGHT OF BRIQUETTE	1139	1113	1143		
DENSITY LB. PER CU.FT.	123.2	123.8	127.8		
STABILOMETER PH AT 1000 LBS.	48	31	25		
2000 LBS.	107	62	46		
DISPLACEMENT	5.50	4.90	4.40		
R-VALUE	18	45	58		
EXUDATION PRESSURE	200	370	530		
THICK. INDICATED BY STAB.	1.31	0.89	0.66		
EXPANSION PRESSURE	0	11	19		
THICK. INDICATED BY E.P.	0.00	0.37	0.63

R-Value: 35

Sample No.	Depth (ft)	Soil/Sample Type	SE	w ₀ (%)
3A	0	(SM) Silty sand, fine to coarse with gravel to 3", red brown	18	6.9

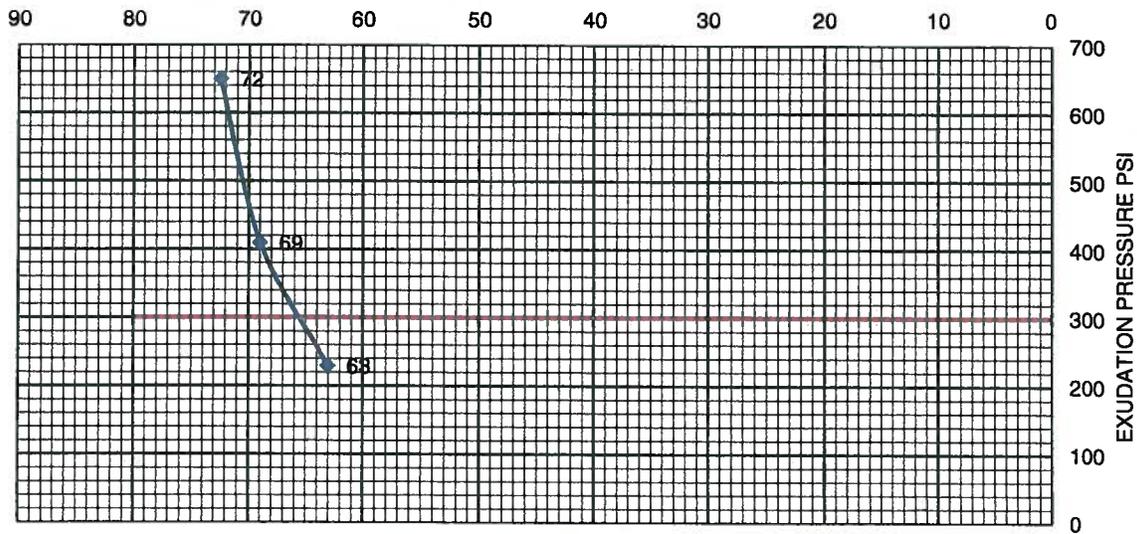
EXUDATION CHART
R-VALUE

Traffic Index (T.I.)	4.0	A	B	C	D
COMPACTOR AIR PRESSURE P.S.I.	350	350	350		
INITIAL MOISTURE %	7.3	7.3	7.3		
WATER ADDED, ML	30	20	10		
WATER ADDED %	2.9	1.9	0.9		
MOISTURE AT COMPACTION %	10.2	9.2	8.2		
HEIGHT OF BRIQUETTE	2.46	2.48	2.51		
WET WEIGHT OF BRIQUETTE	1126	1135	1132		
DENSITY LB. PER CU.FT.	125.9	127.0	126.2		
STABILOMETER PH AT 1000 LBS.	20	18	16		
2000 LBS.	31	28	26		
DISPLACEMENT	6.10	5.30	4.90		
R-VALUE	63	69	72		
EXUDATION PRESSURE	230	410	650		
THICK. INDICATED BY STAB.	0.47	0.40	0.35		
EXPANSION PRESSURE	0	0	0		
THICK. INDICATED BY E.P.	0.00	0.00	0.00

R-Value: 65

Sample No.	Depth (ft)	Soil/Sample Type	SE	w _o (%)
2A/6A	0	Mixture of Poorly Graded Gravel with silt and sand	N/A	7.3

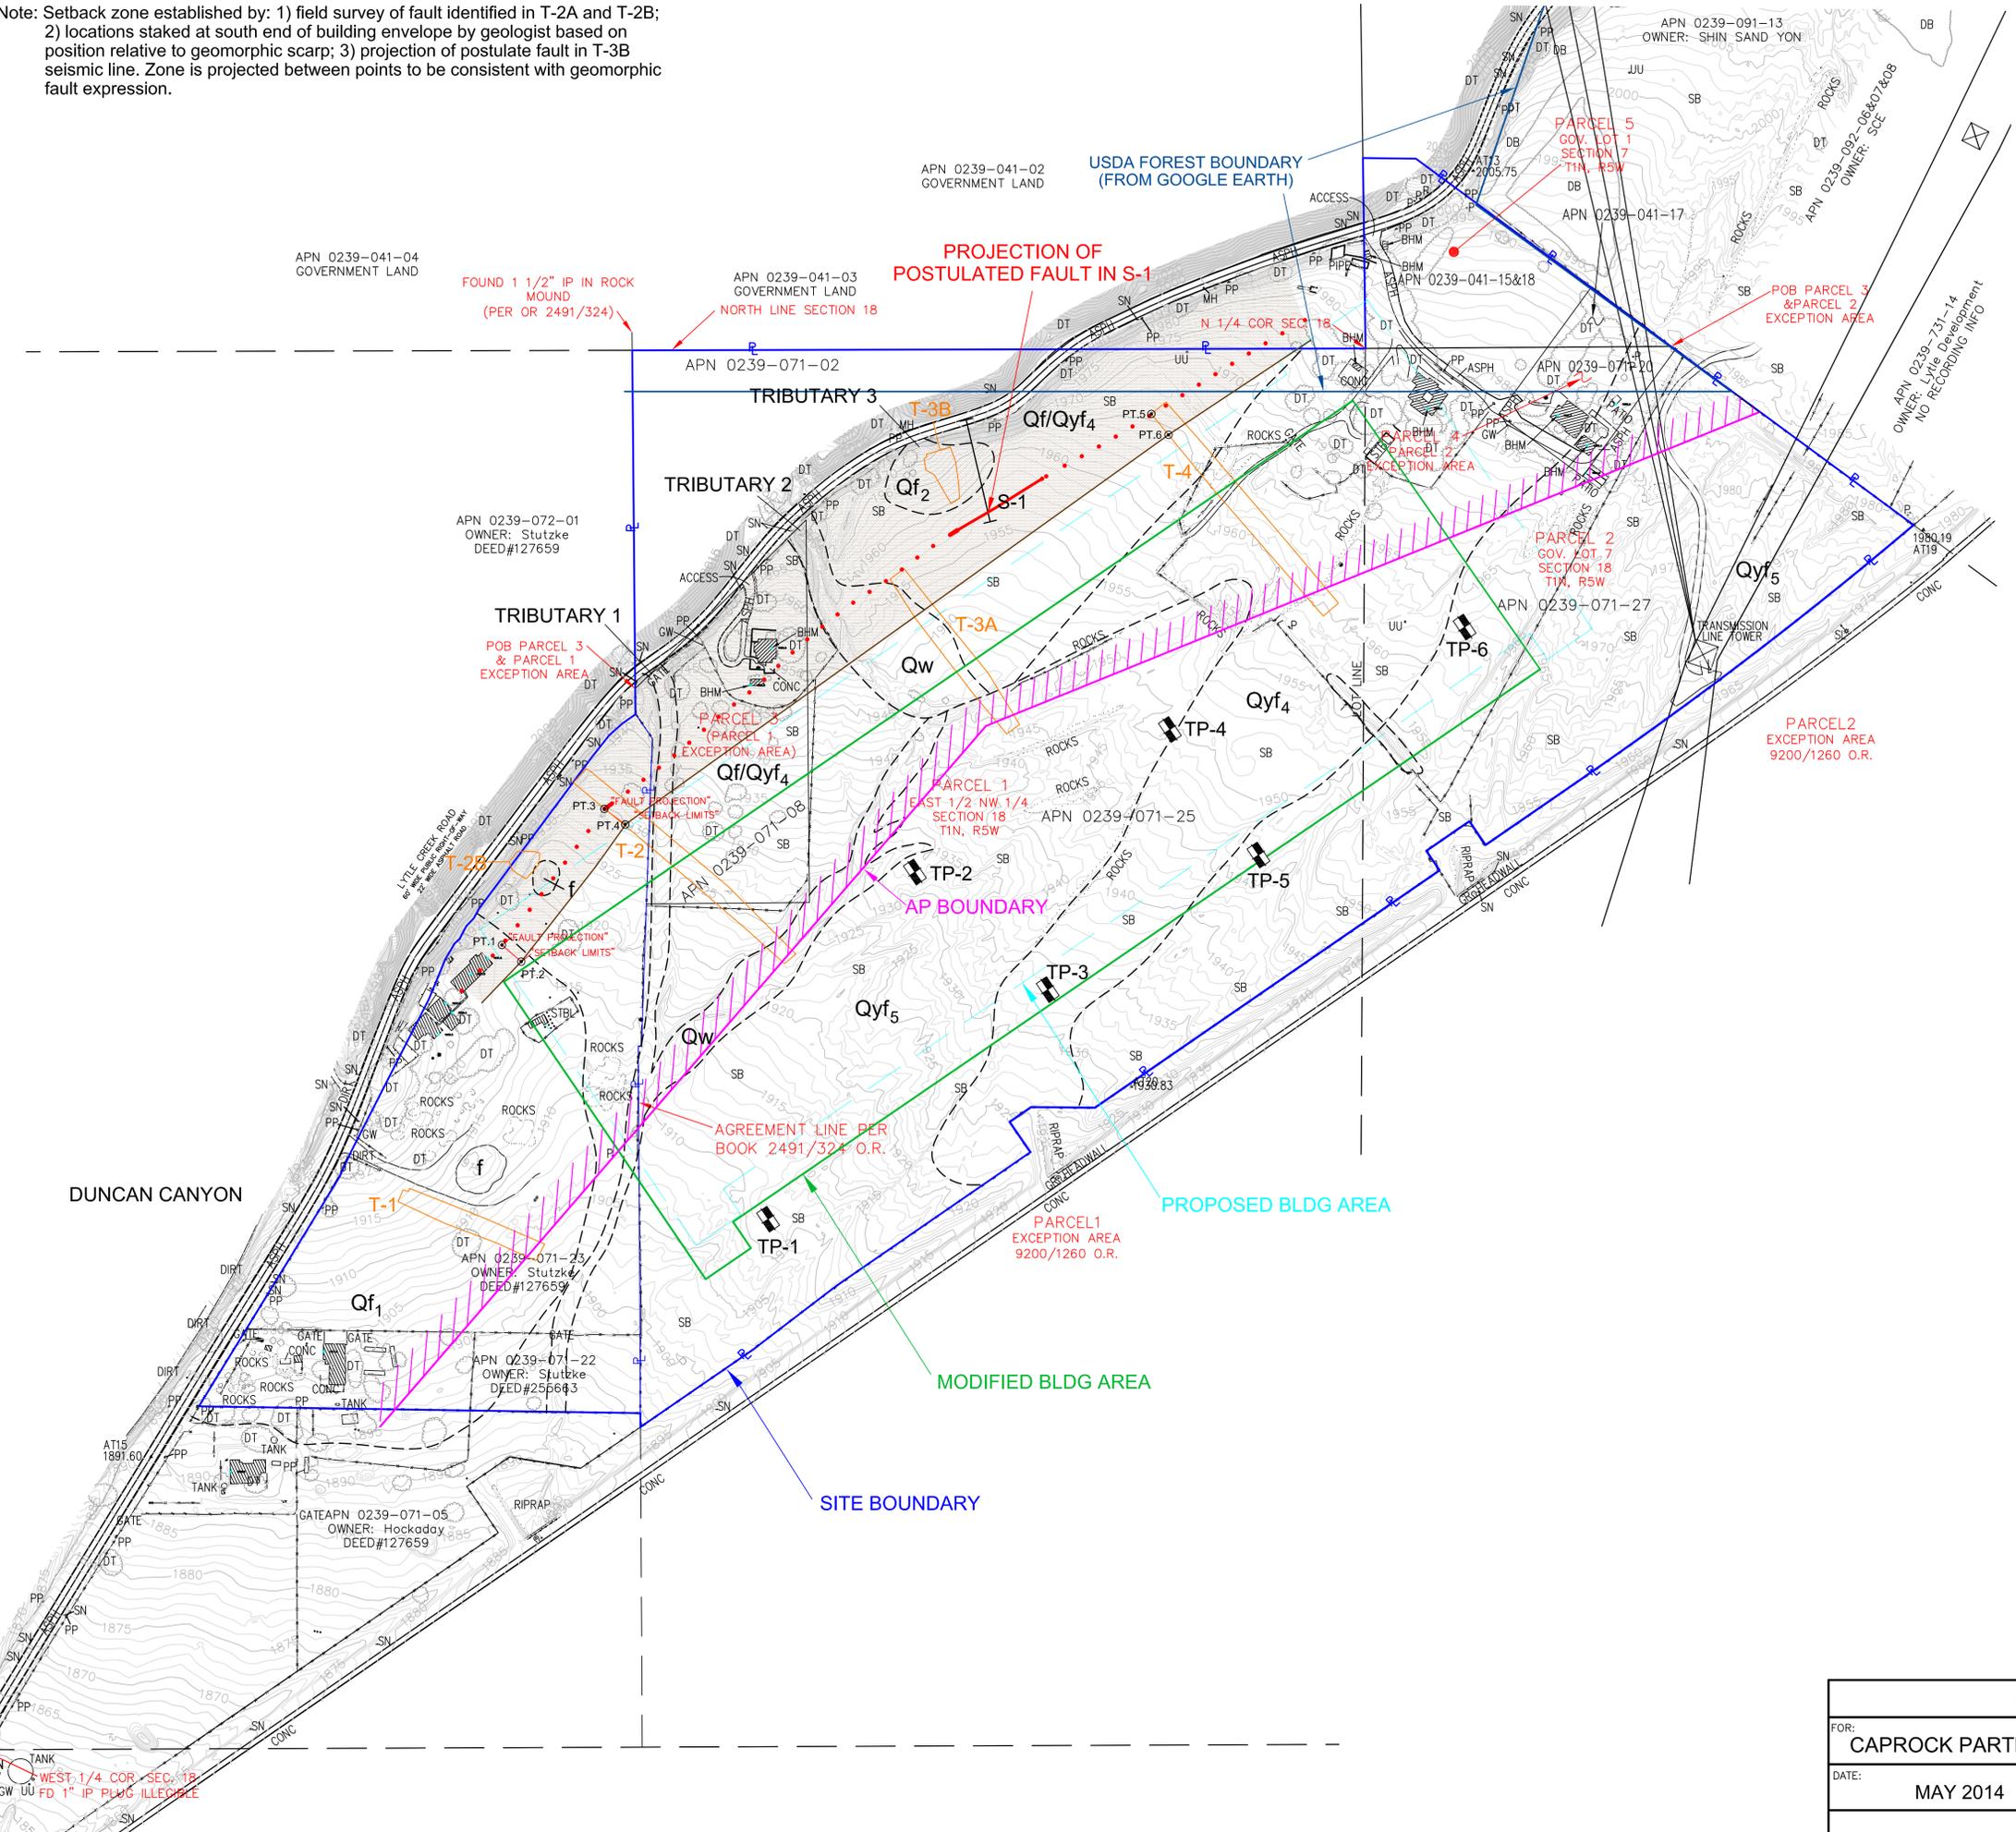
Note: Setback zone established by: 1) field survey of fault identified in T-2A and T-2B; 2) locations staked at south end of building envelope by geologist based on position relative to geomorphic scarp; 3) projection of postulate fault in T-3B seismic line. Zone is projected between points to be consistent with geomorphic fault expression.

- f - fill
- Qw - recent wash deposits
- Qf₁ - sediments of alluvial fan emanating from Duncan Canyon deposited prior to levee construction
- Qf₂ - sediments of small alluvial fan sourced in unnamed canyon
- Qyf₅ - young alluvial-fan sediments sourced from Lytle Creek. Slightly younger than Qyf₄.
- Qyf₄ - young alluvial-fan sediments sourced from Lytle Creek. May include sediments sourced from small tributary canyons emerging along range front.

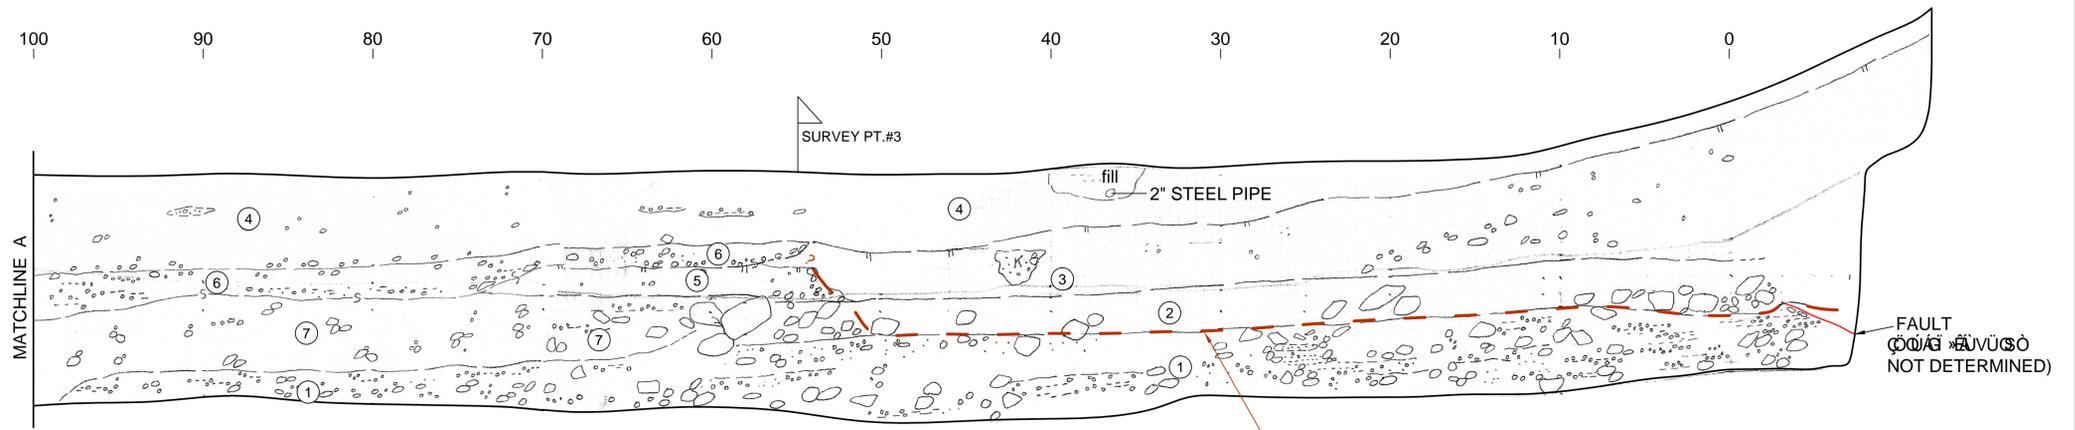
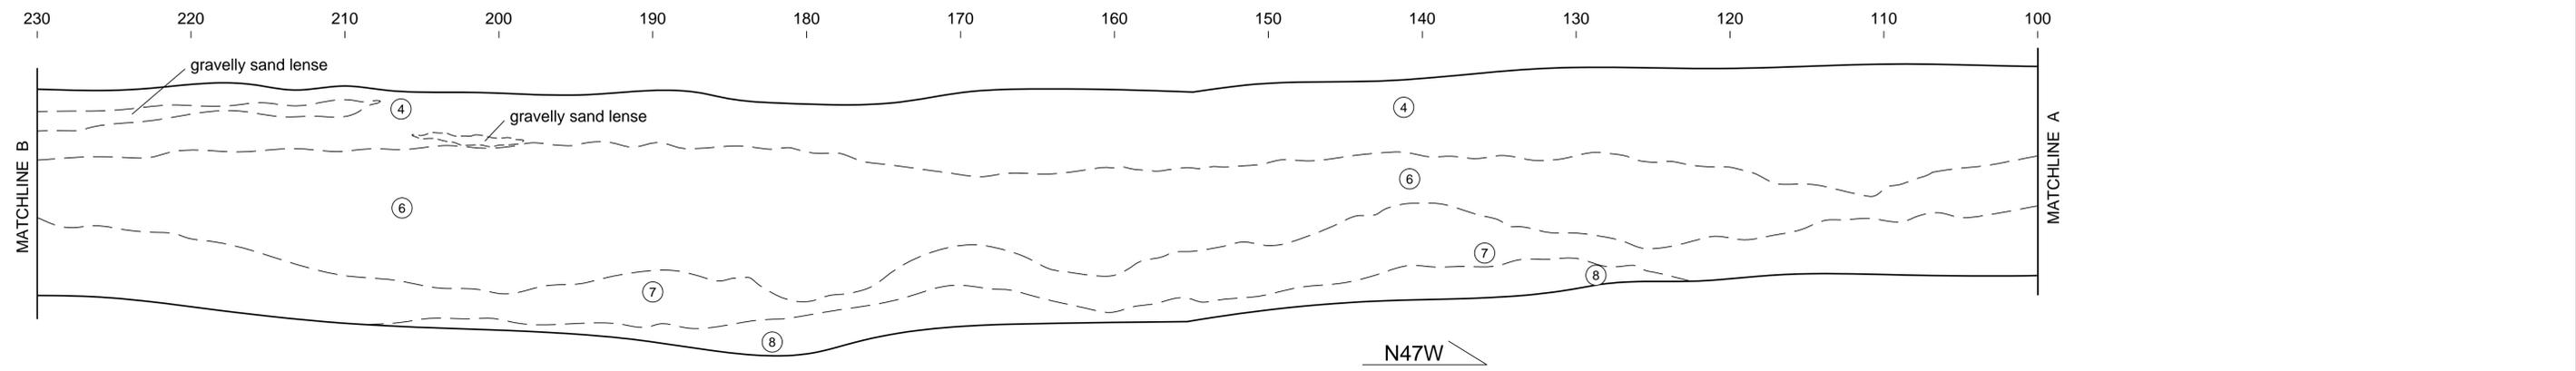
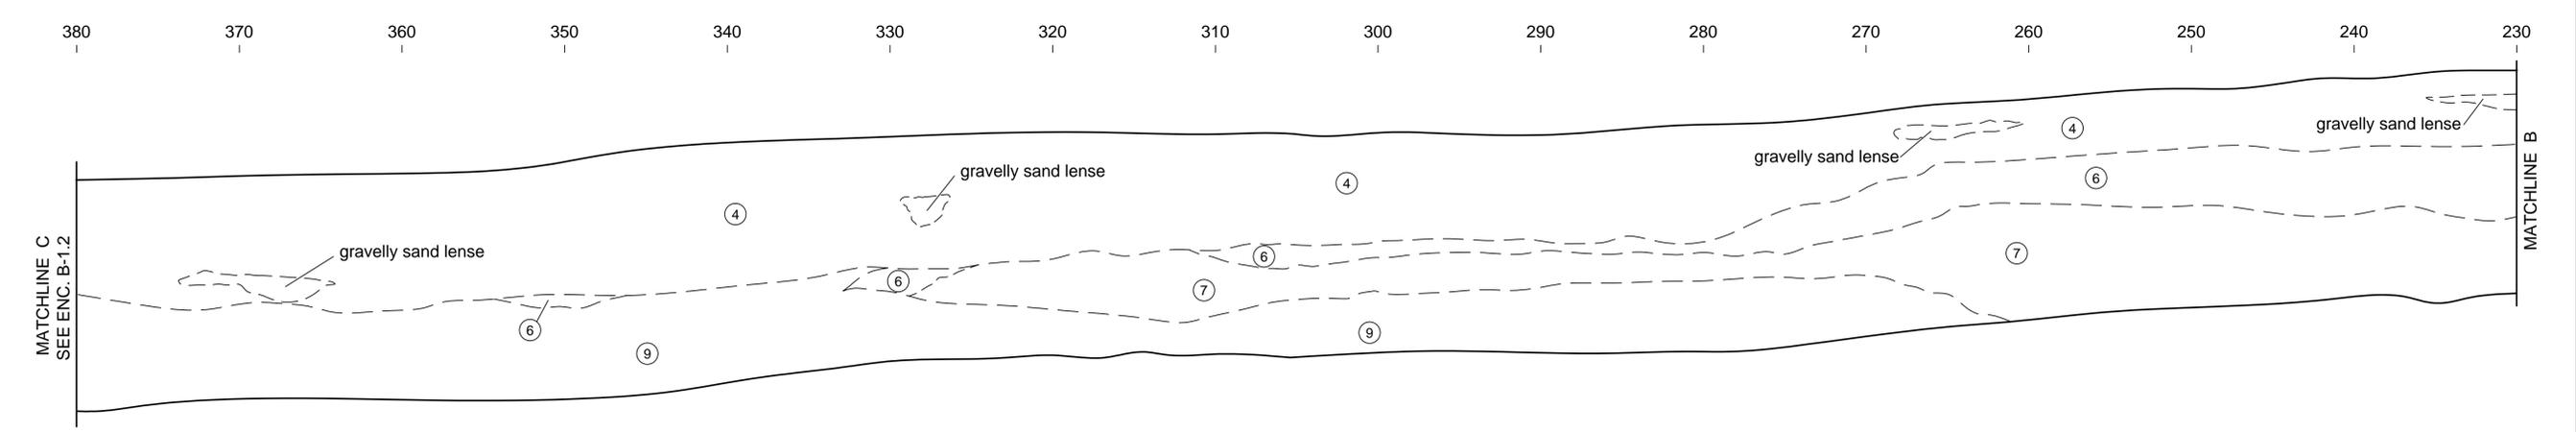
- ① **GRAVELLY SAND:** Brown to Yellowish Brown (10YR 5/3 to 5/4), fine- to coarse-grained with abundant cobbles and boulders, massive to crudely stratified, moist, non cohesive, loose, clasts are predominantly rounded to sub-angular (<5% of clasts show gussification), very light and discontinuous coatings along underside of clasts.

TRENCH 2A - SOUTH WALL		
FOR: CAPROCK PARTNERS	FAULT RUPTURE HAZARD INVESTIGATION PROPOSED I-15 LOGISTICS CENTER LYTLE CREEK ROAD, FONTANA AREA SAN BERNARDINO COUNTY, CALIFORNIA	ENCLOSURE "B-1.1"
DATE: MAY 2014		JOB NUMBER 14176-8
CHJ Consultants

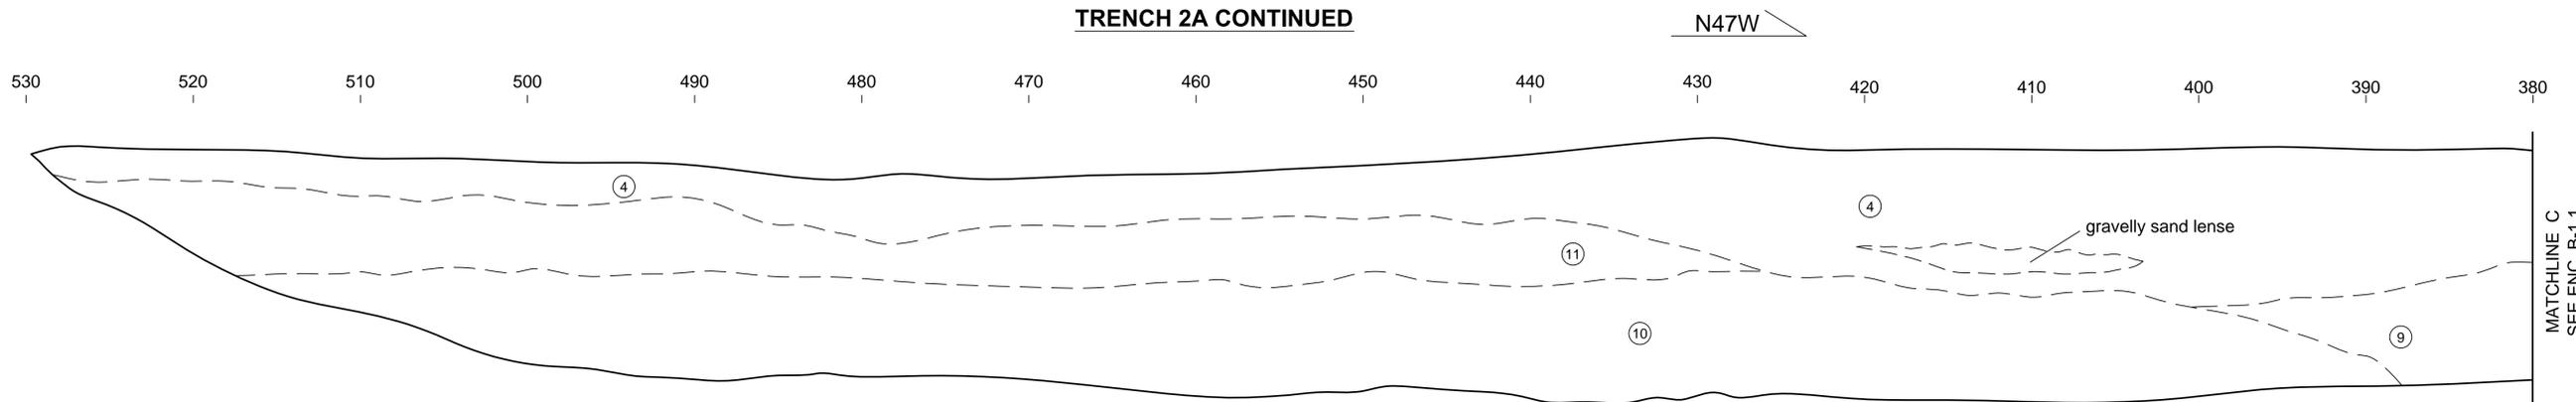
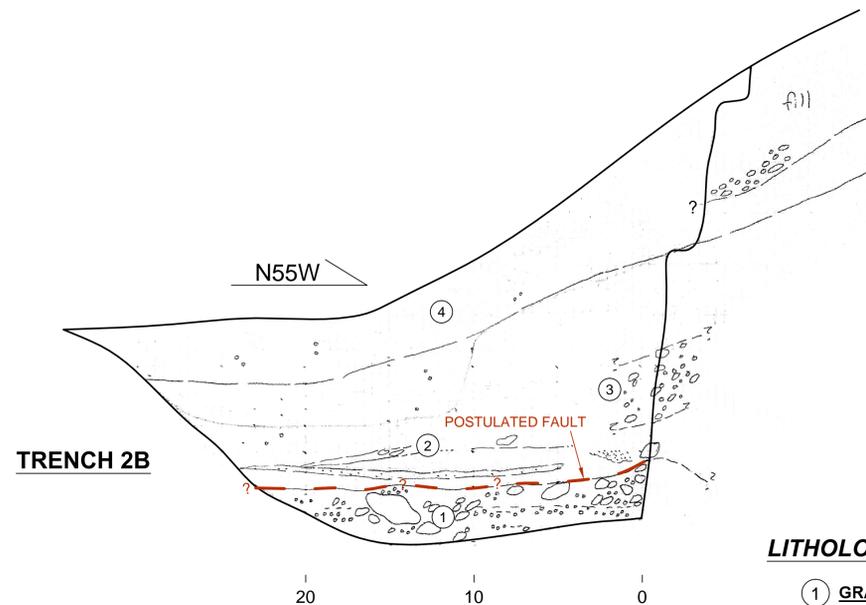
TRENCHES 2A AND 2B - SOUTH WALL

- ① **GRAVELLY SAND:** Brown to Yellowish Brown (10YR 5/3 to 5/4), fine- to coarse-grained with abundant cobbles and boulders, massive to crudely stratified, moist, non cohesive, loose, clasts are predominantly rounded to sub-angular (<5% of clasts show grussification), very light and discontinuous coatings along underside of clasts.

- ① **GRAVELLY SILTY SAND:** Grayish Brown to yellowish brown (10YR 5/2 to 5/4), fine- to coarse-grained, massive where clast-supported to stratified and bedded, cobbles forming crude bedding, few rounded boulders to 24" in size, non cohesive, clasts are rounded to sub-angular, some tablate, durable felsic lithologies dominate, mafic clasts slightly to moderately weathered, discontinuous clay films (alluvium of Lytle Creek fan). Truncated and mantled by Unit 2. Fourteen-inch boulder of Unit 1 type within base of Unit 2 suggests clast plucked from Unit 1 and dragged into Unit 2 above fault plane at Stn. 0.

FOR: CAPROCK PARTNERS	FAULT RUPTURE HAZARD INVESTIGATION PROPOSED I-15 LOGISTICS CENTER LYTLE CREEK ROAD, FONTANA AREA SAN BERNARDINO COUNTY, CALIFORNIA	ENCLOSURE "B-1.2"
DATE: MAY 2014		JOB NUMBER 14176-8
