Appendix E
Geotechnical Investigation Report, Fault Rupture Hazard
Investigation Report

Appendix E.1
Geotechnical Investigation Report

**FAULT RUPTURE HAZARD INVESTIGATION
PROPOSED I-15 LOGISTICS CENTER
LYTLE CREEK ROAD
FONTANA AREA
SAN BERNARDINO COUNTY, CALIFORNIA
PREPARED FOR
CAPROCK PARTNERS
JOB NO. 14176-8**

FAULT RUPTURE HAZARD INVESTIGATION
PROPOSED I-15 LOGISTICS CENTER PROJECT
LYTLE CREEK ROAD
FONTANA AREA
SAN BERNARDINO COUNTY, CALIFORNIA
PREPARED FOR
CAPROCK PARTNERS
JOB NO. 14176-8

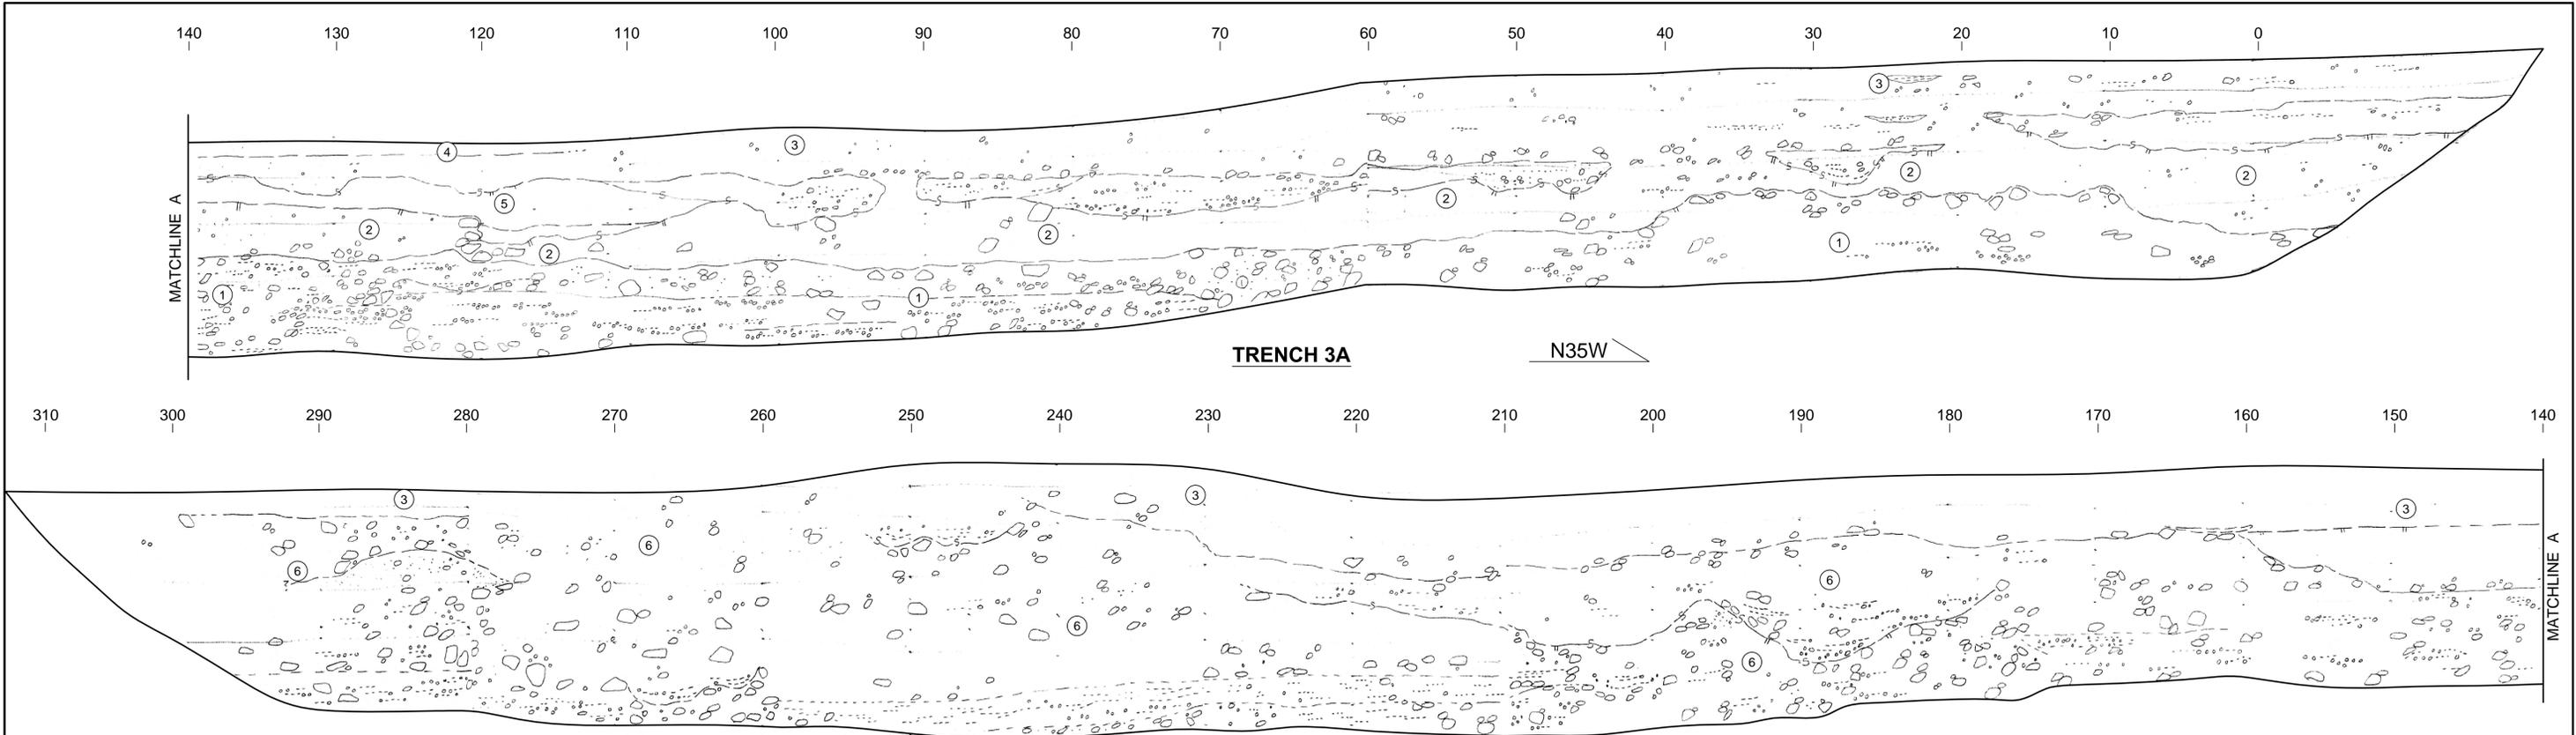
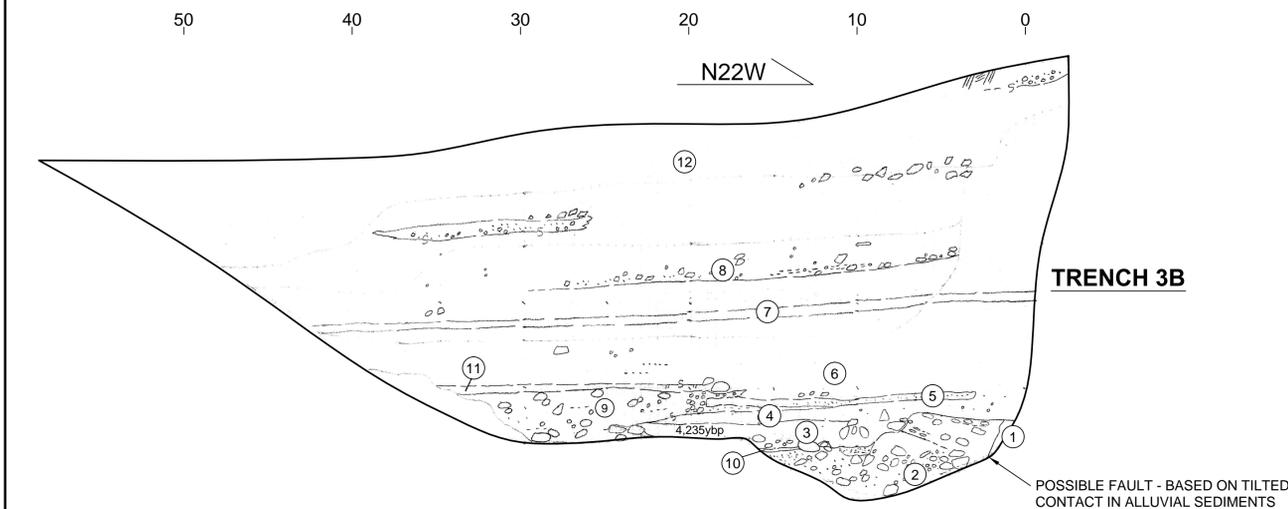
TRENCHES 3A AND 3B - SOUTH WALL

- ① **GRAVELLY SILTY SAND:** Grayish Brown to yellowish brown (10YR 5/2 to 5/4), fine- to coarse-grained, massive where clast-supported to stratified and bedded, cobbles forming crude bedding, few rounded boulders to 20" in size, non cohesive, clasts are rounded to sub-angular, some tabulate, durable felsic lithologies dominate, mafic clasts slightly to moderately weathered, discontinuous clay films (alluvium of Lytle Creek fan).

- ① **GNEISSIC BEDROCK:** Gray to Dark Bluish Gray, fine-grained, slightly weathered, foliated, oxide coatings along joints, rounding on undisturbed faces.

FOR: CAPROCK PARTNERS	FAULT RUPTURE HAZARD INVESTIGATION PROPOSED I-15 LOGISTICS CENTER LYTLE CREEK ROAD, FONTANA AREA SAN BERNARDINO COUNTY, CALIFORNIA	ENCLOSURE "B-2"
DATE: MAY 2014		JOB NUMBER 14176-8

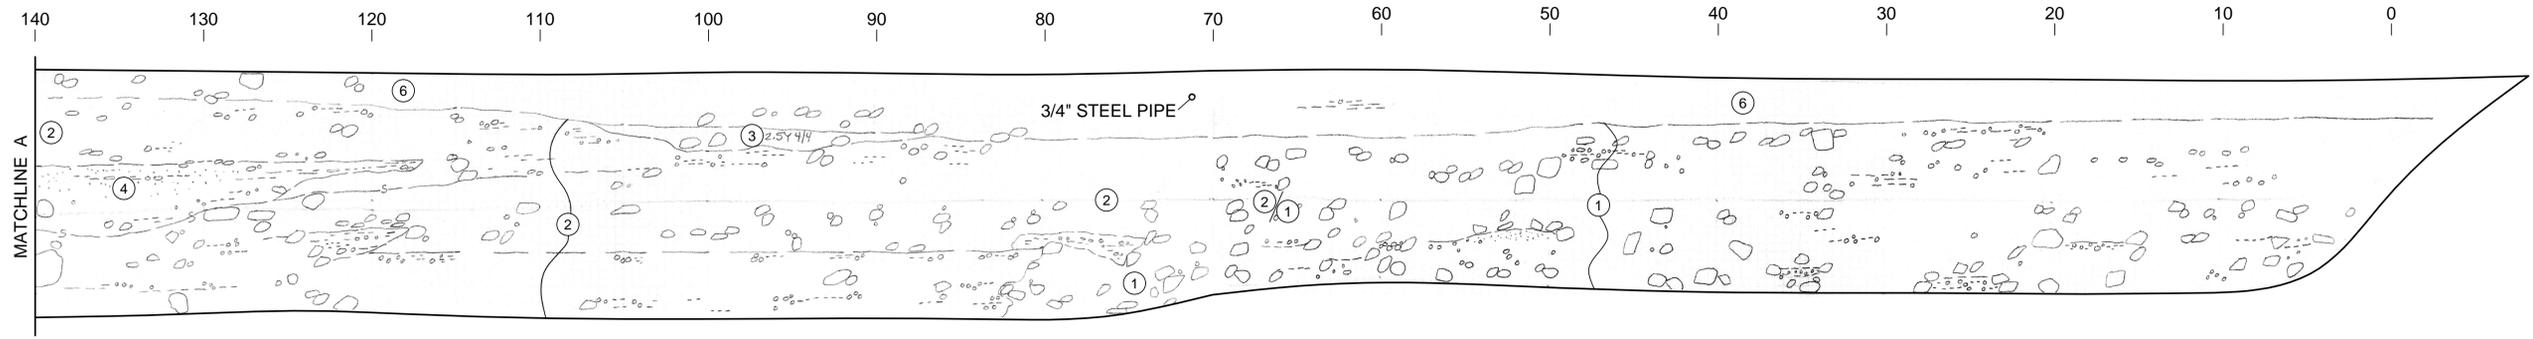
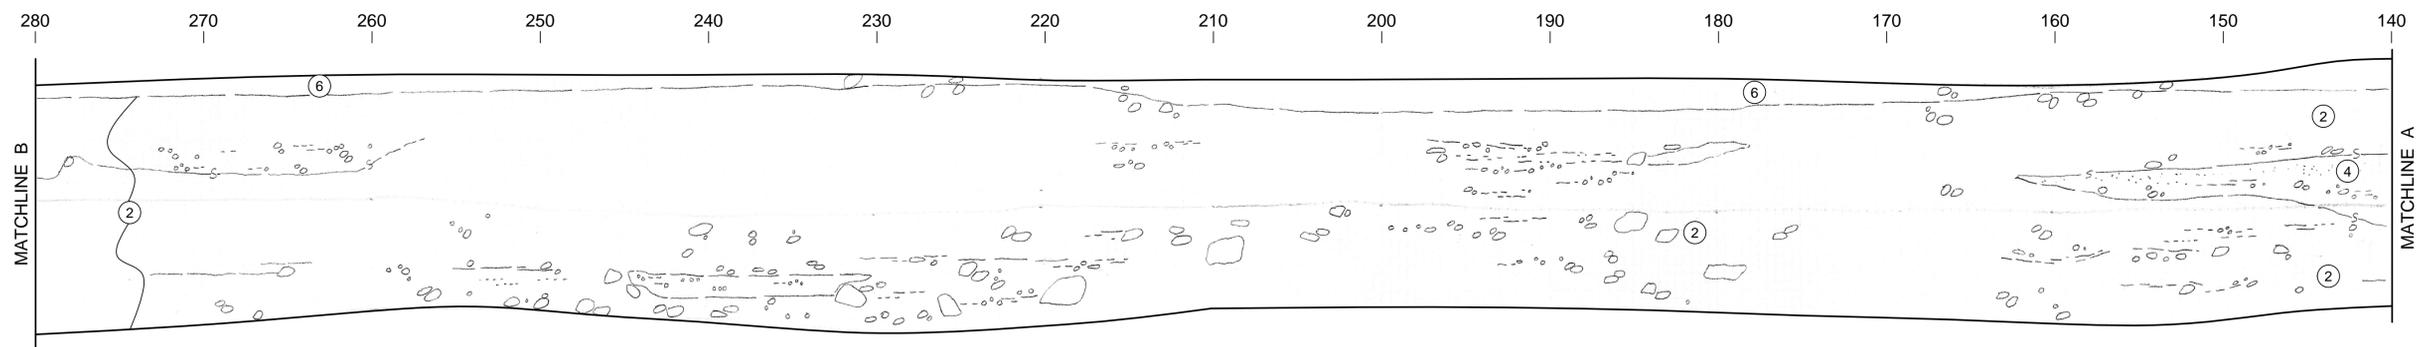
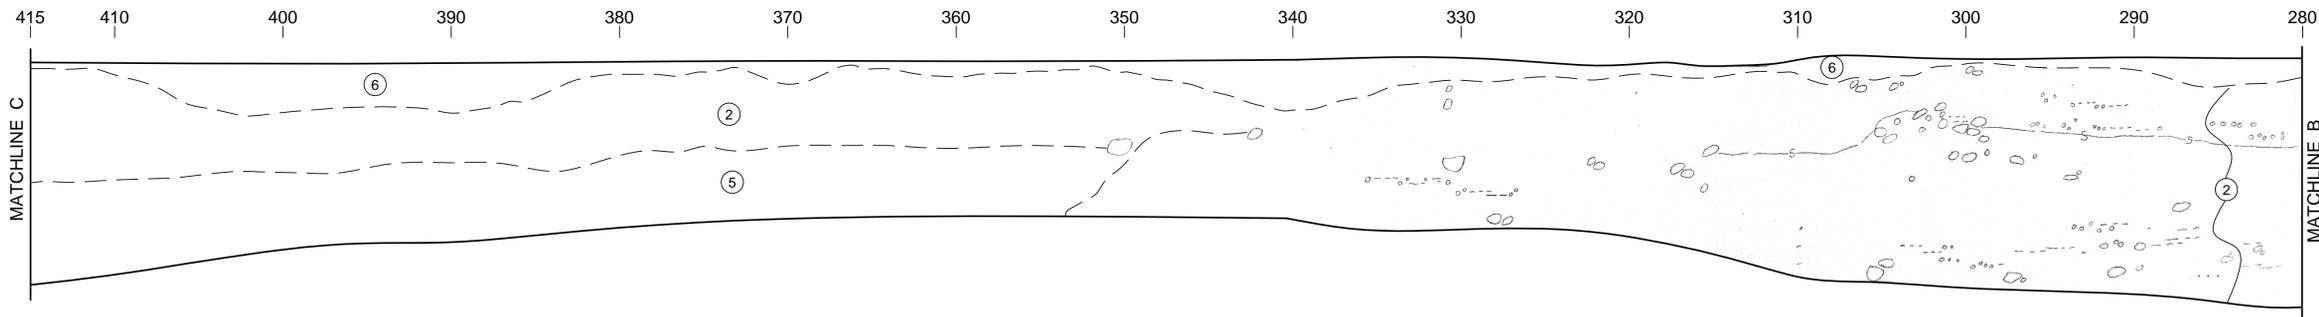
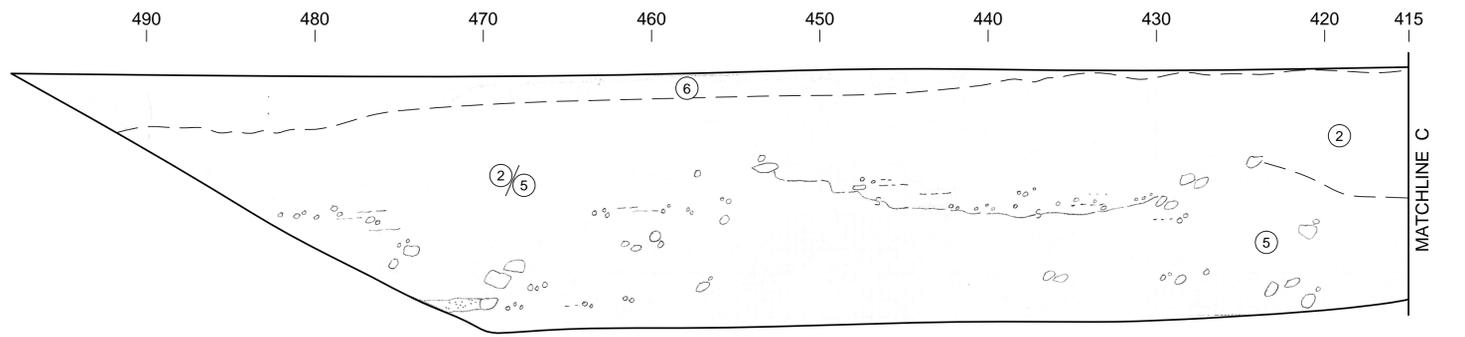
TRENCH 4

- ① **GRAVELLY SILTY SAND:** dark yellowish brown (10YR 4/4), fine- to coarse-grained matrix, massive where clast-supported to stratified and bedded, cobbles forming crude bedding, slightly cohesive, clasts are rounded to sub-angular, durable felsic lithologies and mafic clasts moderately weathered, clay films (alluvium of local fan?).

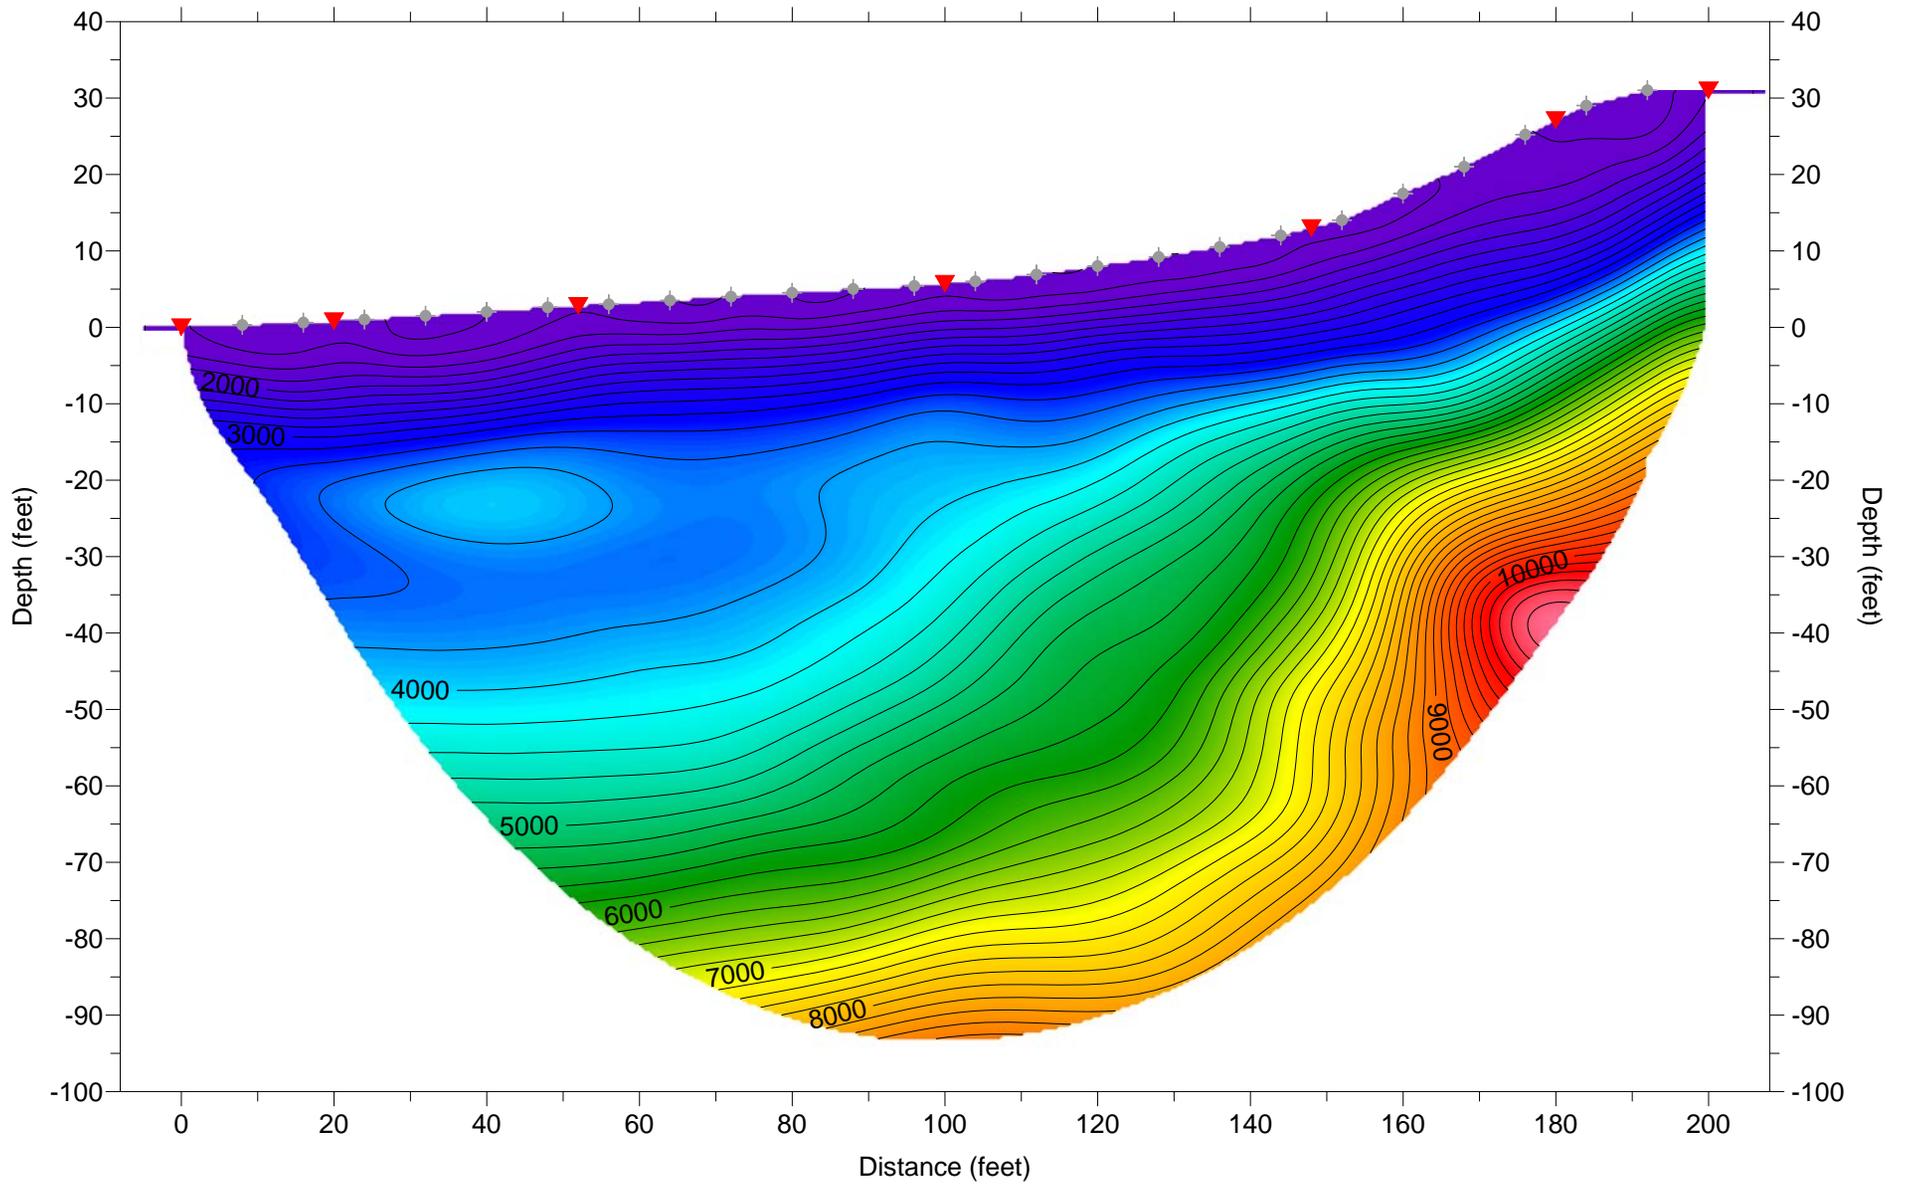
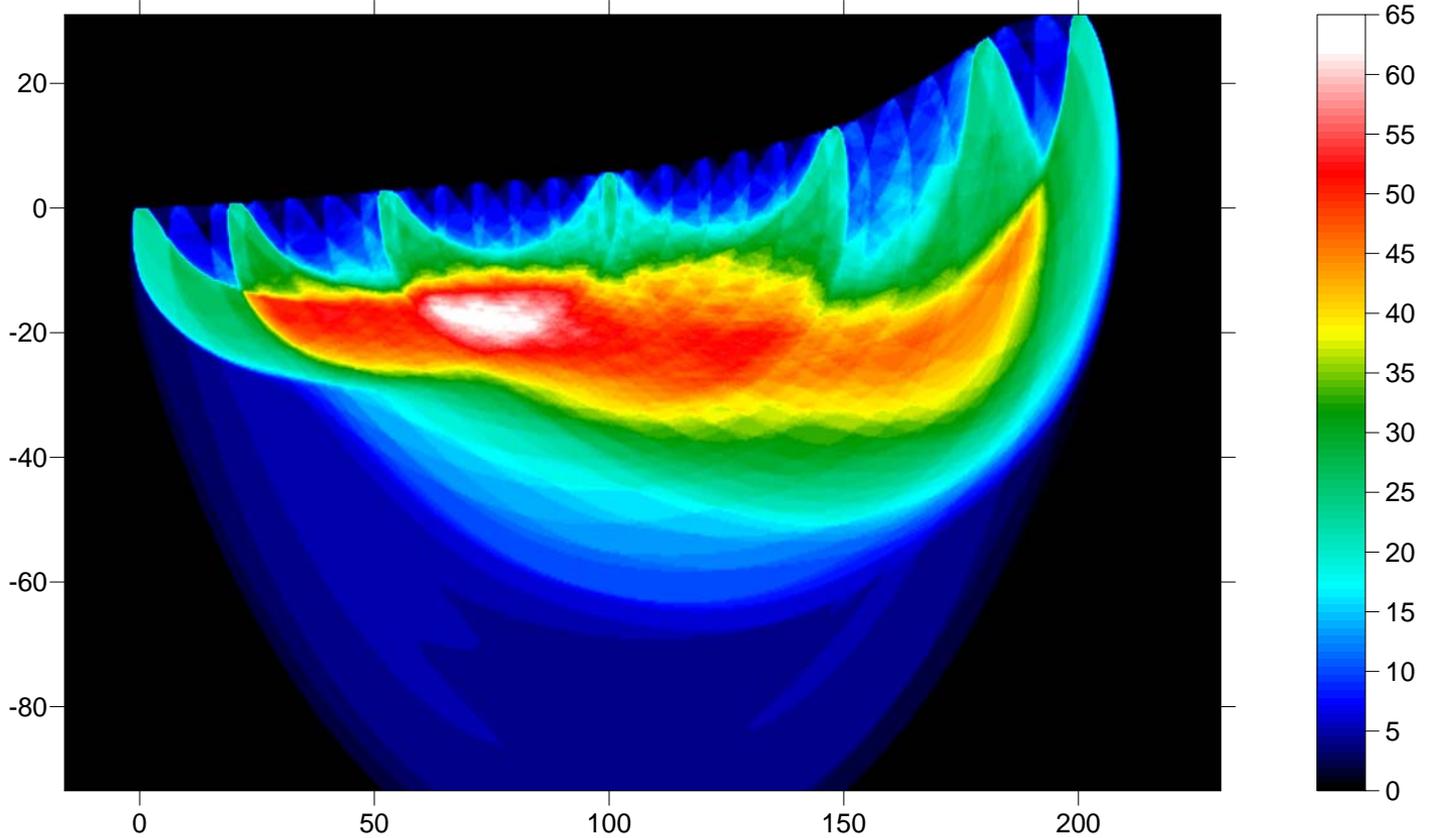
SEISMIC LINE S-1

SEISMIC LINE S-1, 20 WET iterations, RMS error 1.0 %, DeltatV initial model artefacts !, Version 3.31

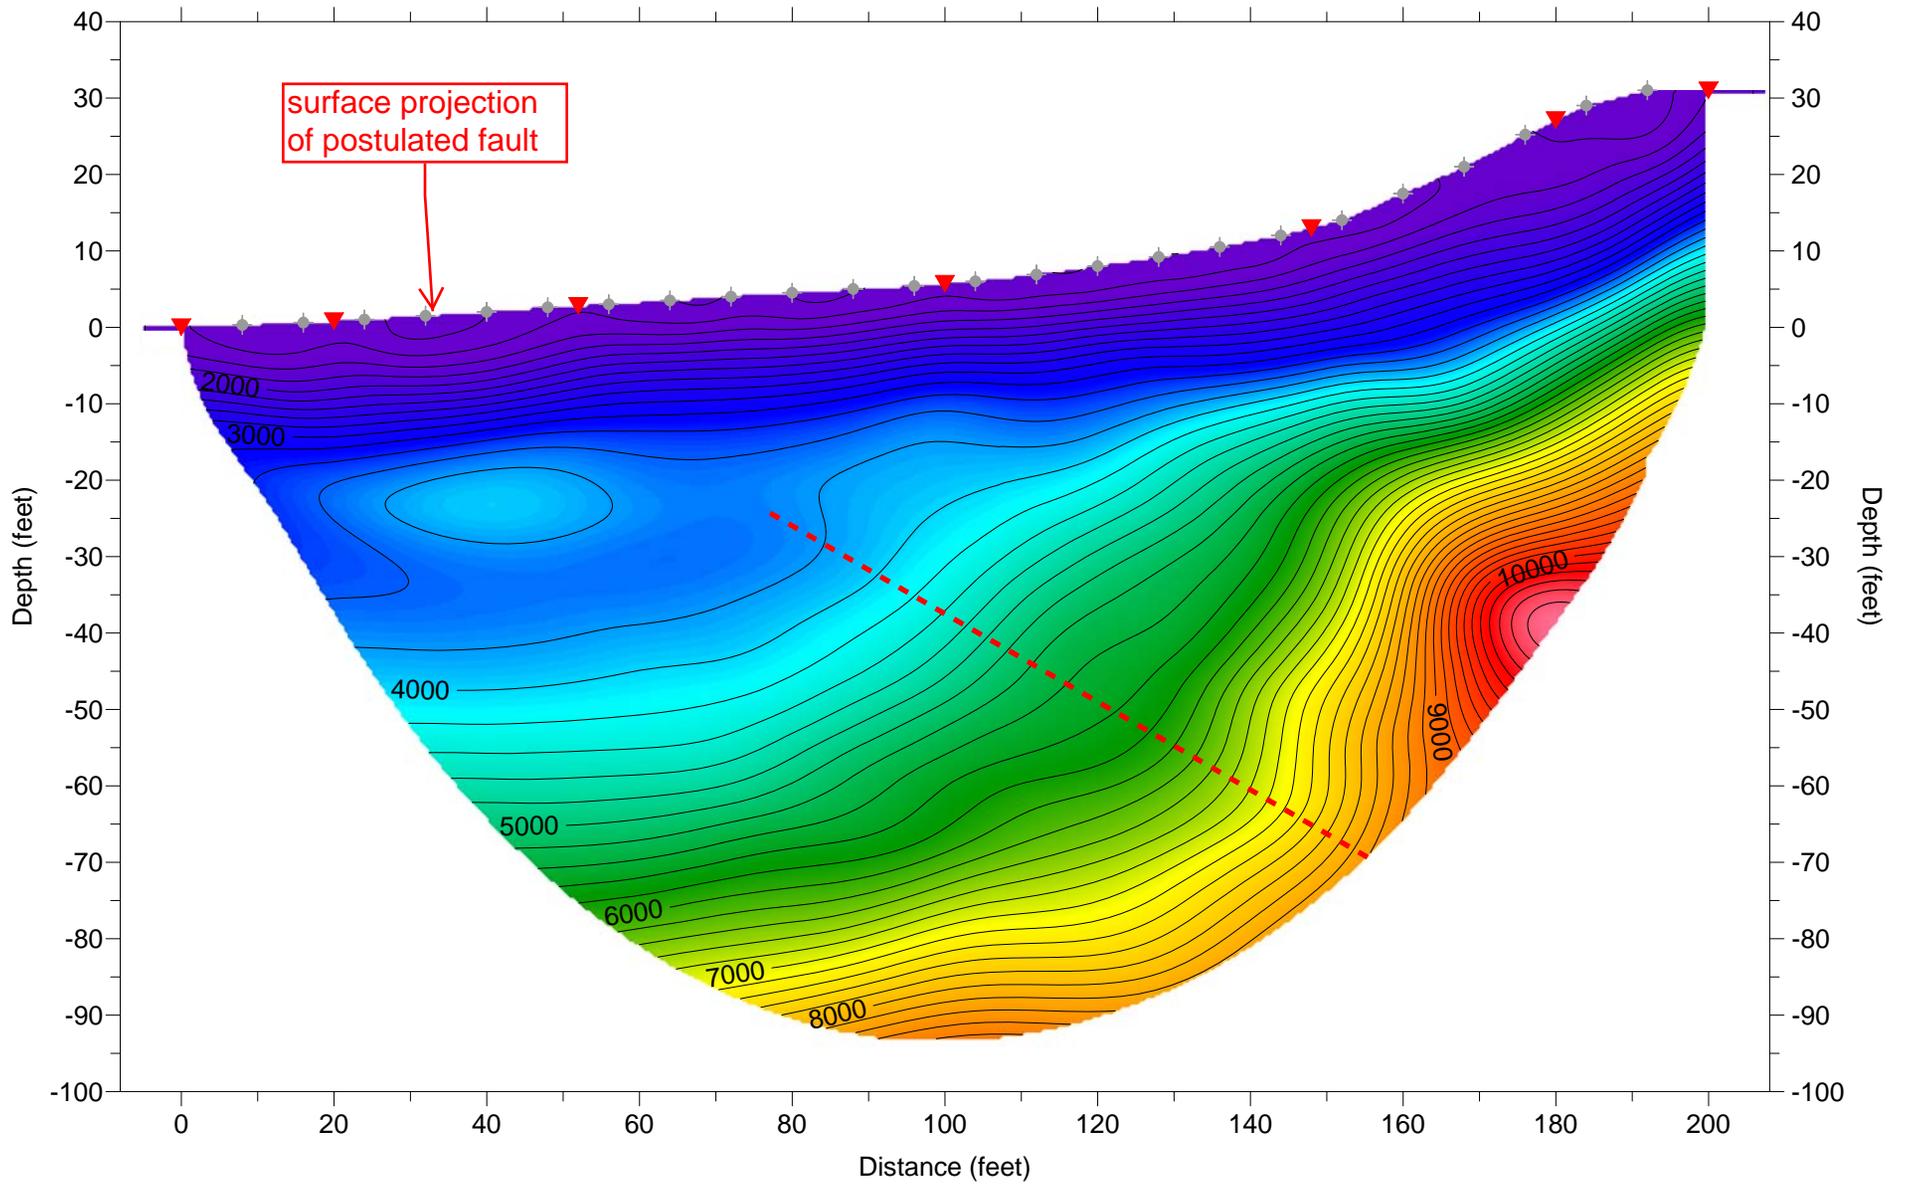
SEISMIC LINE S-1

Enclosure C-2
