ASSESSMENT OF SAFETY RISKS ARISING FROM WIND TURBINE ICING

Colin Morgan*, Ervin Bossanyi*, Mr Henry Seifert**

* Garrad Hassan and Partners Ltd, The Coach House, Folleigh Lane, Long Ashton, Bristol BS18 9JB

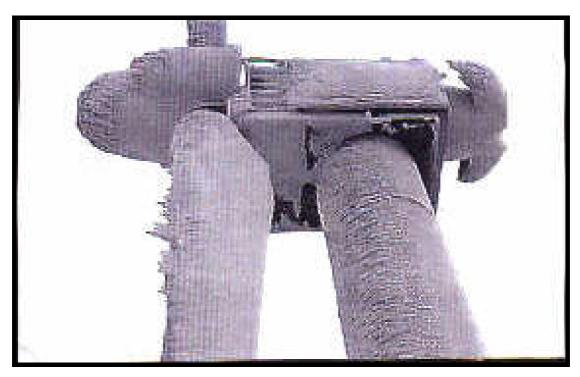
Figure 1 Heavy ice accretion on a 300 kW wind turbine rotor

A typical example of heavy rime icing on a wind turbine rotor is shown in Figure 1. It can clearly be seen that the heaviest ice build-up is at the tip of the blade but what is surprising is the amount of accretion with a chordwise thickness of up to about 0.5m. The build-up at the root of the blade is much less severe compared to nearby stationary structures.

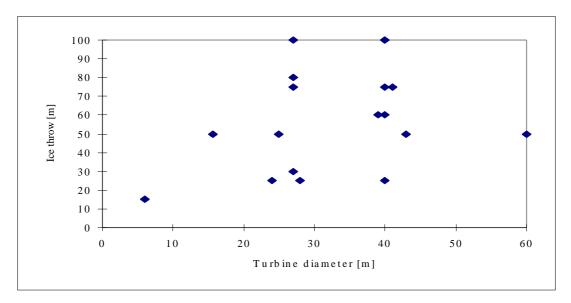
Figure 2 Ice throw data collected by icing questionnaire

Figure 2 summarises the data collected so far, as supplied by DEWI [4]. The data presented in Figure 2 show that most fragments which were found on the ground were estimated to be in the range 0.1 to 1 kg mass and were found 15 to 100 m from the

turbines. Of course these figures must be taken as very approximate, and it is not possible to know how well the ground was searched especially at larger distances from the turbines.

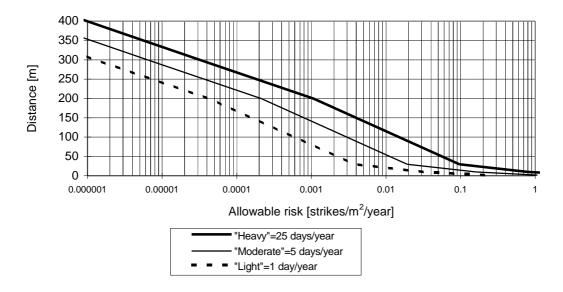
Figure 3 Safety distance for different icing levels (50m rotor)

Figure 3 is based on a rate of ice accretion averaging 75 kg/day during icing conditions, a figure which has been estimated for a 3-bladed turbine of 50m diameter. The allowable risk should be scaled *pro rata* under different assumptions.

Use data presented in Figure 3 to determine the safety distance for the chosen level of allowable risk. Clearly the smaller the level of risk which is to be tolerated, the greater the safety distance which must be allowed.
