## PRELIMINARY GEOTECHNICAL STUDY REPORT

MAHA RESORT AT GUENOC VALLEY  
22000 BUTTS CANYON ROAD  
MIDDLETOWN, CALIFORNIA

7192.04.01.3

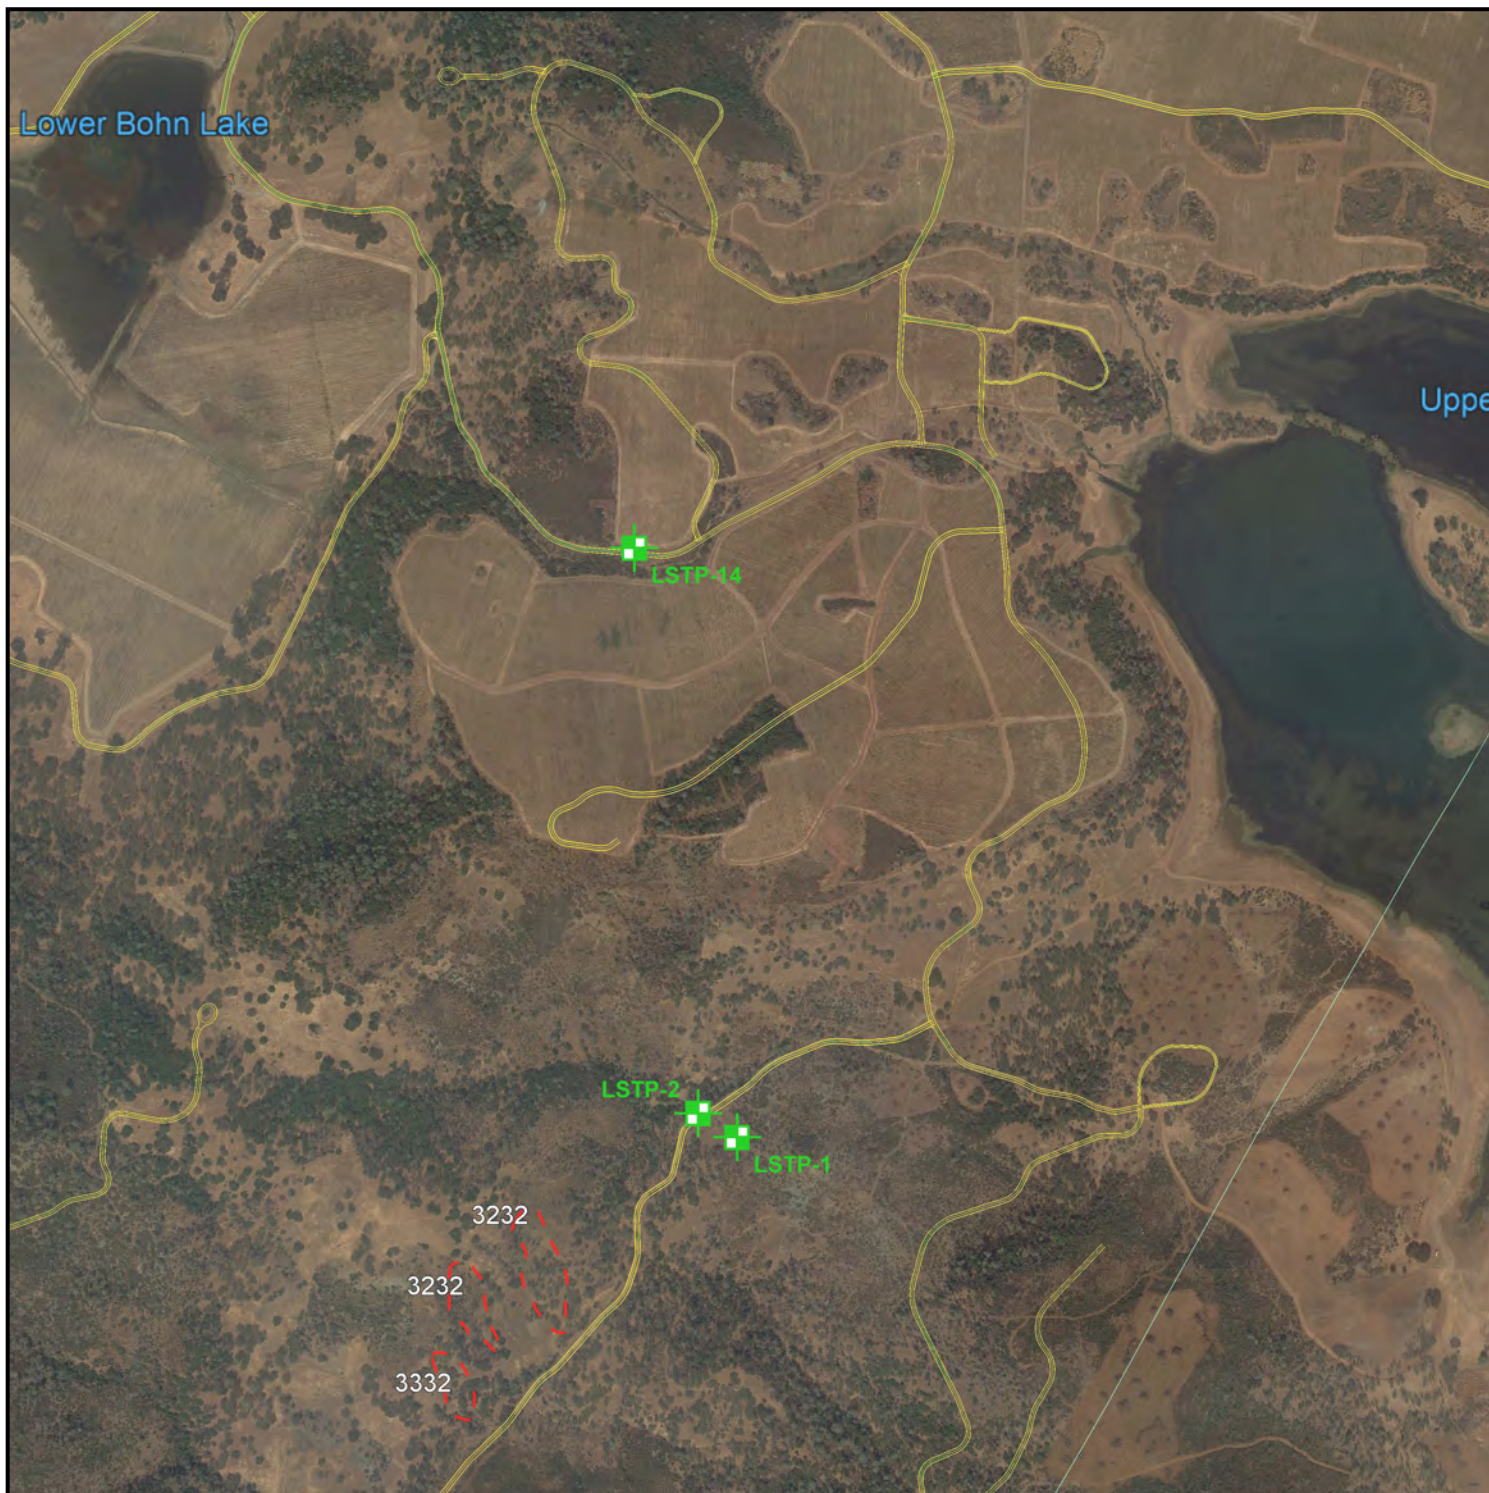
**4b**

# EXPLANATION

Landslide with Arrow Indicating Direction of Movement, Landslide Number Denotes Interpreted Type, Certainty, Thickness and State of Activity, Dashed where approximate (Explanation on Plate 5)

Published landslide maps (Dwyer, 1976) indicate many isolated areas of large-scale slope instability at the site. Presented on Plate 3 is our interpretation of the locations presented on Dwyer's map. Dwyer's "definite" and "probable" landslides primarily occur within areas mapped by Fox et al. (1973) as Franciscan Assemblage including metagraywacke, metagreenstone, metachert, and bodies of serpentine. We outlined these, as well as other areas with suspicious topographic features we observed using LiDAR, on the LiDAR overlay in Google Earth. Our engineering geologists then excavated test pits in several of the areas where planned roads crossed the mapped landslide areas and other suspicious areas based on our LiDAR review. In some cases, the rubbly surface outcrops and "float" (boulders carried downslope by gravity) prevented excavator access to these areas, such as on the northeastern flank of Goat Mountain. Based on our surface and subsurface observations we revised the landslide mapping. Where these physical areas were observed and revised by RGH, the landslide boundaries are considered approximate. We have not undertaken detailed studies of the individual landslide areas. The scope of this phase of investigation was to confirm or refute the presence of actual landslide debris in certain mapped and conspicuous locations that could directly affect road construction at the site. The revised features are presented on Plates 4A through 4E.
