**DRAFT PRELIMINARY GEOLOGICAL HAZARDS  
REVIEW OF PROPOSED COLTON COMMUNITY  
SOCCER PARK, SOUTH OF CONGRESS STREET,  
NORTHWEST OF SANTA RIVER, CITY OF COLTON,  
CALIFORNIA**

Project No. 12269.002

August 8, 2019

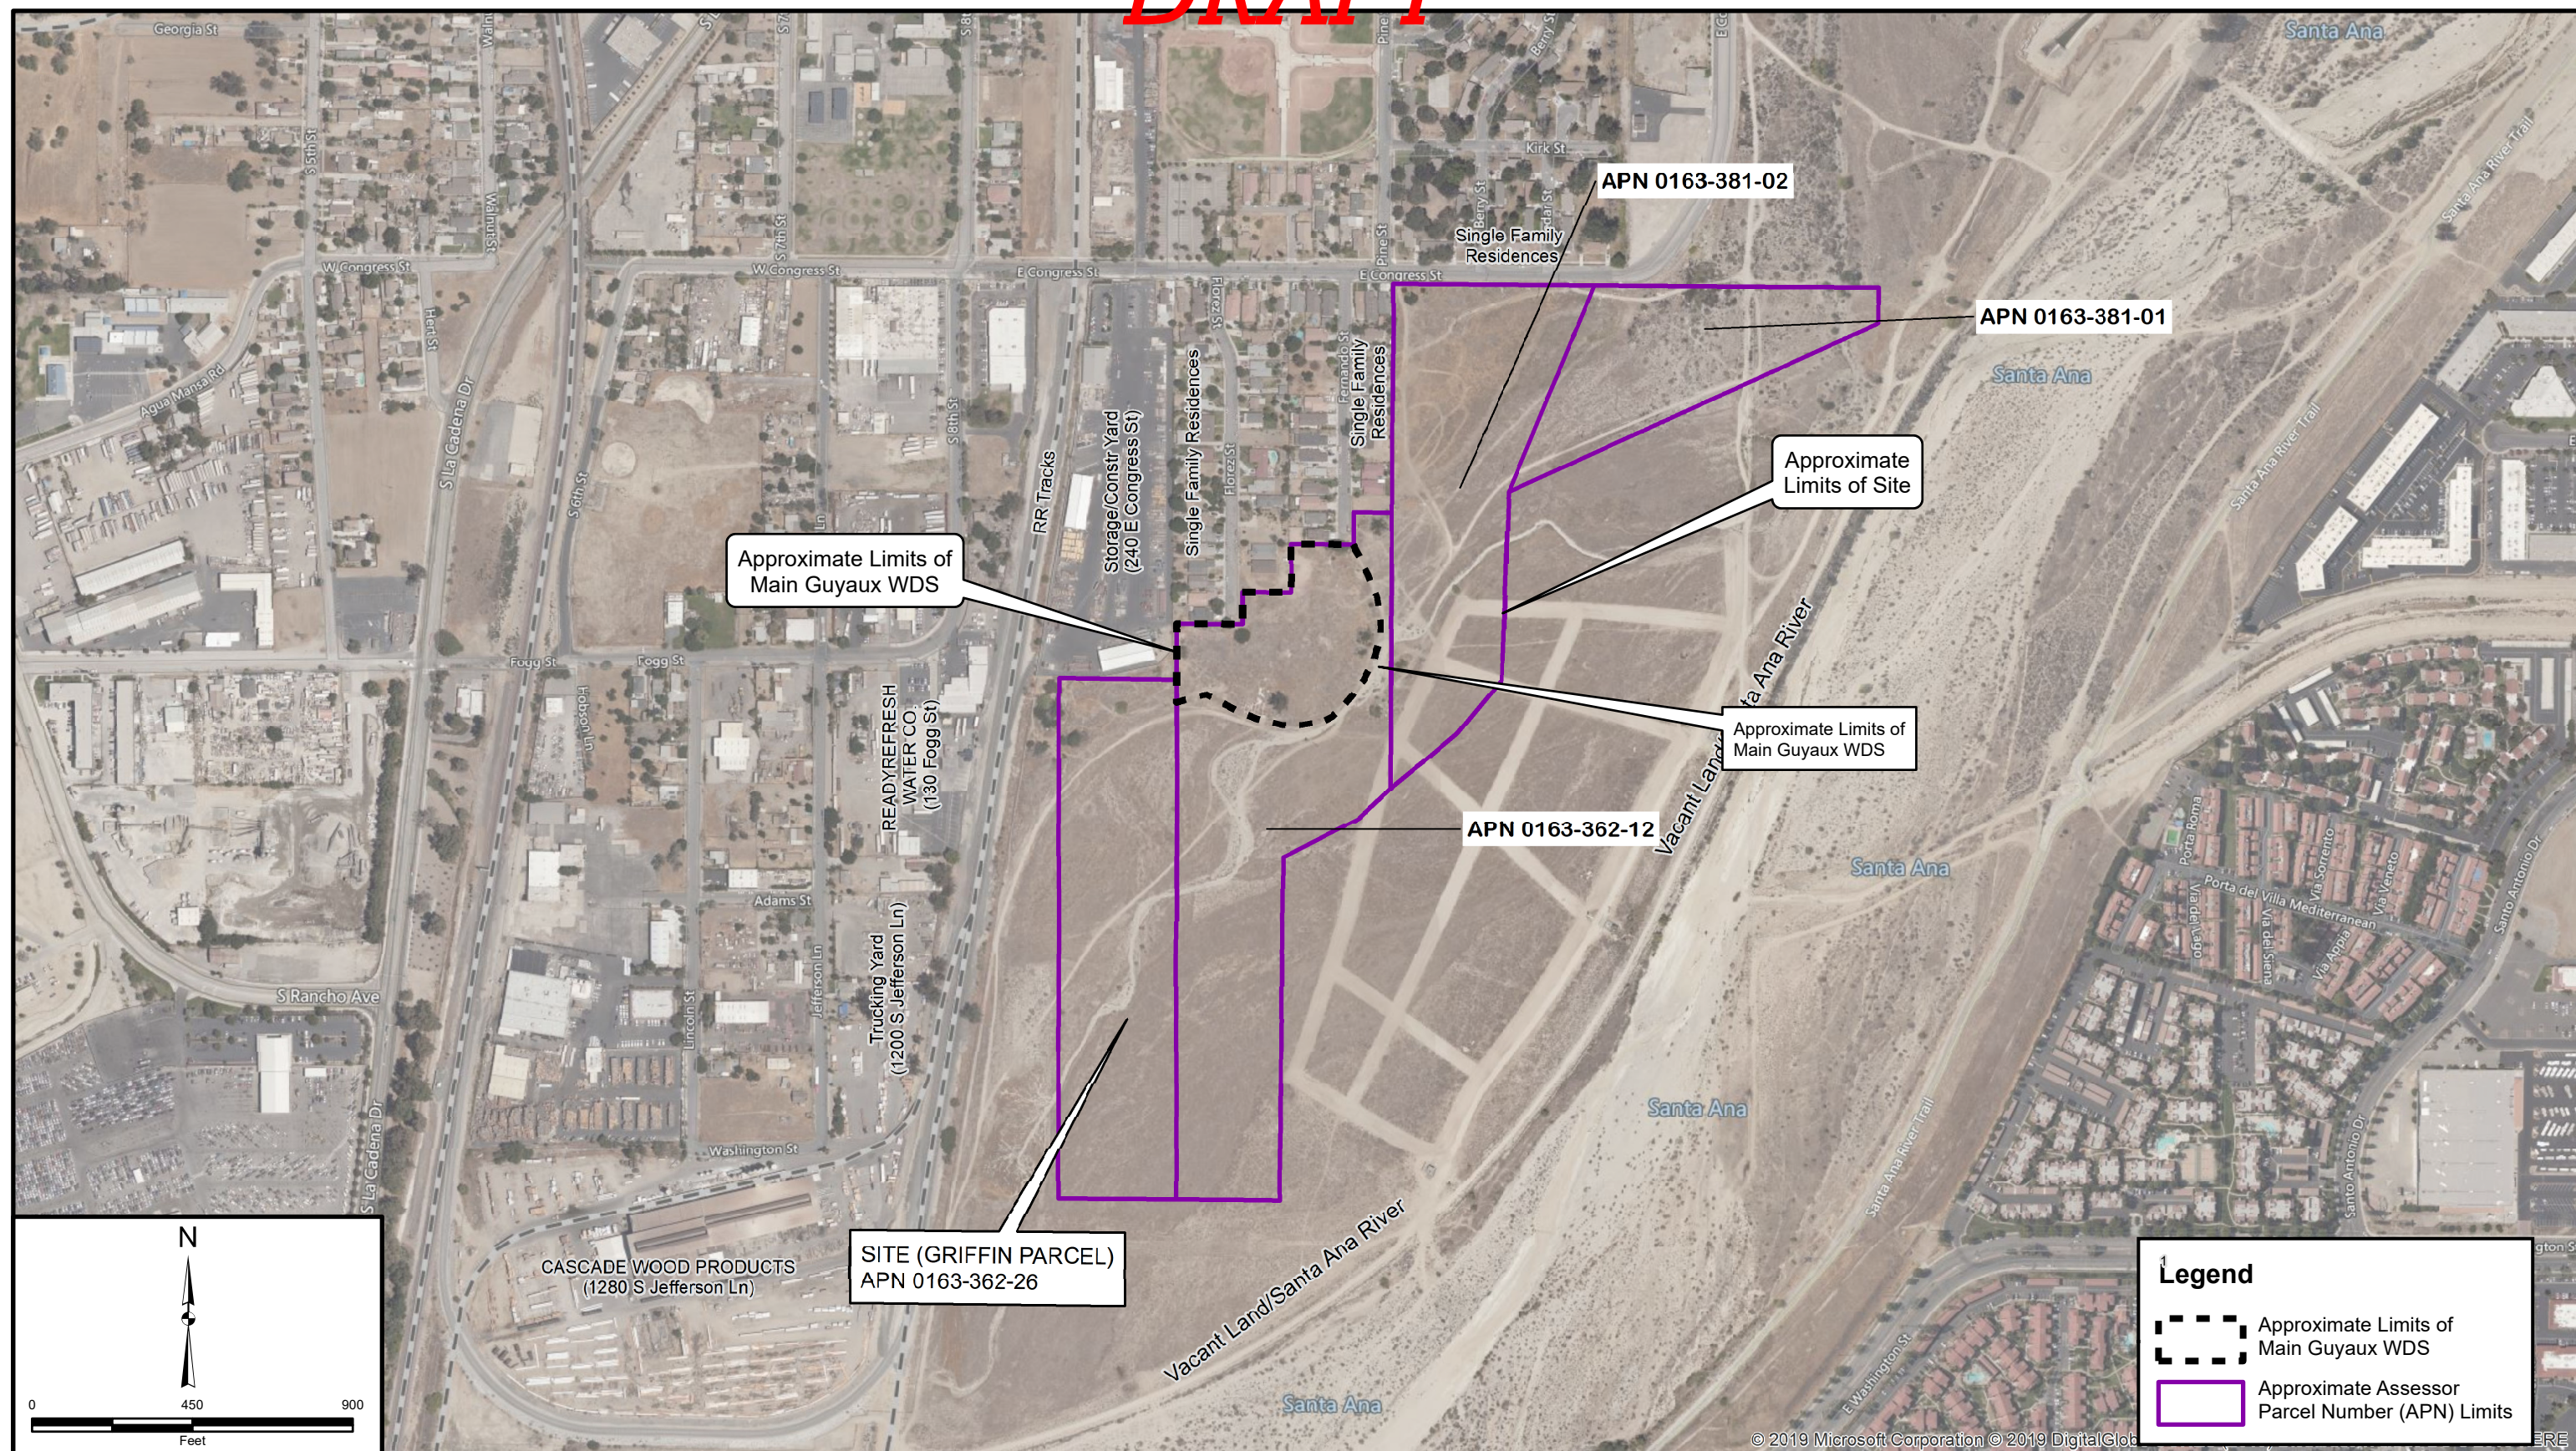
Figure 2

Project: 12269.001		Eng/Geol: RBH	
Scale: 1" = 450'		Date: August 2019	
Base Map: ESRI ArcGIS Online 2019 Thematic Information: Leighton Author: (kman)

## SITE MAP

An approximately 4- to 6-acre portion of the proposed park property located at the southern terminus of Florez and Fernando Streets contains an unlined waste disposal site referred to as the Guyaux Landfill (see Figure 2). The landfill has historically been used for waste disposal of construction debris, such as used brick, concrete, iron waste (slag), plaster molds, rubber, steel, wood, and other deleterious materials. Aerial photographs suggest this landfill use began around the year 1967 with minor apparent activity through 2005. The master plan for the proposed Colton Soccer Park indicates a parking lot proposed over the landfill area.
