# **EXHIBIT I LEACHLINE PERCOLATION TEST**

## ALTEC ENGINEERING CORP.

# LEACHLINE PERCOLATION TEST A PORTION OF APN 0472-131-17

PROPOSED MANUFACTURING SITE LOCATED ON THE WEST SIDE OF NATIONAL TRIALS HIGHWAY SOUTH

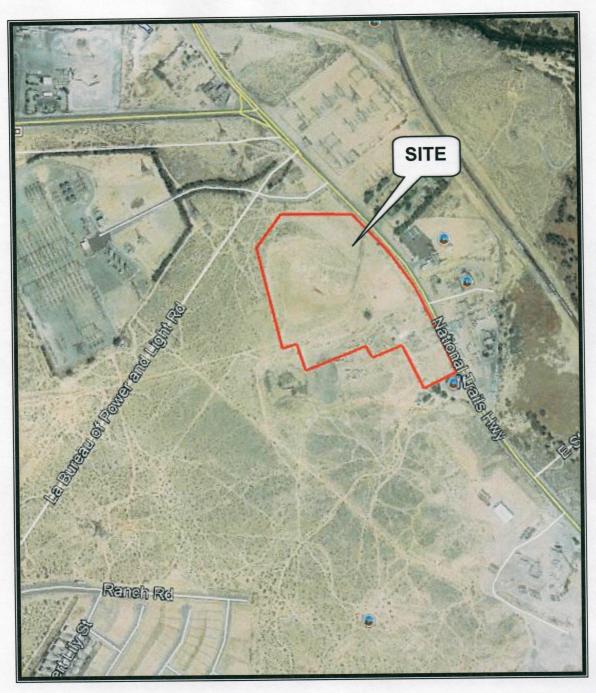
DRAWING 5

AERIAL PHOTOGRAPH - AUGUST, 2018

- Manufacturing Facility with portable office building.
- b) 1 Lot, ±14.1 gross acres. Area covered by this report covers approximately 0.50 acres (Drawing #5).
- c) Septic tank and leachline systems.
- d) No grading for the building pad has been completed. It is anticipated that there will be cuts and fills of up to less than 2 feet.

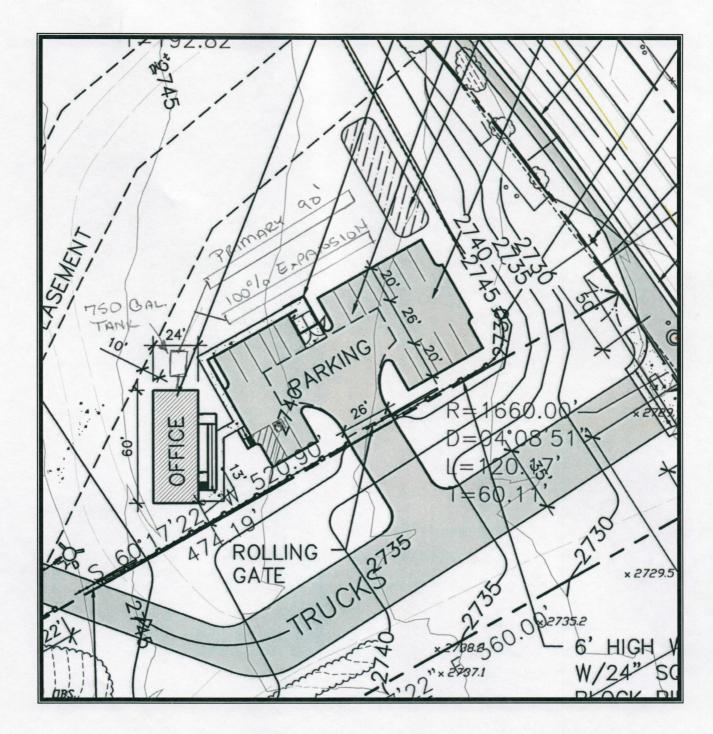
DRAWING 12

SYSTEM LAYOUT
