Notice of Exemption

Project Title: Ross Reservoir Landslide Repair Project

Project Description: The proposed Ross Reservoir Landslide Repair Project involves stabilization of an active slide downslope from the existing Ross Reservoir. The landslide stabilization requires removal of trees and vegetation in the landslide repair area, construction of two tie-ins to the existing 24-inch outlet pipe installation of benches cut into the bedrock, installation of a drainage system within the slide stabilization area, construction of a slope buttress, revegetation of the slide area, relocation of a water transmission line, and construction of a new access road and access improvements. The full project description and avoidance measures are included as Appendix A of this Notice of Exemption. Additional information on the project is provided in Appendix B of this Notice of Exemption. As an initial step in furtherance of the Ross Reservoir Landslide Repair Project, the District has approved the removal of trees and vegetation obstructing the landslide repair area.

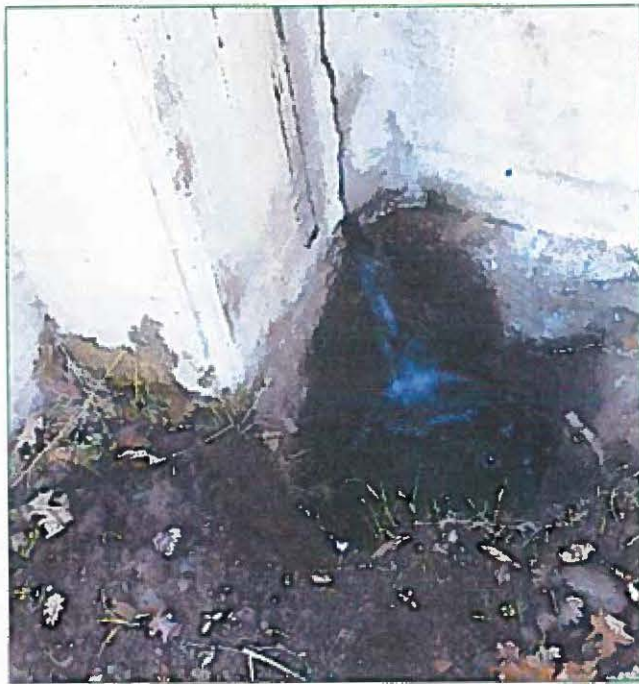
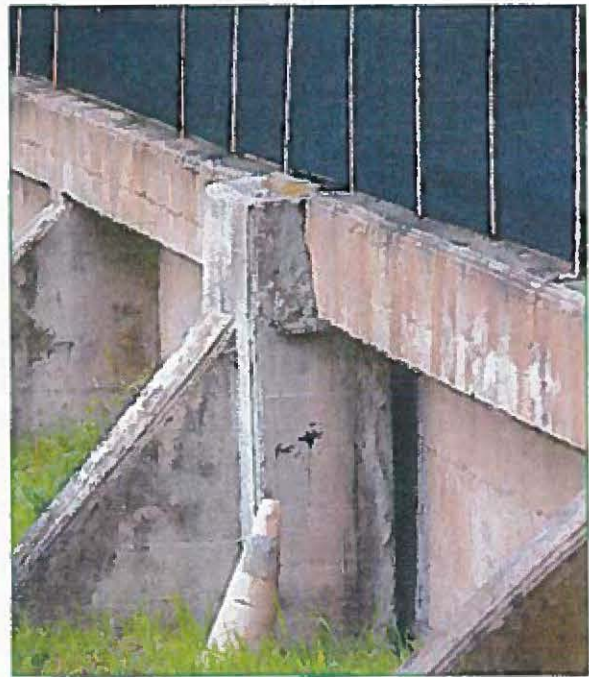
Figure 3 Damage to Reservoir Foundation in 2017 and 2019

2017

2019

The landslide became active again during the rainy season of 2017. District staff covered the top portion of the landslide near the reservoir using plastic tarps to prevent further saturation and movement of the landslide. Movement of the slide was also thought to be exacerbated by leaks from the system piping associated with Ross Reservoir, which were increasing hydrostatic pressures in the soils and causing additional slippage in the landslide. A leak was observed from a 12-inch cast iron pipe outlet (see Figure 3). The valve to the 12-inch pipe (Valve VA-0420A) was shut off to cease flows to the pipe and the pipe has been put out of service. Water services were re-routed using existing, redundant pipelines near Lagunitas Road. To further reduce potential for leaks around the reservoir, MMWD staff also lowered the reservoir water level. Restricting flows from the 12-inch pipe and lowering the reservoir levels appeared to have reduced some of the moisture in the slide that was previously visible during the dry season. During biological surveys in August 2019, however, moisture and a seep were still seen in the slide.
