Geotechnologies, Inc.

File No. 21648

Subject: Preliminary Geotechnical Assessment
Proposed Mixed-Use Development
1330 West Pico Boulevard, Los Angeles, California

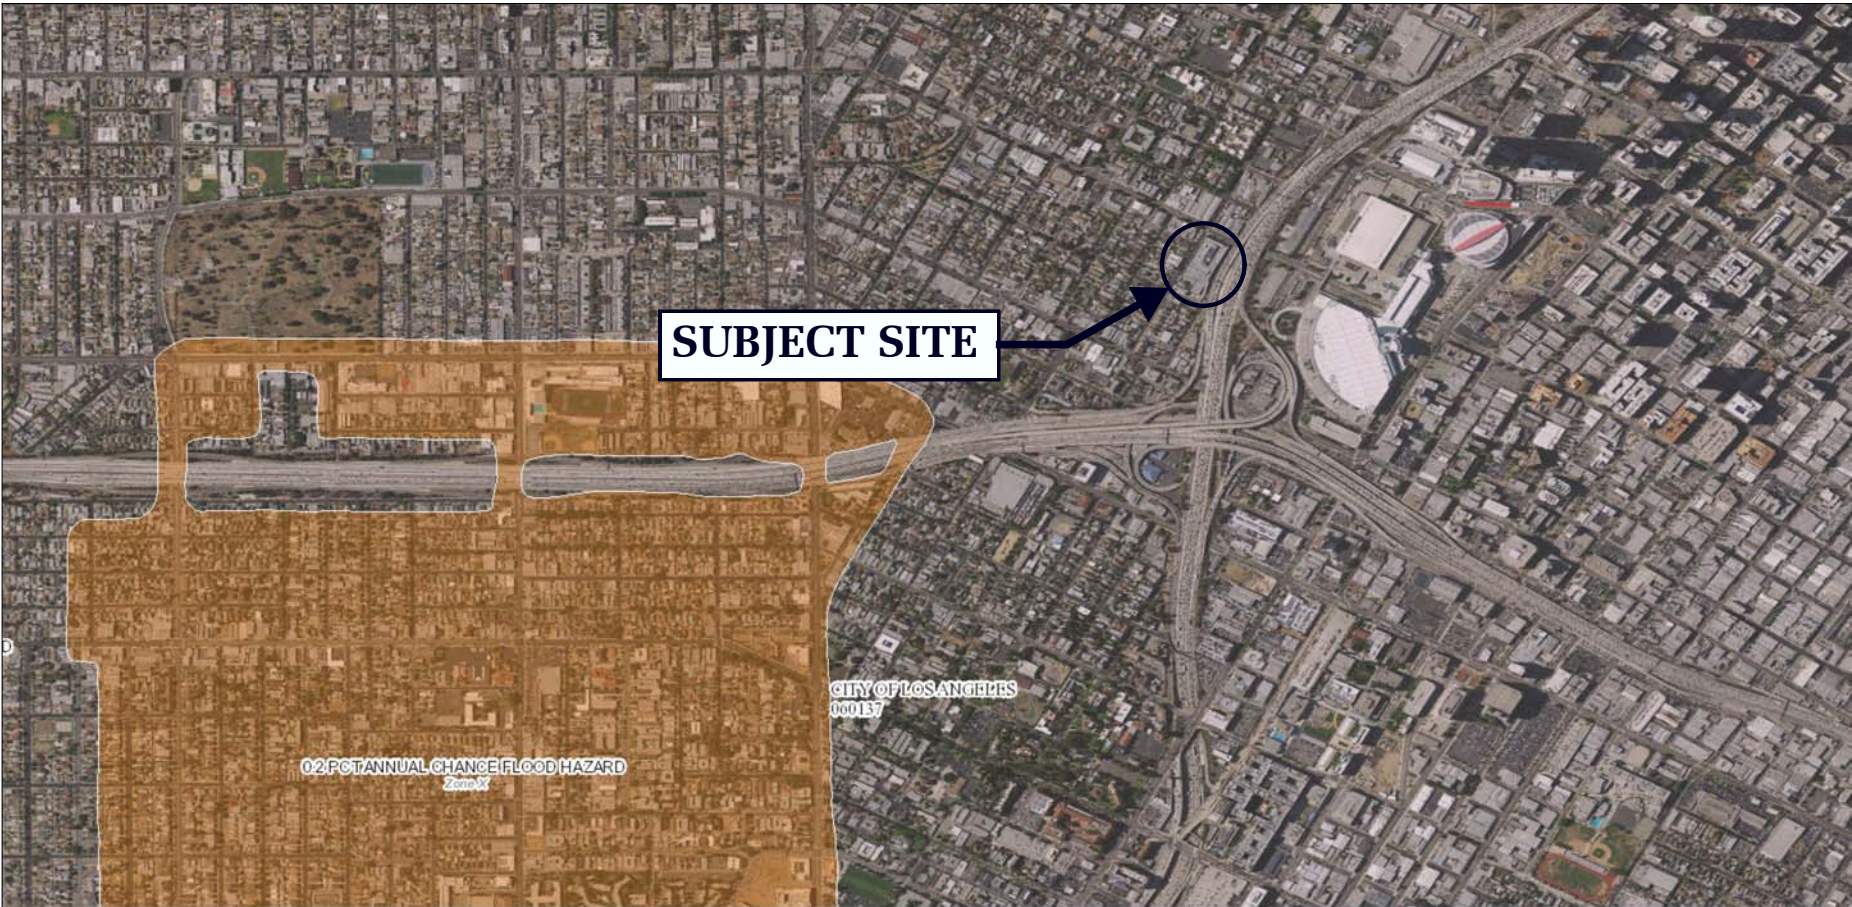
NATIONAL FLOOD INSURANCE PROGRAM
FLOOD INSURANCE RATE MAP

FLOOD HAZARD INFORMATION

LOS ANGELES COUNTY
TRIUNFO CREEK PMR
CALIFORNIA
AND INCORPORATED AREAS
PANEL 1620 OF 2204
